FINAL
RADIOLOGICAL CHARACTERIZATION OF SOILS
AREA IV AND THE NORTHERN BUFFER ZONE

AREA IV RADIOLOGICAL STUDY
SANTA SUSANA FIELD LABORATORY
VENTURA COUNTY, CALIFORNIA

HydroGeoLogic, Inc.
5023 North Parkway Calabasas
Calabasas, California 91302

December 21, 2012

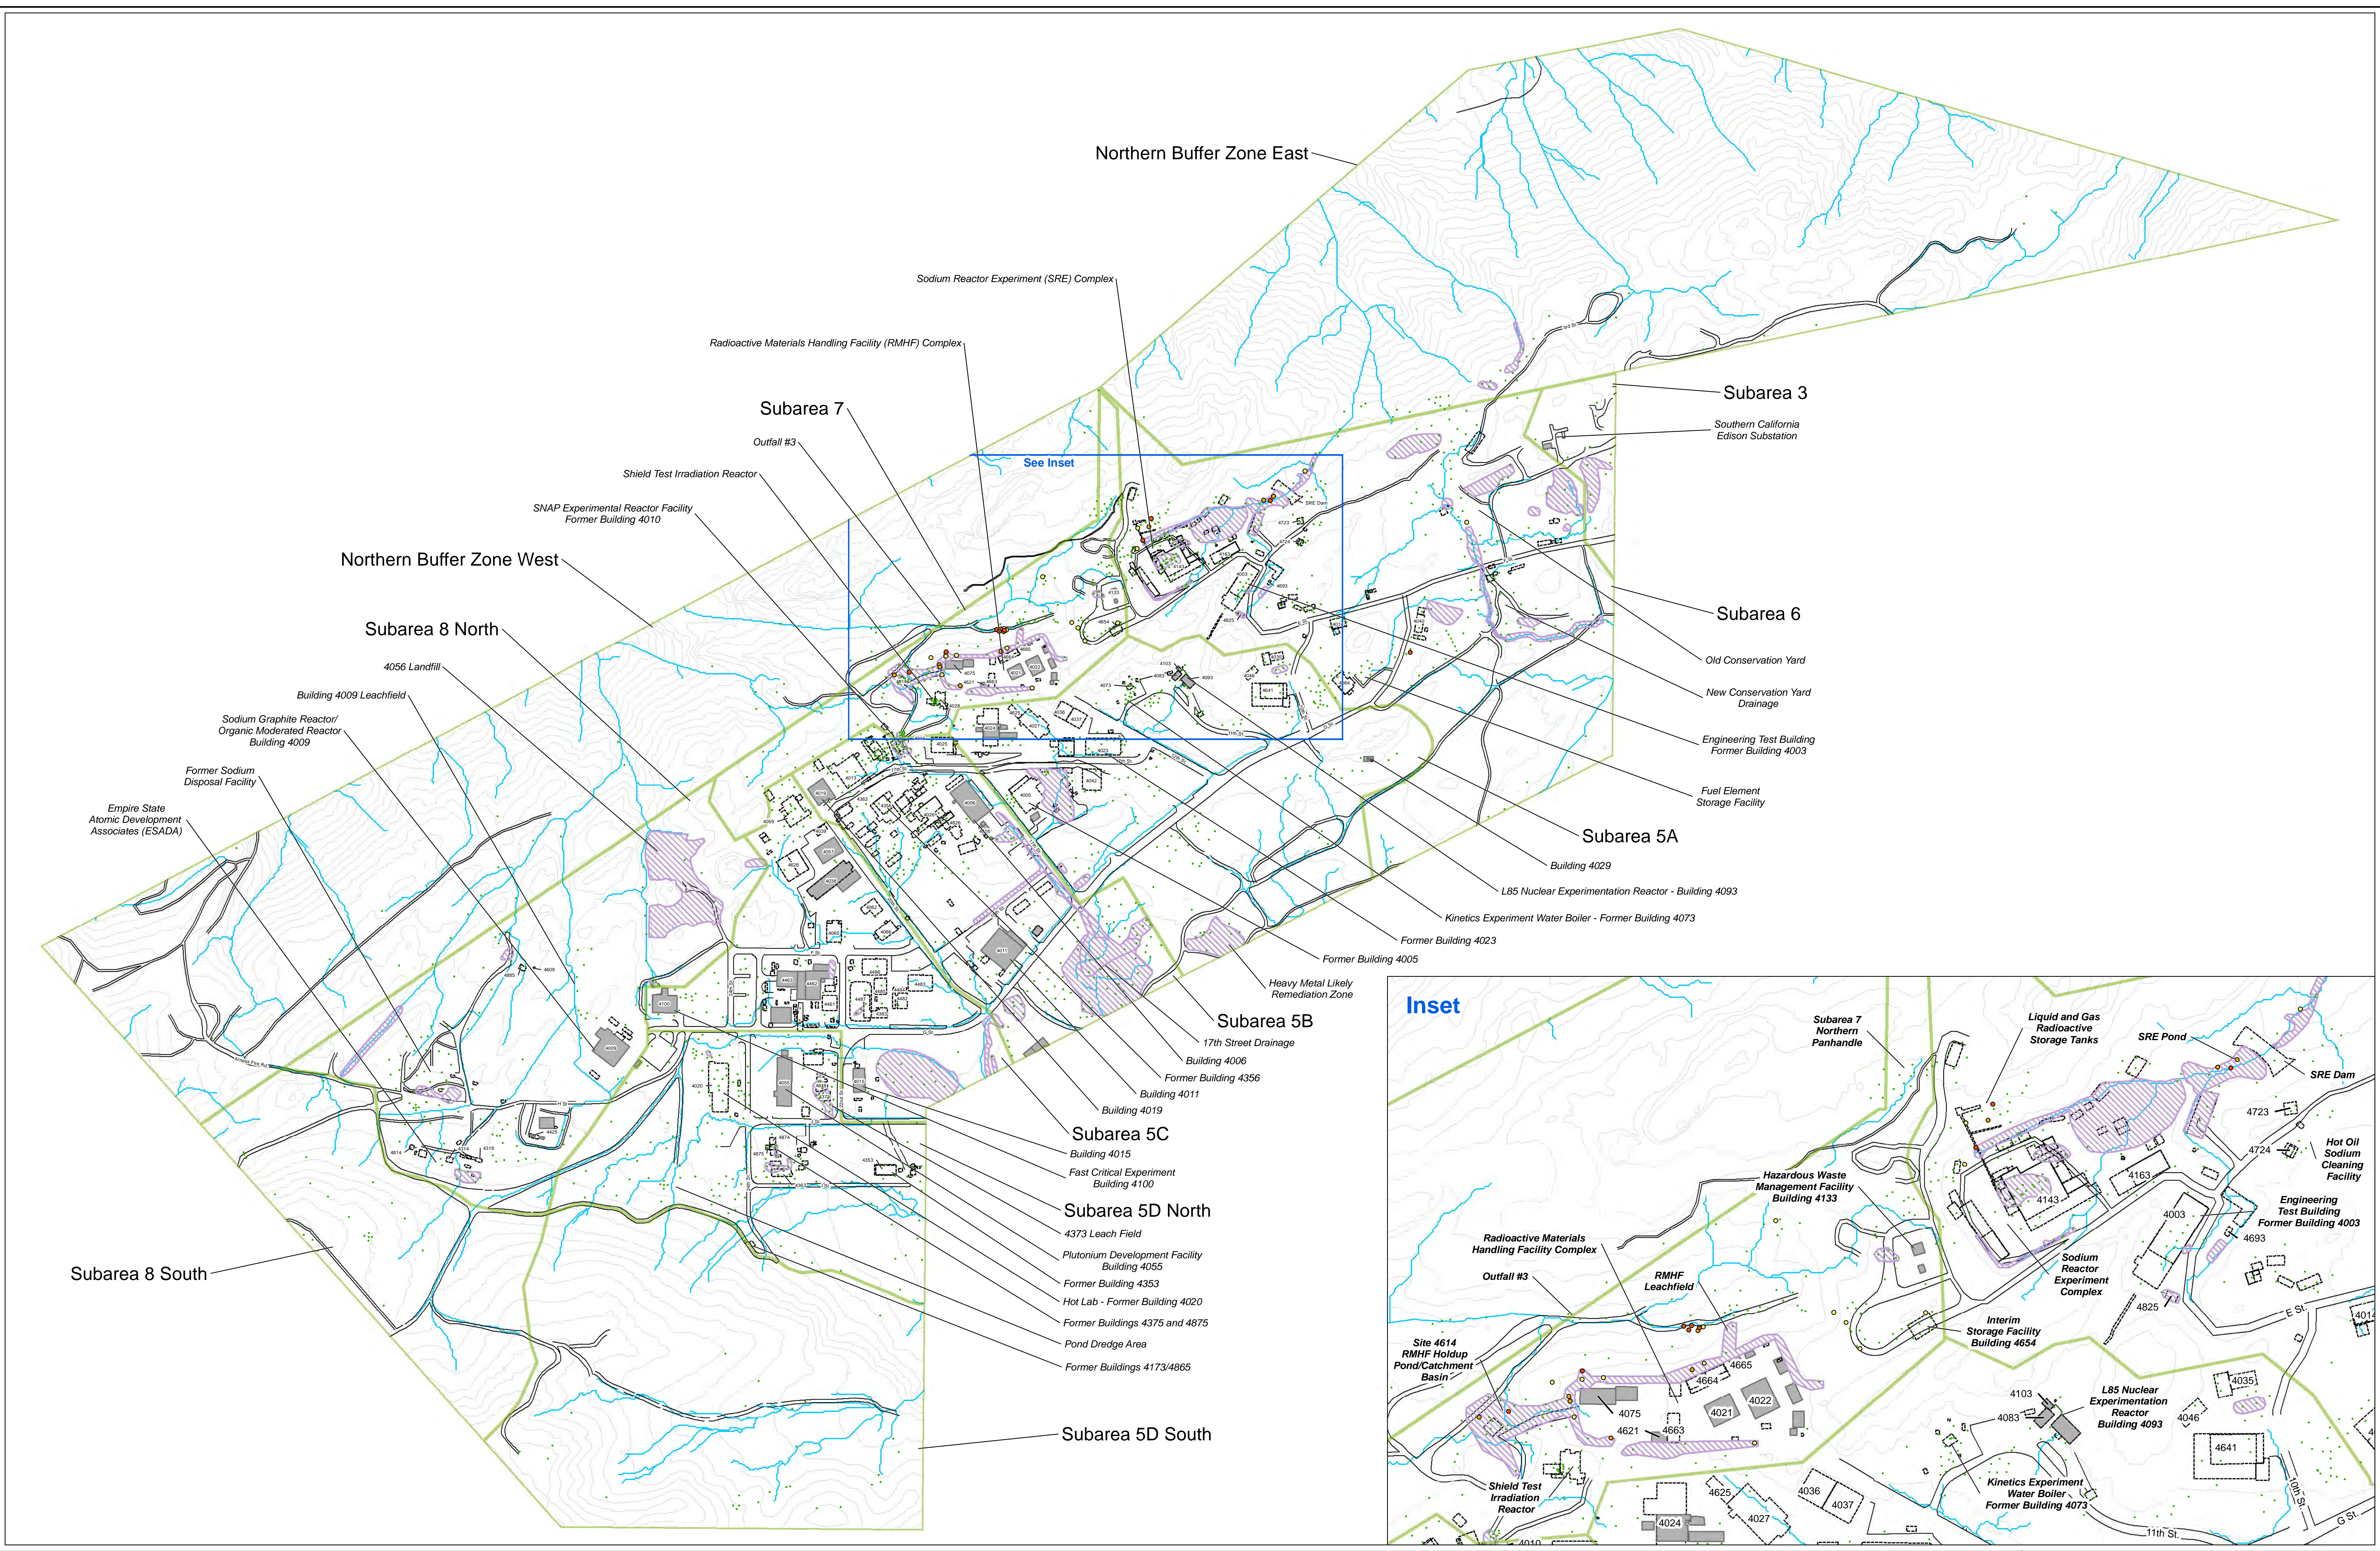
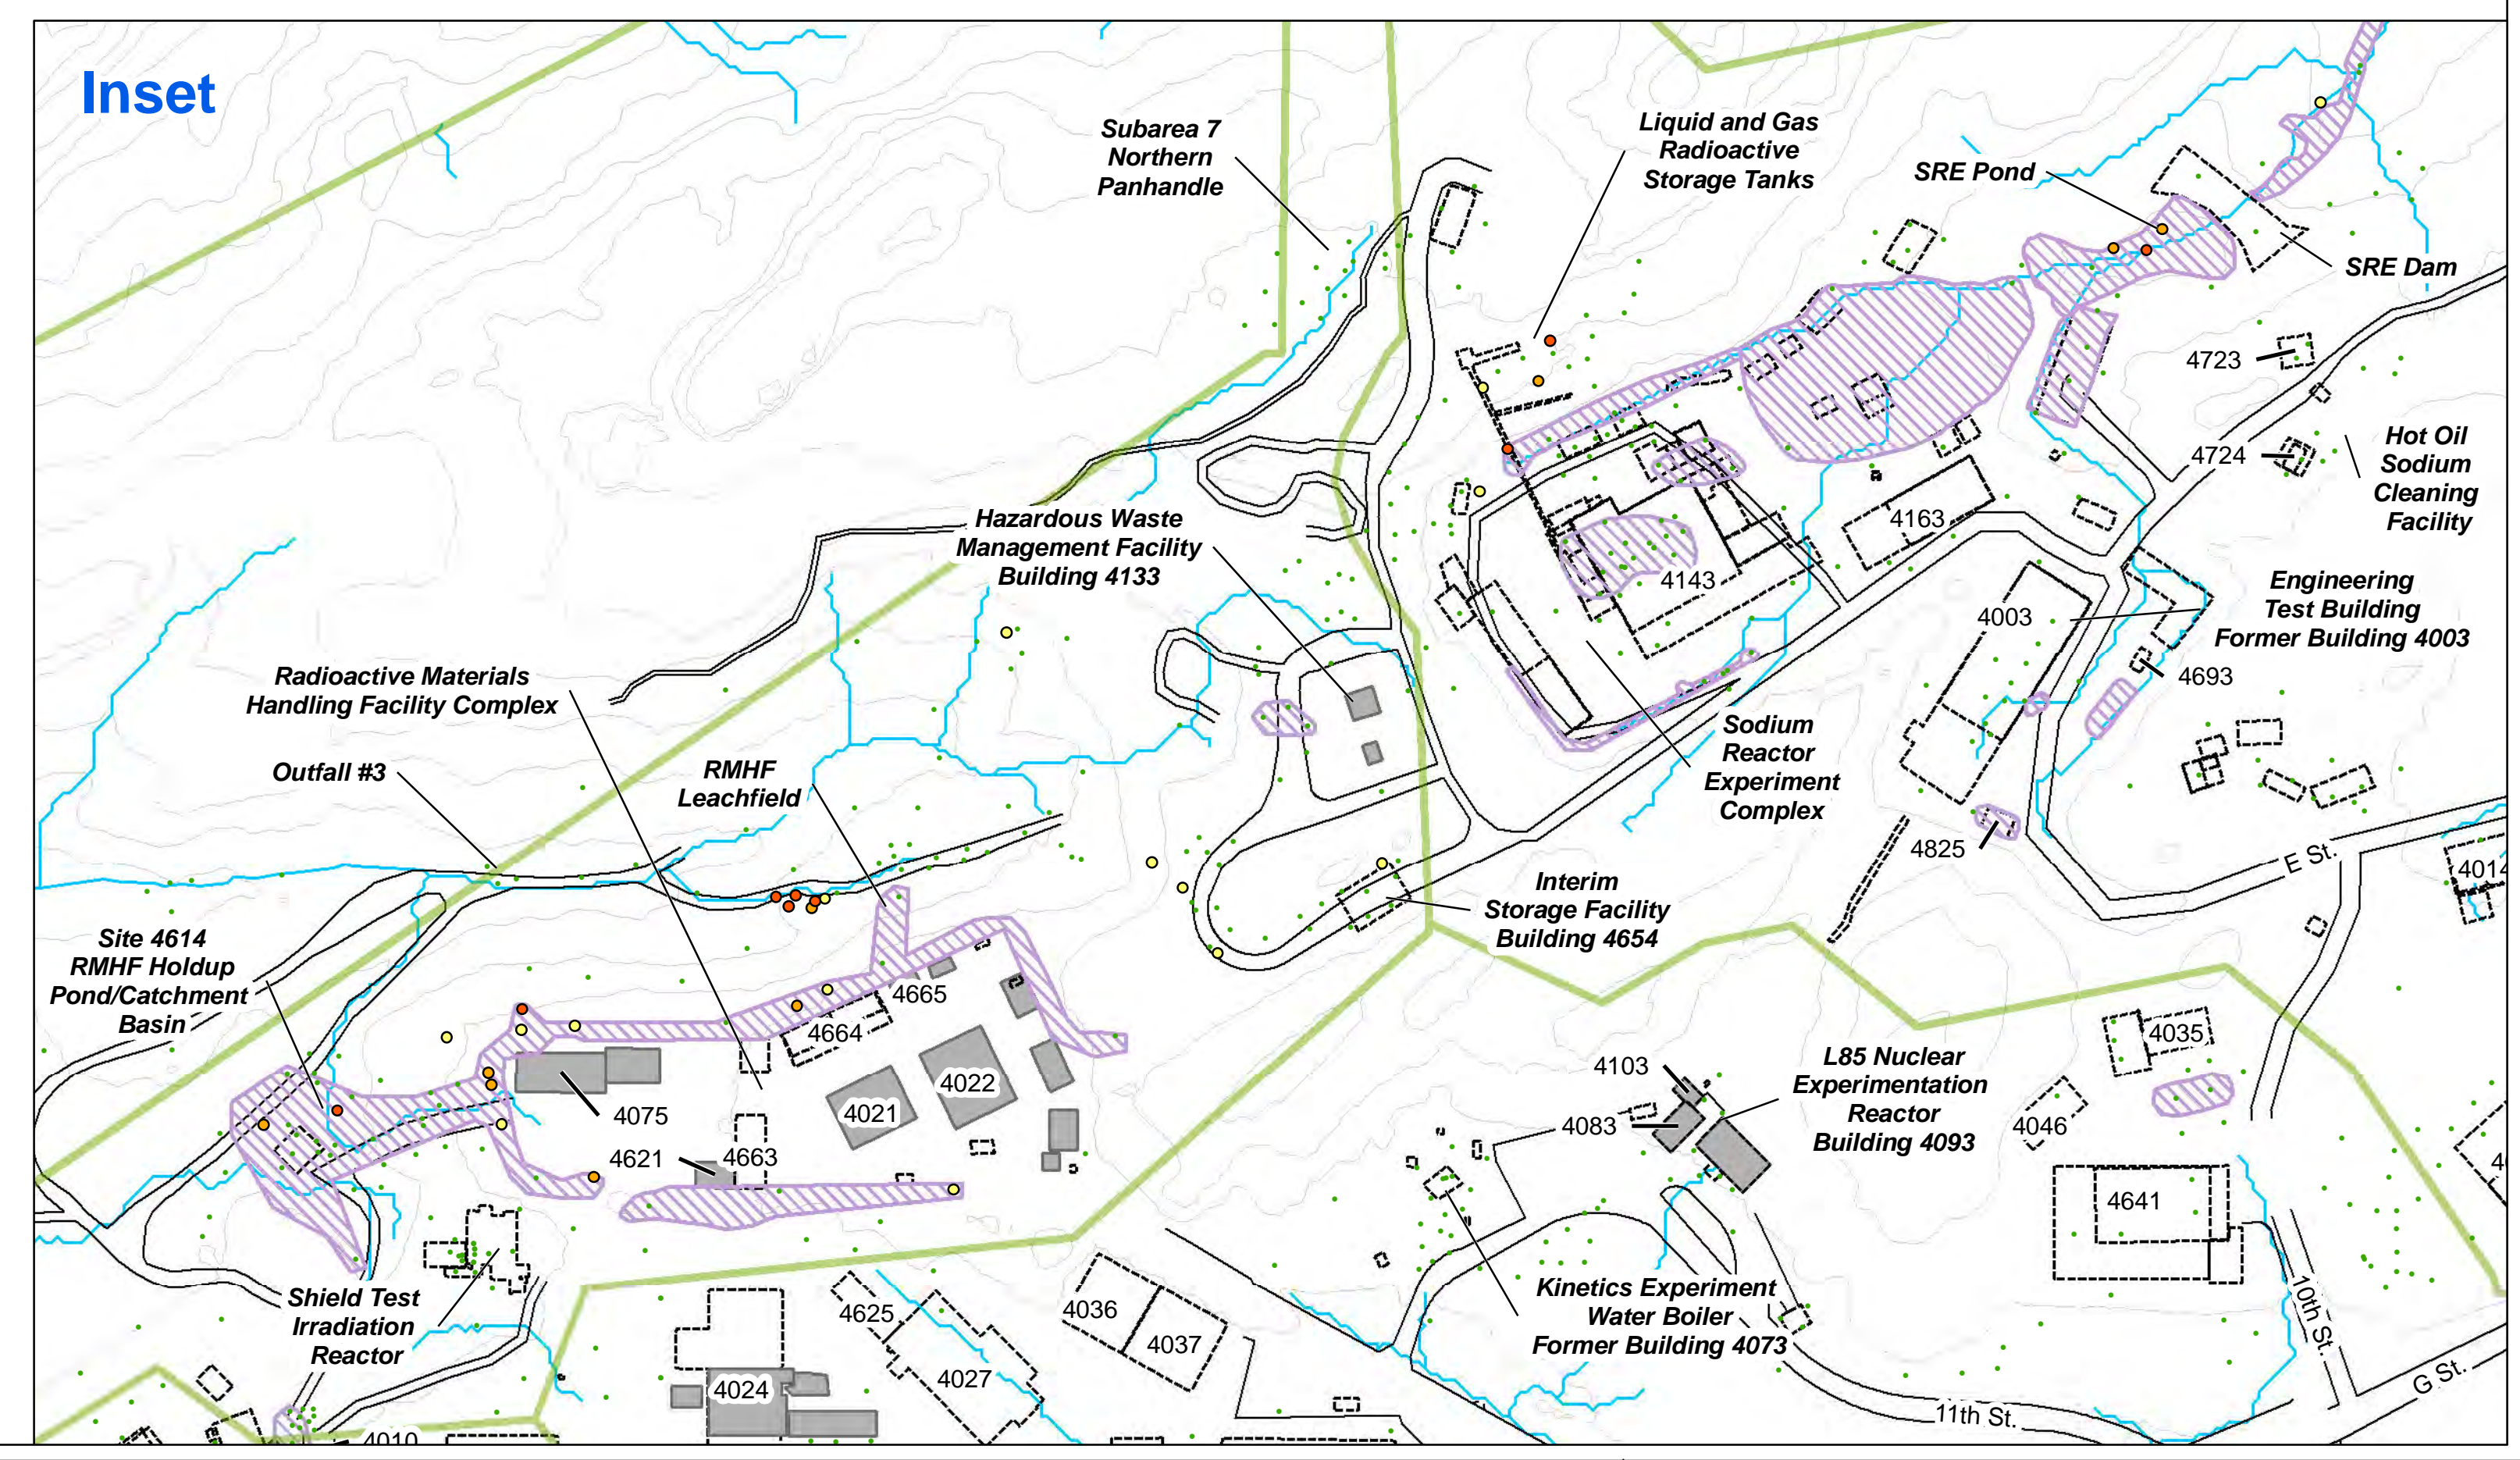
Figure 4.2
Cesium-137
Round 1 and 2 Subsurface Soil
and Sediment Results
Santa Susana Field Laboratory
Area IV and NBZ Radiological Study

Cesium-137 (FAL = 0.193)

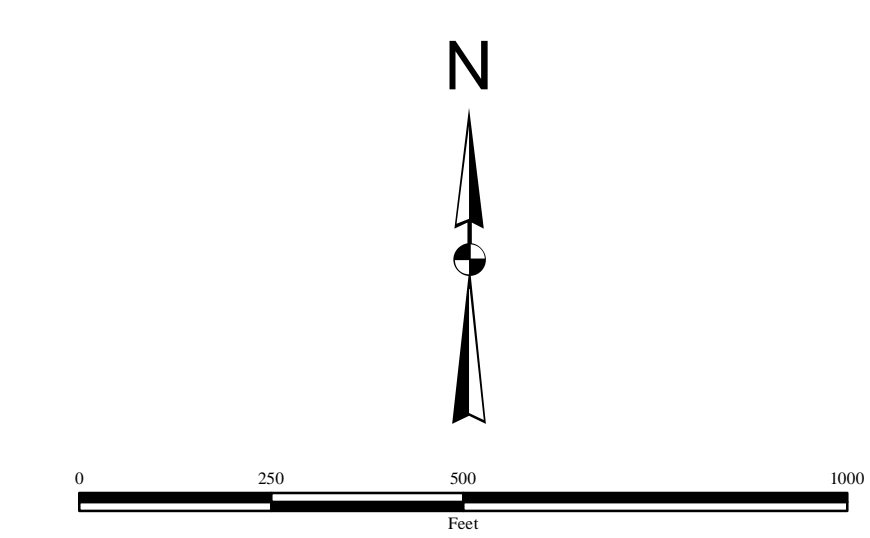
With the exception of Subarea 3, Cs-137 was detected in every subarea and the NBZ. These concentrations are presented by subarea (surface and subsurface) in Tables 4.2 and 4.3 and are illustrated on Figures 4.1 and 4.2. Details pertaining to each subarea regarding the distribution of Cs-137 are provided in the following subsections.

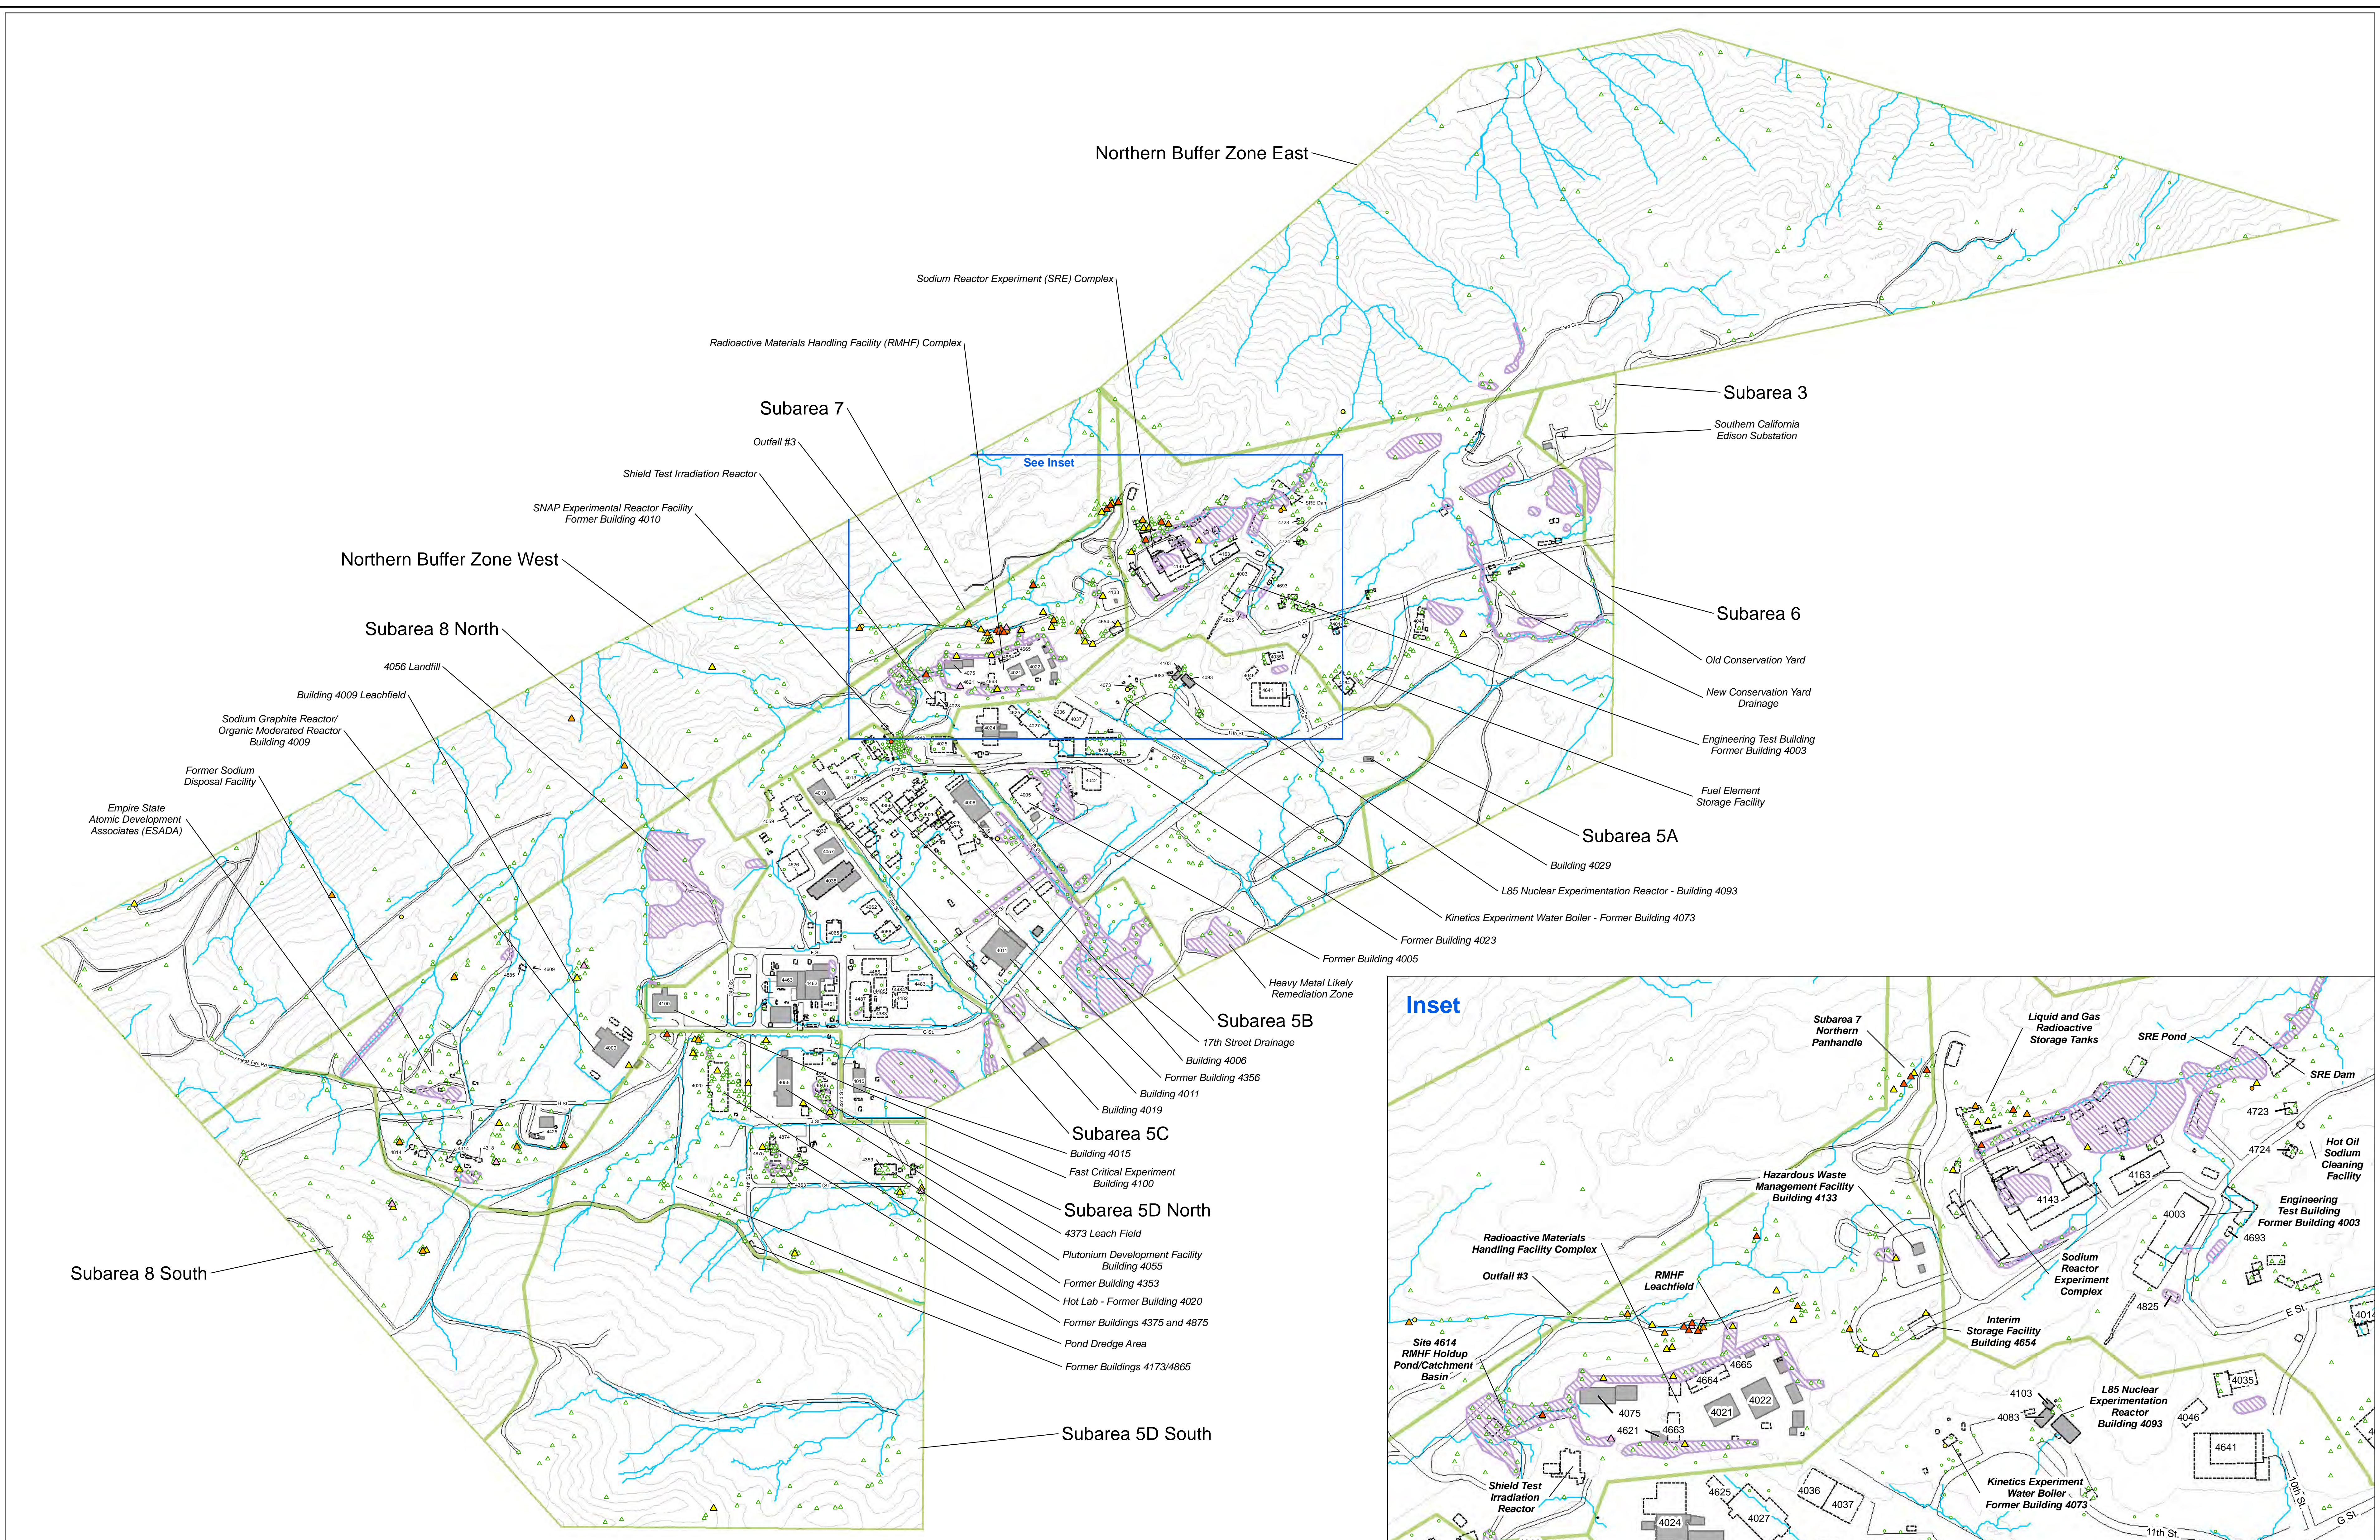
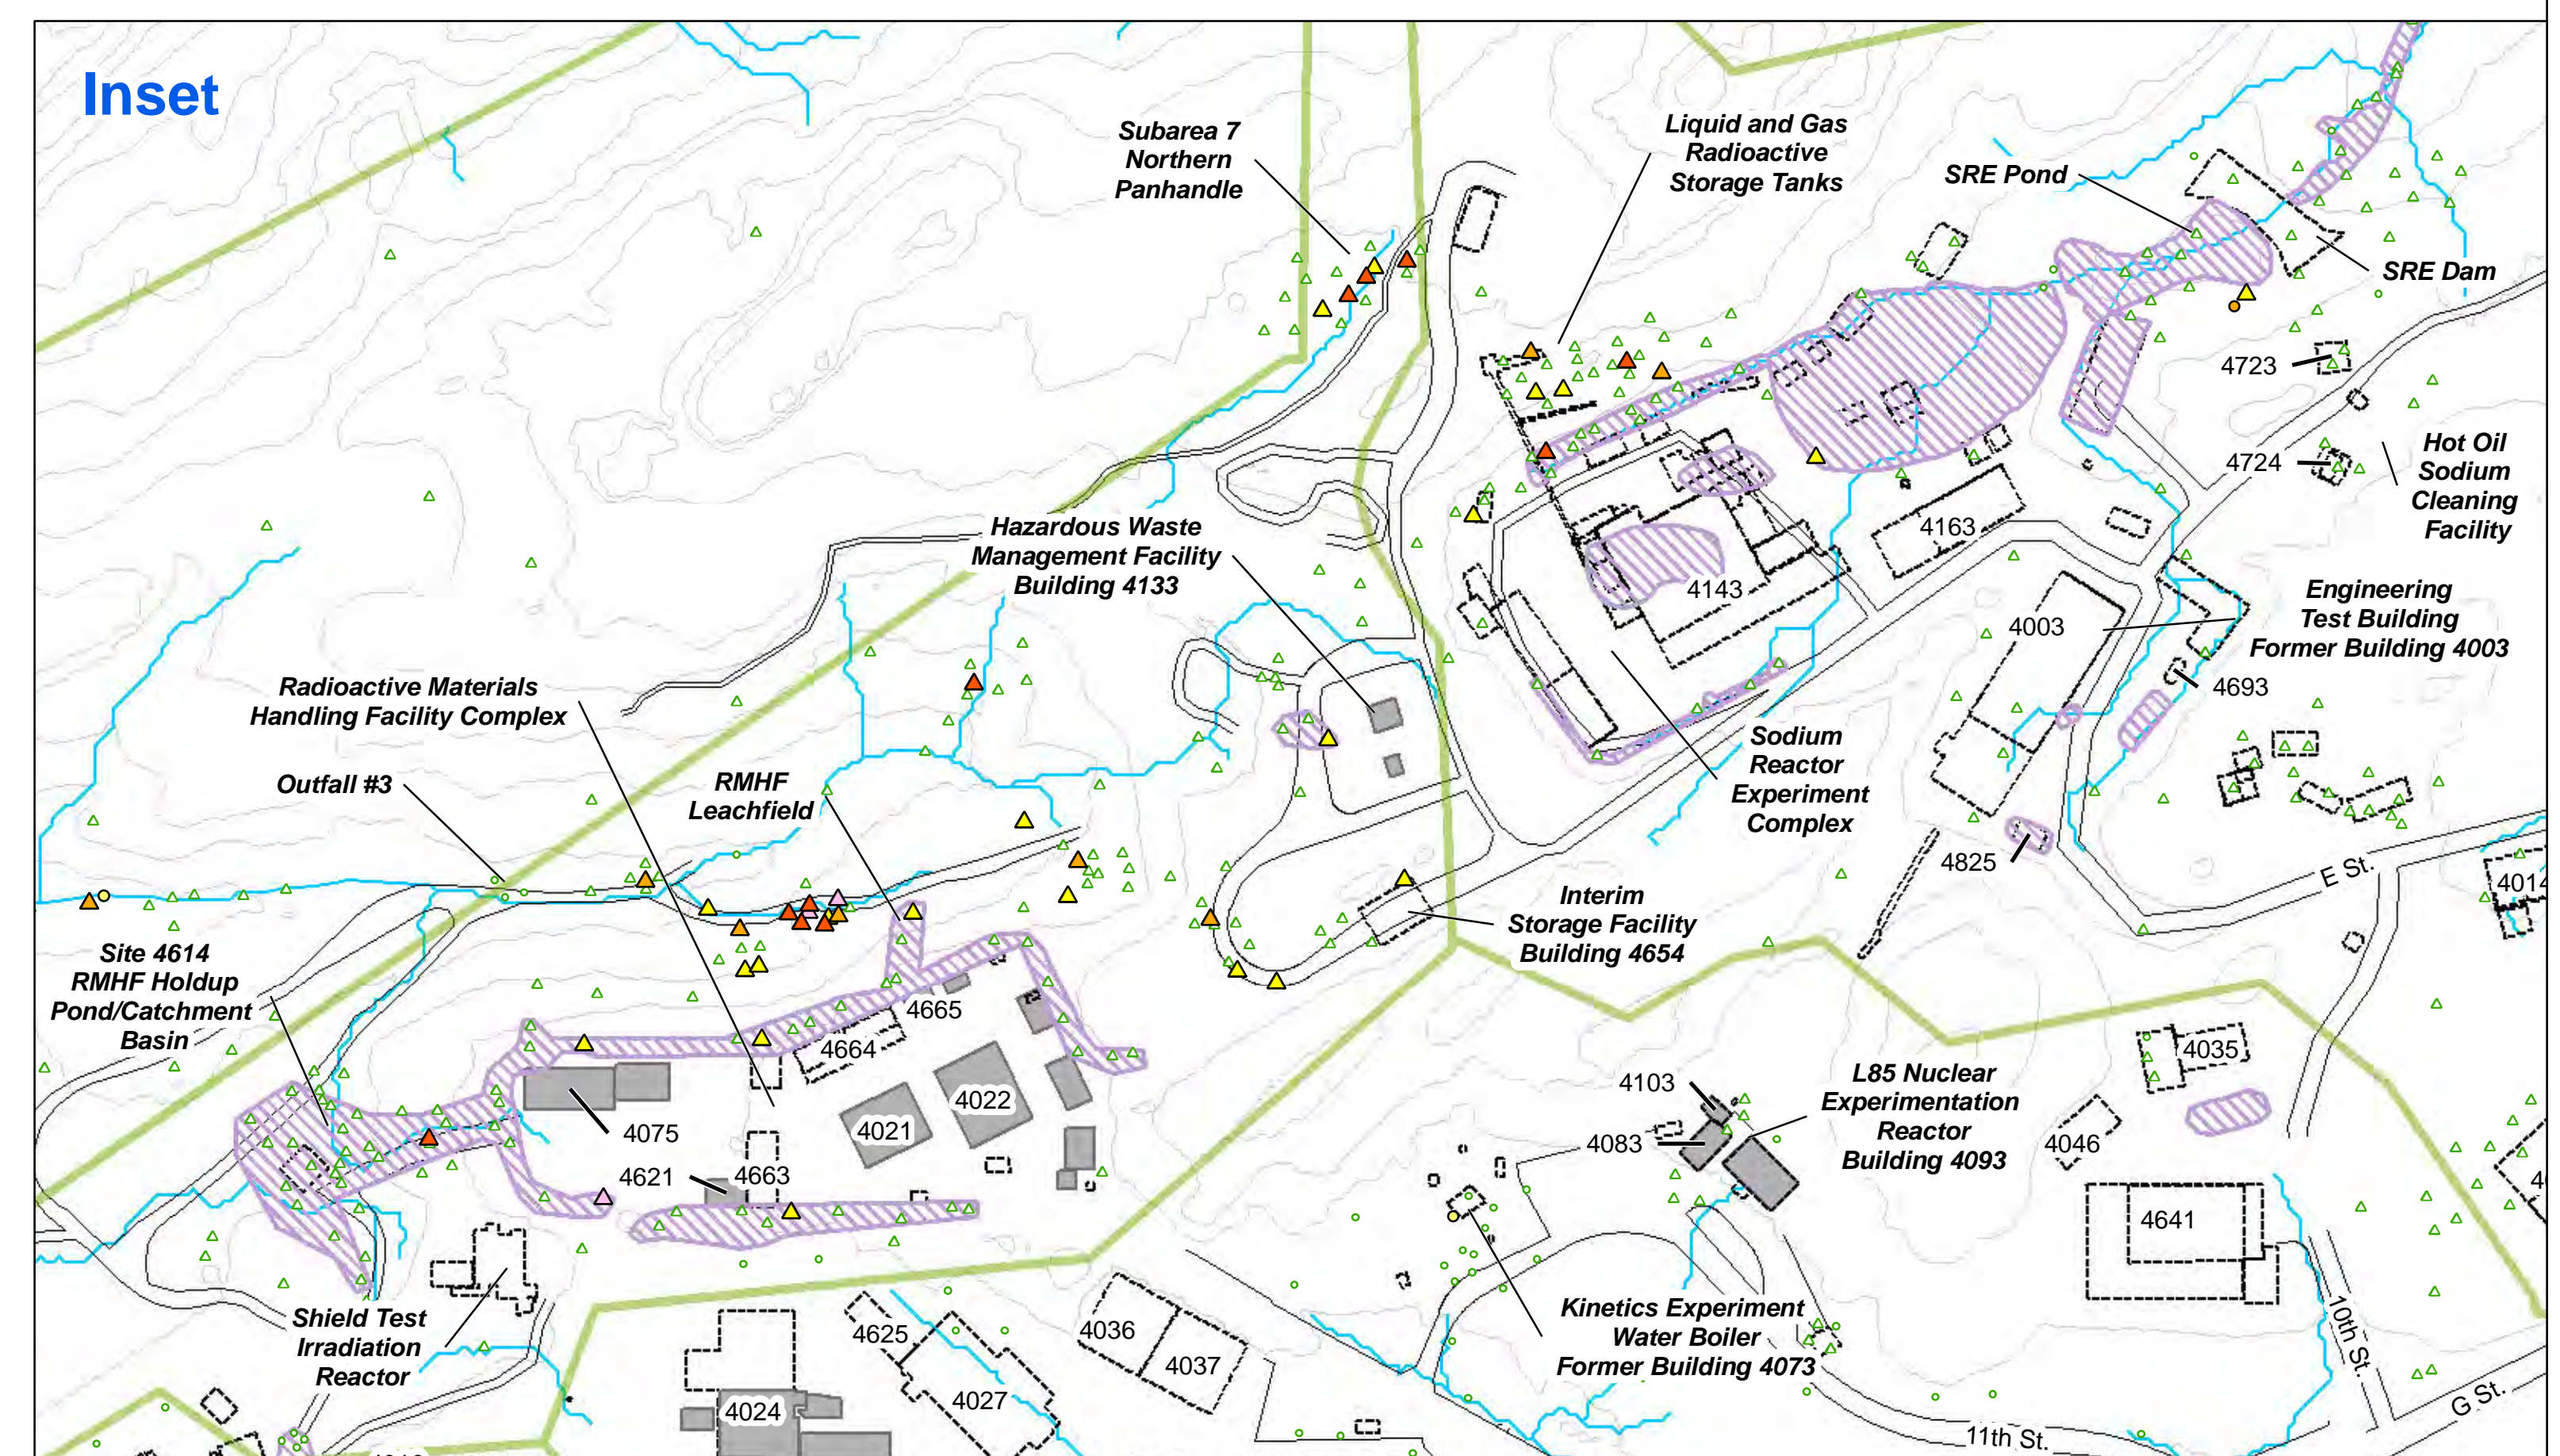
Figure 4.3
Strontium-90
Round 1 and 2 Surface Soil
and Sediment Results
Santa Susana Field Laboratory
Area IV and NBZ Radiological Study

Strontium-90	GEL (FAL = 0.387)	TAL (FAL = 0.0750)
Below FAL	△ (Below 0.387 pCi/g)	○ (Below 0.0750 pCi/g)
FAL to less than 2 times FAL	▲ (0.387 to 0.773 pCi/g)	● (0.0750 to 0.149 pCi/g)
2 times to less than 3 times FAL	▲▲ (0.774 to 1.15 pCi/g)	●● (0.149 to 0.224 pCi/g)
3 times to less than 4 times FAL	▲▲▲ (1.16 to 1.54 pCi/g)	○● (0.225 to 0.299 pCi/g)
Greater than 4 times FAL	▲▲▲▲ (1.55 to 21.3 pCi/g)	●●● (0.300 to 0.563 pCi/g)

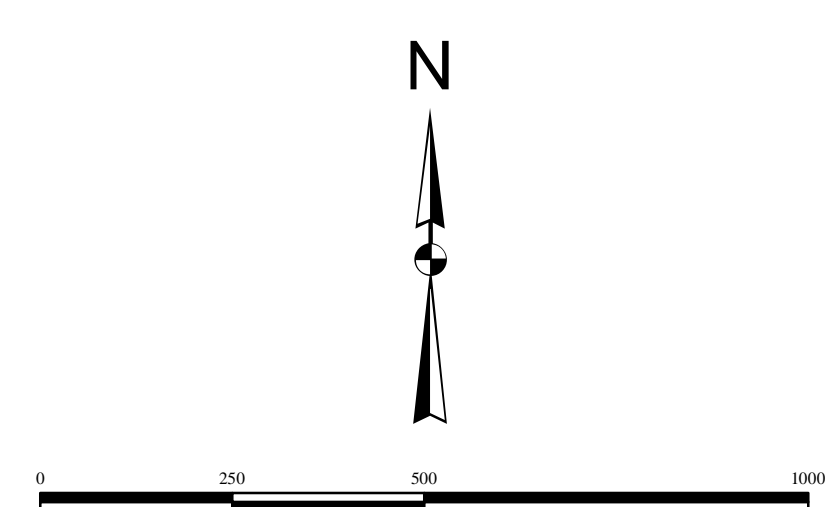
Strontium-90 was detected in 153 soil samples at concentrations above the FALs, ranging from 0.01 to 21.3 pCi/g. Strontium-90 was detected throughout the entire Area IV Study Area. These concentrations are presented by subarea (surface and subsurface) in Tables 4.2 and 4.3 and are illustrated on Figures 4.3 and 4.4. Details pertaining to each subarea regarding the distribution of Sr-90 are provided in the following subsections.
