FINAL
RADIOLOGICAL CHARACTERIZATION OF SOILS
AREA IV AND THE NORTHERN BUFFER ZONE

AREA IV RADIOLOGICAL STUDY
SANTA SUSANA FIELD LABORATORY
VENTURA COUNTY, CALIFORNIA

HydroGeoLogic, Inc.
5023 North Parkway Calabasas
Calabasas, California 91302

December 21, 2012

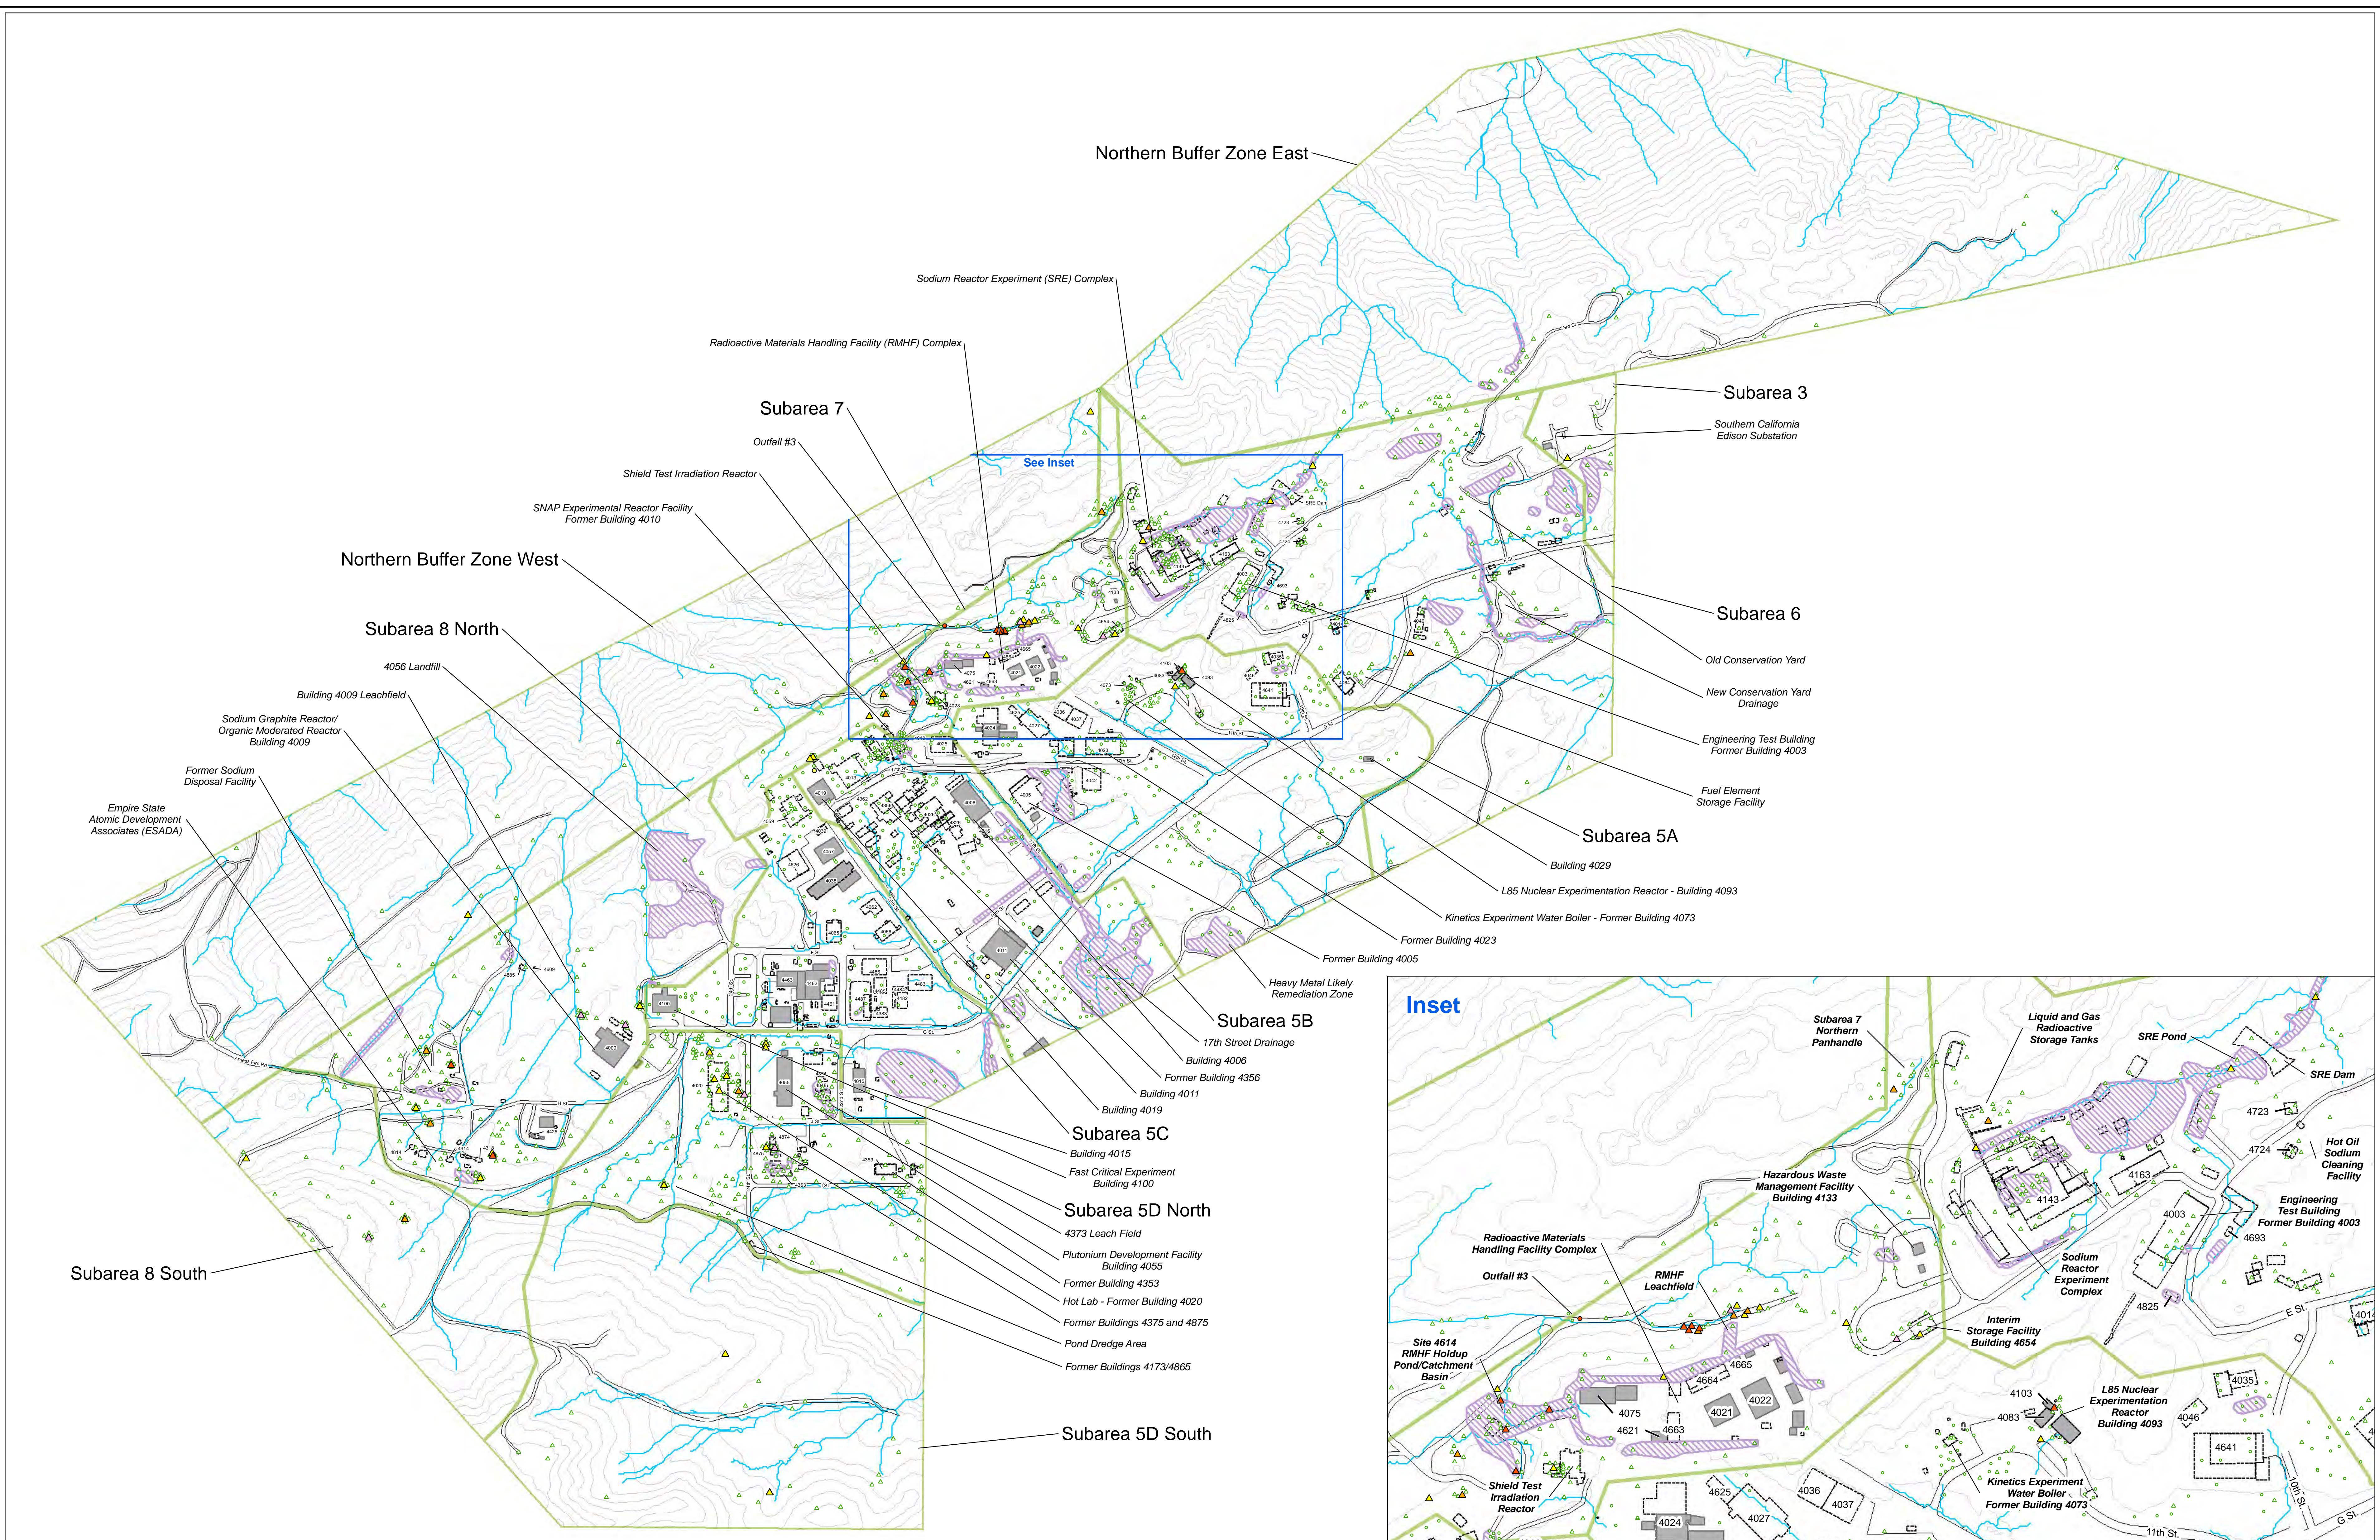
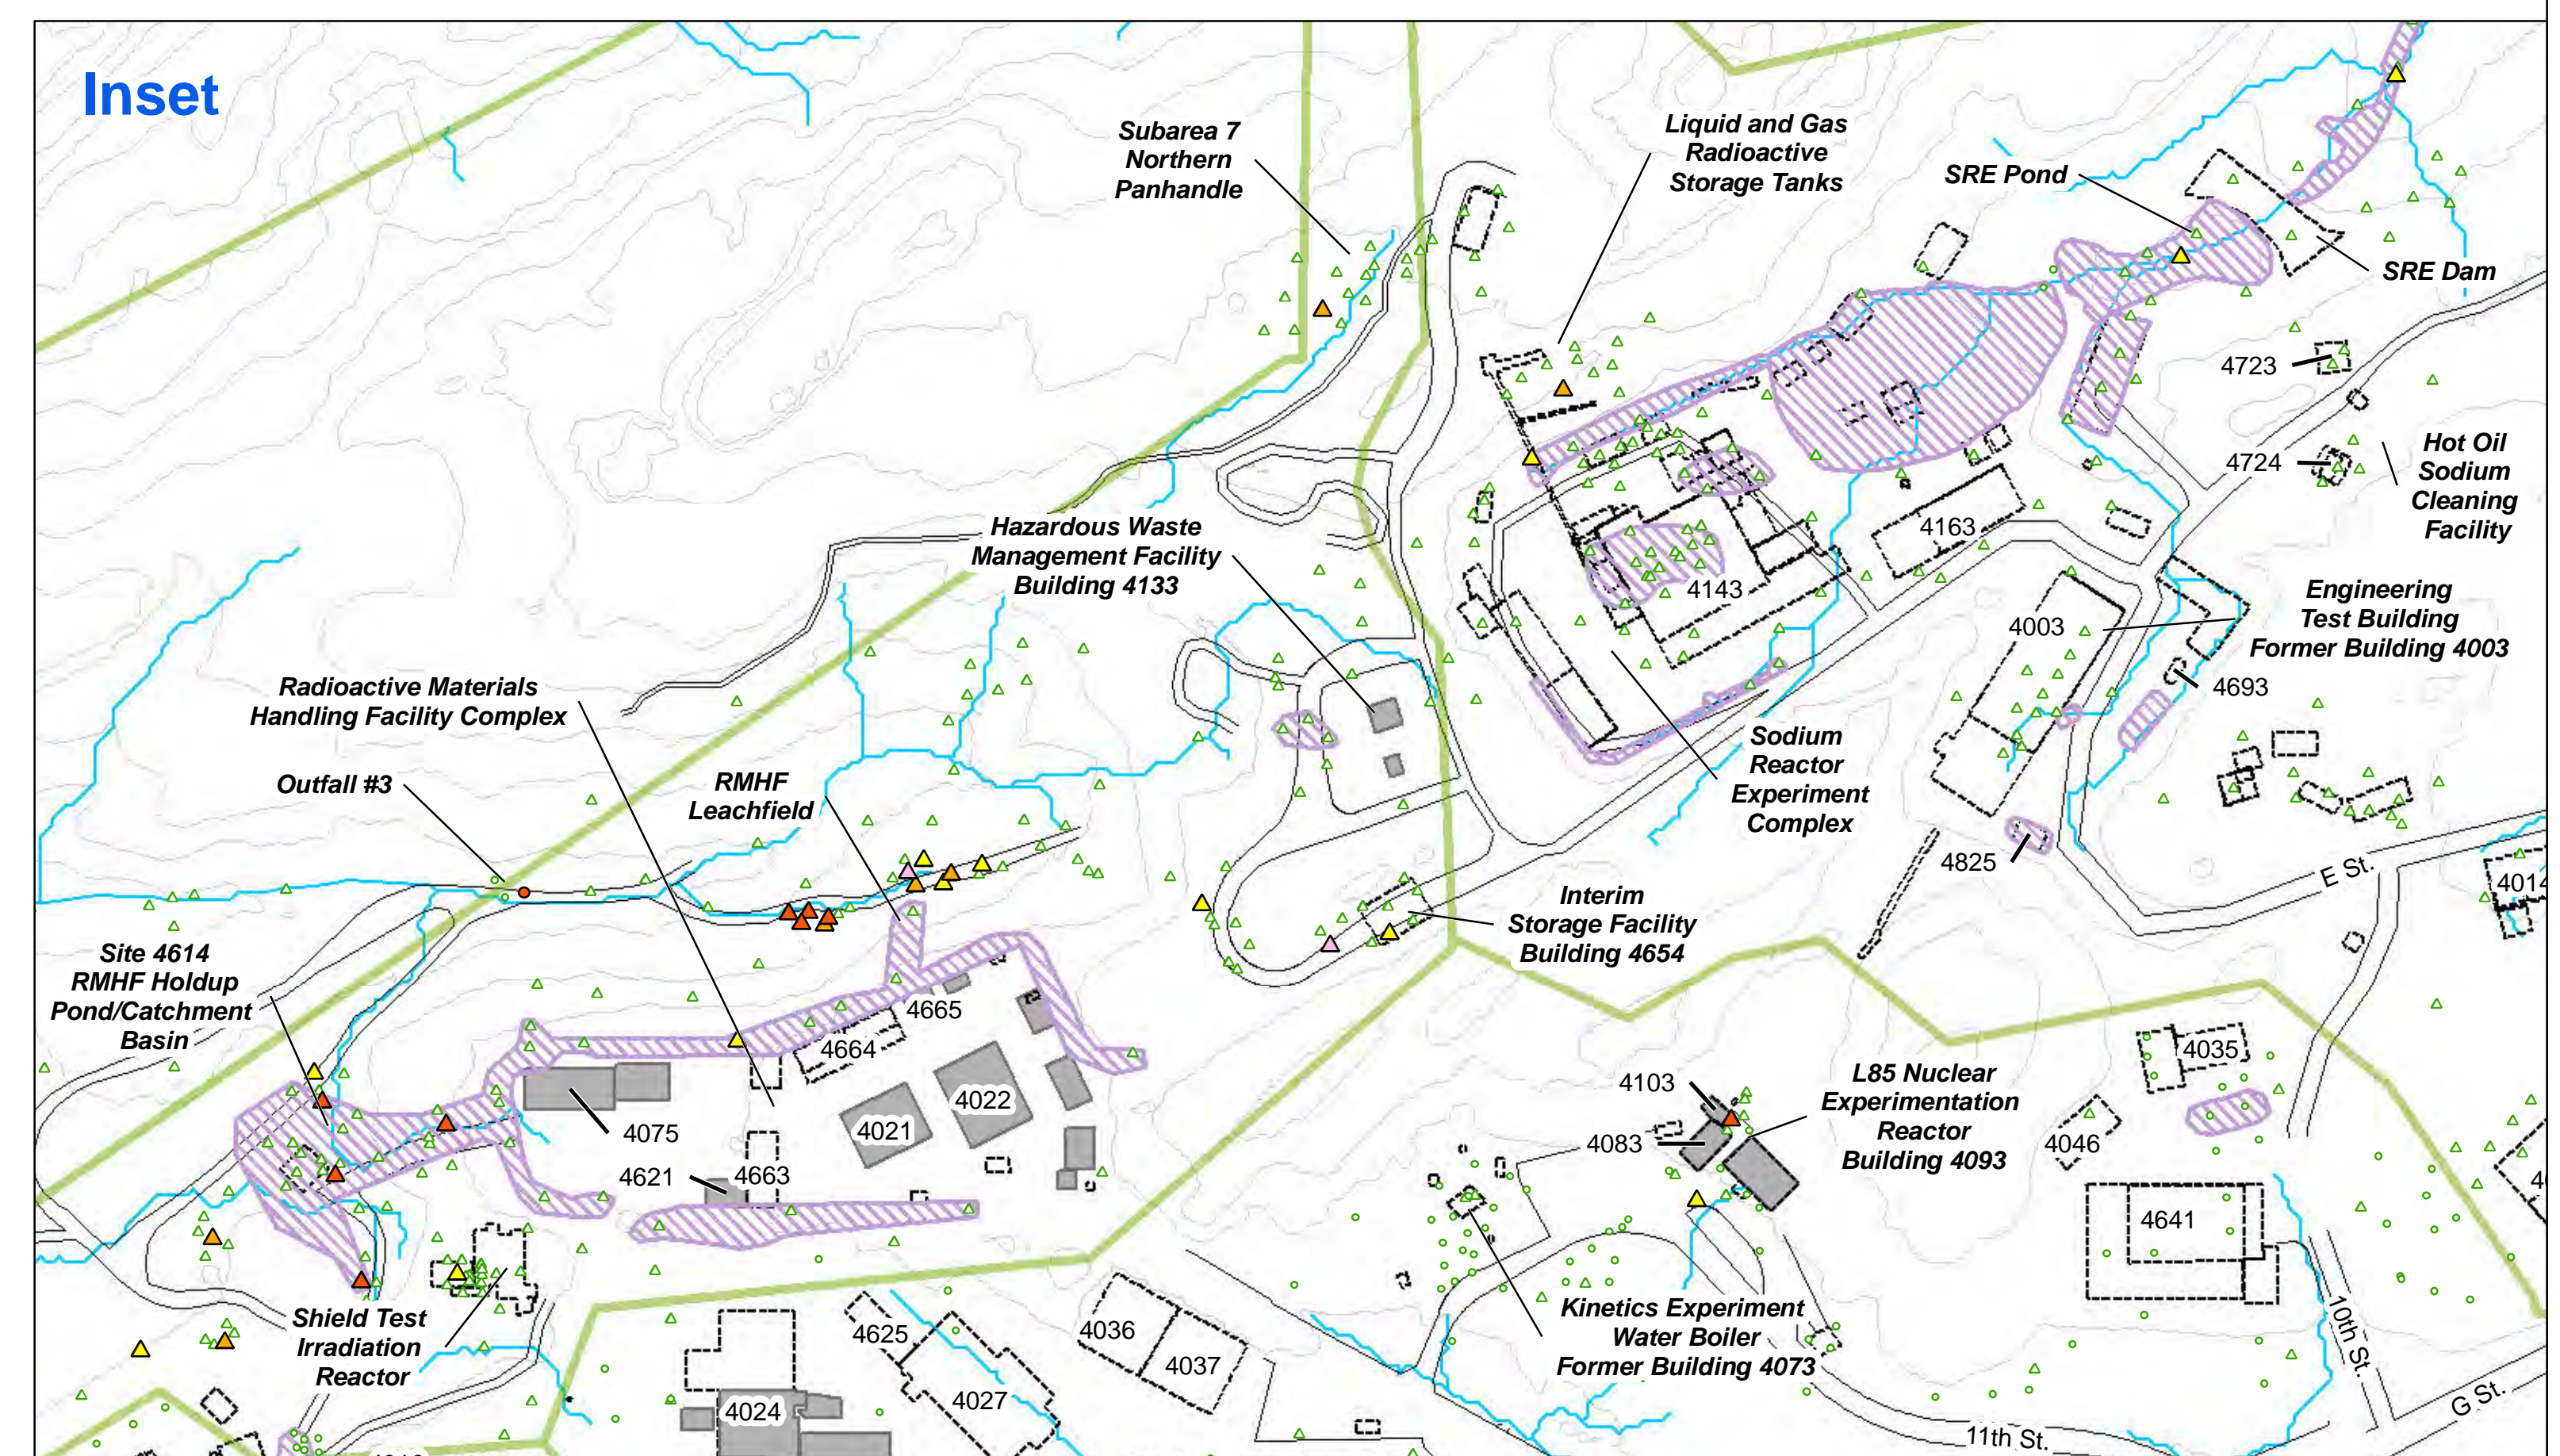
Figure 4.4
Strontium-90
Round 1 and 2 Subsurface Soil and Sediment Results
Santa Susana Field Laboratory
Area IV and NBZ Radiological Study

Strontium-90	GEL (FAL = 0.387)		TAL (FAL = 0.0750)	
	Symbol	Range (pCi/g)	Symbol	Range (pCi/g)
Below FAL	△	(Below 0.387 pCi/g)	○	(Below 0.0750 pCi/g)
FAL to less than 2 times FAL	▲	(0.387 to 0.773 pCi/g)	●	(0.0750 to 0.149 pCi/g)
2 times to less than 3 times FAL	▲	(0.774 to 1.15 pCi/g)	●	(0.149 to 0.224 pCi/g)
3 times to less than 4 times FAL	▲	(1.16 to 1.54 pCi/g)	●	(0.225 to 0.299 pCi/g)
Greater than 4 times FAL	▲	(1.55 to 21.3 pCi/g)	●	(0.300 to 0.563 pCi/g)

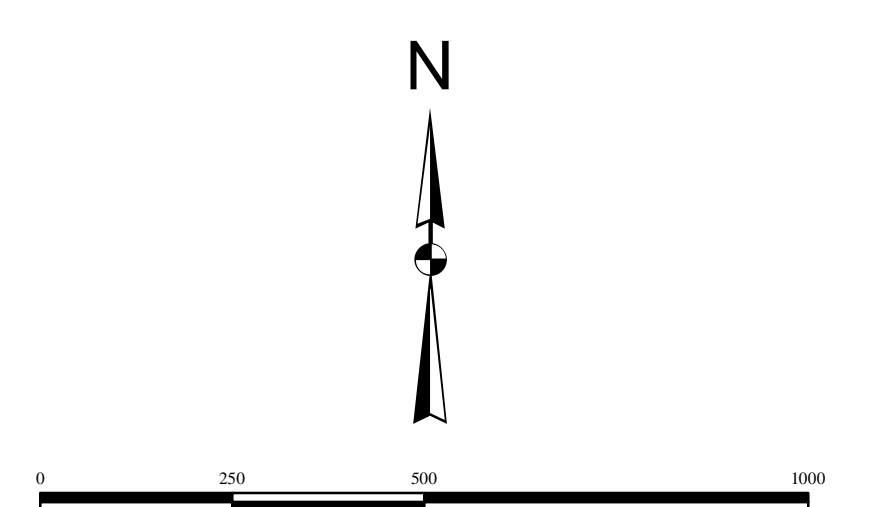
Strontium-90 was detected in 153 soil samples at concentrations above the FALs, ranging from 0.01 to 21.3 pCi/g. Strontium-90 was detected throughout the entire Area IV Study Area. These concentrations are presented by subarea (surface and subsurface) in Tables 4.2 and 4.3 and are illustrated on Figures 4.3 and 4.4. Details pertaining to each subarea regarding the distribution of Sr-90 are provided in the following subsections.

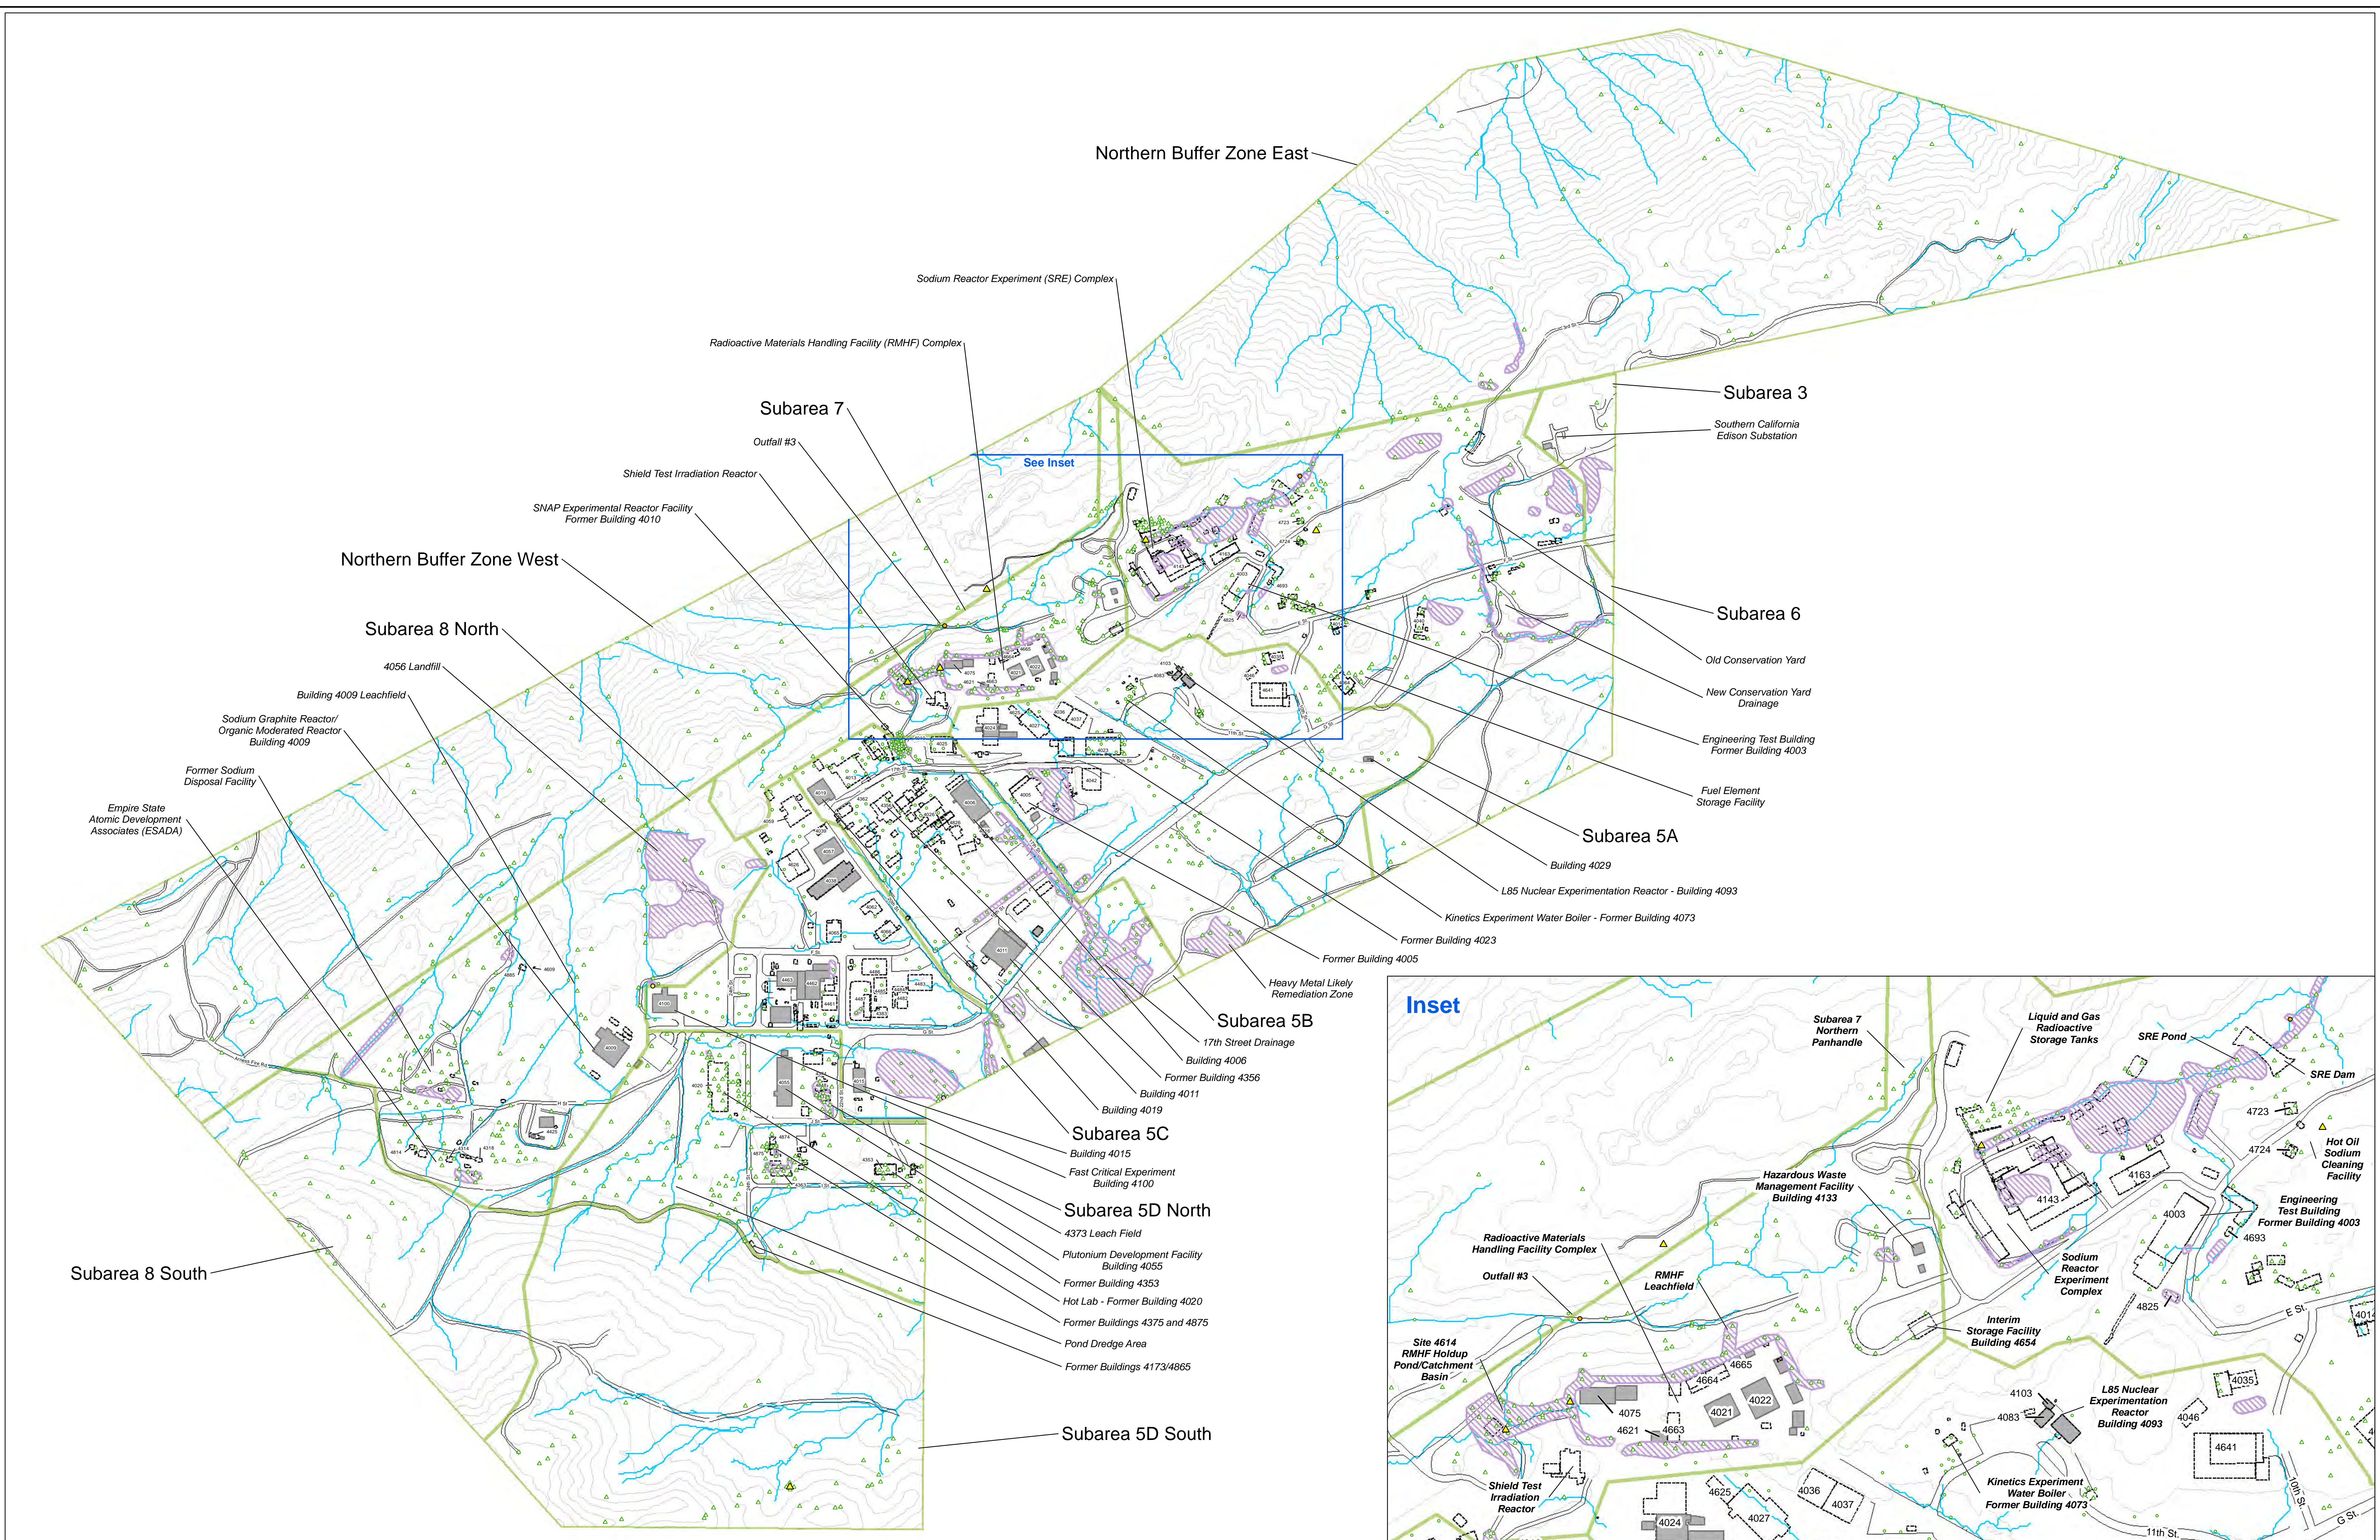
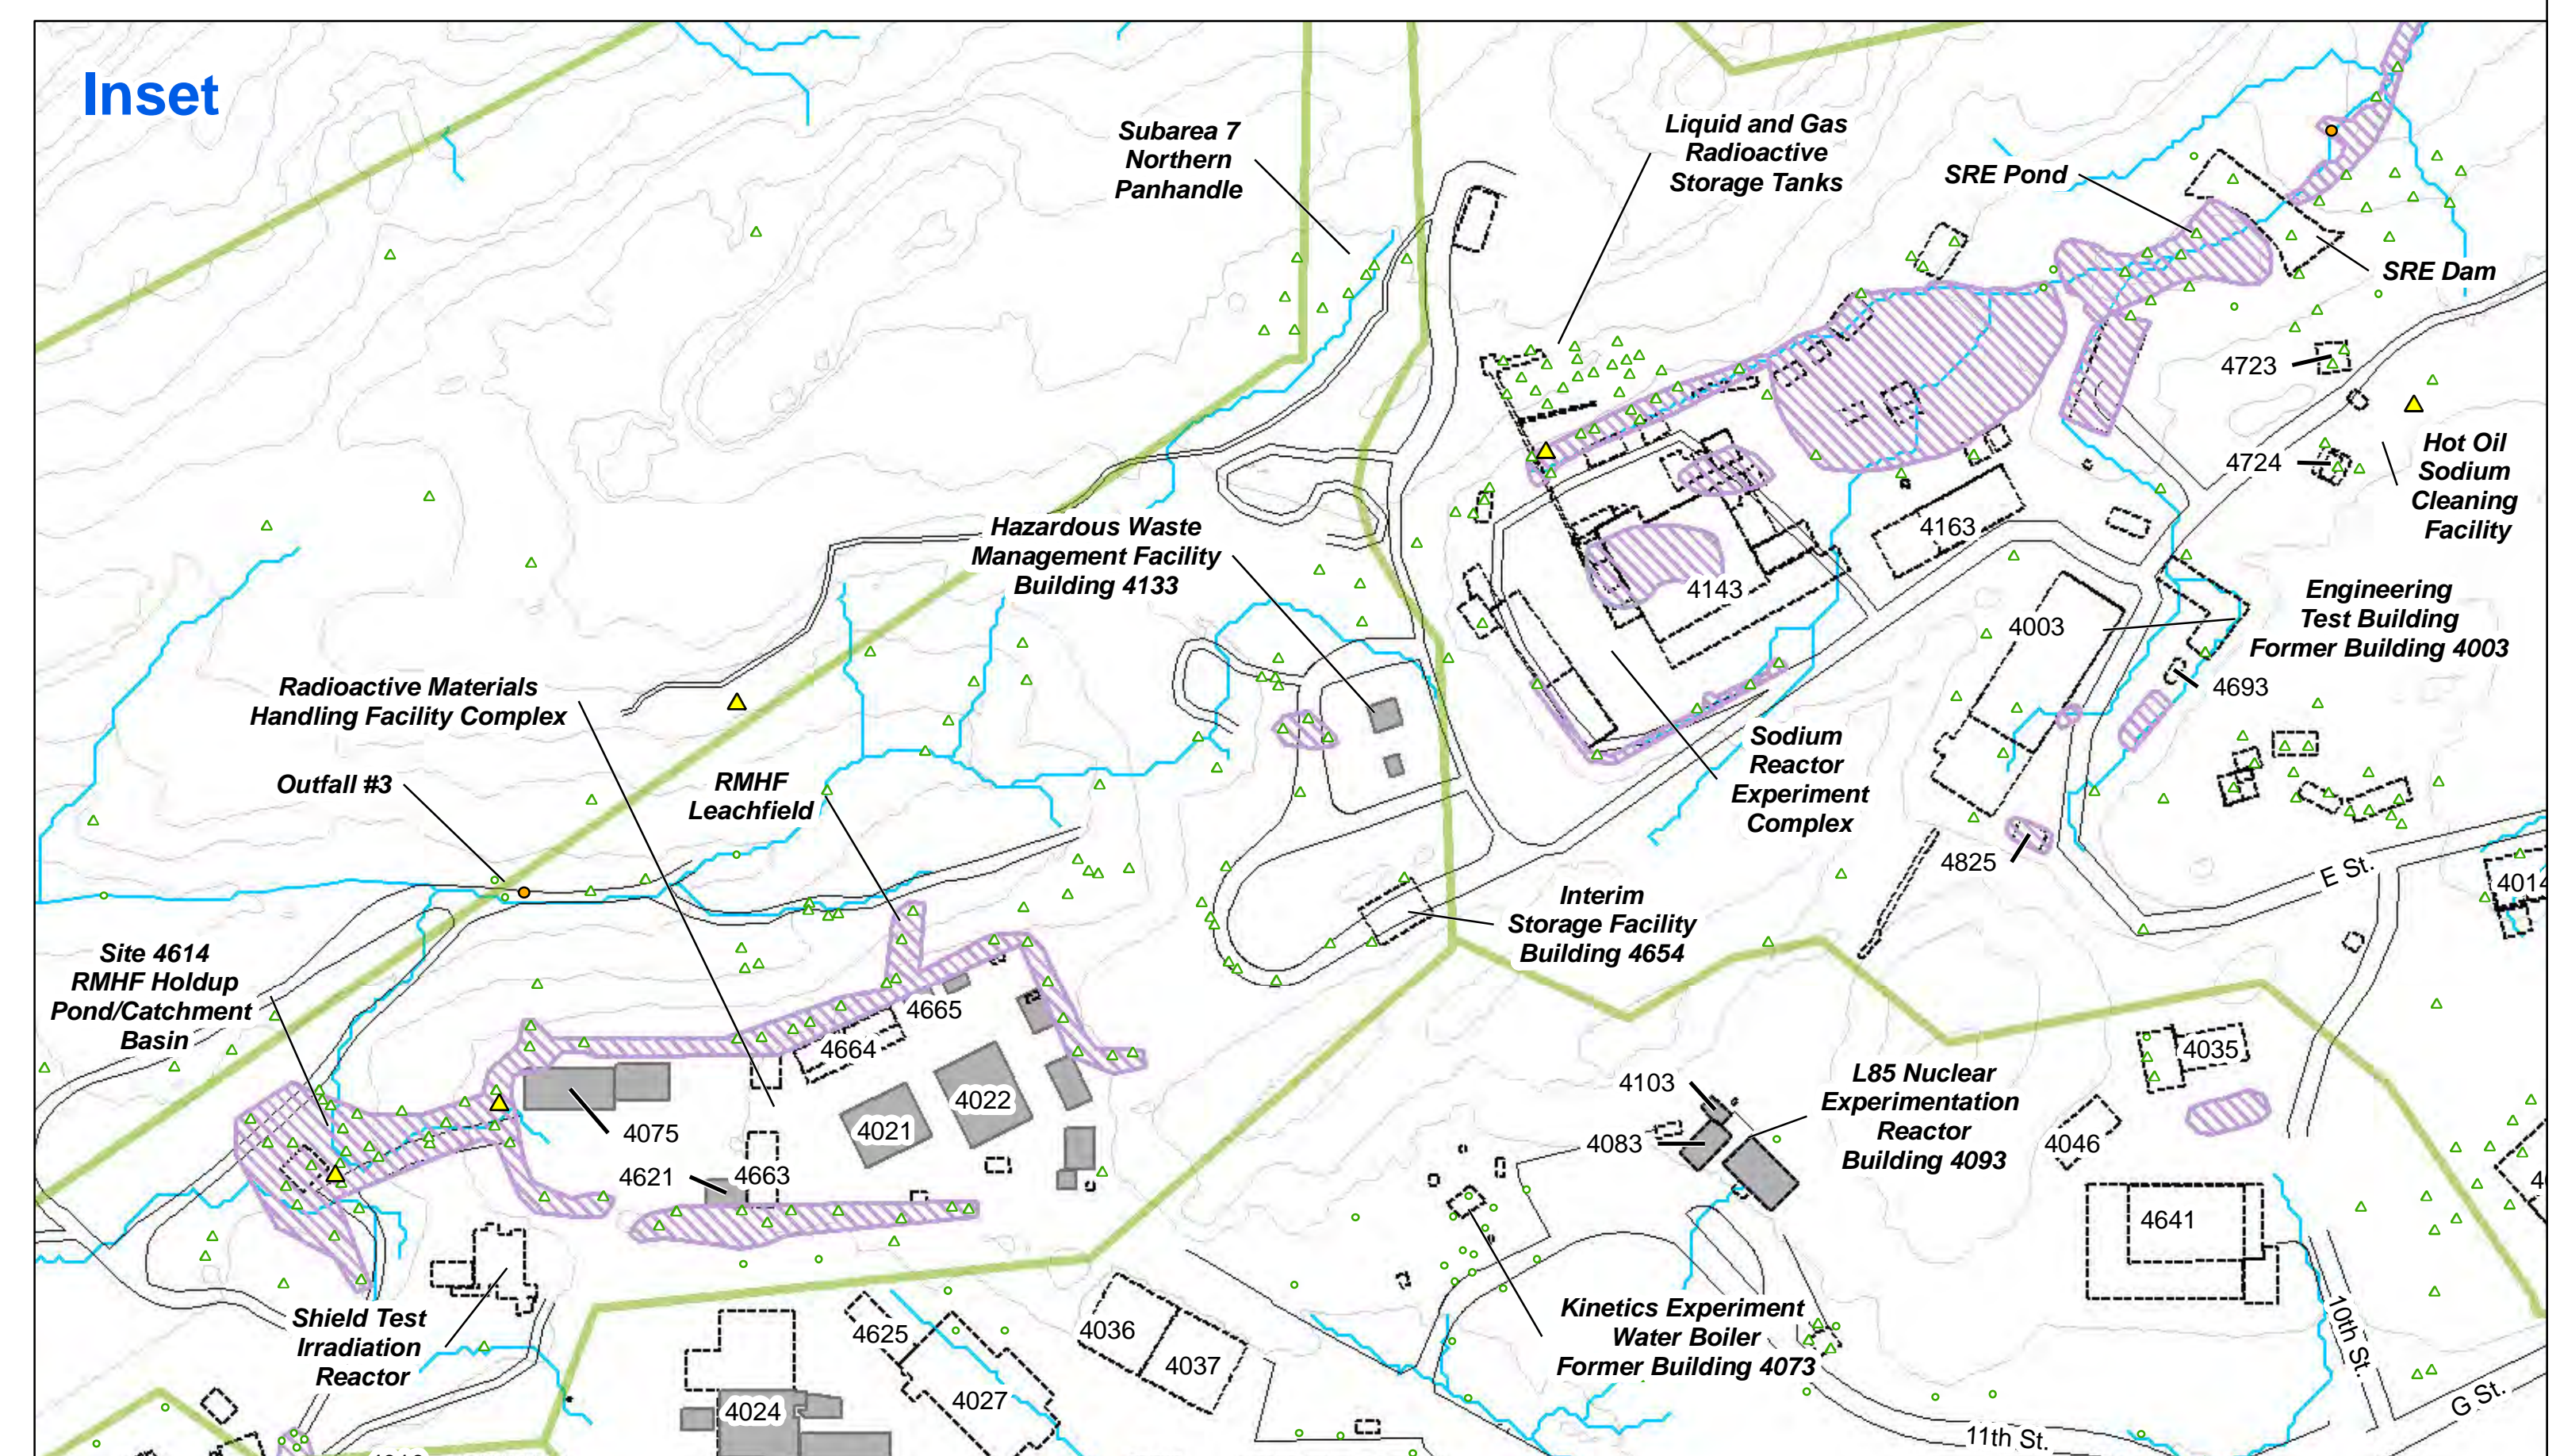
**Figure 4.5
 Plutonium-239/240
 Round 1 and 2 Surface Soil
 and Sediment Results
 Santa Susana Field Laboratory
 Area IV and NBZ Radiological Study**

Plutonium-239/240	GEL (FAL = 0.0369)	TAL (FAL = 0.0142)
Below FAL	△ (Below 0.0369 pCi/g)	○ (Below 0.0142 pCi/g)
FAL to less than 2 times FAL	▲ (0.0369 to 0.0737 pCi/g)	● (0.0142 to 0.0283 pCi/g)
2 times to less than 3 times FAL	▲▲ (0.0738 to 0.110 pCi/g)	●● (0.0284 to 0.0425 pCi/g)
3 times to less than 4 times FAL	▲▲▲ (0.111 to 0.147 pCi/g)	●●● (0.0426 to 0.0567 pCi/g)
Greater than 4 times FAL	▲▲▲▲ (0.148 to x.xxx pCi/g)	●●●● (0.0568 to x.xxx pCi/g)
