FINAL
RADIOLOGICAL CHARACTERIZATION OF SOILS
AREA IV AND THE NORTHERN BUFFER ZONE

AREA IV RADIOLOGICAL STUDY
SANTA SUSANA FIELD LABORATORY
VENTURA COUNTY, CALIFORNIA

HydroGeoLogic, Inc.
5023 North Parkway Calabasas
Calabasas, California 91302

December 21, 2012

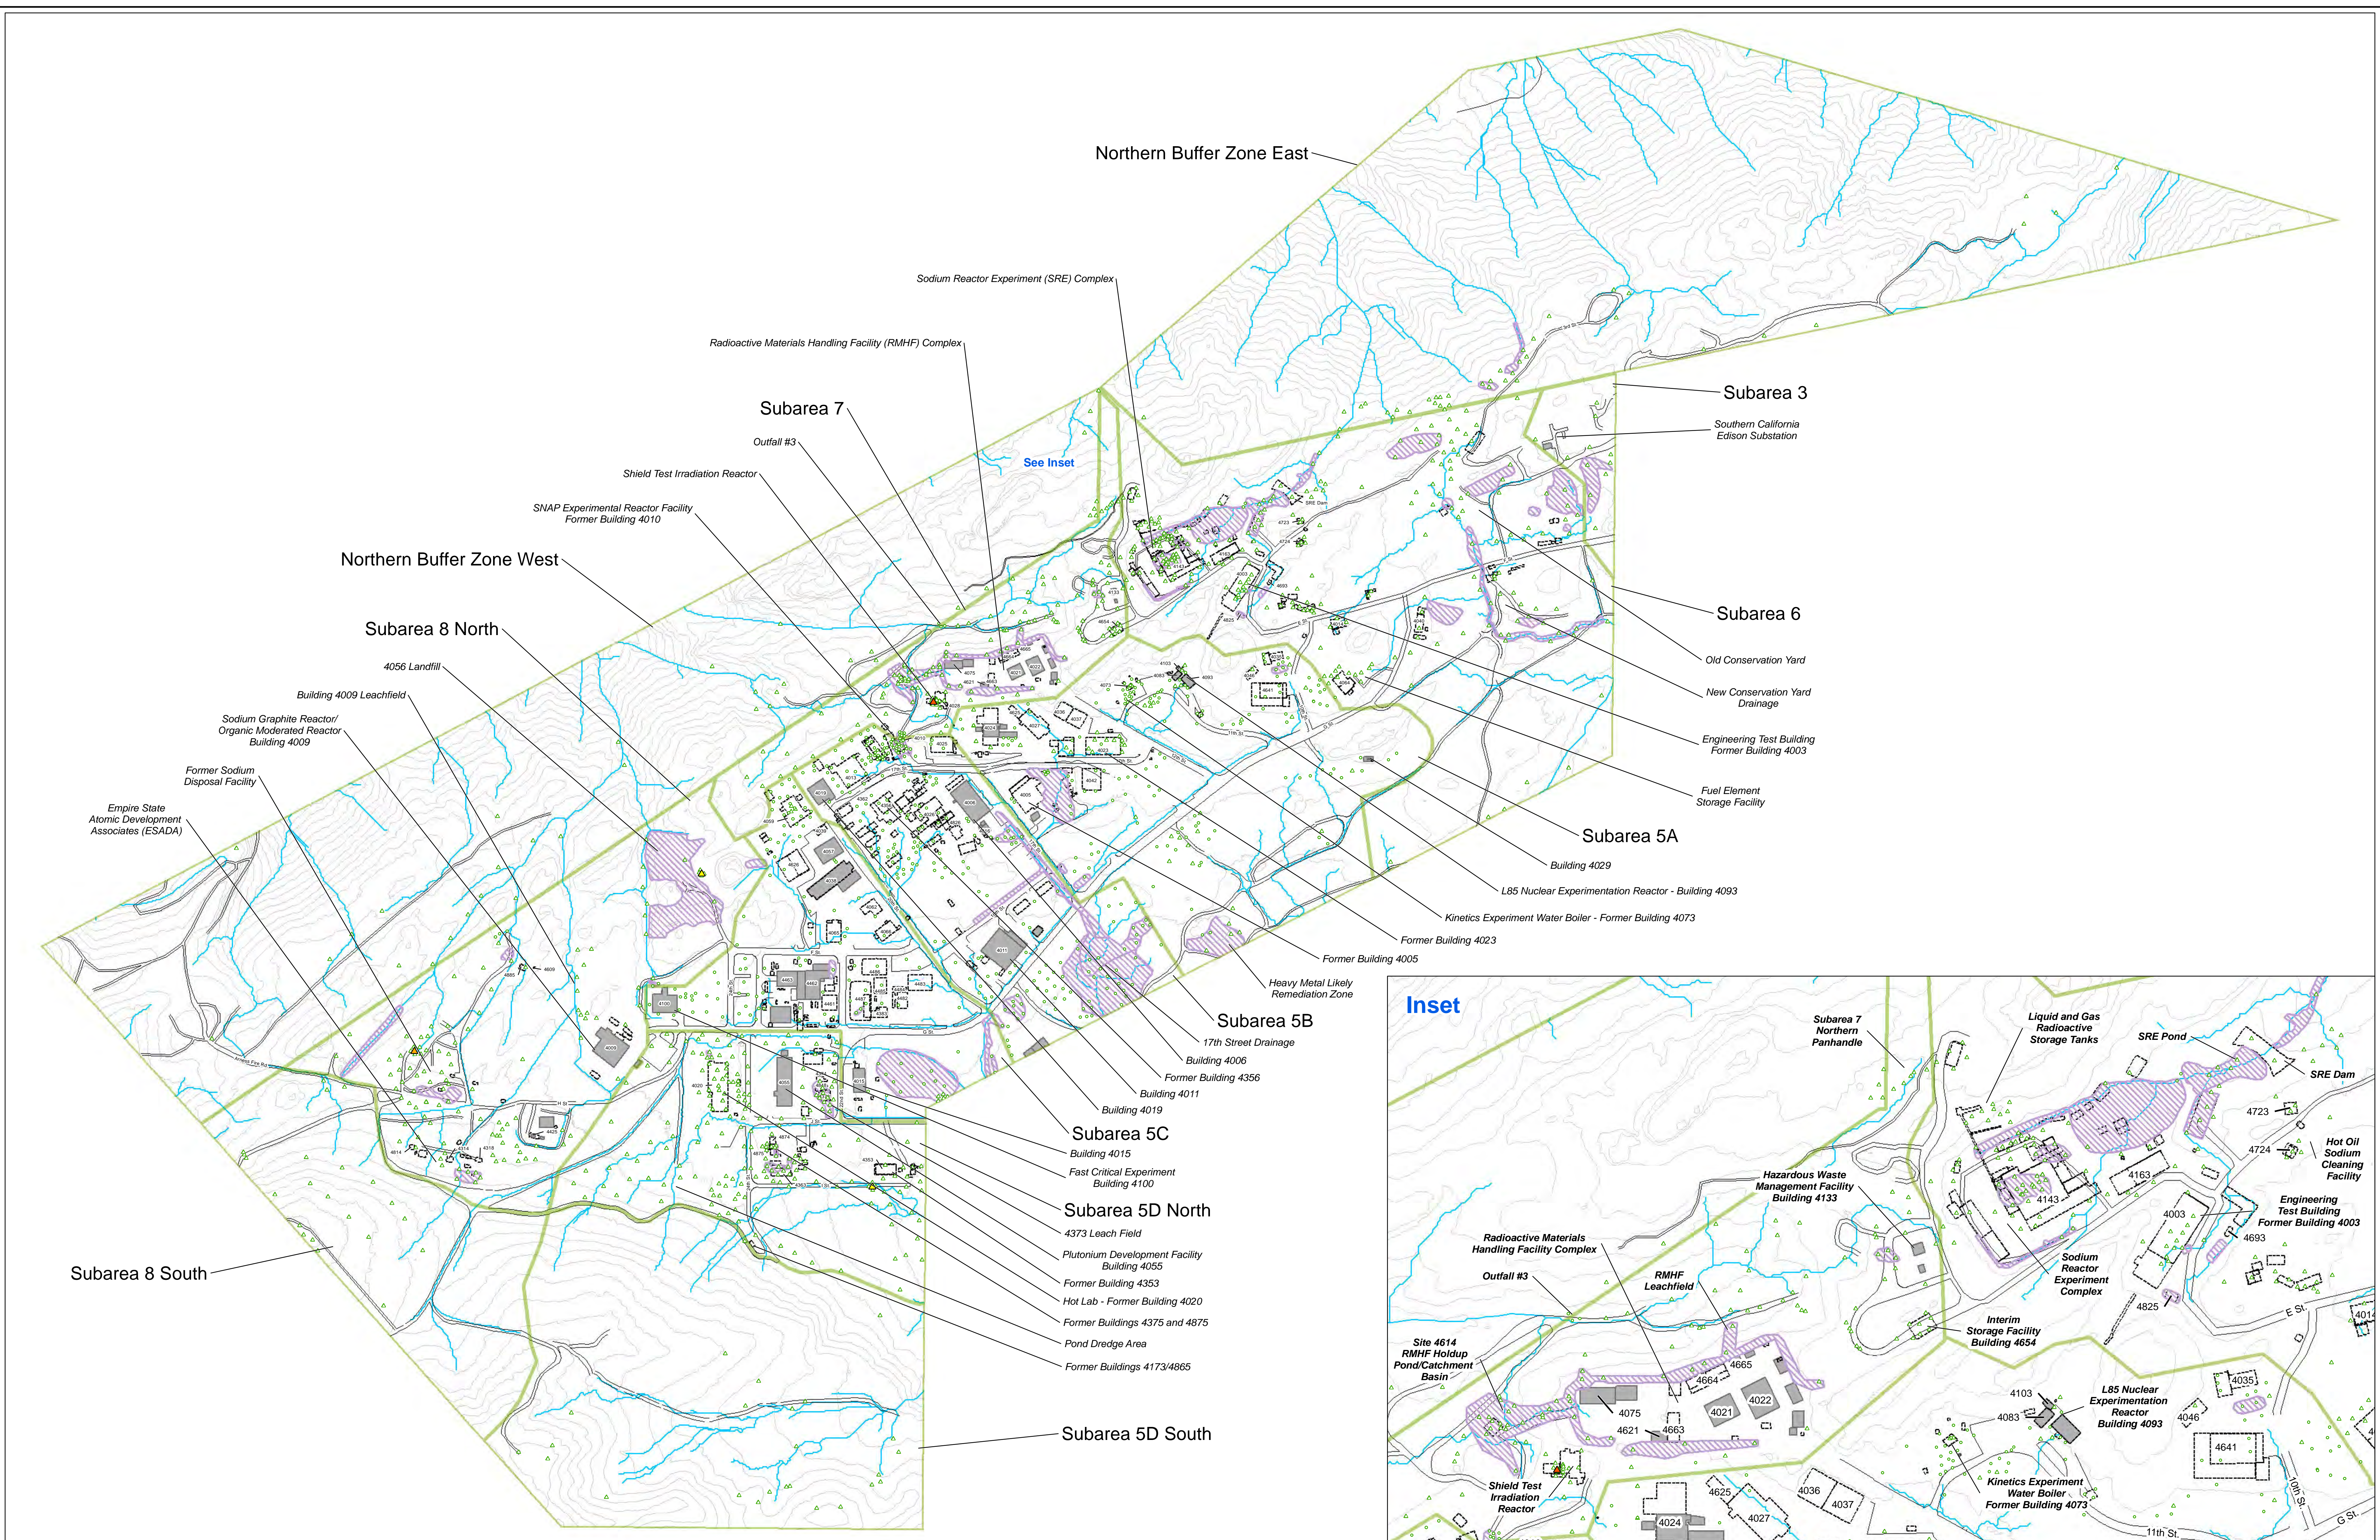
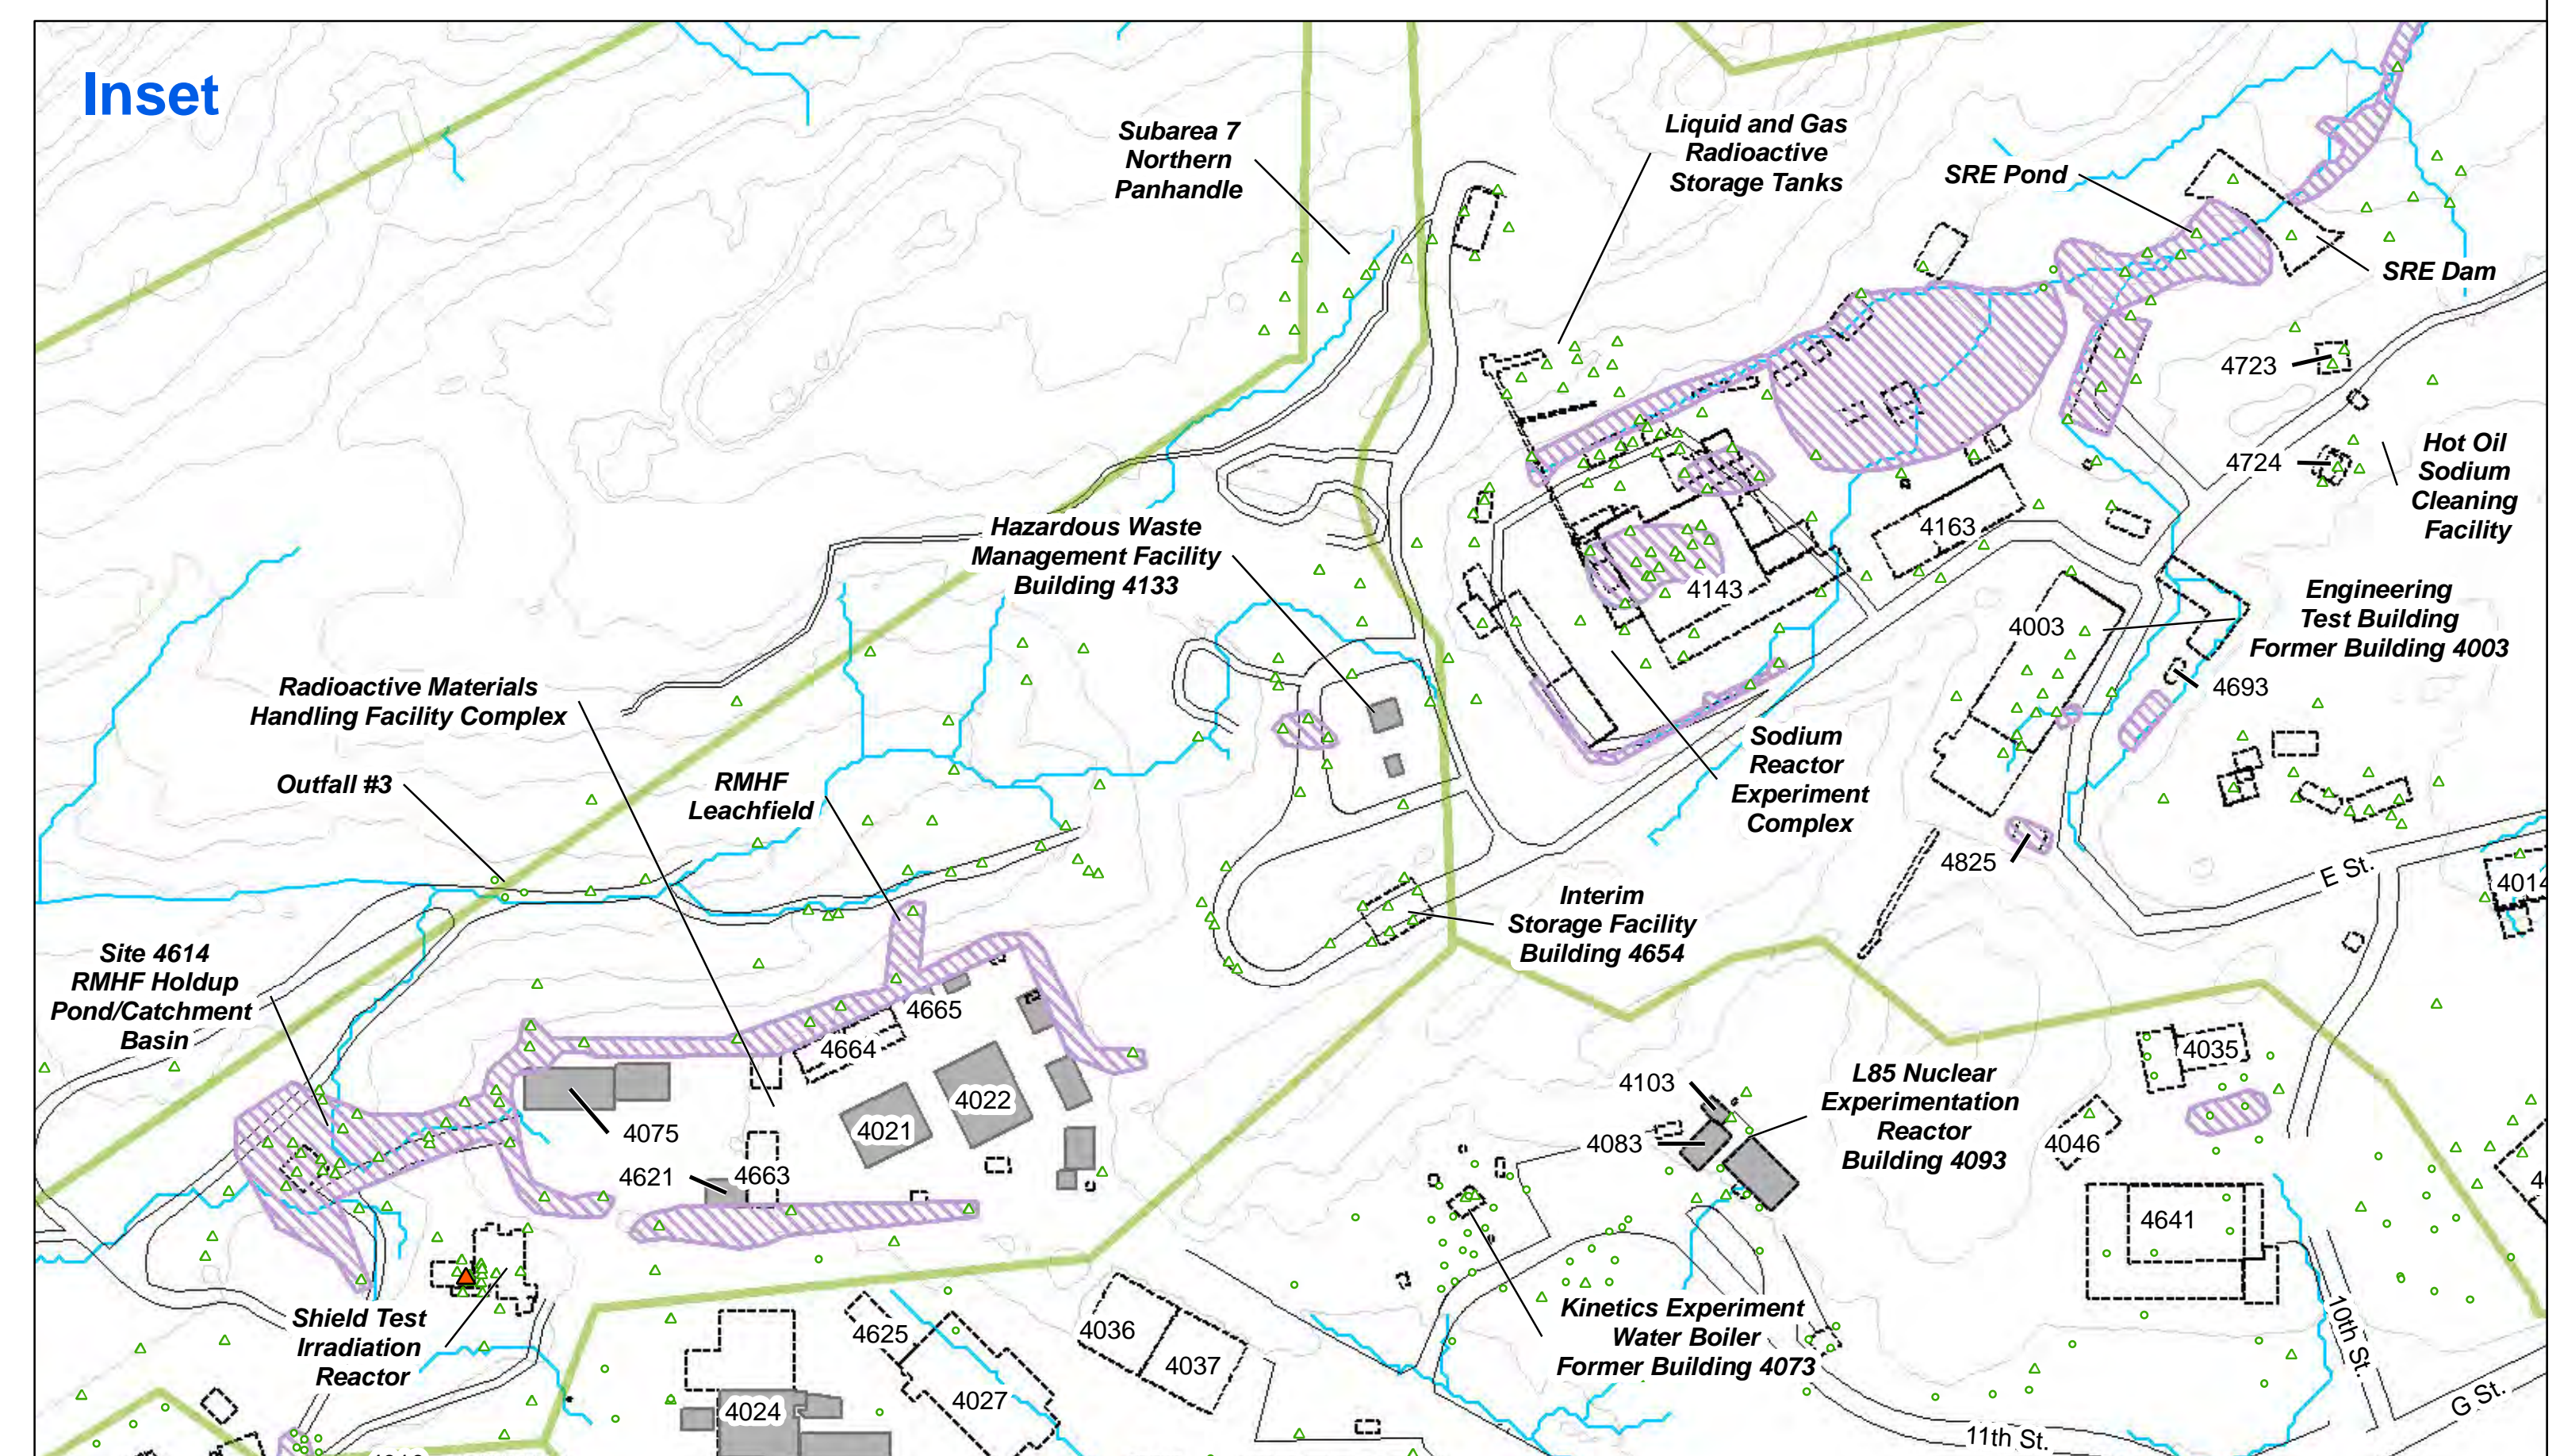
Figure 4.6
Plutonium-239/240
Round 1 and 2 Subsurface Soil and Sediment Results
Santa Susana Field Laboratory
Area IV and NBZ Radiological Study

Plutonium-239/240	GEL (FAL = 0.0369)		TAL (FAL = 0.0142)	
	CL to FAL	(Below 0.0369 pCi/g)	(Below 0.0142 pCi/g)	(Below 0.0142 pCi/g)
FAL to less than 2 times FAL	▲	(0.0369 to 0.0737 pCi/g)	●	(0.0142 to 0.0283 pCi/g)
2 times to less than 3 times FAL	▲	(0.0738 to 0.110 pCi/g)	●	(0.0284 to 0.0425 pCi/g)
3 times to less than 4 times FAL	▲	(0.111 to 0.147 pCi/g)	●	(0.0426 to 0.0567 pCi/g)
Greater than 4 times FAL	▲	(0.148 to x.xxx pCi/g)	●	(0.0568 to x.xxx pCi/g)

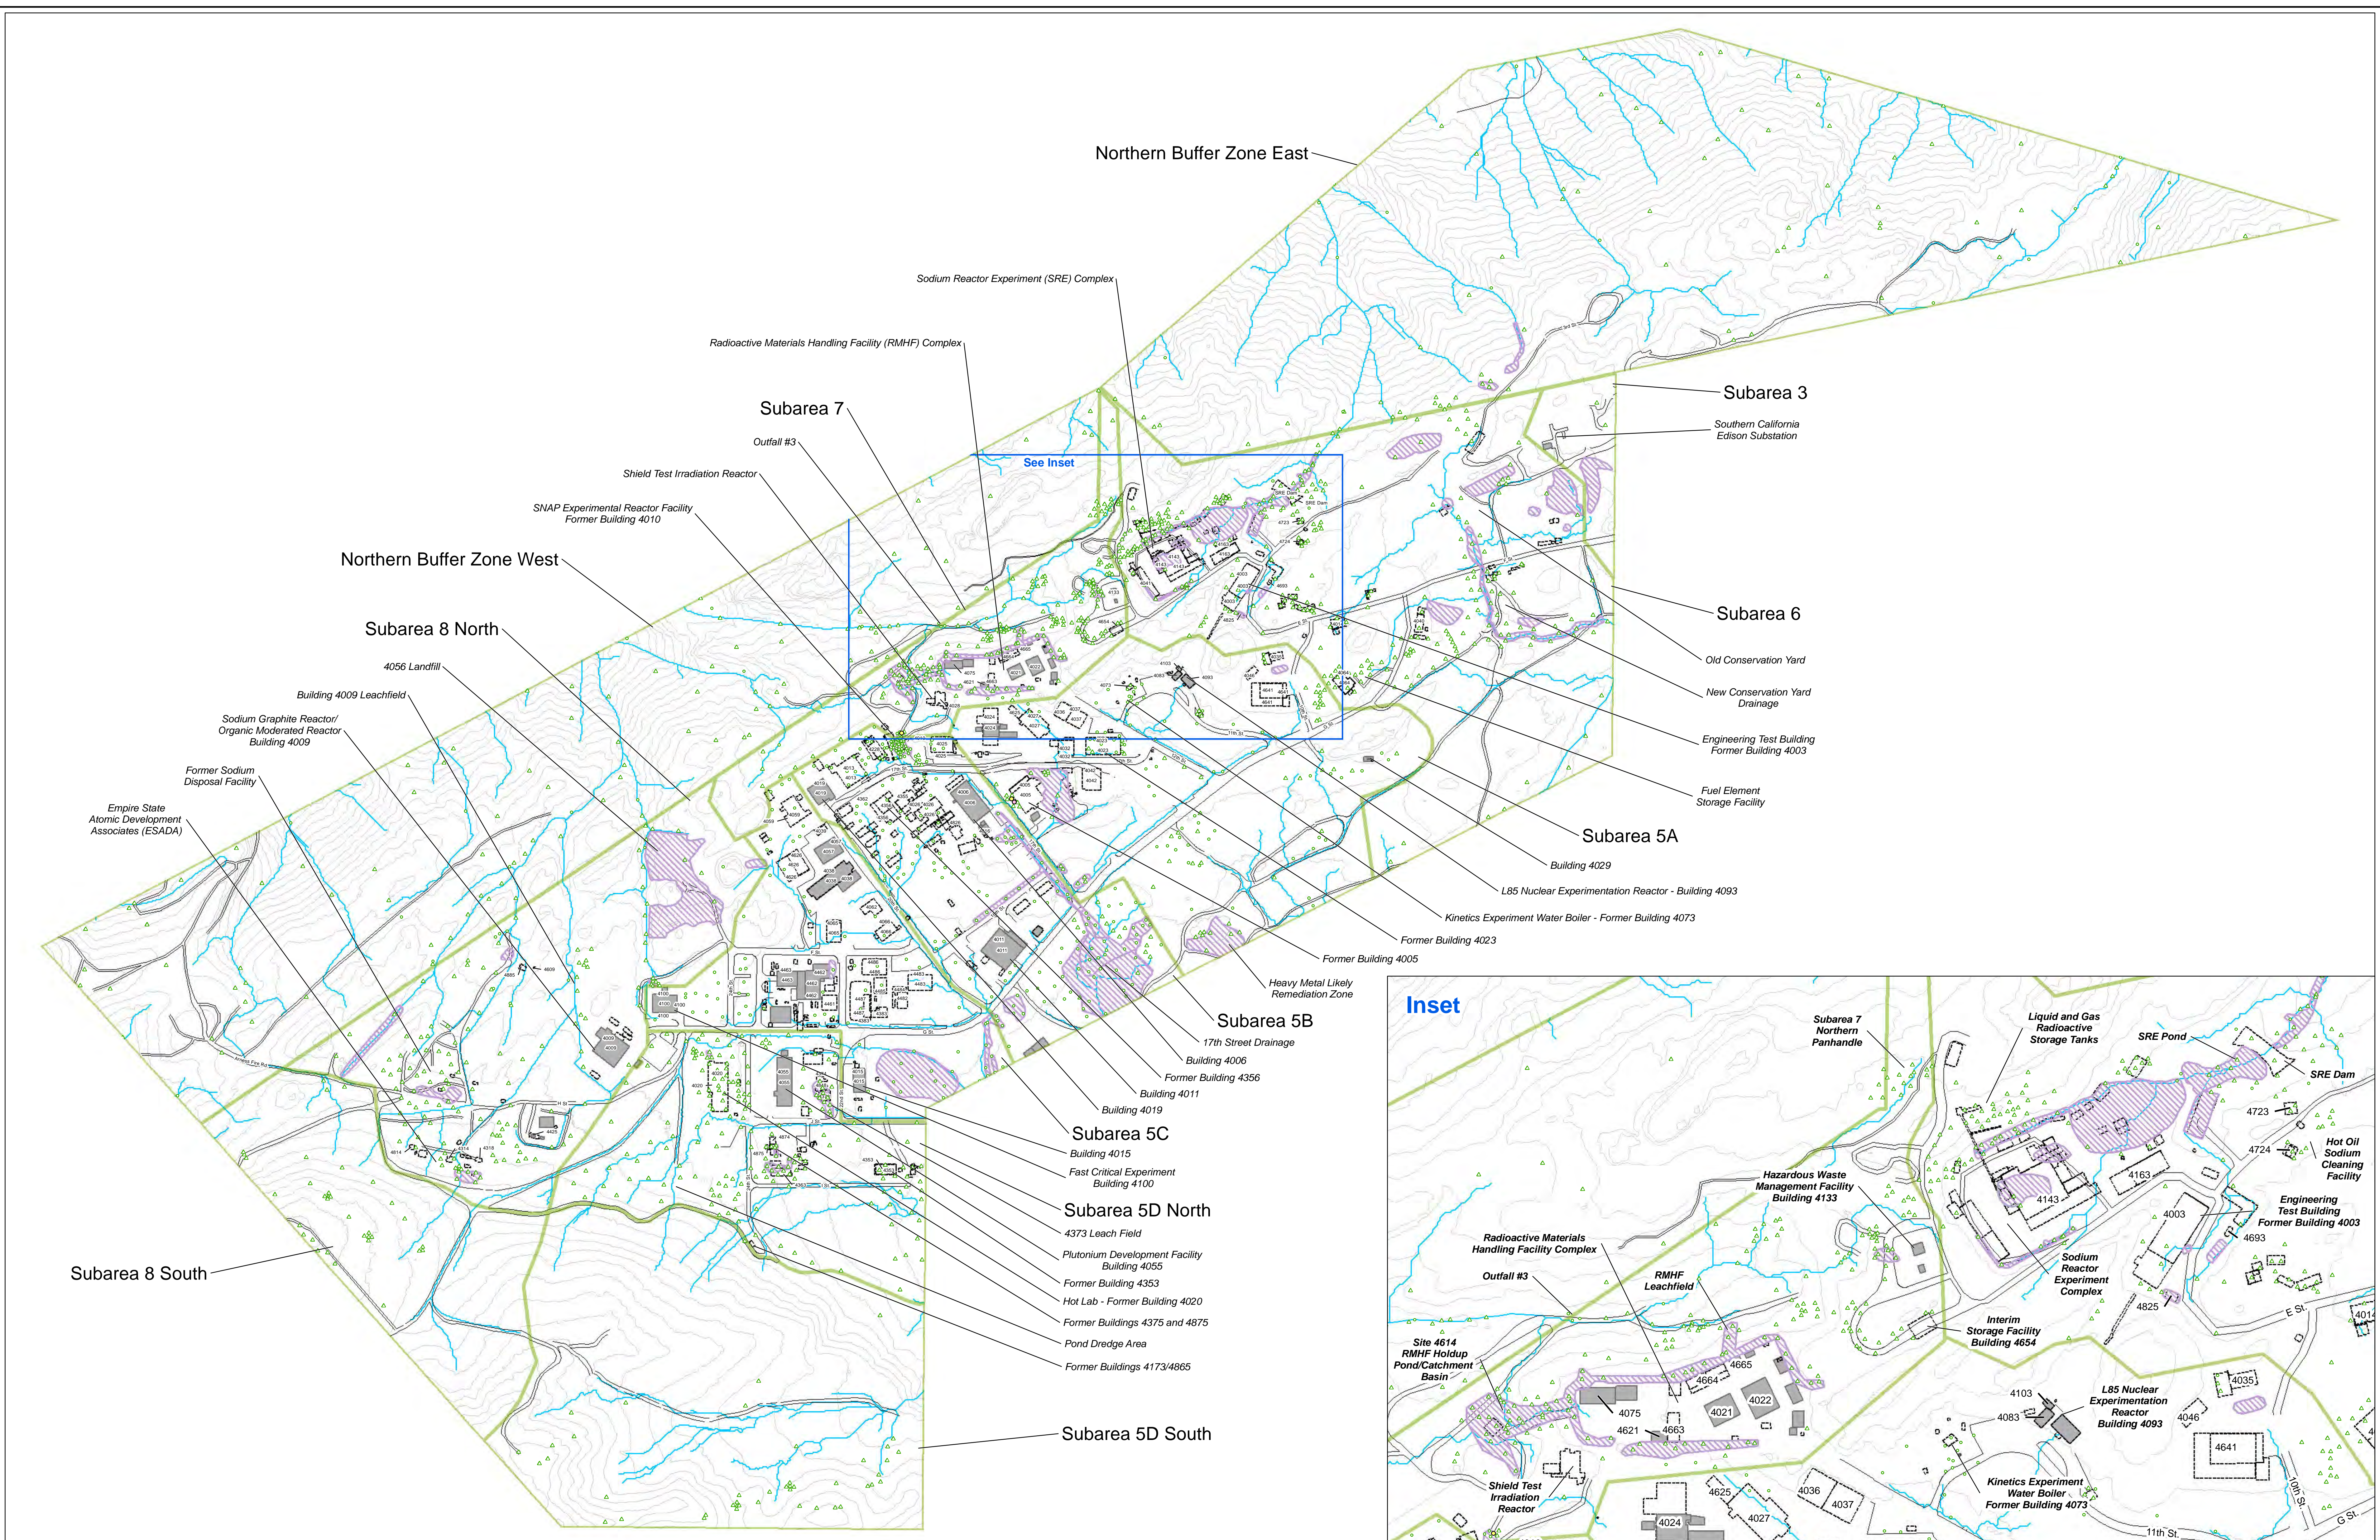
Figure 4.9
Europium-152
Round 1 and 2 Surface Soil
and Sediment Results
Santa Susana Field Laboratory
Area IV and NBZ Radiological Study

Europium-152	GEL (FAL = 0.670)	TAL (FAL = 0.0459)
Below FAL	△ (Below 0.670 pCi/g)	○ (Below 0.0459 pCi/g)
FAL to less than 2 times FAL	▲ (0.0670 to 0.133 pCi/g)	● (0.0459 to 0.0917 pCi/g)
2 times to less than 3 times FAL	▲▲ (0.134 to 0.200 pCi/g)	●● (0.0918 to 0.137 pCi/g)
3 times to less than 4 times FAL	▲▲▲ (0.201 to 0.267 pCi/g)	●●● (0.138 to 0.183 pCi/g)
Greater than 4 times FAL	▲▲▲▲ (0.268 to x.xxx pCi/g)	●●●● (0.184 to x.xxx pCi/g)

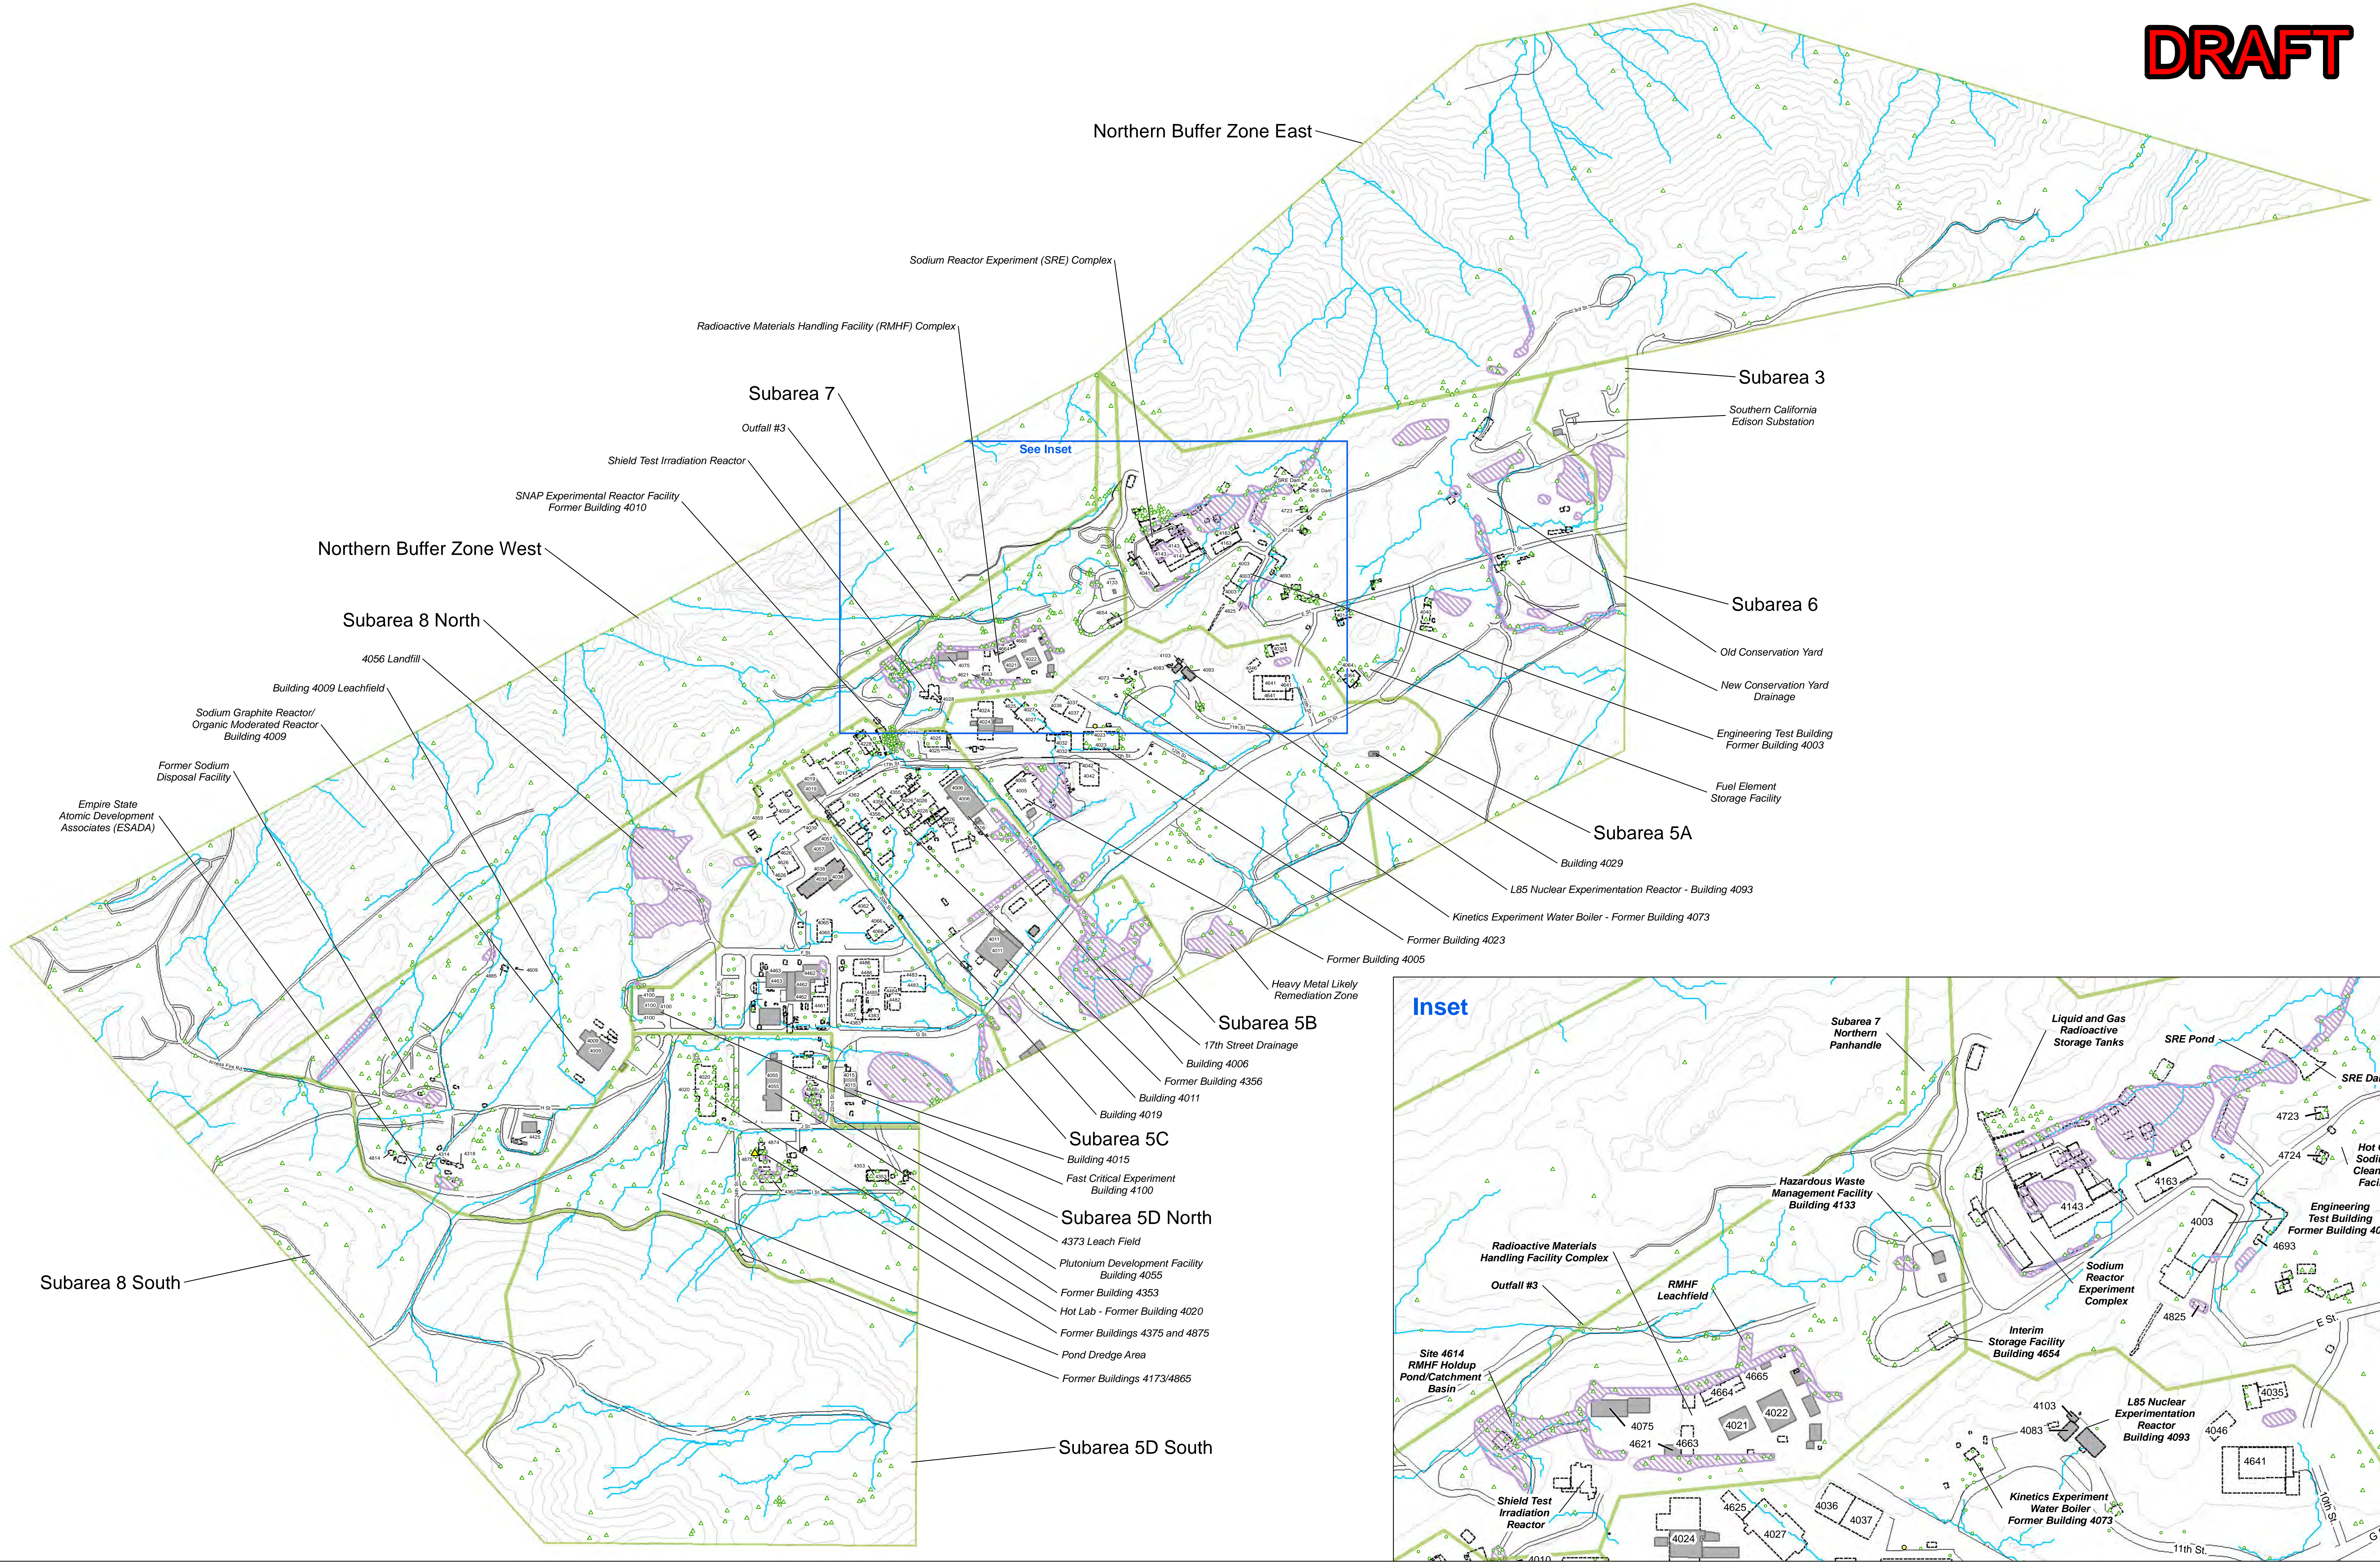
**Figure 4.11
 Plutonium-238
 Round 1 and 2 Surface Soil
 and Sediment Results
 Santa Susana Field Laboratory
 Area IV and NBZ Radiological Study**

Plutonium-238	GEL (FAL = 0.0480)		TAL (FAL = 0.00921)	
	Below FAL	△ (Below 0.0480 pCi/g)	○ (Below 0.00921 pCi/g)	
FAL to less than 2 times FAL	▲ (0.0480 to 0.0959 pCi/g)	● (0.00921 to 0.0183 pCi/g)		
2 times to less than 3 times FAL	▲▲ (0.0960 to 0.143 pCi/g)	●● (0.0184 to 0.0275 pCi/g)		
3 times to less than 4 times FAL	▲▲▲ (0.144 to 0.191 pCi/g)	●●● (0.0276 to 0.0367 pCi/g)		
Greater than 4 times FAL	▲▲▲▲ (0.192 to x.xxx pCi/g)	●●●● (0.0368 to x.xxx pCi/g)

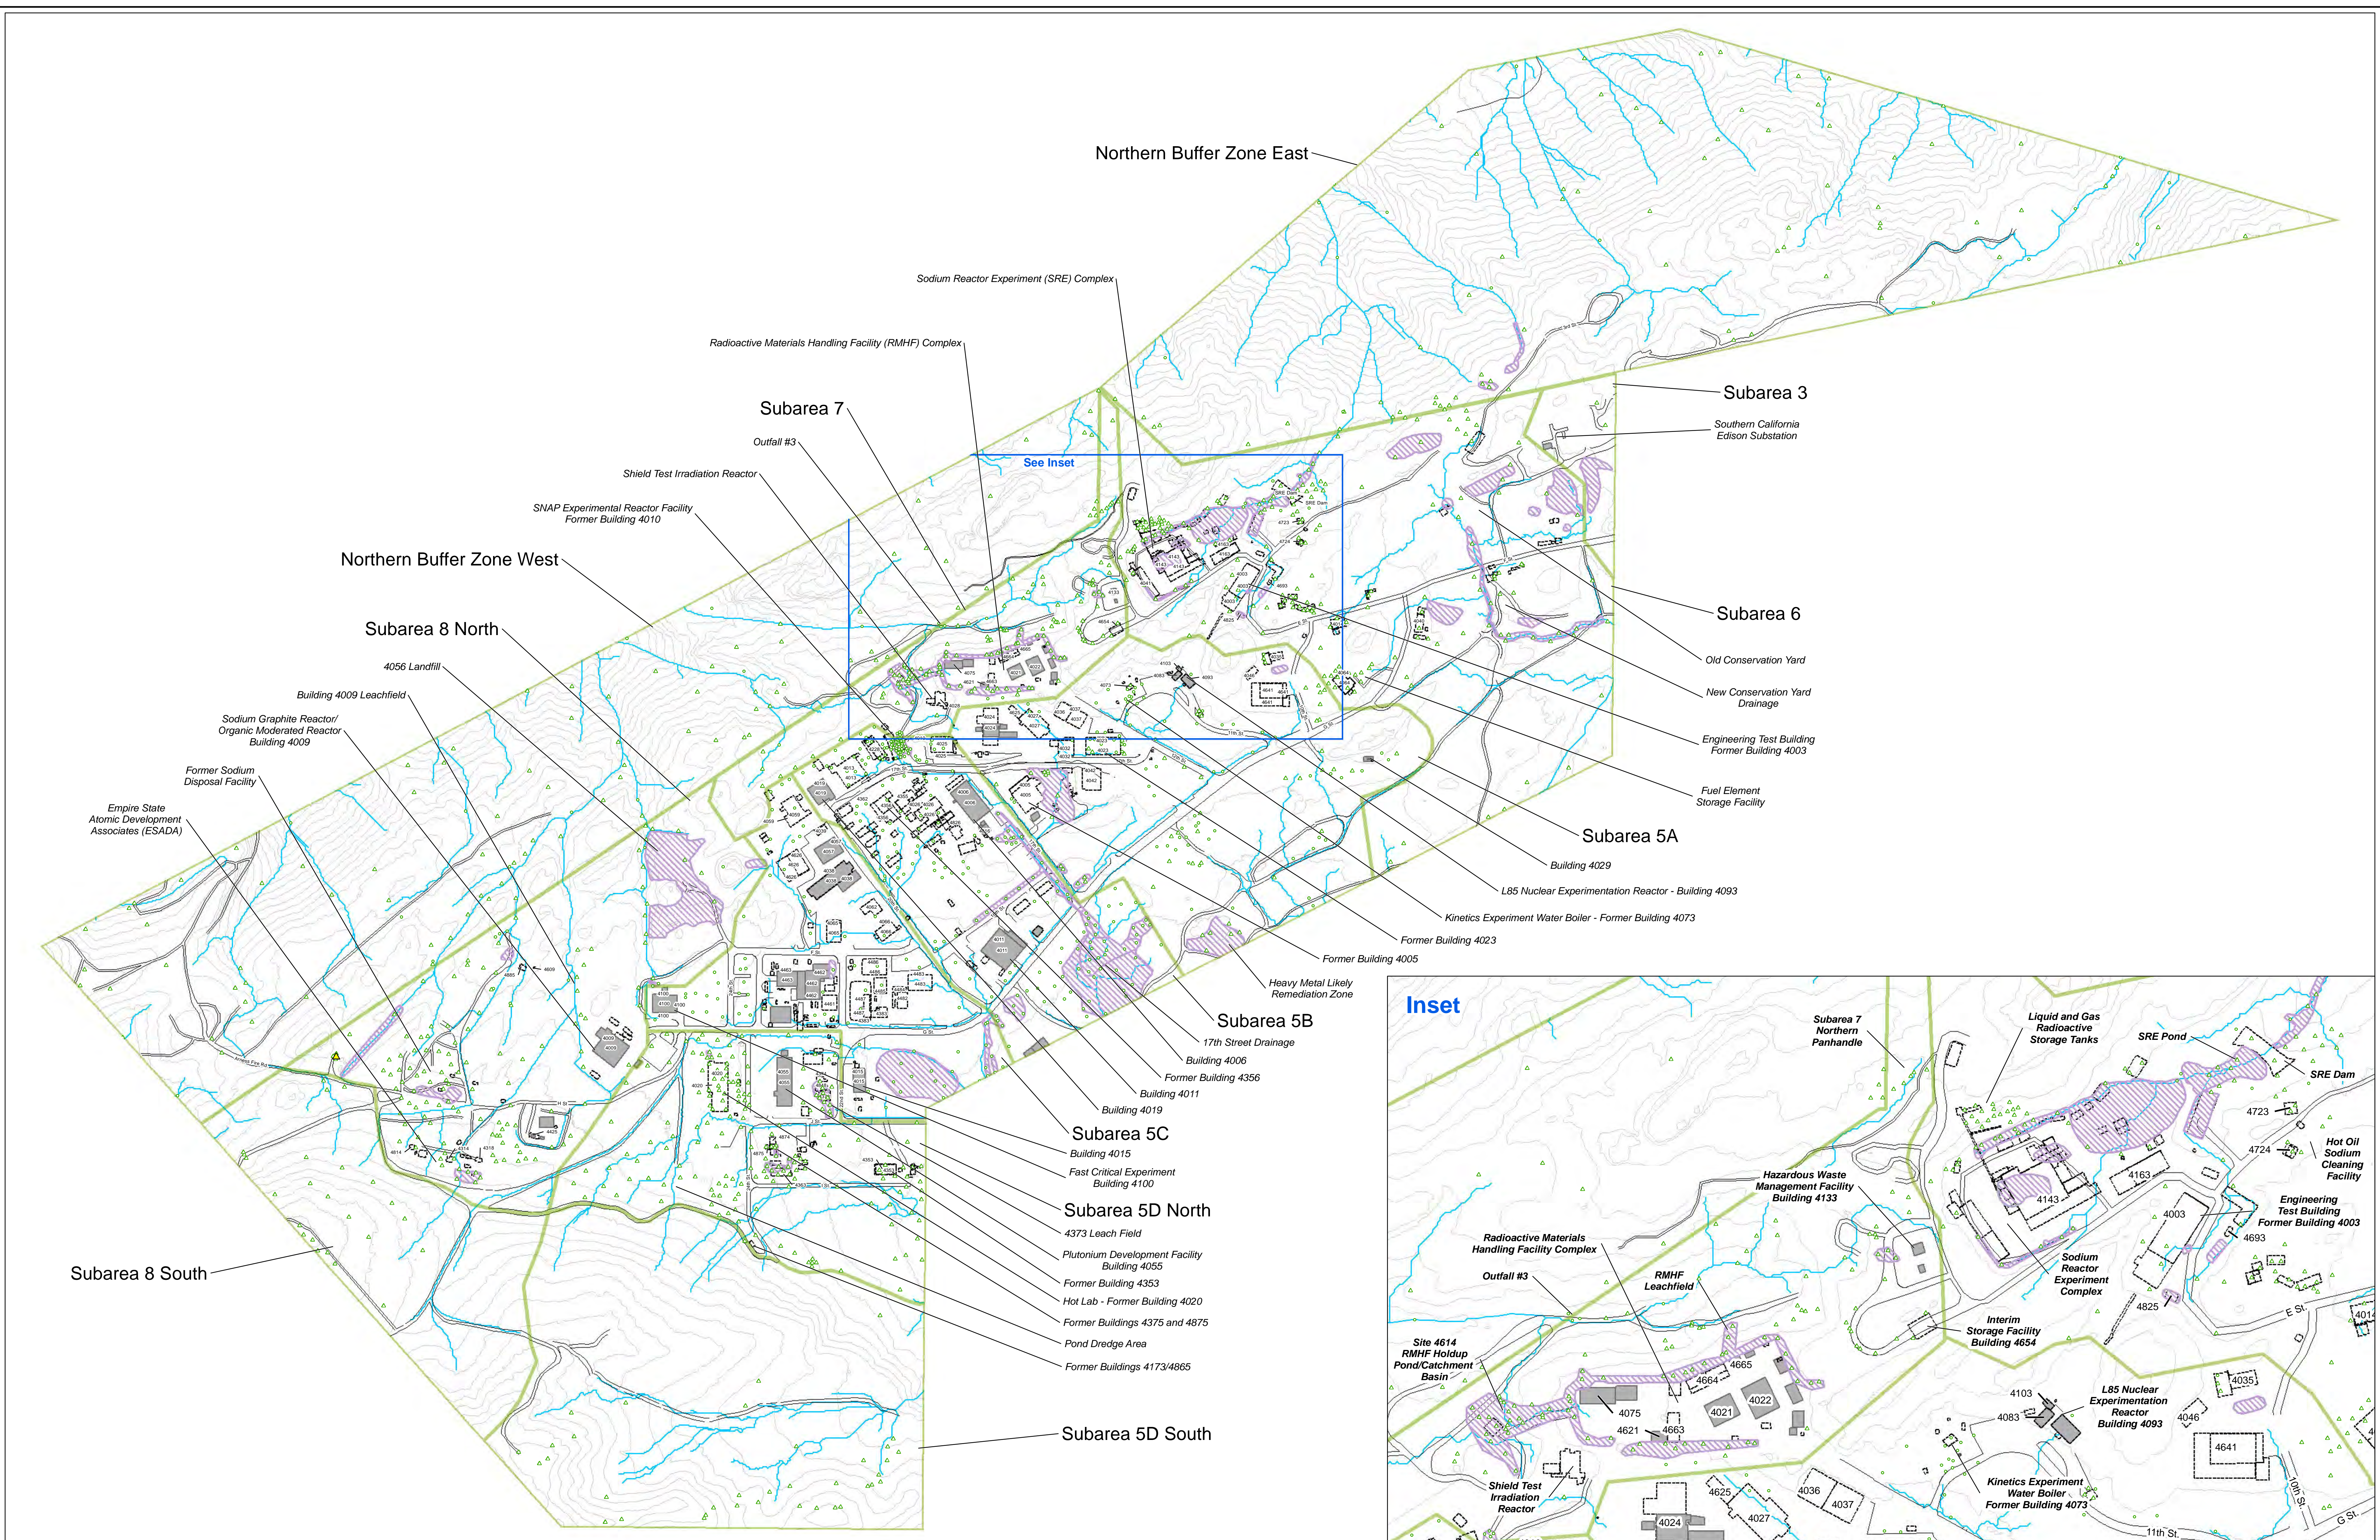
Figure 4.12
Americium-241
Round 1 and 2 Surface Soil
and Sediment Results
Santa Susana Field Laboratory
Area IV and NBZ Radiological Study

Americium-241	GEL (FAL = 0.0410)	TAL (FAL = 0.0162)
Below FAL	△ (Below 0.0410 pCi/g)	○ (Below 0.0162 pCi/g)
FAL to less than 2 times FAL	△ (0.0410 to 0.0819 pCi/g)	○ (0.0162 to 0.0323 pCi/g)
2 times to less than 3 times FAL	△ (0.0820 to 0.122 pCi/g)	○ (0.0324 to 0.0485 pCi/g)
3 times to less than 4 times FAL	△ (0.123 to 0.163 pCi/g)	○ (0.0486 to 0.0647 pCi/g)
Greater than 4 times FAL	△ (0.163 to x.xxx pCi/g)	○ (0.0648 to x.xxxx pCi/g)
