FINAL
RADIOLOGICAL CHARACTERIZATION OF SOILS
AREA IV AND THE NORTHERN BUFFER ZONE

AREA IV RADIOLOGICAL STUDY
SANTA SUSANA FIELD LABORATORY
VENTURA COUNTY, CALIFORNIA

HydroGeoLogic, Inc.
5023 North Parkway Calabasas
Calabasas, California 91302

December 21, 2012

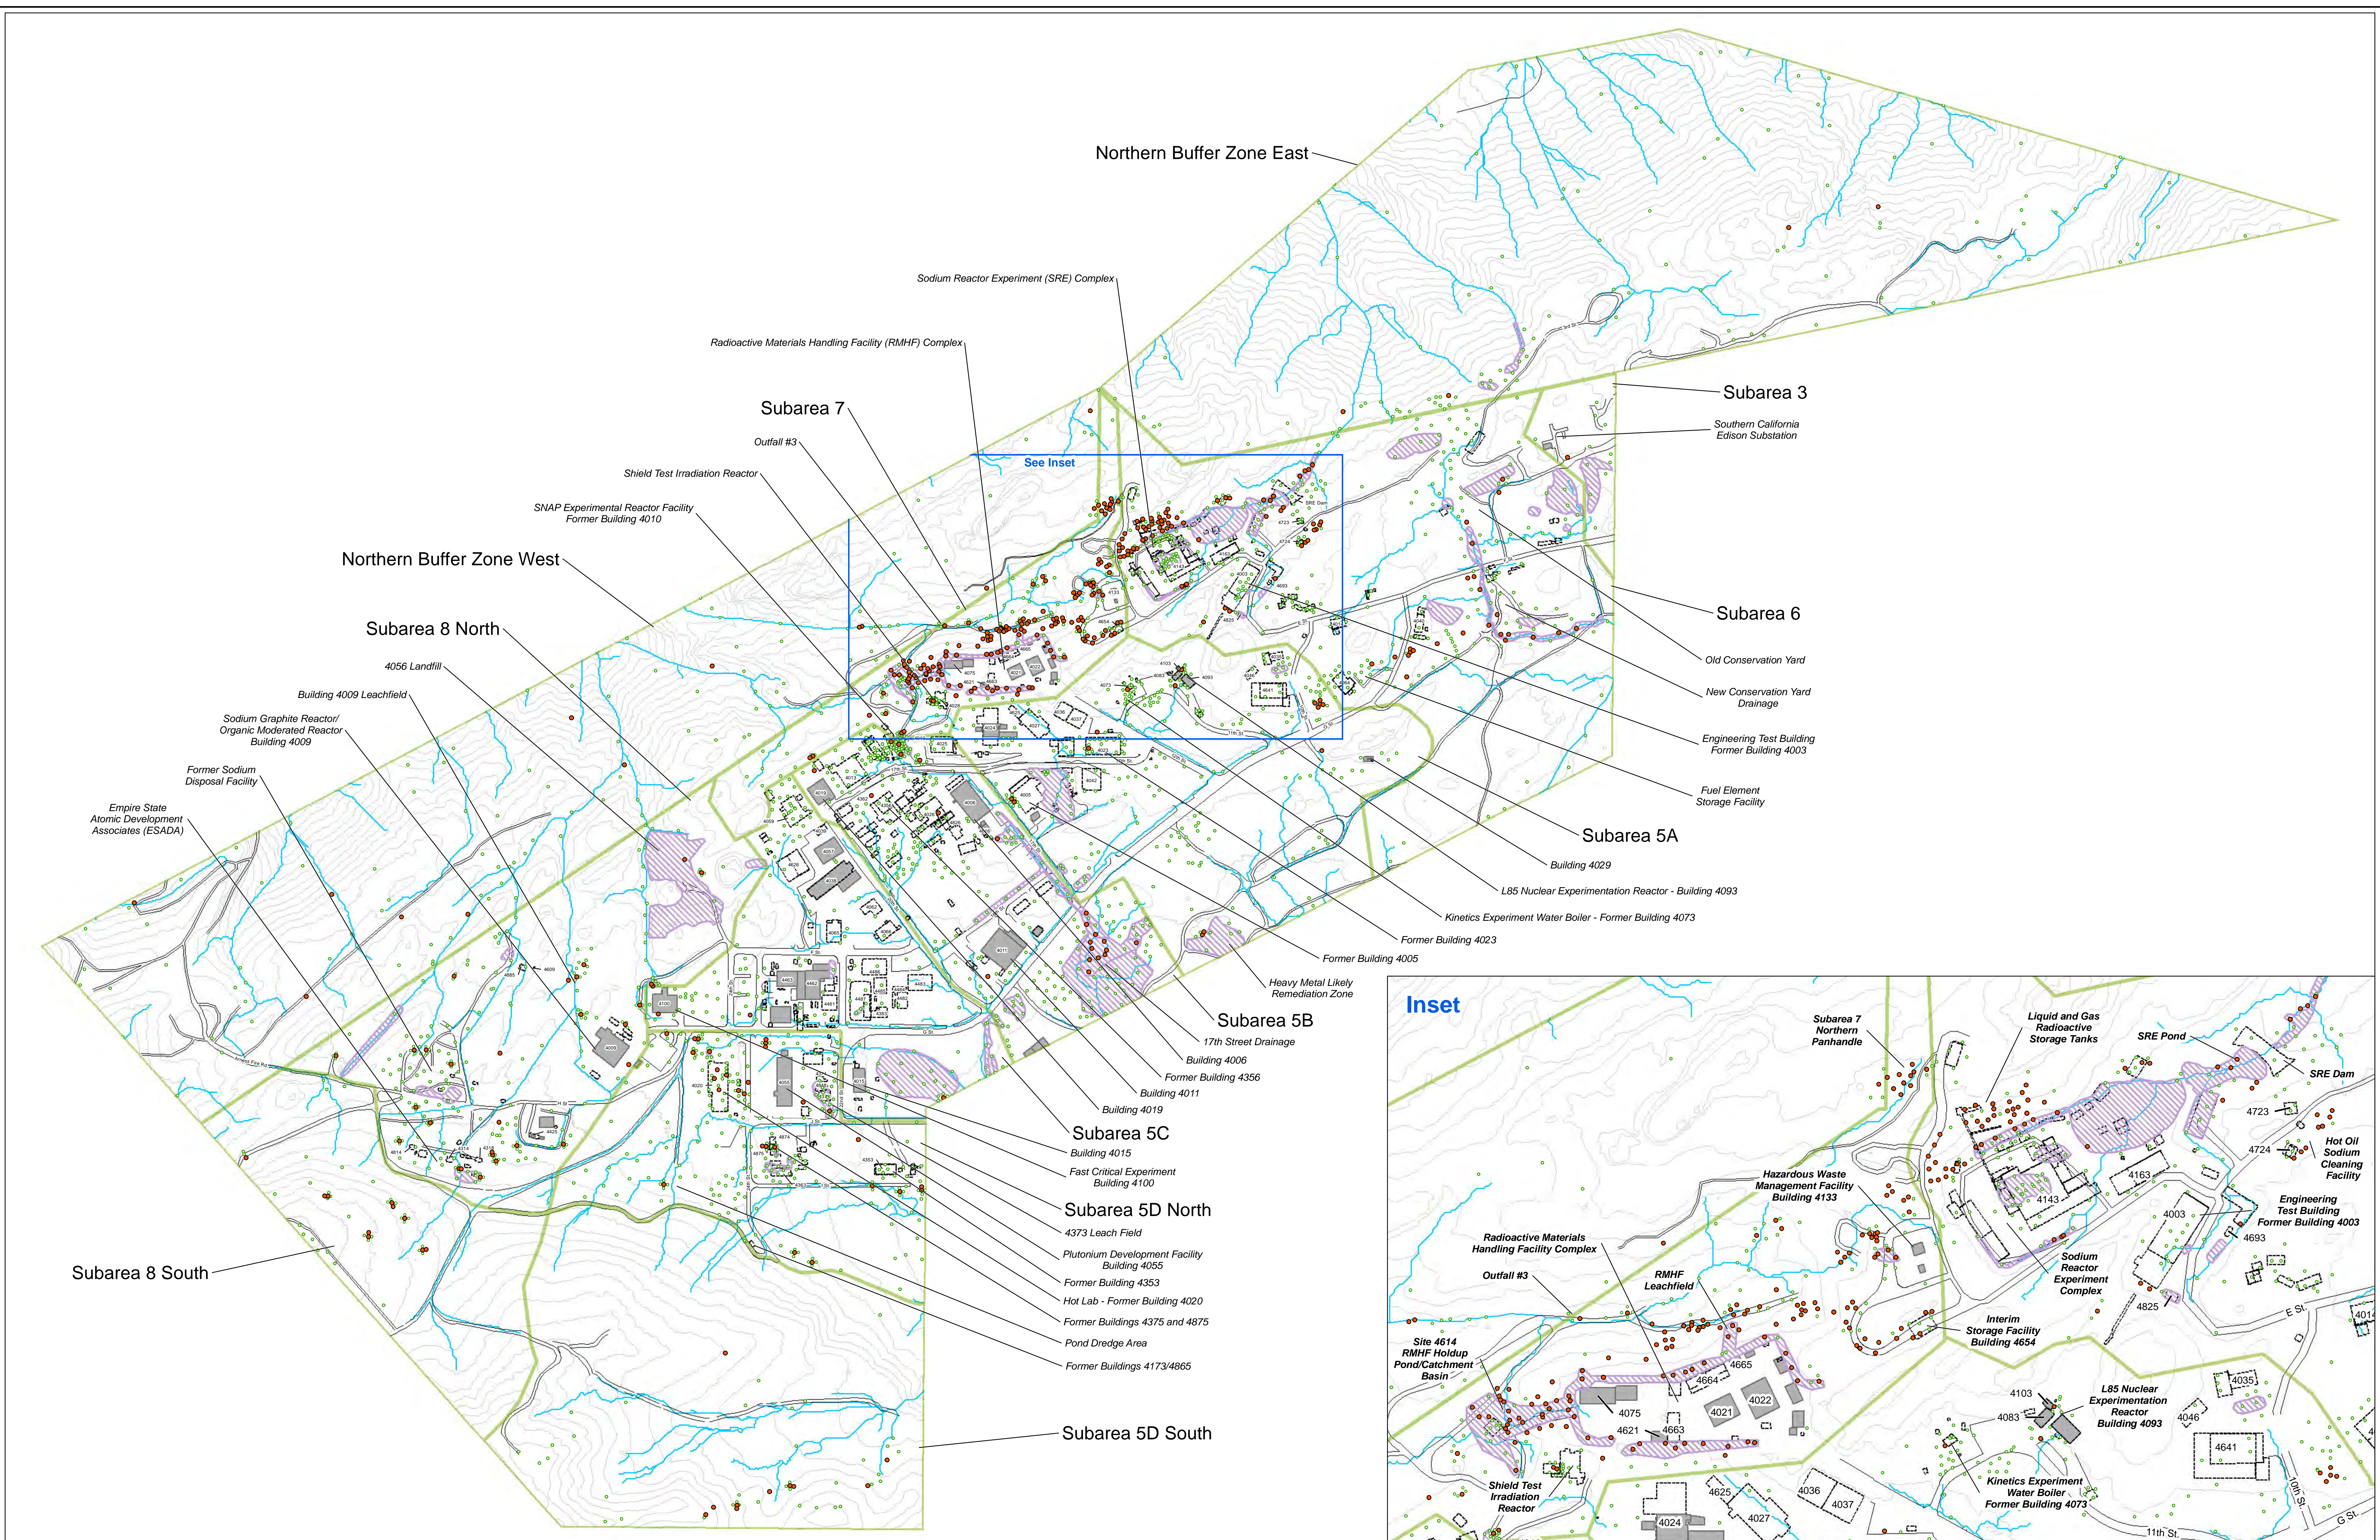
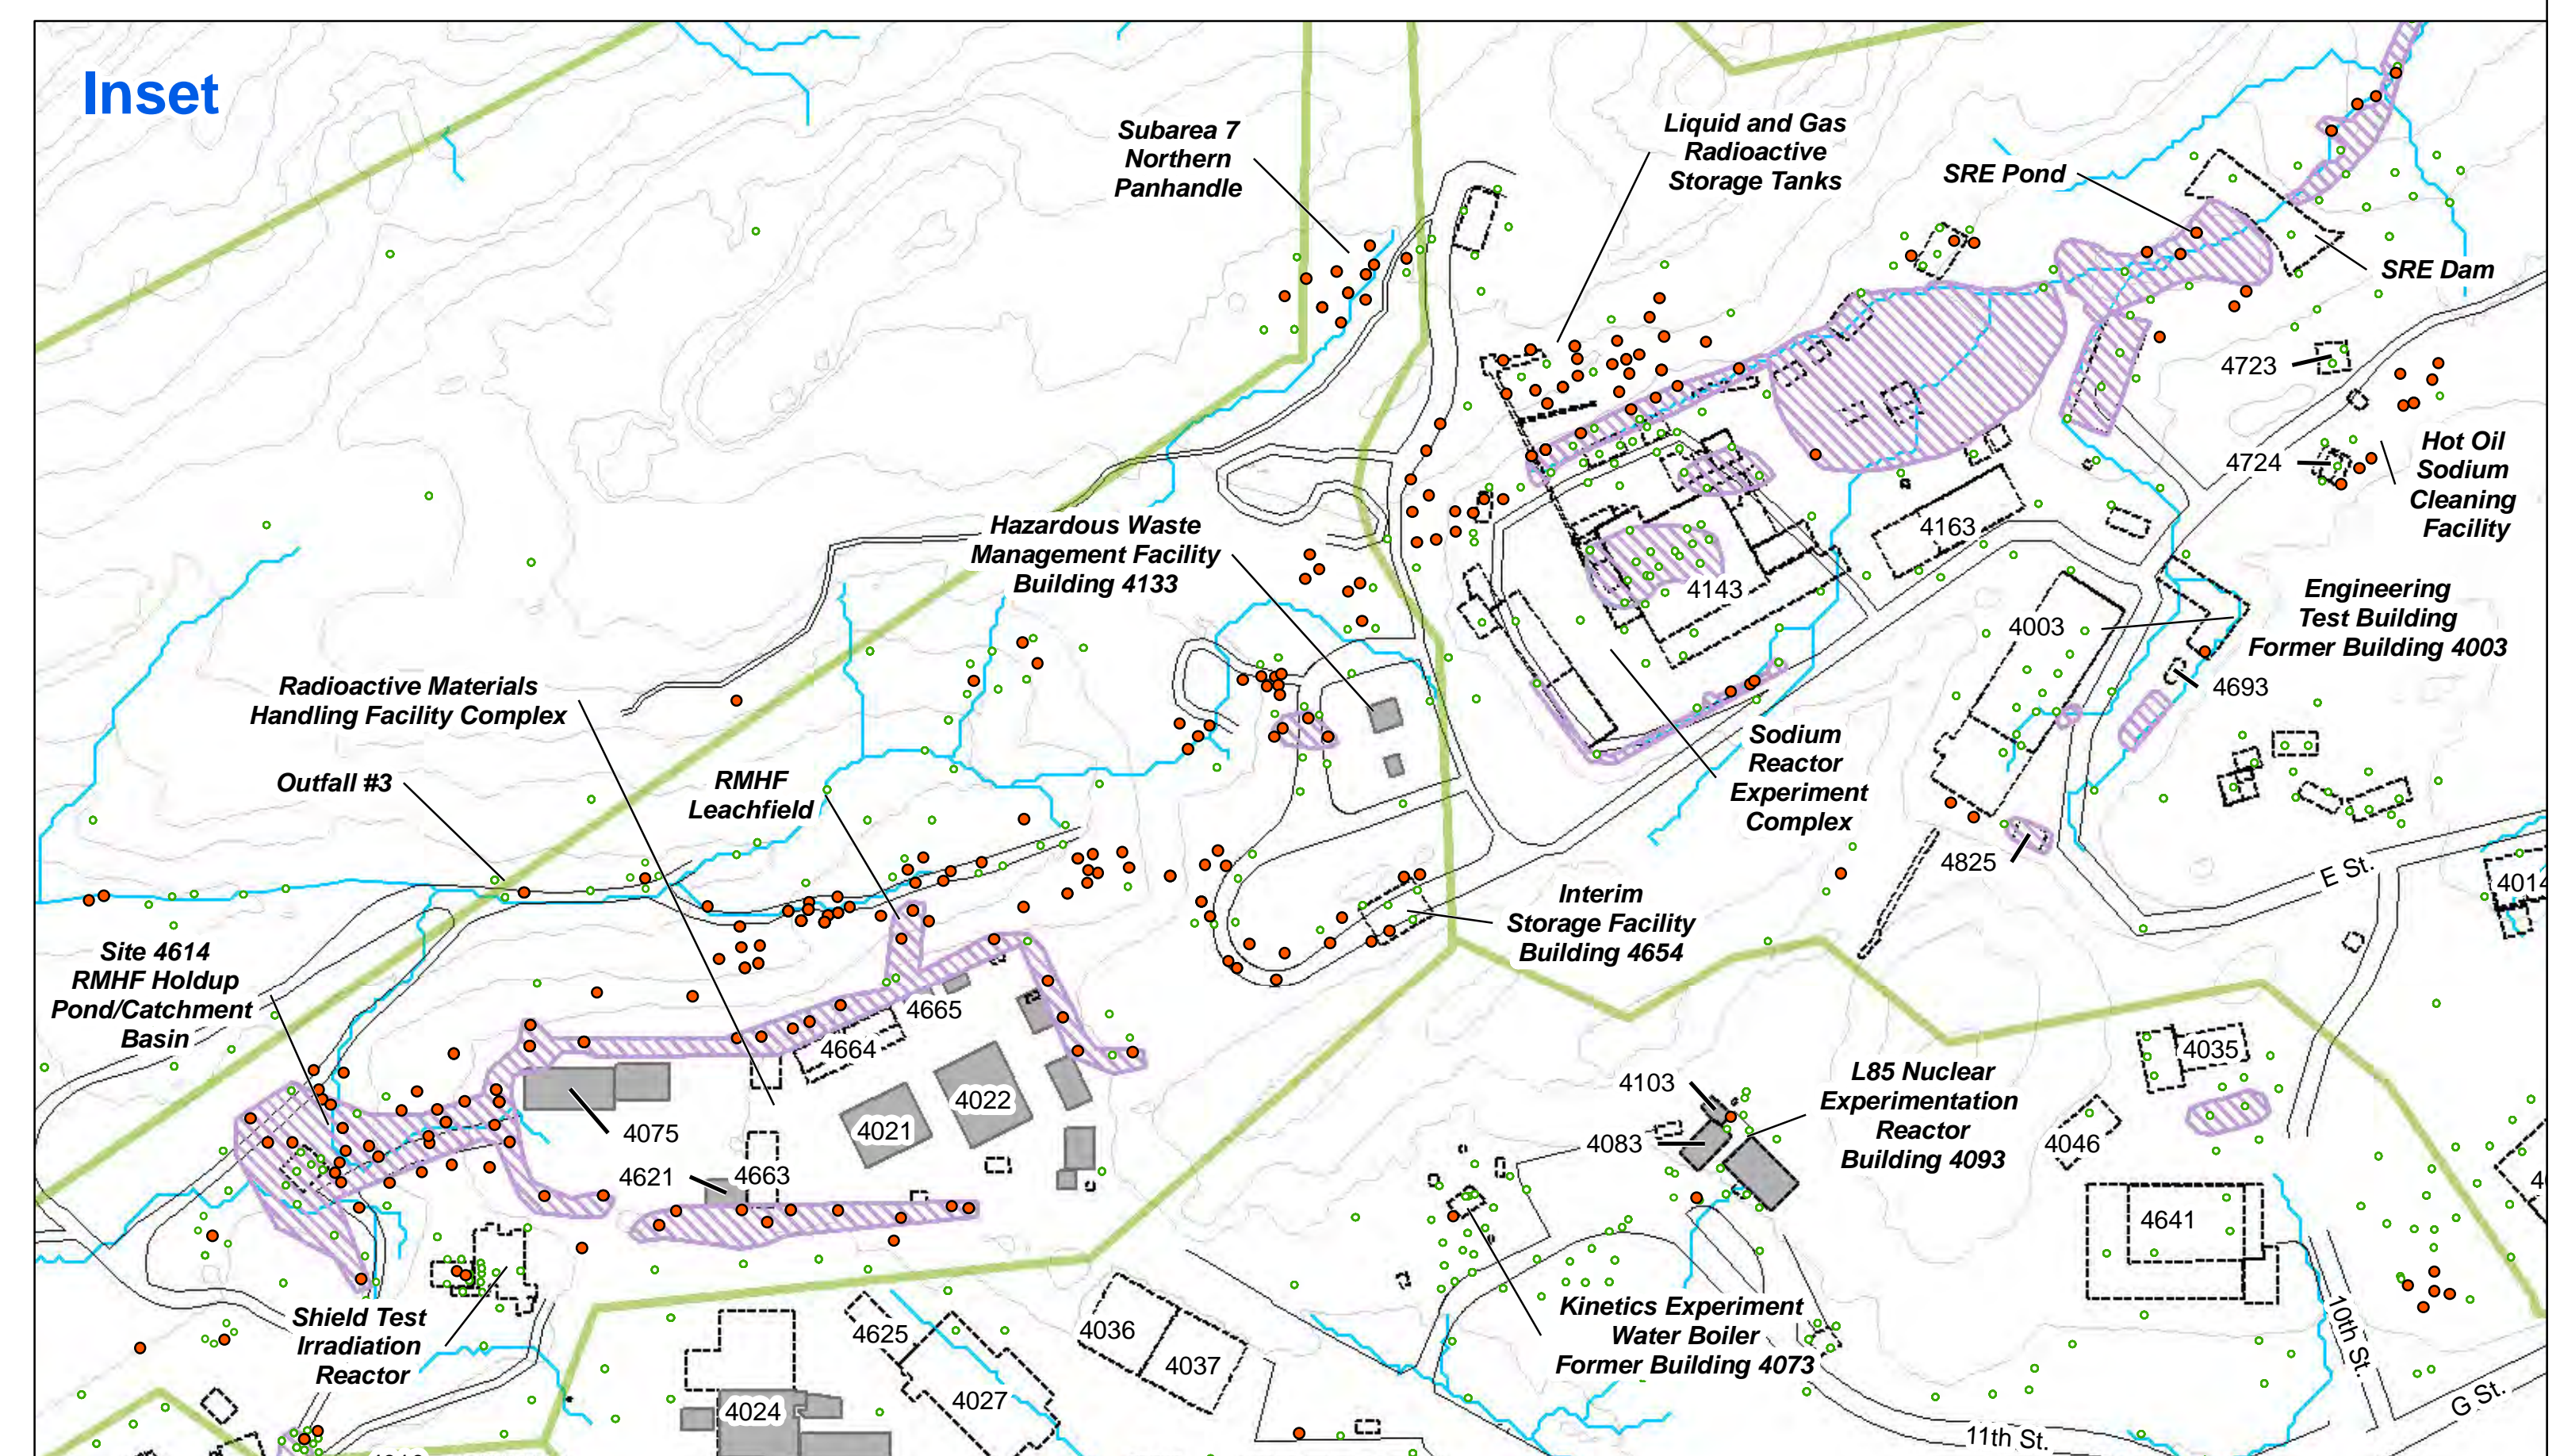
Figure 4.15
Curium-243/244
Round 1 and 2 Subsurface Soil and Sediment Results
Santa Susana Field Laboratory
Area IV and NBZ Radiological Study

A majority of the Radiological Areas of Interest are congregated within specific areas or are associated with key facilities. Figure 5.1 illustrates all sample locations where one or more radionuclides were identified at concentrations greater than their respective FAL. These locations have been grouped into 48 Radiological Areas of Interest, not including the NBZ East and NBZ West, where no specific key feature was present. The Radiological Areas of Interest, the operational history, and associated analytical results are summarized in Table 5.1.

Select Radionuclides of Concern, Surface and Subsurface
 Below FAL
 One or more radionuclides equal or greater than FAL
