**FINAL**  
**RADIOLOGICAL CHARACTERIZATION OF SOILS**  
**AREA IV AND THE NORTHERN BUFFER ZONE**

**AREA IV RADIOLOGICAL STUDY**  
**SANTA SUSANA FIELD LABORATORY**  
**VENTURA COUNTY, CALIFORNIA**

**HydroGeoLogic, Inc.**  
**5023 North Parkway Calabasas**  
**Calabasas, California 91302**

**December 21, 2012**

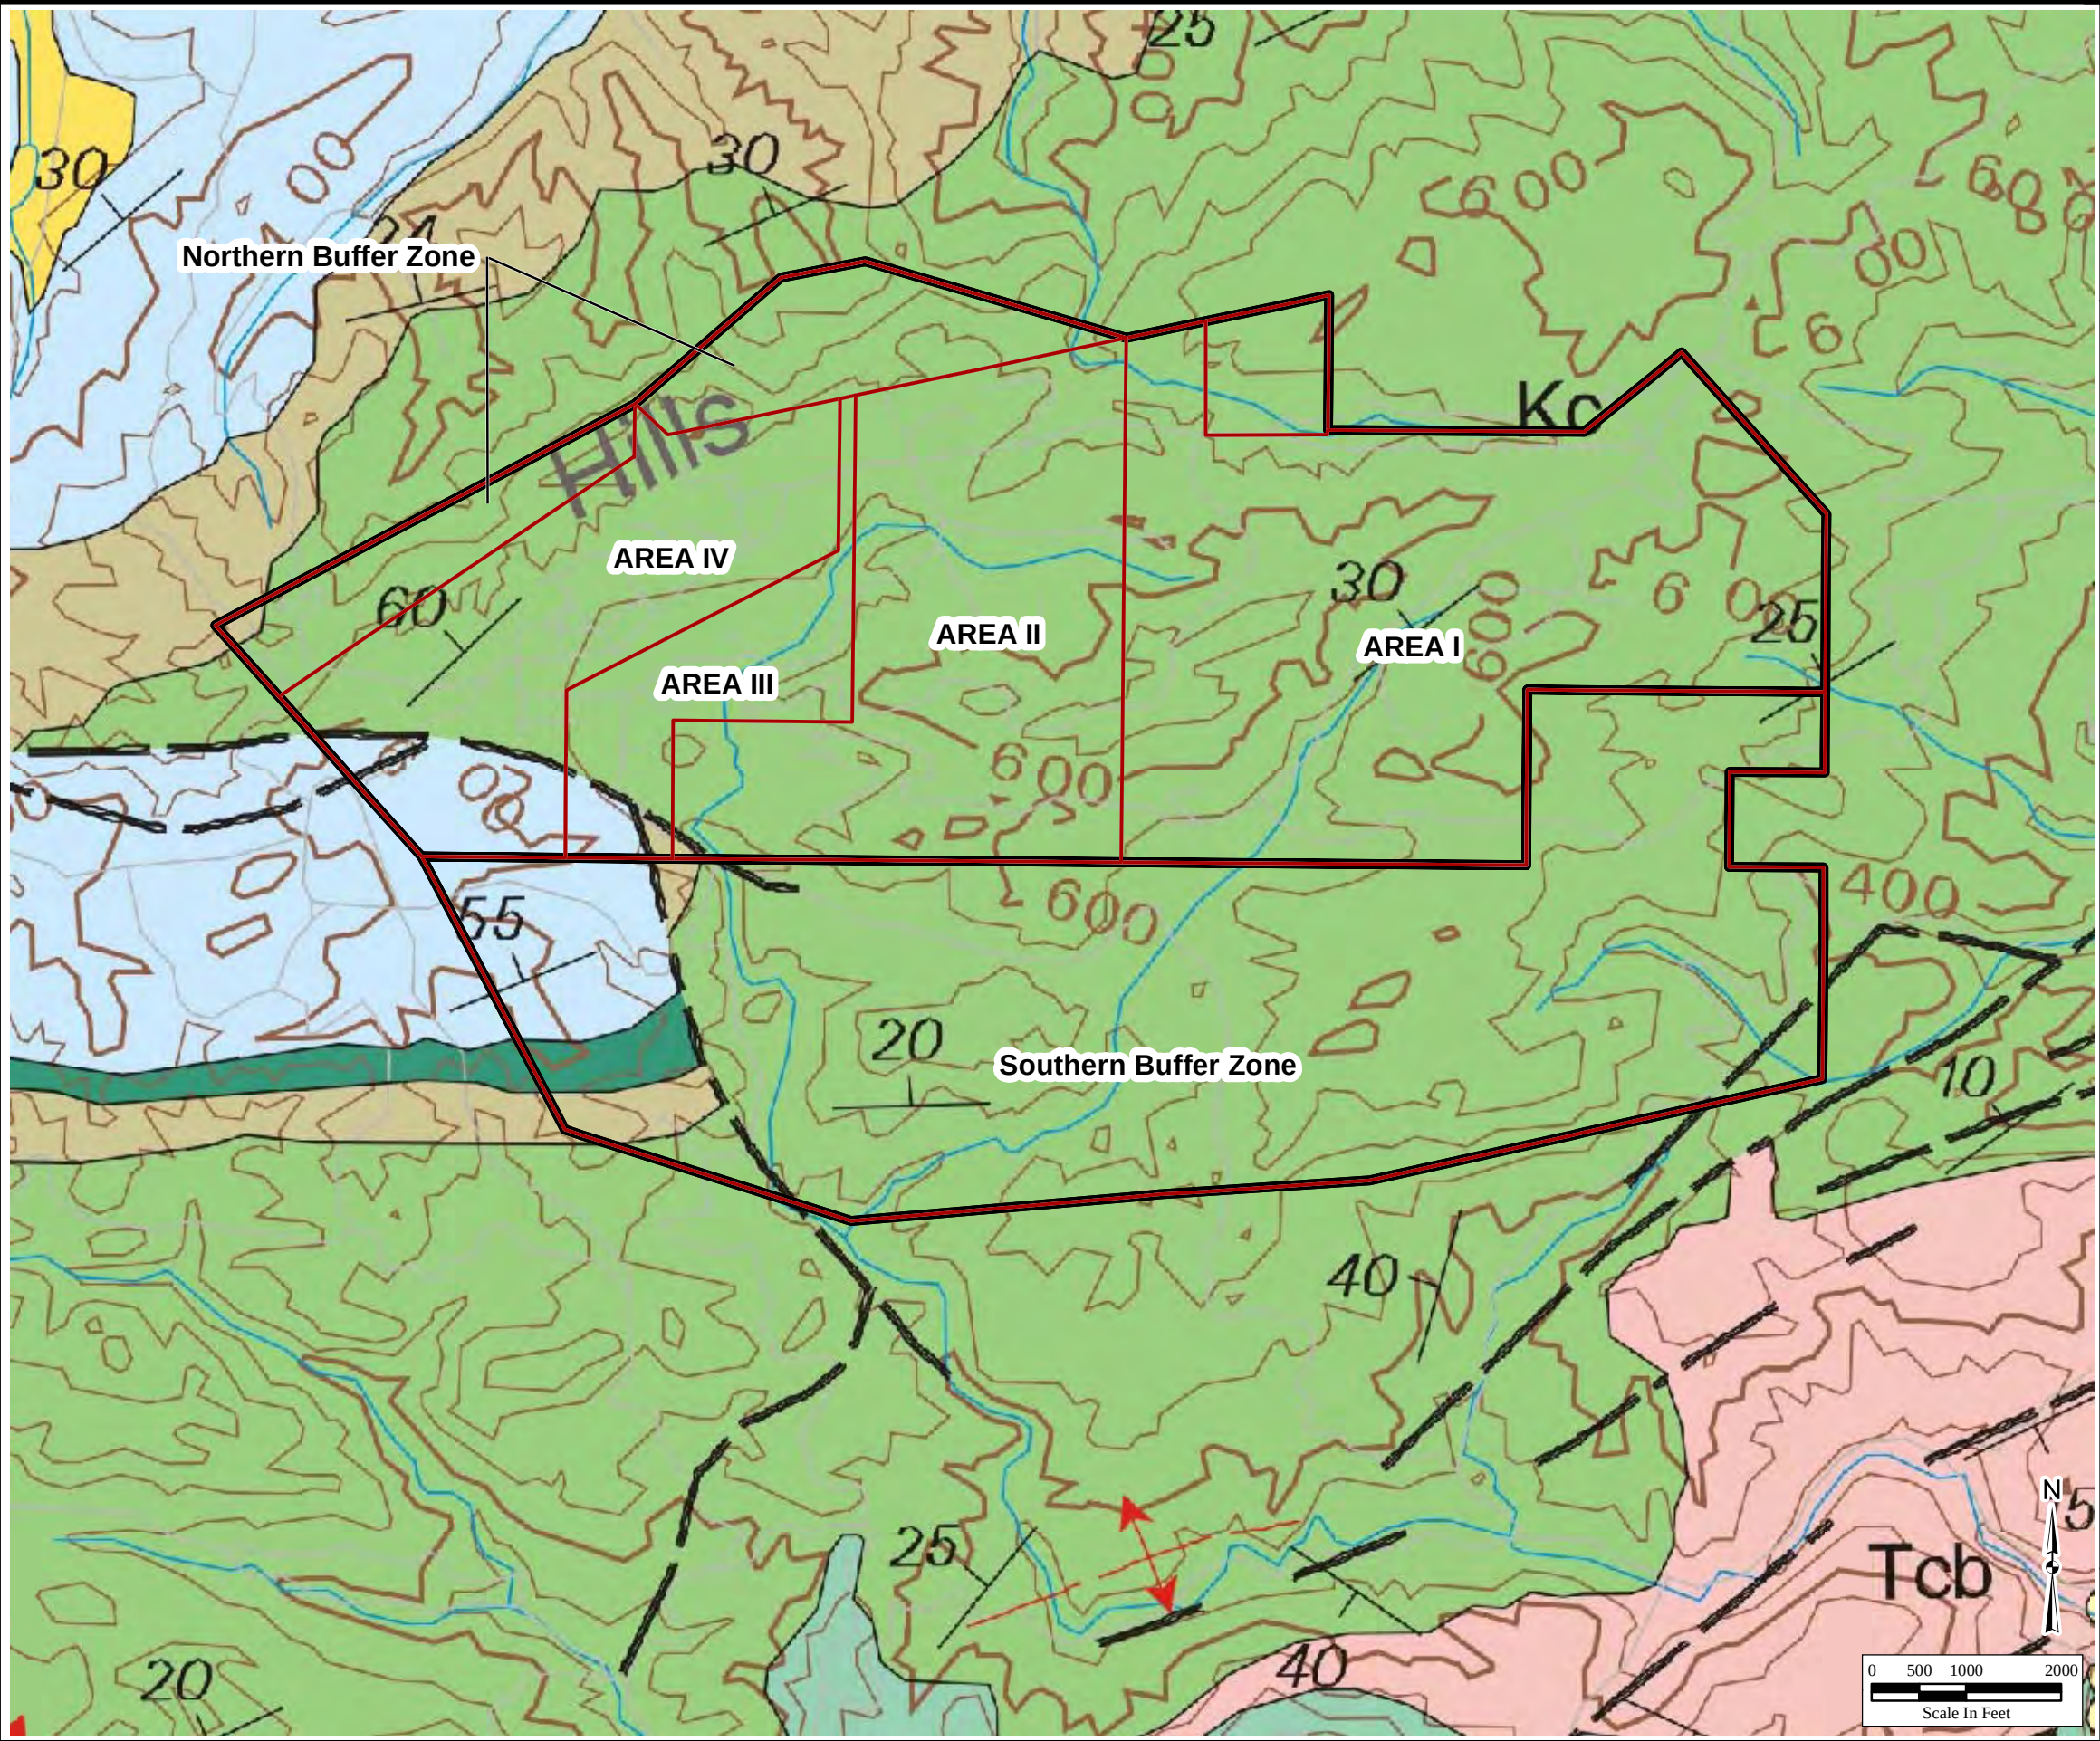
**Figure 2.5**  
**Geologic Map**  
**Santa Susana Field Laboratory**

Fault (approximate location)

The Chatsworth Formation consists of three unnamed members. The members were deposited by turbidity currents in a deep ocean at depths ranging from 4,000 to 5,000 feet. Turbidity currents cause massive submarine landslides from the continental shelf into submarine canyons which are generally more than a half-mile wide and greater than ten miles in length. During periods without turbidity currents, silt and clay particles from runoff filtered to the ocean floor and formed the siltstone strata found in the formation.

Deposited in the late Cretaceous, the Chatsworth Formation is in excess of 6,000 feet thick. The uppermost member is a thick strata of light gray to brown sandstone, which is hard, coherent, arkosic, micaceous, primarily medium grained separated by thin partings of siltstone. The middle member is a gray conglomerate of cobbles of rounded, polished clasts of quartzite, porphyry and granitic rocks in hard rock matrix. The lower member is gray clay shale, crumbly with ellipsoidal fracture where weathered, and may include sandstone strata.

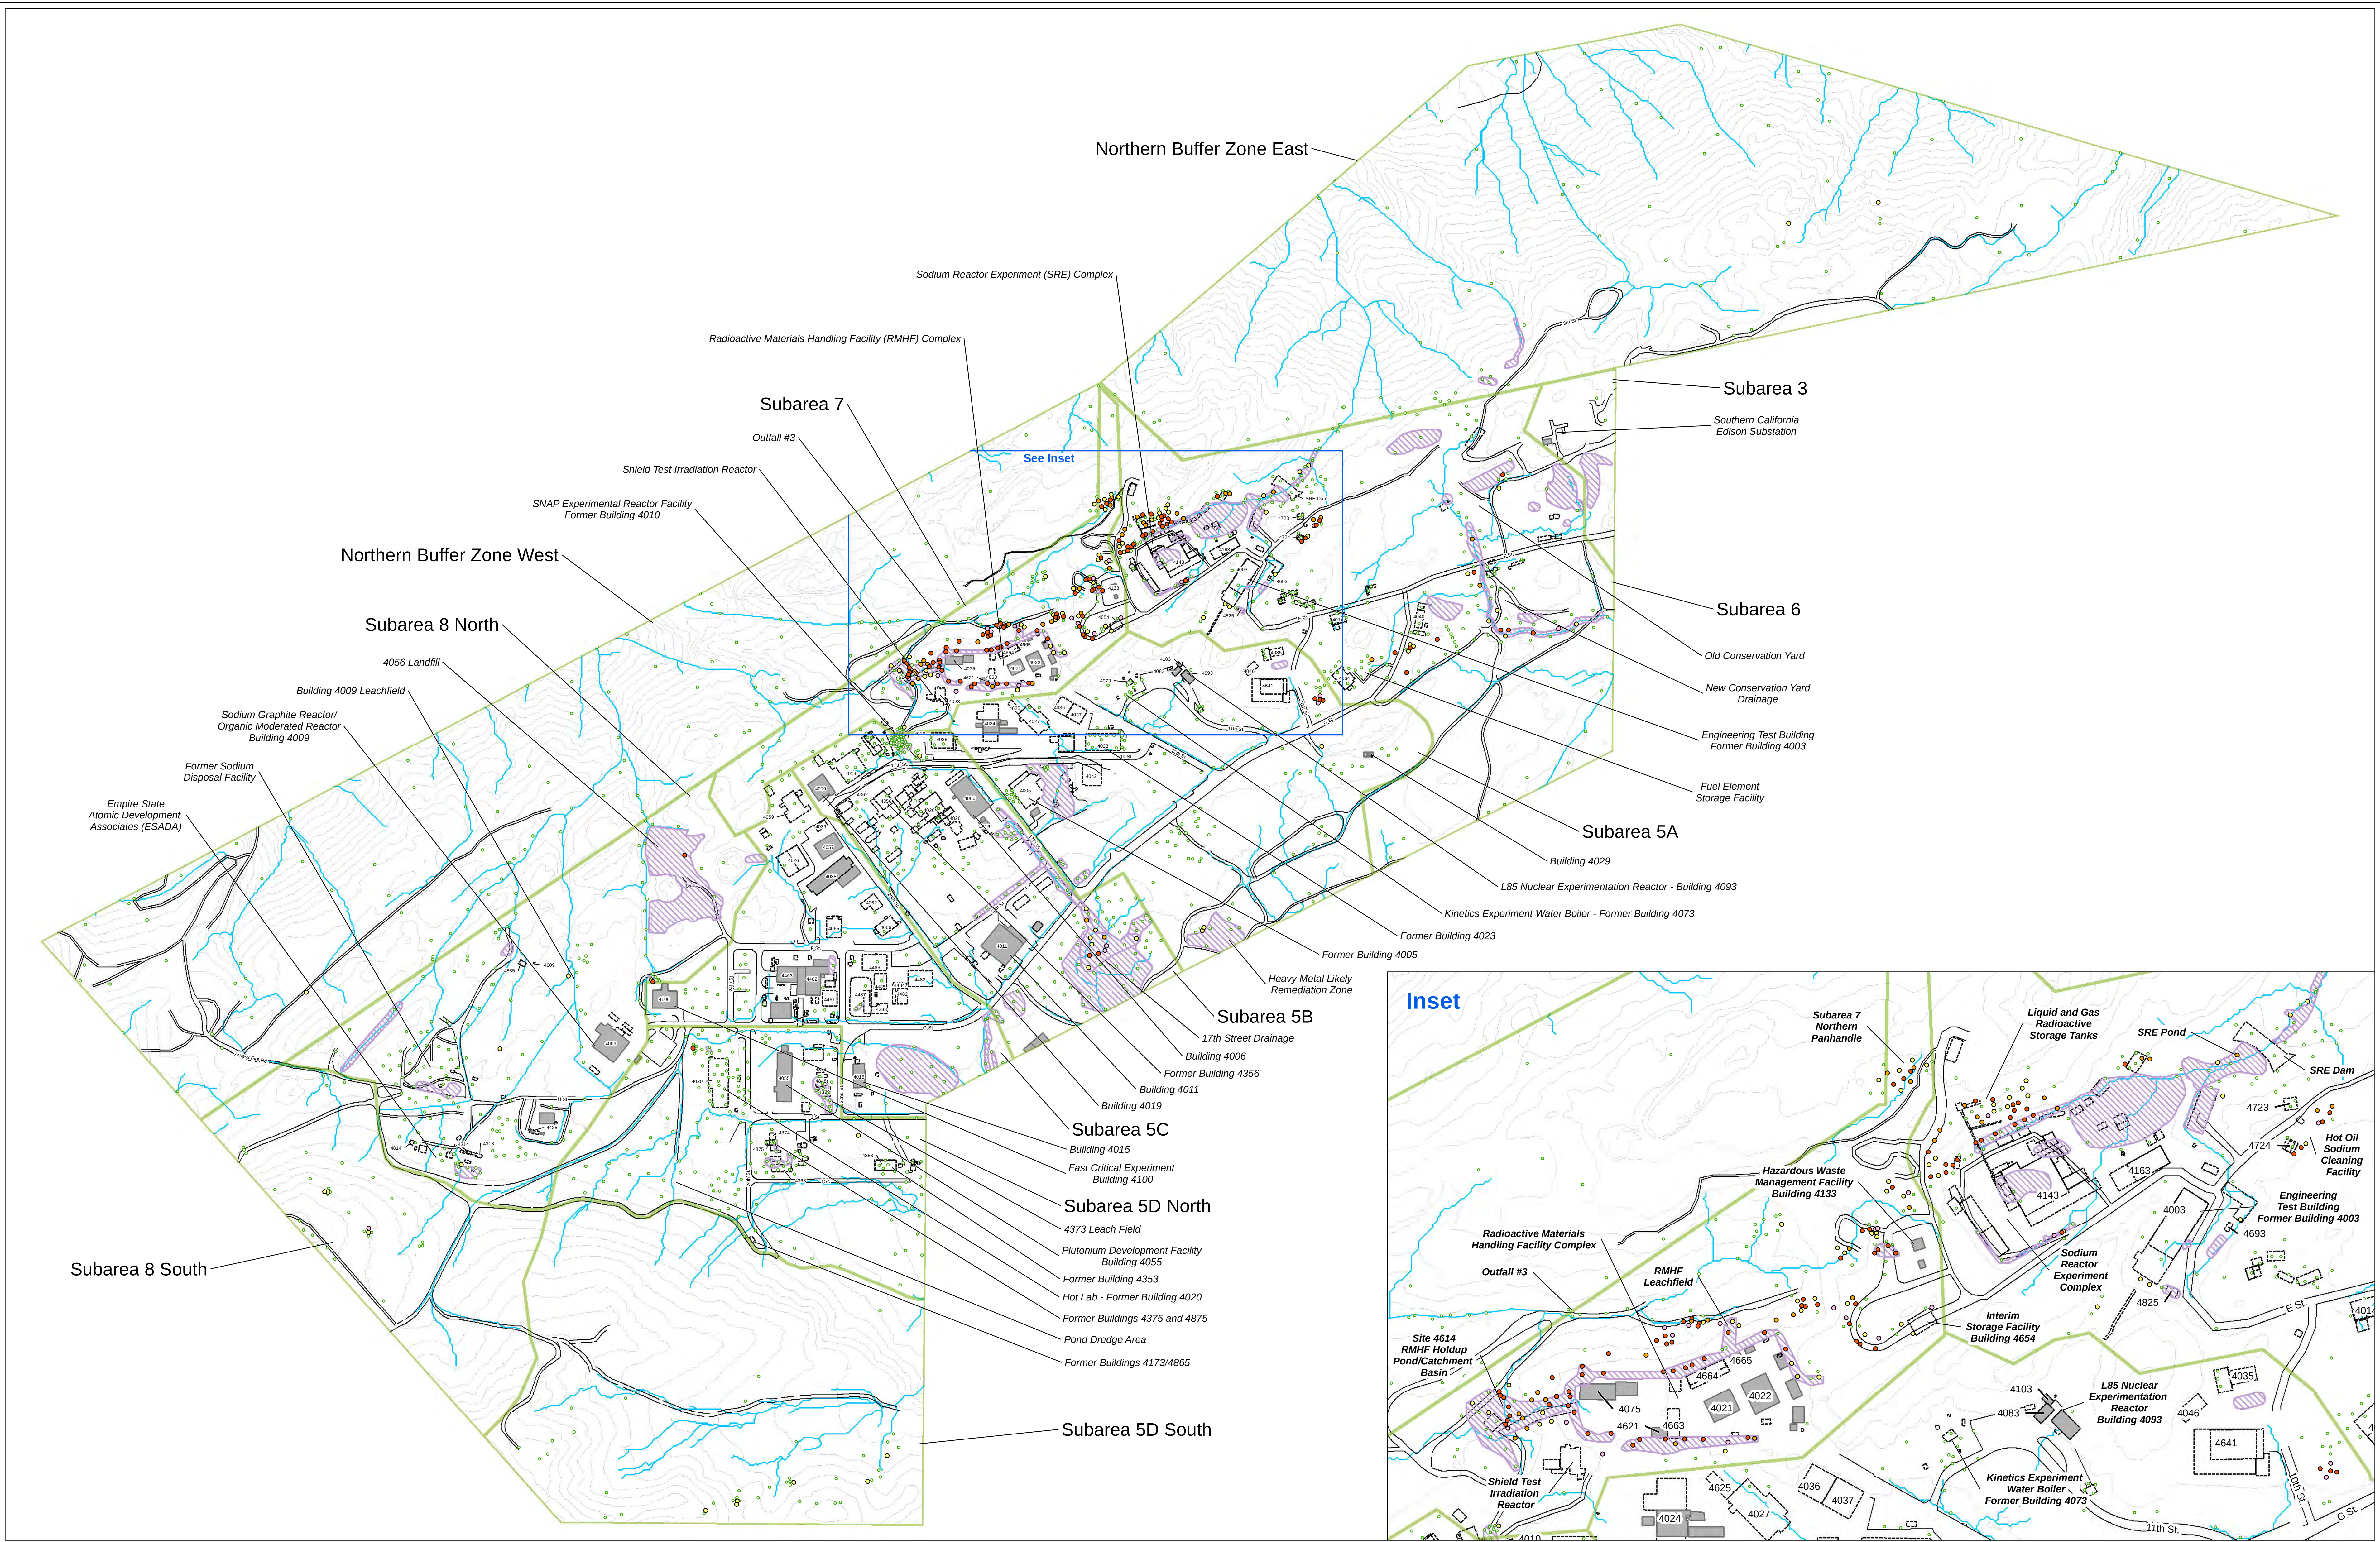
**Figure 4.1**  
**Cesium-137**  
**Round 1 and 2 Surface Soil**  
**and Sediment Results**  
**Santa Susana Field Laboratory**  
**Area IV and NBZ Radiological Study**

**Cesium-137 (FAL = 0.193)**

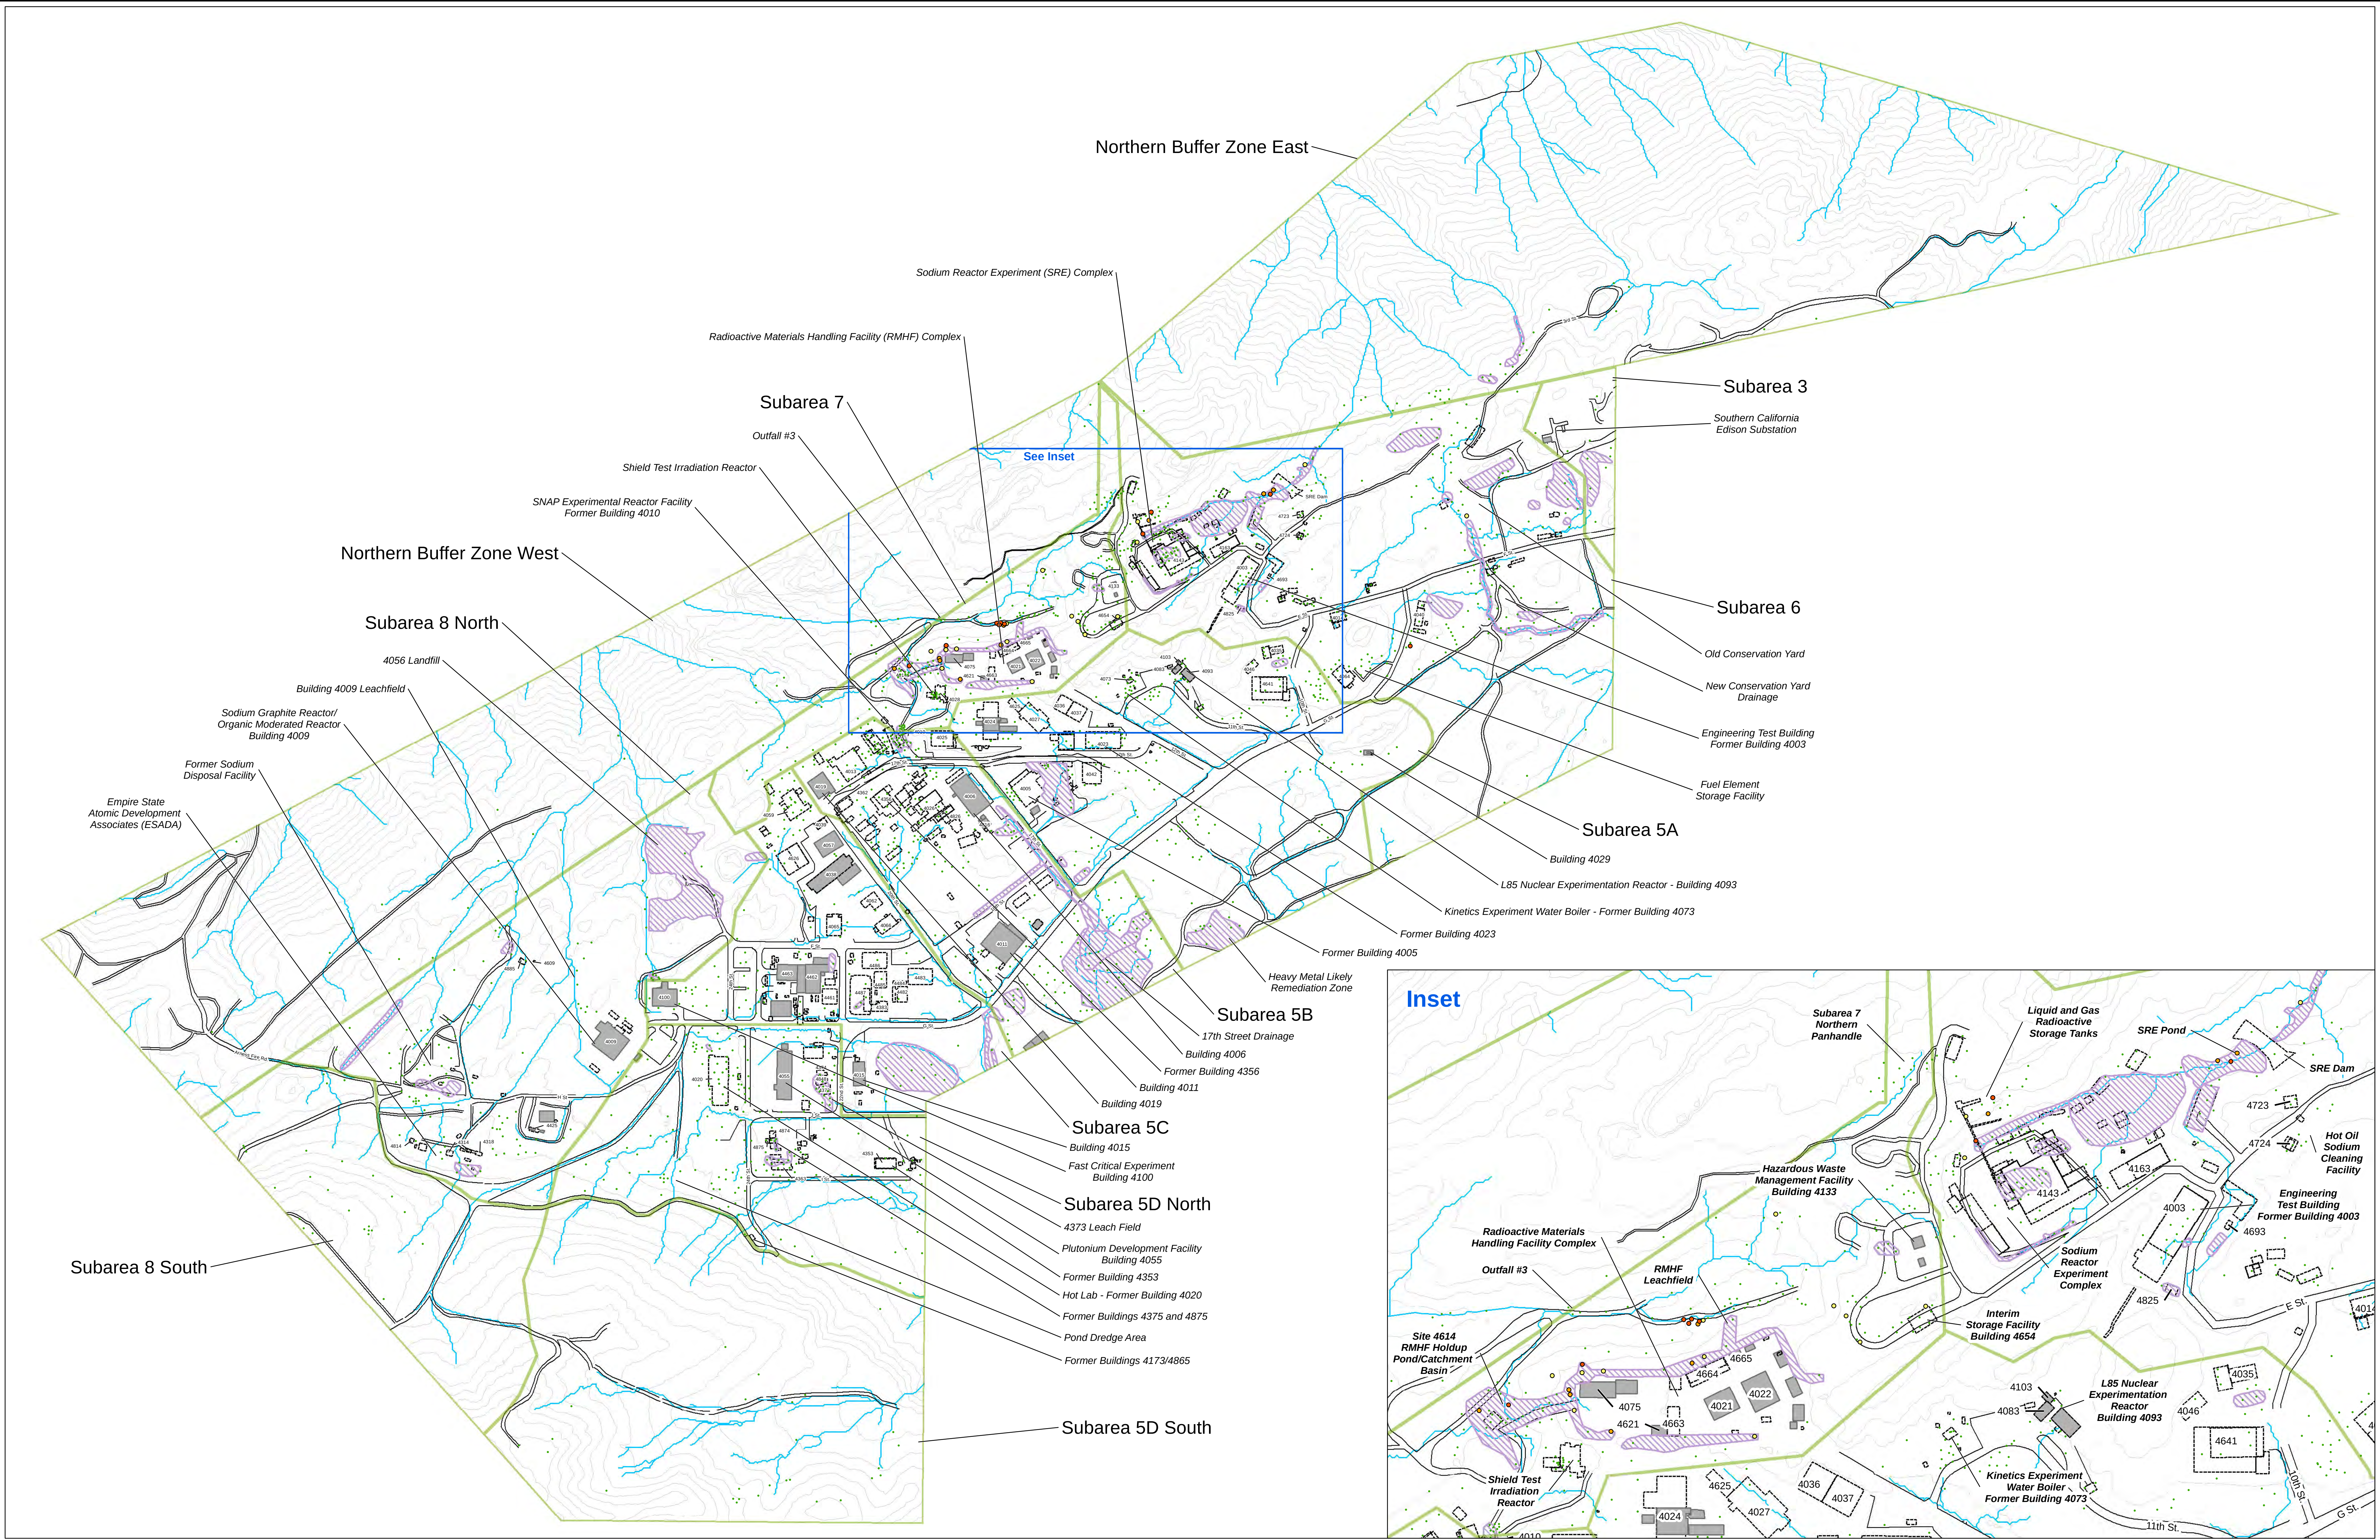
Figure 4.2  
Cesium-137  
Round 1 and 2 Subsurface Soil  
and Sediment Results  
Santa Susana Field Laboratory  
Area IV and NBZ Radiological Study

Cesium-137 (FAL = 0.193)

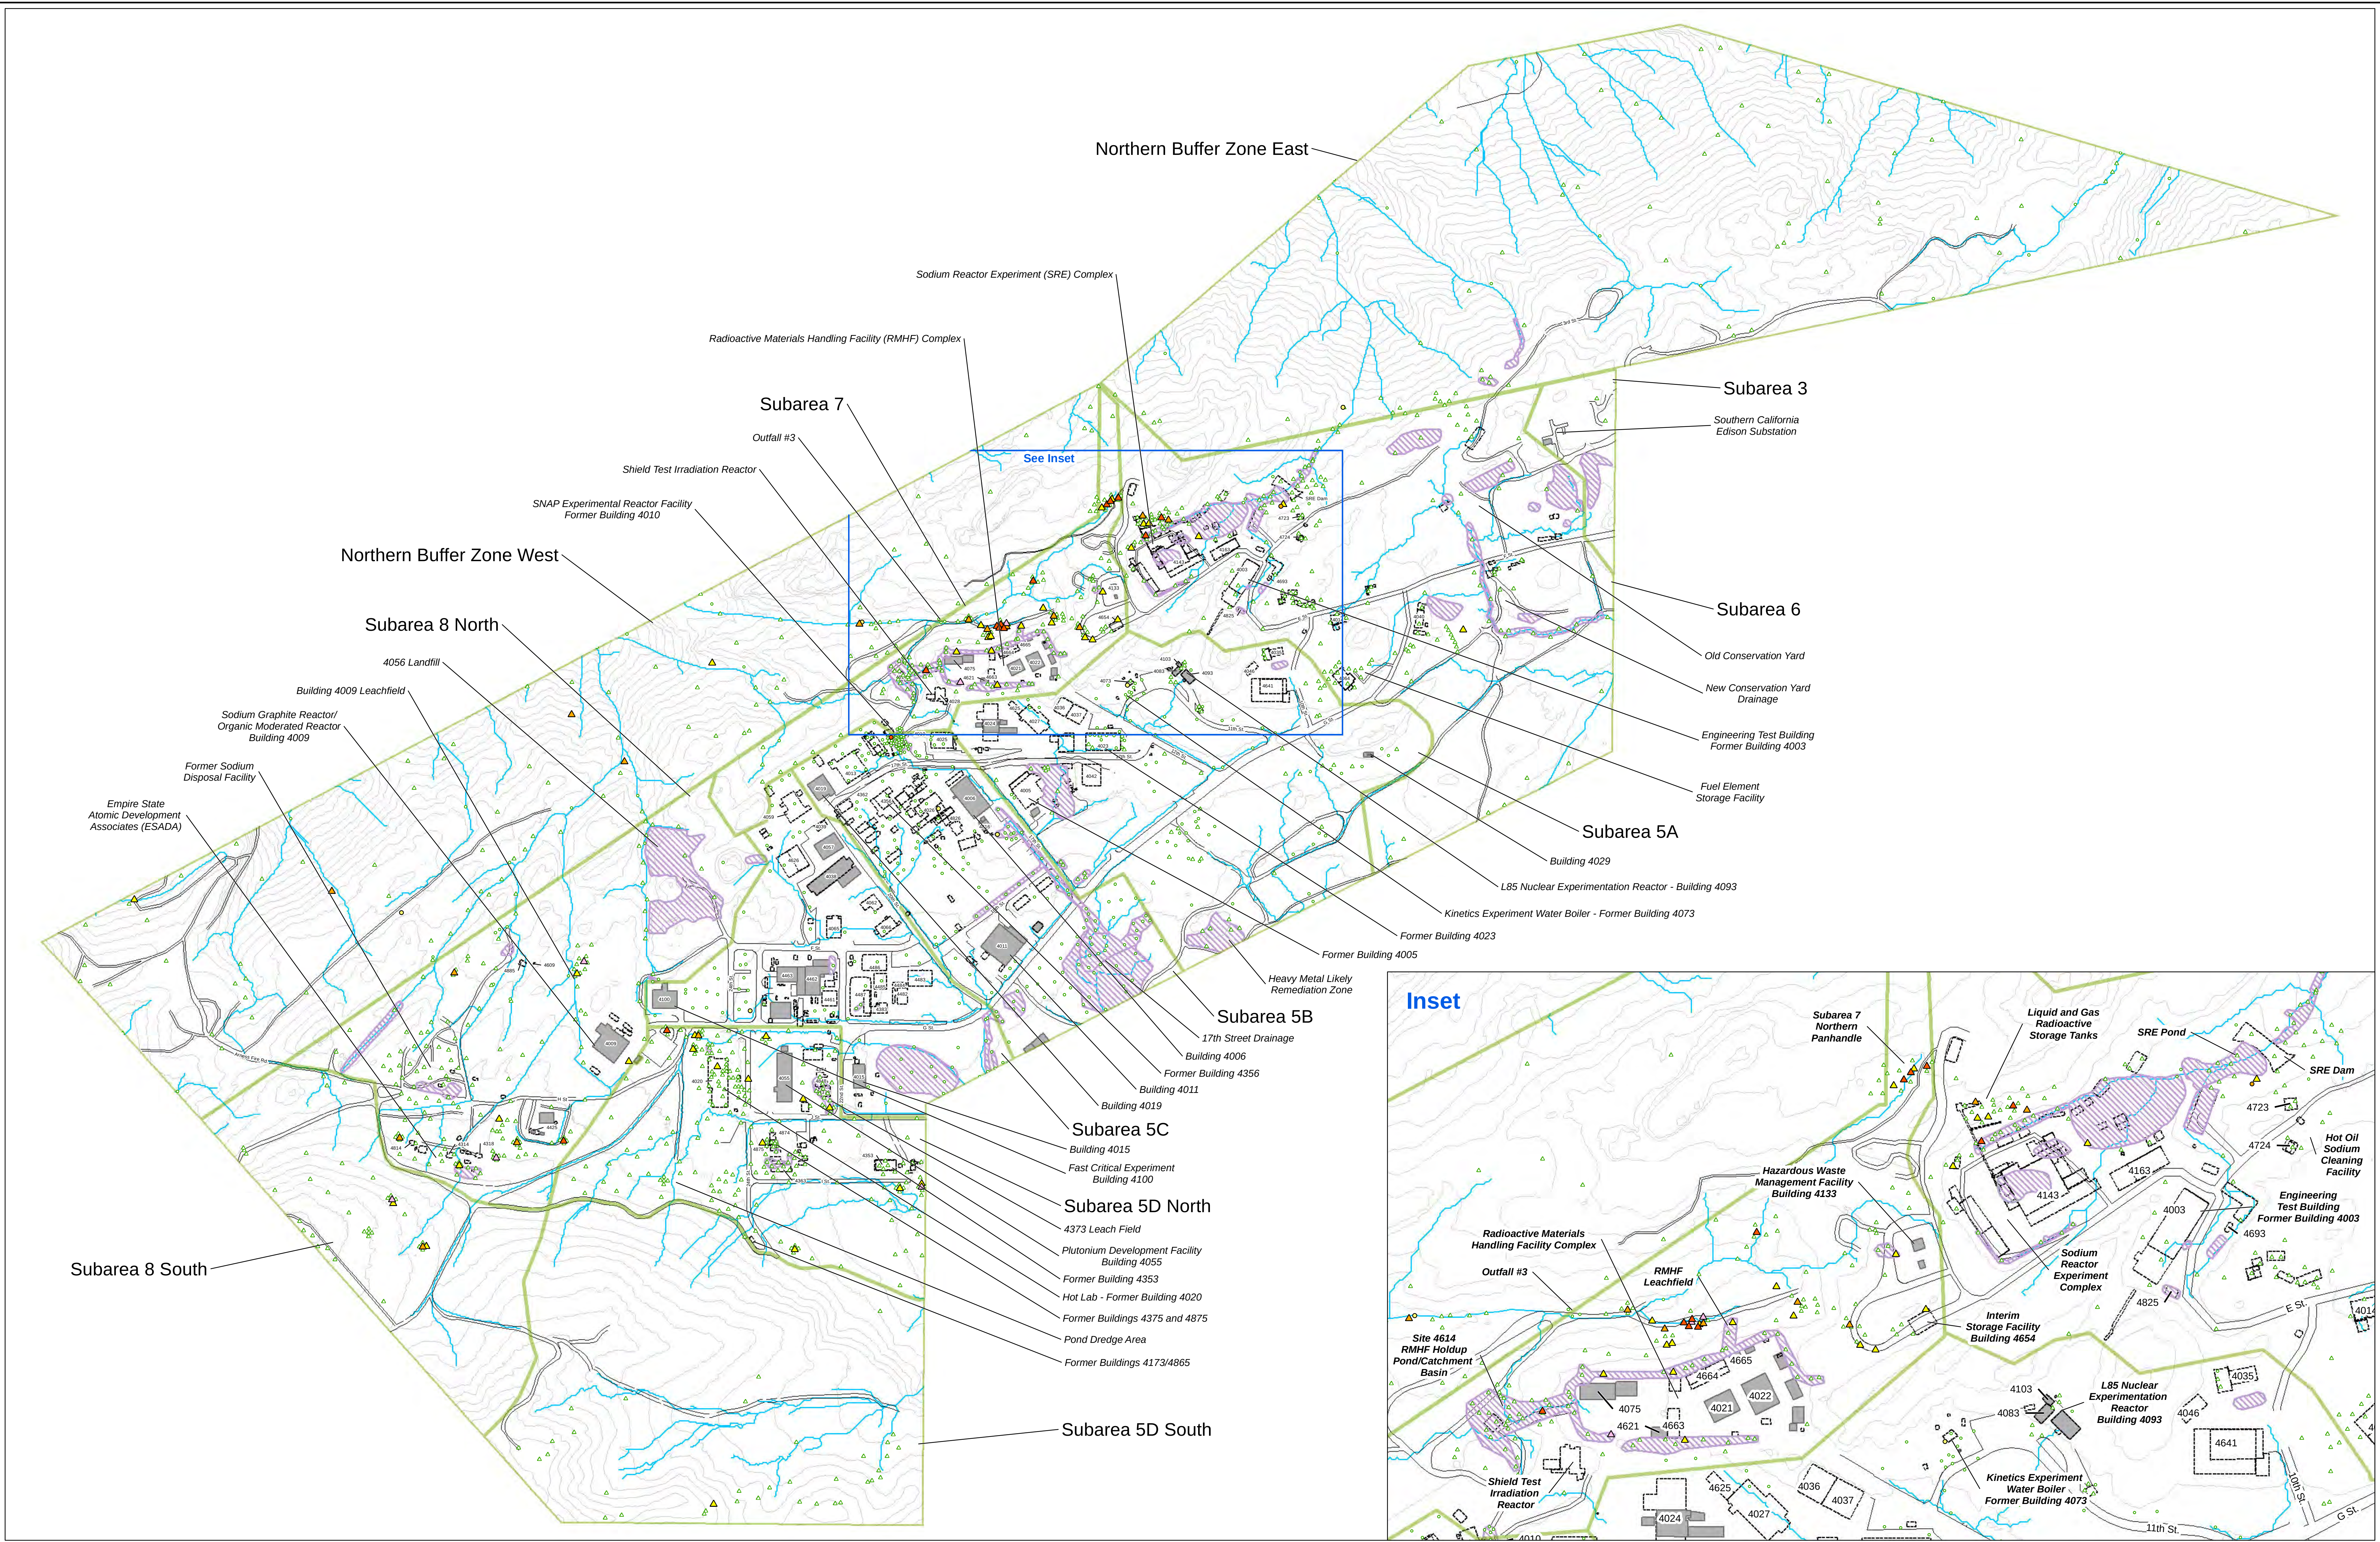
**Figure 4.3**  
**Strontium-90**  
**Round 1 and 2 Surface Soil**  
**and Sediment Results**  
**Santa Susana Field Laboratory**  
**Area IV and NBZ Radiological Study**

**Strontium-90**

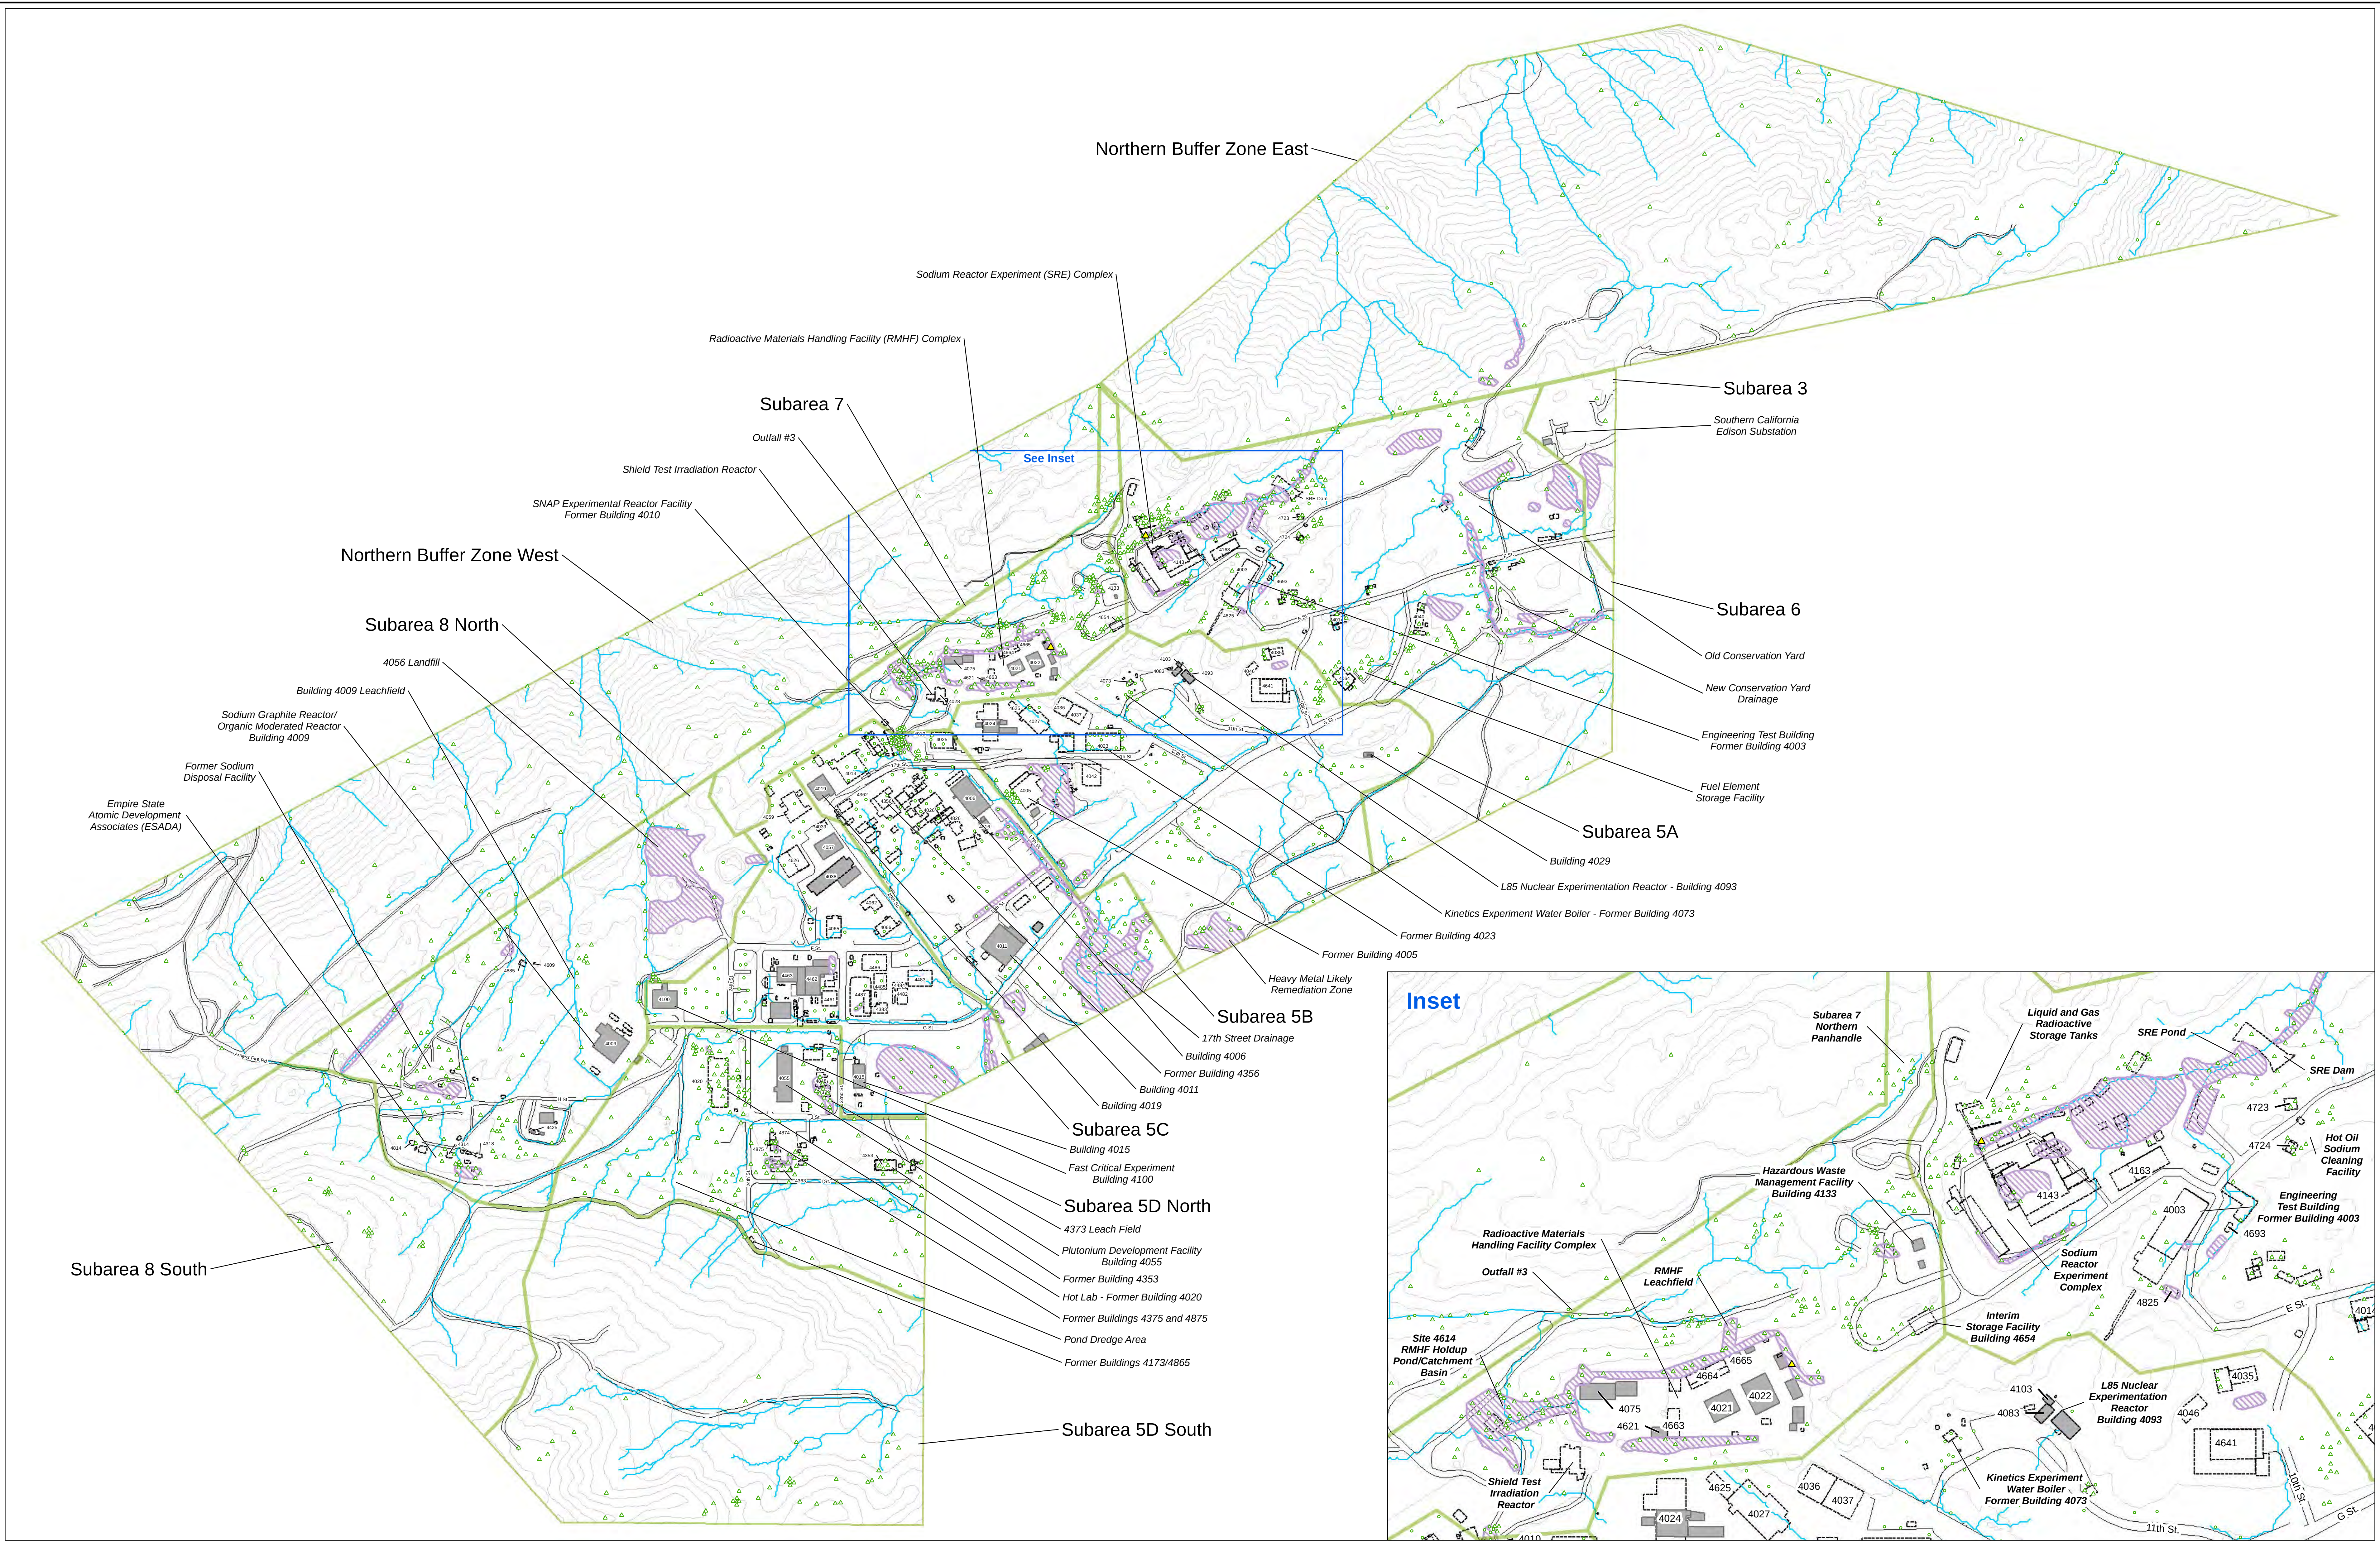
**Figure 4.7  
Cobalt-60  
Round 1 and 2 Surface Soil  
and Sediment Results  
Santa Susana Field Laboratory  
Area IV and NBZ Radiological Study**

**Cobalt-60**

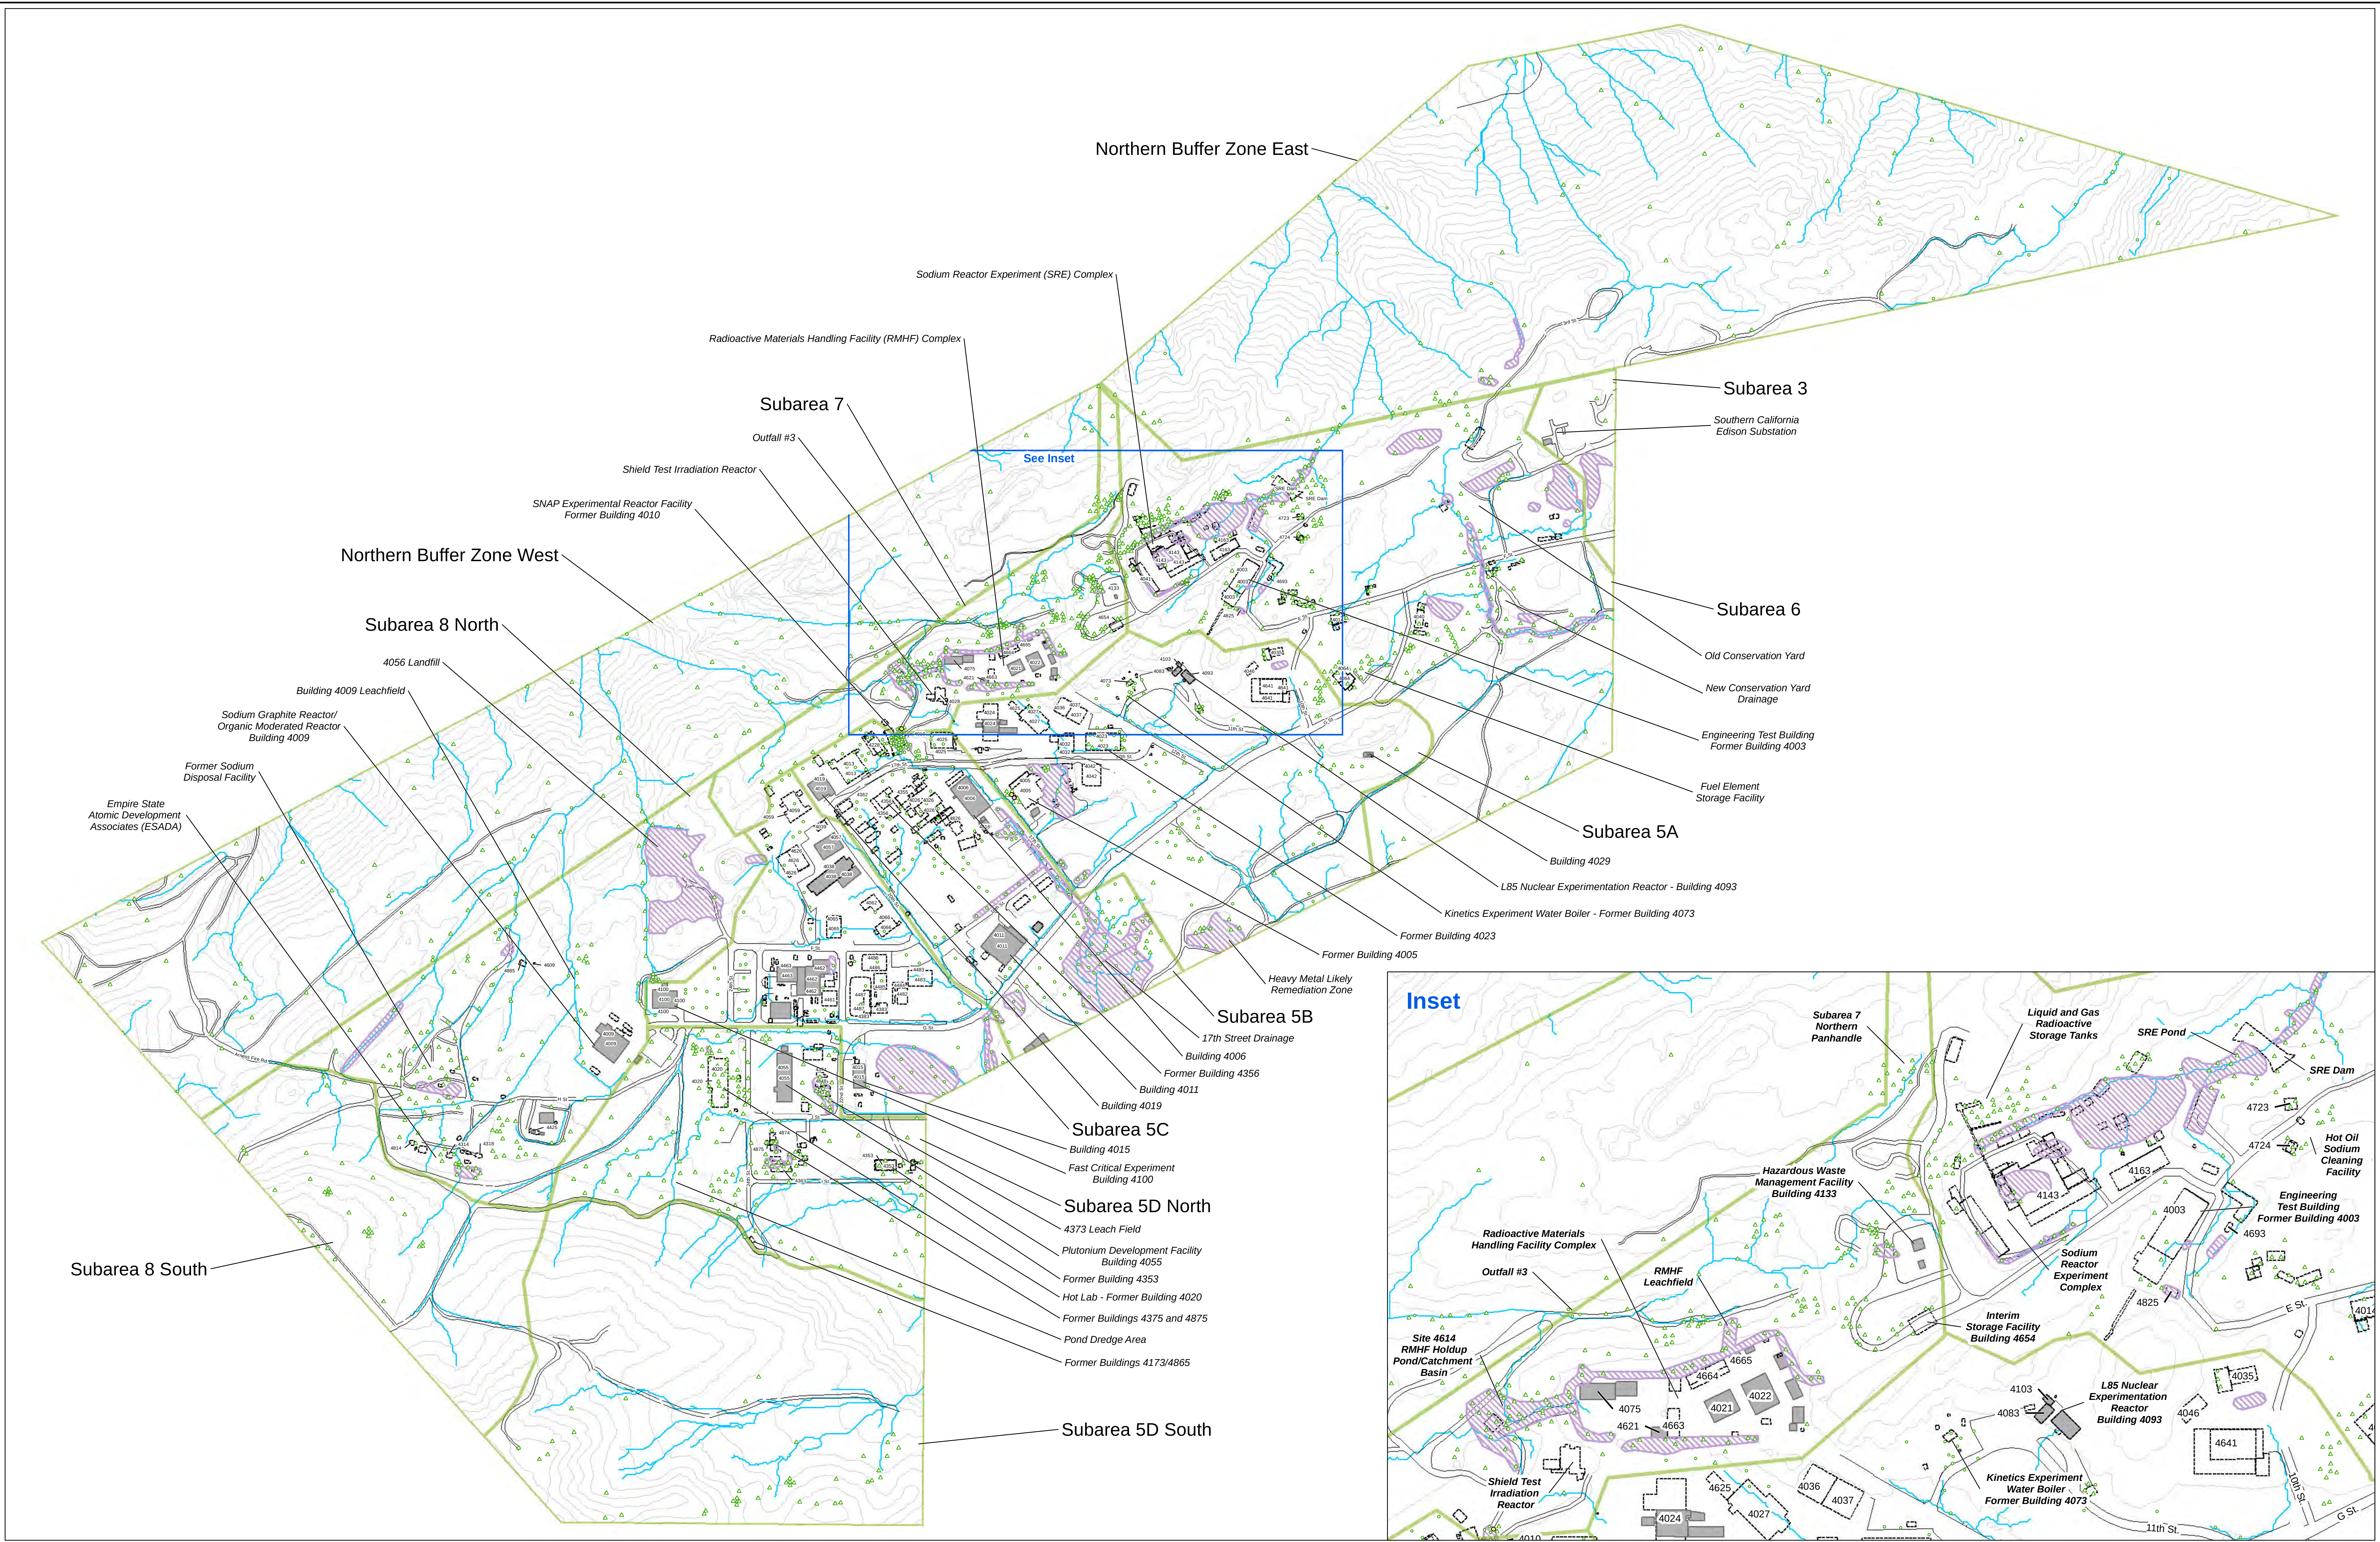
Figure 4.9  
Europium-152  
Round 1 and 2 Surface Soil  
and Sediment Results  
Santa Susana Field Laboratory  
Area IV and NBZ Radiological Study

Europium-152
