**FINAL**  
**RADIOLOGICAL CHARACTERIZATION OF SOILS**  
**AREA IV AND THE NORTHERN BUFFER ZONE**

**AREA IV RADIOLOGICAL STUDY**  
**SANTA SUSANA FIELD LABORATORY**  
**VENTURA COUNTY, CALIFORNIA**

**HydroGeoLogic, Inc.**  
**5023 North Parkway Calabasas**  
**Calabasas, California 91302**

**December 21, 2012**

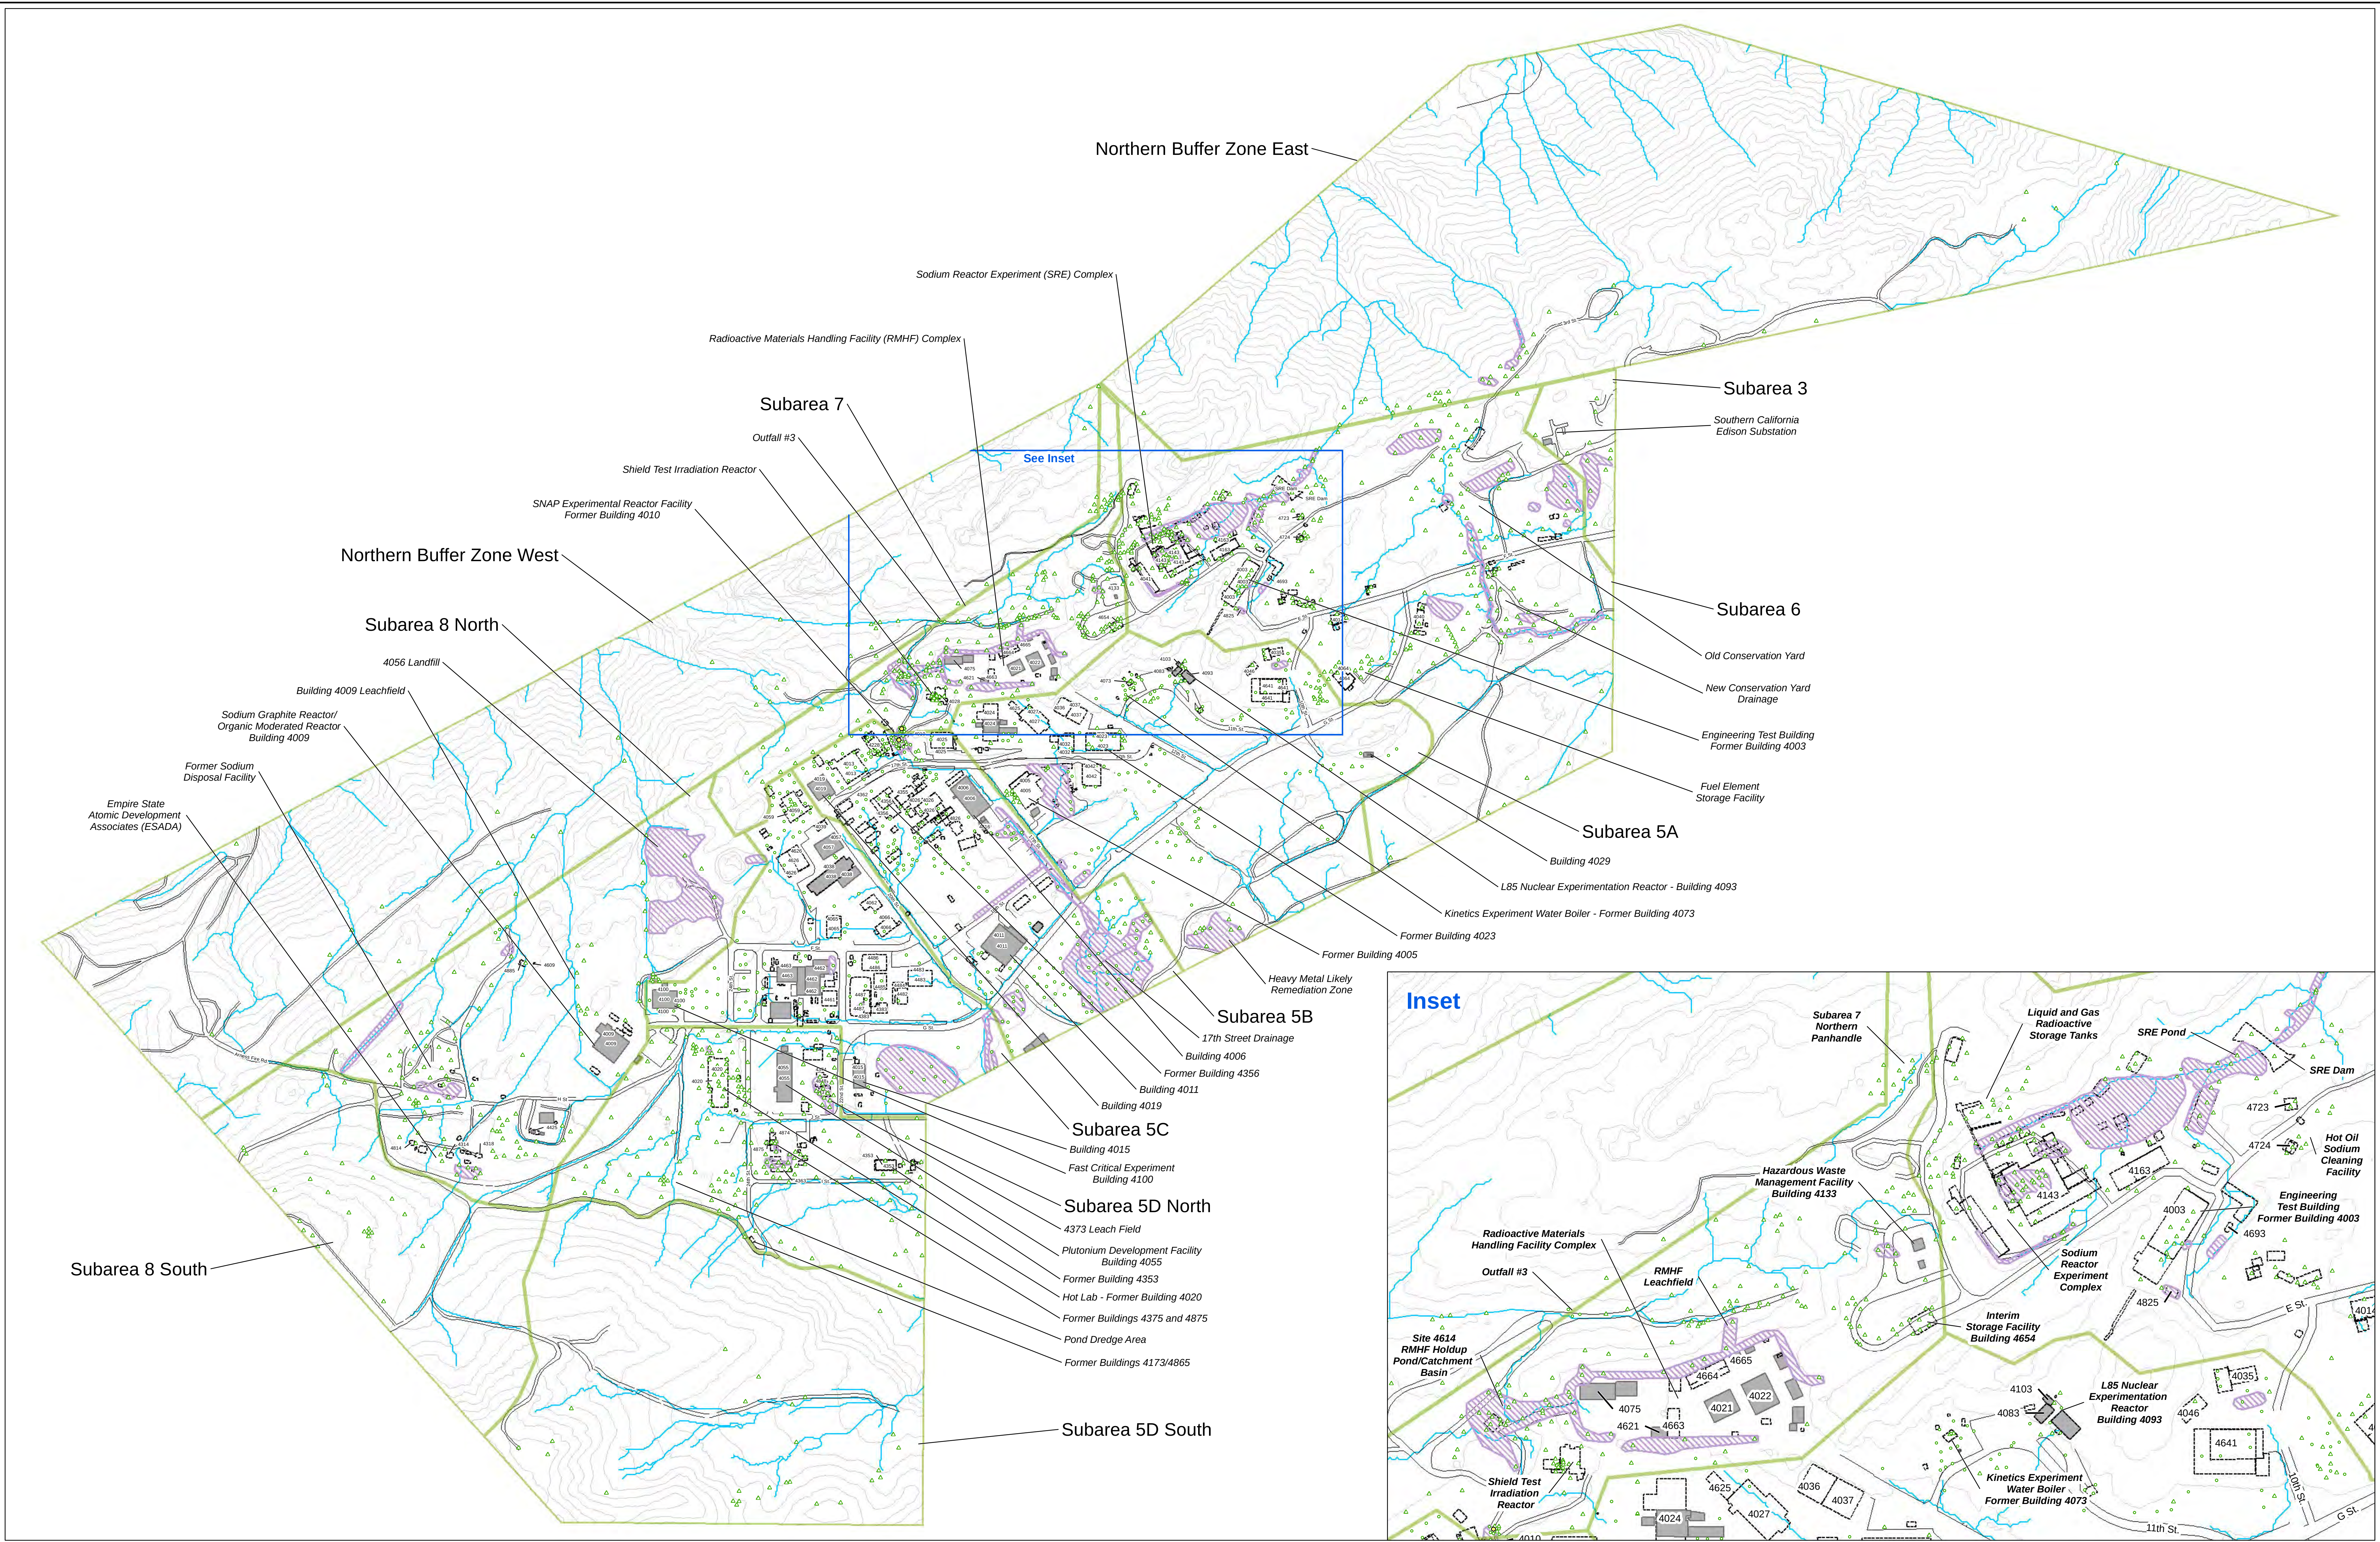
**Figure 4.10**  
**Europium-152**  
**Round 1 and 2 Subsurface Soil**  
**and Sediment Results**  
**Santa Susana Field Laboratory**  
**Area IV and NBZ Radiological Study**

**Europium-152**

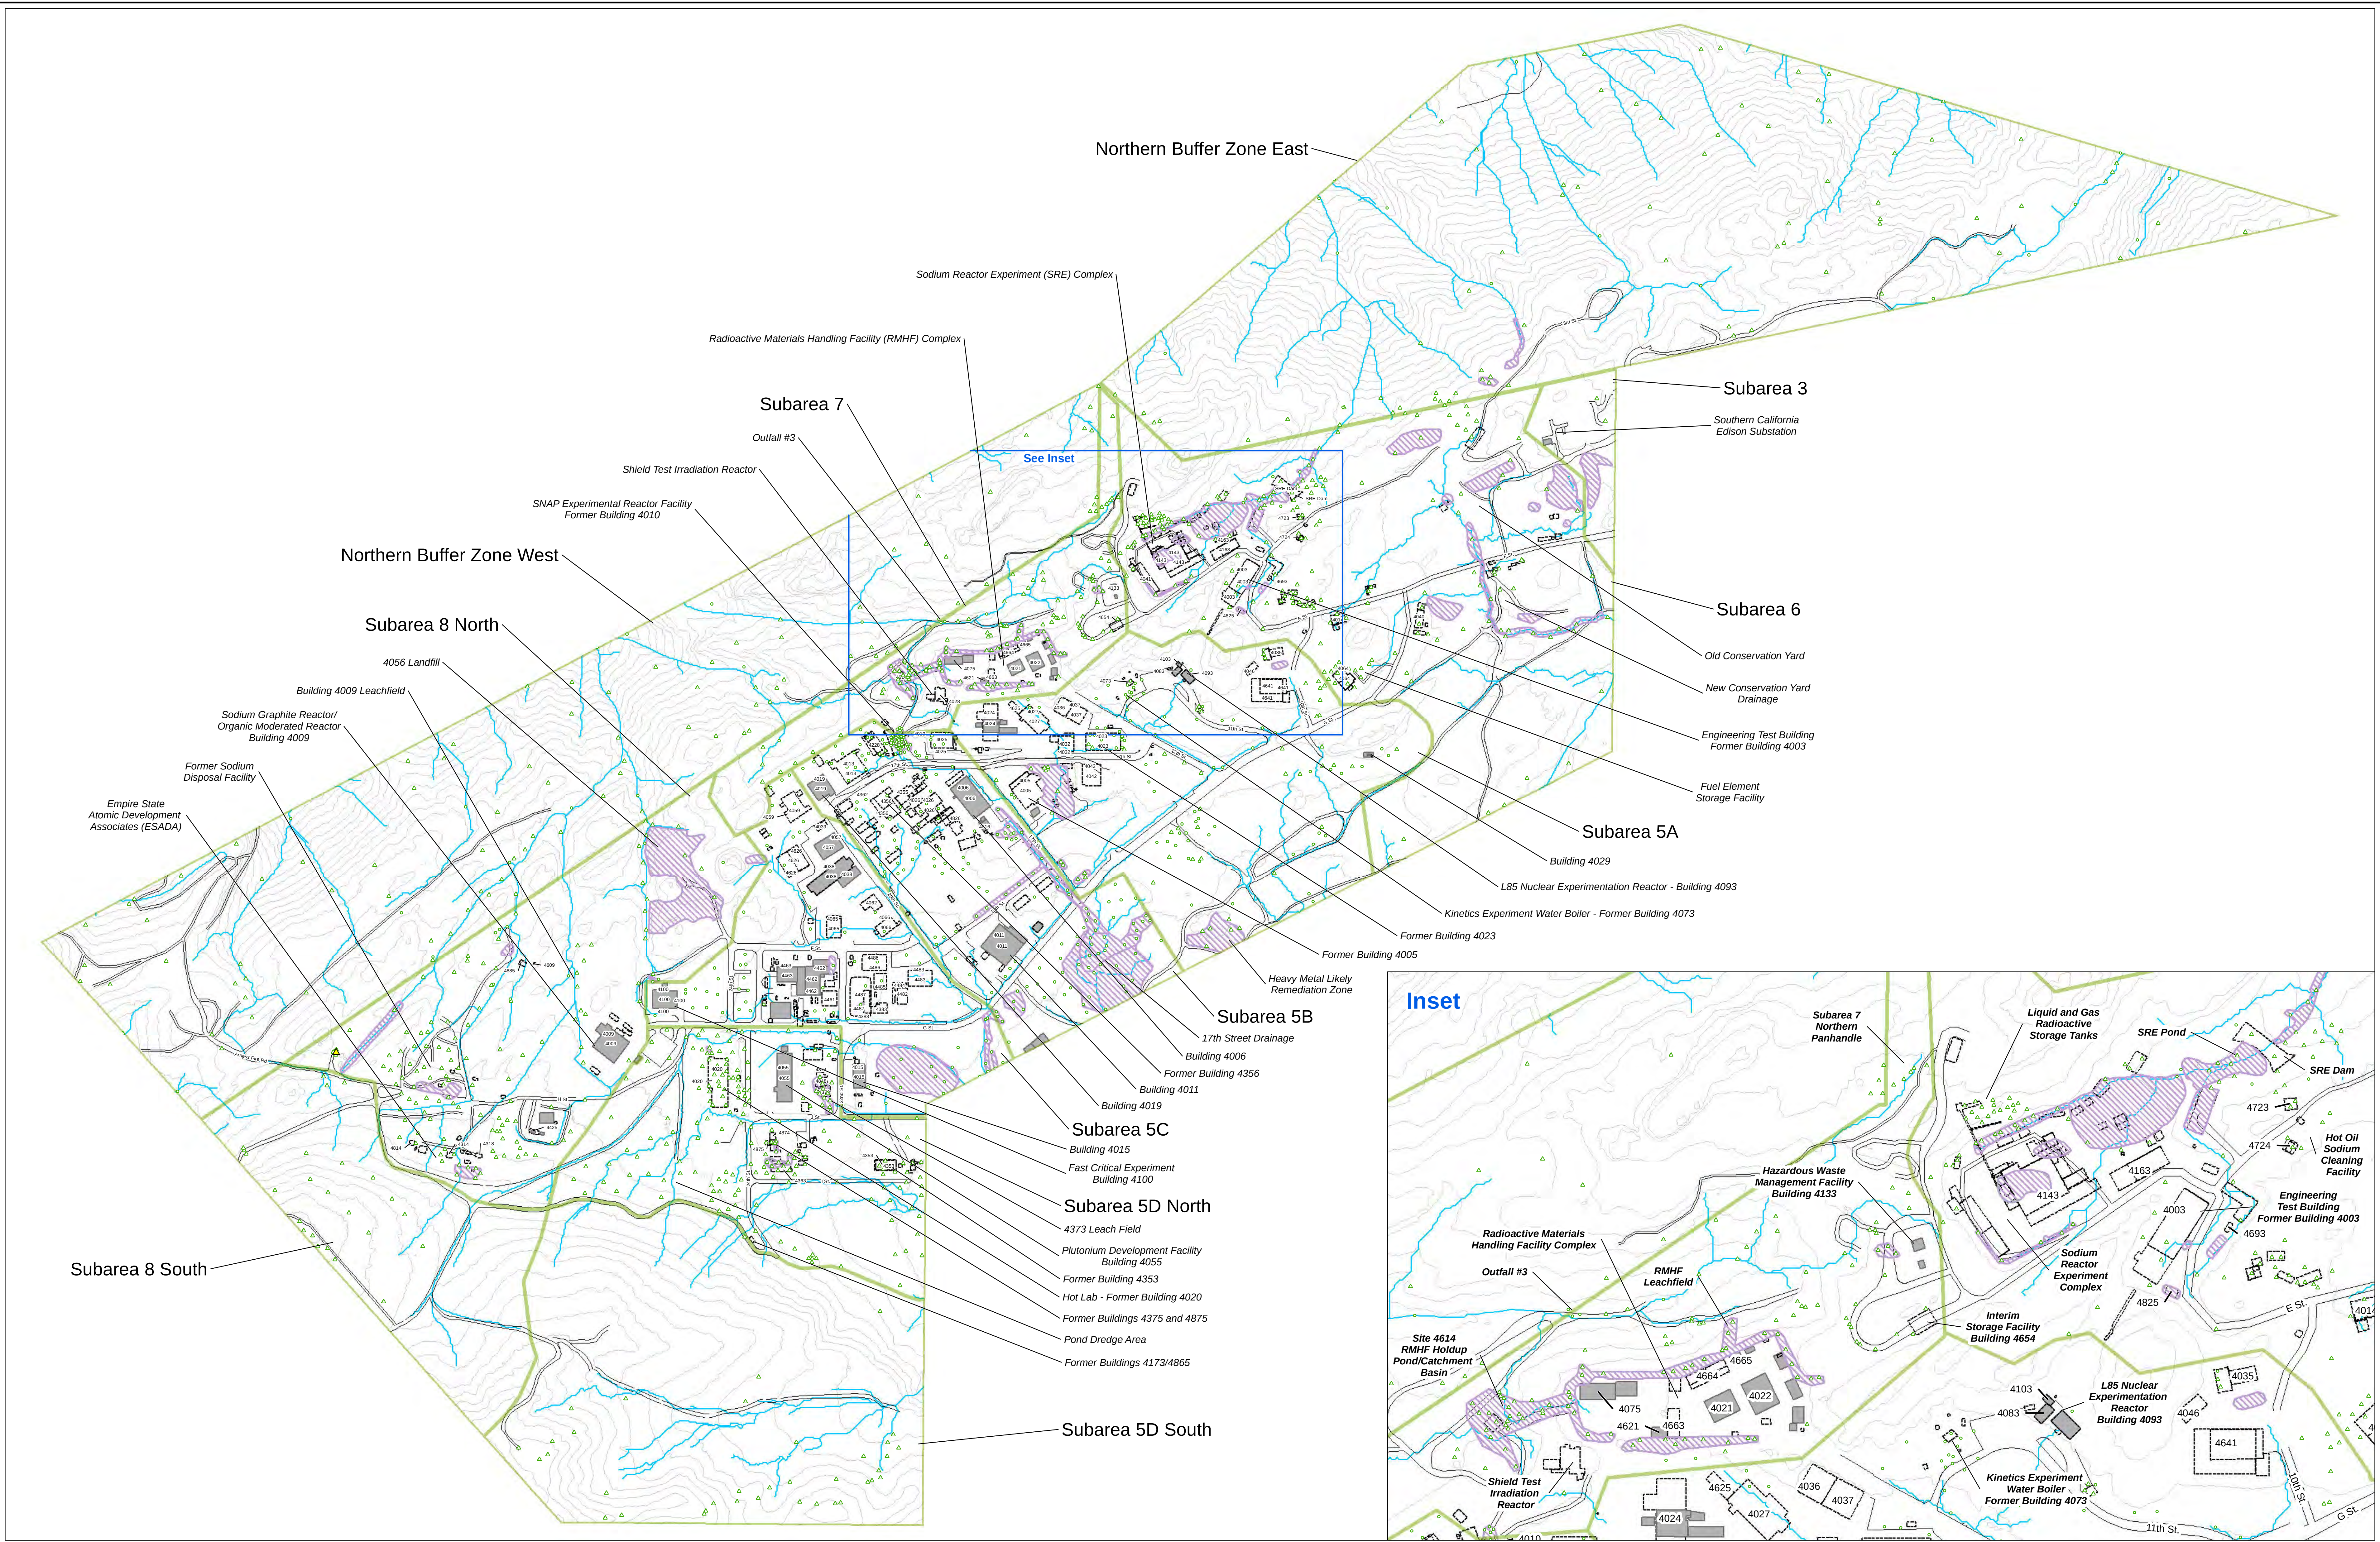
**Figure 4.12  
Americium-241  
Round 1 and 2 Surface Soil  
and Sediment Results  
Santa Susana Field Laboratory  
Area IV and NBZ Radiological Study**

**Americium-241**

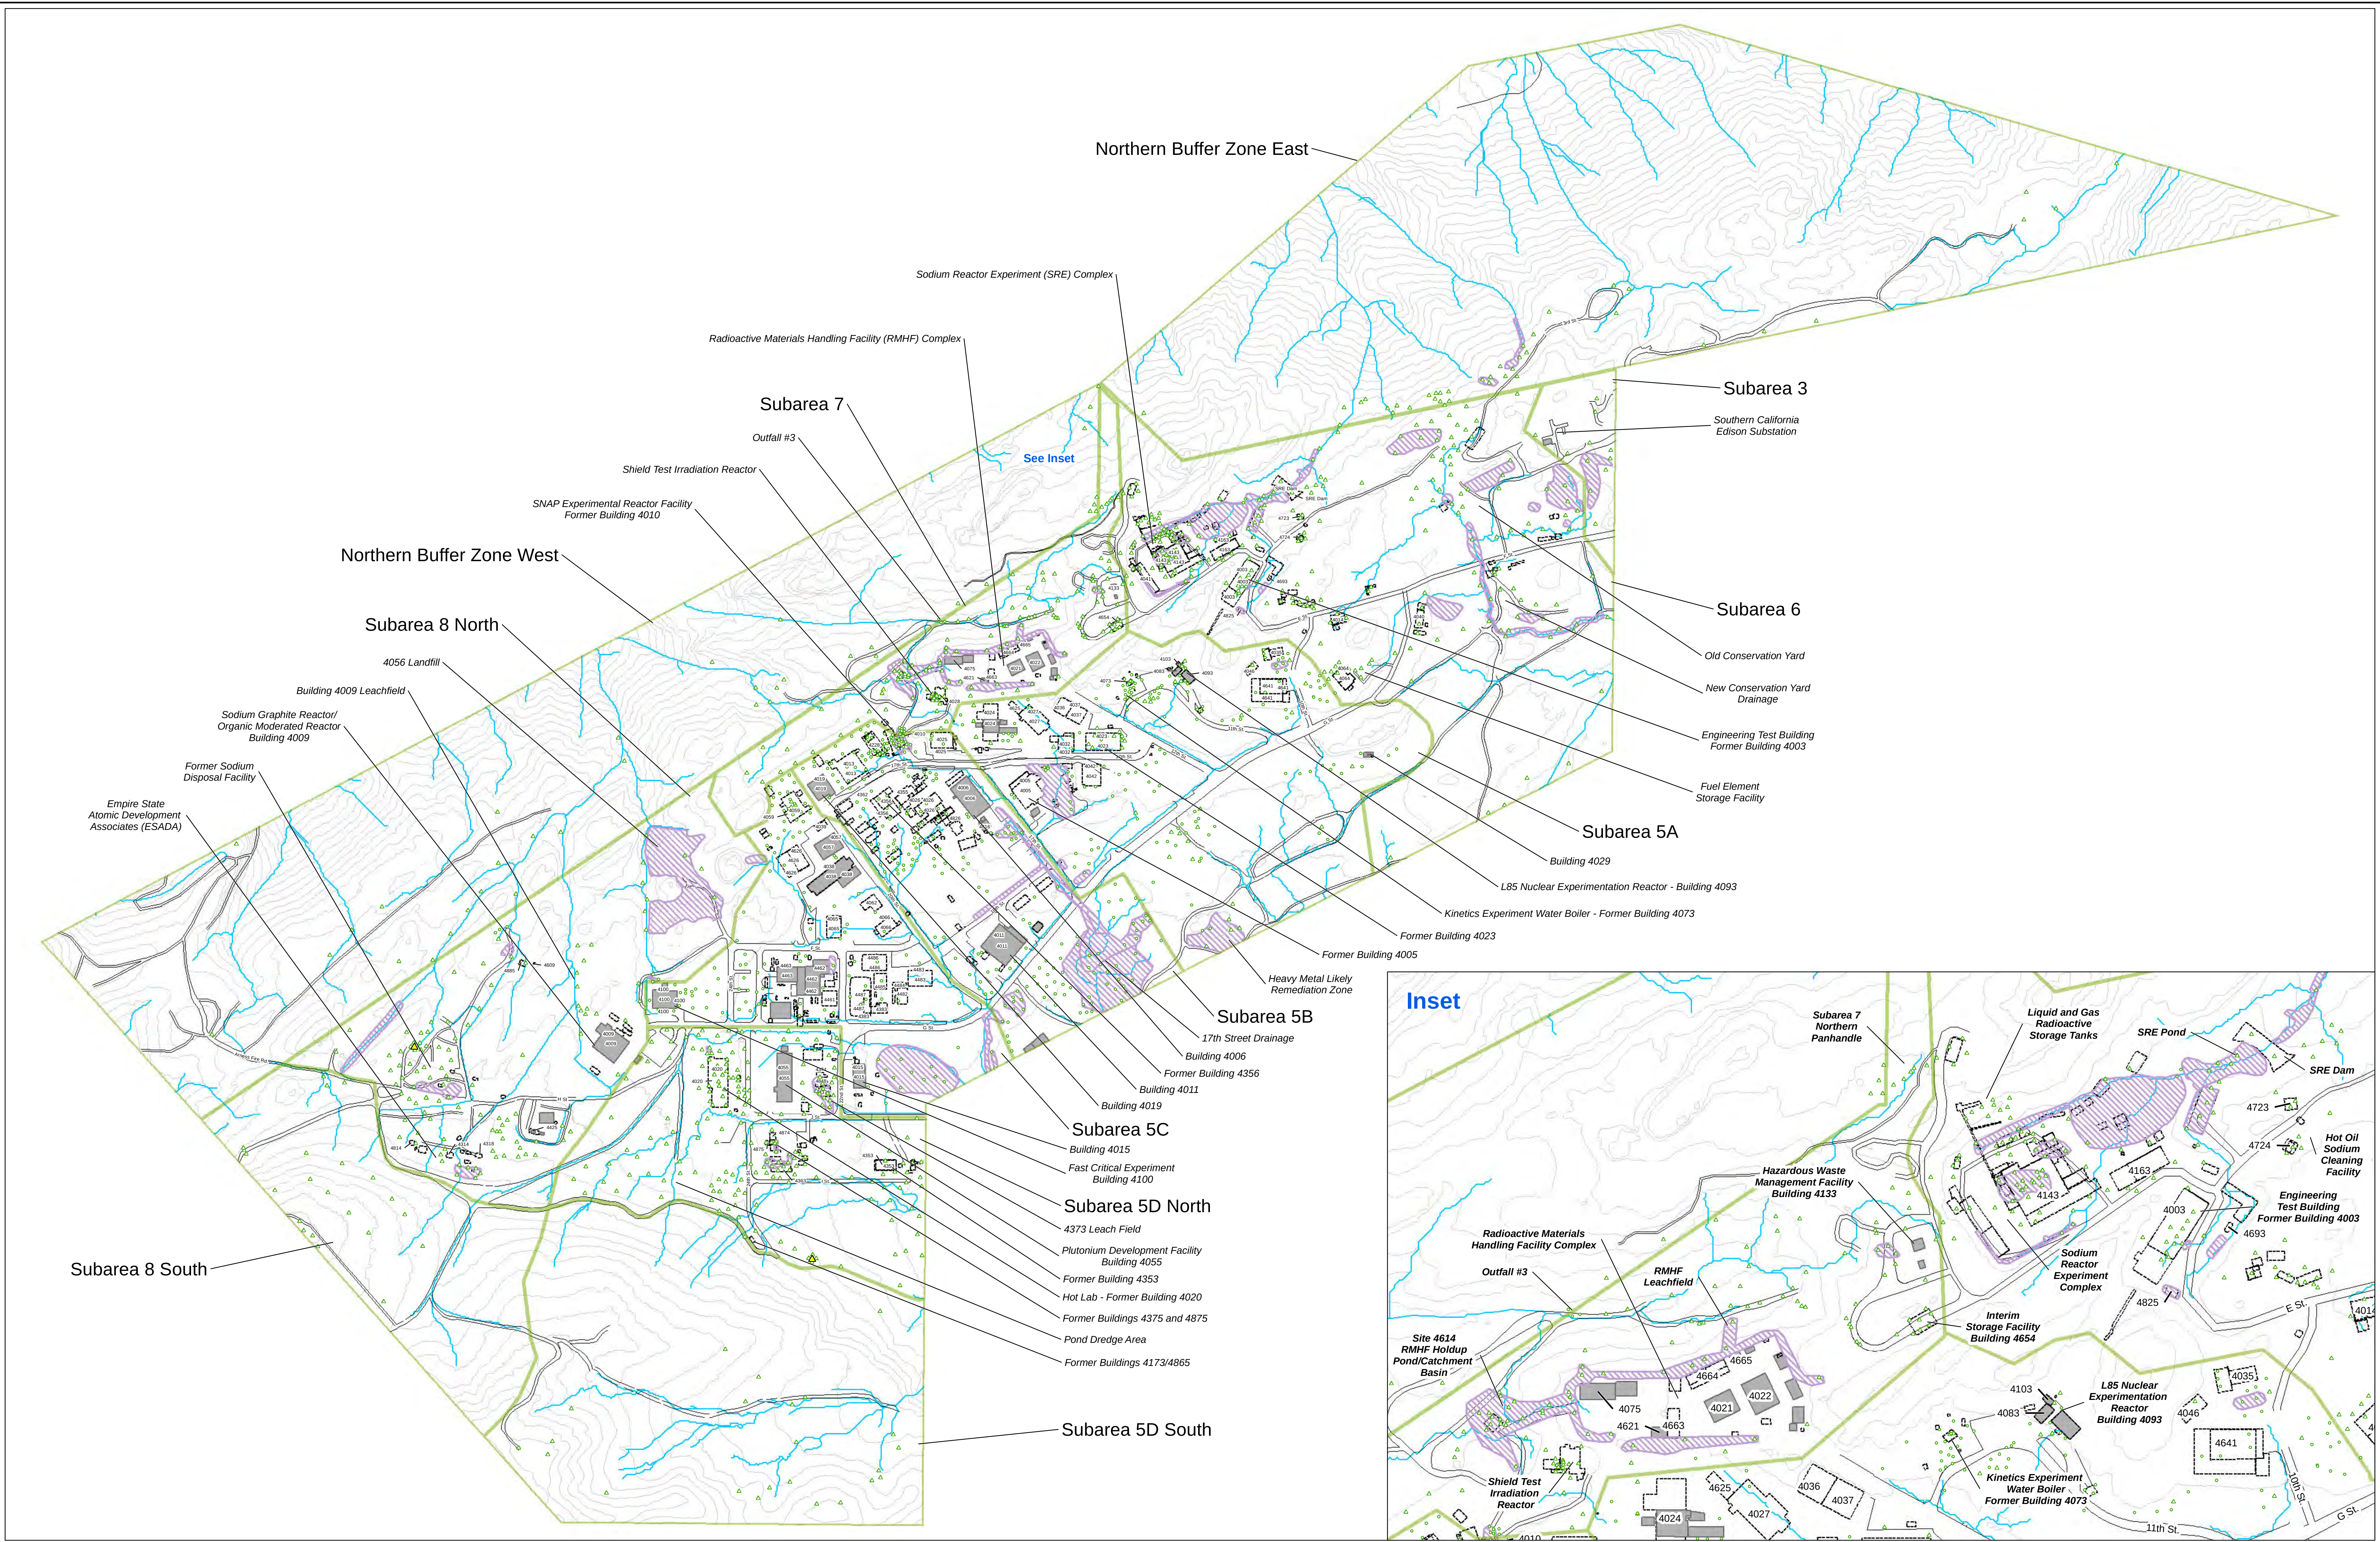
**Figure 4.13**  
**Americium-241**  
**Round 1 and 2 Subsurface Soil**  
**and Sediment Results**  
**Santa Susana Field Laboratory**  
**Area IV and NBZ Radiological Study**

**Americium-241**

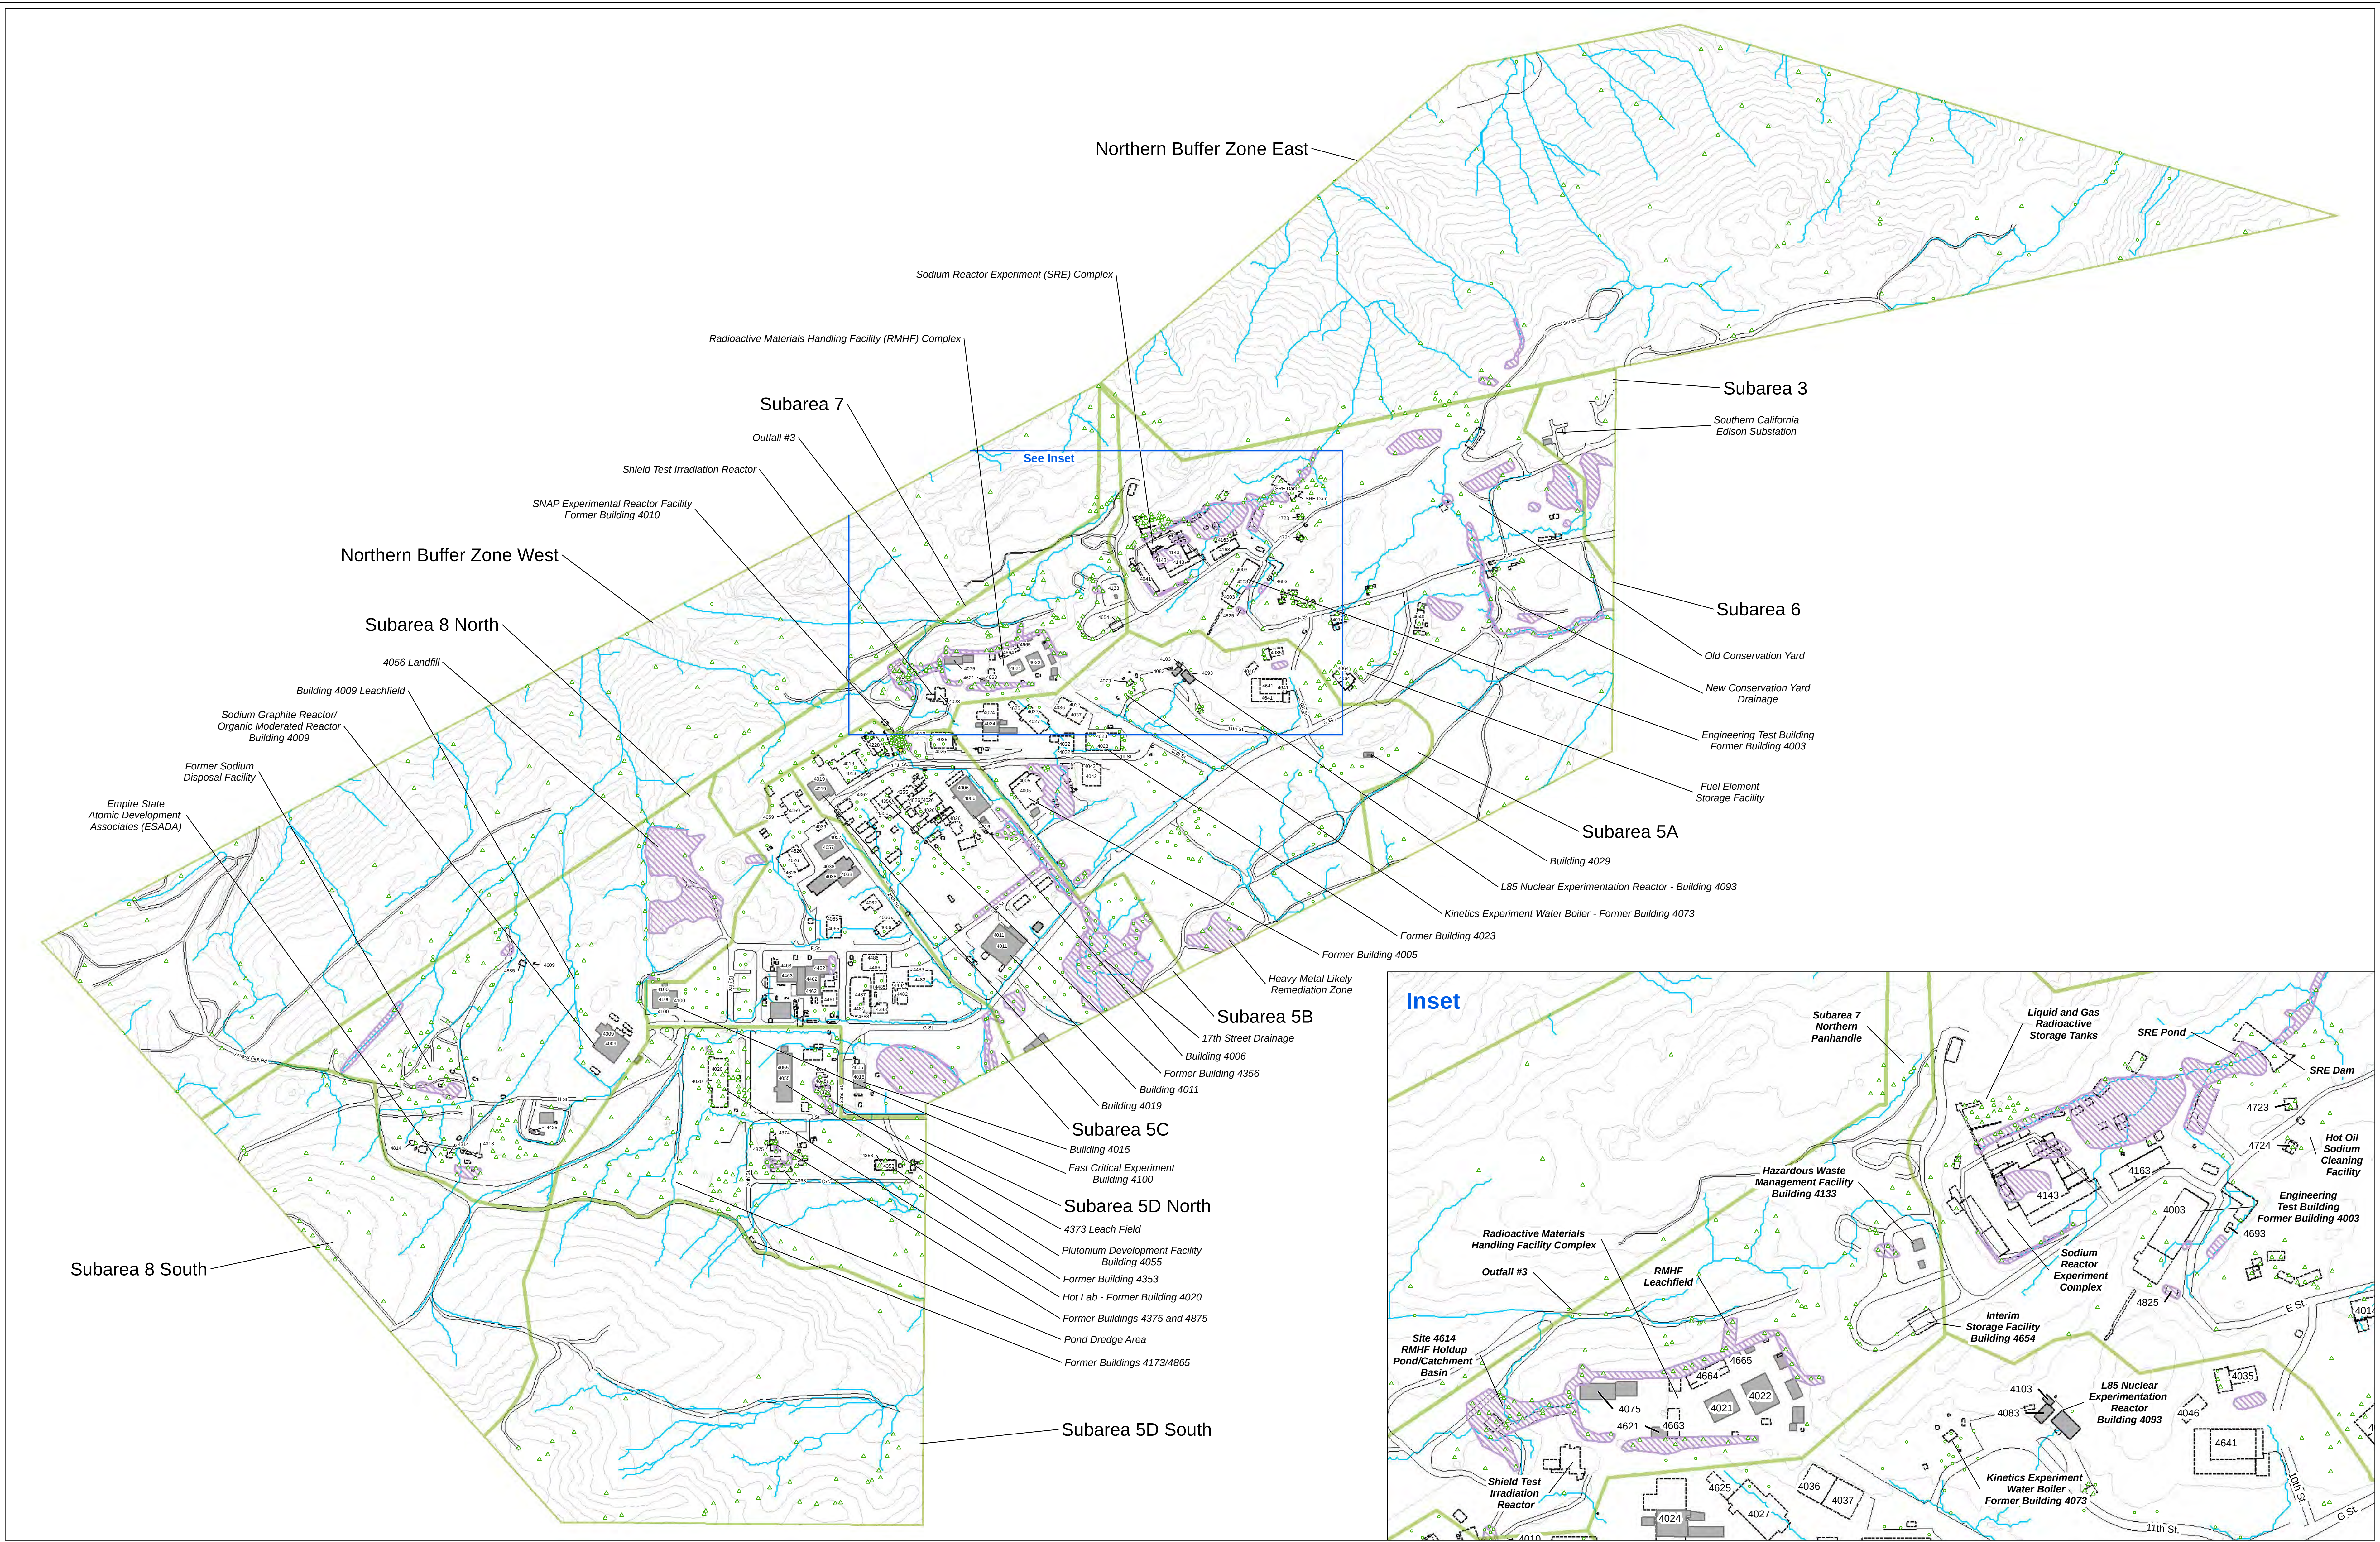
**Figure 4.14**  
**Curium-243/244**  
**Round 1 and 2 Surface Soil**  
**and Sediment Results**  
**Santa Susana Field Laboratory**  
**Area IV and NBZ Radiological Study**

Curium-243/244

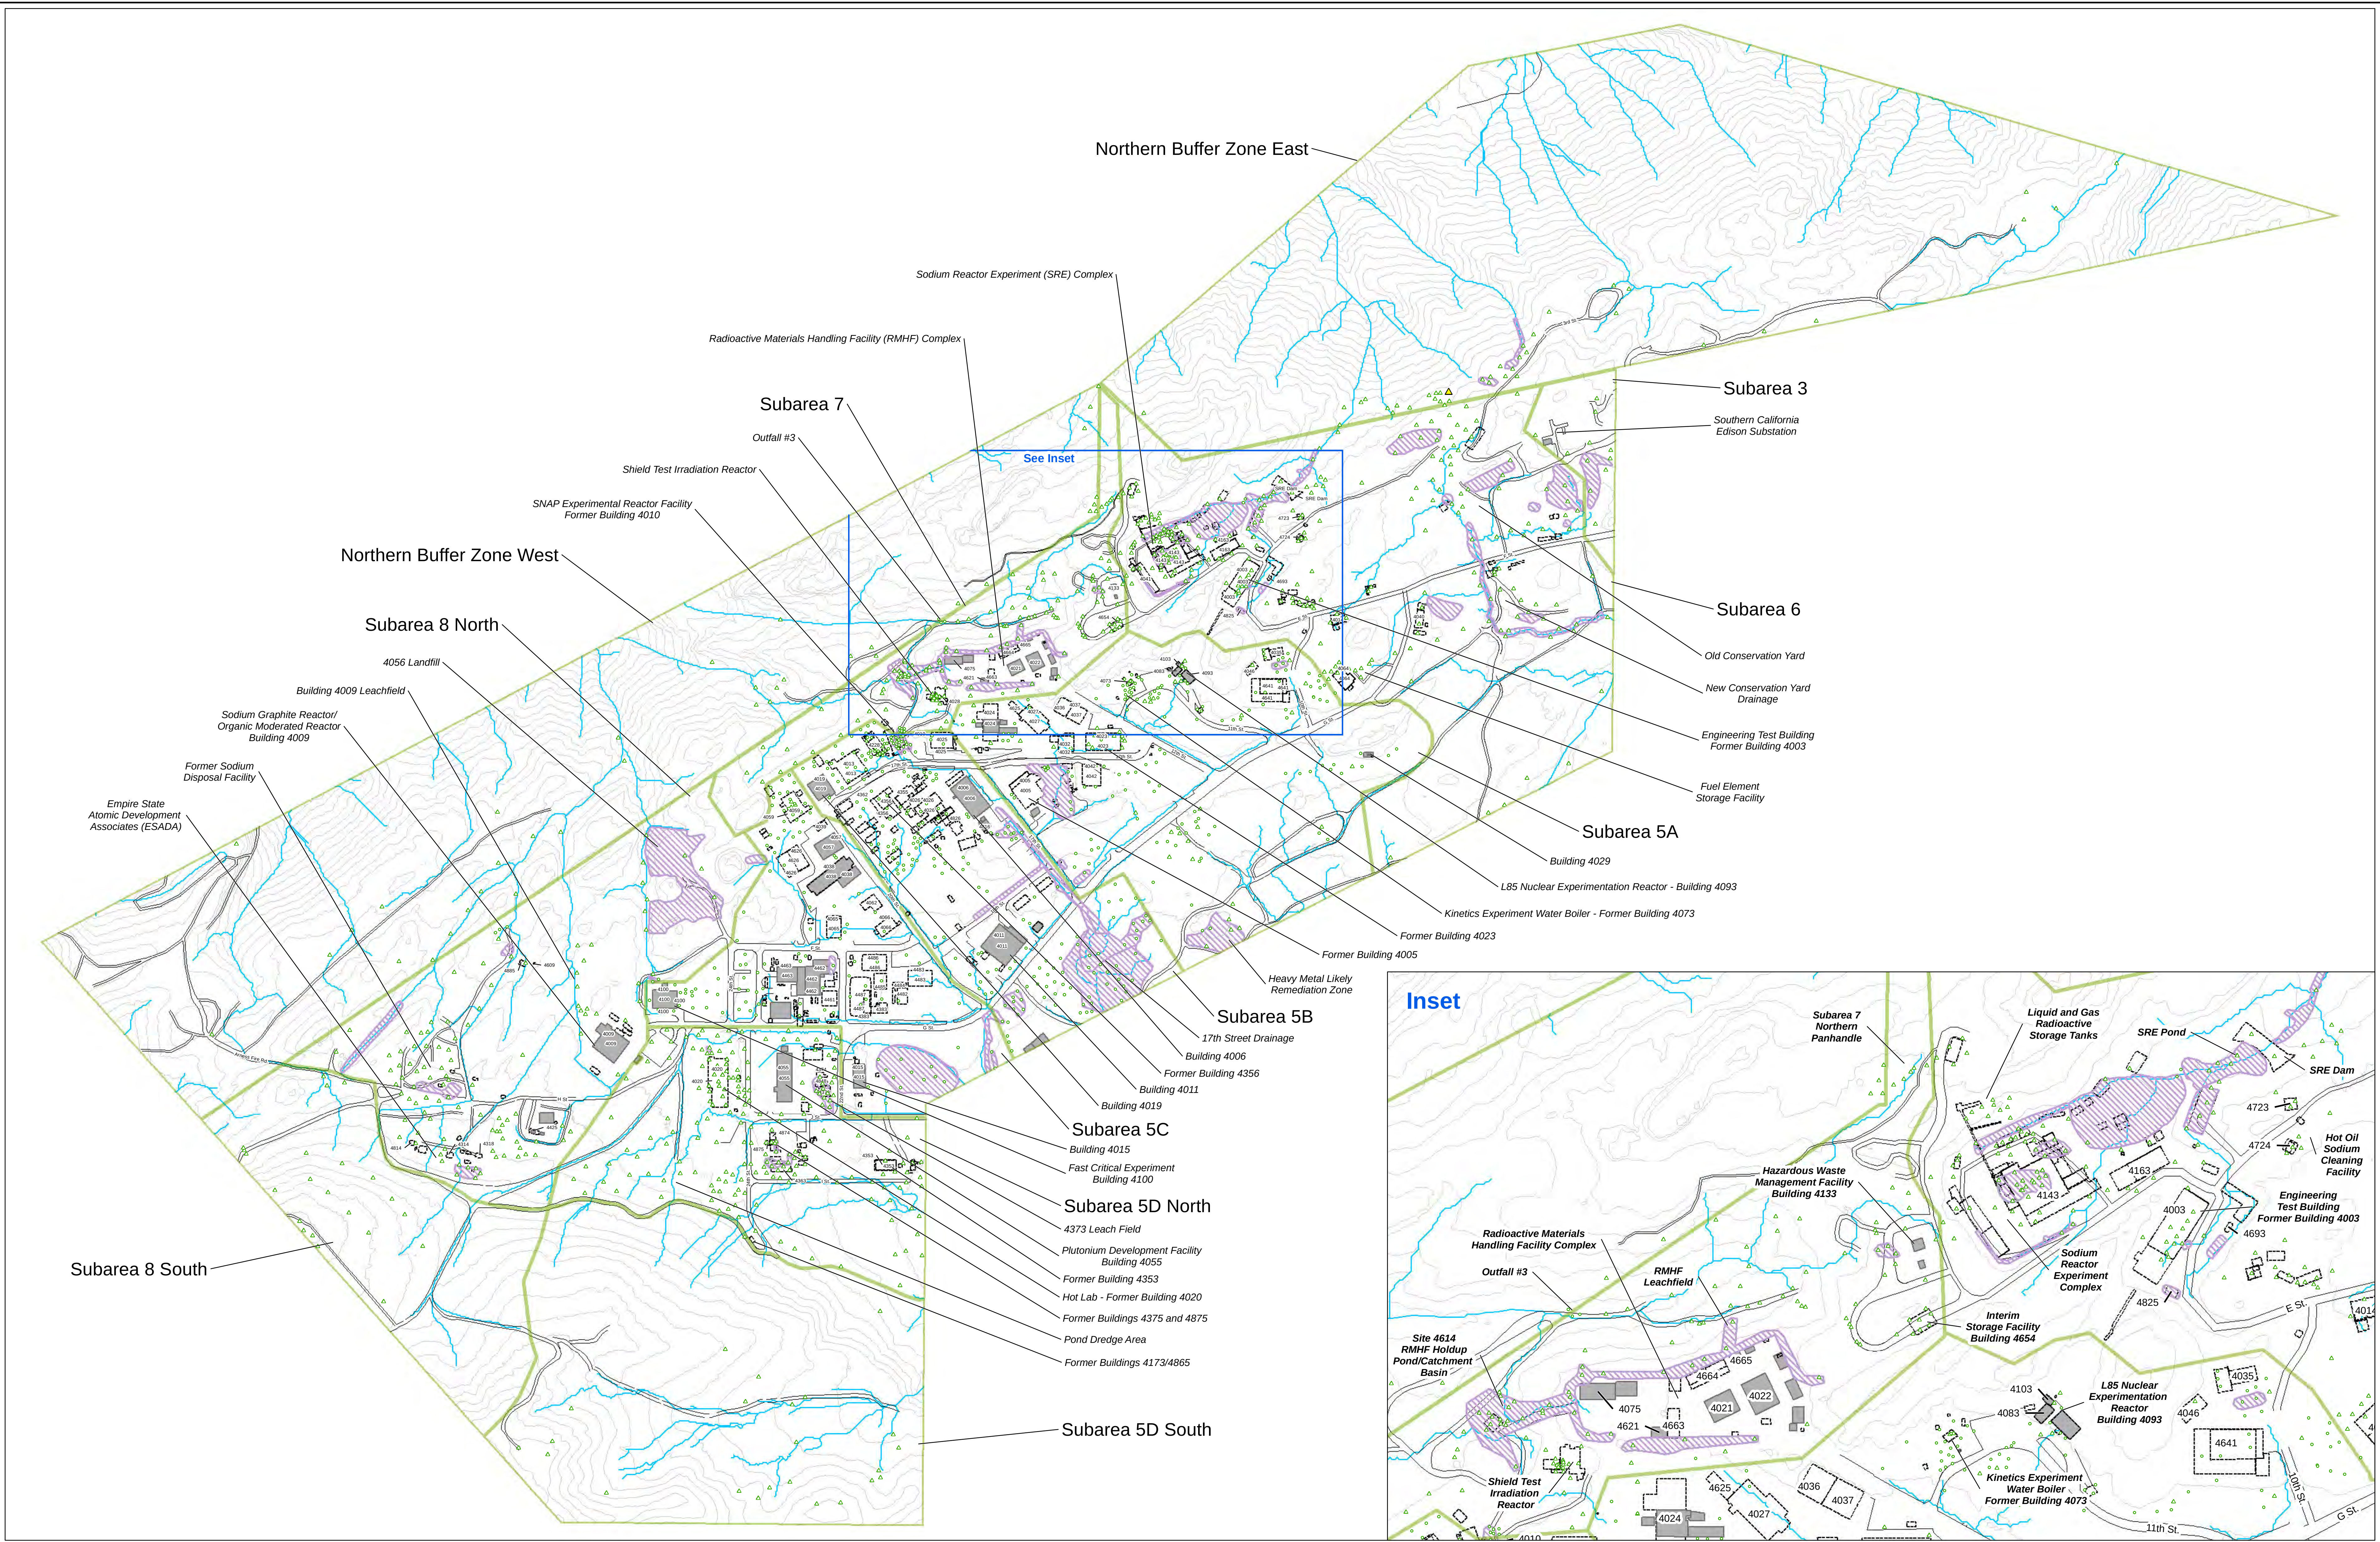
**Figure 4.15**  
**Curium-243/244**  
**Round 1 and 2 Subsurface Soil**  
**and Sediment Results**  
**Santa Susana Field Laboratory**  
**Area IV and NBZ Radiological Study**

Curium-243/244

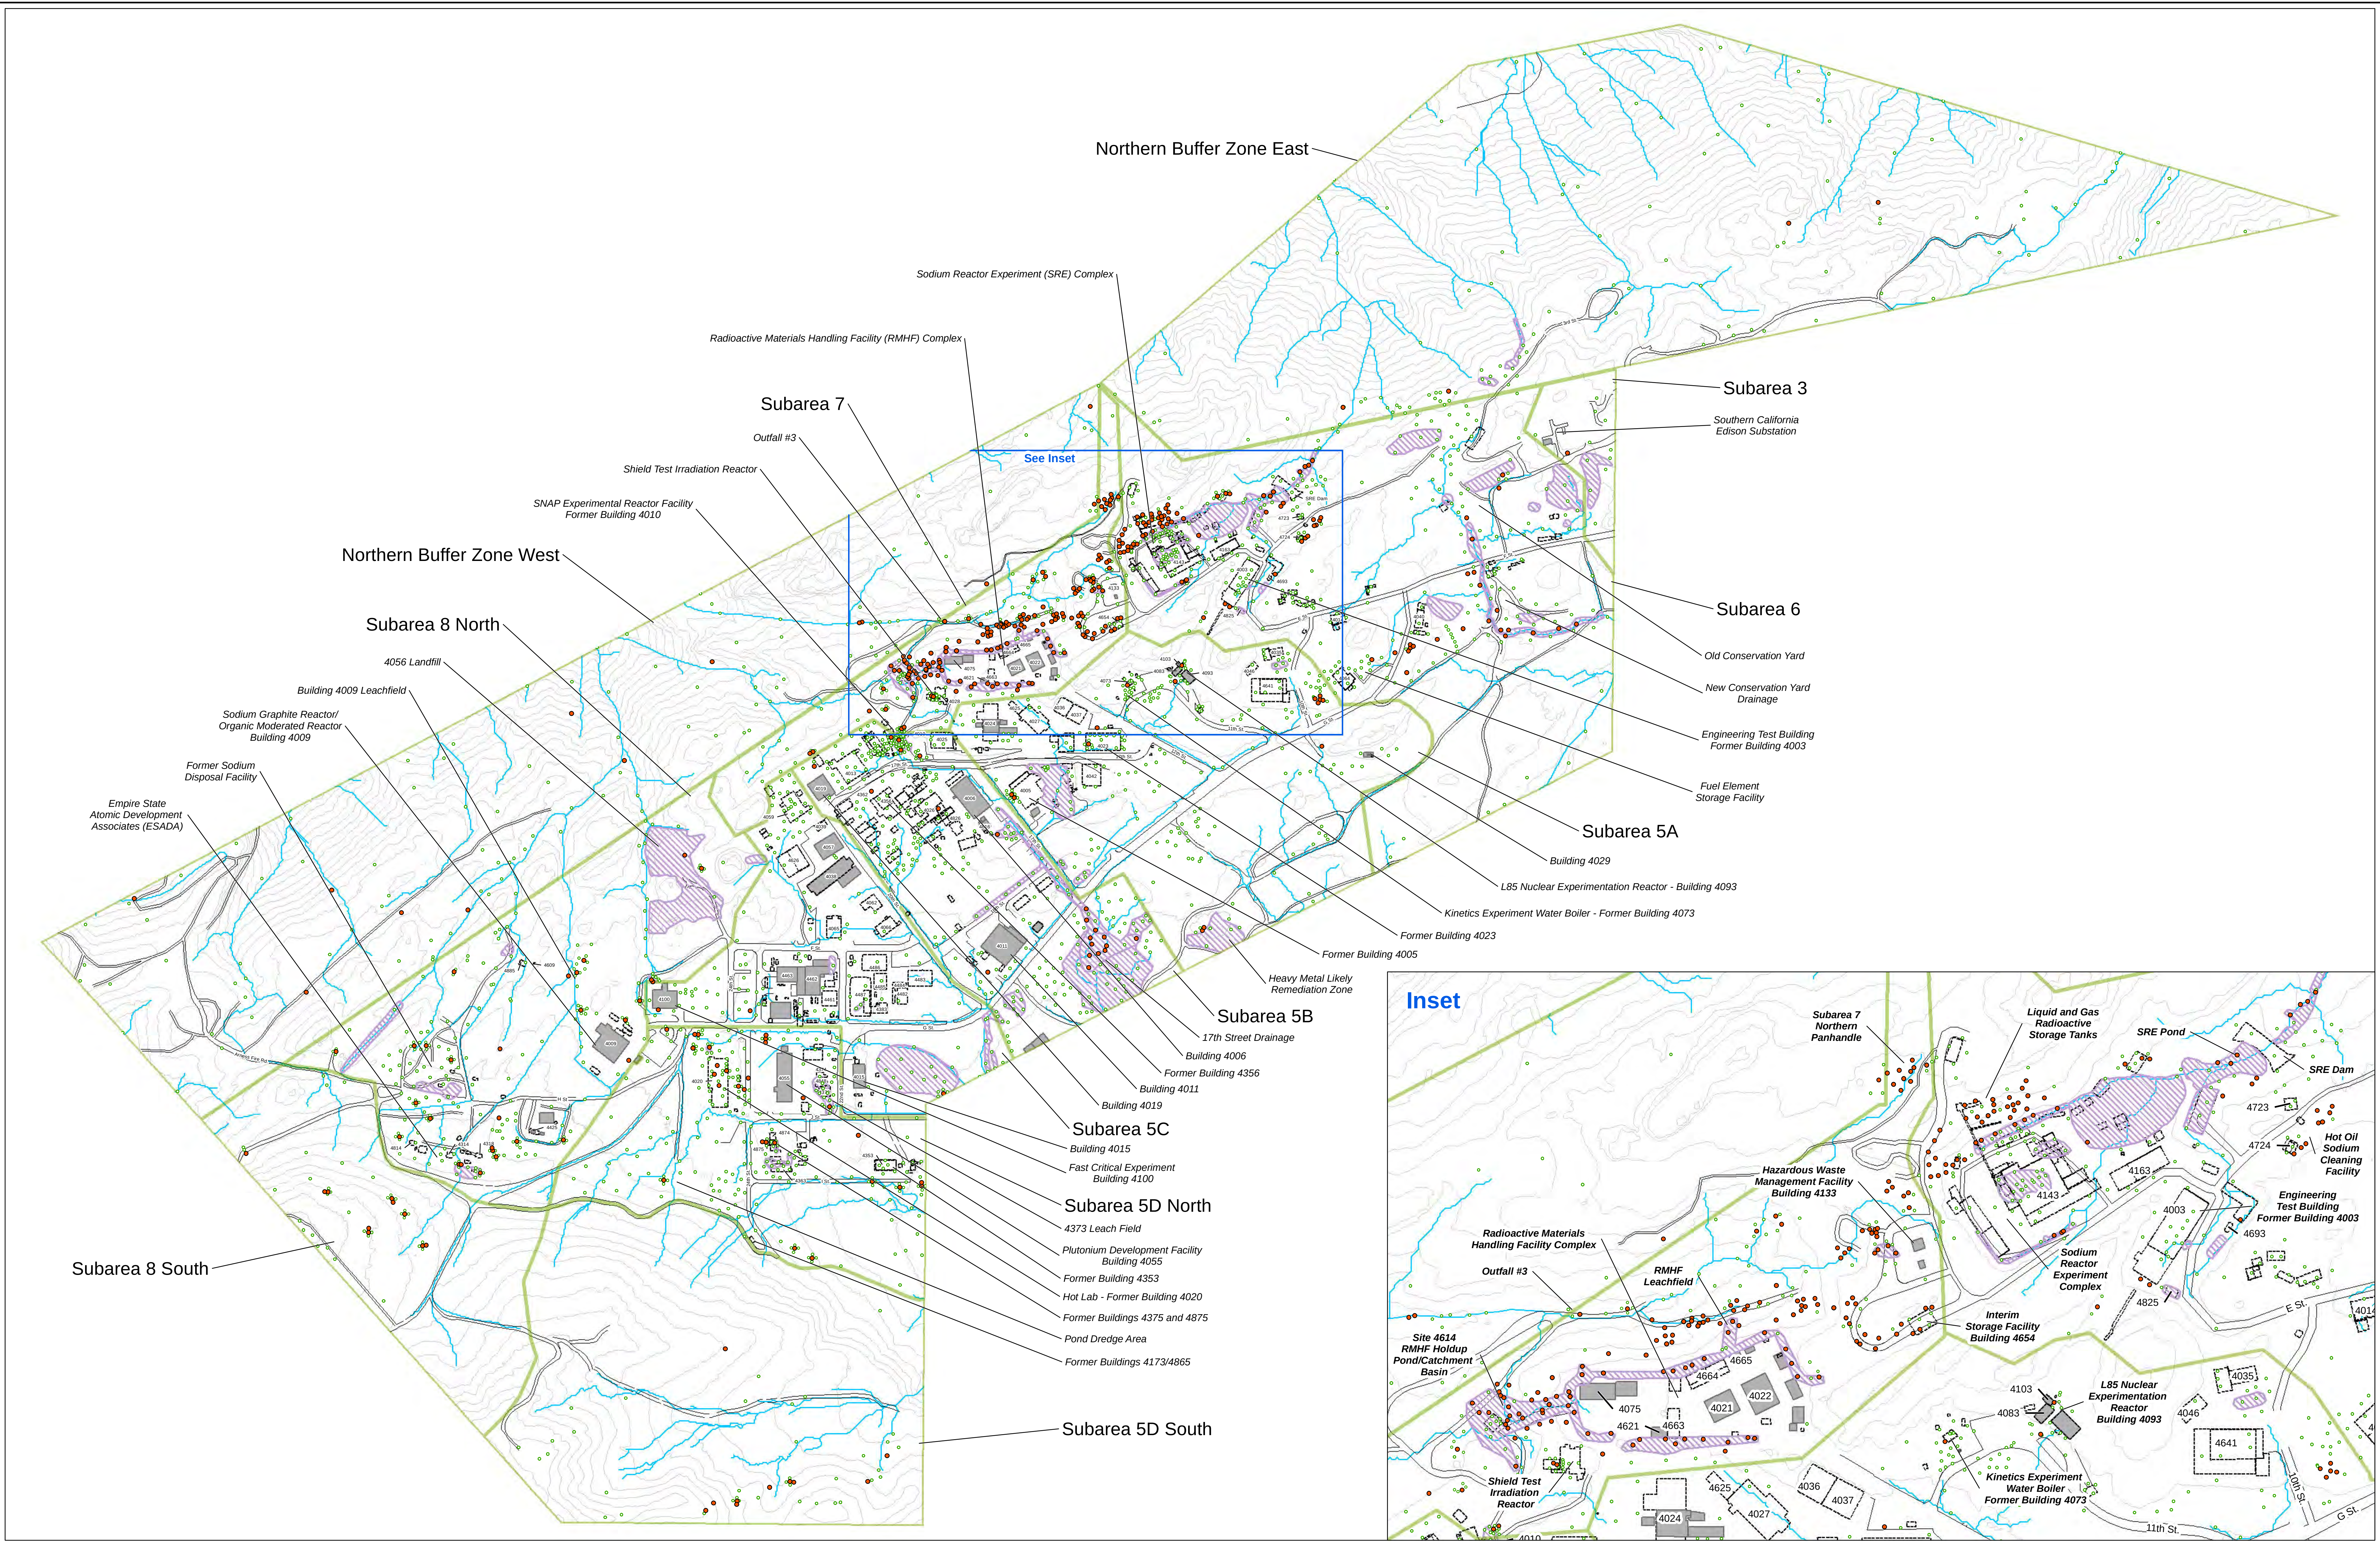
Figure 5.1

Select Radionuclides of Concern, Surface and Subsurface

Select radionuclides include: Americium-241, Curium-243/244, Cesium-137, Cobalt-60, Europium-152, Europium-154, Nickel-59, Plutonium-238, Plutonium-239/240, Tritium, and Strontium-90
