# **EXHIBIT 11**

5 Federal Power Act Section 202(c)  
6 Emergency Order TransAlta  
7 Centralia Generation

Order No. 202-25-11

8  
9 **DECLARATION OF CLINTON LAMOREAUX**  
10 **IN SUPPORT OF**  
11 **MOTION TO INTERVENE, REQUEST FOR REHEARING,**  
12 **AND MOTION TO STAY BY STATE OF WASHINGTON**

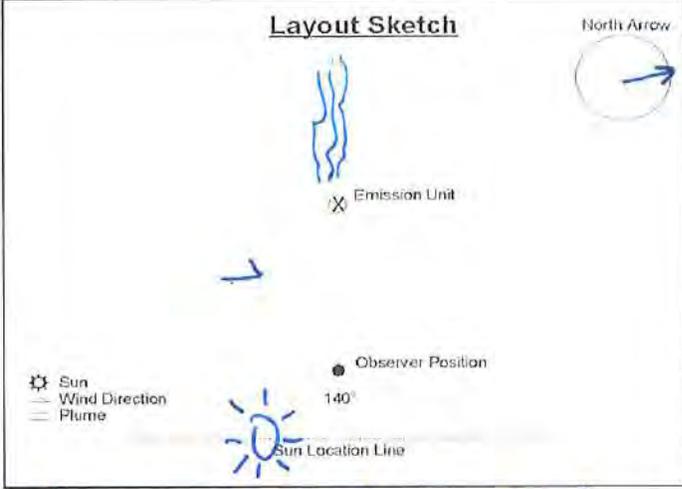
Average Opacity:	
Range Of Opacity:	
Describe Emission Unit:	Unit 2 Boiler
Height Above Ground:	470'
Height Relative To Observer:	470'
Distance From Observer:	~1050'
Direction From Observer:	W
Describe Emissions:	Attached Steam Plume
Emission Color:	White
Describe Background:	Sky
Background Color:	Gray
Sky Conditions:	Cloudy
Temperature:	65°F
Wind Speed:	1-2 mph
Relative Humidity:	85%
Wind Direction:	
Wet Bulb Temp.:

Comments: Plume rising vertically; not enough wind to affect plume direction

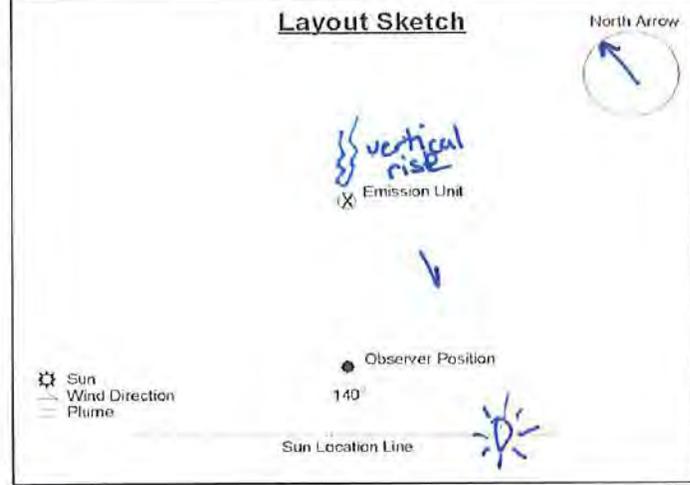
Comments: observation made from parking lot

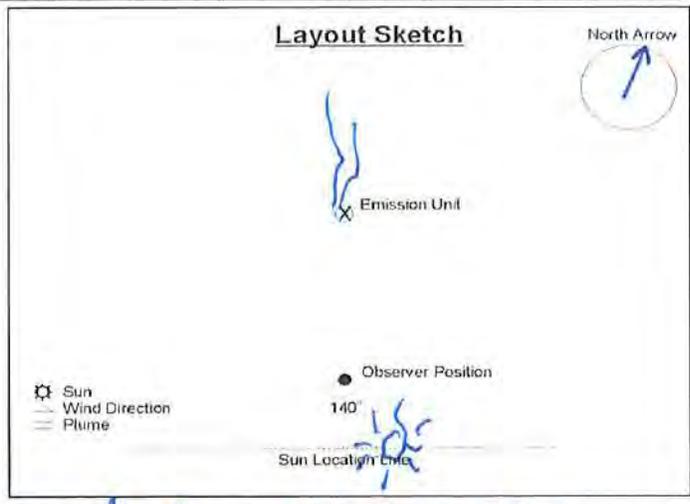
Comments: Plume is rising vertically. Observed from top of 12 FA Bin.

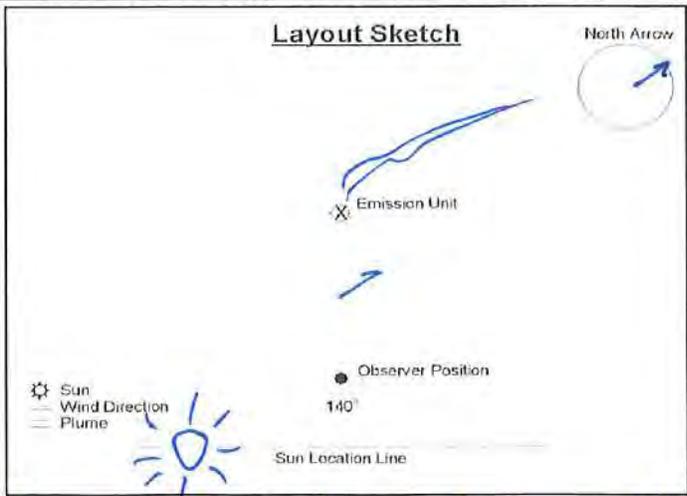
Comments: *Due to foggy conditions at ground level, I had to stand significantly closer than normal to make observations. Would have delayed, but this is the last working day in 2023 for me.*
