**VERNAL POOL BRANCHIOPOD HABITAT ASSESSMENT  
FOR THE BOEING SANTA SUSANA FIELD LABORATORY  
VENTURA COUNTY, CALIFORNIA**

**August 2014**

**Project No. 1402-0661**

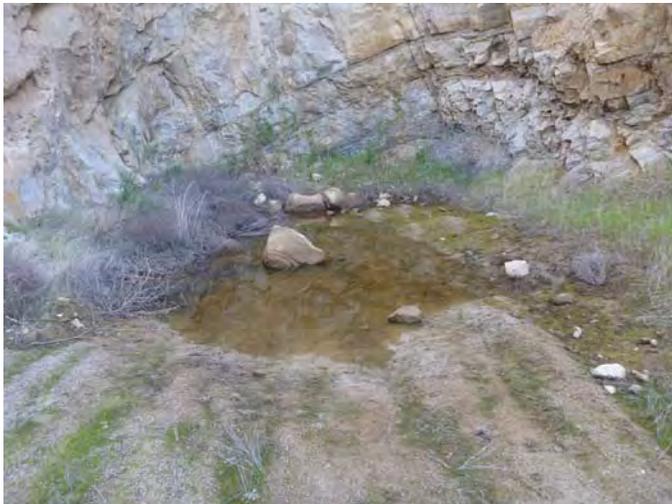
Photograph A. View of remaining ponded area within the footprint of removed test stand. This feature is located in the "Bowl" in Boeing Area I.

Of the potential habitat features mapped during the site assessment, only six were inundated at the time of field surveys (Figure 3). The six features that were inundated included an old structural footprint where test stand facility was removed in the portion of the Project Site referred to as the Bowl, Silvernale Pond in Area III, and a series of four ponds in a sandstone pool complex also in Area III. All remaining features mapped during the site assessment surveys were noted as features with the potential for ponding water consisting of topographic low areas, excavated sites, and sandstone pools. All of the features that were observed during dry conditions and mapped based on topographic position will need to be surveyed during the appropriate time in the wet season to determine whether they do pond water and provide potential habitat for VPBs.

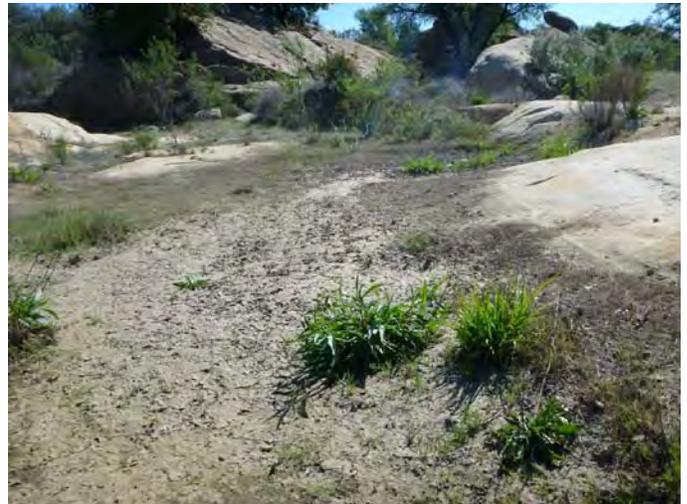
Photograph B. View of interim source removal action and passive restoration area with topographic low areas mapped as potential VPB habitat based on soil cracks and staining. Dry at the time of field surveys.

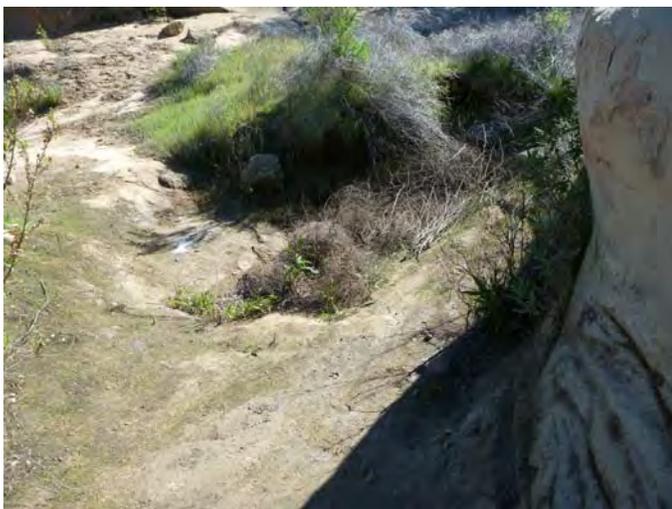
Photograph C. View of interim source removal action and passive restoration area with topographic depressions mapped as potential VPB habitat. This feature is located outside the project area north of Boeing Area I.

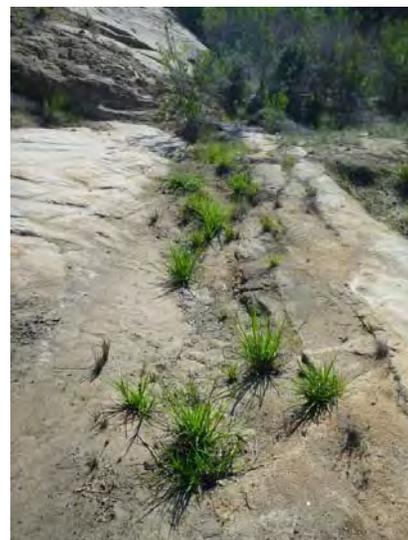
Photograph D. View of interim source removal action and passive restoration area with topographic depressions mapped as potential VPB habitat. This feature is located outside the project area north of Boeing Area I.

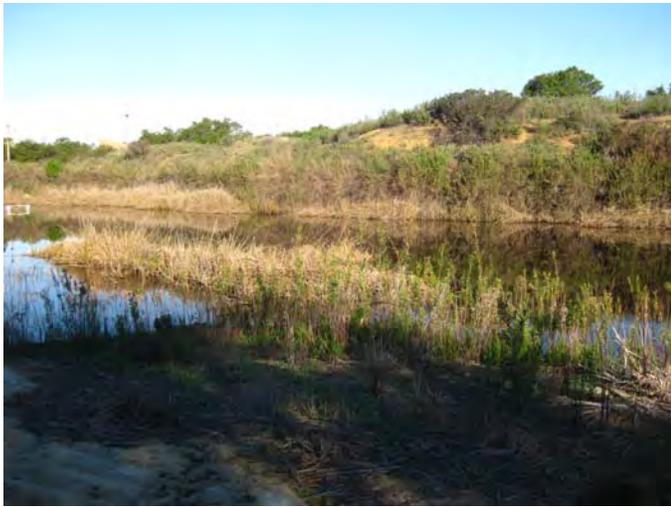
Photograph E. View of Silvernail Pond in Boeing Area III. This pond dries during most years but was inundated at the time of field surveys.

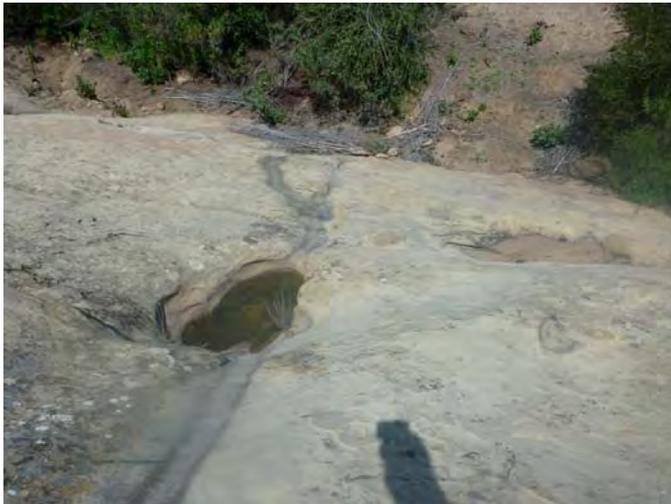
Photograph G. View of sandstone pool chute complex located in Boeing Area III. Some of the pools in this complex were inundated at the time of field surveys.

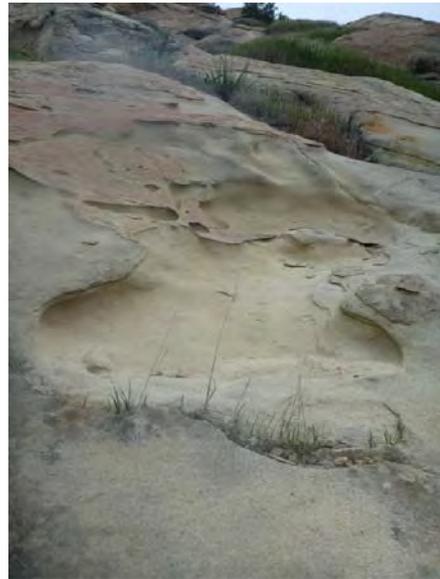
Photograph H. View of isolate sandstone pool located in Boeing Area I. Dry at the time of field surveys.
