AI-ERDA-13158

BUILDING 003
DECONTAMINATION AND DISPOSITION
FINAL REPORT

CONTRACT: AT(04-3)-701
ISSUED: FEBRUARY 25, 1976

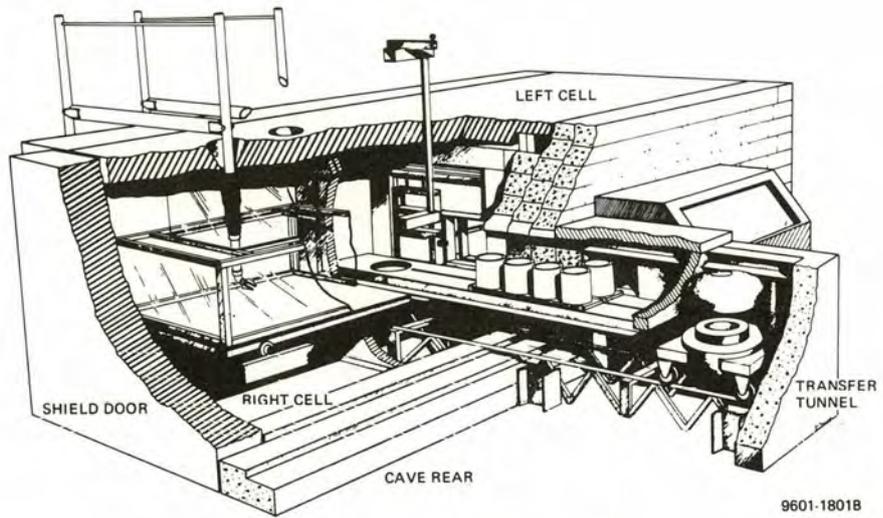
9601-1801B

The Hot Cave (Figure 1) was totally dismantled and all materials and equipment removed from the site. Dismantling included removal of:

Figure 1. Hot Cave Layout

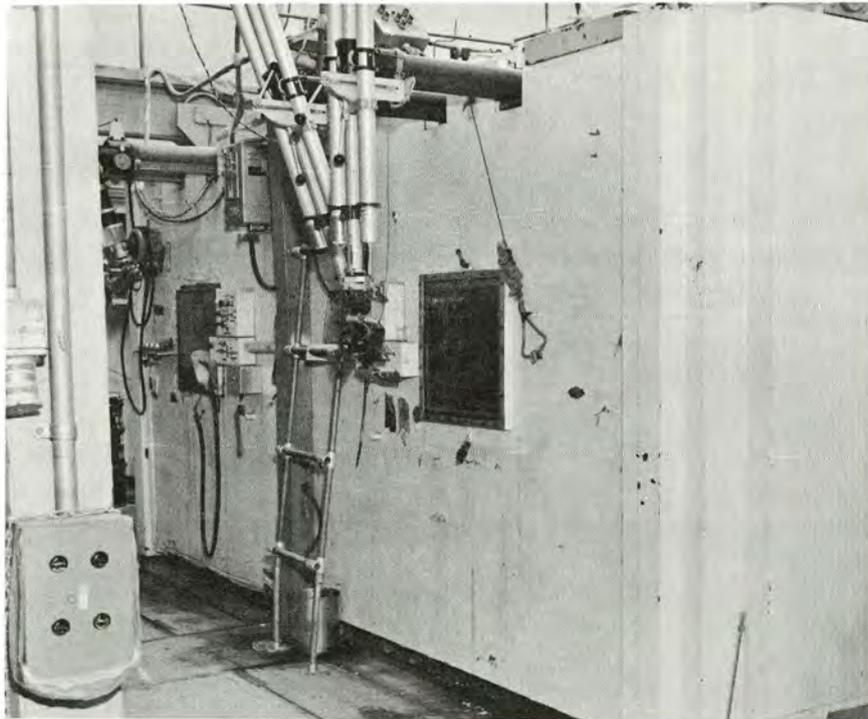
9070-6206-SRE

Figures 2, 3, 4, and 5 present views of the Hot Cave front, side, rear, and top respectively, prior to dismantling.

Figure 2. Front of Hot Cave

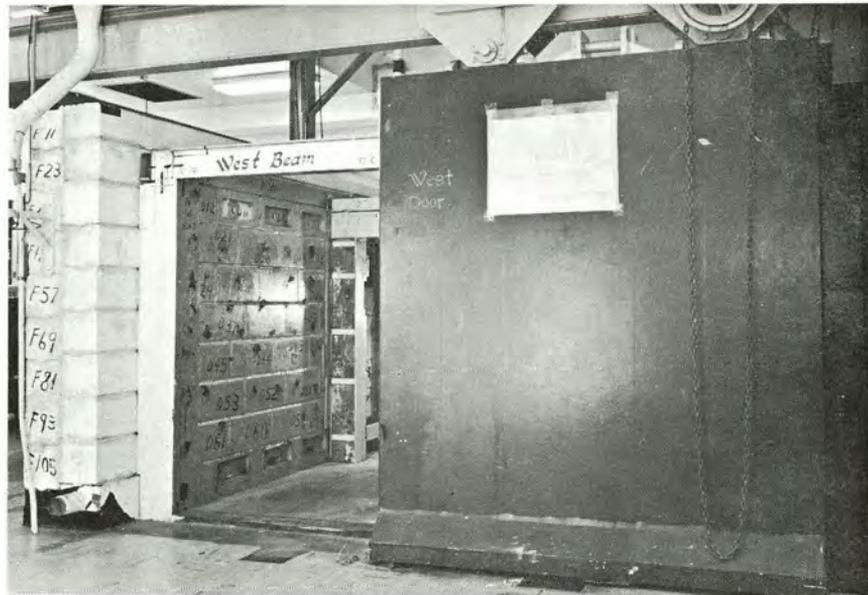
7522-1805C

Figure 3. Side View of Hot Cave

Plastic sheet entry enclosures (Figure 6) were constructed, one each for the east and west door openings. The enclosures allowed opening the cell doors for personnel entry, and prevented the spread of contamination into the Building 003 high bay. The Hot Cave exhaust system was operated throughout the Hot Cave decontamination activities. This system also vented the entry enclosures when the cell doors were opened. The building and the cell doors (Figure 3) were kept

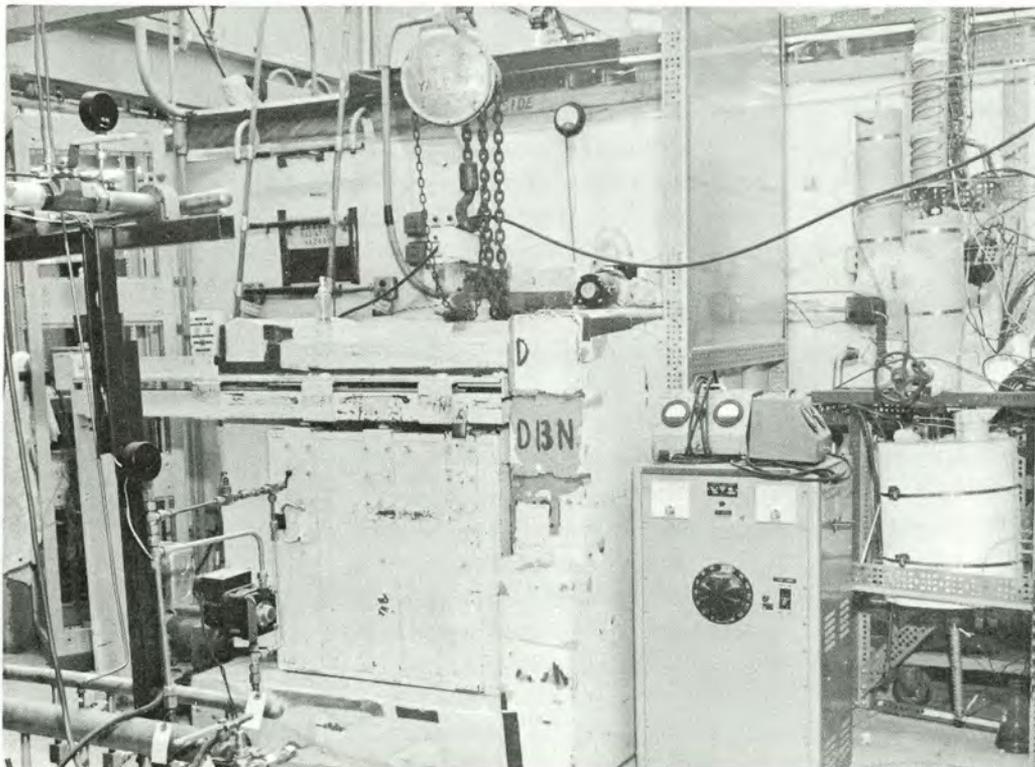
9070-6217-SRE

Figure 4. Rear of Hot Cave

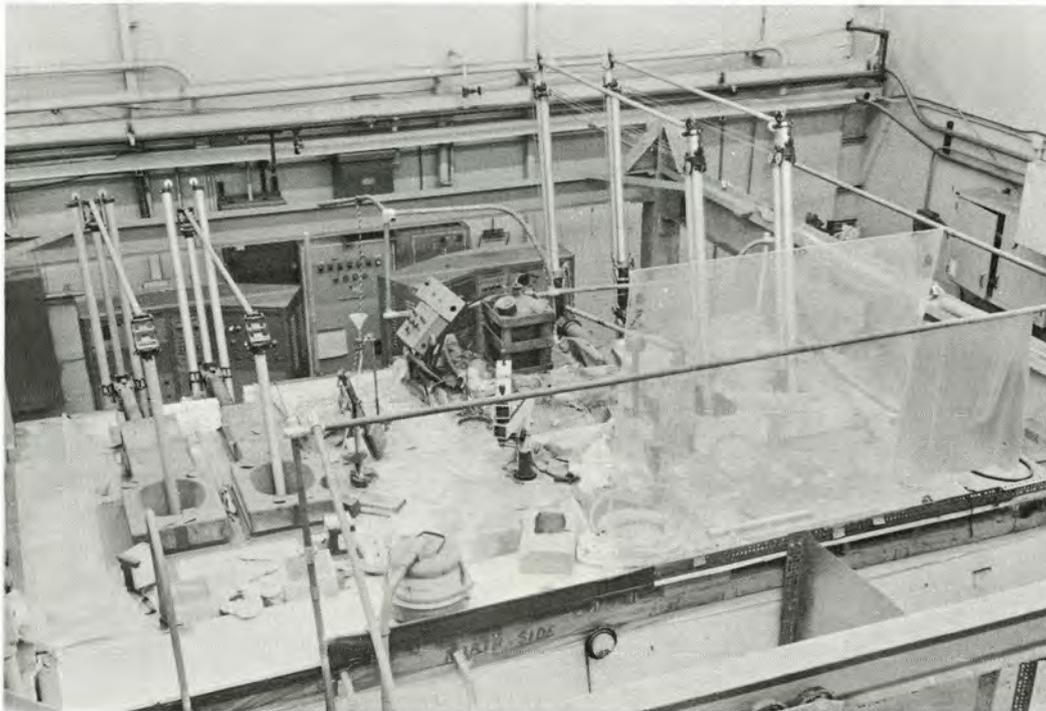
Figure 5. Top of Hot Cave 9070-6215-SRE

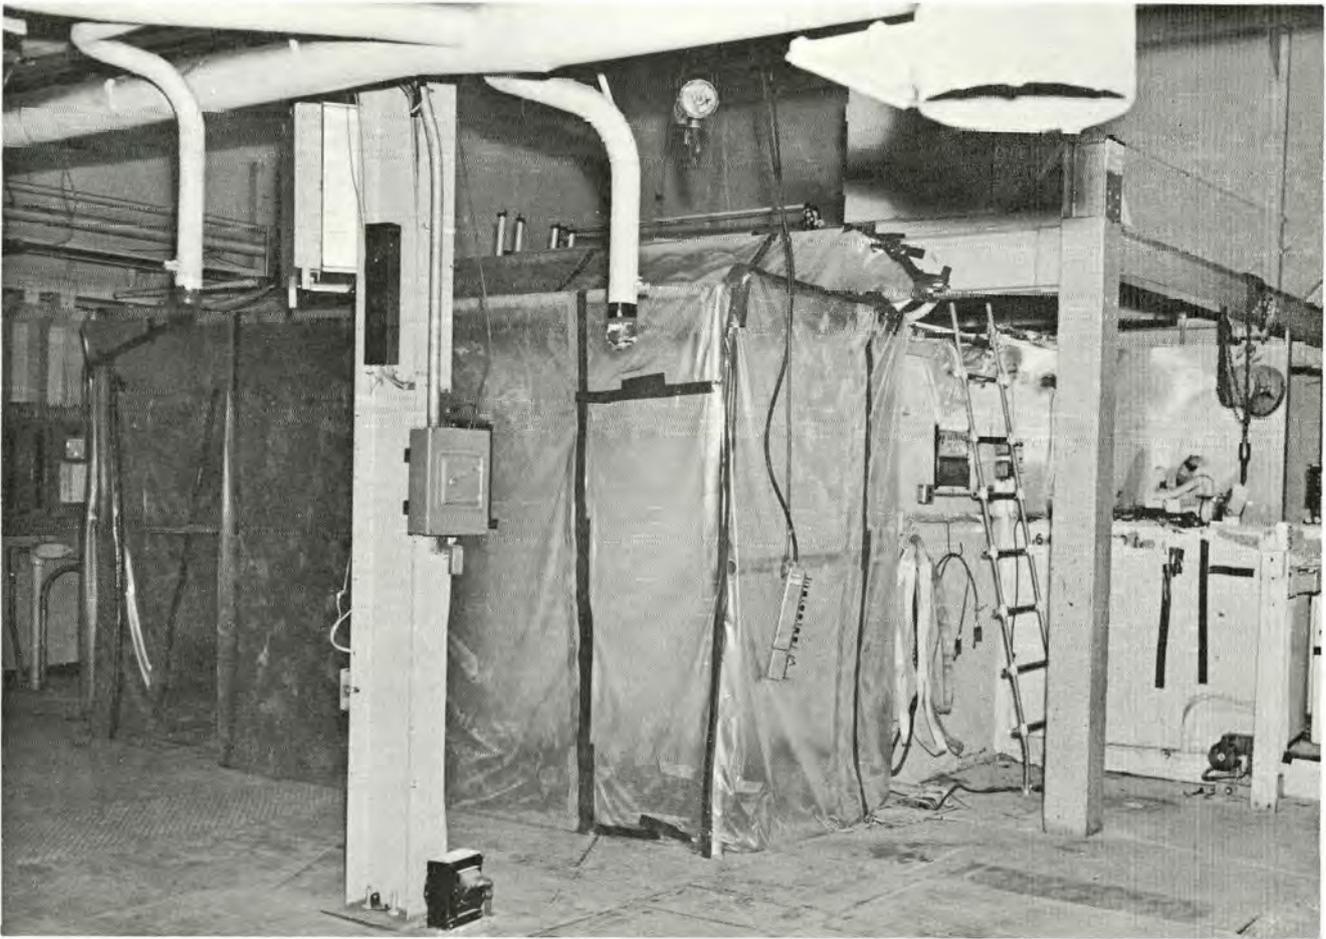
7704-6220

Figure 6. Cell Door Enclosure

The east cell of the Hot Cave was entered and decontaminated first. Restricted Access Entry Permit No. 17602 was issued by the Health, Safety, and Radiation Services Department. Figure 6 shows the typical entry enclosure erected over the cell door.

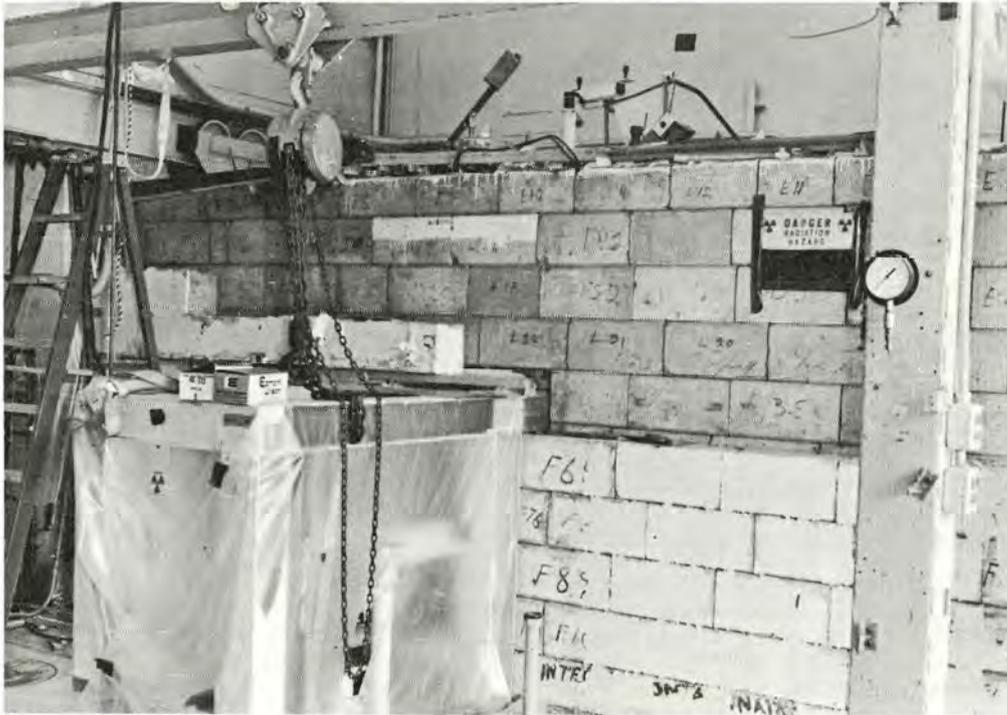
9070-6239

burial at Beatty, Nevada. After the area was decontaminated, the shield blocks surrounding the tunnel were removed. Each block was examined for contamination. A plastic sheet cover was taped over the tunnel to prevent contamination spread (Figure 7).

Figure 7. Transfer Tunnel Entry Cover

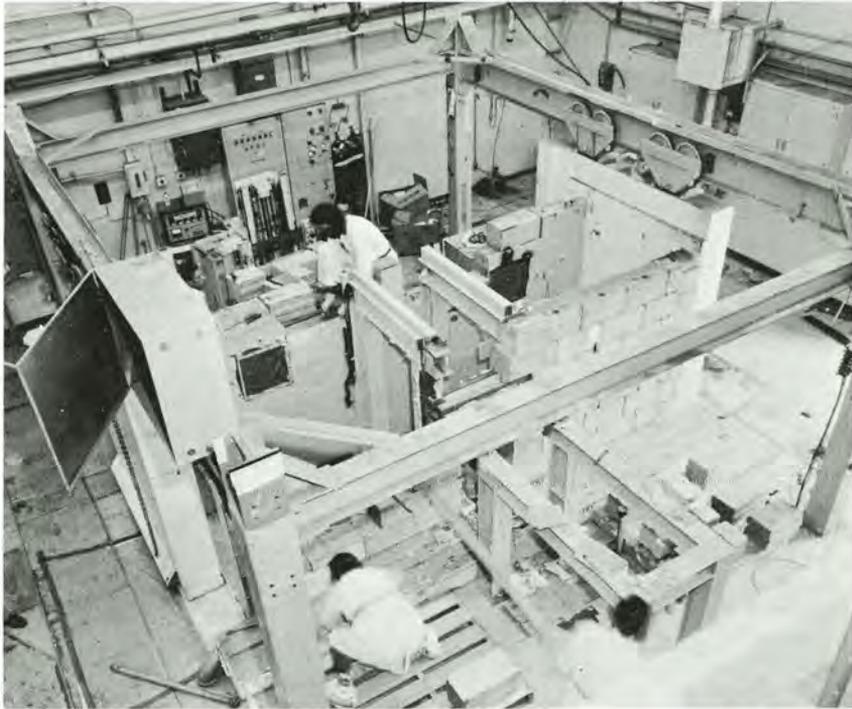
9070-6244

The cell roof and wall shield blocks were removed. The contaminated roof blocks were wrapped with plastic sheets. The wall blocks were in layers three deep. Two of the blocks located over the west cell in the second layer were found to be contaminated. These were decontaminated to less than the limits specified in Table 1 of the Plan. The floor area exposed upon block removal was surveyed and found to be free of contamination. The blocks making up the interior layer were found to be contaminated and were disposed of as radioactive waste. Figure 8 shows the block wall disassembled.

Figure 8. Disassembly of Block Walls

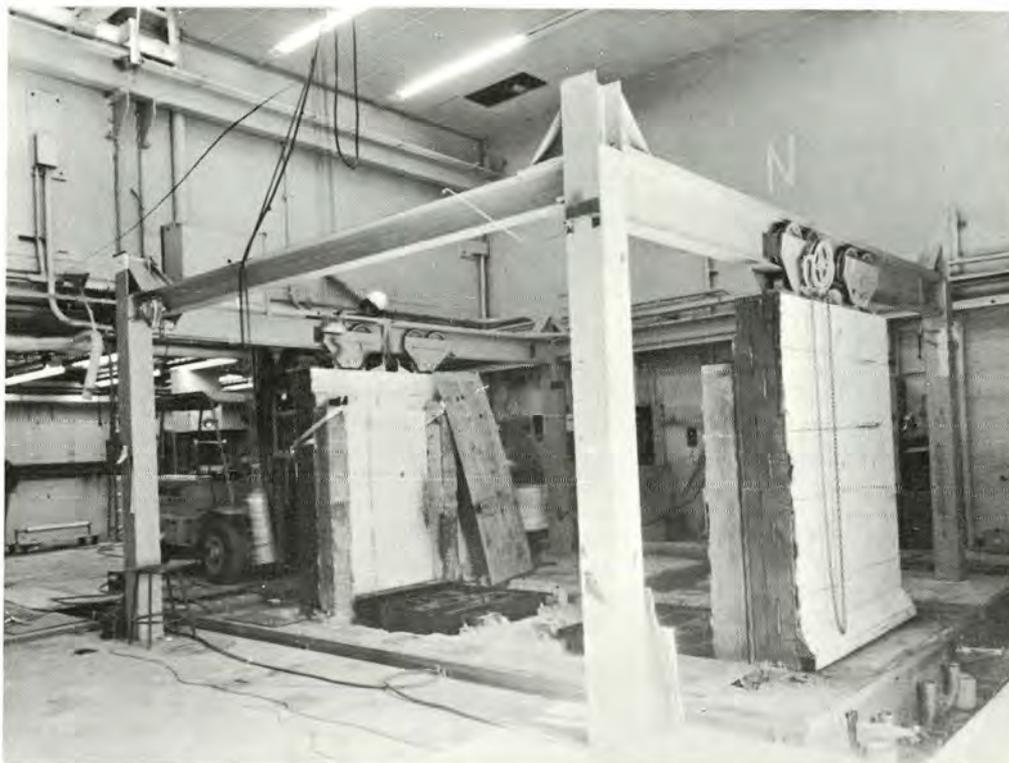
9070-6249

Each cell contained a stainless-steel pan about 3 ft by 3 ft and 8 in. deep. These pans provided a junction and distribution system for the exhaust air, electrical power, instrumentation, and radioactive waste. Figure 9 shows the pans just inside the door structure. The pans were partially decontaminated and the remaining contamination was fixed with a spray paint. Removal of these pans was difficult because of the massive 18-in. thick reinforced concrete that had been poured around the pans and the connecting ducts and conduits when constructed.

Several techniques for removal were employed. Oxy-acetylene flame cutting and carbon arc fusing were tried but progress was extremely slow. The concrete grout behind the pan metal absorbed most of the applied heat, preventing rapid melting of the metal. Air breathing equipment was used by the operator in addition to the usual protective clothing. A special exhaust duct for removal of the generated fumes was connected to the building radioactive exhaust system.

Figure 9. Floor Pans at Base of Doors

The two 12-ton shield doors and supporting steel structure (Figure 9) were sold to a salvage contractor for \$735 who dismantled and removed it all without charge. Prior to release of this structure to the salvage contractor, the doors were

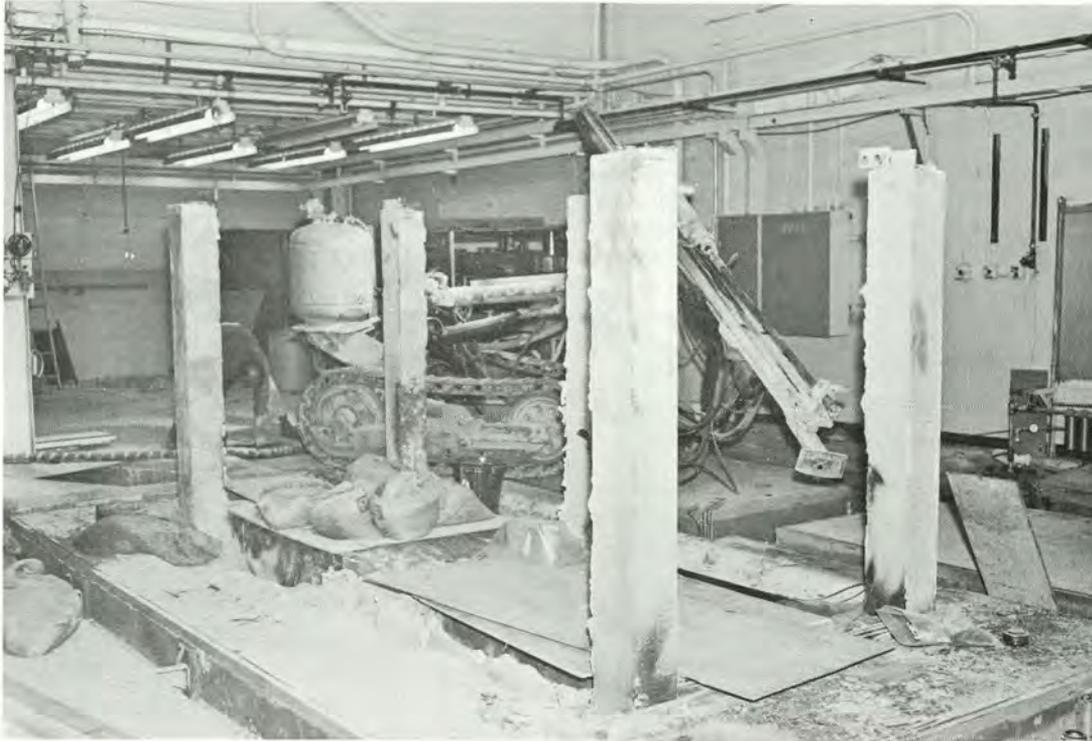
9070-6248

The pans were finally removed using explosives. The demolition subcontractor drilled several holes beneath the pans and set off charges. The force of the explosive charges was contained by sand bags over the pans and the concrete. Figure 10 shows preparations for blasting. After repeating the drilling and explosive detonations several times, the pans were loosened. The air sampler recorded no detectable airborne contamination during the drilling and blasting.

Figure 10. Drill Rig and Preparation for Blasting

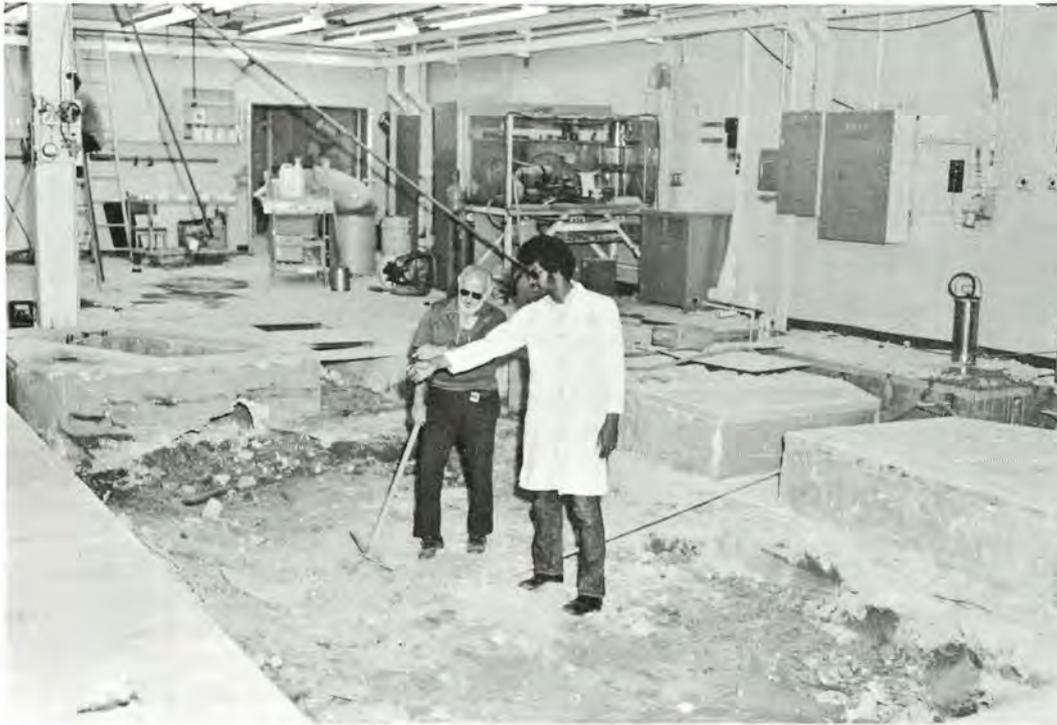
9070-6250

The Hot Cave radioactive exhaust filters were removed, wrapped in plastic, and shipped to Beatty, Nevada for burial. Exhaust ducts and liquid waste lines were removed and also wrapped and shipped to the burial site. The two liquid waste tanks associated with the Hot Cave were partially decontaminated. These holdup tanks were later removed by the contractor using a back hoe, and packaged for shipment to the burial site. The remaining noncontaminated concrete, rubble, and soil at the Hot Cave site were removed by the contractor. Figure 11 shows the completed excavation. This area was subsequently

Figure 11. Excavation of Hot Cave Floor

excavated further to construct a mockup of the SRE reactor vessels as part of the tooling development for the planned dismantling of the SRE.

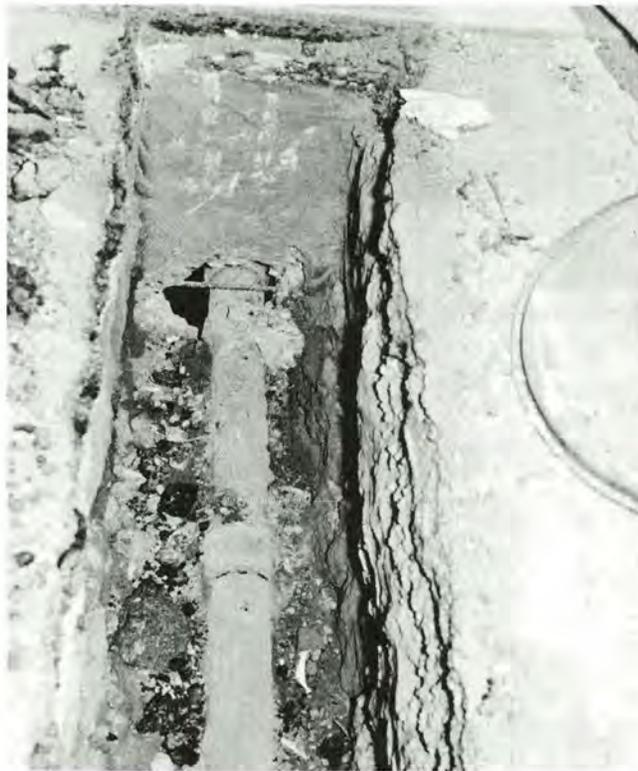
7704-6629

The radioactive waste sinks, which had been decontaminated after their last usage, one in the high bay and one in the upstairs laboratory, were removed and packaged for shipment to Beatty, Nevada for burial. To remove the drain lines required breaking through the concrete floor for a distance of about 60 ft and excavating. Figure 12 shows a section of the excavation. The soil in the vicinity of the drain lines was sampled and analyzed for radioactivity. The lines were removed by breaking them at the joints. There was no residual

Figure 12. Excavation of Radioactive
Waste Drain Line

liquid in the lines, but in the removal process the soil became contaminated when pieces of pipe came into contact with the soil. In the areas where radioactivity was found, the soil was removed, packaged in 55-gallon drums and shipped to Beatty, Nevada for burial. A final check of the trenches with direct reading instruments and by soil sampling showed the area to be free of contamination. The holdup tank at the end of the drain line was removed and sent to Beatty, Nevada for burial. The trenches were then backfilled and paved with concrete.

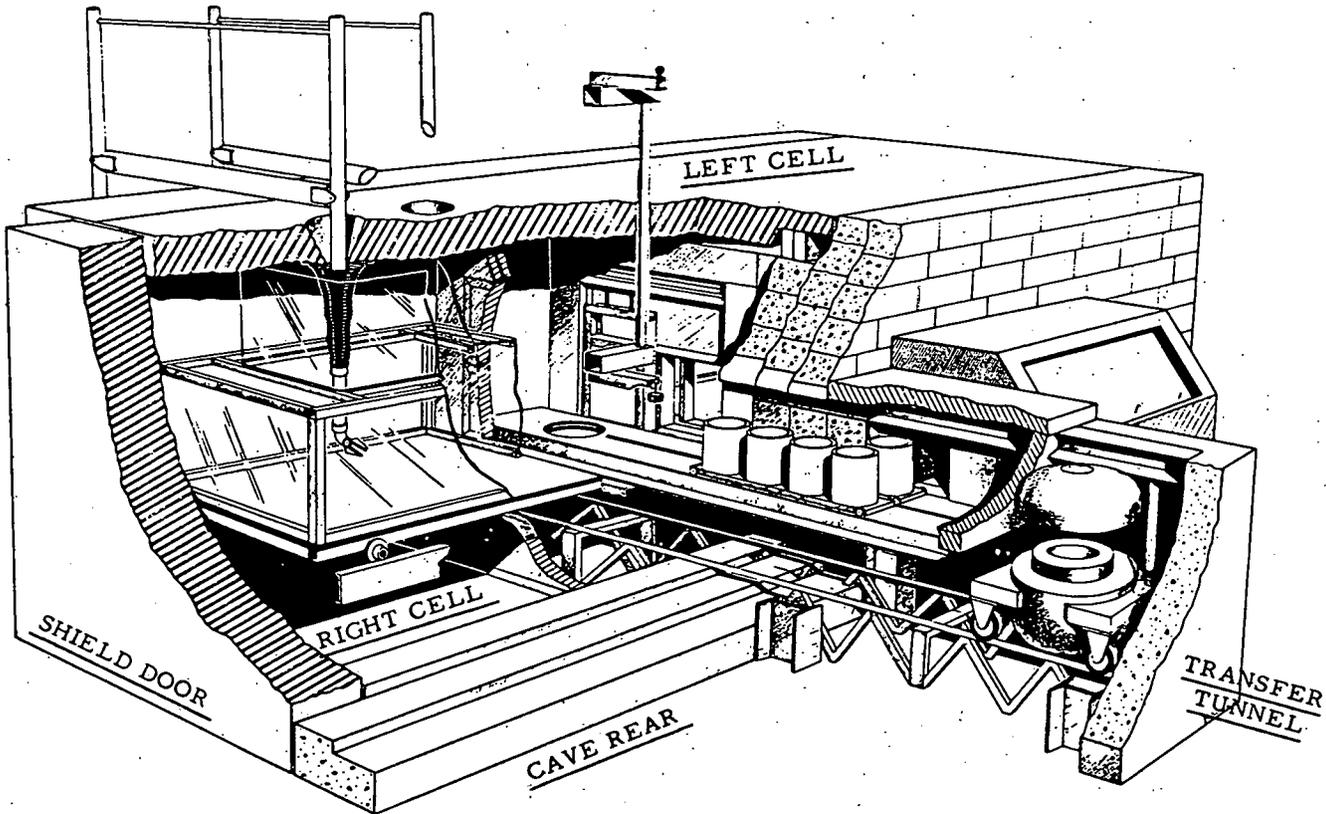
9601-1801A

The hot cave consists of two cells and a transfer tunnel for introducing and removing material from either cell (see Figure 1). The following will be dismantled or removed:

Figure 1. Hot Cave Layout
