# Chicago South, Illinois, Site

## SITE CERTIFICATION SUMMARY

# Chicago South, Illinois, Site Certification Data Summary Worksheet

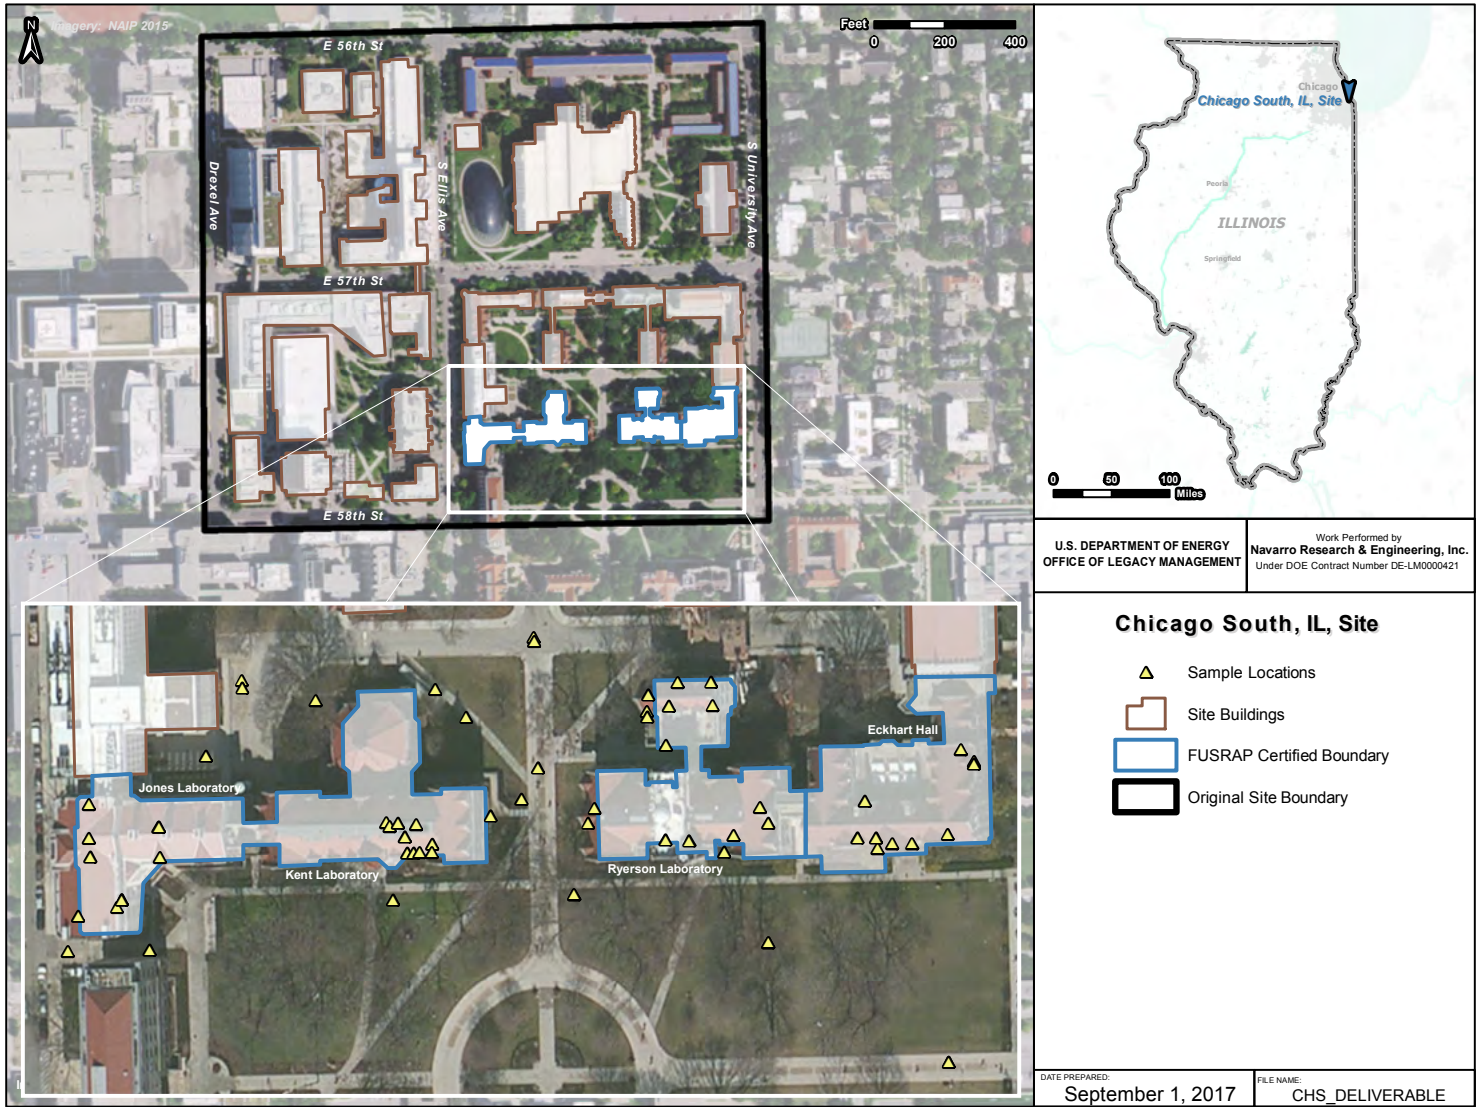
# Chicago South, Illinois, Site Map

For more detailed results of the post-remediation sampling, see the [Site Certification Data Summary Worksheet](#) on pages 4-12. For a detailed map of the site and sampling locations, see the [Site Overview Map](#) on page 13.
