## **Columbus East, Ohio, Site**

This Site Certification Summary provides information about the **Columbus East, Ohio, Site**. The U.S. Department of Energy Office of Legacy Management is responsible for long-term stewardship of the site under the **Formerly Utilized Sites Remedial Action Program**.

### **Columbus East, Ohio, Site Certification Data Summary Worksheet**

## Columbus East, Ohio, Site Map

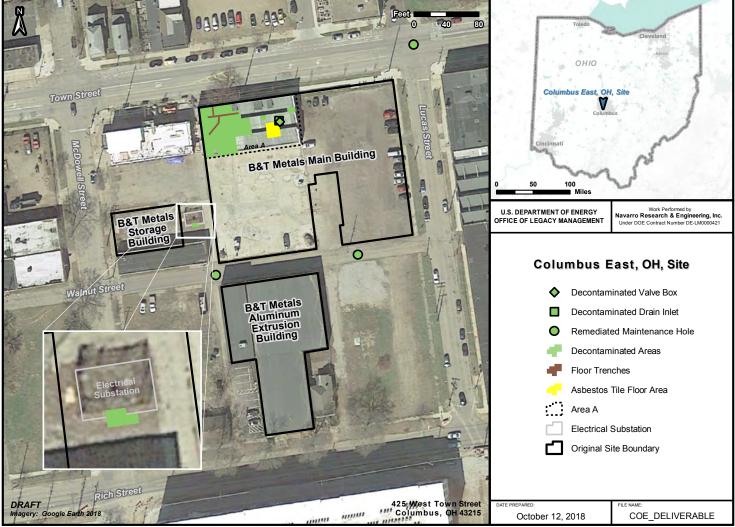
Areas requiring radiological remediation included the interior of the northwest corner of the main building, the rain gutters above this area, three exterior maintenance holes (M-1, M-2, and M-6), and 4 square yards of exterior soil adjacent to an electrical substation.

For more detailed results of the post-remediation sampling, see the Site Certification Data Summary Worksheet on page 3. For a detailed map of the site and sampling locations, see the Site Overview Map on page 4.
