Gnome-Coach, New Mexico, Site

A Plowshare Site/Offsite

This fact sheet provides information about the **Gnome-Coach site**. Long-term stewardship responsibilities for this site are managed by the **U.S. Department of Energy Office of Legacy Management**.

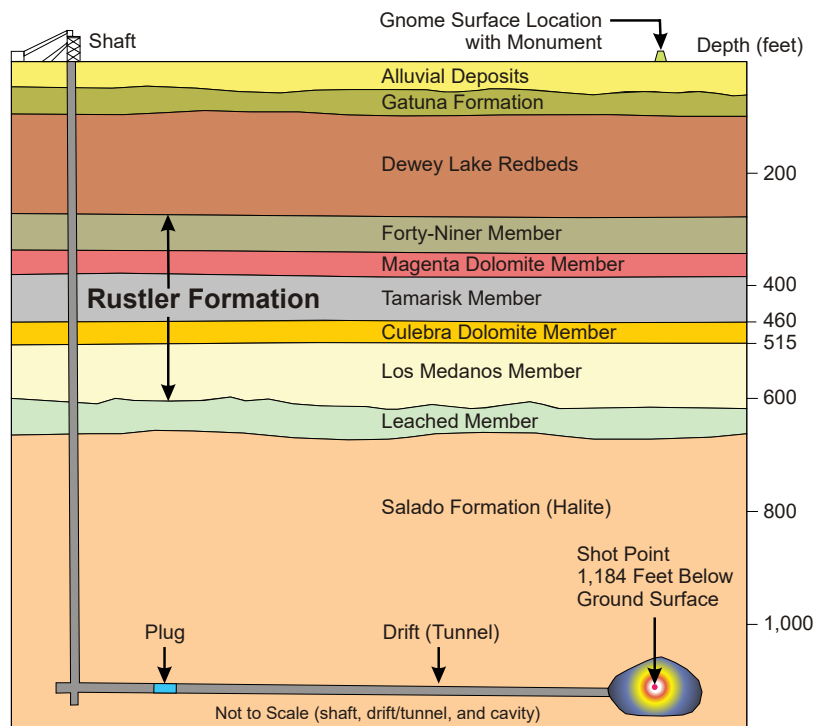
Gnome-Coach, New Mexico, Site cross section.

AEC personnel performed the nuclear test in the Salado Formation at a depth of 1,184 feet on Dec. 10, 1961. The Salado Formation is a 1,500-foot-thick bed of halite (salt) that is highly impermeable. The nuclear device was placed in the formation through a mined emplacement shaft and horizontal drift or tunnel (see cross section on Page 2). The underground nuclear detonation produced extremely high temperatures that vaporized the surrounding rock and created a cavity at the detonation depth. Immediately following the detonation, close-in stemming materials (used to contain explosion gases) failed, and gases from the detonation cavity vented to the atmosphere through the tunnel and emplacement shaft. A video taken five months after the test shows scientists accessing the cavity through the emplacement shaft and tunnel. The video is available at www.youtube.com/watch?v=Xh9eYitrLaM. Post-test drilling and preparations for another underground nuclear test, called project Coach, began shortly after the Gnome test. AEC scheduled the Coach experiment for 1963, but later canceled the project before carrying it out. The site is still referred to as the Gnome-Coach site.

U.S. Geological Survey (USGS) personnel conducted a groundwater tracer test in 1963 using four dissolved radionuclides — tritium, iodine-131, strontium-90, and cesium 137 — as tracers. They injected these isotopes into groundwater through a well in the Culebra Dolomite Member of the Rustler Formation (see cross section on Page 2). The purpose of the tracer test was to evaluate the potential movement of radionuclides through the Culebra Dolomite aquifer.

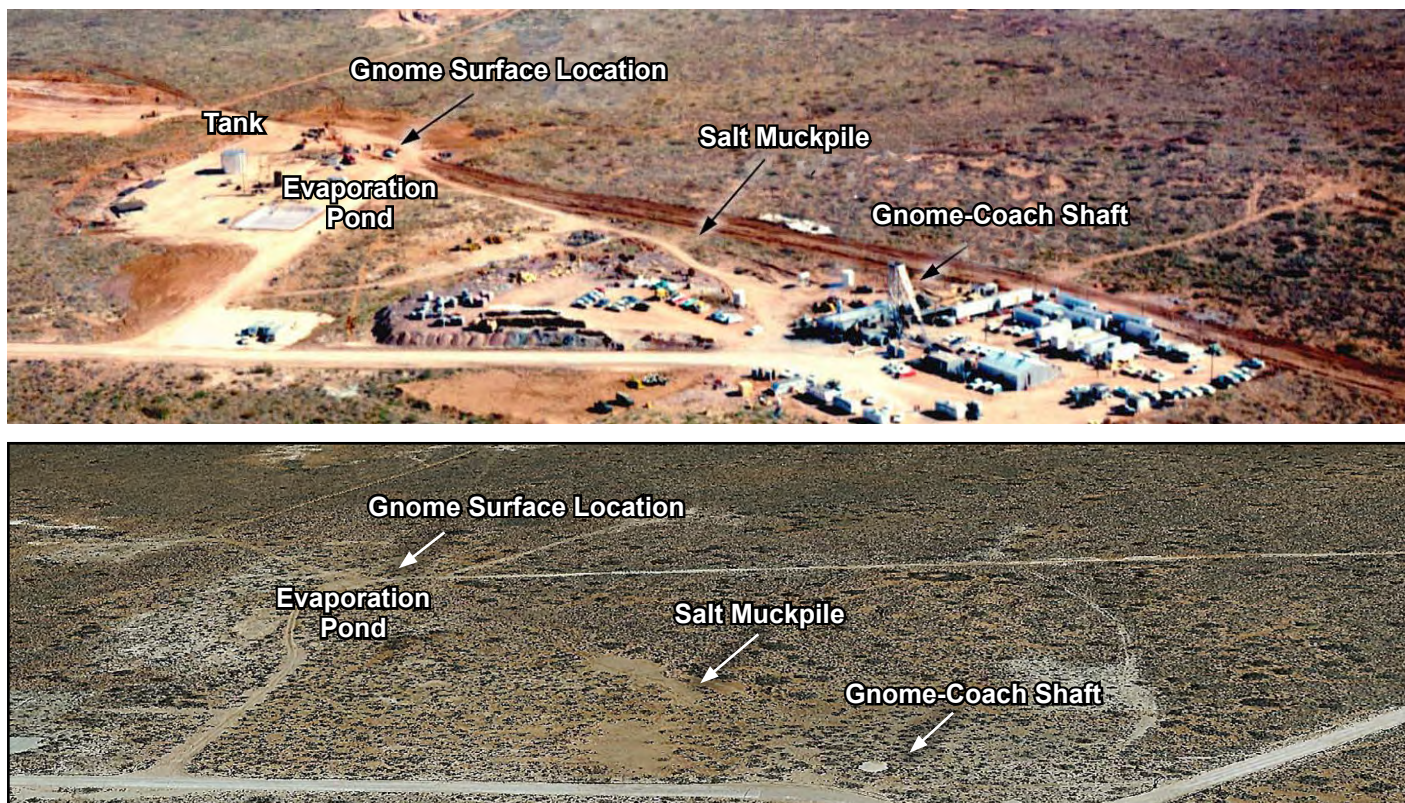
Top: View of Gnome-Coach, New Mexico, Site in 1961; Bottom: View in 2014.
