## Gnome-Coach, New Mexico

### A WEAPONS RELATED AND VELA UNIFORM SITE

This fact sheet provides information about the **Gnome-Coach site**. Long-term stewardship responsibilities for this site are managed by the **U.S. Department of Energy Office of Legacy Management** under the **Plowshare/Vela Uniform/Weapons Related Program**.

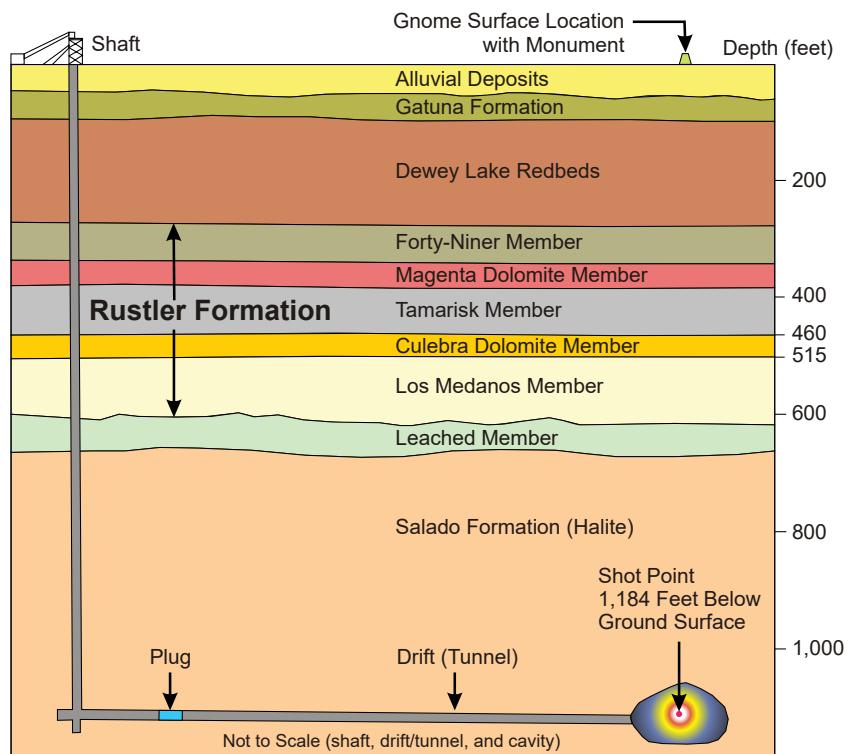
Gnome-Coach, New Mexico, Site cross section.

AEC personnel performed the nuclear test in the Salado Formation at a depth of 1,184 feet on Dec. 10, 1961. The Salado Formation is a 1,500-foot-thick bed of halite (salt) that is highly impermeable. The nuclear device was placed in the formation through a mined emplacement shaft and horizontal drift or tunnel (see cross section on Page 2). The underground nuclear detonation produced extremely high temperatures that vaporized the surrounding rock and created a cavity at the detonation depth. Immediately following the detonation, close-in stemming materials (used to contain explosion gases) failed, and gases from the detonation cavity vented to the atmosphere through the tunnel and emplacement shaft. A video taken five months after the test shows scientists accessing the cavity through the emplacement shaft and tunnel. The video is available at [www.youtube.com/watch?v=Xh9eYitrLaM](https://www.youtube.com/watch?v=Xh9eYitrLaM). Post-test drilling and preparations for another underground

U.S. Geological Survey (USGS) personnel conducted a groundwater tracer test in 1963 using four dissolved radionuclides — tritium, iodine-131, strontium-90, and cesium-137 — as tracers. They injected these isotopes into groundwater through a well in the Culebra Dolomite Member of the Rustler Formation (see cross section on Page 2). The purpose of the tracer test was to evaluate the potential movement of radionuclides through the Culebra Dolomite aquifer.

Contamination remains in the detonation cavity, tunnel, and shaft and in the Culebra Dolomite where the USGS conducted the tracer test. Properties of the Salado Formation make it nearly impermeable, which makes any continuous movement of water through the formation highly unlikely. The Culebra Dolomite is a widespread, laterally continuous, fractured carbonate aquifer. Although groundwater within the Culebra is of poor quality because of naturally high concentrations of dissolved solids (salt), it is a

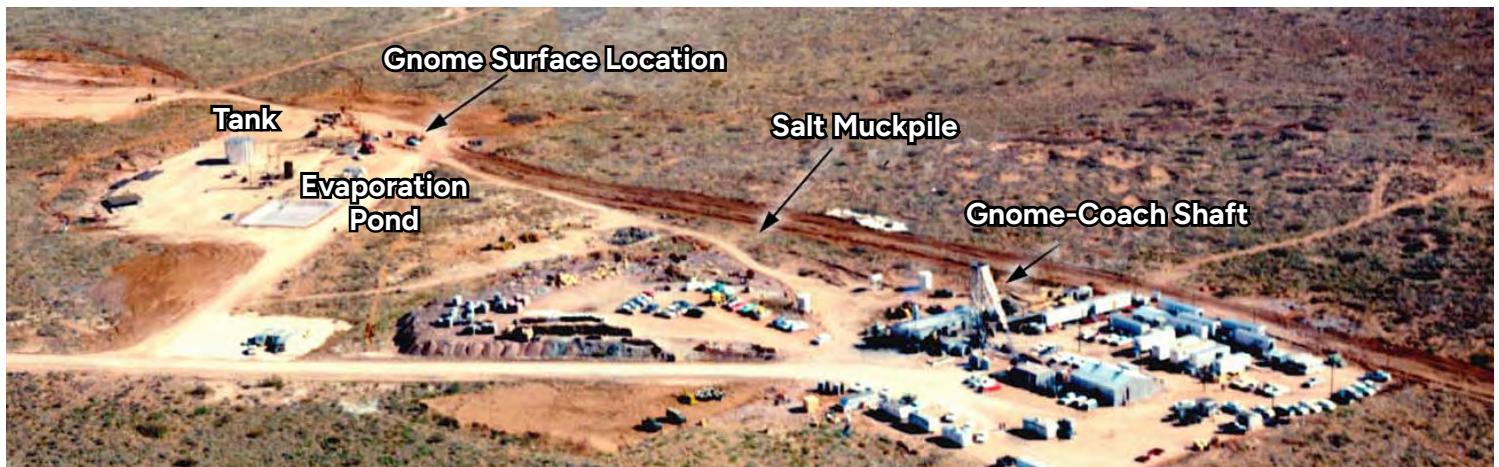
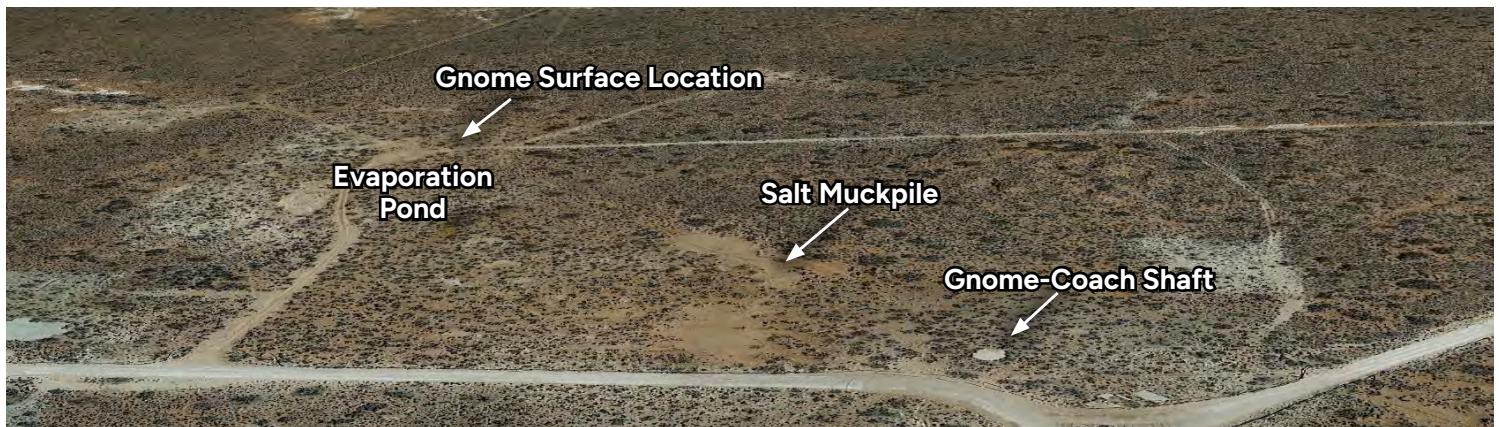
Top: View of Gnome-Coach, New Mexico, Site in 1961; Bottom: View in 2014.
