Maxey Flats, Kentucky | Disposal Site

A CERCLA SITE

12.2025 | 4

This fact sheet provides information about the **Maxey Flats site**. Long-term stewardship responsibilities for this site are managed by the **U.S. Department of Energy Office of Legacy Management** under the **Comprehensive Environmental Response, Compensation, and Liability Act and the Resource Conservation and Recovery Act**.

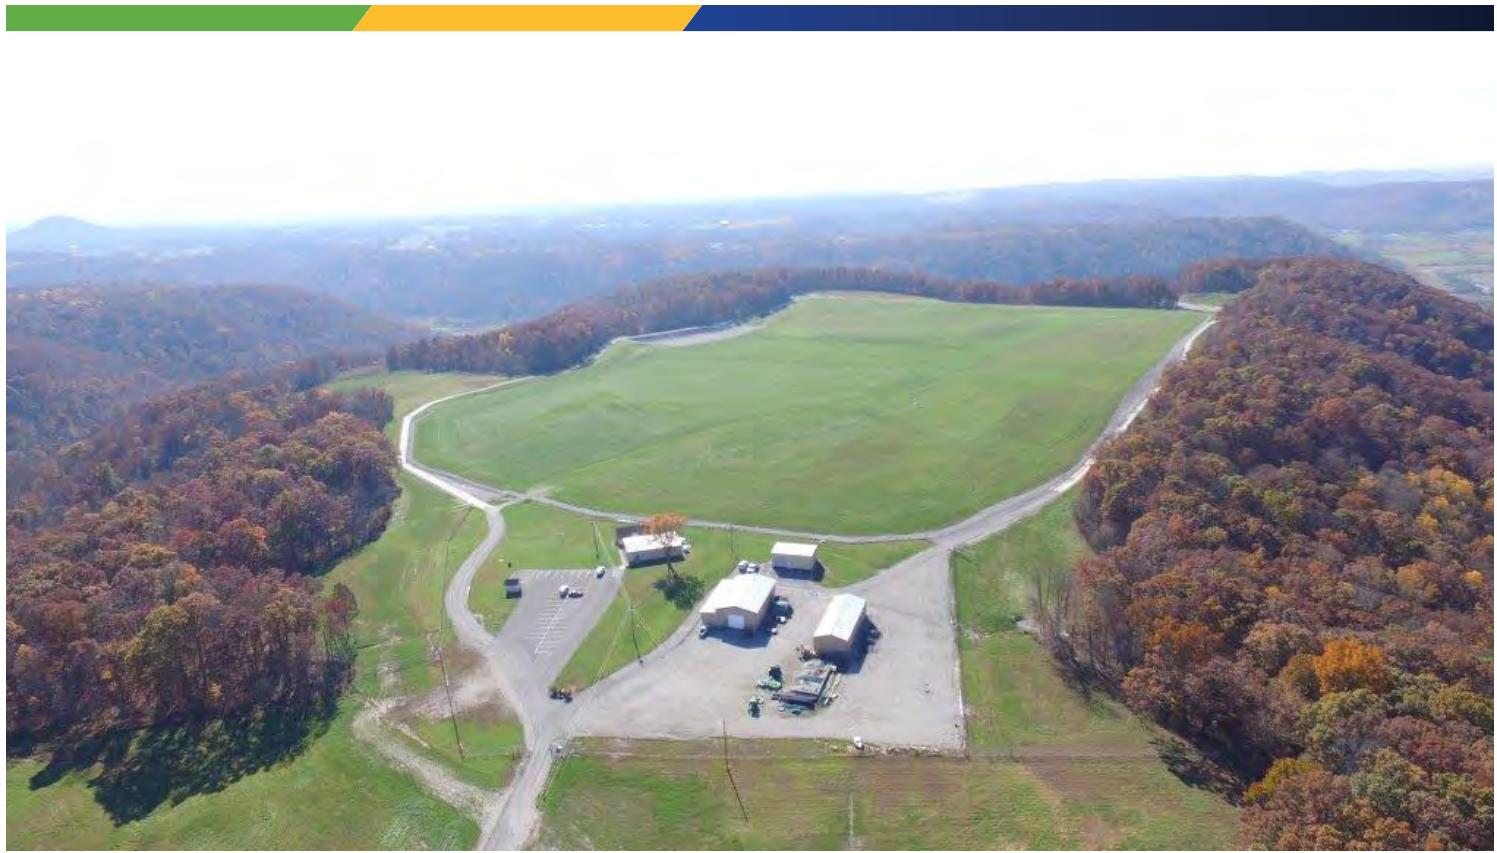
2017 Aerial View of the Maxey Flats Disposal Site; Substantial Completion of the Final Cap Was Achieved in November 2016.

determine the acceptable subsidence criteria, in consultation with the commonwealth. The commonwealth has presented EPA with subsidence data verifying that the trench stabilization criteria have been achieved. After evaluating the data, EPA agreed with the criteria and approved the commonwealth's request to proceed to the final closure period beginning September 2013. Final closure included construction of a permanent earthen cap consisting of layers of plastic covered with soil and vegetation. Substantial completion of the final cap was achieved in November 2016.
