Maxey Flats, Kentucky, Disposal Site

A CERCLA site

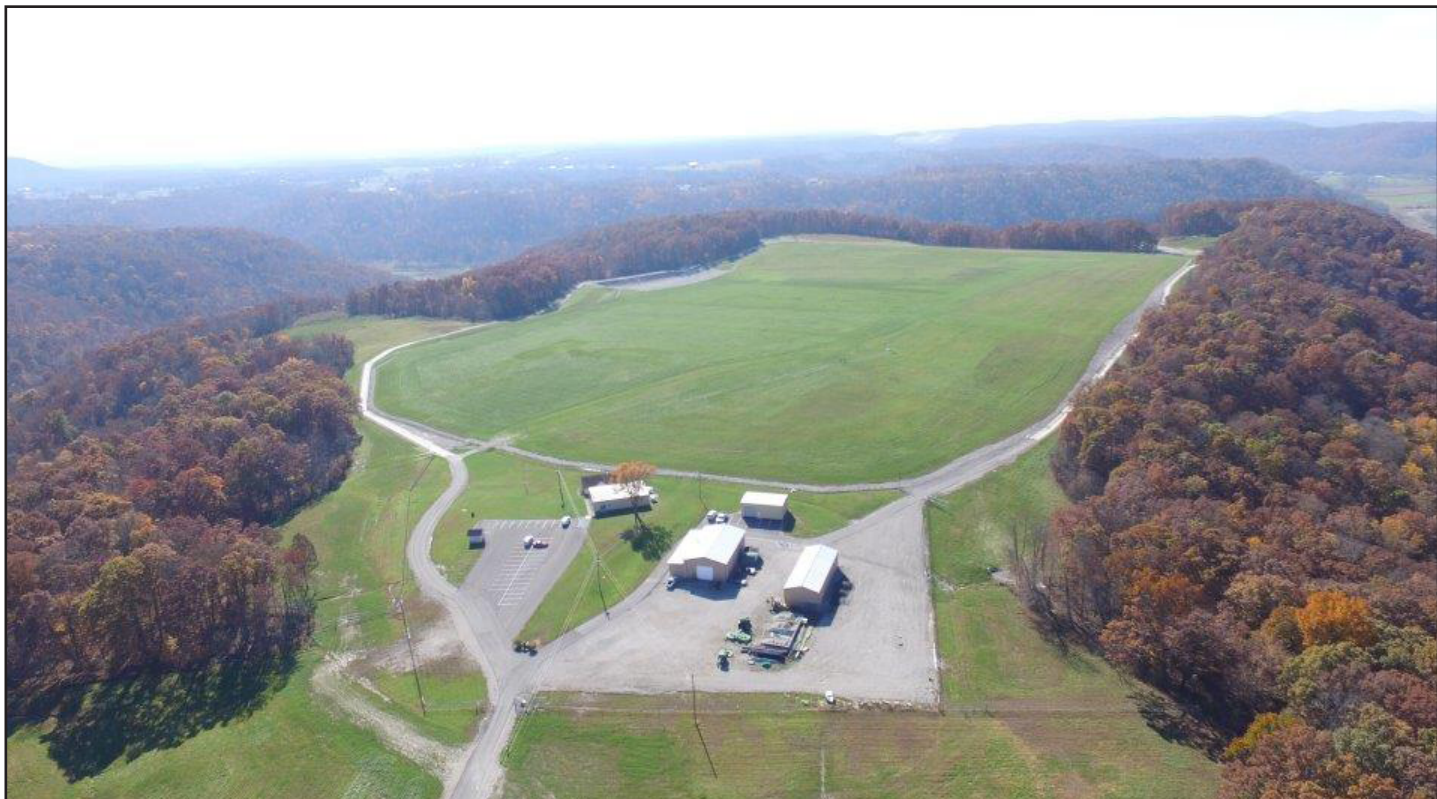
2017 Aerial View of the Maxey Flats Disposal Site; Substantial Completion of the Final Cap Was Achieved in November 2016.

The end of the interim maintenance period and the beginning of the final closure period is defined in the ROD as the time when subsidence of the trenches has nearly ceased and final cap installation can begin. EPA is required to determine the acceptable subsidence criteria, in consultation with the commonwealth. The commonwealth has presented EPA with subsidence data verifying that the trench stabilization criteria have been achieved. After evaluating the data, EPA agreed with the criteria and approved the commonwealth's request to proceed to the final closure period beginning September 2013. Final closure included construction of a permanent earthen cap consisting of layers of plastic covered with soil and vegetation. Substantial completion of the final cap was achieved in November 2016.
