Rio Blanco, Colorado | Site

A PLOWSHARE/VELA UNIFORM/WEAPONS RELATED SITE

This fact sheet provides information about the **Rio Blanco, Colorado, Site**. Long-term stewardship responsibilities for this site are managed by the **U.S. Department of Energy Office of Legacy Management**.

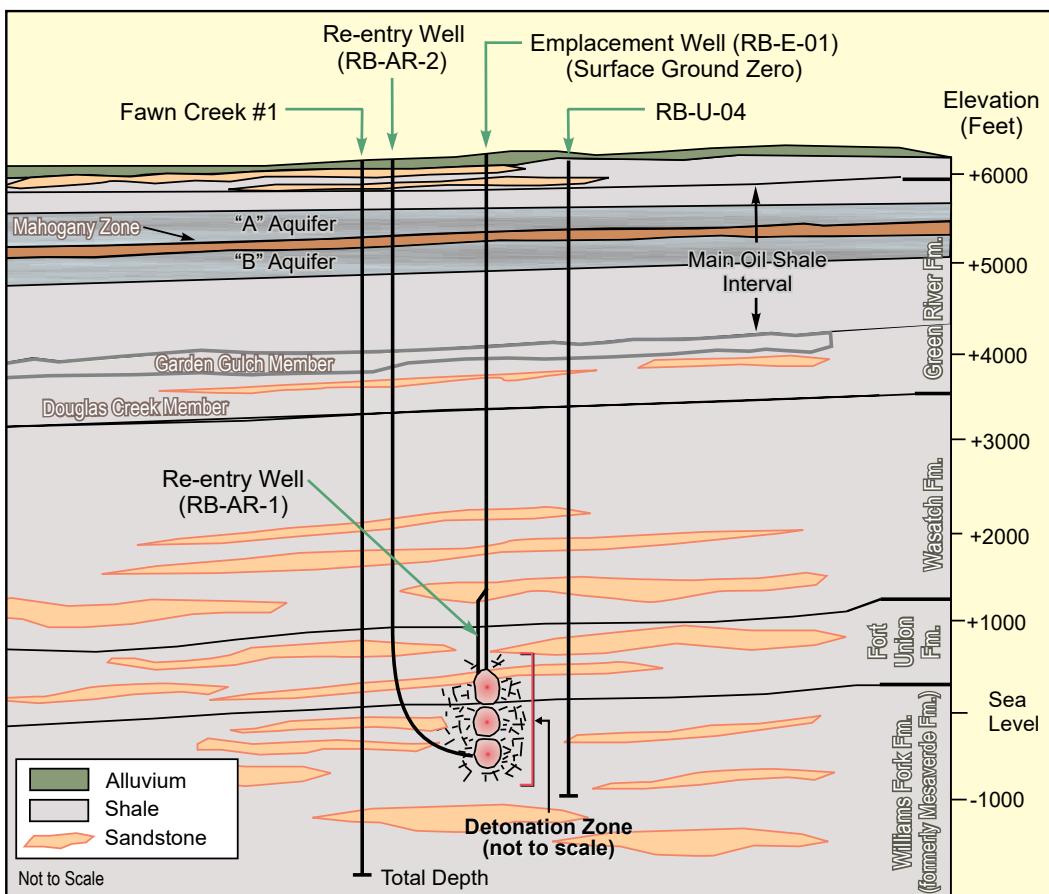
Generalized cross section of the Rio Blanco, Colorado, Site.

The detonations took place at depths of 5,840; 6,230; and 6,690 feet in a single emplacement well and fractured the gas-bearing sandstones at the base of the Fort Union Formation and the upper part of the Williams Fork Formation. They produced extremely high temperatures that vaporized the surrounding rock, temporarily creating a cavity at each depth. The fractured rock above each cavity collapsed shortly after the detonation, filling the cavity with rubble and forming a collapse chimney above each detonation point. It was expected that the collapse chimneys would be connected, allowing for improved gas production from the fractured rock surrounding each one.

The detonations took place in the upper Williams Fork and lower Fort Union Formations. These formations are not very permeable, so test-related radionuclides are not expected to travel far from the source area. The only aquifers in the area are in the surficial alluvium and the underlying Green River Formation. The base of the Green River Formation is about 3,000 feet above the depth of the detonations.
