## **Fact Sheet**

This fact sheet provides information about the **Gasbuggy Site**. Long-Term stewardship responsibilities for this site are managed by the U.S. Department of Energy Office of Legacy Management.

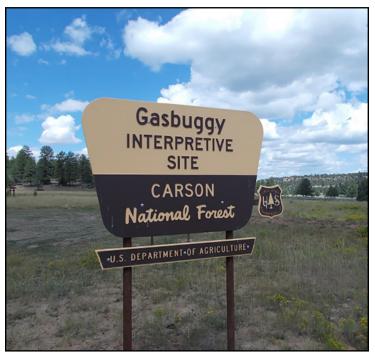
A permanent monument consisting of a brass plaque mounted in a concrete base was placed at surface ground zero at the site. Wording on the plaque describes the historical significance of the project and restrictions on subsurface excavation.

Gasbuggy, New Mexico, Interpretive Site.

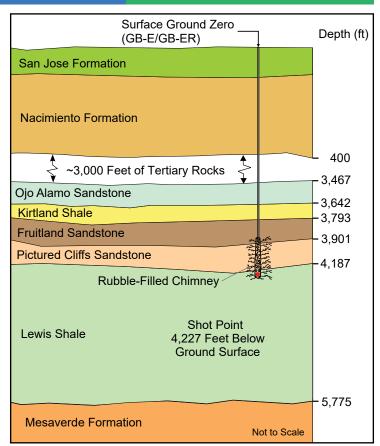
Cross Section of the Gasbuggy, New Mexico, Site.

On December 10, 1967, the U.S. Atomic Energy Commission (AEC), a predecessor agency of the U.S. Department of Energy (DOE), detonated a 29-kiloton-yield nuclear device in the emplacement well (GB-E) at a depth of 4,227 feet in an attempt to stimulate production of natural gas from the overlying gas-bearing Pictured Cliffs Formation. The detonation produced extremely high temperatures that vaporized a volume of rock, temporarily creating a cavity surrounded by a fractured area extending outward from the detonation point. Shortly after the detonation, the overlying fractured rock collapsed into the void space, creating a rubble-filled collapse chimney that extends above the detonation point. As the former cavity cooled, the melted and vaporized rock collected and solidified at the bottom of the former cavity (now the lower part of the collapse chimney). Most of the high-melting-point radionuclides were trapped in this solidified melt rock, which is often referred to as melt glass due to its (glassy) texture.

A reentry well (GB-ER) was drilled into the collapse chimney created by the detonation, and contaminated gas in the detonation zone (former cavity and collapse chimney) was produced and flared through a series of production tests. Production testing began in July 1968 and ended in October 1969 after producing 213 million cubic feet of natural gas during five tests. The test stimulated gas production in greater quantities than in nearby conventional gas wells, but the natural gas still had measurable amounts of radioactive constituents. Results of the natural gas production testing were evaluated, and it was determined that the gas had a significantly lower heat value and that fracturing into the gas-bearing formation outward from the chimney (above the cavity) did not penetrate as extensively as expected. In 1976, it was decided that no further testing would be conducted at the site.

Subsurface contamination remains in the detonation zone near the GB-E emplacement borehole. Numerical modeling studies have been conducted to assess the impacts that nearby producing natural gas wells may have on the detonation zone. Results of modeling effort indicate that contamination associated with the underground nuclear test is limited to the detonation zone and not expected to migrate to any of the near by gas wells. The producing natural gas wells near the site are routinely sampled and the sample results continue to show that no Gasbuggy test-related radionuclides have been detected.
