## Building America Case Study

# Capillary Break Beneath a Slab: Polyethylene Sheeting Over Aggregate

Southwestern Pennsylvania

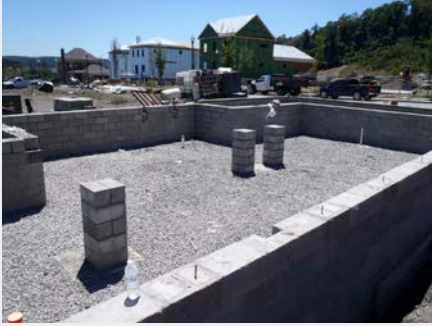
Place and level ½-in. aggregate at least 4 in. deep within the footer.

An example of this strategy is a single-family, 2,000-ft<sup>2</sup> home with three bedrooms, two and a half baths, and a conditioned (closed) crawlspace. First, the builder pours the footers for the home on level ground. Next, the builder fills the space within the footers with ½-in.-diameter aggregate to a depth of 8 in. Although aggregate depth in new construction often is only 4 in., this builder employs an 8-in. depth of aggregate to provide a larger area to accommodate any water beneath the slab. It also allows room for installation of a passive radon system that routes 4-in. PVC pipe within the inside perimeter of the footer.

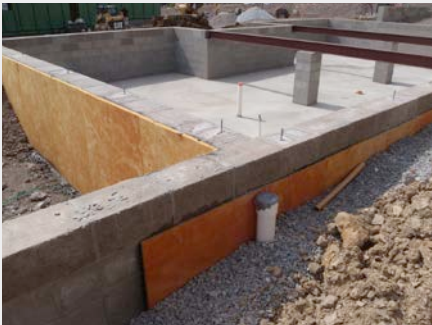
After the 6-mil polyethylene sheeting is laid over the aggregate, carefully pour the concrete over it.

After the aggregate is in place and level, the builder lays 6-mil polyethylene sheeting flat within and on top of the footer. The vapor retarder is run over the footer to provide an additional capillary break and over the foundation wall to prevent moisture wicking. The sheeting is not lapped up the sides of the walls; however, the joints of the flat sheets overlap each other by 12 in. and are sealed with tape. For additional ground-level water management, the builder also sprays waterproofing on the exterior of the below-grade foundation wall and brick ledge, along with adding exterior drains encased in aggregate. This spray-applied waterproofing (not dampproofing) is installed prior to slab preparation. Finally, the builder pours the concrete slab directly over the polyethylene sheeting, using care not to damage the sheeting.

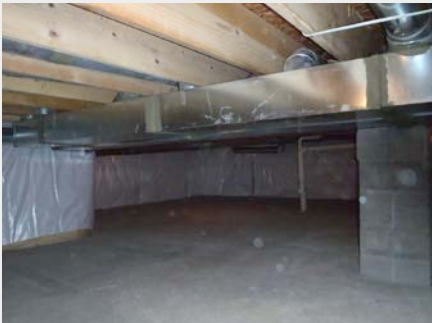
The result is a closed crawlspace with a slab protected from water wicking up through the slab.
