Holcomb-Naselle Transmission Line Rebuild Project

Draft Environmental Assessment

DOE/EA - 2091

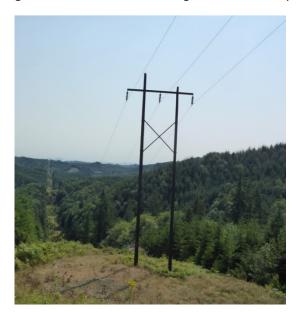
Figure 2-1. Existing Two-Pole Wood Structure

The existing transmission line is made up of 159 structures— mostly two- and three-pole wood H-frame structures. Many of the wood-pole structures have guy wires used to increase structure stability. Photos of the existing transmission line structures are shown in Figures 2-1 and 2-2.

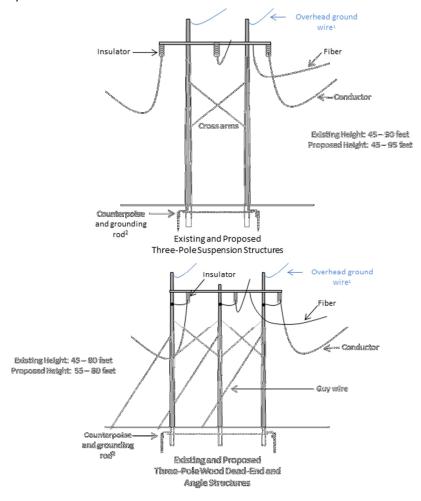
Figure 2-3. Existing and Replacement Wood Pole Structures

- 1. Proposed overhead ground wire would extend only 0.5 mile from the Holcomb and Haselle substations.
- Counterpoise would be installed at all structures supporting overhead ground wire and structures where all poles would be replaced.

Structure replacement would include installing steel cross arms and braces, dampers, insulators, guy wires and anchors (Figure 2-3). Cross arms hold up the conductors; cross braces form an "X" between wood poles for stability; and dampers minimize vibration of conductors. Wood cross arms and cross braces also would be replaced with steel cross arms and braces on structures not replaced. Insulators are strings of bell-shaped devices that prevent electricity from moving from the conductors to the structures and traveling to the ground. The existing ceramic insulators would be replaced with glass insulators that can be more reflective depending on the angle of the viewer and the sun.

Two-pole wood suspension structures are used where the structures are in a straight alignment or where the structure makes a slight turn (turning angles less than 3 degrees). They are the lightest structures because they do not have to withstand the stresses created by angles in the conductors (Figures 2-1 and 2-3). The three-pole wood dead-end structures are stronger because they use guy wires and are placed at intervals along the line to independently hold the weight and tension of the conductors. They are also used at turning angles greater than 3 degrees or on longer spans (Figures 2-2 and 2-3).

Conductors are the wires on the structures that carry the electrical current (Figure 2-3). The transmission line supports three conductors. The new conductors would be installed with new hardware and insulators. New non-reflective conductors would be 0.84 inches in diameter and would be installed after the replacement structures are erected.

New and replacement counterpoise would be buried between the poles and connected to grounding rods (Figure 2-3). The disturbance area for installing counterpoise would be within the permanent structure disturbance area.
