# AUDIT REPORT

DOE-OIG-20-32

**THE DEPARTMENT OF ENERGY'S  
WILDLAND FIRE PREVENTION  
EFFORTS AT THE OAK RIDGE  
RESERVATION**

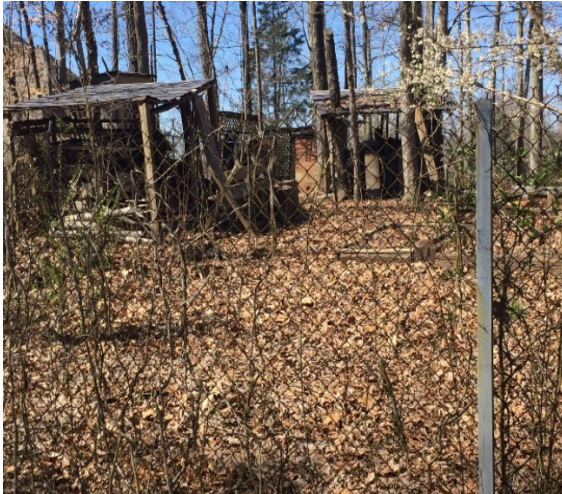
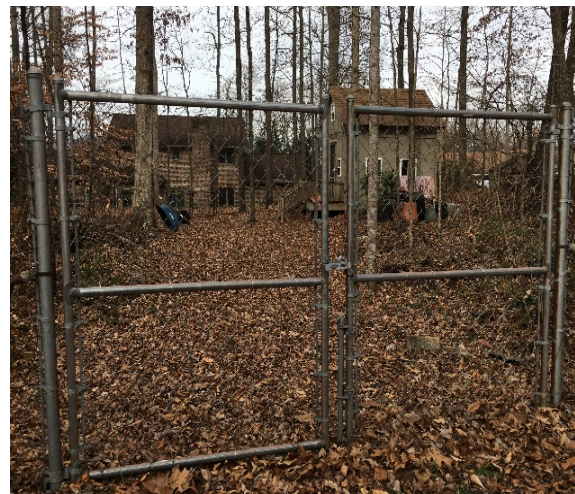
- Structures, such as wooden storage sheds, playsets, and swimming pools with electrical components, installed on Reservation property;
- Access gates with private homeowner locks installed on the Reservation’s fence; and
- Combustible materials such as tree branches and leaves piled on Reservation property.

Examples of combustible debris (left) and a wooden shed on Reservation property as well as a private access gate with a lock (right) installed on the Reservation’s fence along North Boundary Road (Pictures taken and provided by Reservation Management Branch Chief and Reservation Forester)

1. Assess wildland urban interface areas to ensure that Reservation boundaries are identified;
2. Determine a path forward to address potential encroachment on Reservation property, once boundaries have been established for wildland urban interface areas, to reduce higher risks and increased exposure to common and wildland fire causes and litigation, thereby protecting the safety and security of the Reservation and surrounding communities;

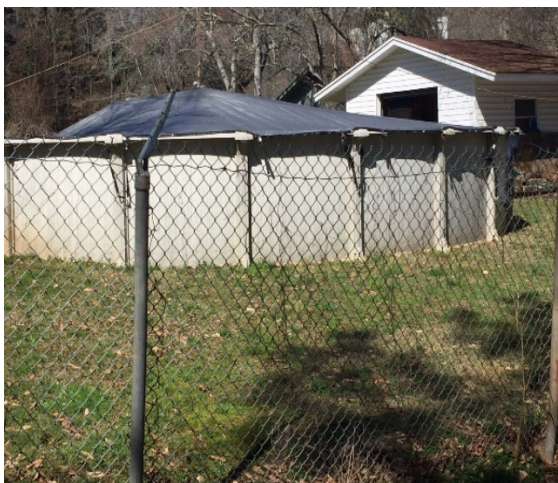
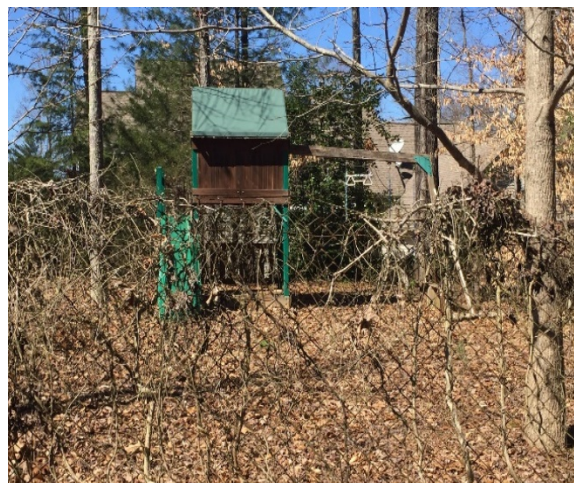
Example of a swimming pool (left) along Midway Turnpike and wooden playset (right) installed on Reservation property along North Boundary Road (Pictures taken and provided by Reservation Management Branch Chief and Reservation Forester)

The issues we observed were particularly troubling since the occurrences were within locations designated as the most significant interface areas of concern by Reservation Management

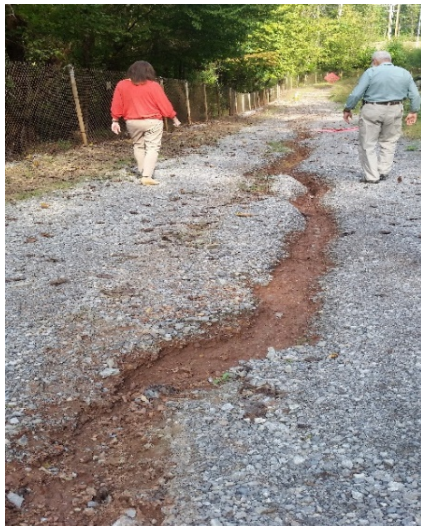
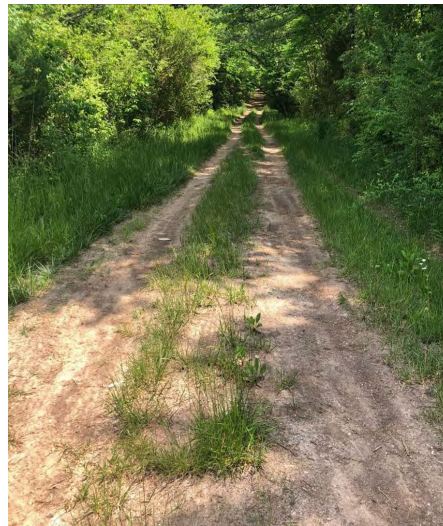
We found that fire roads necessary for establishing fire breaks and providing access for firefighters and equipment had not been maintained in accordance with applicable regulations as required by the Reservation's Wildland Fire Management Program and roads and grounds maintenance contracts. As defined in each of these documents, fire roads are to be maintained in accordance with the 2002 edition of NFPA 1144, *Standard for Protection of Life and Property from Wildfire* (NFPA 1144). The NFPA 1144 requires that fire roads support the weight of heavy equipment such as fire engines, provide a minimum road width to allow two vehicles to pass, and provide vertical clearances so vehicles can pass under the forest canopy. The Reservation's roads and grounds maintenance contracts that were in effect during the period of our review identified specific width standards and clearance requirements to maintain Reservation fire roads. Specifically, in the current roads and grounds contract, issued in 2018, Task 2.1.5, Fire Grid Road Inspection and Maintenance, requires inspection and maintenance of all existing fire grid roads in accordance with applicable regulations, citing the 2002 edition of NFPA 1144. Further, the two previous versions of the contract included in our review also contained a task related to existing fire grid road maintenance. In particular, Task 4.3.11, Construct New and Maintain Existing Fire Grid, stated that wildland fire grid roads were to meet NFPA requirements, including 13'6" overhead clearance from vegetation and 20'-30' road widths.

Similar conditions were also noted in the Oak Ridge Office Year 1 Roadway Baseline Inspection report, commissioned by Reservation Management in 2018, which identified portions of 40 of the 48 reviewed wildland fire roads that did not meet road width standards, including those which also had washout conditions or excess vegetation. Noncompliance with road standards has been a self-identified and known issue since the Reservation's Wildland Fire Management Program was established in 2005. Reservation officials indicated that some of the fire roads could not meet the standards due to terrain and other barriers; therefore, a variance from the road standards was needed. However, while Reservation officials provided documentation showing that a variance was considered, officials were unable to provide evidence that a variance was requested. As noted earlier, these roads are crucial because they provide emergency personnel and equipment access into areas where fires are burning for containment. By not meeting standards, wildland fire response is restricted to smaller firefighting brush trucks with limited water capacity<sup>8</sup>, which could increase the duration of a wildland fire. Additionally, inadequate fire road widths prohibit emergency vehicles from being able to turn around or pull over, leading to traffic congestion and creating unsafe conditions for incident responders. The following images illustrate the conditions described above that we observed with Reservation Management:

Example of washout conditions (left) on Midway Turnpike as well as improper clearance and excess vegetation (right) on Sam Grubb Road  
(Picture on left taken by audit team; picture on right obtained from Oak Ridge Office Year 1 Roadway Baseline Inspection report)

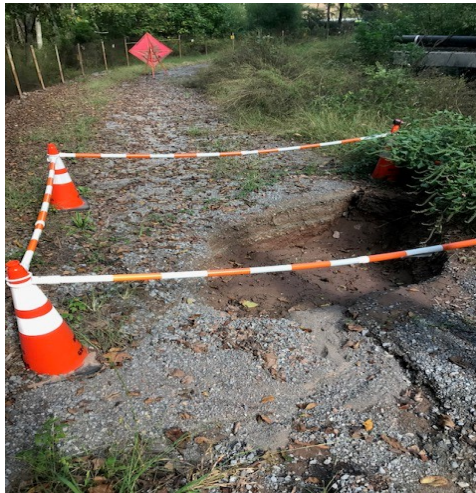
Compounding the fire road maintenance issue, we found that fire roads were also impacted by failing culverts which, in some instances, led to road closures. This is concerning because the Reservation has over 580 culverts, the majority of which support fire roads.

Example of a road closure due to a failed culvert  
on Midway Turnpike  
(Picture taken by audit team)

According to Reservation Management officials, approximately 243 culverts had been identified as requiring complete replacement or significant repair. While Reservation Management started requesting funding to address these culverts in fiscal year (FY) 2017, officials indicated that years of deferred maintenance has led to failing culverts, which compromised fire road safety and access. In 2018, six culverts structurally failed and temporary fixes were implemented to reopen the roads. While these temporary fixes allowed for emergency and security vehicle access, these roads cannot support the weight of heavy equipment necessary to respond to wildland fire events. According to Reservation Management budget documentation, more culverts are anticipated to fail over the next year, which could have a direct impact on mission success. Given the importance of fire roads, the lack of proper maintenance could hinder response times and create hazardous conditions for firefighters.

To its credit, in recognition of the failing culverts noted above, Reservation Management commissioned a study in FY 2017 to assess the condition of culverts throughout the Reservation. The study, conducted by the U.S. Army Corps of Engineers, verified that more than 200 culverts were in danger of failing within the next 10 years and noted that more than 30 may fail within the next year. Based on the results of the assessment, Reservation Management developed a prioritized list of culverts for repair or replacement and had begun requesting funding to address the failing culverts.

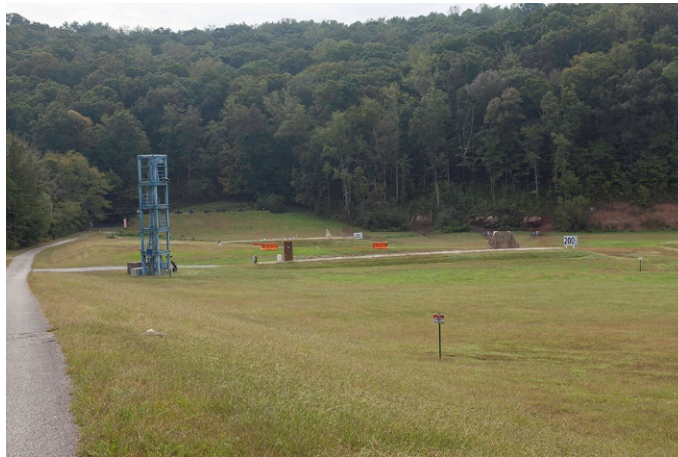
In addition, we also observed a forested area along the edge of live fire ranges, which was concerning due to the potential for a wildland fire from the heavy fuel buildup within the surface danger zones<sup>9</sup> of the ranges. While Reservation Management officials have acknowledged the need for thinning of dense pine trees at several locations within these areas, there was no mitigation plan in place to reduce the threat.

Example of a forested area within the live firing ranges surface danger zones at the Central Training Facility  
(Picture taken and provided by a Y-12 National Security Complex official)

Subsequent to our fieldwork, Reservation officials indicated that although the need for mitigation efforts within surface danger zones was needed, it was considered a low priority due to accessibility issues.

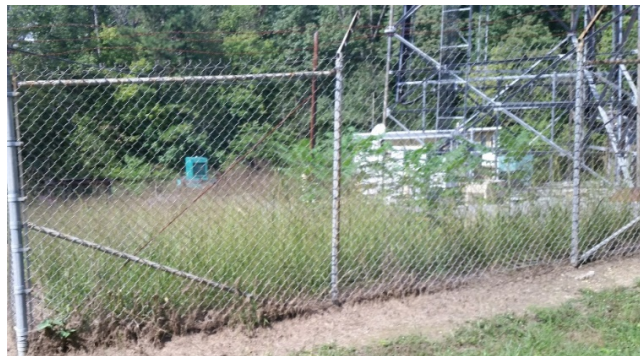
Federal officials are to inspect the easement areas for compliance with easement terms. However, as highlighted by the picture below and our discussion with Reservation Management officials, these inspections did not always occur.

Example of excess vegetation around communication equipment owned by an offsite entity  
(Picture taken by audit team)

4. Analyze staffing to ensure essential oversight activities related to wildland fire management are performed; and
5. Update the Wildland Fire Management Plan to include an assessment of wildland fire risk for the Reservation and surrounding communities and a mitigation plan to address identified risks.
