# Long-Term Surveillance and Maintenance Plan for Completed FUSRAP Sites Document History

This document serves as the Long-Term Surveillance and Maintenance (LTS&M) Plan for the Formerly Utilized Sites Remedial Action Program (FUSRAP) completed sites that have been released for unrestricted use based on the final radiological conditions at each site.

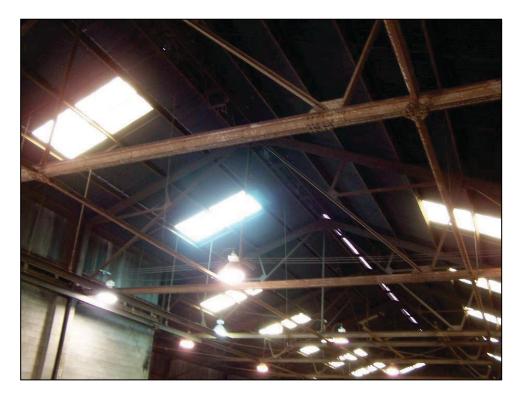
Figure 5-5. Roof System Where Supplemental Limits Were Applied, Aliquippa, Pennsylvania, Site, September 2005

Before remedial action began, the contaminated areas of both buildings were more accurately defined, revealing more residual uranium contamination than had been originally identified. In Building 3, contaminated areas included approximately 11,000 ft<sup>2</sup> of overhead area (11 trusses, roof panels, two exhaust turrets and associated ducts, light fixtures, wiring, and conduit); 990 yd<sup>3</sup> of soil and concrete from the west bay area; 1100 ft<sup>2</sup> of contaminated walls; 19,000 ft<sup>2</sup> of contaminated floors; 5 yd<sup>3</sup> from a mica pit; 14 yd<sup>3</sup> from the west cutter pit; and 35 yd<sup>3</sup> of soil from along the western side of the building. The contamination for Building 8 consisted of 530 ft<sup>2</sup> of overhead area (three trusses and roof panels); 5800 ft<sup>2</sup> of floor area; 1140 ft<sup>2</sup> of wall area; and 13 yd<sup>3</sup> of brick and soil. These areas were decontaminated in 1993 and 1994 using high-efficiency particulate air (HEPA) filtered vacuums for dust; wire brushes, scrapers, and sandpaper for rust; excavation for soil and concrete; and removal of equipment, exhaust turrets, ductwork, and ventilators. Approximately 100 yd<sup>3</sup> of building material waste was reduced in size and sent to a licensed disposal facility in Clive, Utah. Figure 5-2 through Figure 5-5 show photographs of the relevant areas.

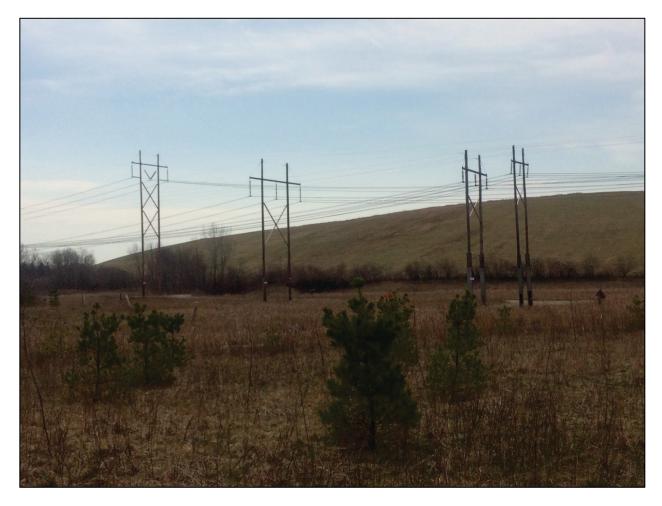
Figure 6-2. Overhead Transmission Lines Owned by National Grid, 2016

A few small, isolated areas of residual radioactive contamination could not be excavated around the bases of National Grid's onsite utility poles (Figure 6-2). National Grid is required by EPA to comply with institutional controls for the site, including the use of a soil management plan, should a need arise to excavate around the utility poles in the future. Any soil disturbance of the utility poles will be coordinated through EPA and MassDEP. This coordination will include notification to DOE by EPA or MassDEP if radioactive contamination is expected so that cost allocation for the response, transportation, and disposal of the radioactively contaminated waste can be determined.

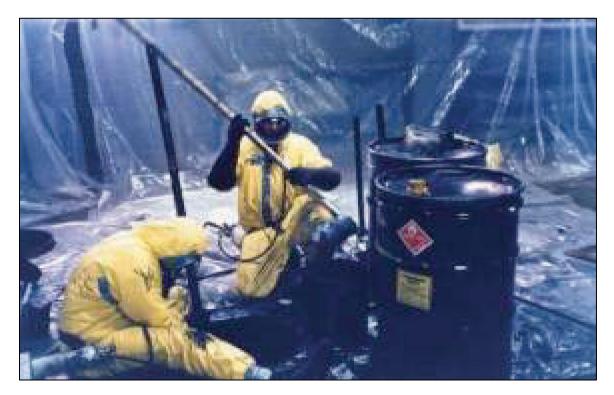
Figure 11-2. Removing Sludge and Placing It in Drums at the Chicago North Site, September 1987 (DOE Digital Archive)

Wastes removed from the National Guard Armory during remedial action were placed in 55-gallon steel drums for disposal. The sludges from the catch basins contained mixed wastes that were treated to elevate the flash point and were solidified for disposal offsite. All wastewater generated from remedial action activities was placed in drums and temporarily stored onsite.
