Moab UMTRA Project Flood and Drought Mitigation Plan

Revision 11

January 2022

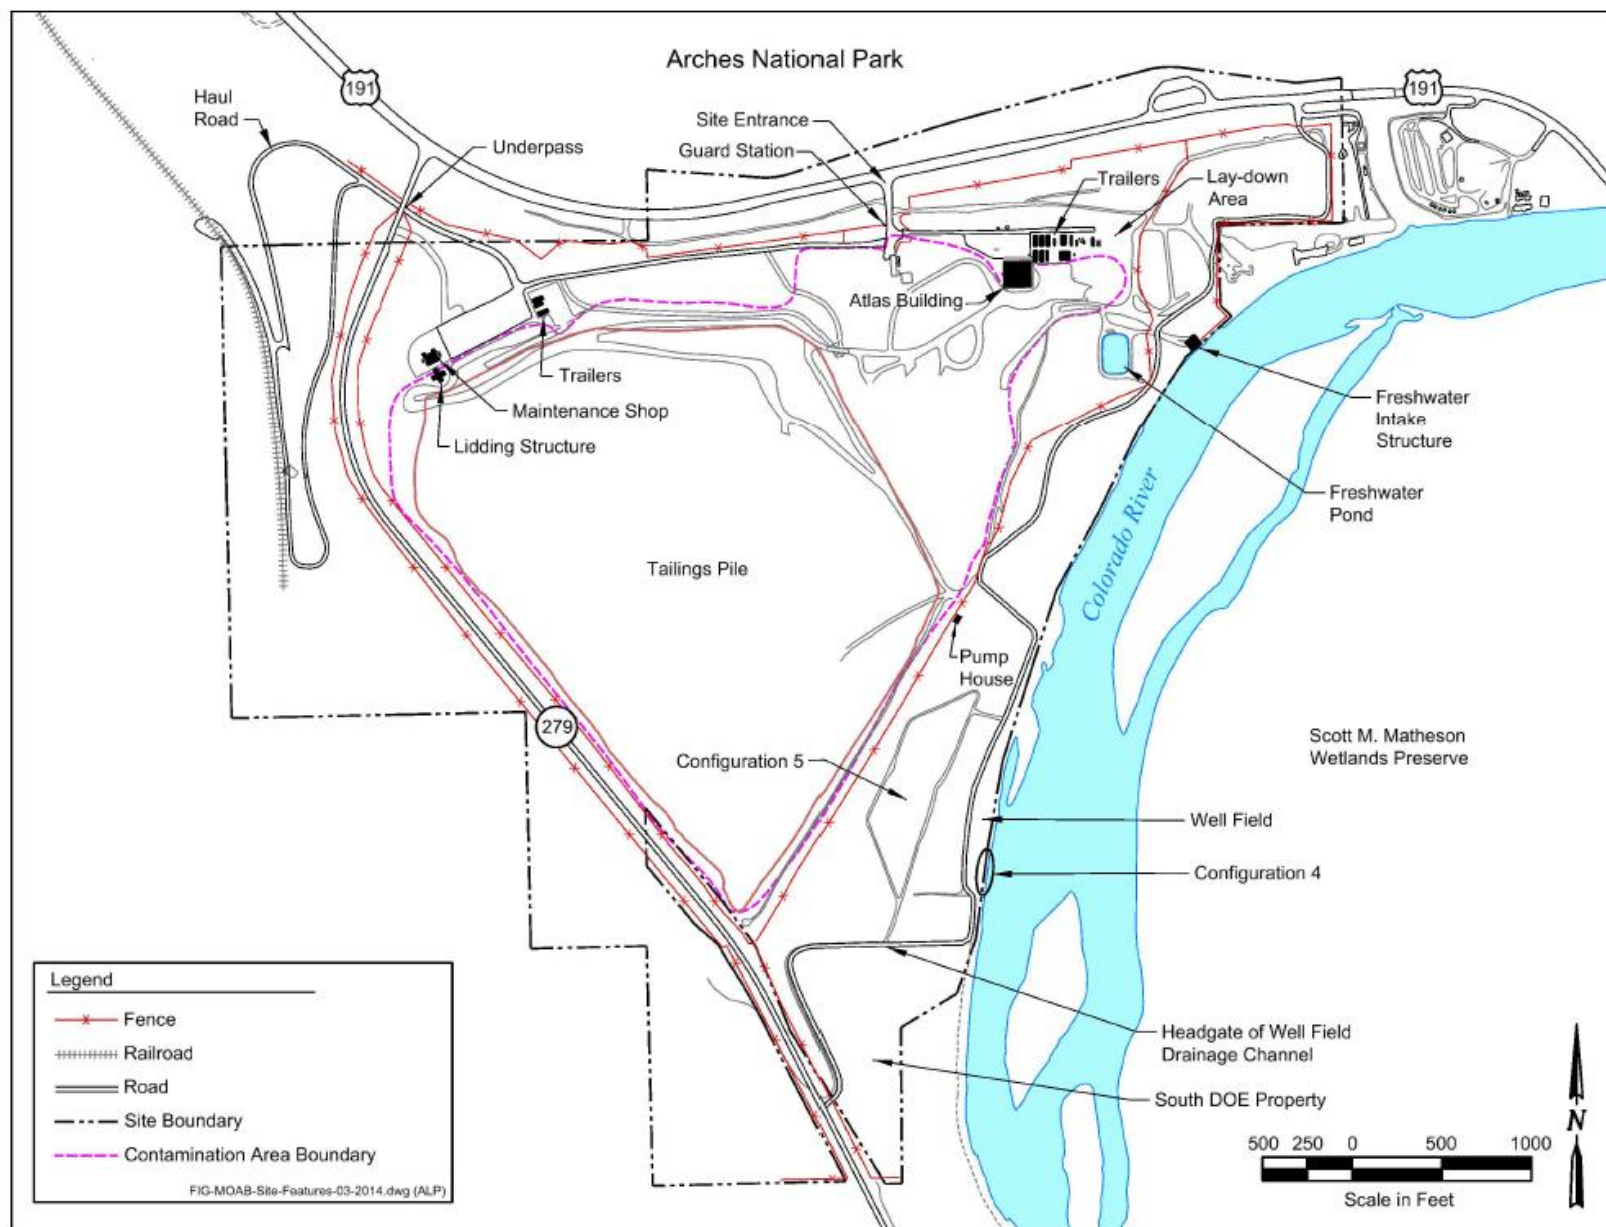
Figure 1. Moab Site Features

Several features of the Moab site are shown in Figure 1. The site is transected by the Moab Wash, which flows during significant storm events. North of the Wash is a freshwater intake structure that supplies a pond used for irrigation, dust control, decontamination, rinsing containers, and injection water as part of groundwater interim action (IA) remediation. Low stage of the Colorado River associated with drought conditions can result in insufficient water flowing into the Project's freshwater intake structure. The IA well field is located between the toe of the tailings pile and the river south of the Moab Wash. The site is susceptible to flooding because about 160 acres of the nearly 480 acres of the property are within the 100-year floodplain of either the Colorado River or the Moab Wash.

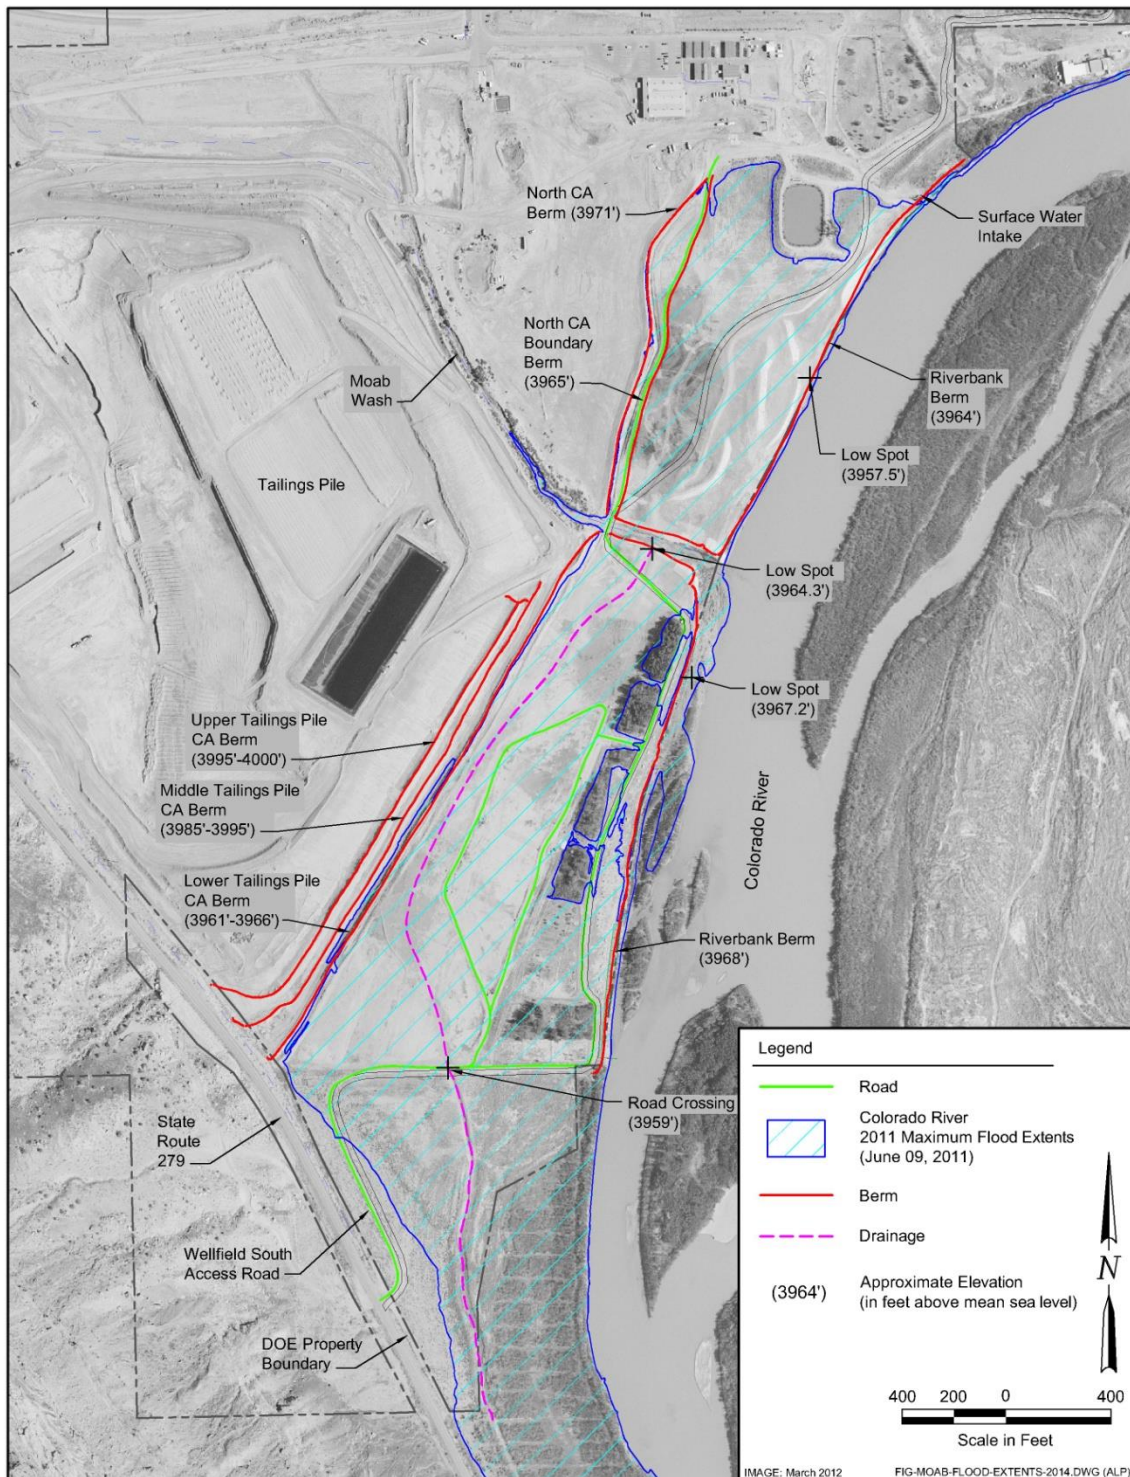
Figure 2. Moab Site Features, Colorado River Elevations, 2011 Flood Extent, and CA Berms and Elevations

During spring of 1983 and 1984, the Moab site was reportedly flooded up to the toe of the tailings pile. The most significant recent site flooding event occurred in 2019 (Figure 2), when the peak runoff reached 40,000 cfs, which is equivalent to a river surface elevation of 3,967.2 ft mean sea level (msl) on June 10, and the river flow was above the average annual peak flow from early June through late August. The impacts of this flooding event are well documented in the *Moab UMTRA Project 2019 Flood Response Summary* (DOE-EM/GJTAC3035).

Once flows exceed approximately 33,000 cfs, the low point on the berm along the Moab Wash will be topped, and river water is expected to flow to the south within the constructed channel that runs through Configuration (CF) 5 from the Moab Wash. At a flow near 35,000 cfs, Colorado River water will enter the well field from the south in the drainage channel noted on Figure 2.

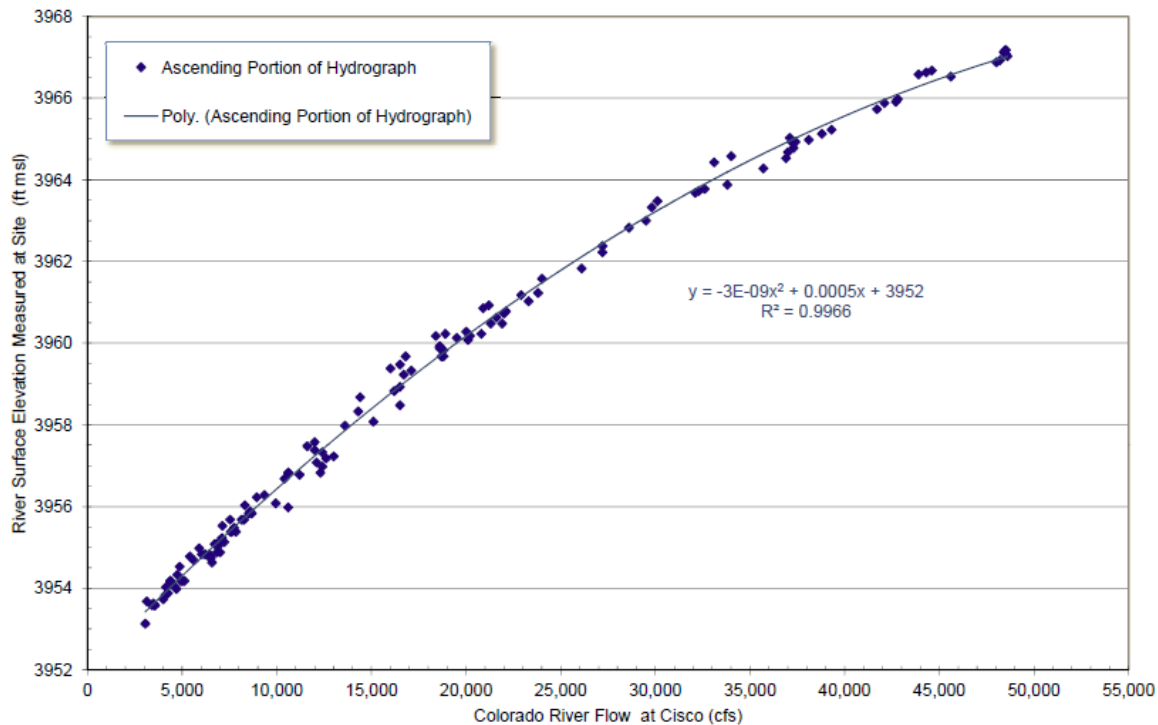
Figure 3. Cisco River Gage vs. Site Elevation Gage

Figure 3 represents a rating curve generated using the 2011 flows for the site based on the river flows measured at the Cisco gaging station and the corresponding river surface elevation measured at the site river intake structure. Ground surface elevation shows a low point on the riverbank south of the freshwater pond with an elevation of 3,957 ft msl (Figure 2). Using the rating curve, the associated river surface elevation for flows above 10,750 cfs will exceed the land surface elevation at this location, allowing river water to begin to migrate into the area.

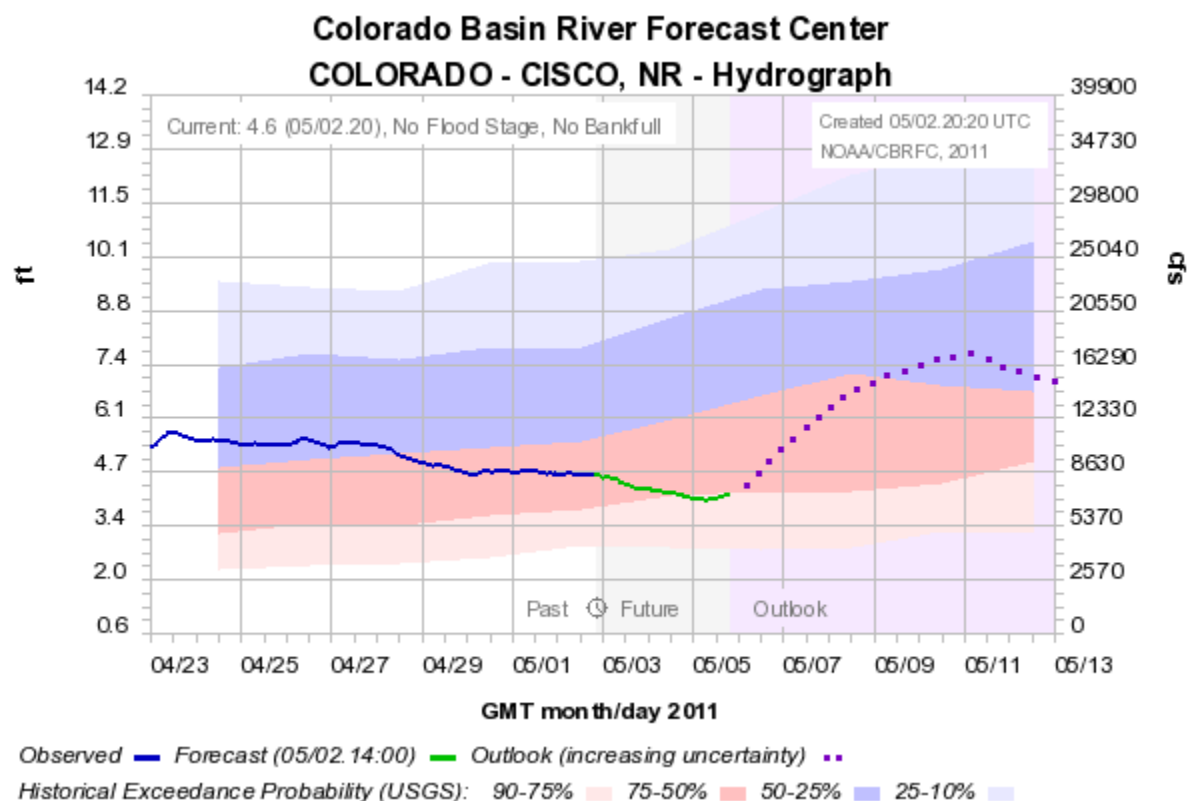
Figure 4. Example Hydrograph From Cisco, Utah, Gaging Station

Estimated Colorado River flow rates for the Cisco, Utah, gaging station (based on upstream flow rates and weather systems impacting the Colorado River basin) can be monitored on the National Oceanic and Atmospheric Administration (NOAA) website at <http://www.cbrfc.noaa.gov/river/station/flowplot/flowplot.cgi?CLRUI>. Figure 4 shows an example hydrograph from the Cisco gage.

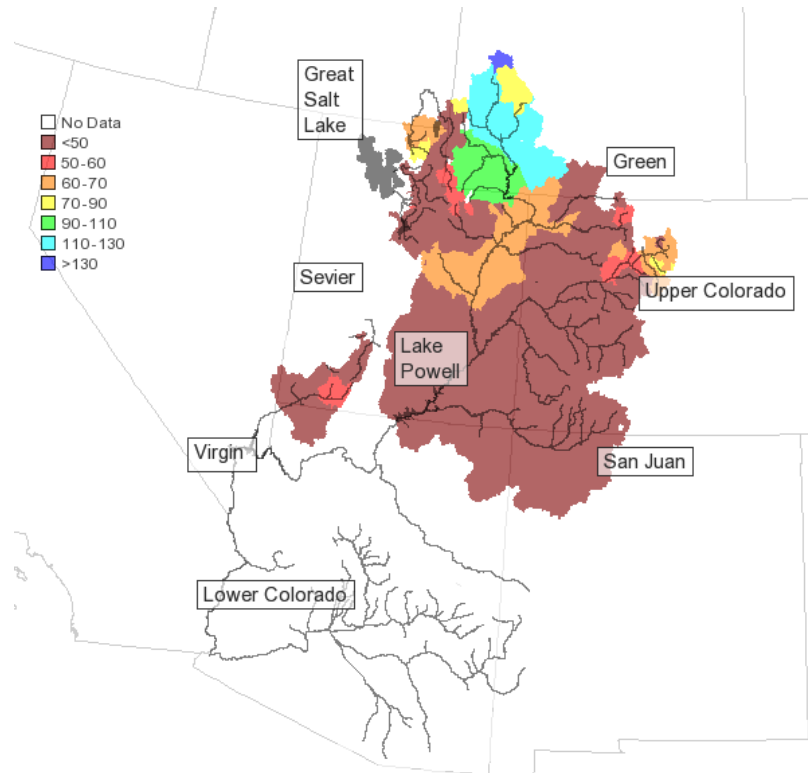
Figure 5. CBRFC Percent Average Water Supply Conditions for June 1, 2018

Figure 5 shows the water supply forecast for June 1, 2018, during drought conditions. During 2018 the peak river flow was only 8,470 cfs, approximately one-third of the average, and flows decreased below 2,000 cfs by late-September. In addition, NOAA has a separate program called the National Integrated Drought Information System (NIDIS) (drought.gov), which includes a national drought early warning system.

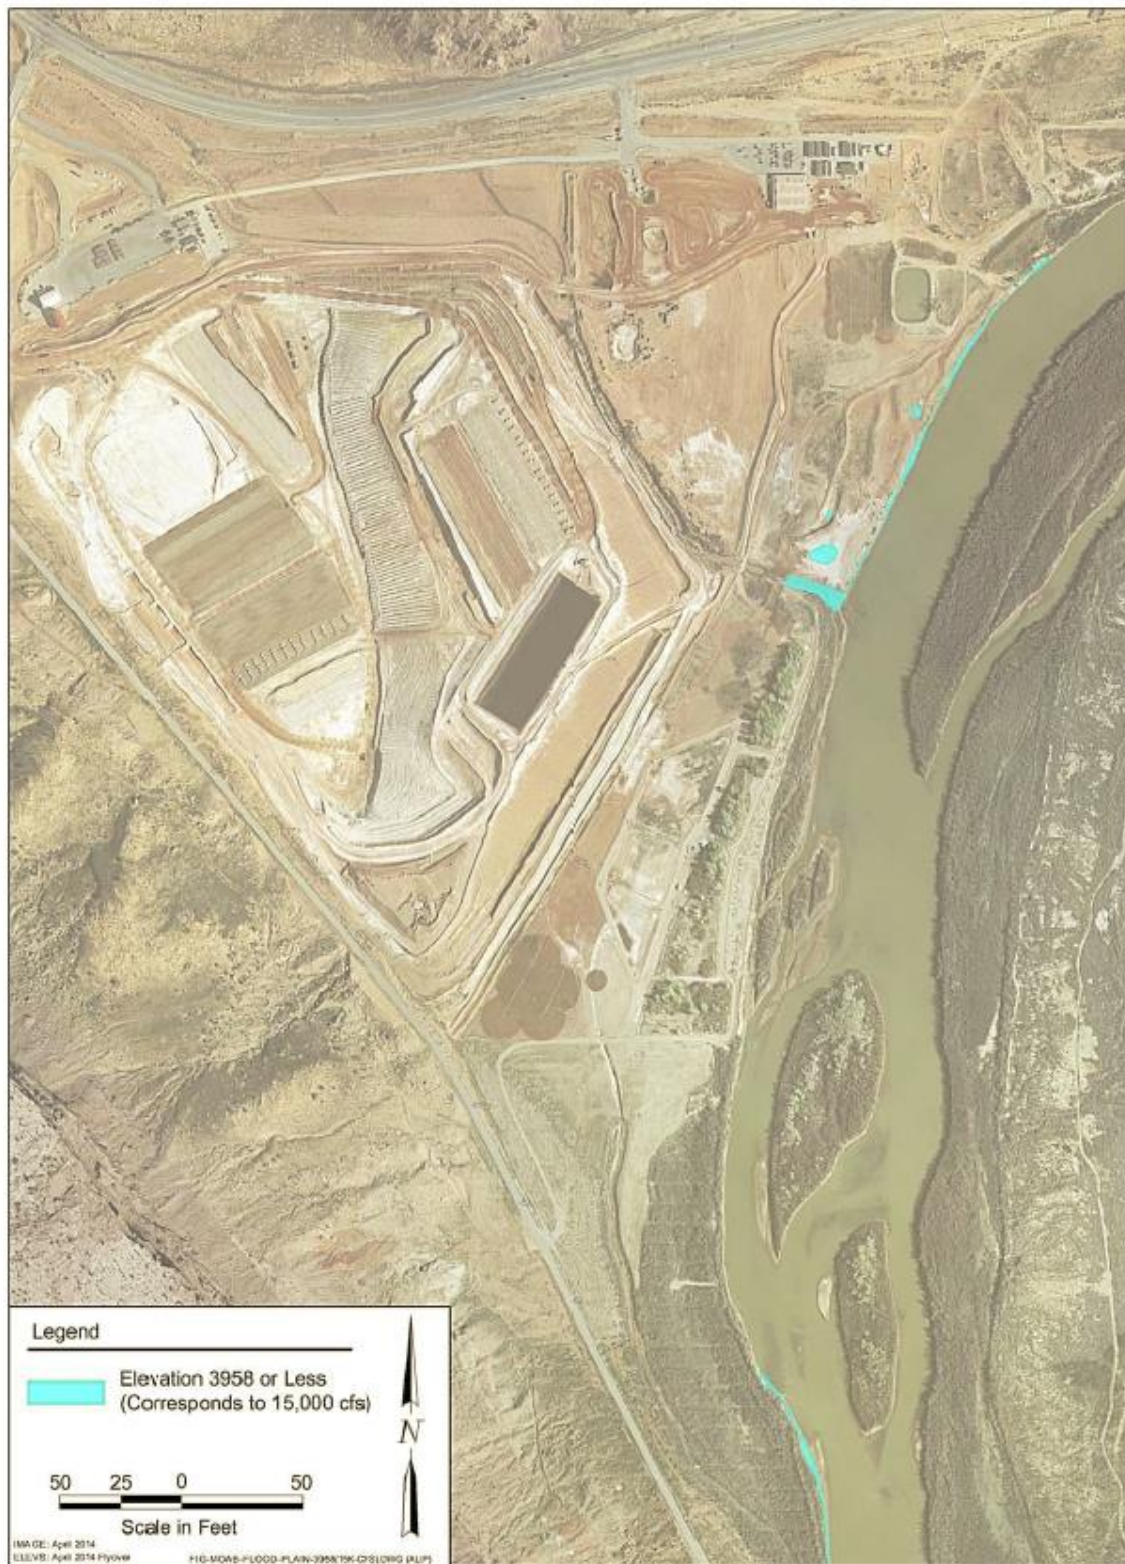
Figure A-1. Potential Impact of 15,000 cfs

These trigger points account for increases in flow rate that may occur over the weekend, when site support is reduced. Figures A-1 through A-4 in Appendix A show the ground elevation, the elevation of specific river flows, and how the site may be impacted.

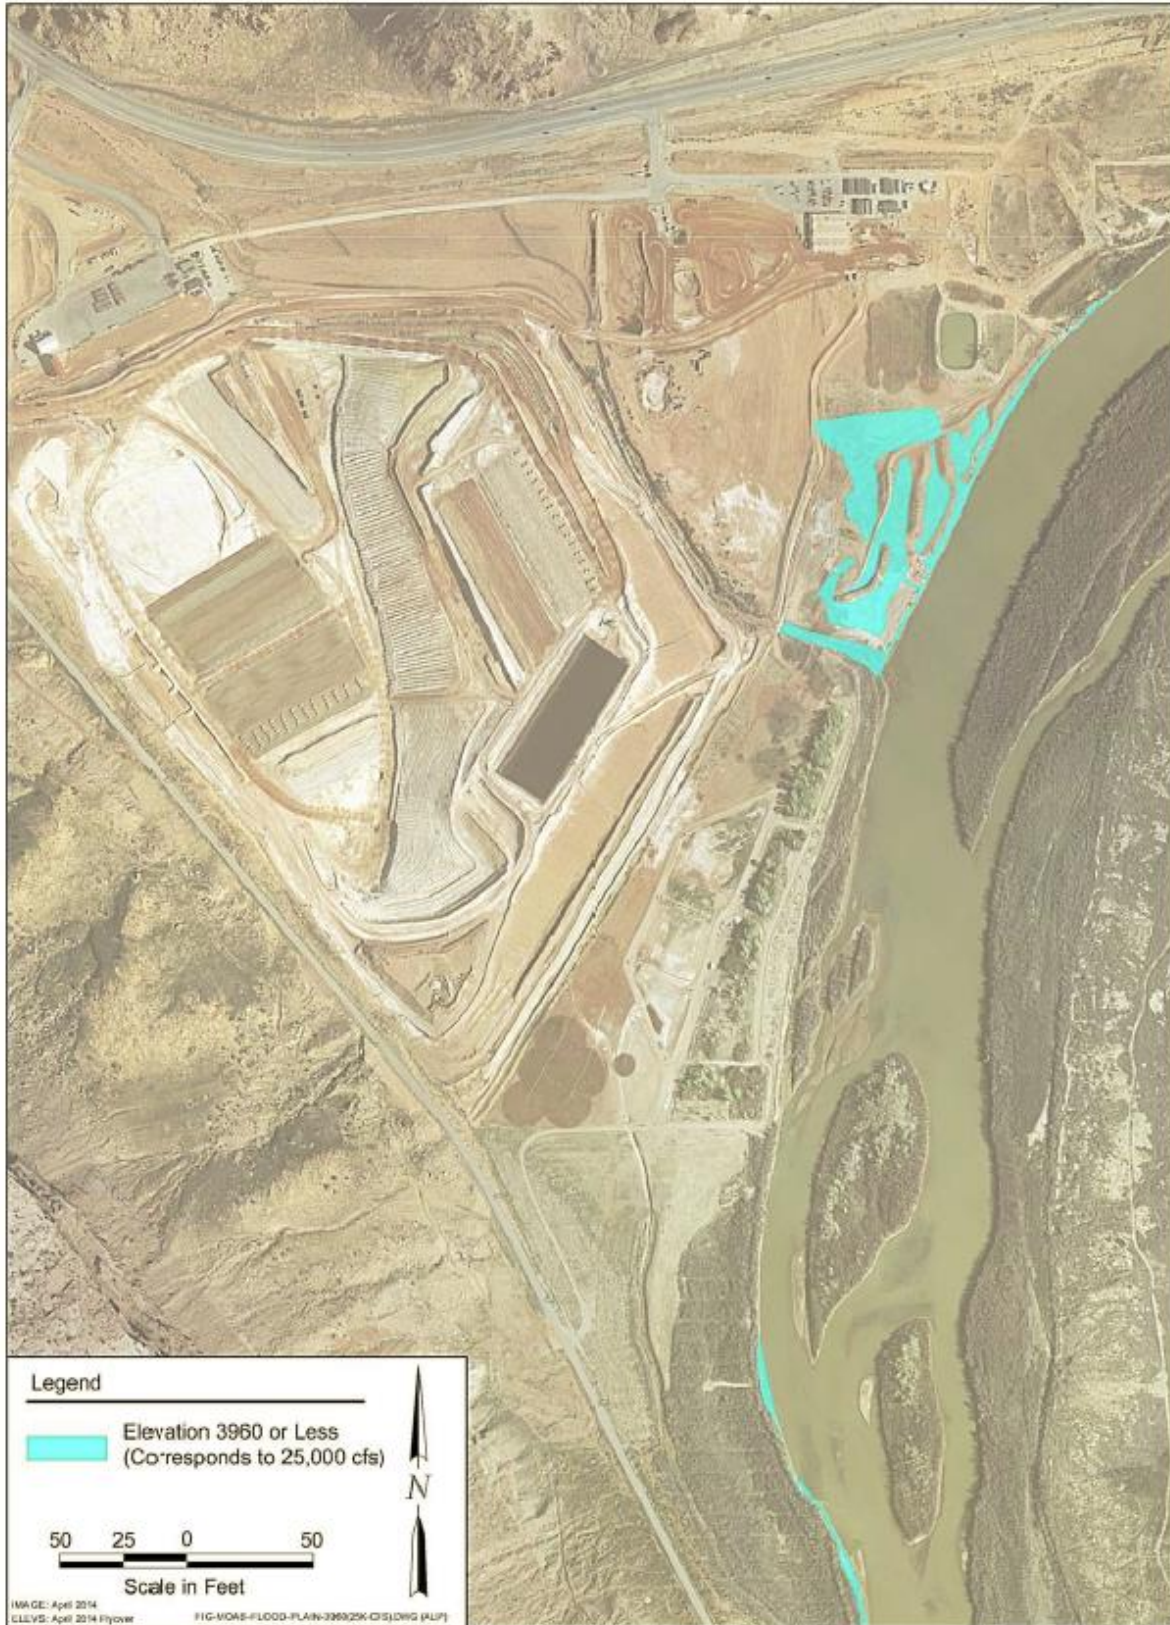
Figure A-2. Potential Impact of 25,000 cfs

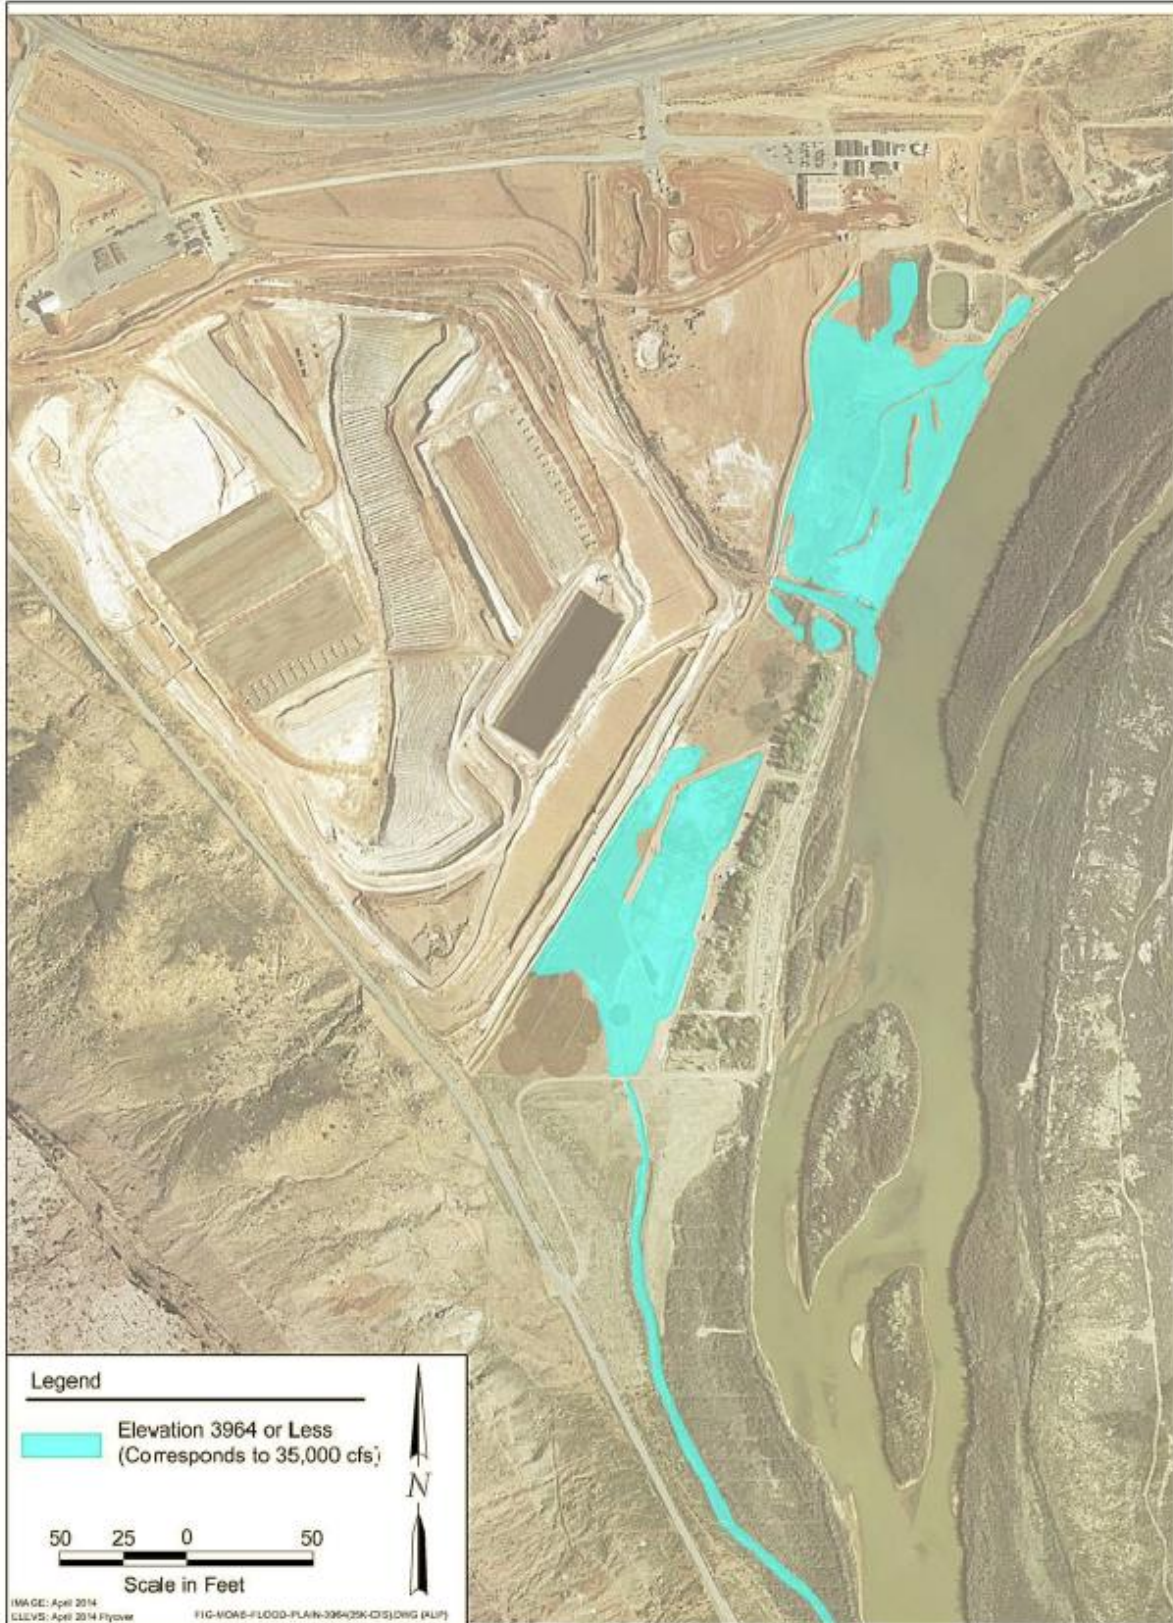
Figure A-3. Potential Impact of 35,000 cfs

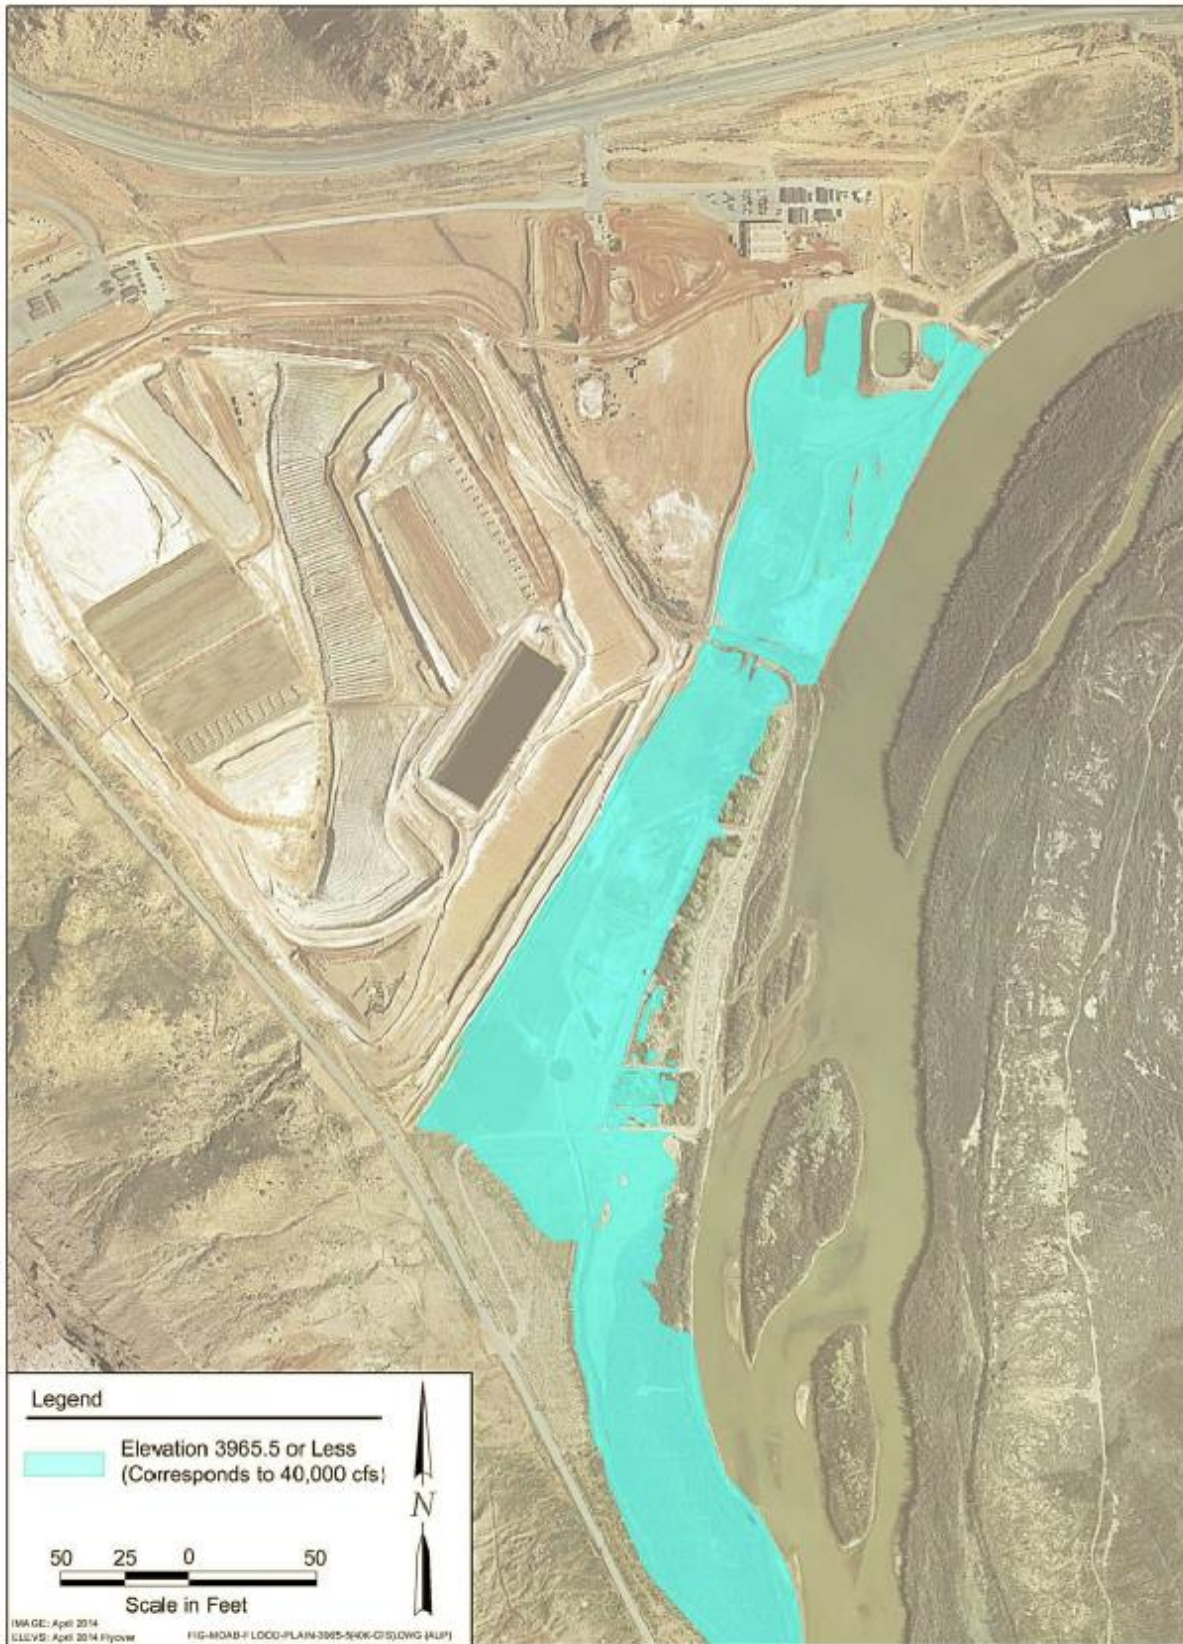
Figure A-4. Potential Impact of 40,000 cfs
