FERNALD PRESERVE

# 2021 Site Environmental Report

**U.S. Department of Energy**  
**Office of Legacy Management**  
Issued May 2022

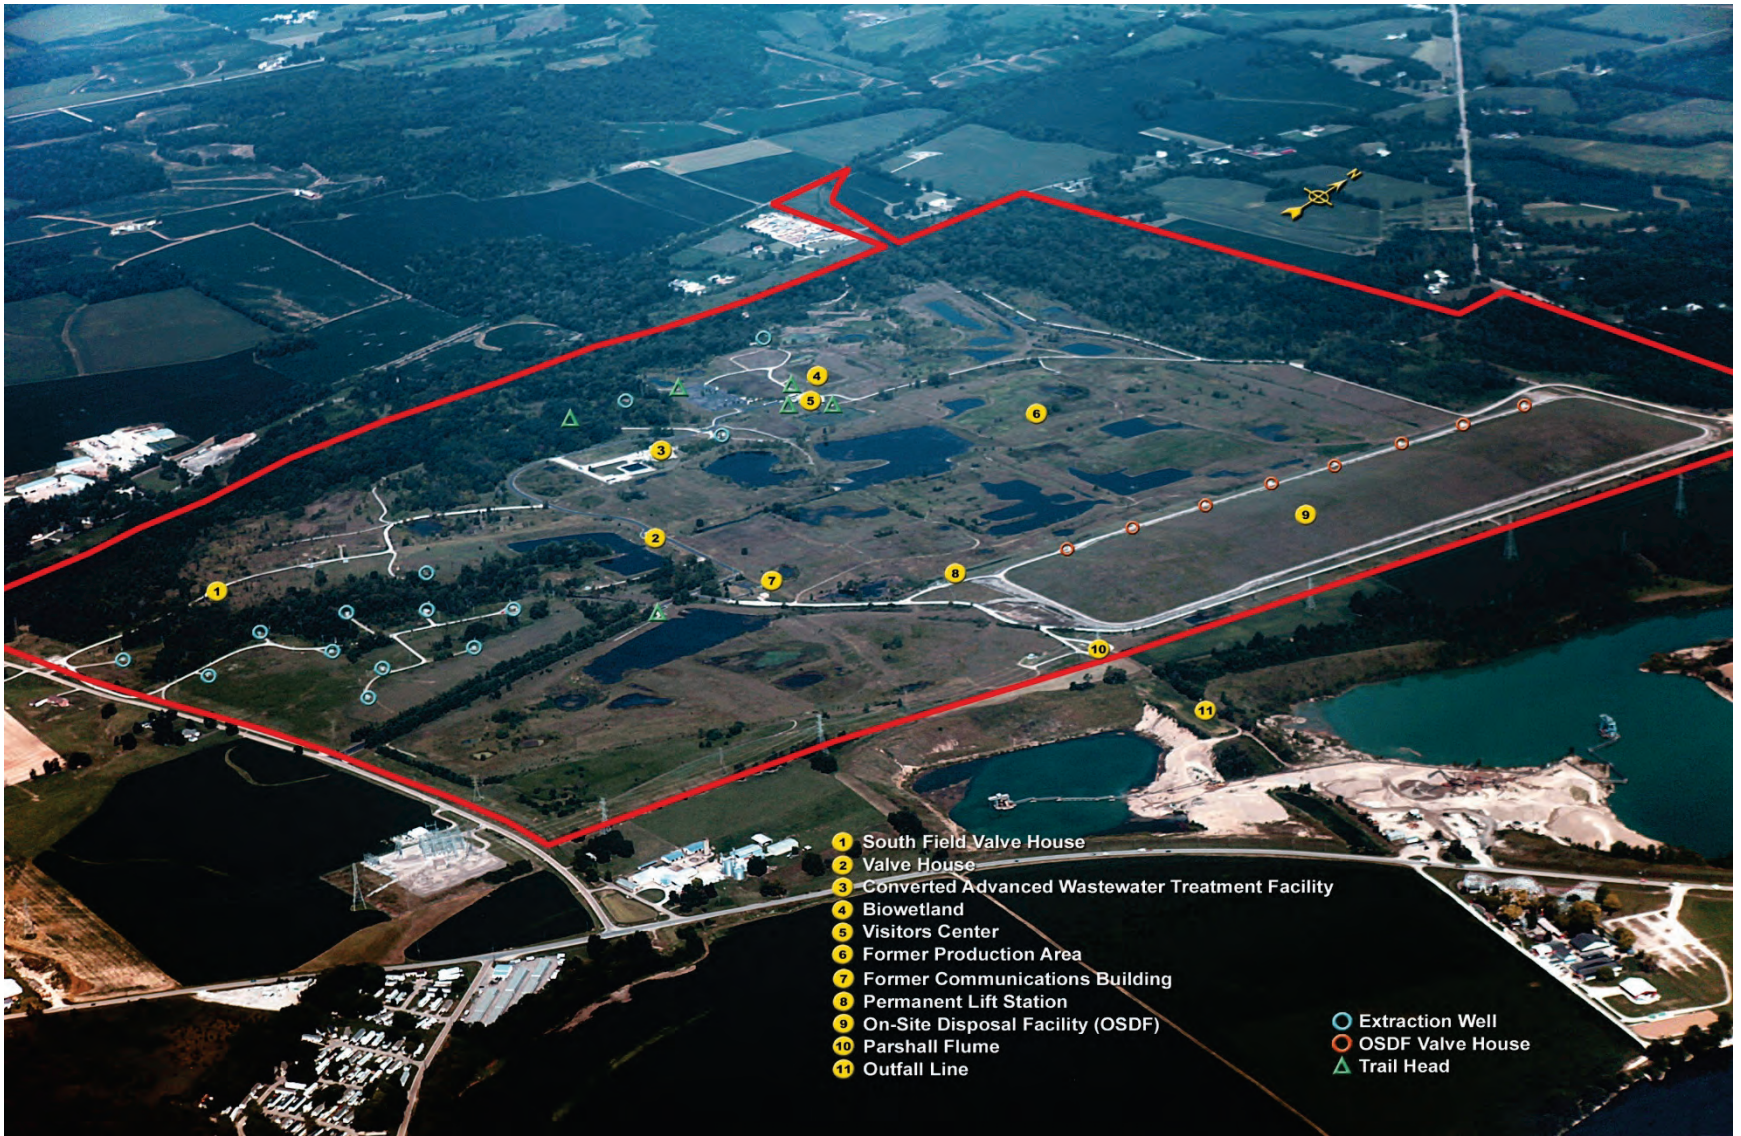
Figure 3. Fernald Preserve Perspective

Figure 3 depicts the location of the major physical features of the site, such as the buildings and supporting infrastructure. The Former Production Area and the OSDF dominate this view. The Former Production Area occupied approximately 136 acres in the center of the site and the OSDF occupies approximately 100 acres. The Great Miami River cuts a terraced valley to the east of the site, and Paddy's Run (an intermittent stream) flows from north to south along the site's western boundary. In general, the site lies on a terrace that slopes gently among vegetated bedrock outcrops to the north, southeast, and southwest.

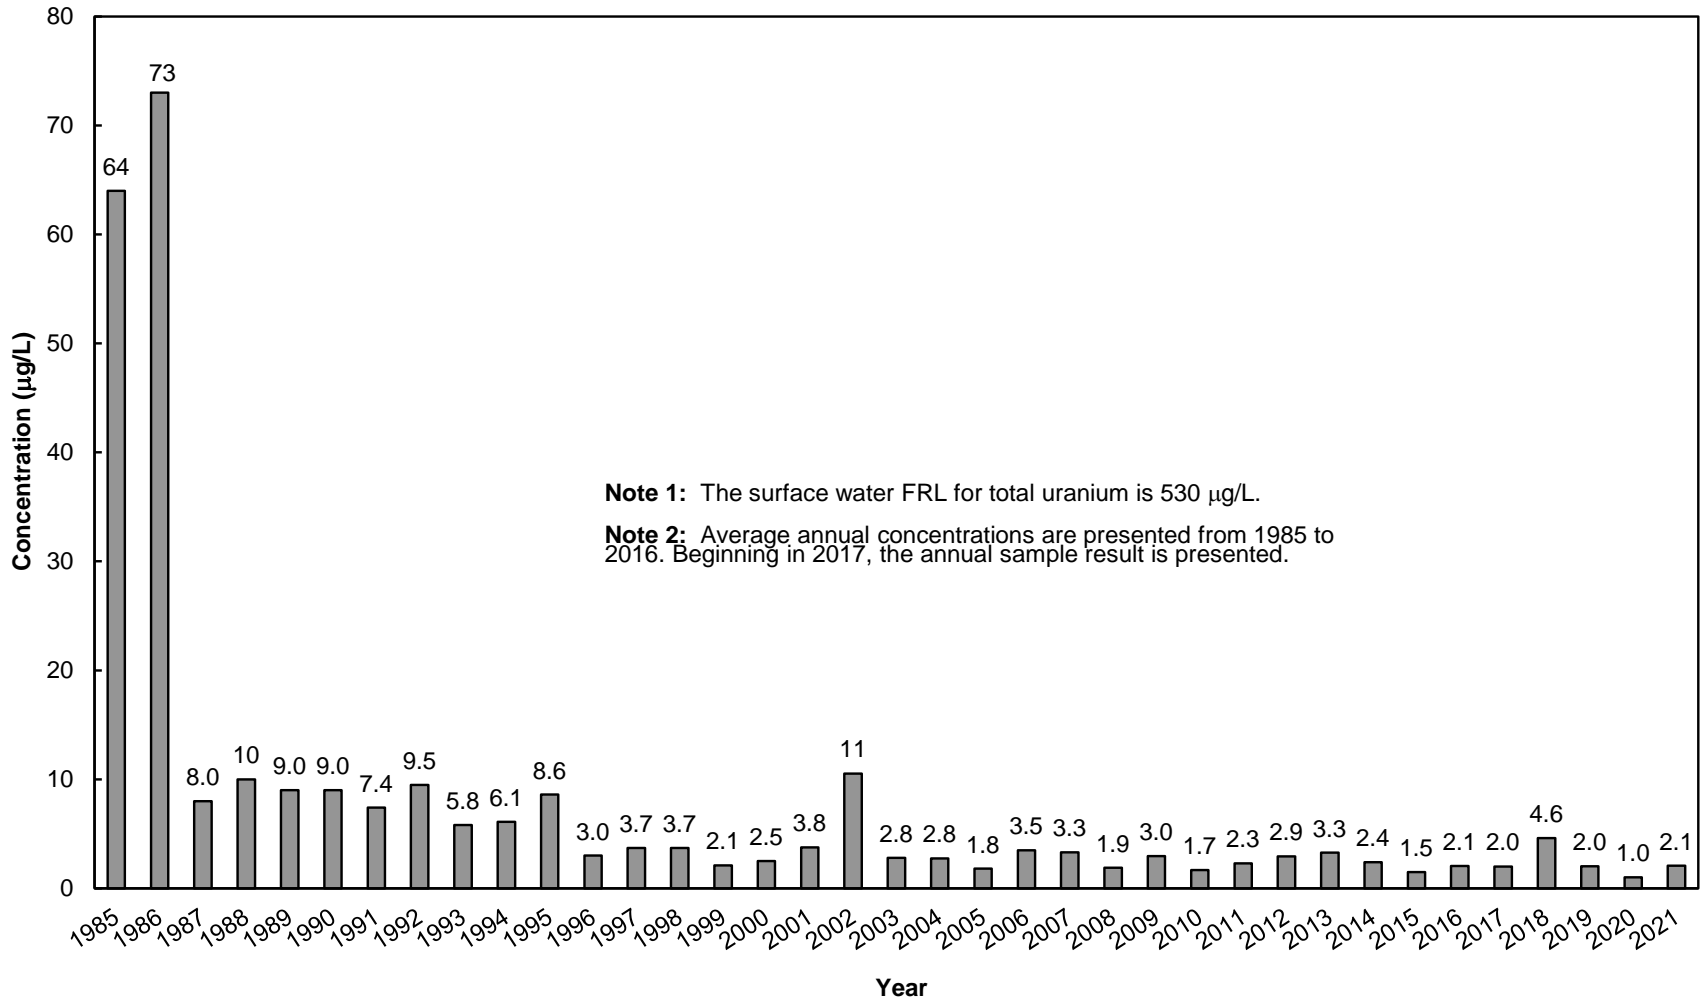
Figure 23. Annual Average Total Uranium Concentrations in Paddys Run at Willey Road (SWP-03 Sample Location)

No total uranium results exceeded the surface water FRL of 530  $\mu\text{g/L}$  during 2021 at these two locations. The total uranium concentration at SWP-03 in the sample collected March 16, 2021, was 2.1  $\mu\text{g/L}$ , well below the surface water total uranium FRL of 530  $\mu\text{g/L}$ . Figure 23 illustrates the decrease of the total uranium concentration in Paddys Run from 1985 through 2021. The large decrease in concentration in 1987 is attributable to the installation of the storm water retention basin in 1986, which greatly reduced the volume of contaminated runoff flowing into Paddys Run from the Former Production Area.

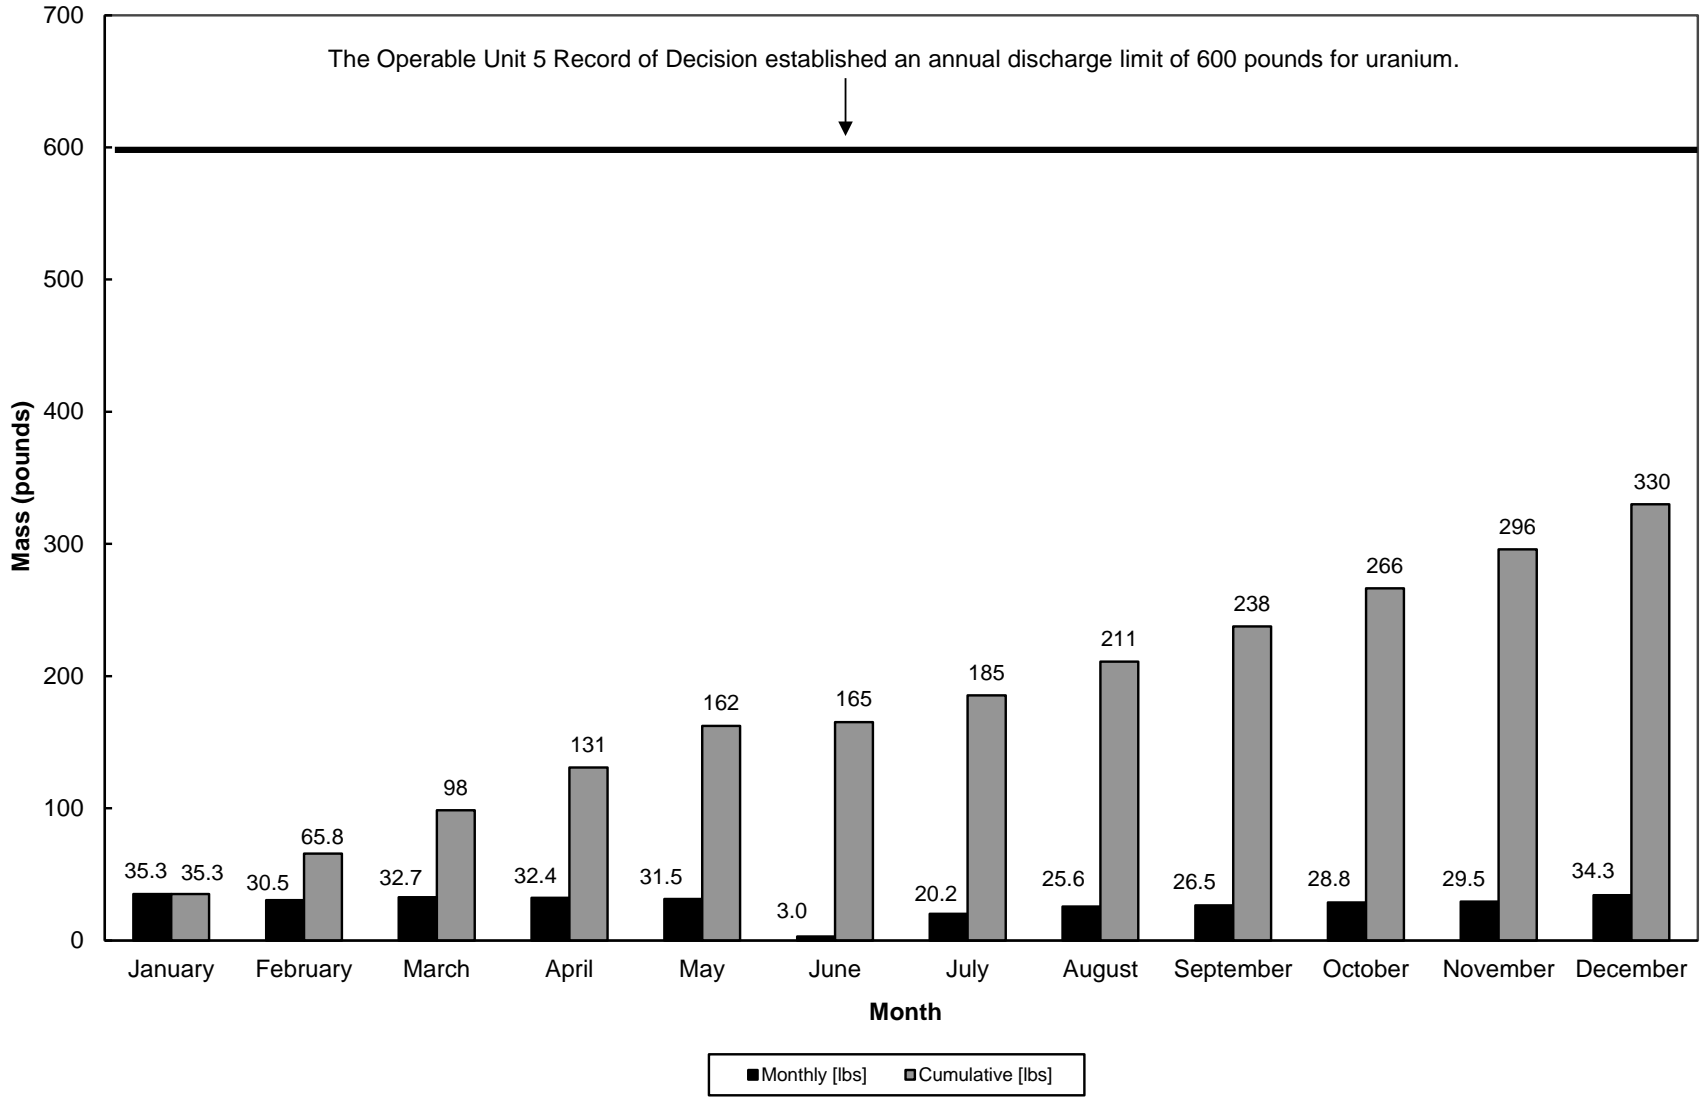
Figure 24. Mass of Uranium Discharged to the Great Miami River Through the Parshall Flume (PF 4001) in 2021

As identified in Figure 24, 330 lb of uranium in effluent were discharged to the Great Miami River through the Parshall Flume (PF 4001) in 2021. In addition to the effluent, uncontrolled runoff is also contributing to the amount of uranium entering surface water. Figure 26 presents the mass of uranium from the uncontrolled runoff and controlled discharges from 1993 through 2021.
