**Preliminary Assessment/Site Inspection Report
Santa Susana Field Laboratory
Simi Valley, California**

**EPA ID No.: CAN000908498
USACE Contract No.: W91238-06-F-0083
Document Control No.: 12767.063.419.1650**

November 30, 2007

**Prepared by:
Weston Solutions, Inc.
1575 Treat Blvd, Suite 212
Walnut Creek, CA 94598**

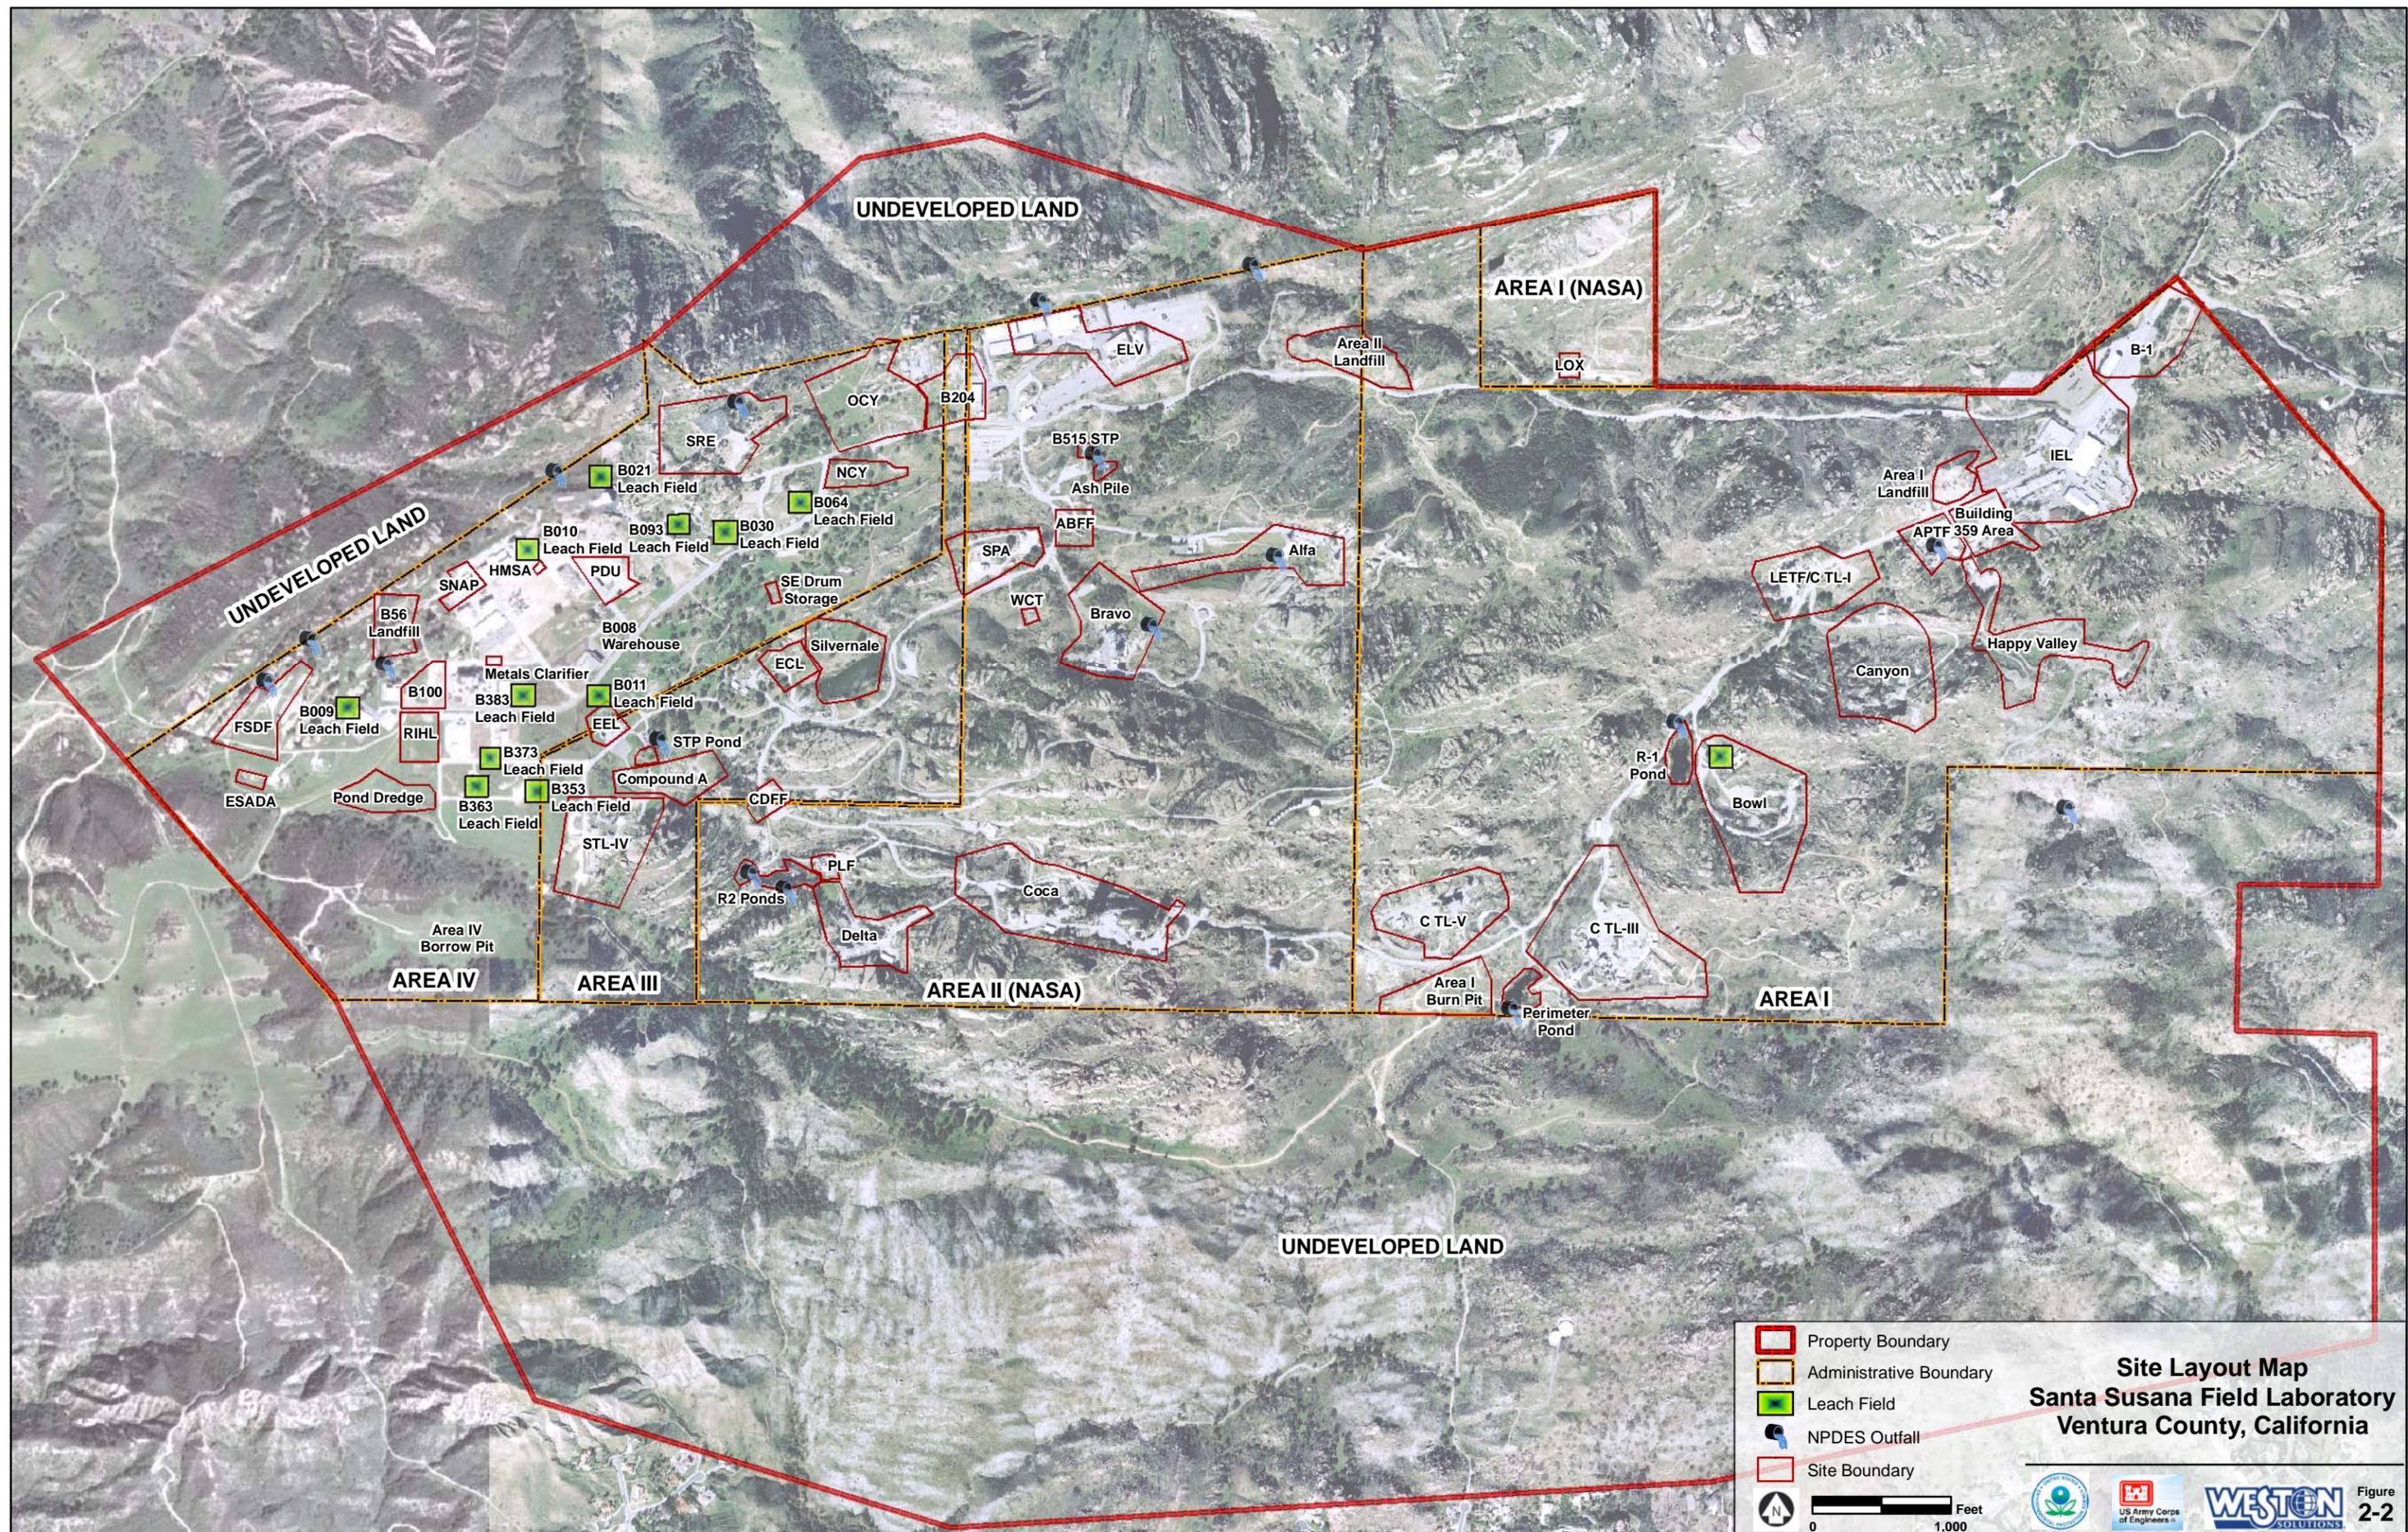
Site Layout Map
Santa Susana Field Laboratory
Ventura County, California

The SSFL site is divided into four administrative areas (Areas I, II, III, and IV), with undeveloped land acting as buffer zones to the northwest and south, as shown in Figure 2-2. The size, location, and current ownership of these areas are as follows:
