### **Fact Sheet**

This fact sheet provides information about the **Central Nevada Test Area (CNTA), Nevada, Site**. This site is managed by the **U.S. Department of Energy Office of Legacy Management**.

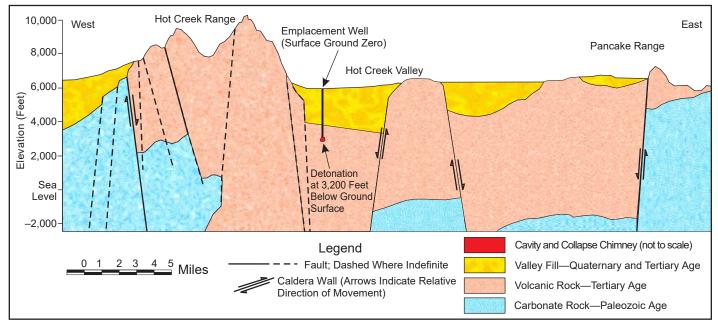
Cross Section of the Central Nevada Test Area.

The Hot Creek Valley fill consists of poorly sorted alluvium composed primarily of volcanic rocks derived from the

adjacent ranges. The alluvium is underlain by volcanic tuff and sedimentary rocks derived from volcanic material and welded tuff interbedded within a volcanic rock sequence.

Groundwater occurs in both the alluvial and volcanic sections. The depth to groundwater near the UC-1 emplacement

borehole is about 400 feet below ground surface.
