### Follow-up Q&A from the March 22, 2005 DOE Community Meeting

Here are answers to questions that we received, but were unable to answer, at our last DOE meeting on March 22. We are committed to answering all of your questions.

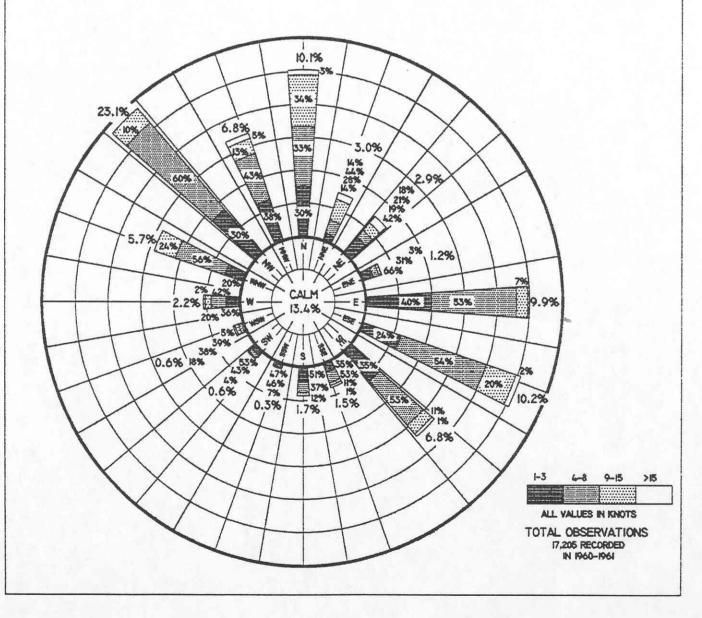
# ANNUAL SURFACE WIND ROSE ROCKWELL SANTA SUSANA FIELD LABORATORY

Wind Rose charts for recent years have been included in a variety of published documents available in the information repositories. These charts identify the direction of the wind and its velocity distribution over an annual average. A 1960 – 1961 Annual Surface Wind Rose for the SSFL (then known as the 'RDFTL') is presented on the other side of this page.
