# Moab UMTRA Project Crescent Junction Disposal Cell Interim Completion Report Addendum - N

Revision 0

December 2024

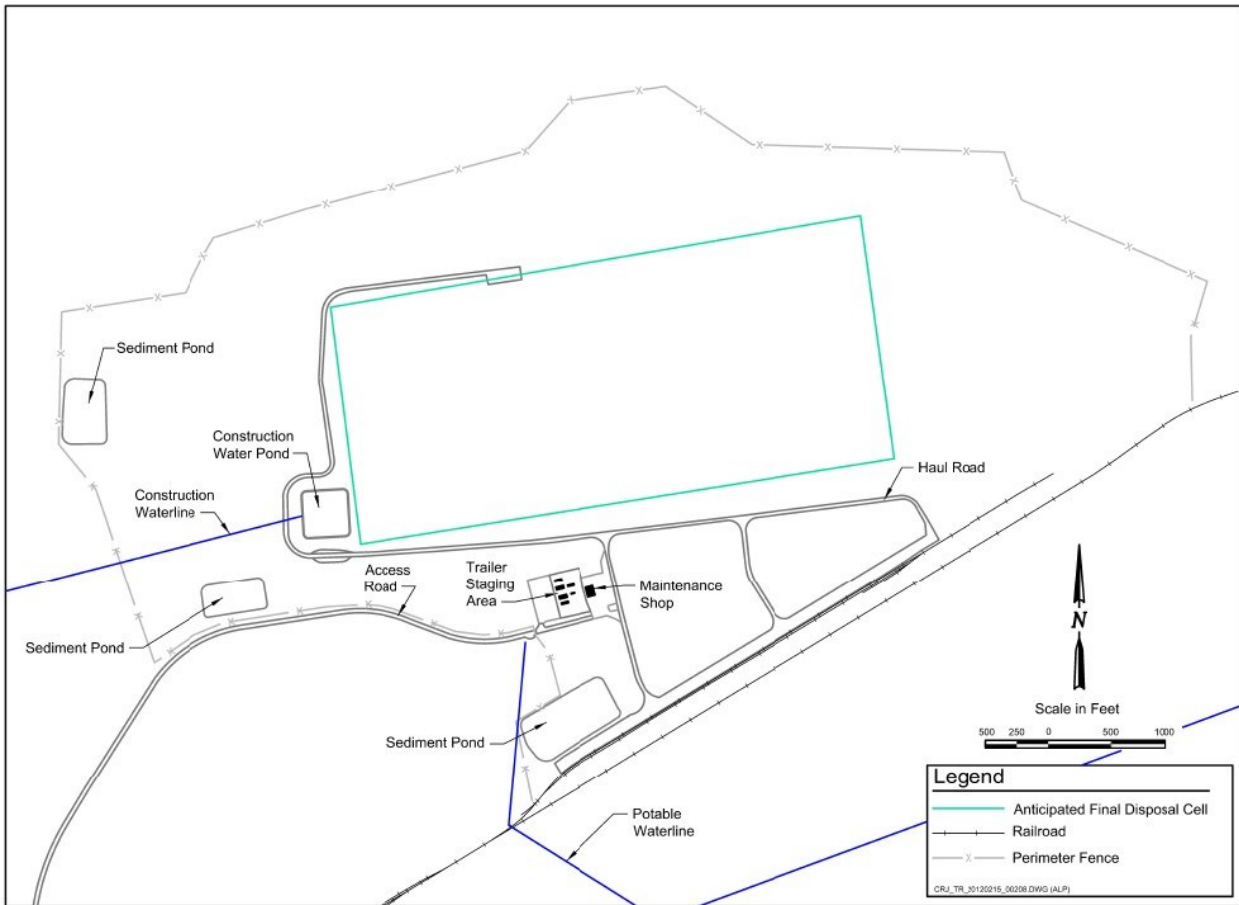
*Figure 2. Crescent Junction Site Features*

The Moab site is located about 3 miles northwest of the city of Moab in Grand County. The Crescent Junction site is located northeast of the junction of Interstate 70 and U.S. Highway 191, approximately 30 miles north of the Moab site, also in Grand County (see Figure 1). The completed disposal cell will generally be rectangular and will encompass approximately 230 acres. Figure 2 shows general features of the Crescent Junction site.

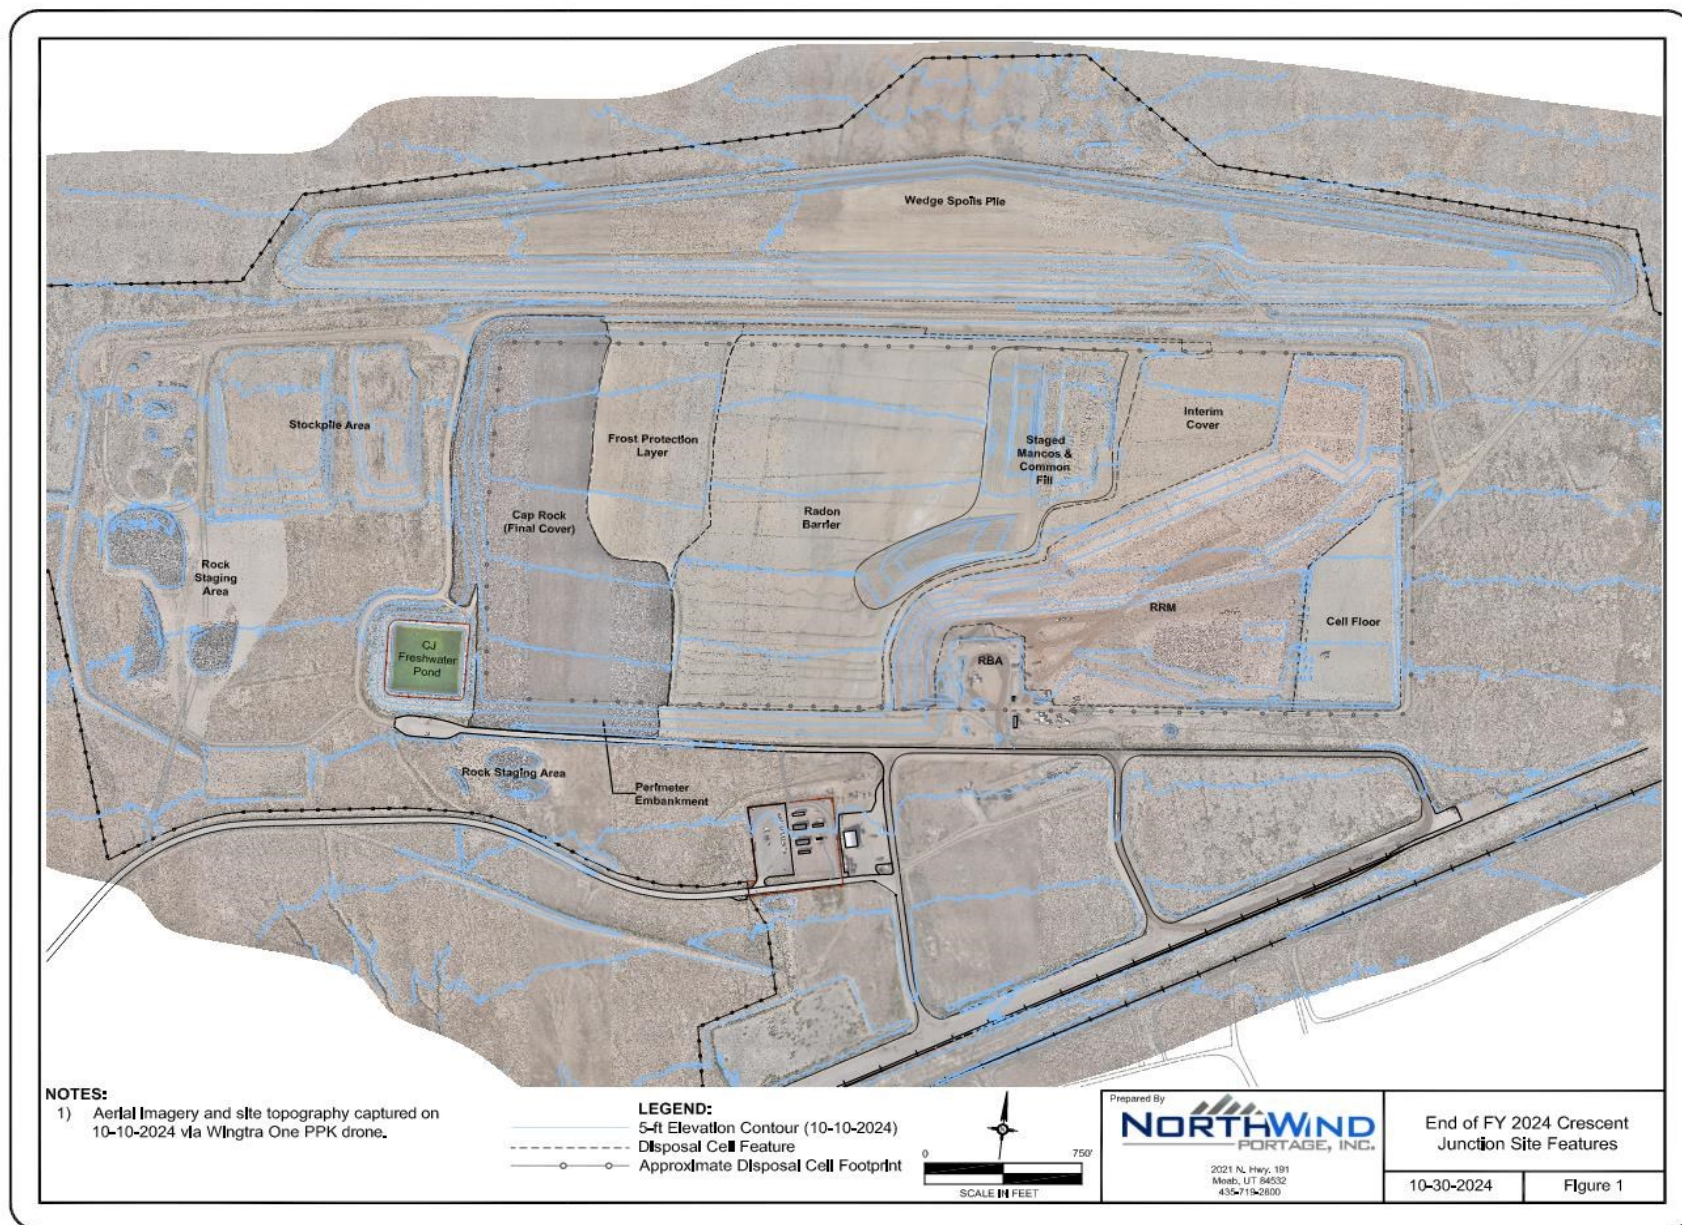
Figure 3. General Extent of Cover Layers and Cell Floor Excavation

excavation and placement of each type of material, performed in accordance with design specifications or drawings and with Addendum E of the *Remedial Action Plan* (RAP), the *Remedial Action Inspection Plan* (RAIP). The distribution survey associated with each material type is also included in this section, as appropriate. Figure 3 shows the general extent of cell cover layers as of the end of this Addendum period.

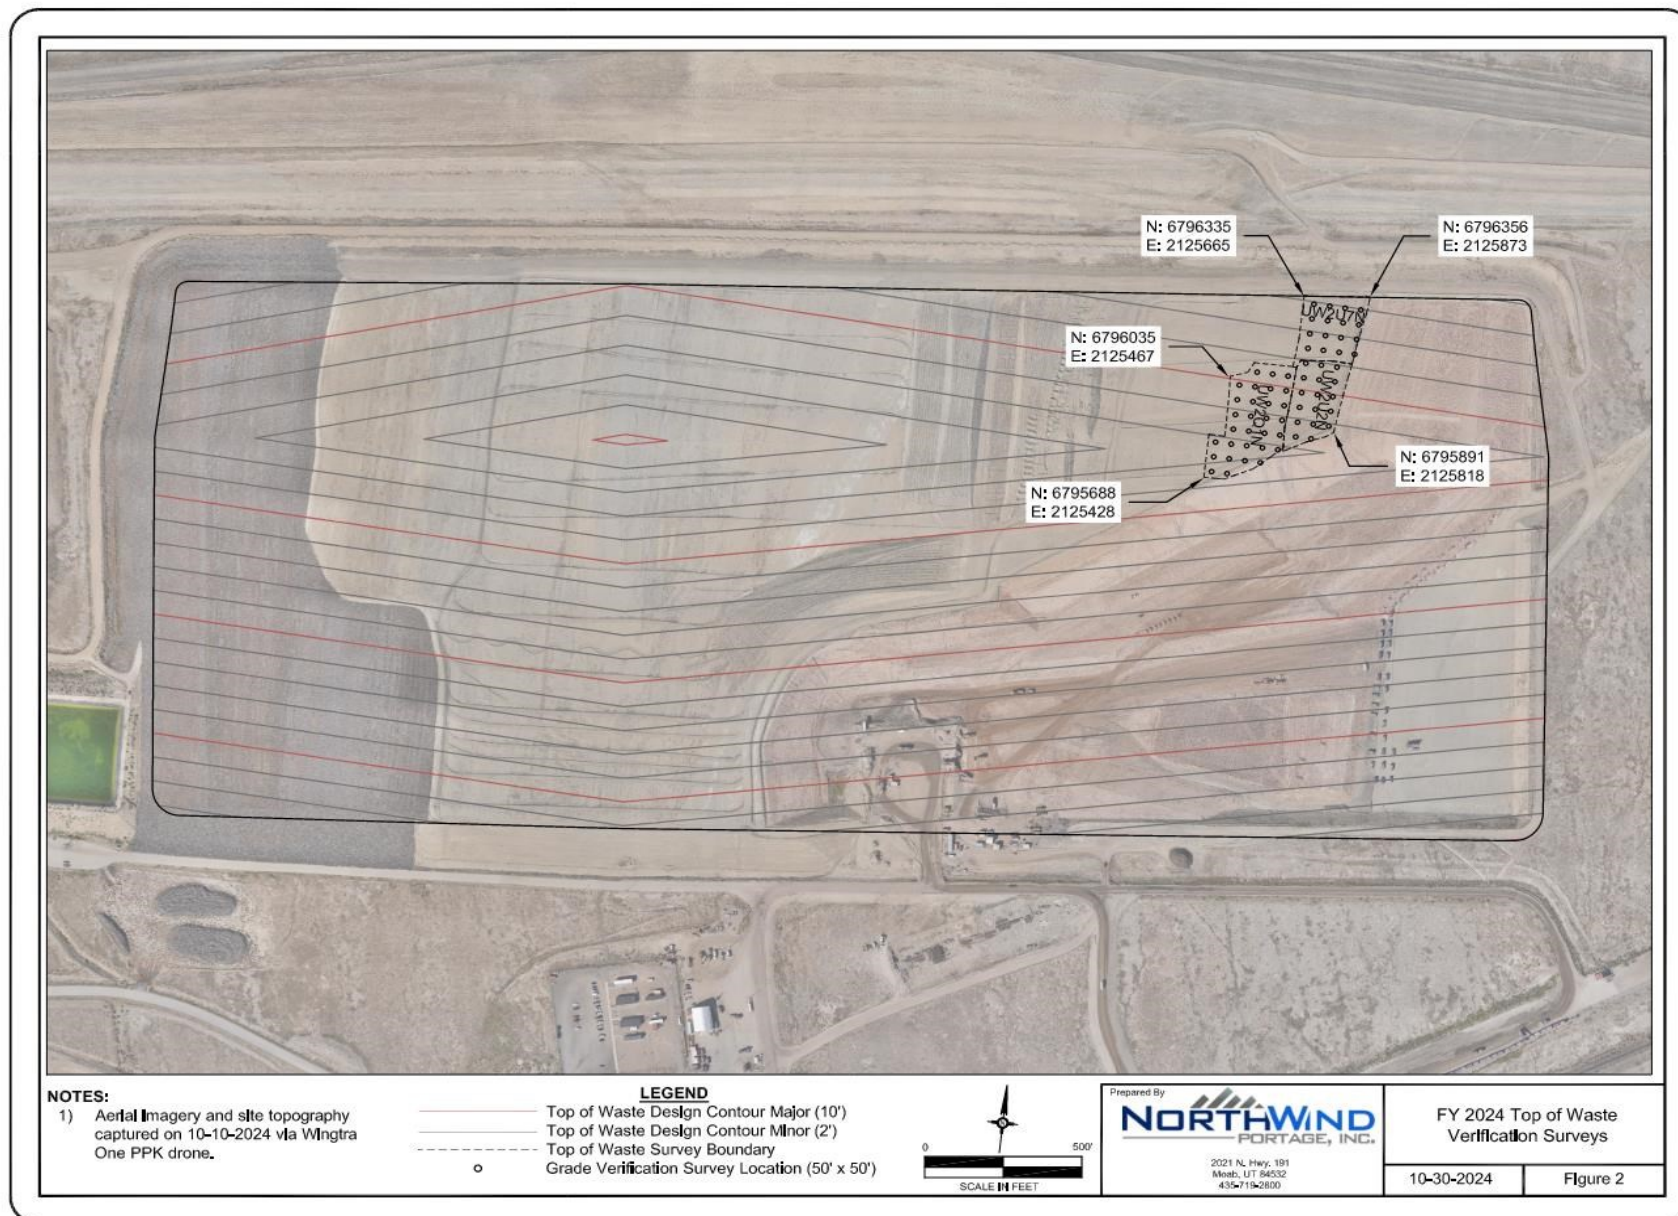
Figure 4. Distribution of Survey Points to Verify Compliance with RRM Specifications

RRM inspections and tests are shown in Table 3. The distribution of survey points is shown in Figure 4. The standard proctor test results summary, lift approval summaries, one lift approval package for RRM, and top-of-waste buyoff survey are provided in Appendix A2.

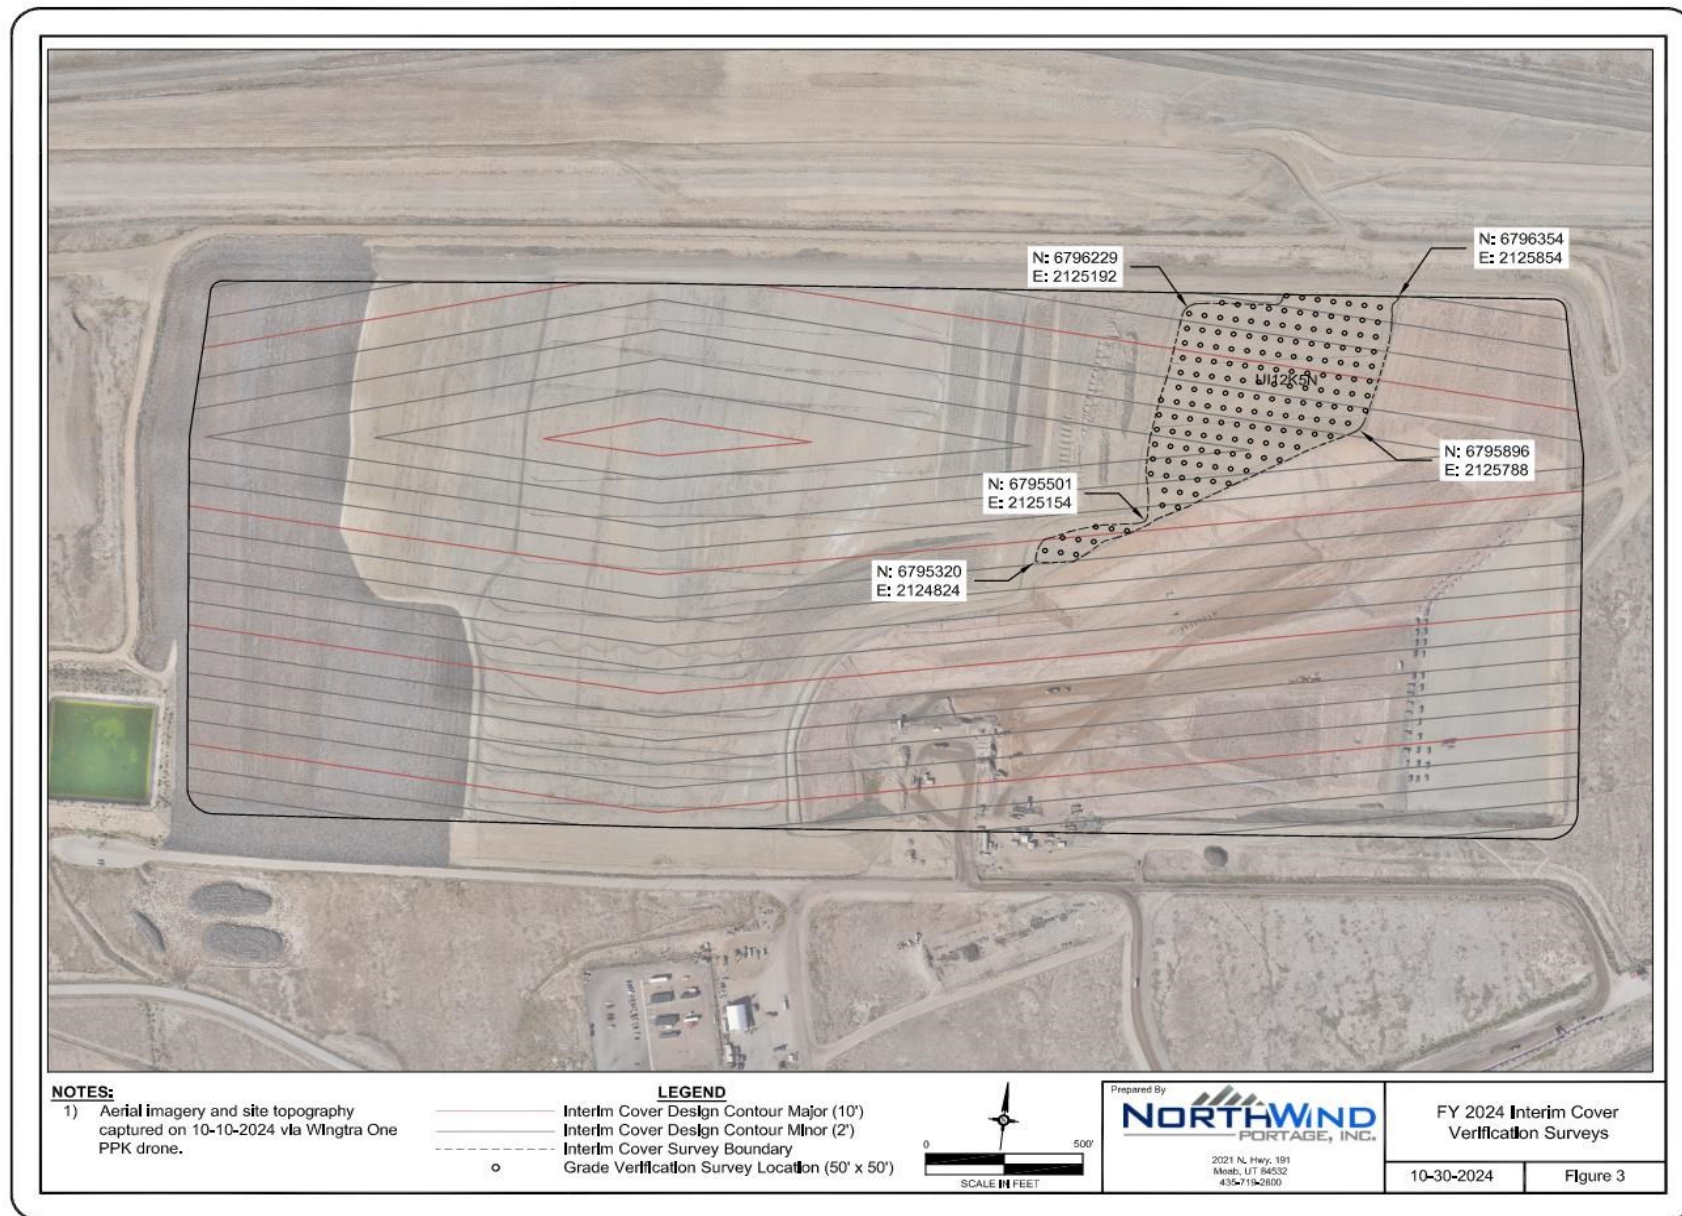
Figure 5. Distribution of Survey Points to Verify Compliance with Interim Cover Specifications

The inspection and testing for the interim cover can be found in Table 4. The distribution of survey points is shown in Figure 5. The standard proctor test results summary, lift approval summaries, one lift approval package, and buyoff surveys for the interim cover are provided in Appendix A3.

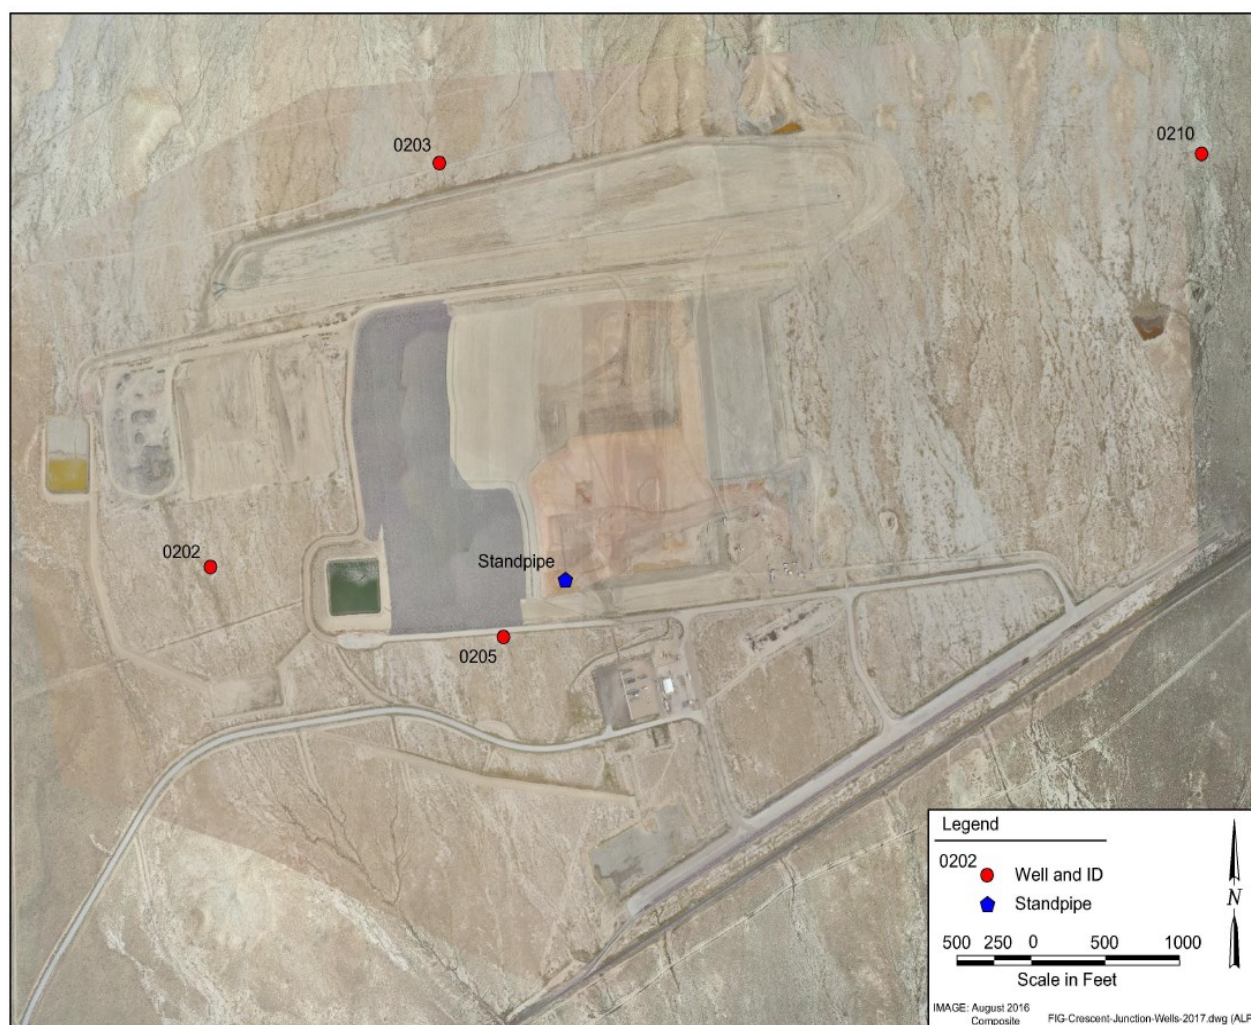
Figure 6. Locations of Monitoring Wells and Standpipe

A second standpipe was installed on May 11, 2023. Table 9 provides the results of the standpipe (locations shown on Figure 6) monitoring for the presence of free liquids in the disposal cell. During this reporting period, no water was present in the standpipe.
