## **APPENDIX G. VISUAL SIMULATIONS AND VIEWSHEDS**

**Figure G-1**  
**Viewshed Analysis**  
**North Plains Connector**  
**Grid United**

**Figure G-3**  
**Key Observation Points**  
North Plains Connector  
Montana and North Dakota

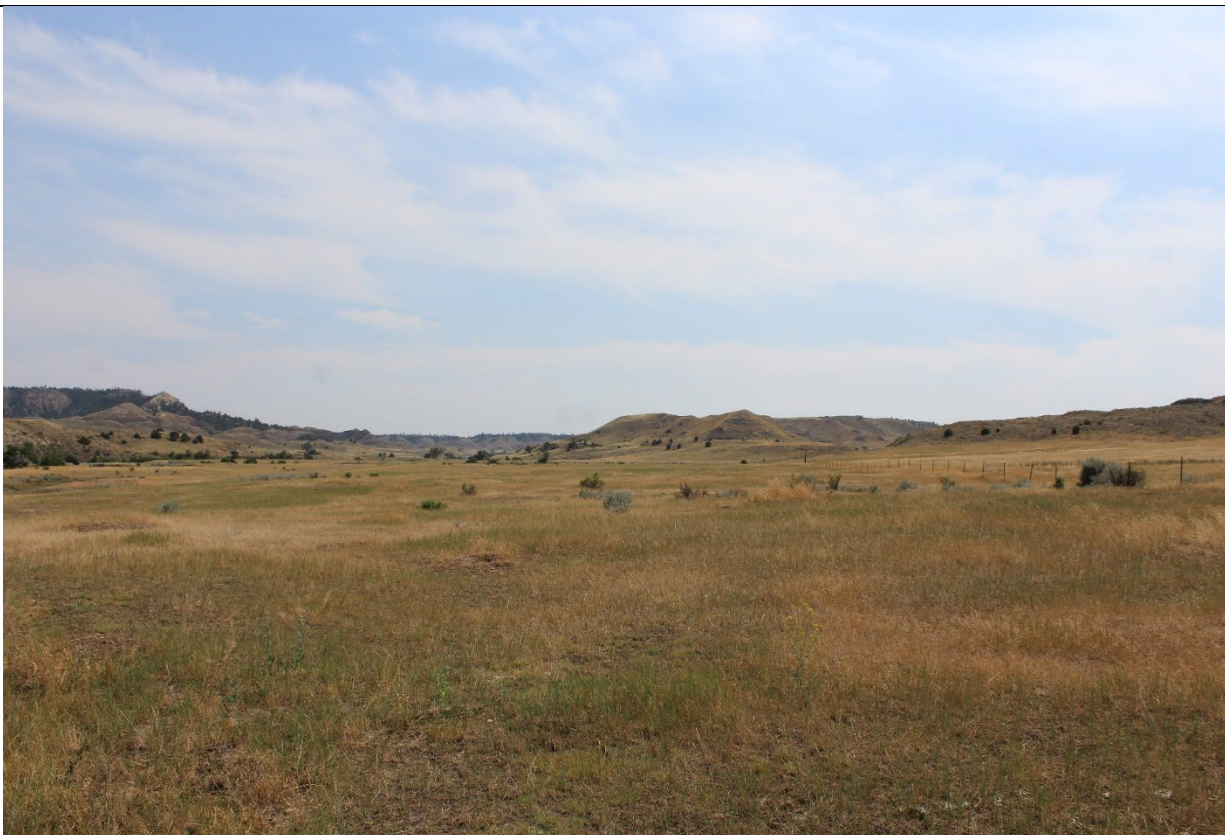
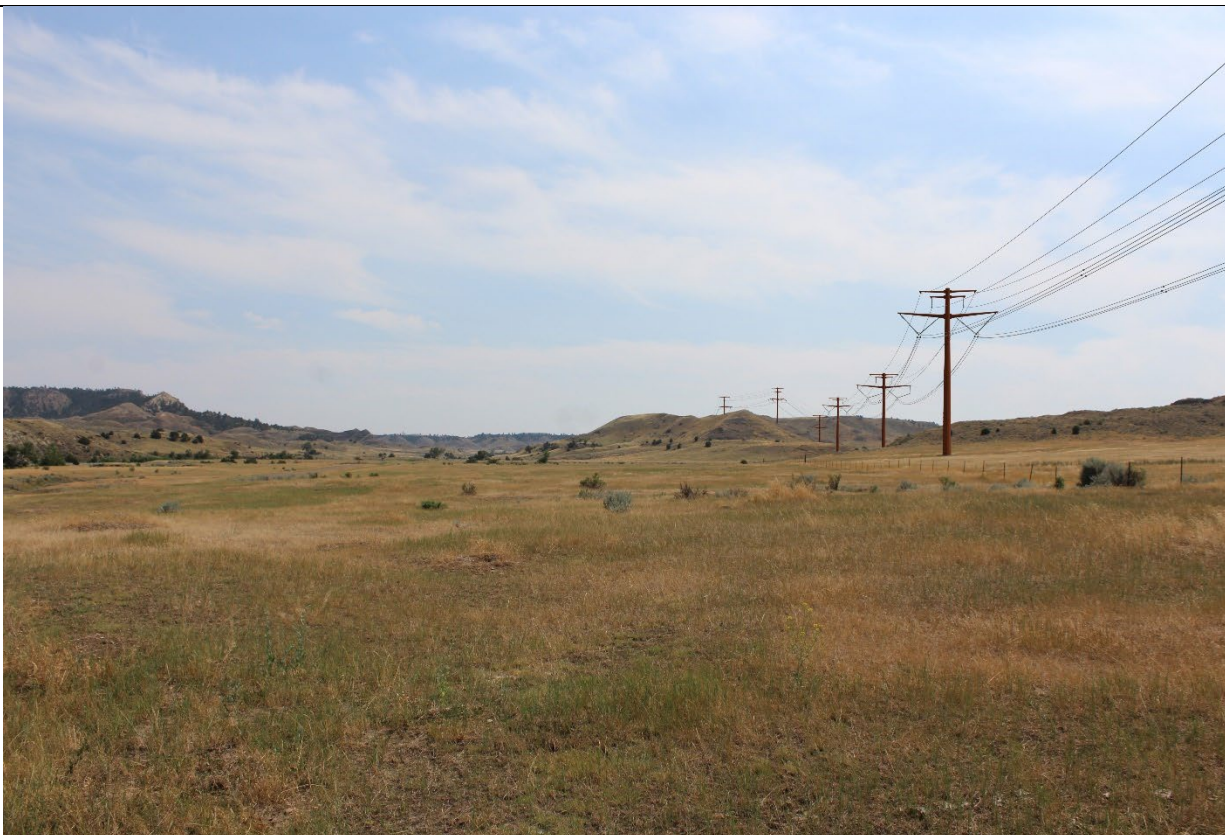
Photo 1. MT-02b Before

| | Landform/Water | Vegetation | Structures |
|---|---|---|---|
| <b>Form</b> | bold, jagged, wide, softer rolling hills | complex, irregular, accenting terrain | vertical |

| | Landform/Water | Vegetation | Structures |
|---|---|---|---|
| <b>Form</b> | NA | NA | vertical, geometric, prominent |

| | | Features | | | | | | | | | | | |
|---|---|---|---|---|---|---|---|---|---|---|---|---|---|
| Elements | Form | | | | X | | | | X | | X | | |

Does project design meet visual resource management objectives?  
Yes

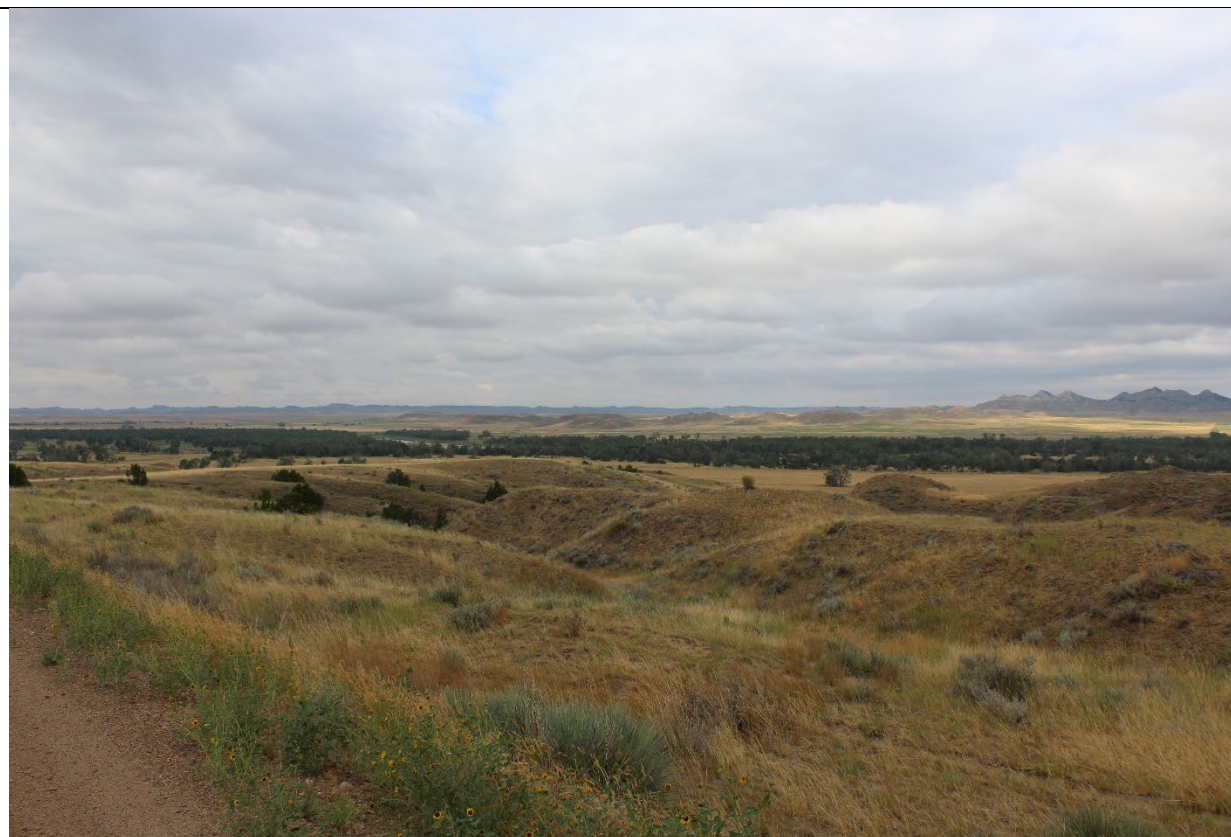
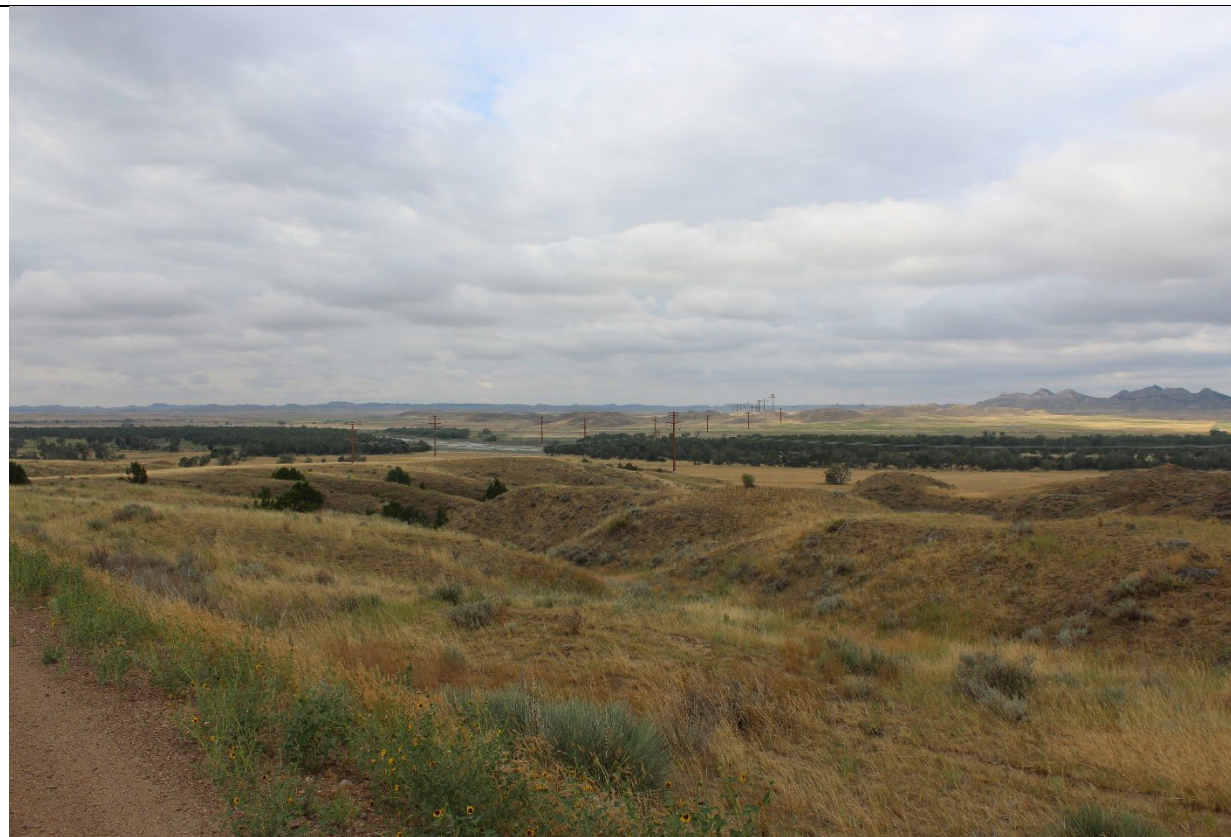
Photo 3. MT-03 Before

| | Landform/Water | Vegetation | Structures |
|---|---|---|---|
| <b>Form</b> | NA | No longer continuous | vertical, geometric |

| Degree of Contrast | | Features | | | | | | | | | | | |
|---|---|---|---|---|---|---|---|---|---|---|---|---|---|
| Elements | Form | | | | X | | X | | | | X | | |

Does project design meet visual resource management objectives?  
Yes

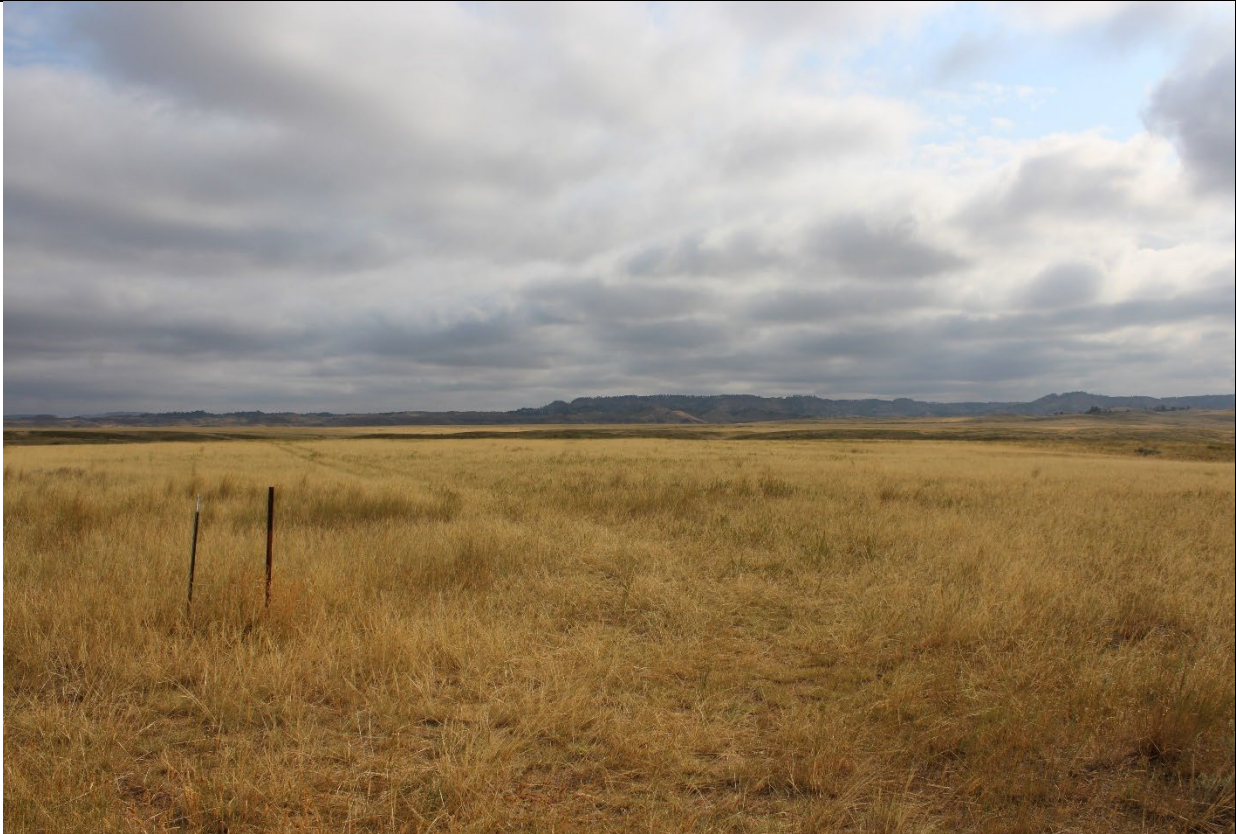
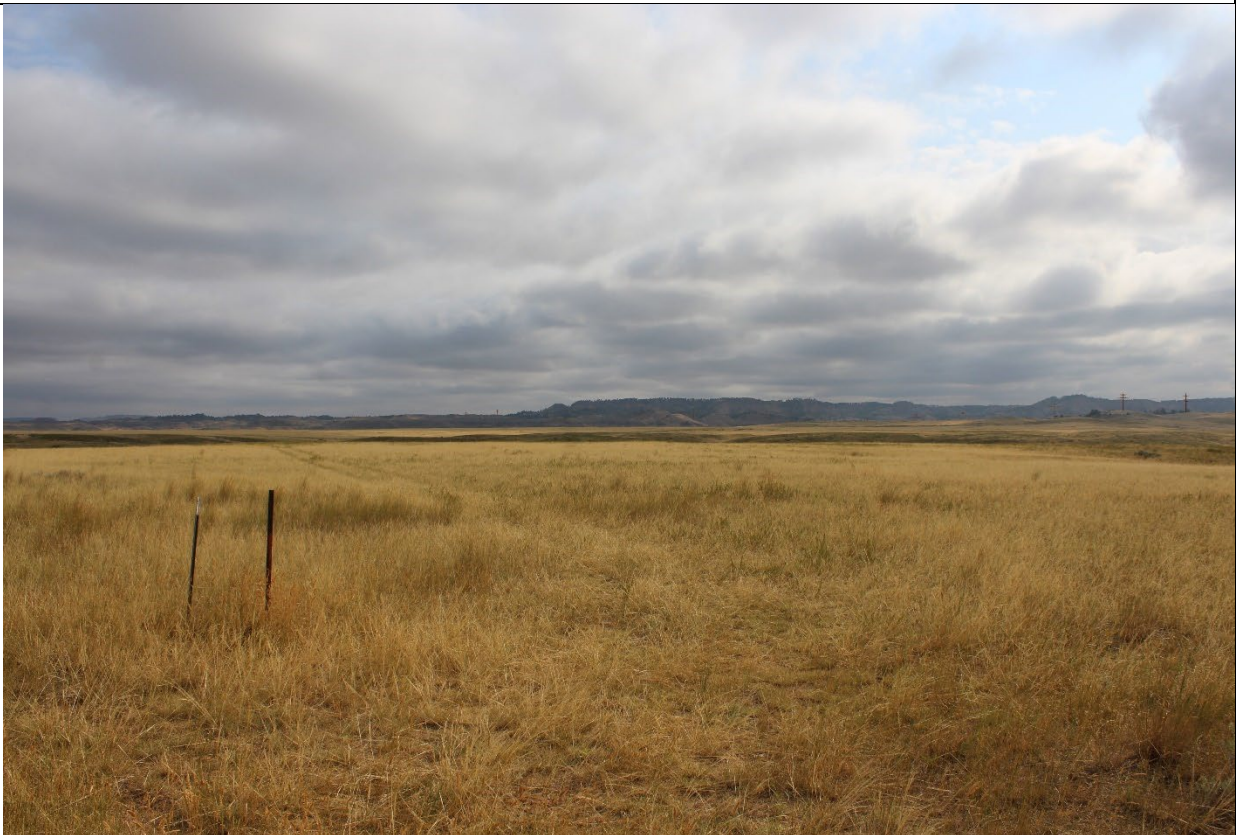
Photo 5. MT-04 Before

| | Landform/Water | Vegetation | Structures |
|---|---|---|---|
| <b>Form</b> | NA | NA | vertical, geometric |

| | | Features | | | | | | | | | | | |
|---|---|---|---|---|---|---|---|---|---|---|---|---|---|
| <b>Elements</b> | Form | | | | X | | | | X | | | X | |

Does project design meet visual resource management objectives?  
Yes

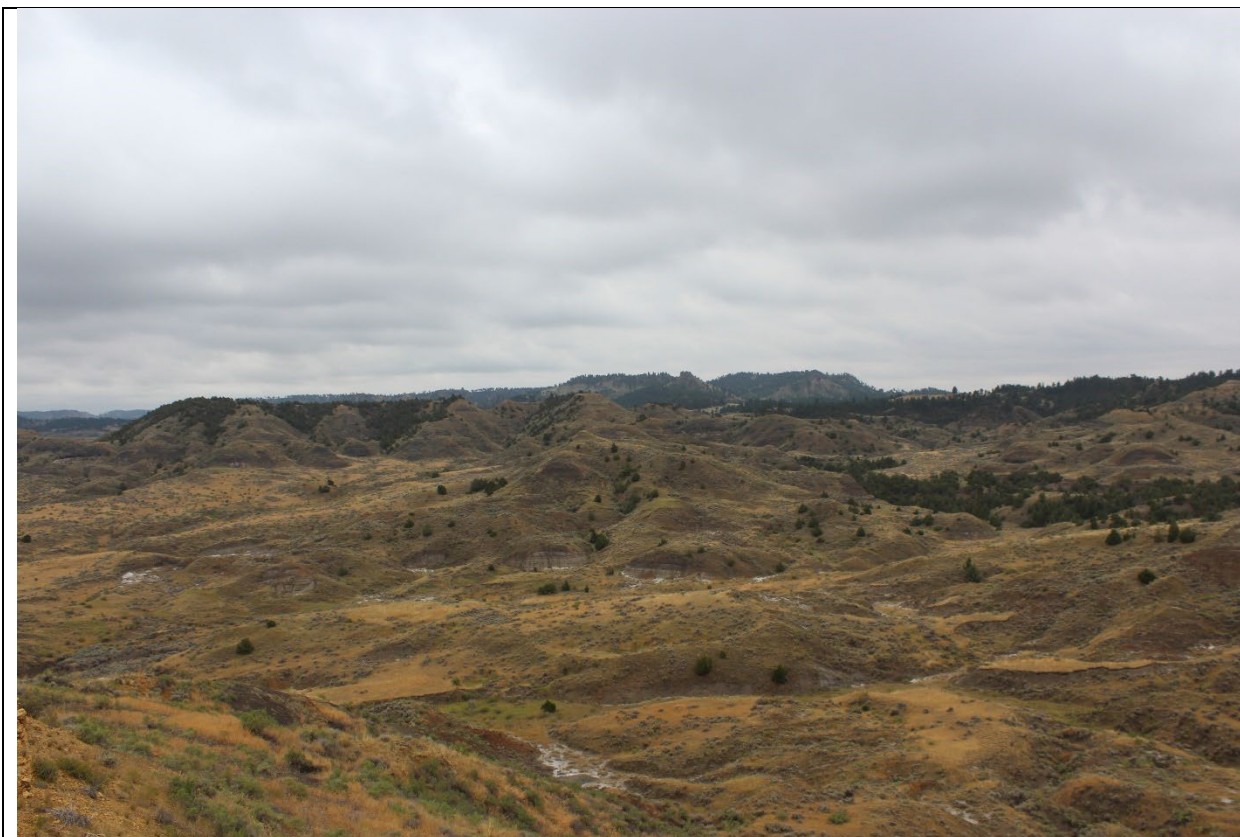
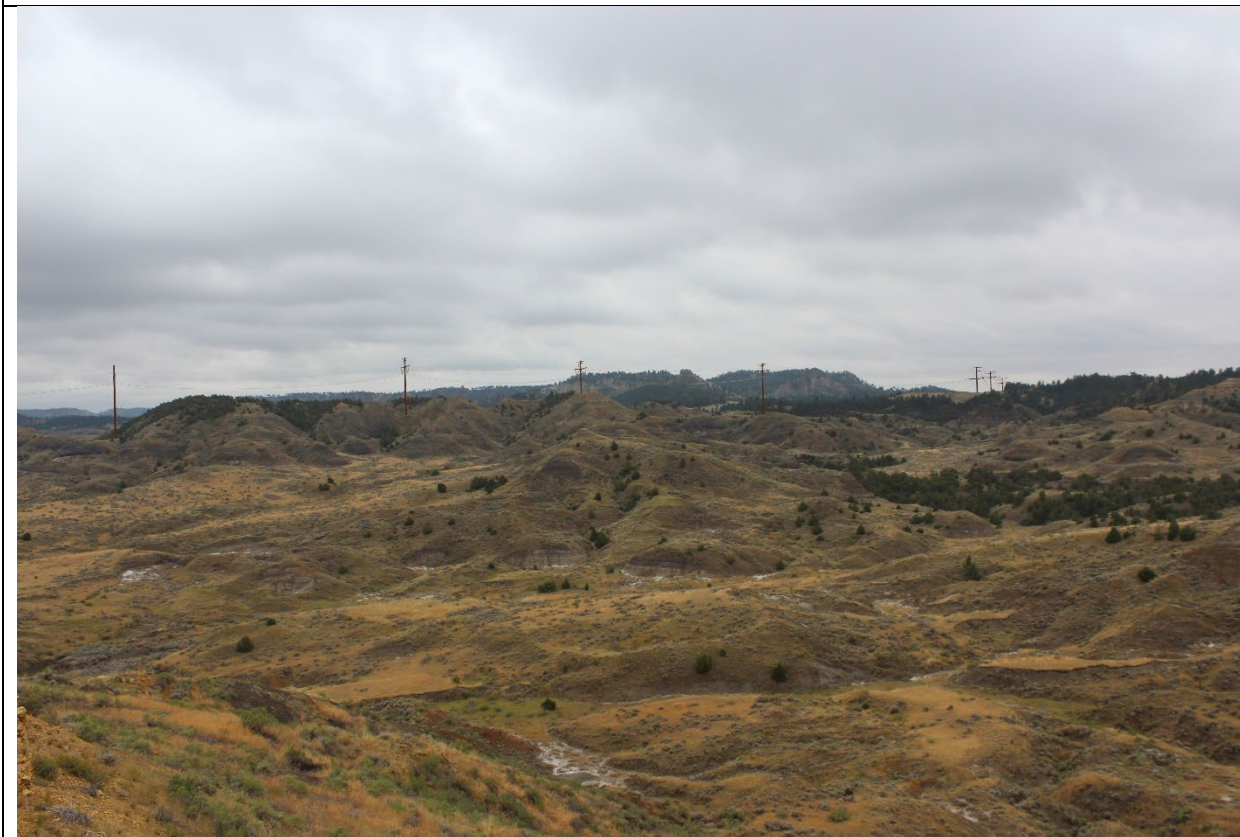
Photo 7. MT-05a Before

| | Landform/Water | Vegetation | Structures |
|---|---|---|---|
| <b>Form</b> | NA | break in continuity with terrain | vertical, geometric |

| | | Features | | | | | | | | | | | |
|---|---|---|---|---|---|---|---|---|---|---|---|---|---|
| Elements | Form | | | | X | | | X | | | X | | |

Does project design meet visual resource management objectives?  
No

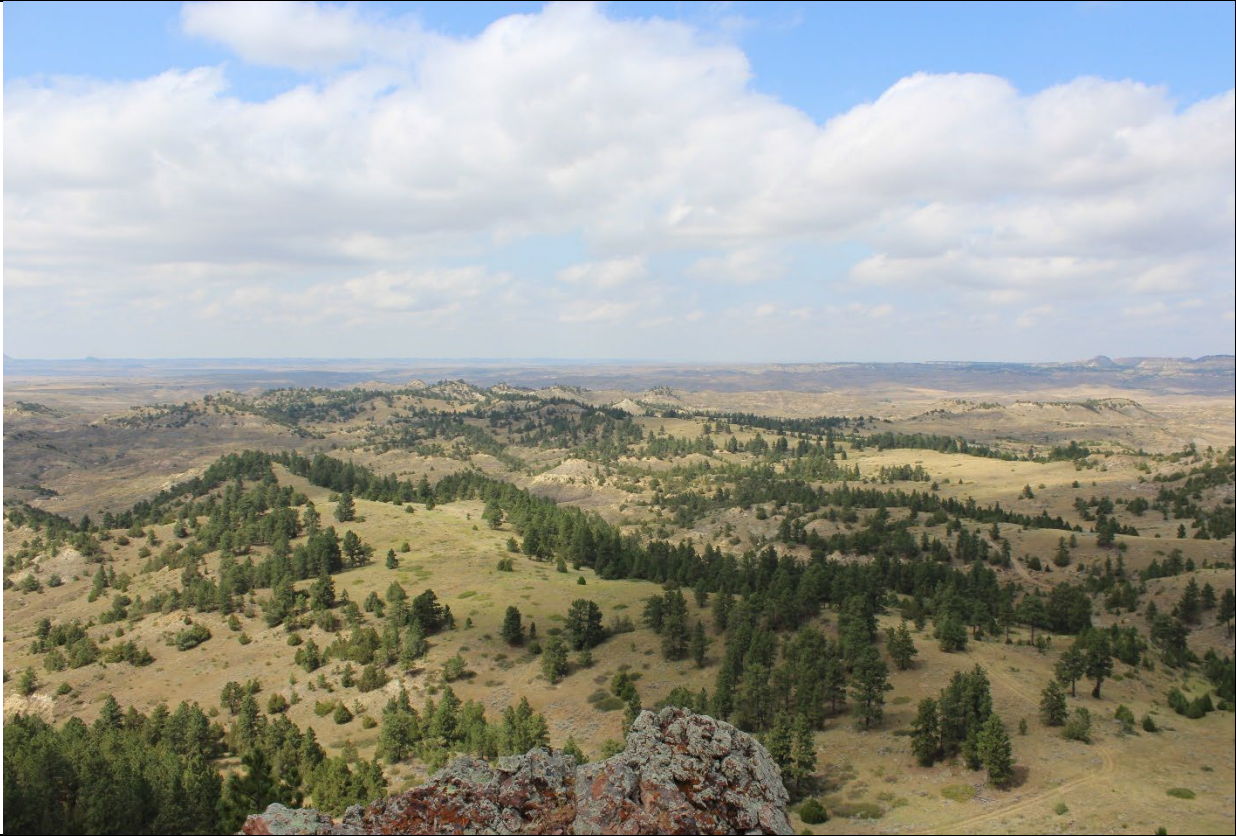
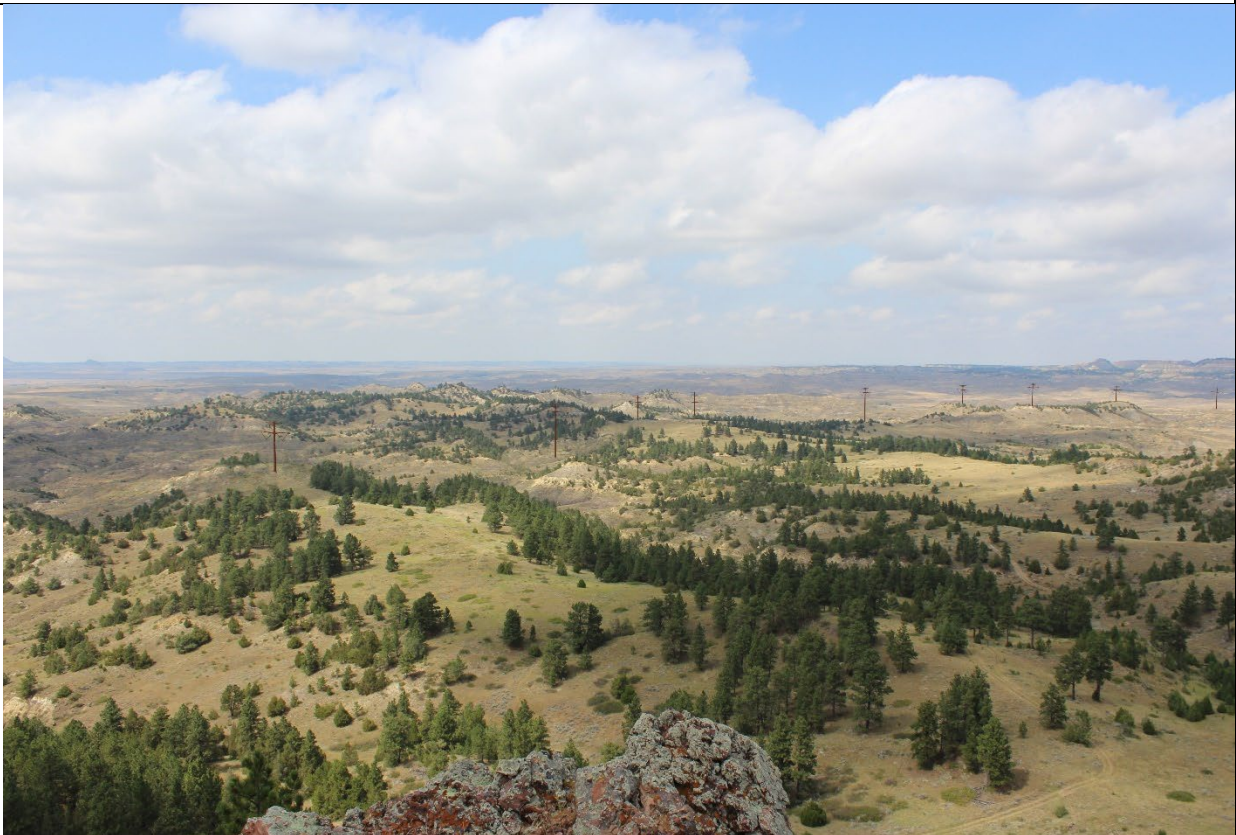
Photo 9. MT-05bNW Before

| | Landform/Water | Vegetation | Structures |
|---|---|---|---|
| <b>Form</b> | NA | break in continuity with terrain | vertical, geometric |

| Degree of Contrast | | Features | | | | | | | | | | | |
|---|---|---|---|---|---|---|---|---|---|---|---|---|---|
| Elements | Form | | | | | | X | | | | X | | |

Does project design meet visual resource management objectives?  
No

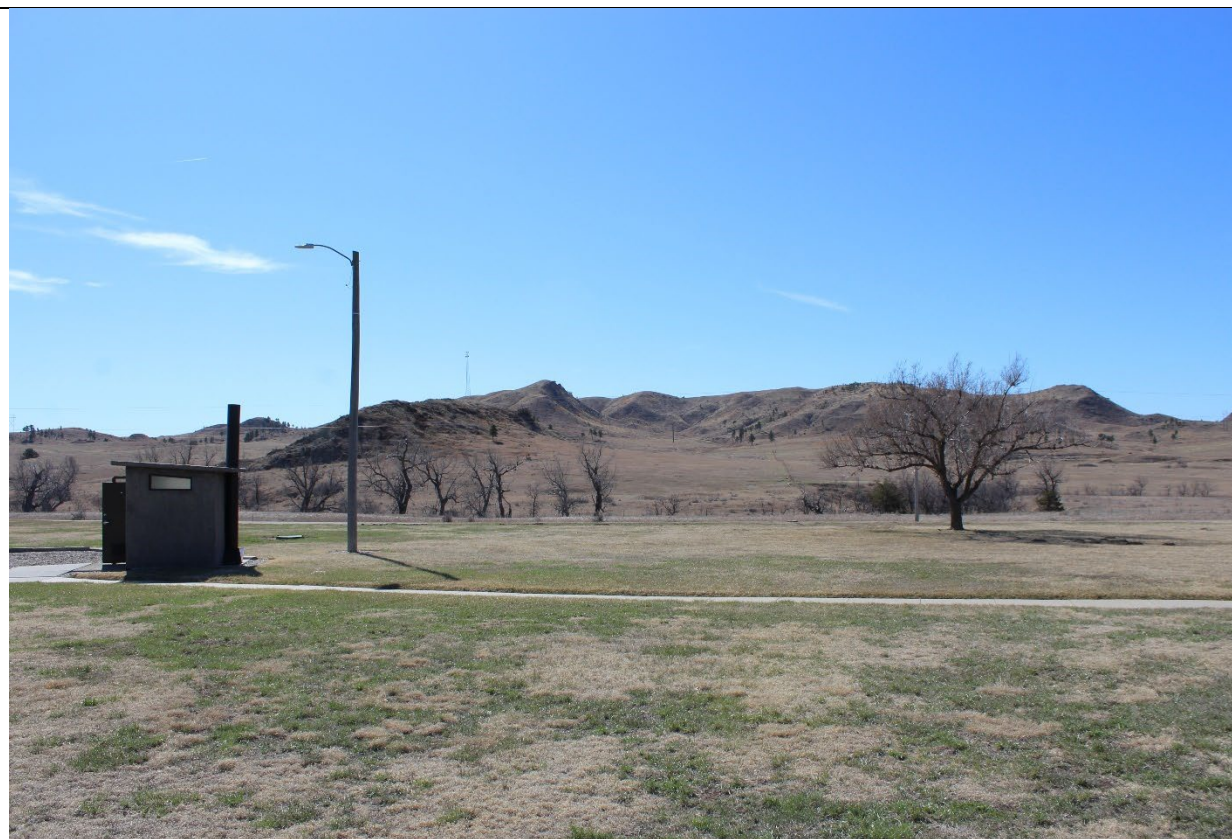
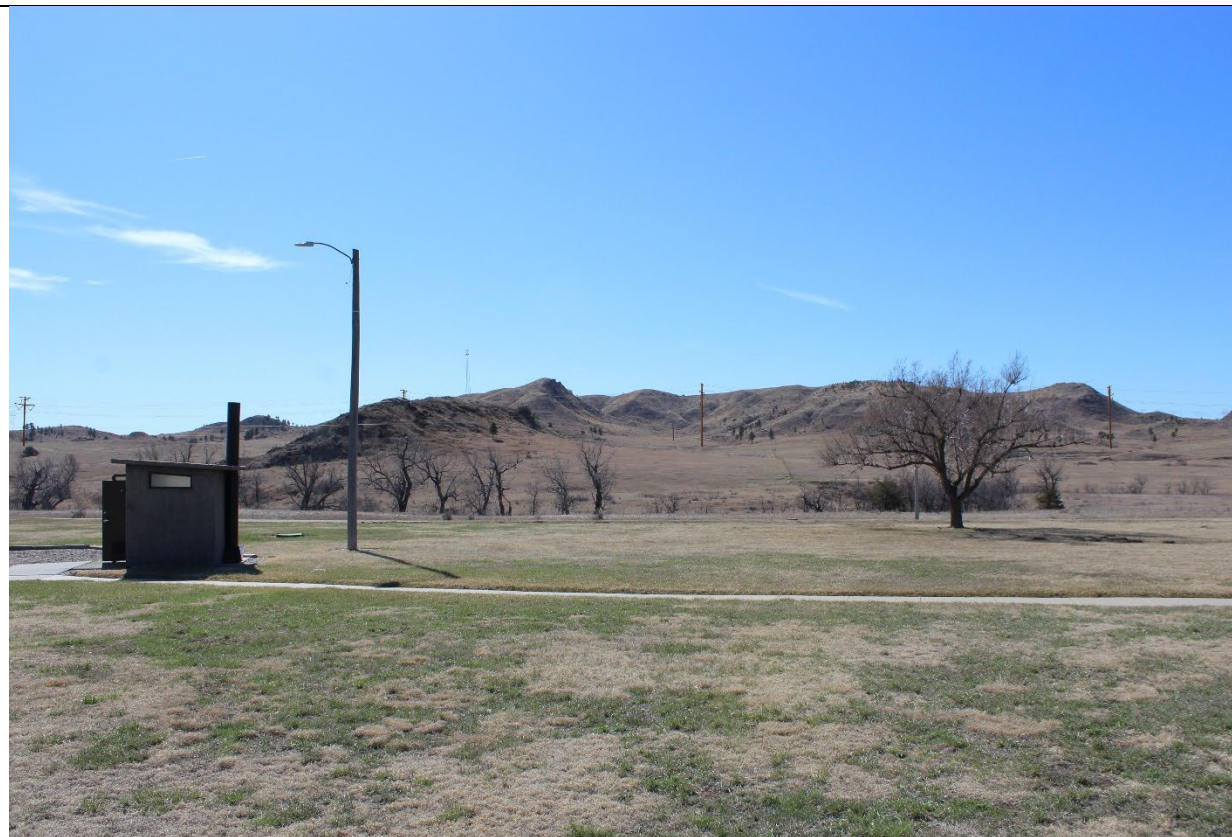
Photo 13. MT-06 Before

| | Landform/Water | Vegetation | Structures |
|---|---|---|---|
| <b>Form</b> | NA | NA | vertical, geometric |

| | | Features | | | | | | | | | | | |
|---|---|---|---|---|---|---|---|---|---|---|---|---|---|
| <b>Elements</b> | Form | | | | X | | | | X | | | X | |

Does project design meet visual resource management objectives?  
Yes

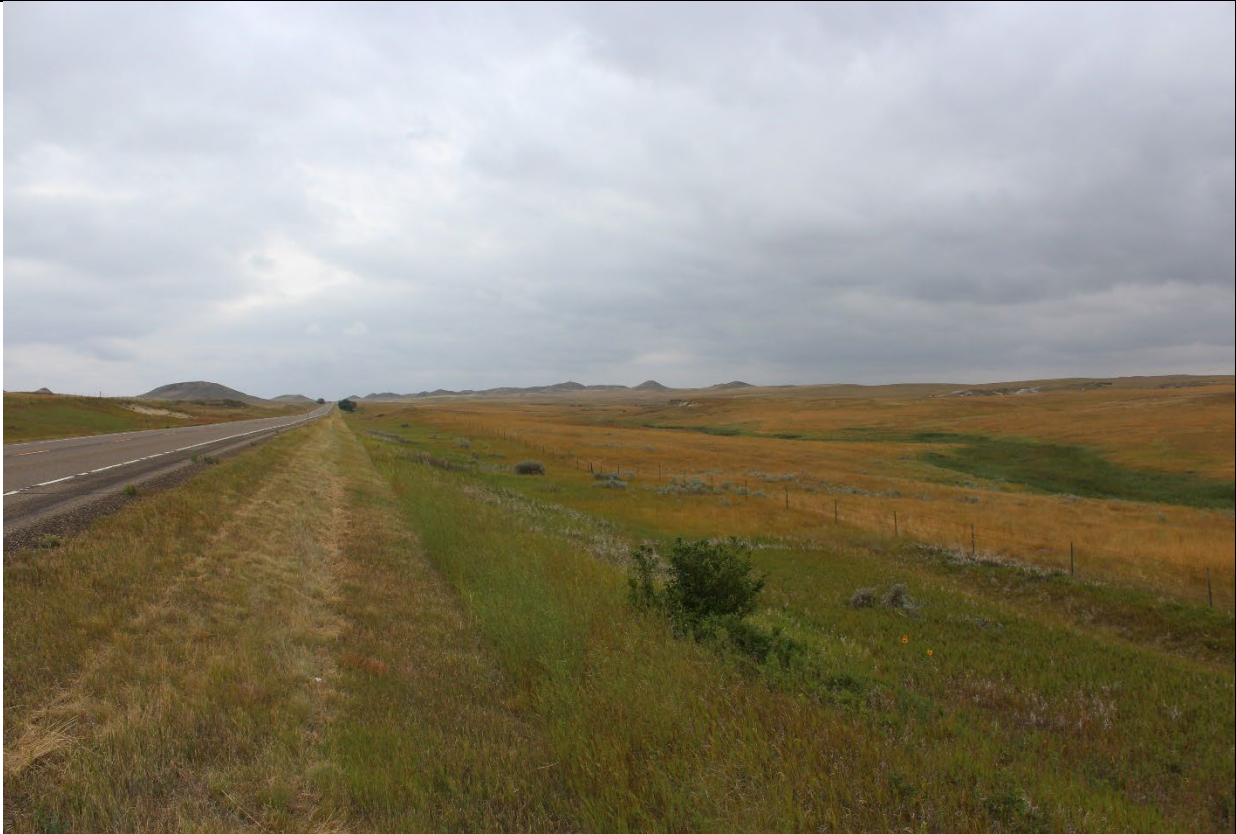
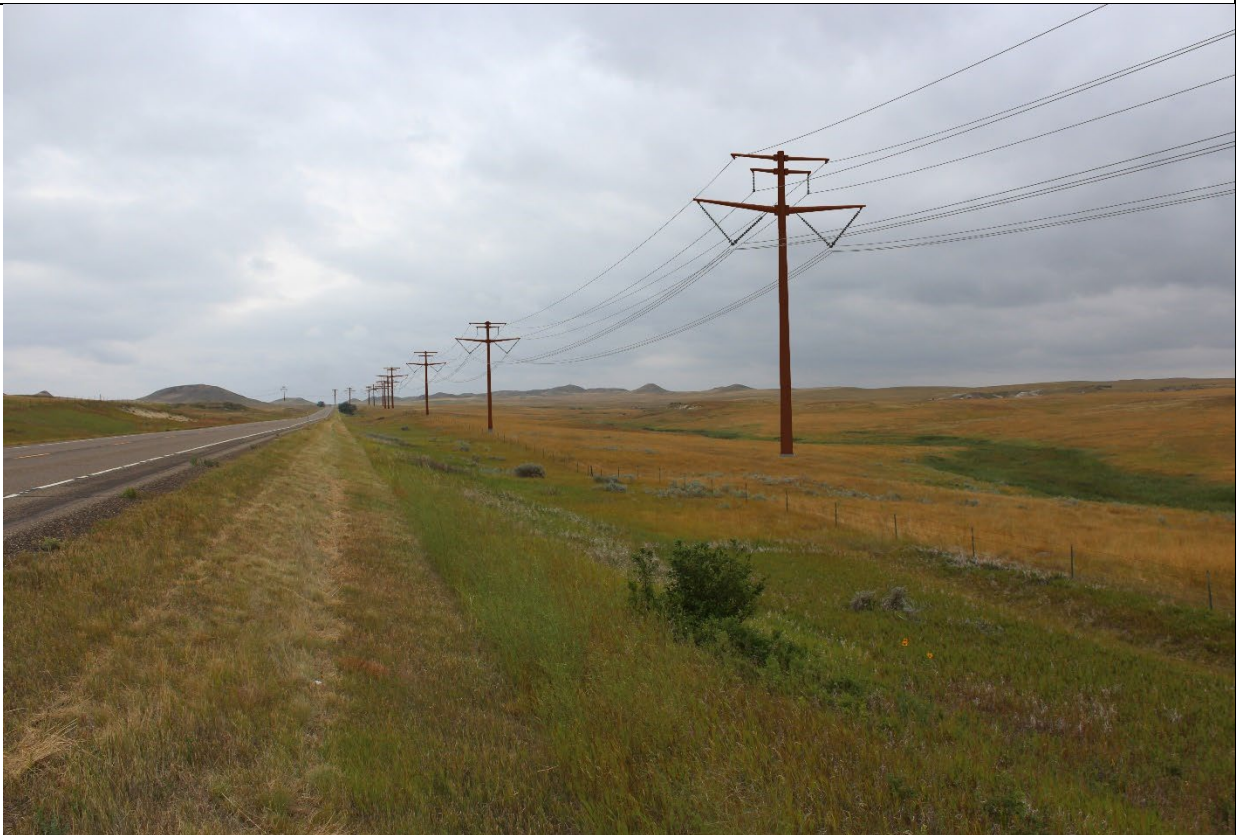
Photo 15. MT-07 Before

| | Landform/Water | Vegetation | Structures |
|---|---|---|---|
| <b>Form</b> | NA | NA | vertical, geometric |

| Degree of Contrast | | Features | | | | | | | | | | | |
|---|---|---|---|---|---|---|---|---|---|---|---|---|---|
| Elements | Form | | | | X | | | | X | X | | | |

Does project design meet visual resource management objectives?  
No
