Distribution System Audits, Leak Detection, and Repair

Kirtland Air Force Base – Leak Detection and Repair Program

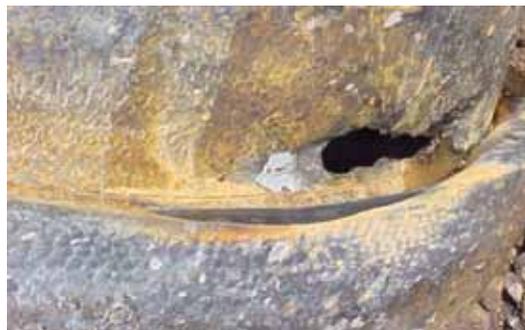
Figure 1: Photo of the largest leak found during the survey (joint offset) with a water loss rate of 150 gallons per minute

The largest leak that was found was in a 30 inch supply line in a remote, undetected area of the base, which flowed at about 150 gallons per minute at the time of discovery. This leak was caused by an offset joint and is shown in Figure 1. A smaller leak identified and estimated at 30 gallons per minute is shown in Figure 2. All repairs took place in a three-month window, with the largest leaks repaired first.

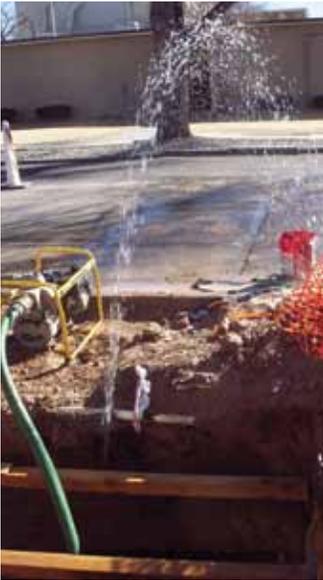
Figure 2: Photo of a secondary leak found during the survey, which was losing water at a rate of 30 gallons per minute.
