## Building America Efficient Solutions for Existing Homes

# Case Study: Habitat for Humanity of Palm Beach County

Lake Worth, Florida

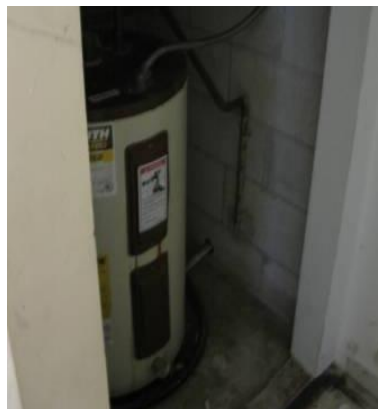
The largest energy savings came from replacing this 30-gal tank electric water heater with a 50-gal electric/heat pump hybrid water heater. The new water heater will save an estimated \$182 annually in energy costs. Only relatively minor modifications were required to fit the new water heater in the old unit's space.

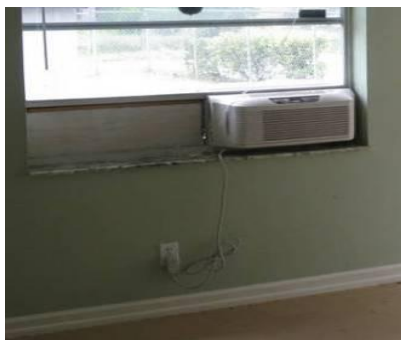
**Left:** This SEER 10 window unit was replaced with a SEER 14.5 central air conditioner, which will save an estimated \$109 each year. **Right:** The new air handler required additional effort to fit into the existing air handler closet space.
