## Building America Efficient Solutions for Existing Homes

# Case Study: Habitat for Humanity South Sarasota County

Venice, Florida

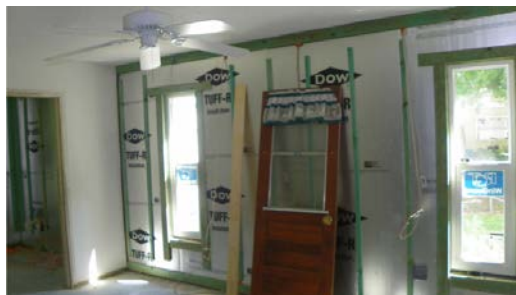
HFH removed old drywall and filled numerous holes in the concrete block walls before insulating them with continuous R-7.5 foil-faced rigid insulation. Borate-treated furring strips were attached over the insulation to provide an air gap behind the new drywall. (Photo Source: Calcs-Plus)

- Uninsulated concrete block walls require removal of all interior wallboard to seal numerous holes and add continuous foil-faced rigid insulation (see photo on first page).

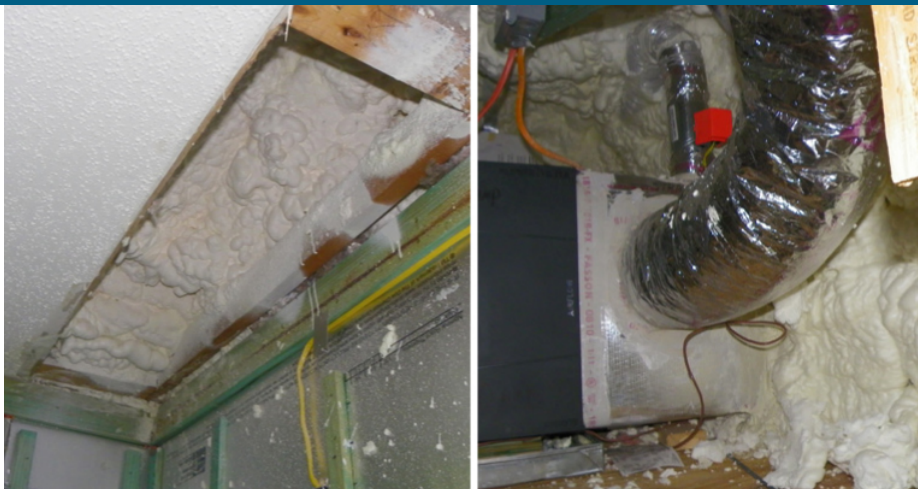
Ceiling drywall was removed along the perimeters of the home to access the attic. Open-cell spray foam was sprayed along the underside of the low-pitch roof to provide an R-21 air sealed, insulated attic space to house the new SEER 16.25 heat pump. (Photo Sources: Calcs-Plus)

- An unvented attic was implemented to air seal the whole house, bring the ducts and air handler inside the thermal envelope, and add insulation to the attic. An unvented attic was the best solution because of numerous large air pathways from the existing vented attic to the house. Perimeter ceiling drywall was removed and replaced after spraying the attic with open-cell foam (see photos).
