**DOE CHALLENGE HOME
CASE STUDY****e2 Homes**

FEATURED HOME/DEVELOPMENT:**Project Data:**

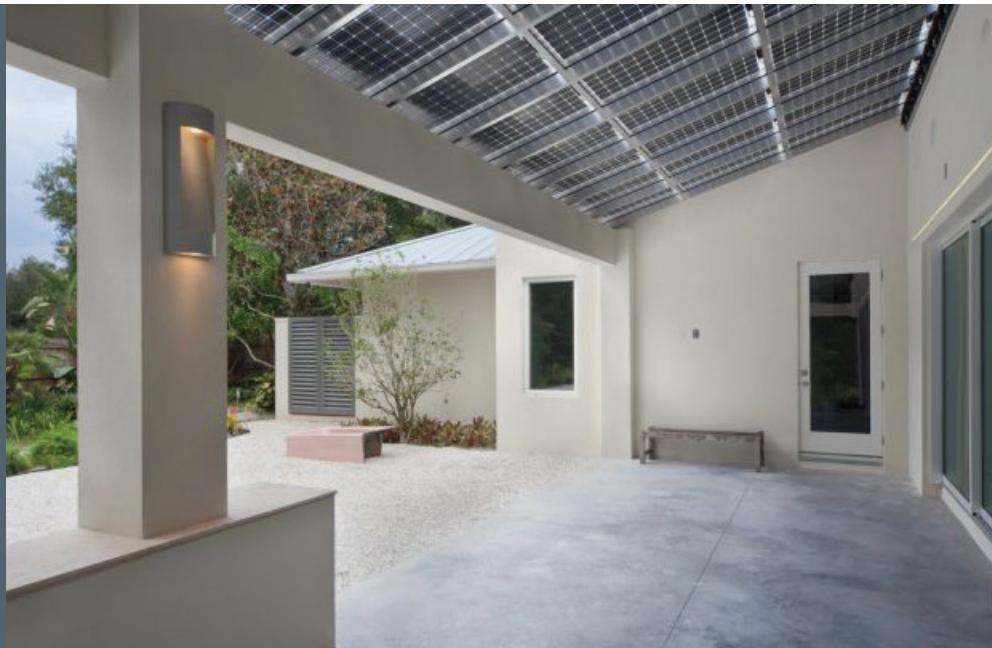
All of the 962-ft² porch roof is comprised of solar panels with a 13.4-kW solar array system. The 69 panels don't sit on top of the roof; they are the roof. The completely watertight structure allows about 15% of natural light to filter through the panels, lighting the space below. The panels are dual surface meaning they can produce power from any sunlight reflected up onto their lower surface for up to 30% greater than rated power production. All wiring is hidden within the canopy's aluminum support beams.

With the home designed for maximum energy efficiency, indoor air quality, and water conservation, the 13.5-kW photovoltaic system is now the appropriate last step for zero net-energy performance. "The key to creating any zero net-energy home while keeping costs down is to focus on energy conservation [in the design]," explains Smith. Rather than mounting the 69 solar panels on the roof, the solar installer fit them together to form a watertight structure that literally is the roof of the home's 962-ft² porch. The 195-Watt solar panels are bifacial, meaning they can generate some electricity from reflected light that hits the bottom side of the panels. The panels also permit about 15% of the daylight to filter through them, lighting the porch area beneath. The hybrid inverter converts the panel-produced direct current power into a utility-compatible alternating current, using a unique technology that overcomes the limitations of traditional central string inverter systems, but at a much lower cost than micro-inverter systems.

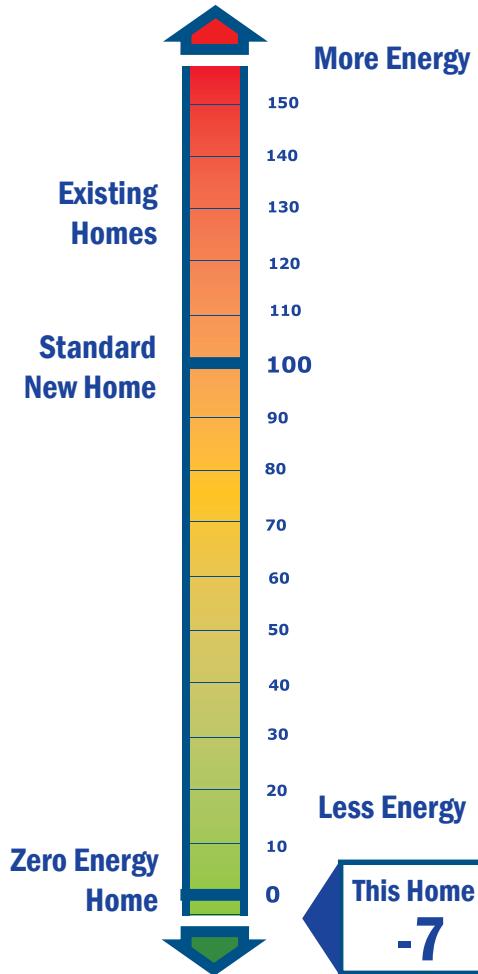
HERS® Index

Without solar power, the home scores a HERS 57, which is well below the HERS 100 for a standard home built to code. With its photovoltaic system, the home produces better than zero net-energy performance, with a score of HERS -7. This translates into no electric utility bills and even \$123 annually in the homeowner’s pocket from the utility.

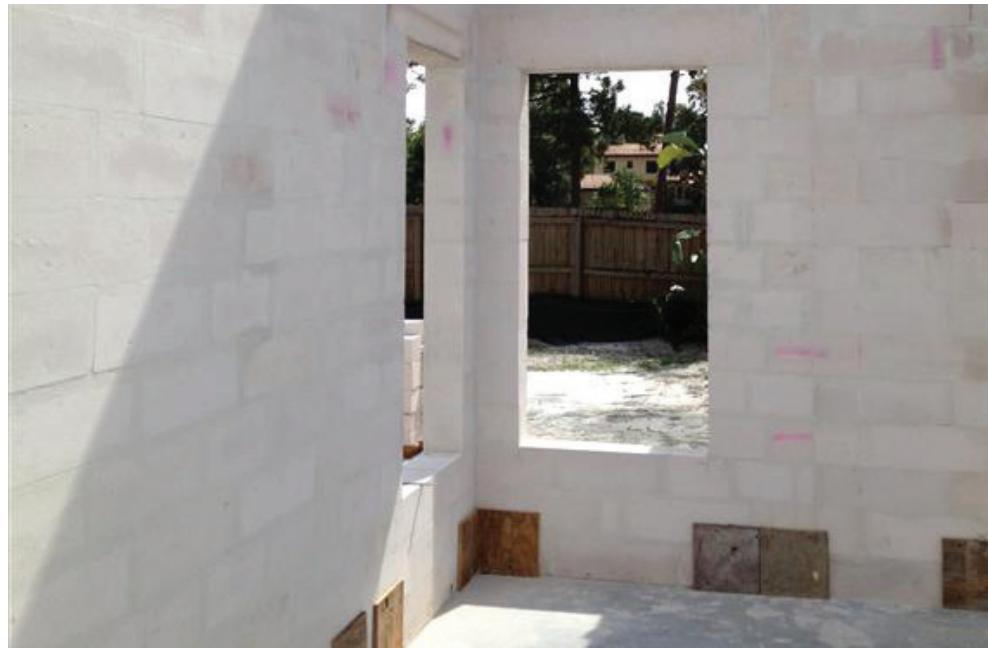
The walls are built of 2 ft. x 8 in. x 8 in. autoclaved aerated concrete (AAC) blocks. AAC is made of most of the ingredients found in concrete but in a process something like bread making: sand is ground like flour and mixed with water, cement, and a little bit of aluminum powder. The mixture is poured into railroad car-sized molds and allowed to sit for 4 hours while the aluminum reacts with the cement forming millions of tiny bubbles in the concrete and causing it to rise, more than doubling in size. Rebar is set into the foam-like concrete, which is cut into blocks or slabs that are baked in ovens. The hardened, aerated concrete is then ready to be used to build walls and foundations.

The exterior walls were constructed of autoclaved aerated concrete (AAC) blocks. “My client wanted AAC to avoid using drywall [in this hot humid climate],” said Smith. Breathable plasters and paints designed for AAC are applied directly to the blocks as finishes. “They have been using it in Europe for about 80 years, and they are about the same price as insulated concrete forms (ICFs),” said Smith. Like concrete block, AAC is mold-resistant, non-combustible, and not penetrable by termites or pests, but the unique foam-like structure of the AAC also results in good insulating performance (R-8 for an 8-inch block), effective sound resistance, light weight (one-fifth the weight of concrete), easy workability since it can be readily sawed or drilled, and excellent structural capabilities (AAC blocks and panels are reinforced with steel rebar). While AAC has a steady state R-value R-8 for an 8-inch wall, researchers say an 8-inch AAC wall has an “effective” or “mass enhanced” value of about R-21, especially in areas with large day-night temperature fluxuations.
