## **Fact Sheet**

This fact sheet provides information about the **Durango** sites. These sites are managed by the **U.S. Department** of Energy Office of Legacy Management under Title I of the Uranium Mill Tailings Radiation Control Act of 1978.

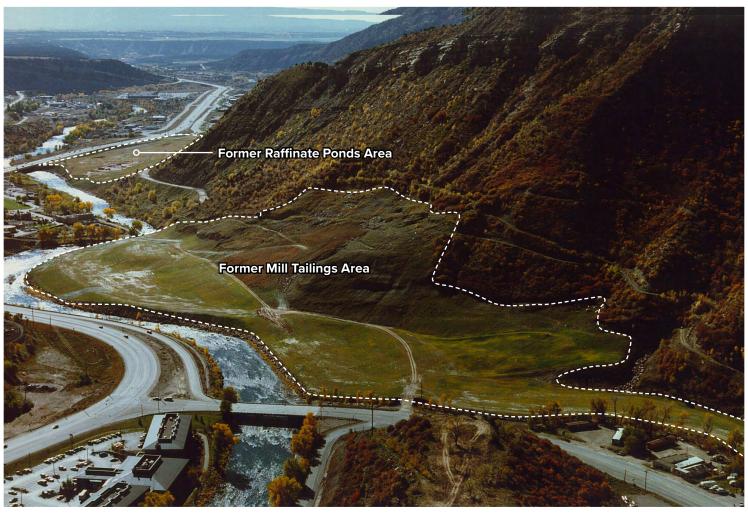
View of Durango, CO, Remediated Processing Site (1991)

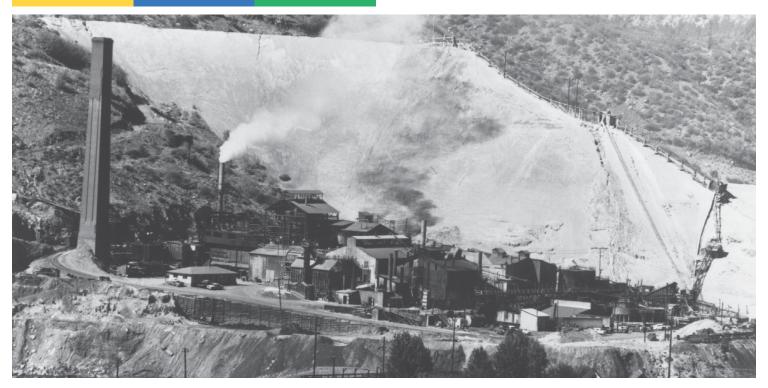
Durango mill during active operations (date unknown). The smokestack for the old lead smelter is to the left, with the large tailings pile and conveyances across the center.
