# Rocky Flats Site, Colorado Annual Report Summary

Calendar Year 2019

Rocky Flats Stewardship Council Meeting

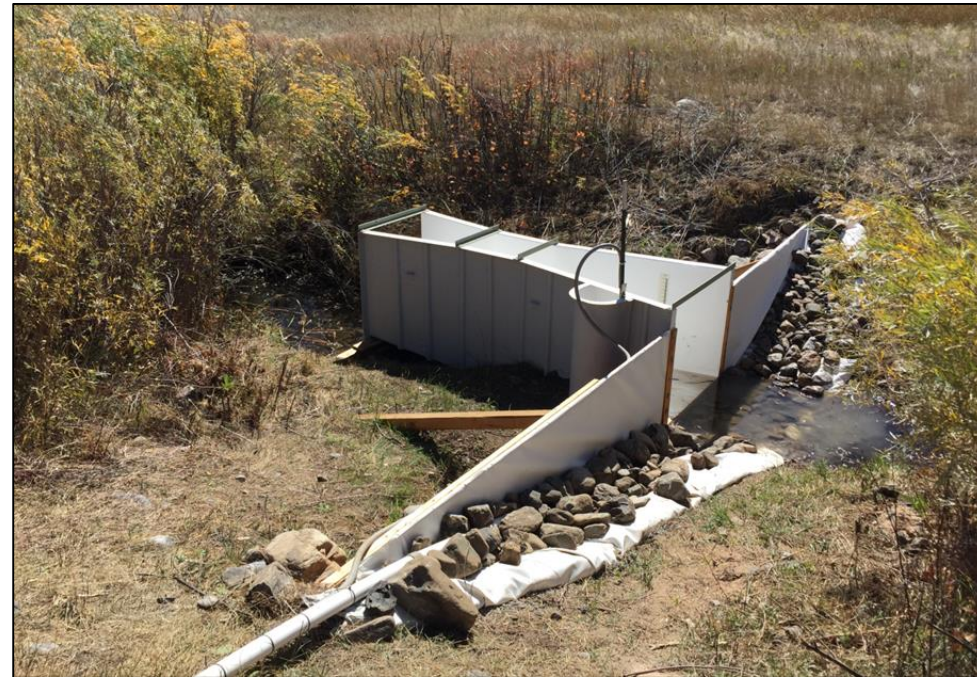
*Performance Monitoring Location GS59*

- Original Landfill (OLF) — Woman Creek
  - Quarterly concentrations for all analytes were below applicable RFLMA standards during all of calendar year (CY) 2019

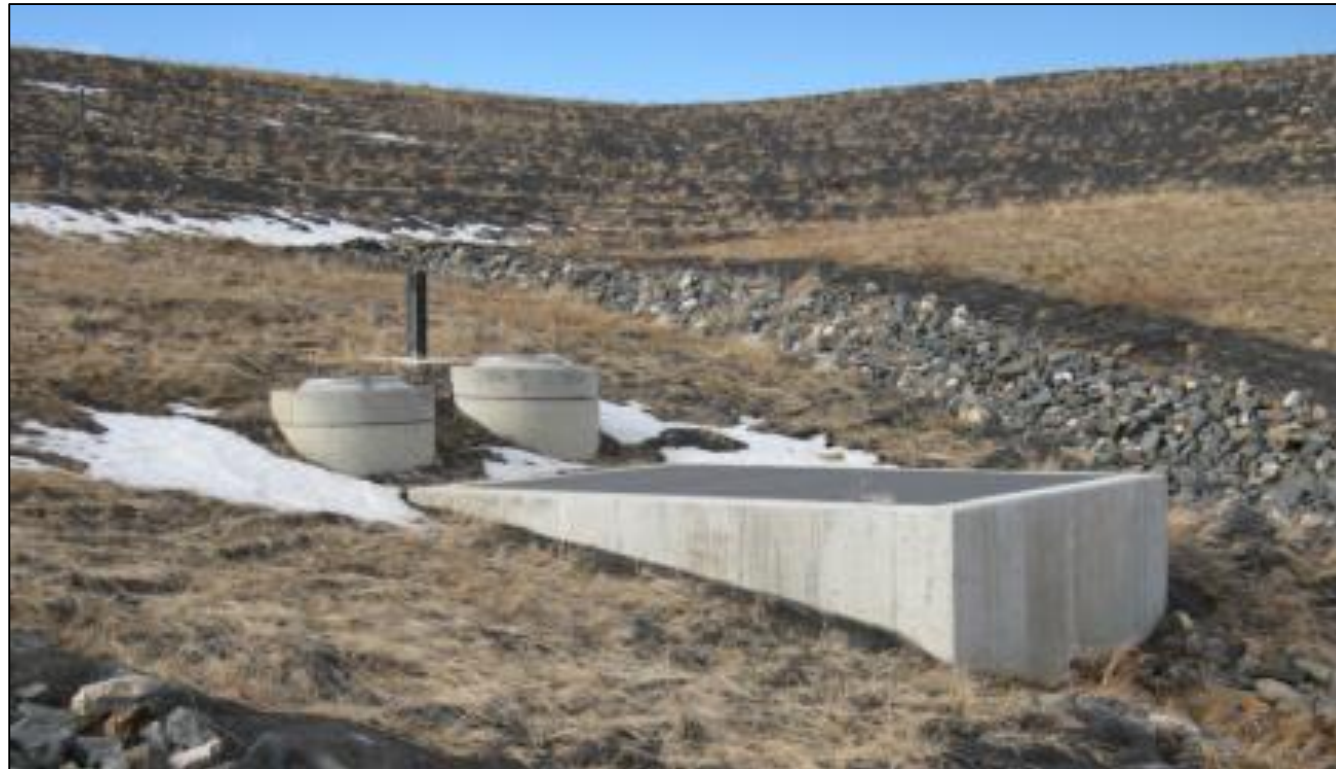
*Present Landfill Treatment System (PLFTS)*

- Present Landfill (PLF) — location PLFSYSEFF
  - Quarterly concentrations for all analytes were below applicable RFLMA standards during all of CY 2019

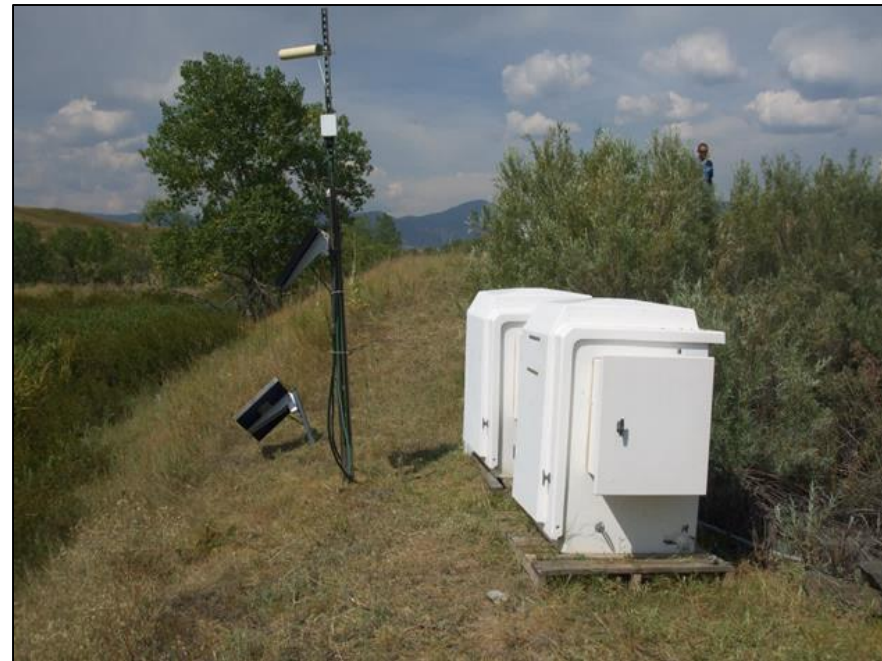
*POE Monitoring Location SW027*

- 12-month rolling average plutonium (Pu) concentrations at location SW027 were above the RFLMA standard of 0.15 picocuries per liter (pCi/L) — a reportable condition under the RFLMA — for January through April 2019
  - See RFLMA Contact Record (CR) 2019-01
  - Due to the very small volumes of water monitored at SW027 in 2019, no composite samples could be collected
  - Concentrations at the Woman Creek point of compliance (WOMPOC), downstream of SW027, remained well below 0.15 pCi/L
- No other RFLMA point of evaluation (POE) analyte concentrations were reportable during 2019

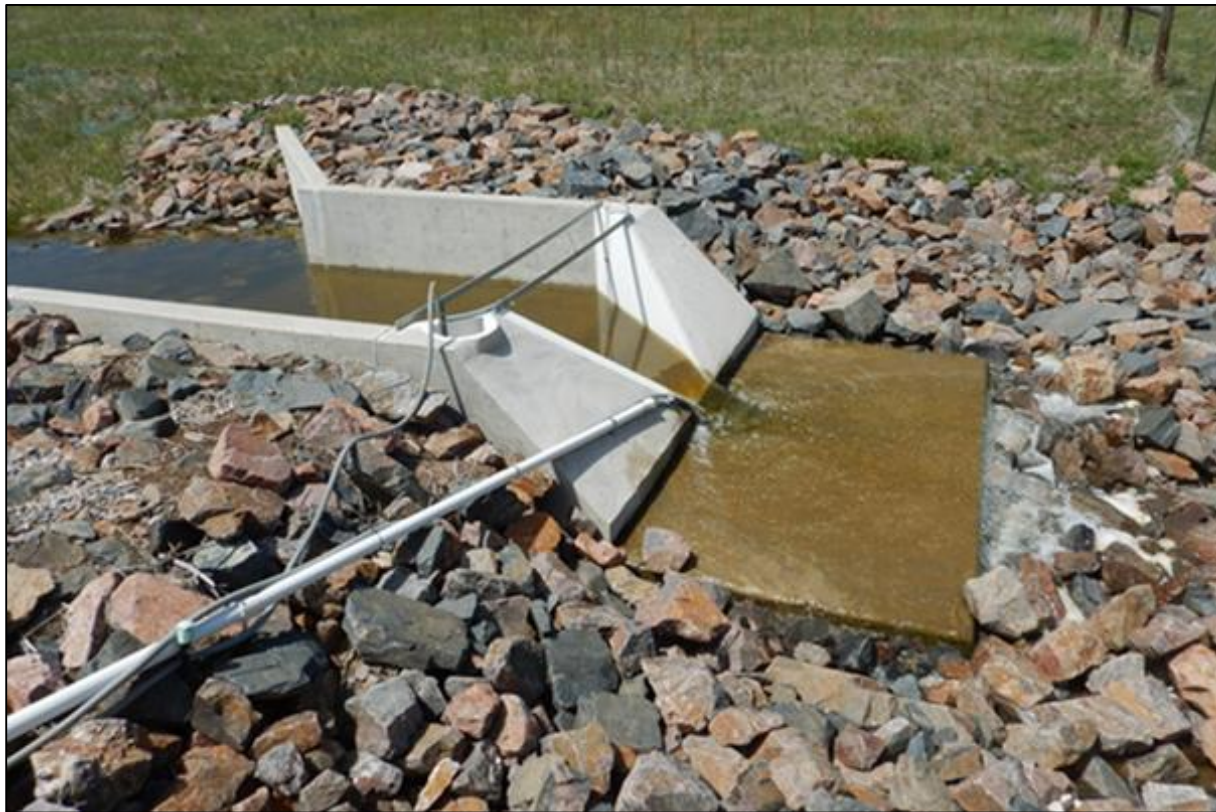
*POC Monitoring Location WALPOC*

- No RFLMA point of compliance (POC) analyte concentrations were reportable during 2019

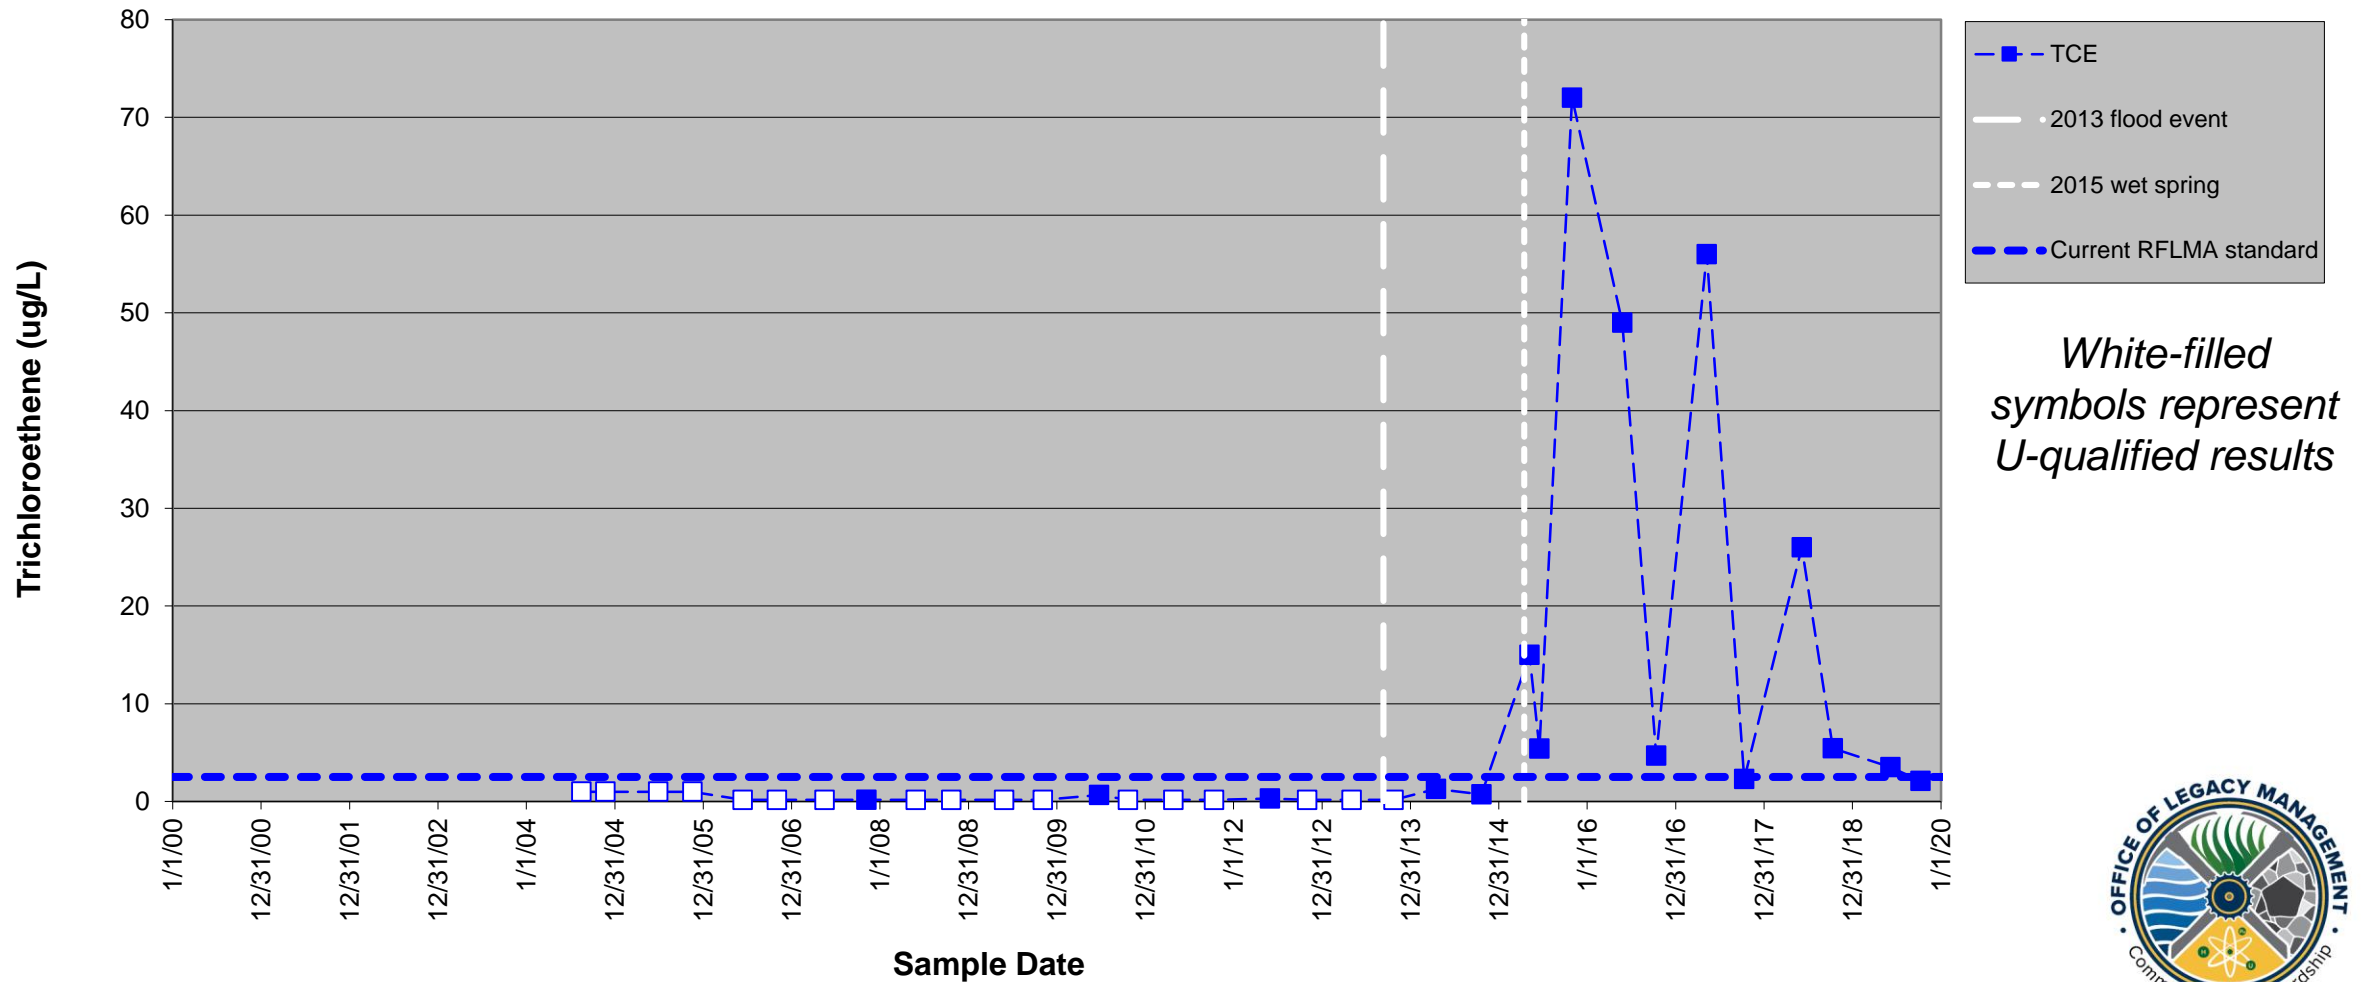
## TCE in AOC Well 10304

*White-filled symbols represent U-qualified results*

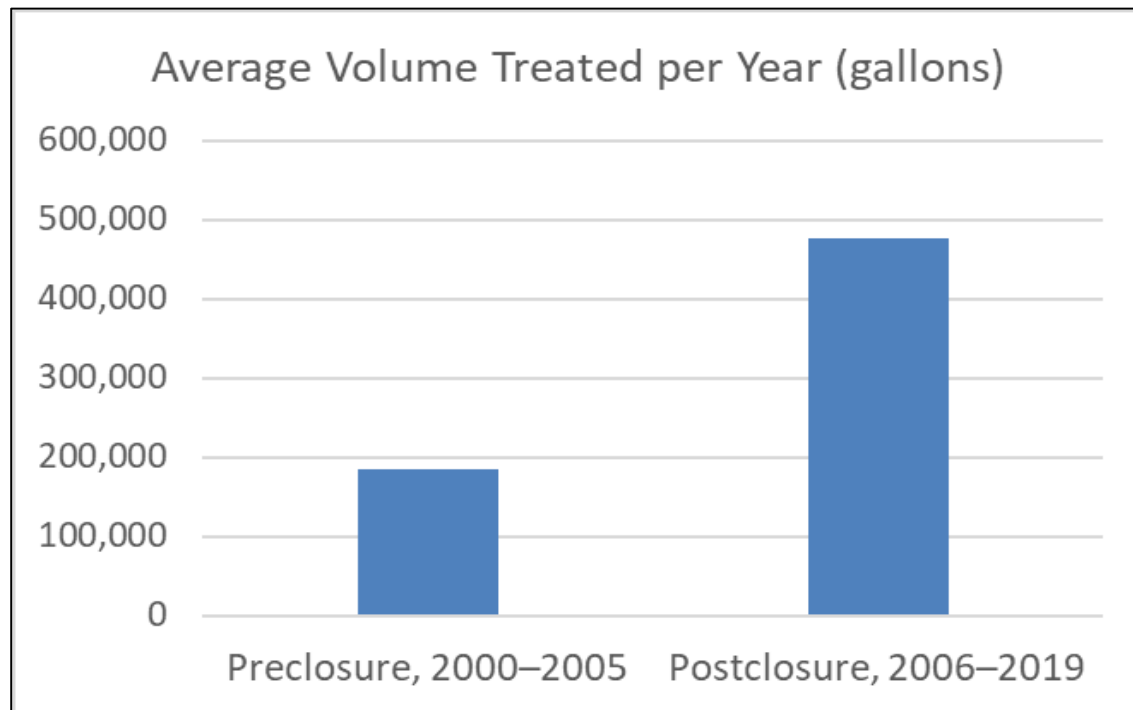
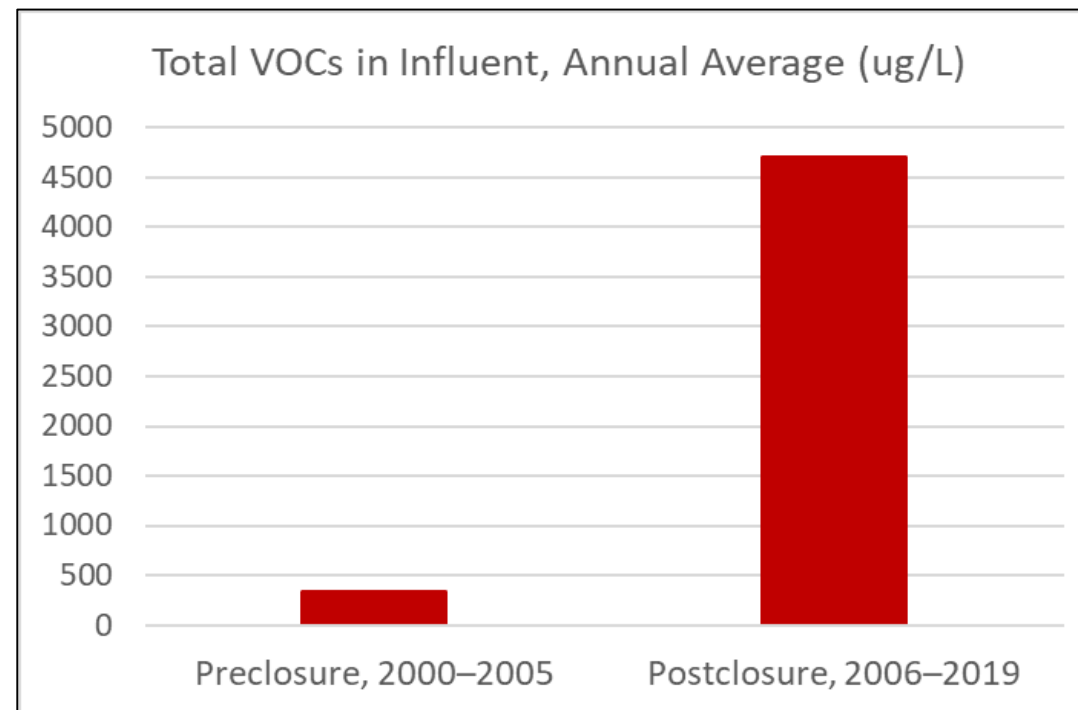
- Mound Site Plume Collection System (includes Mound Site Plume Treatment System)

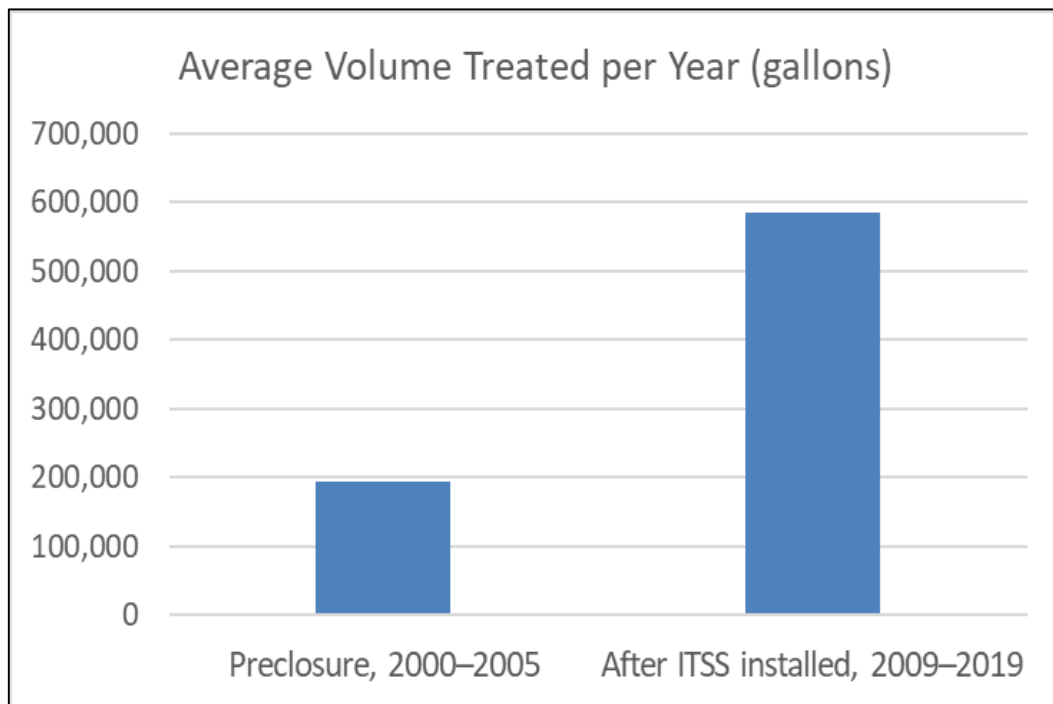
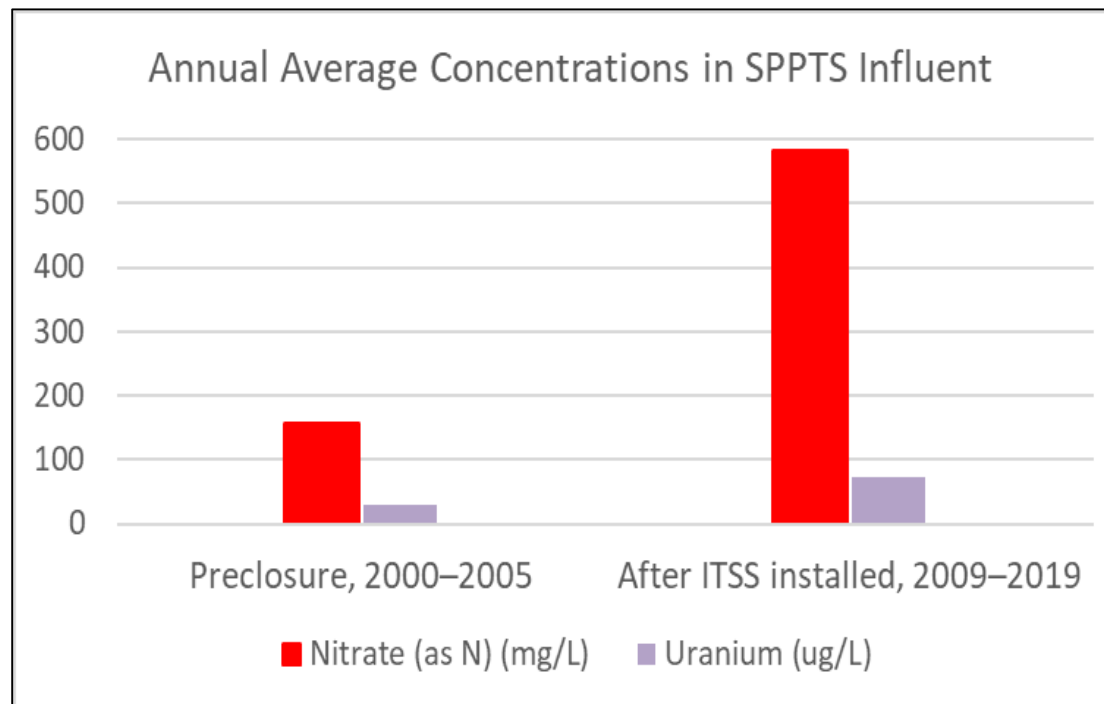
- SPPTS

Note: the ITSS is the Interceptor Trench System Sump installed in late 2008

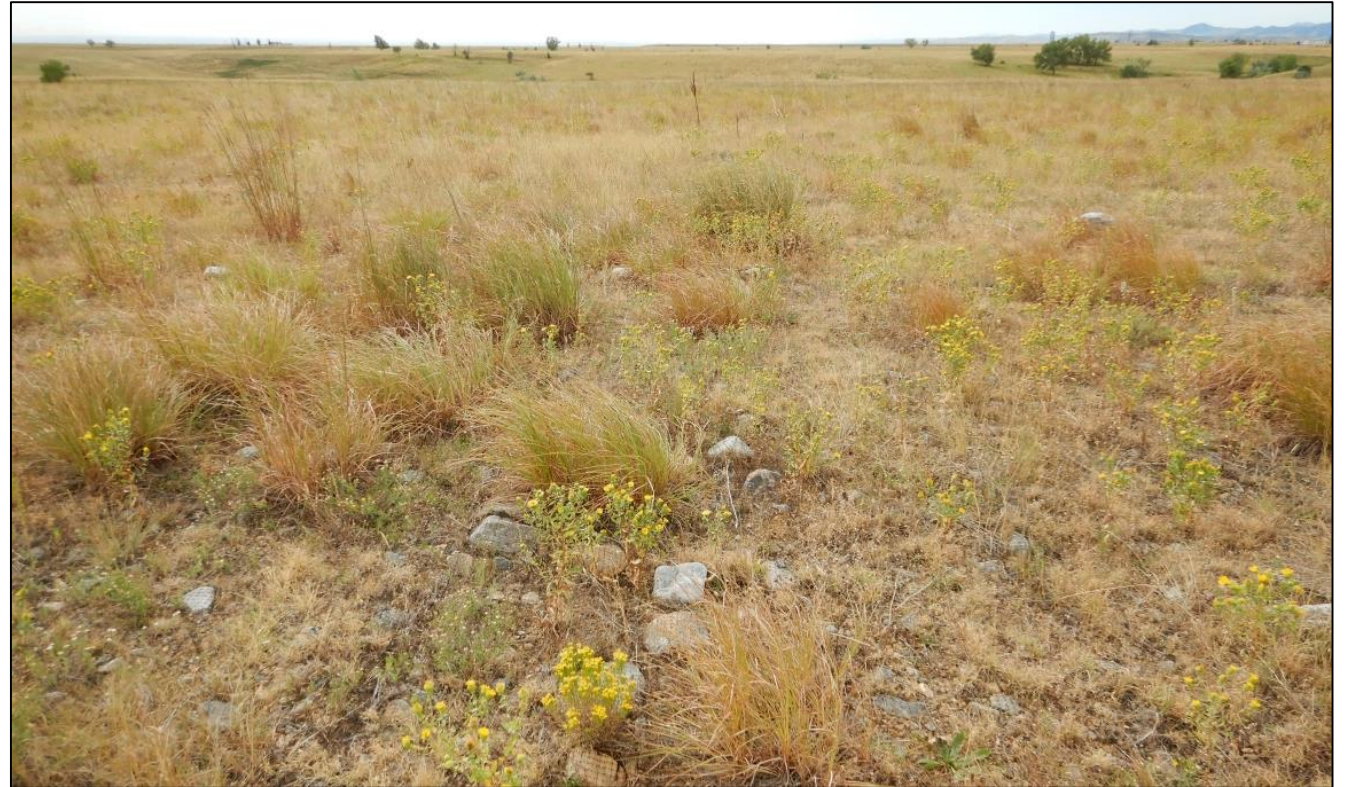
- Performed quarterly and weather-related inspections (six inspections in 2019)
- Landfill in good condition
  - No significant issues identified
- Settlement monuments surveyed annually
  - Vertical settling at each monument was within design limits

*Vegetation on top of the Present Landfill — 2019*

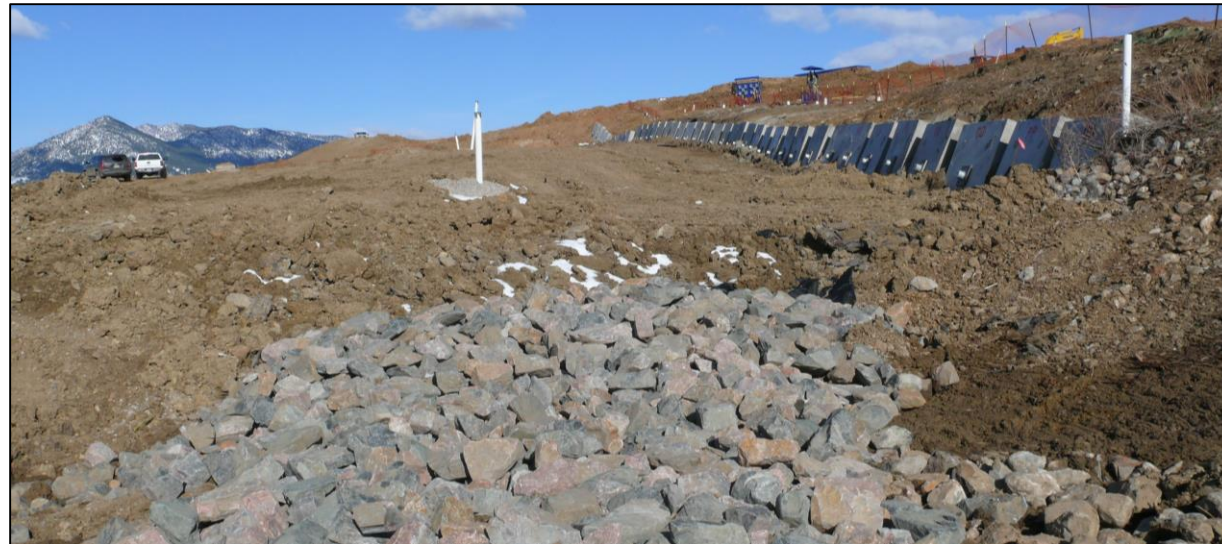
- Performed monthly and weather-related inspections (13 in 2019)
- Surveyed eight settlement monuments quarterly
  - Vertical settling at each monument was within design limits
- OLF Stabilization project ongoing, as of April 23, 2020:
  - 246 of 265 anchors are installed and locked off
  - Interceptor collection trenches are installed
  - Earthwork continues

*East area facing west, showing bubble-up structure with anchor row*

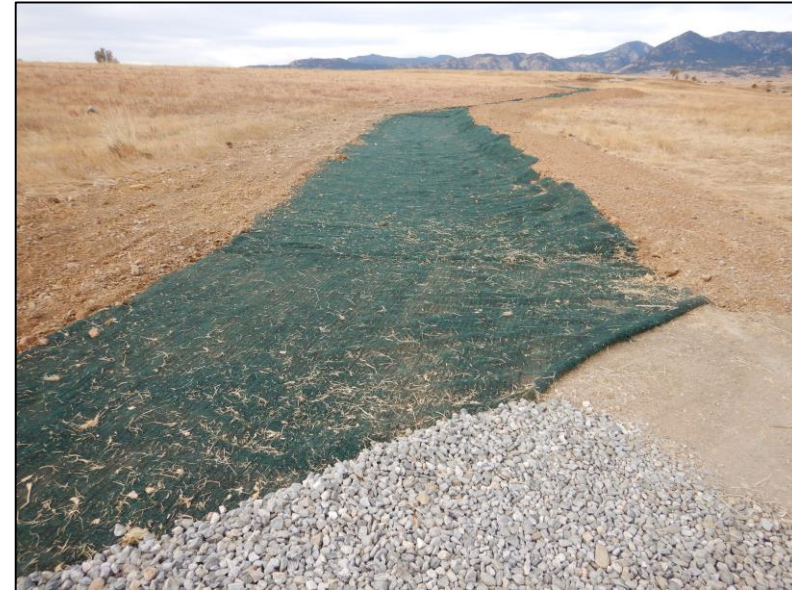
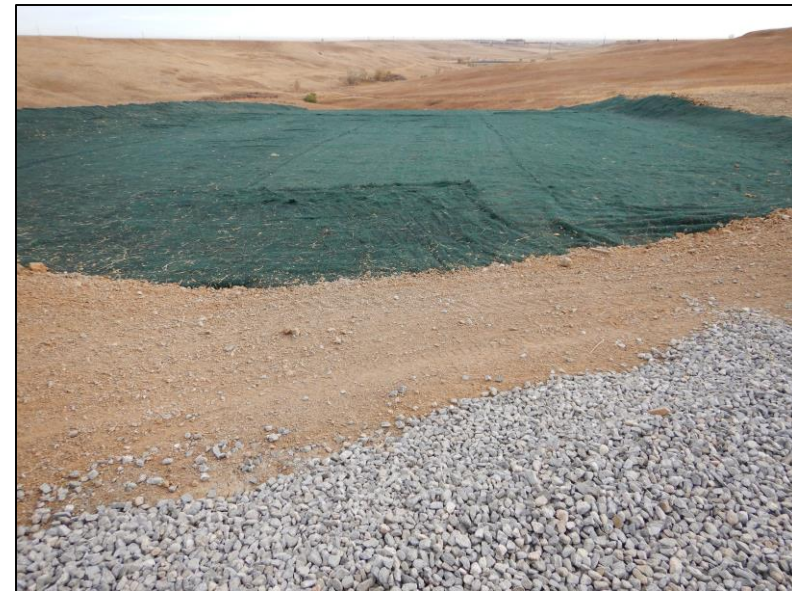
- Visual observations made weekly
- Slump monitoring points surveyed monthly as a Best Management Practice
  - Visual observations and monitoring data show slope creep
  - Greater movement during wetter periods
- SPPTS Road Area Surface Water Diversion Project (RASWDP)

*SPPTS RASWDP at project completion*

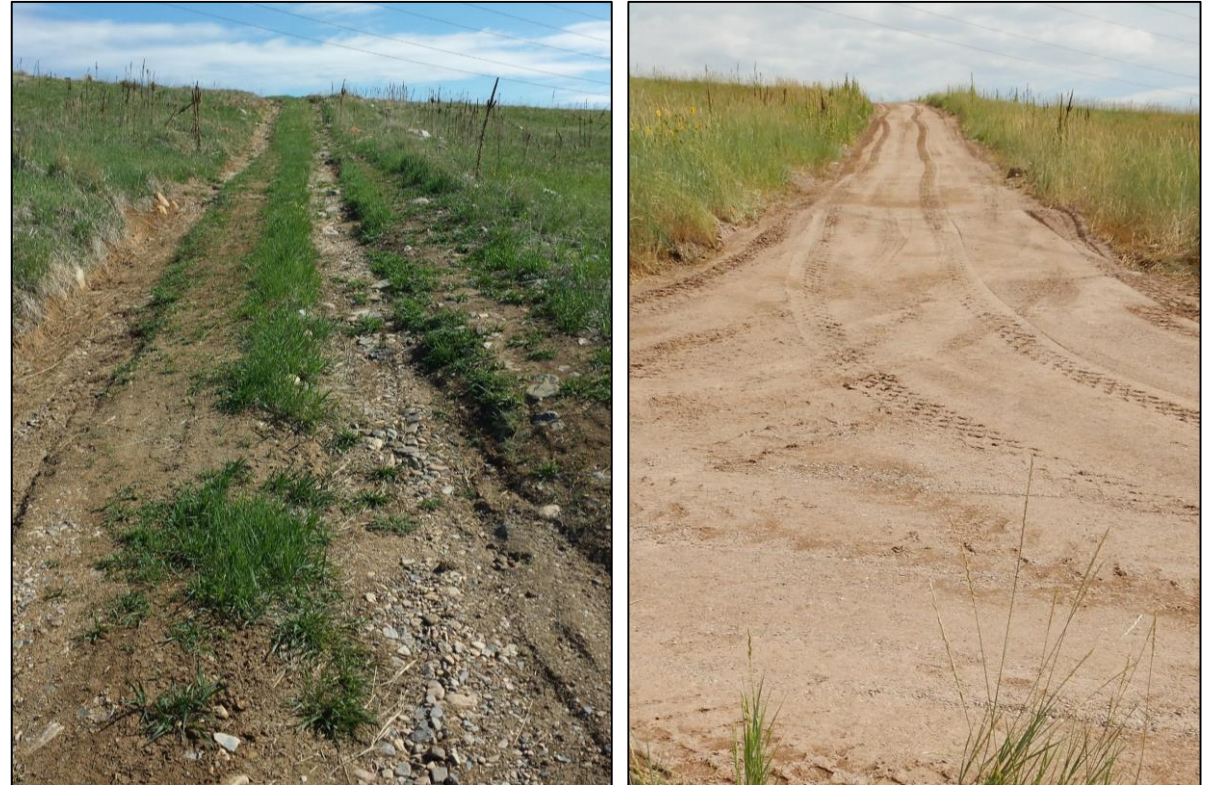
- Site roads regraded and dust suppressant applied to the primary routes (July through September), and repaired a few other spots
- Site erosion controls monitored and maintained
- U.S. Fish and Wildlife Service wildlife refuge surrounding COU is open

*Road repairs — 2019 (before and after)*
