U.S. DEPARTMENT OF
ENERGY

2015 Annual Site Inspection and Monitoring Report for Uranium Mill Tailings Radiation Control Act Title II Disposal Sites

November 2015

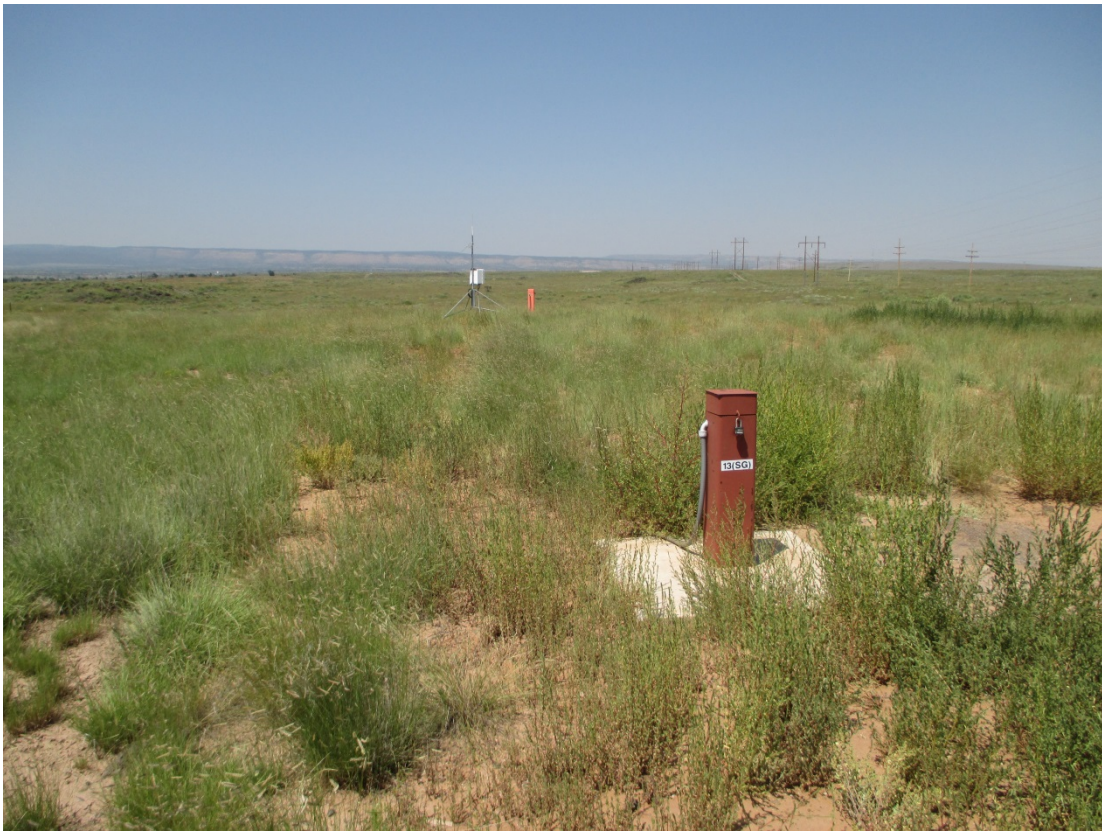
BLU 8/2015. PL-3. Monitoring wells 13(SG) and 21(M).

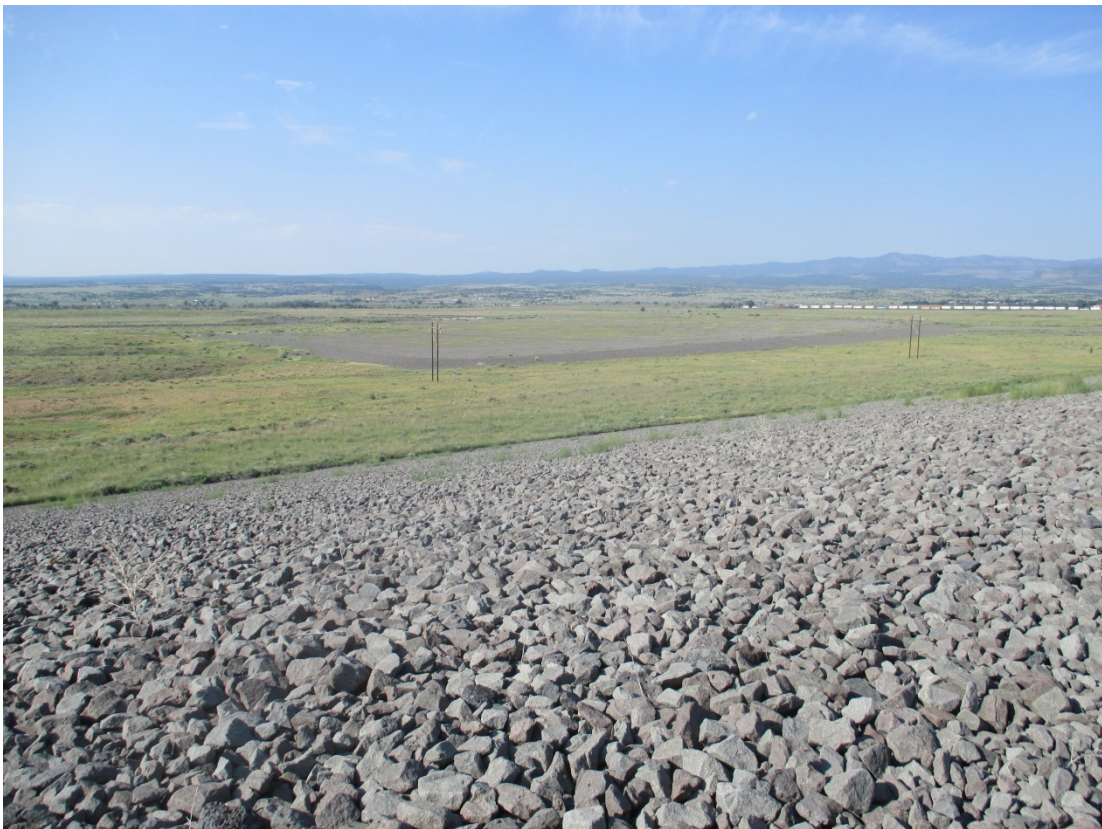
BLU 8/2015. PL-10. Carbonate tailings disposal cell viewed from main tailings disposal cell.

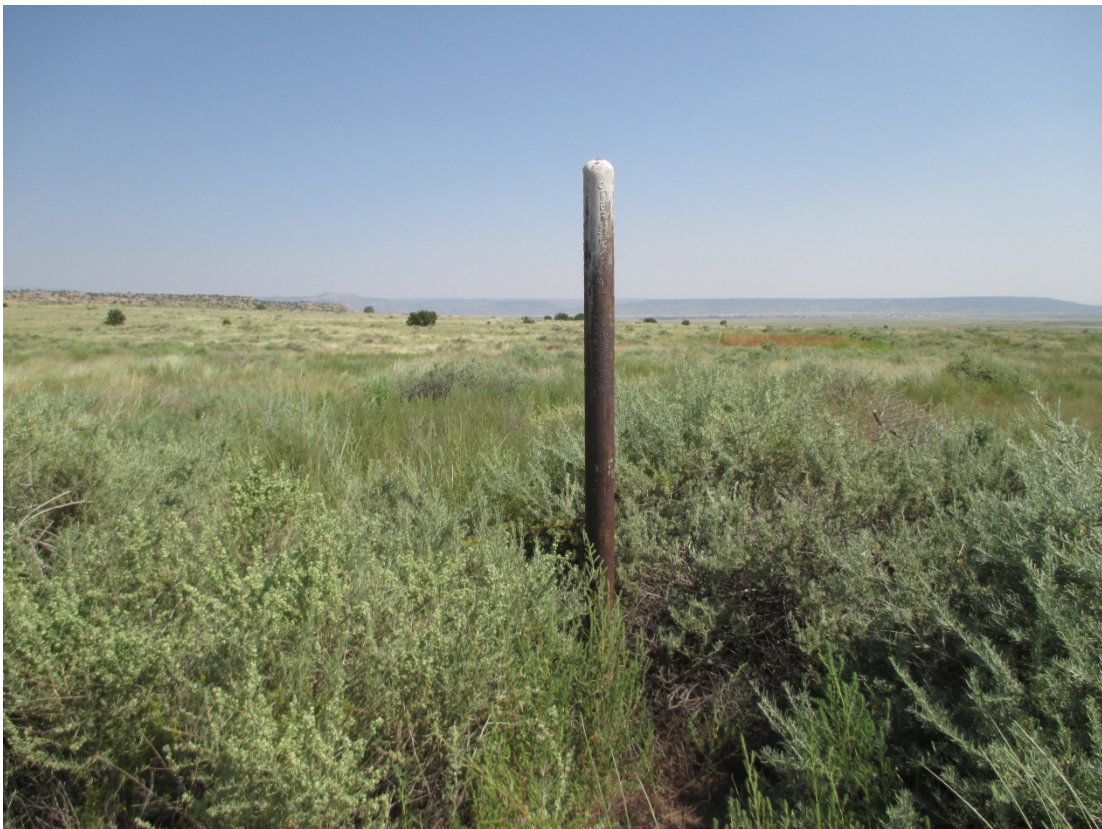
BLU 8/2015. PL-14. Monument at decommissioned injection well.

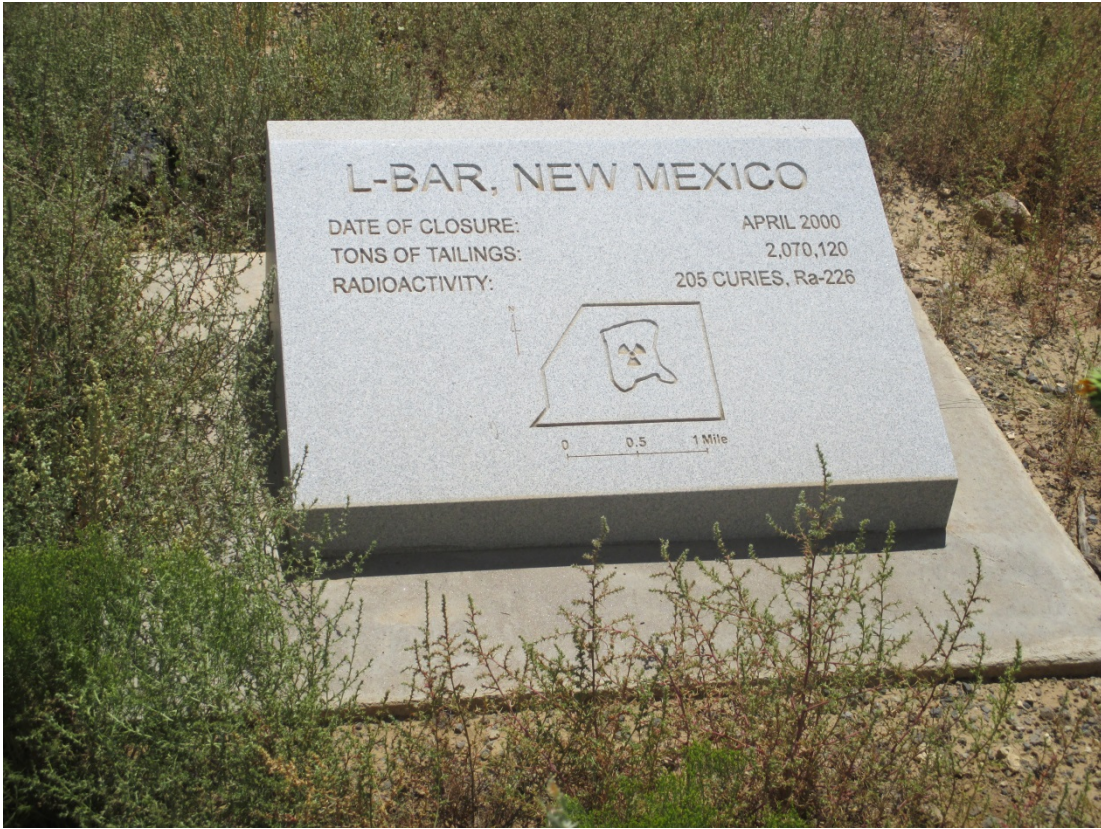
BAR 8/2015. PL-2. Site marker.

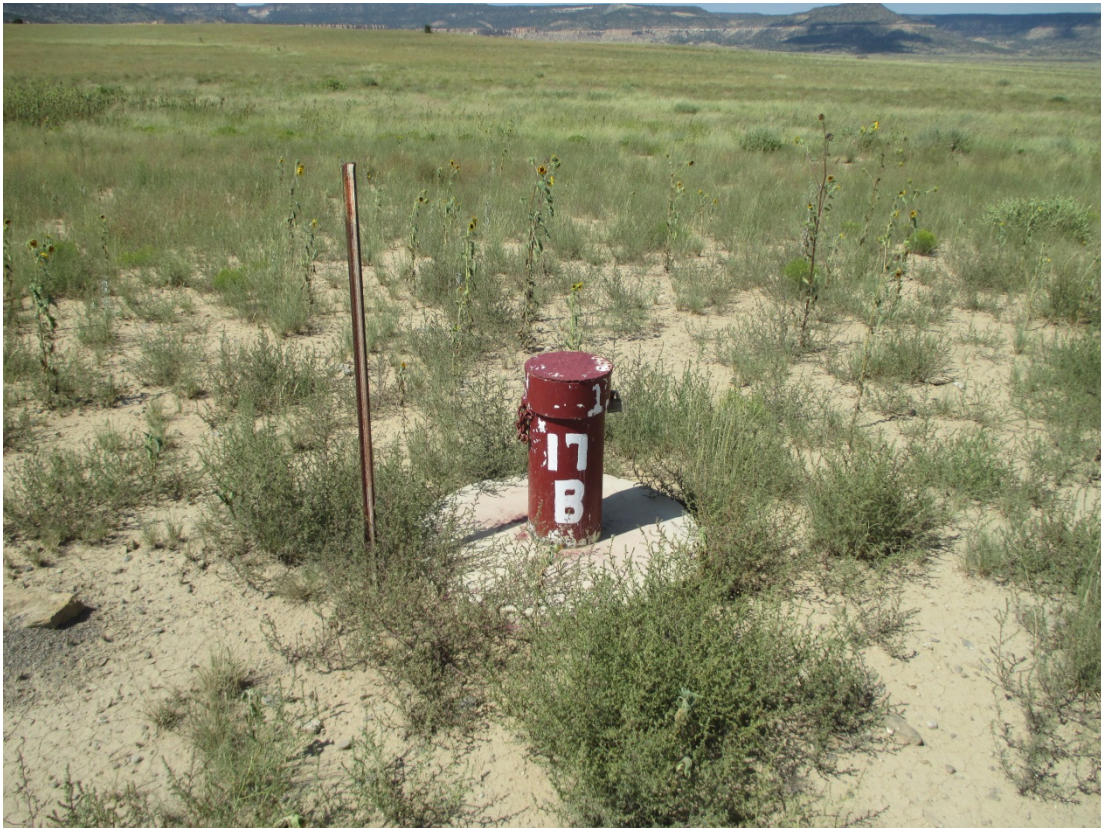
BAR 8/2015. PL-3. Monitoring well 17B.

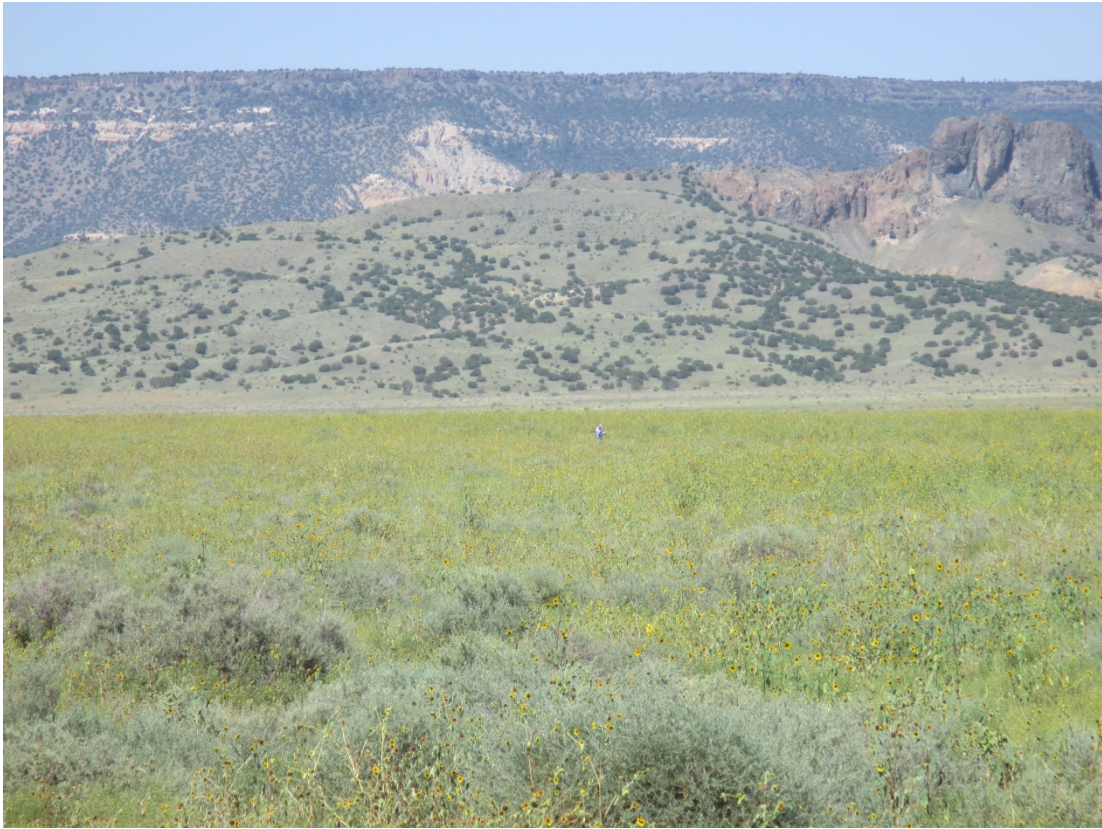
BAR 8/2015. PL-4. Vegetation on tailings impoundment top slope.

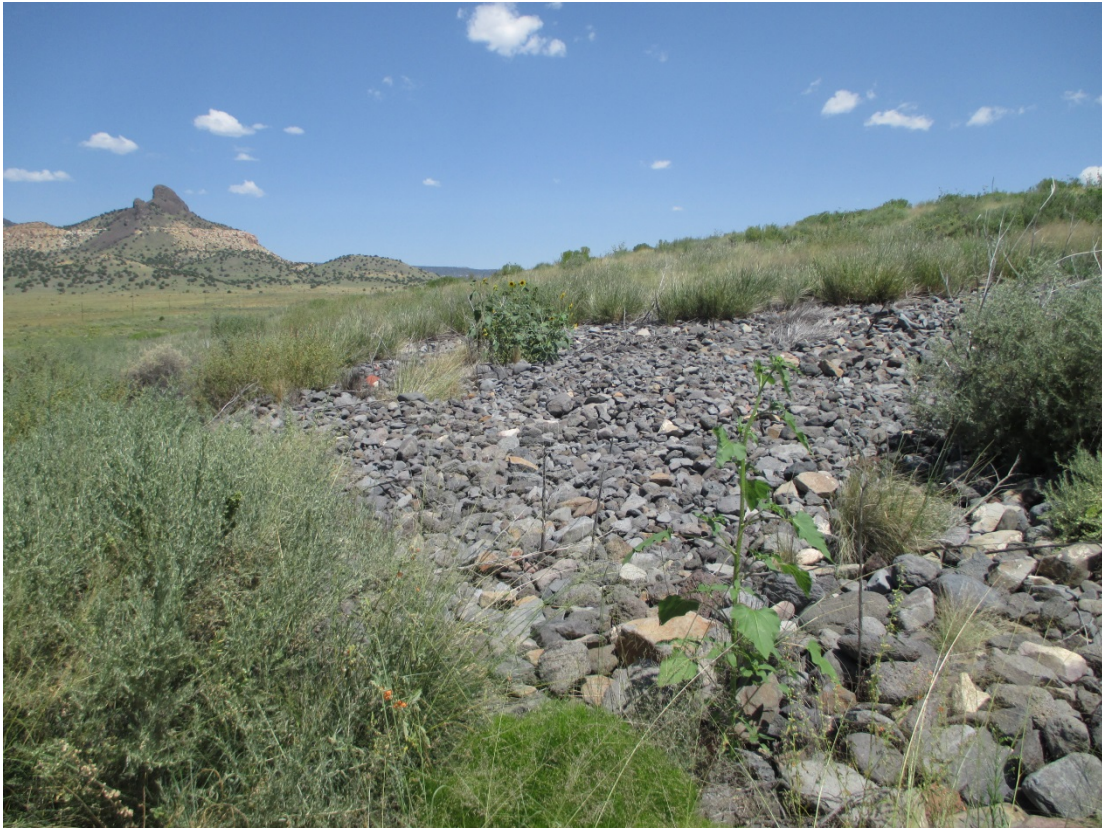
BAR 8/2015. PL-6. Rock-armored slope of containment dam.

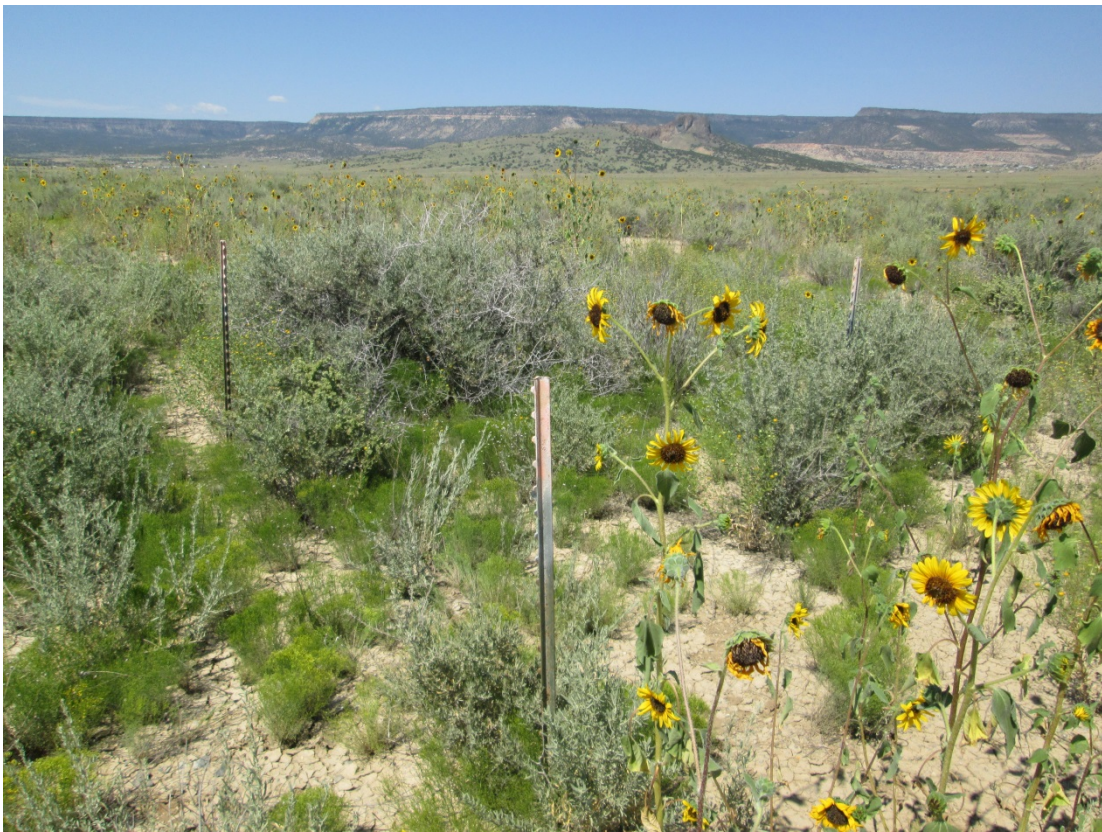
BAR 8/2015. PL-11. Erosion monitoring point and vegetation plot E1.

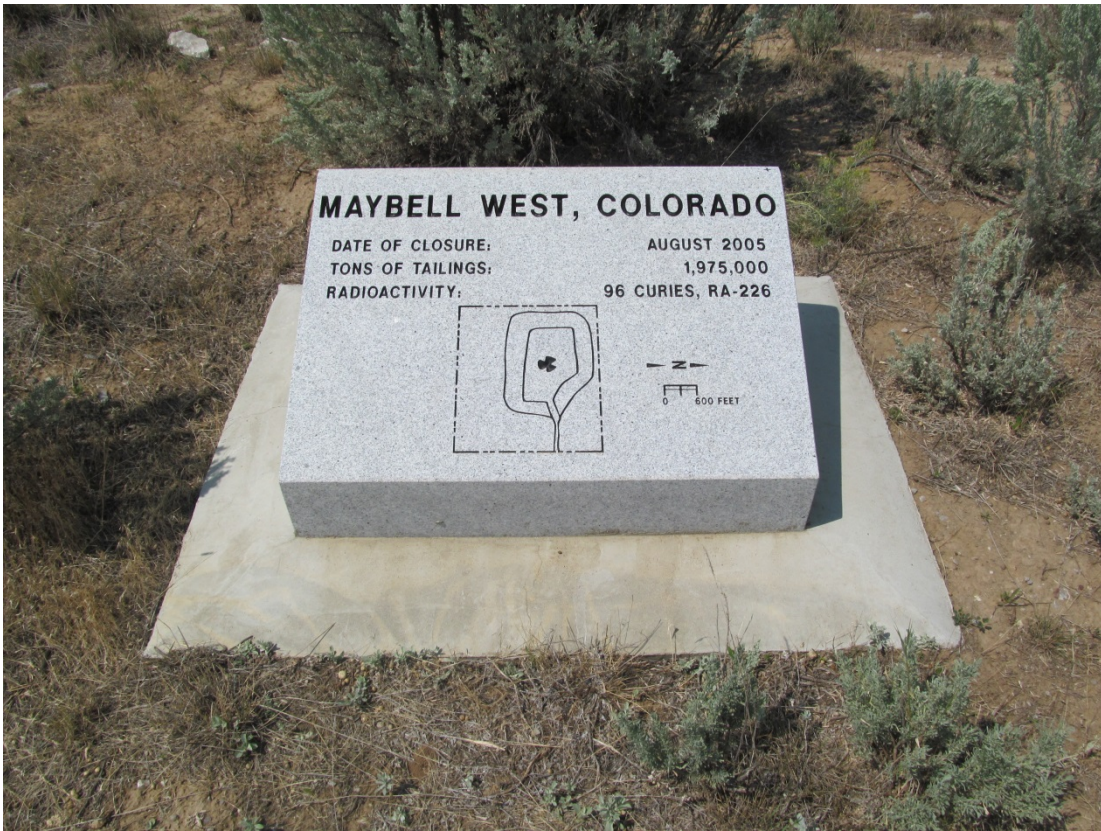
MAW 8/2015. PL-4. Site marker.

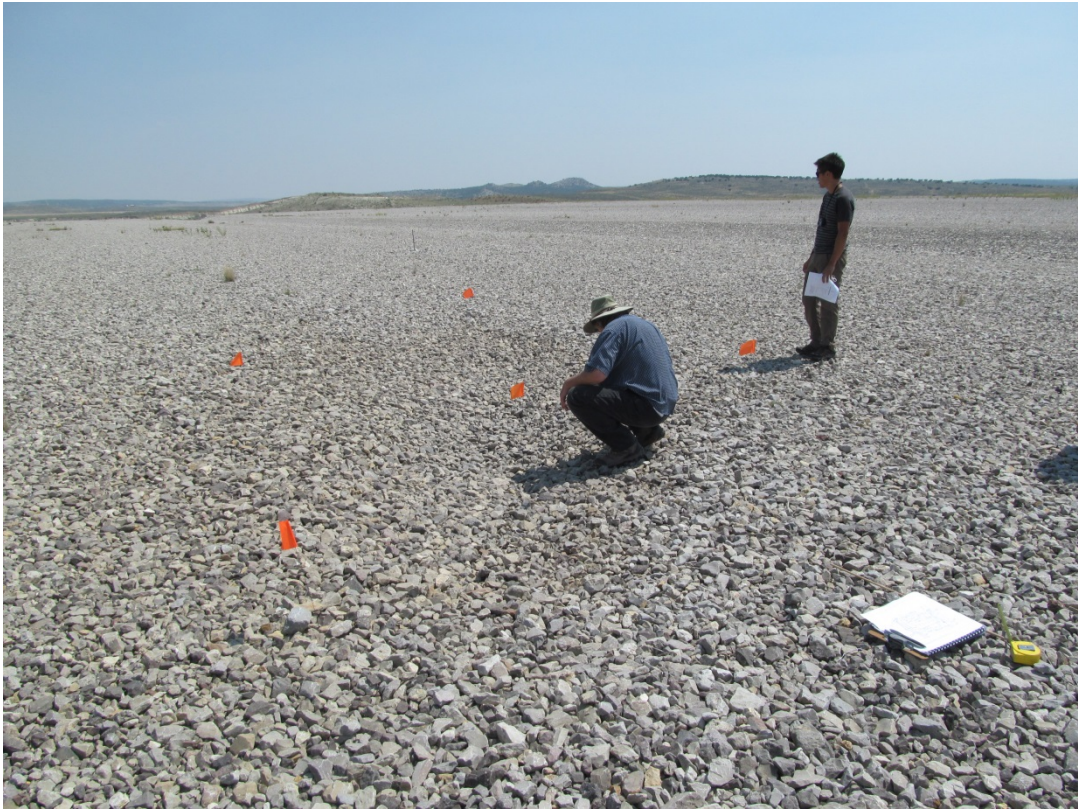
MAW 8/2015. PL-6. Depression on disposal cell top.

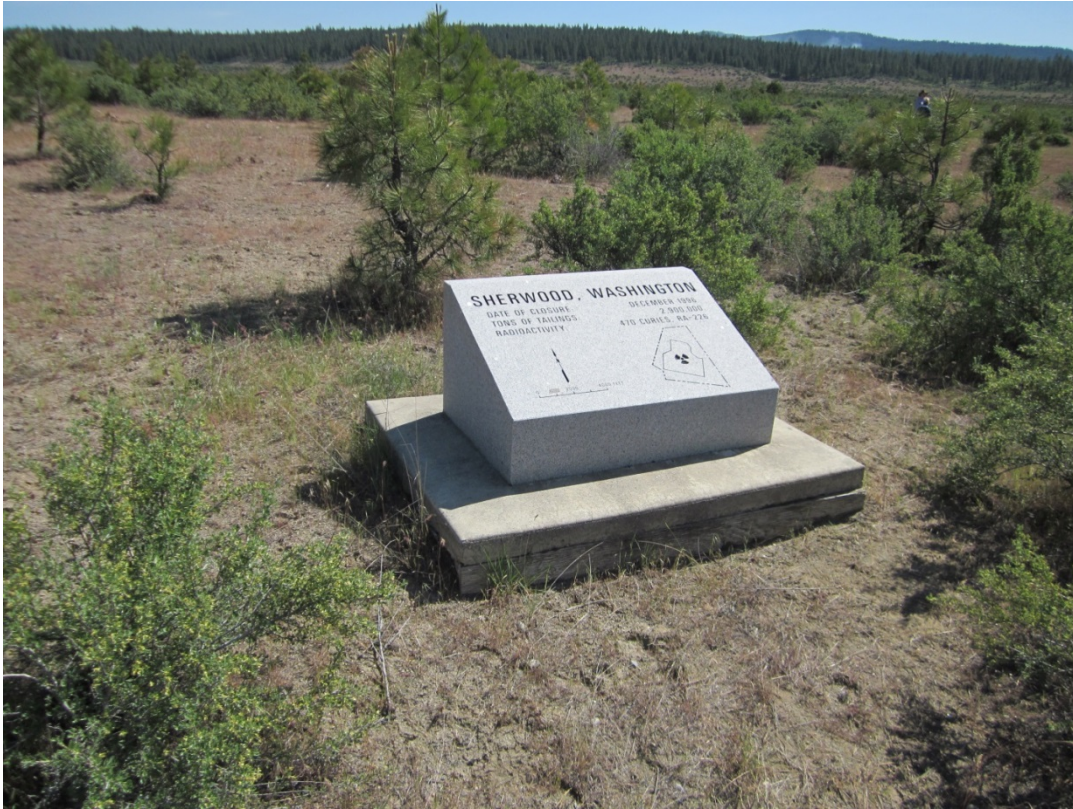
One granite site marker is located on the southwest side of the site where the access road lies closest to the site boundary. The marker was in excellent condition (PL-1).

SHE 4/2015. PL-1. Granite site marker.

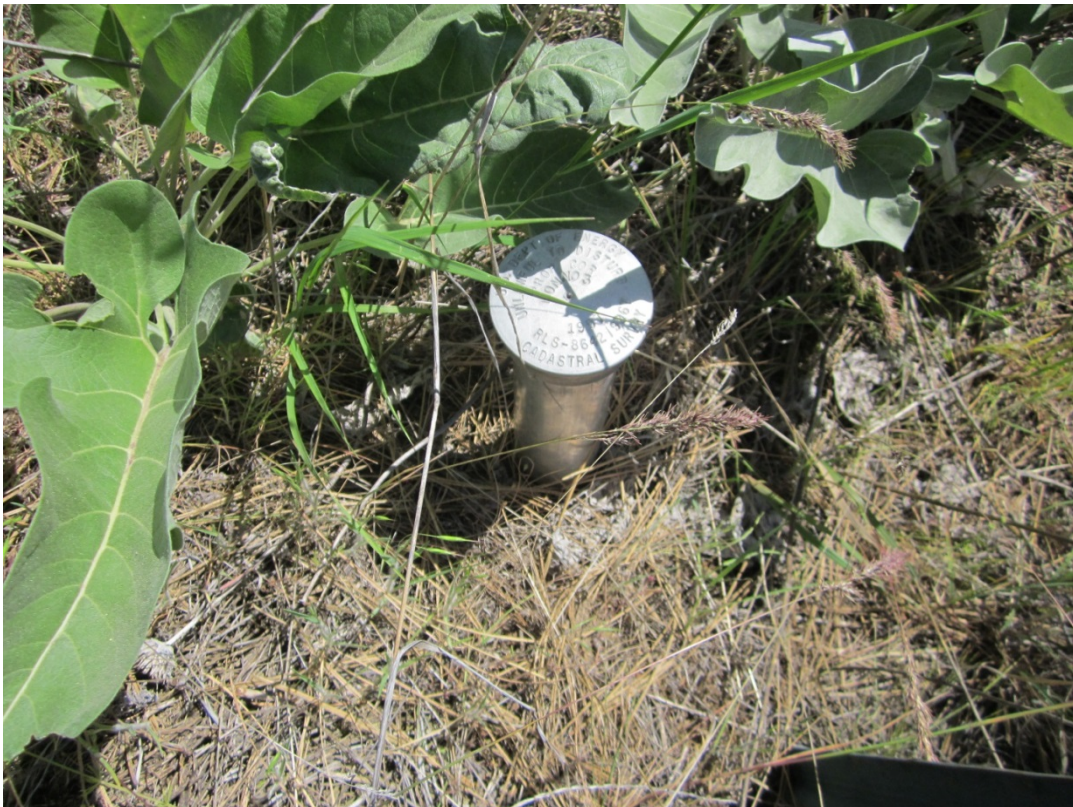
Six boundary monuments set in concrete define the site boundary (PL-2). Boundary monument BM-3A, located near the granite site marker, is bent but does not need to be repaired. Because surrounding vegetation had made it difficult to locate some of the monuments, metal t-posts have been installed at each monument location. Boundary monuments BM-1 and BM-5 were verified to be in good condition during the July 2015 groundwater sampling event.

SHE 4/2015. PL-2. Boundary monument BM-3.

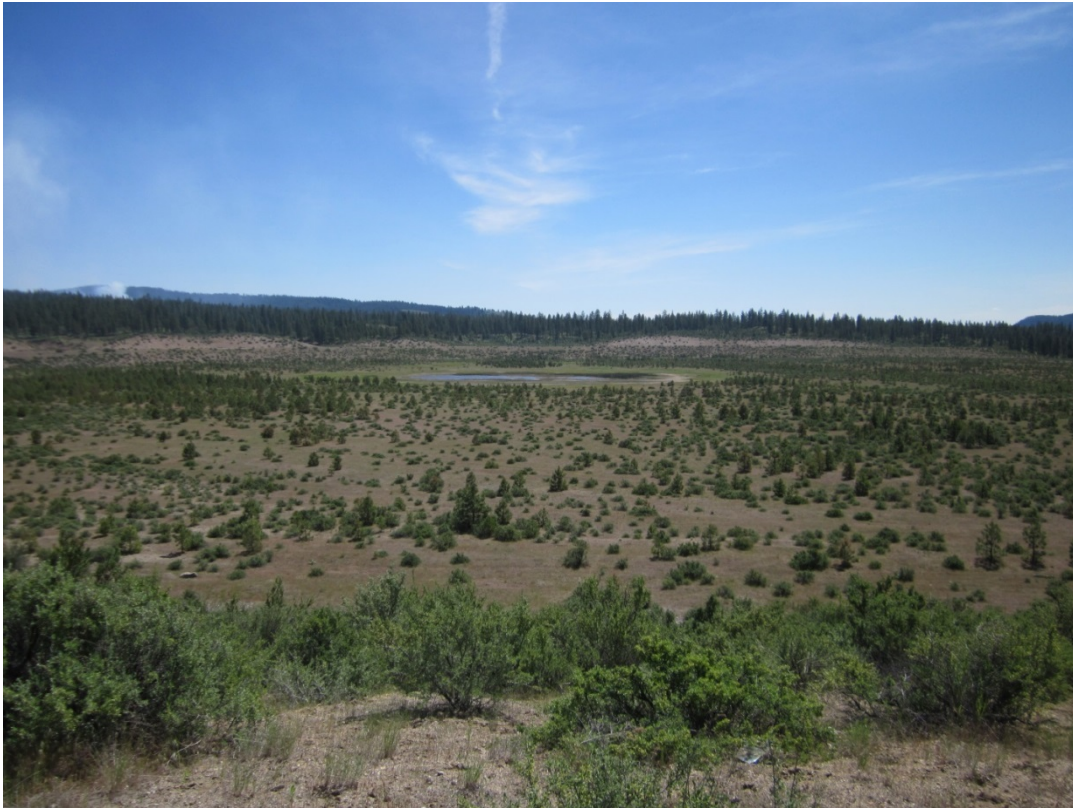
SHE 4/2015. PL-3. Disposal cell surface from west, Pond 1.

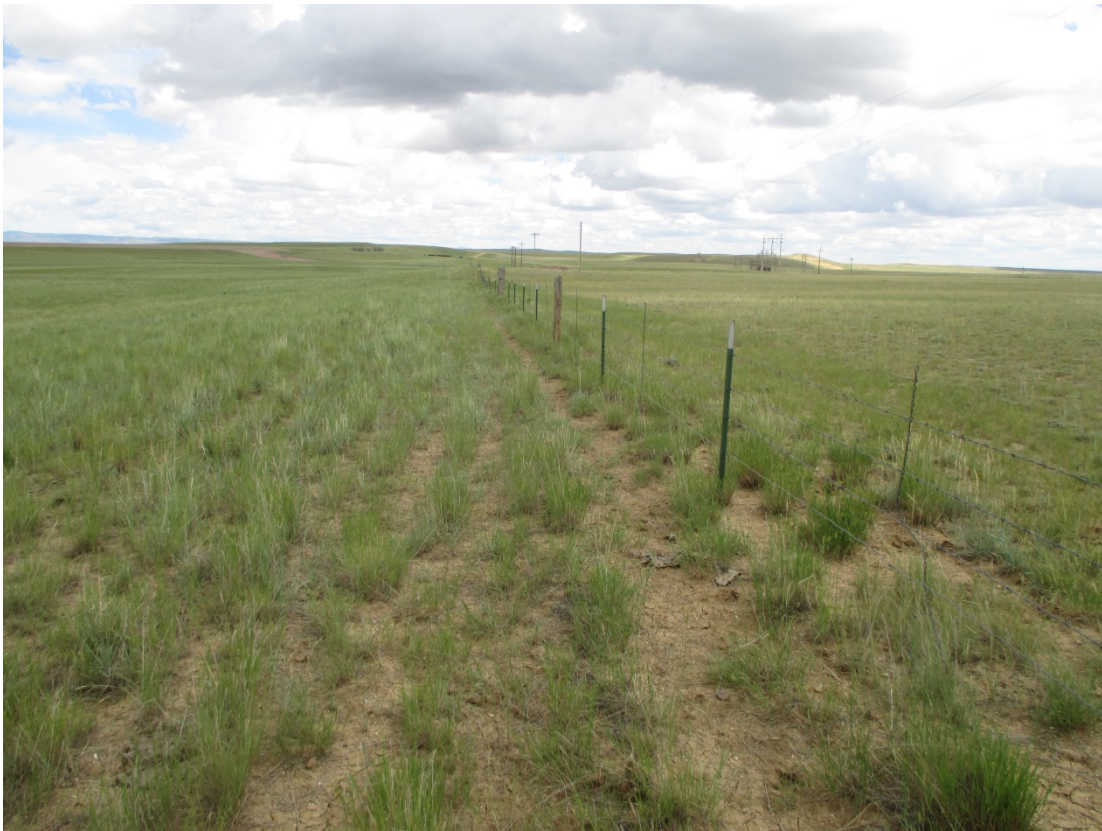
SBS 7/2015. PL-1. South fence line.

A four-strand barbed-wire perimeter fence encompasses the site to facilitate land management by DOE (PL-1). The perimeter fence was in excellent condition except for a damaged portion crossing the north end of Pit 4. The damaged portion is not maintained because of steep slopes and recurring snow damage. The grazing licensee, in cooperation with the adjacent property owner, erected a solar-powered electric fence around the north rim of Pit 4 in 2007 to bypass the damaged section and to give cattle access to each side of the pit. Sections along the north perimeter are secured with a temporary wire fence. Ur-Energy Inc., the adjacent landowner, will use these sections to access a topsoil stockpile area on the DOE site.

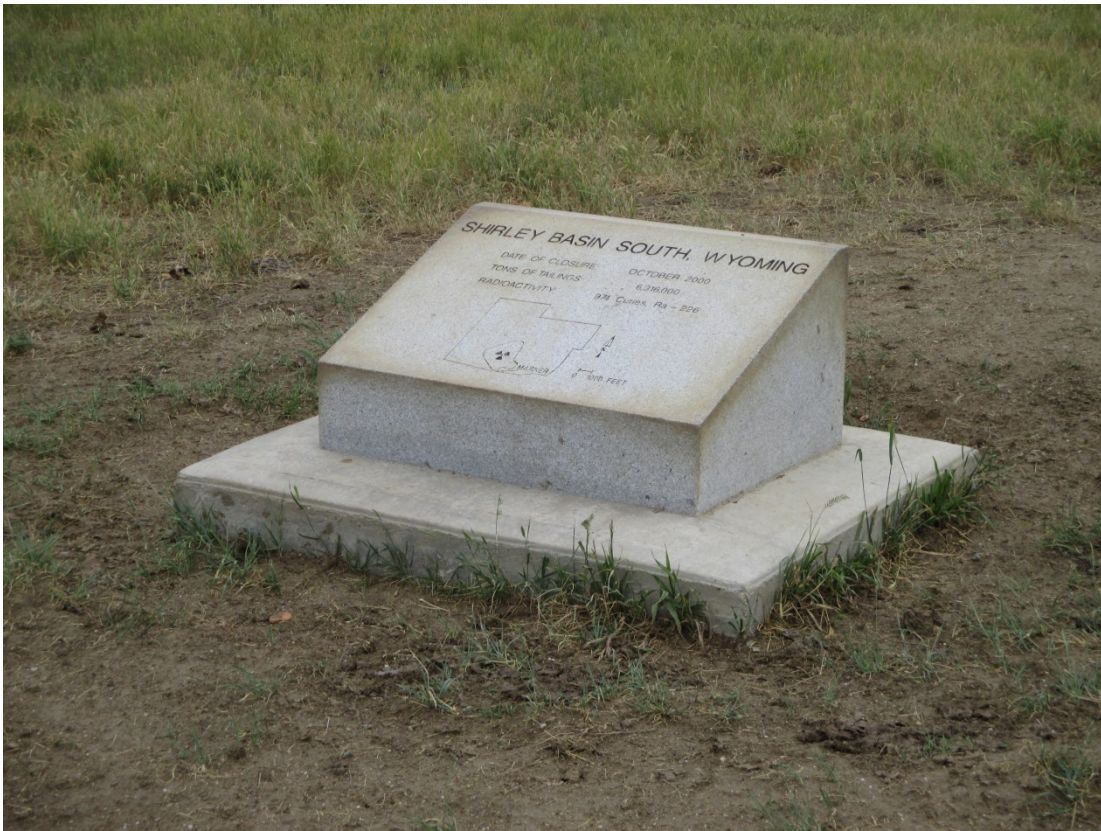
SBS 7/2015. PL-3. Site marker.

The granite site marker, which is located at the site entrance, was in excellent condition (PL-3). Twenty-six monuments delineate the site property boundary; the boundary monuments were in excellent condition (PL-4).

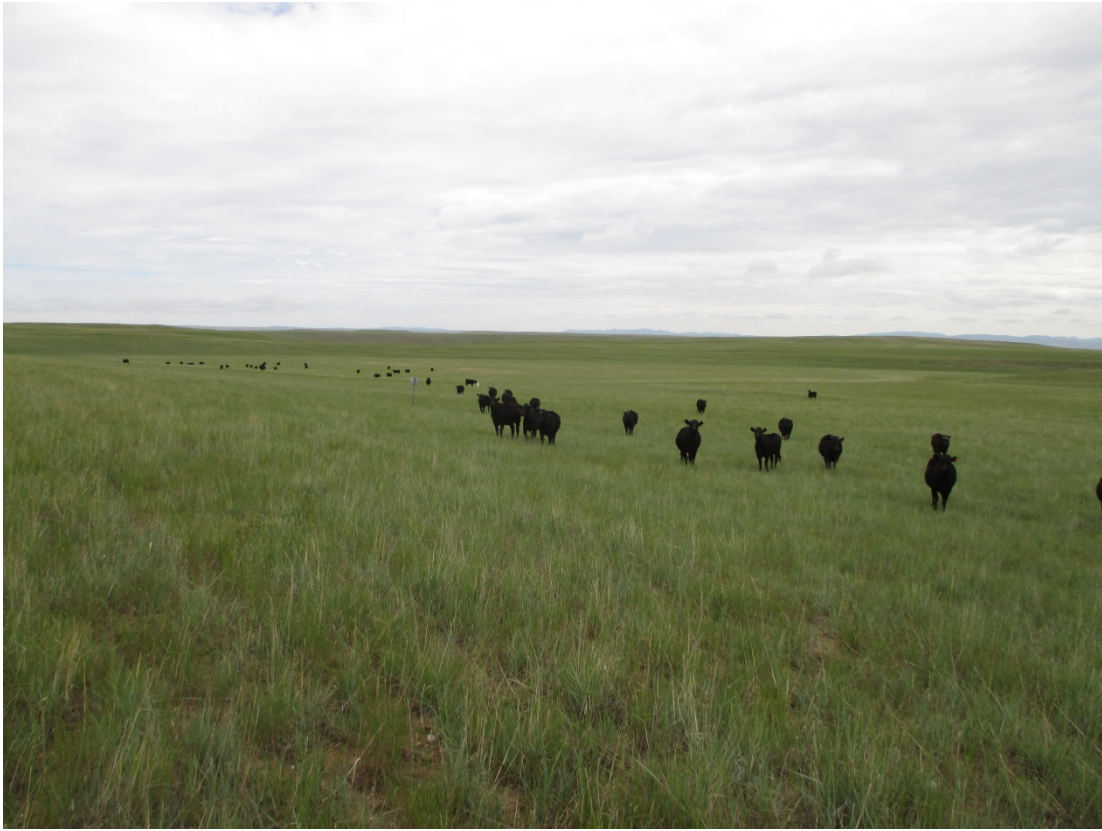
SBS 7/2015. PL-9. Cattle in east drainage basin.

portion of the PMF channel that flows eastward and discharges into the east drainage basin captures a larger drainage area; this basin was dry at the time of the inspection (PL-9). These closed drainage basins are large enough to accommodate the PMF water volumes. The diversion channels were in excellent condition, and no active erosion was apparent in the channels.
