2025 ANNUAL SITE INSPECTION AND MONITORING REPORT FOR

# Uranium Mill Tailings Radiation Control Act Title II Disposal Sites

DECEMBER  
**2025**

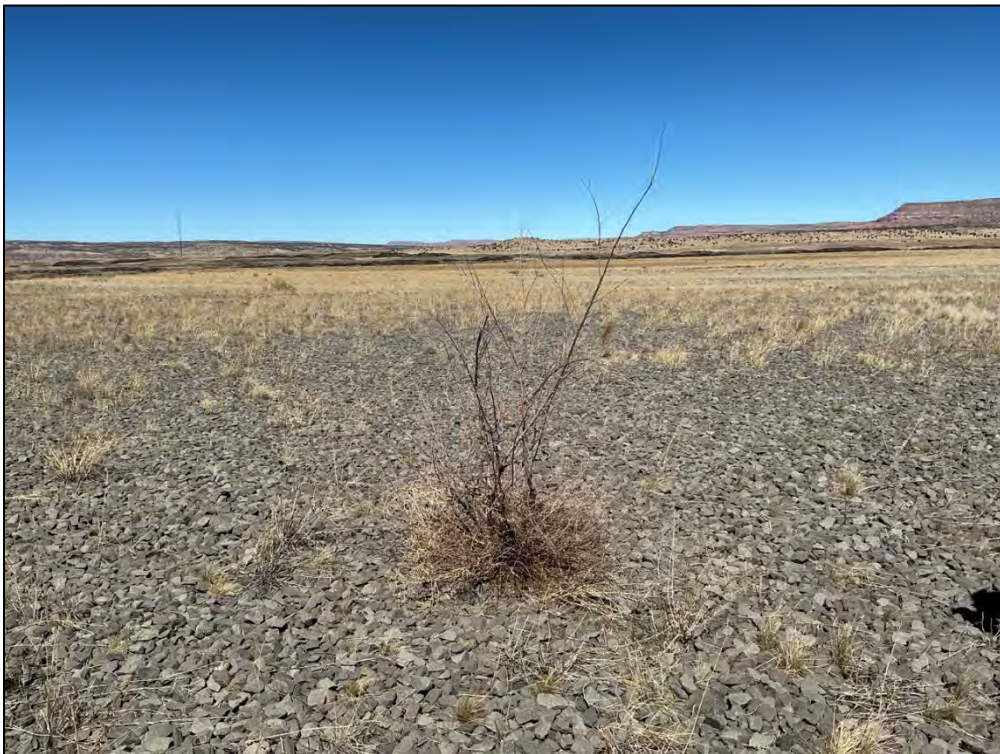
*PL-10. Elm Tree on the Main Tailings Disposal Cell*

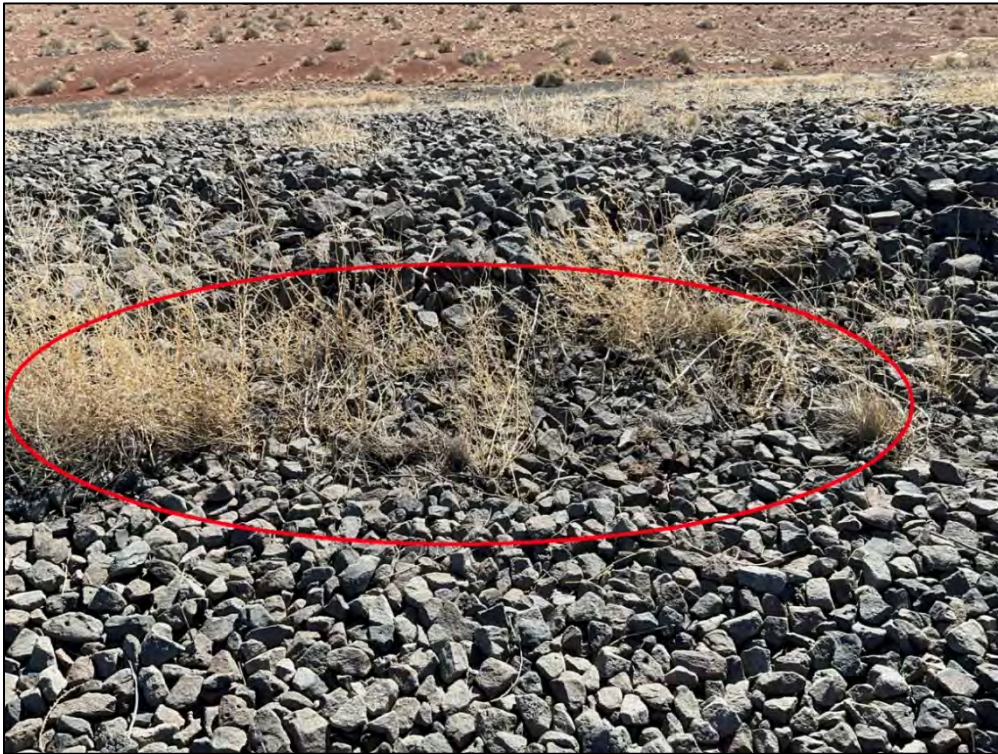
*PL-13. Potential Depression MT-03*

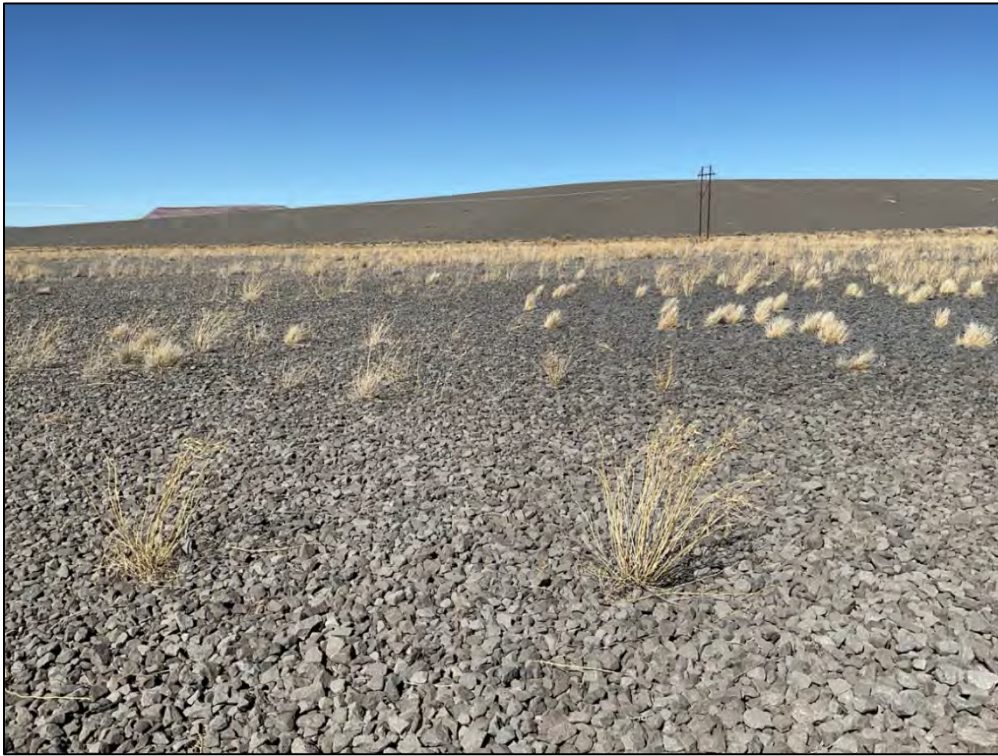
*PL-15. Shallow Depression CT-01*

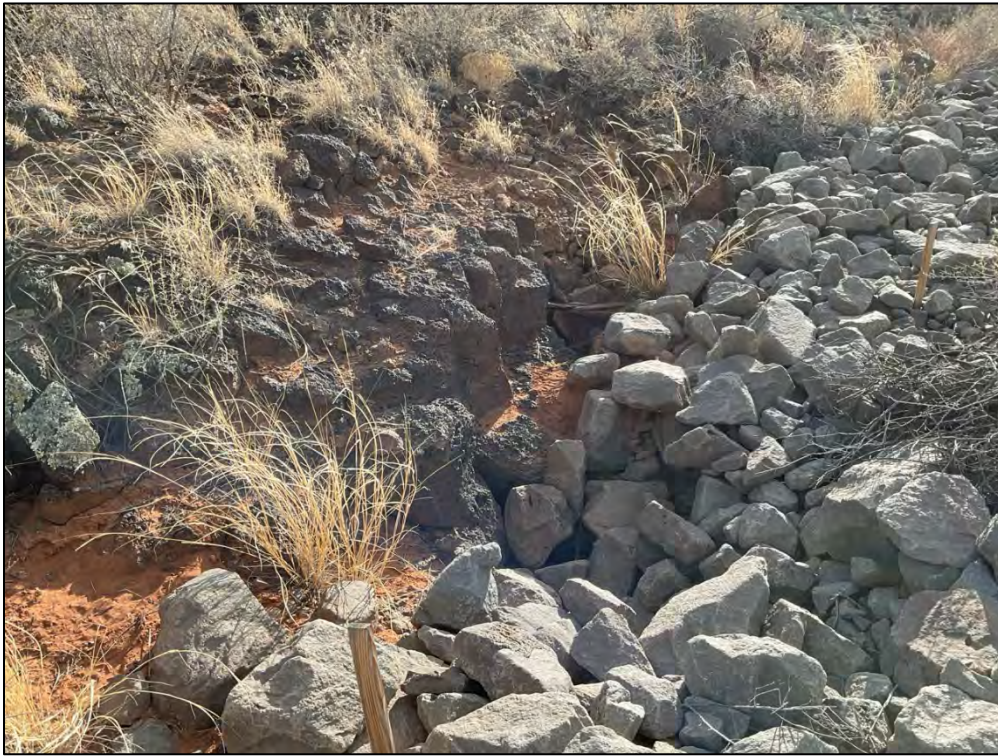
*PL-17. View of East Dump Erosional Area Facing West*

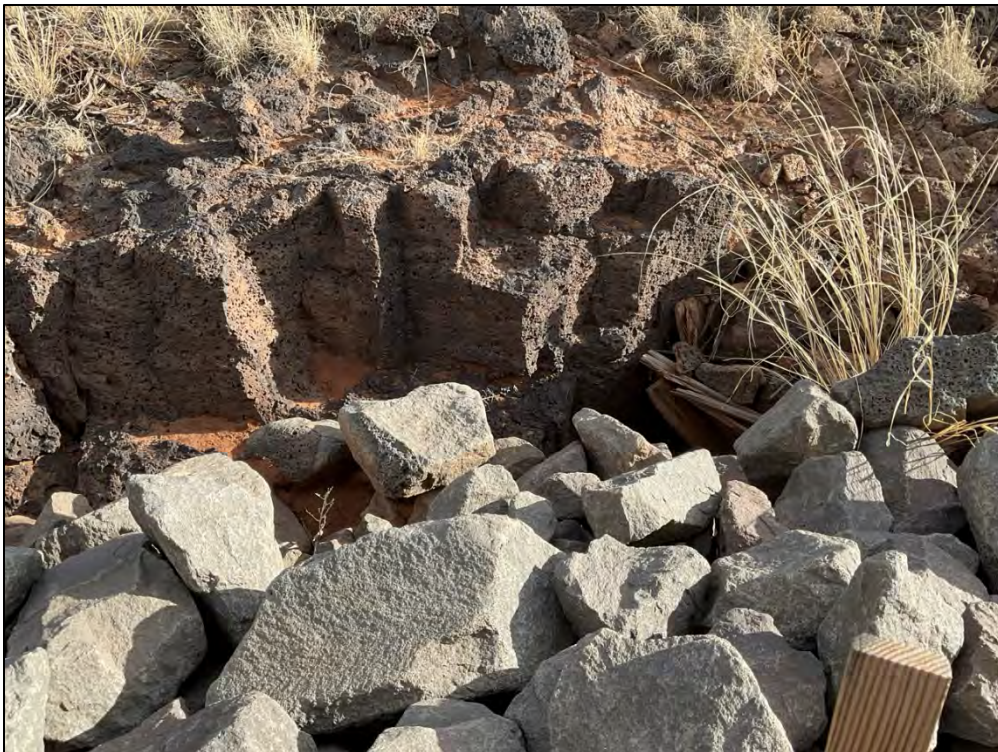
*PL-18. View of East Dump Erosional Area Facing South*

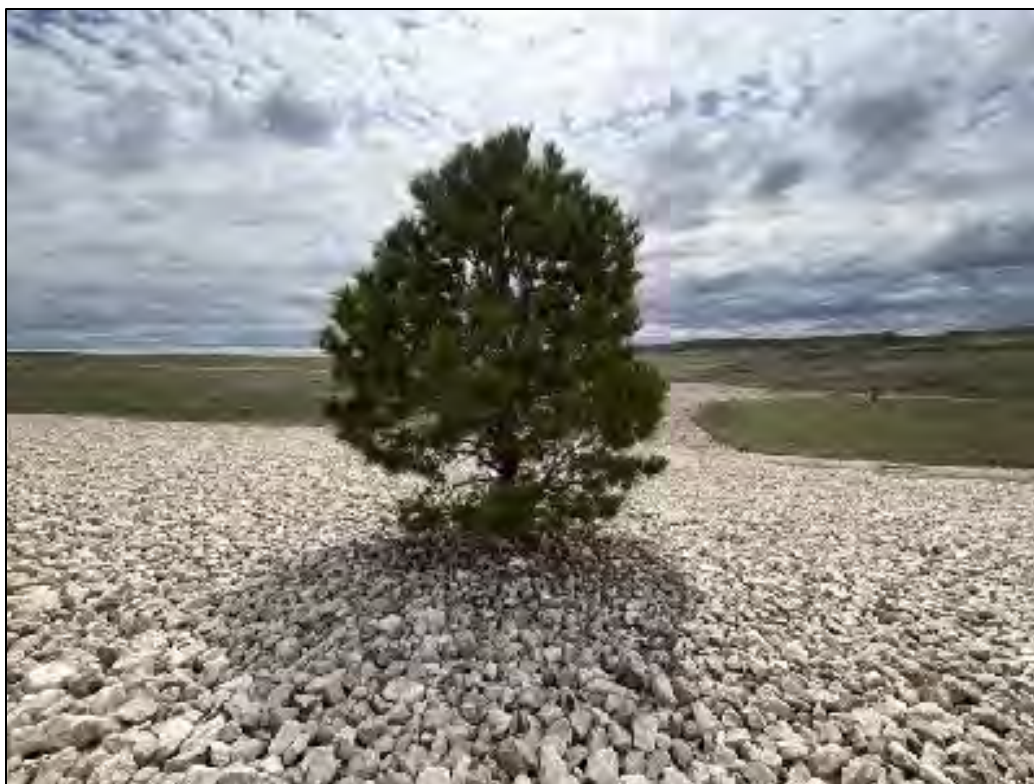
*PL-4. Ponderosa Pine on Containment Dam*

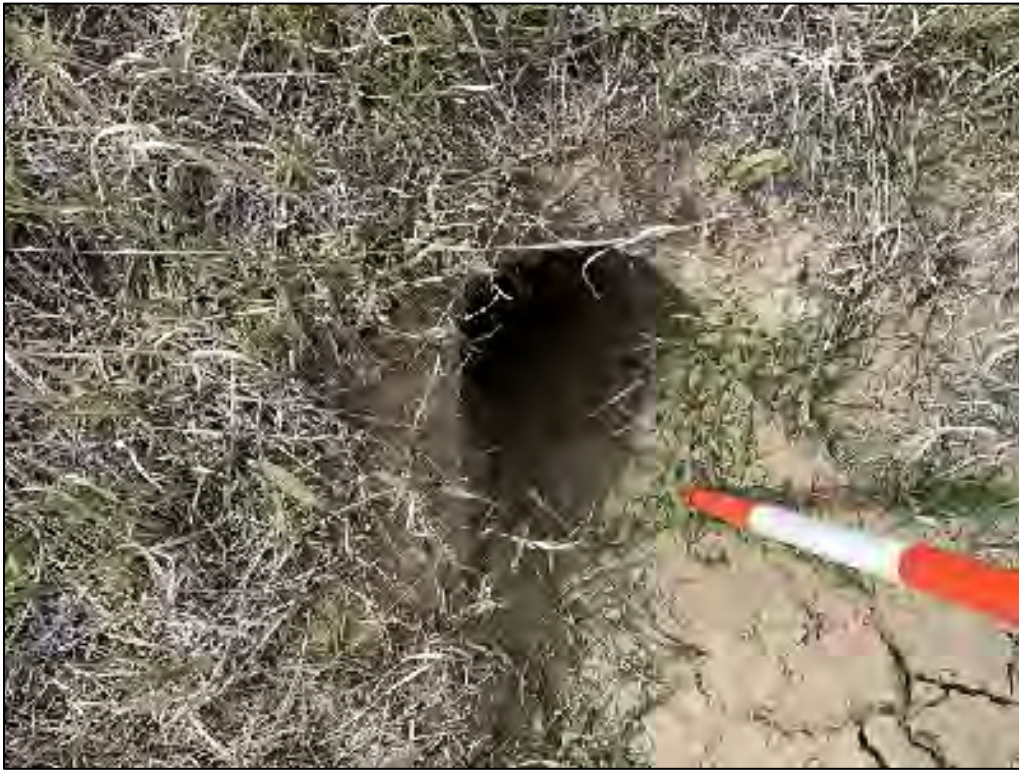
*PL-7. Looking into Larger Animal Burrow*

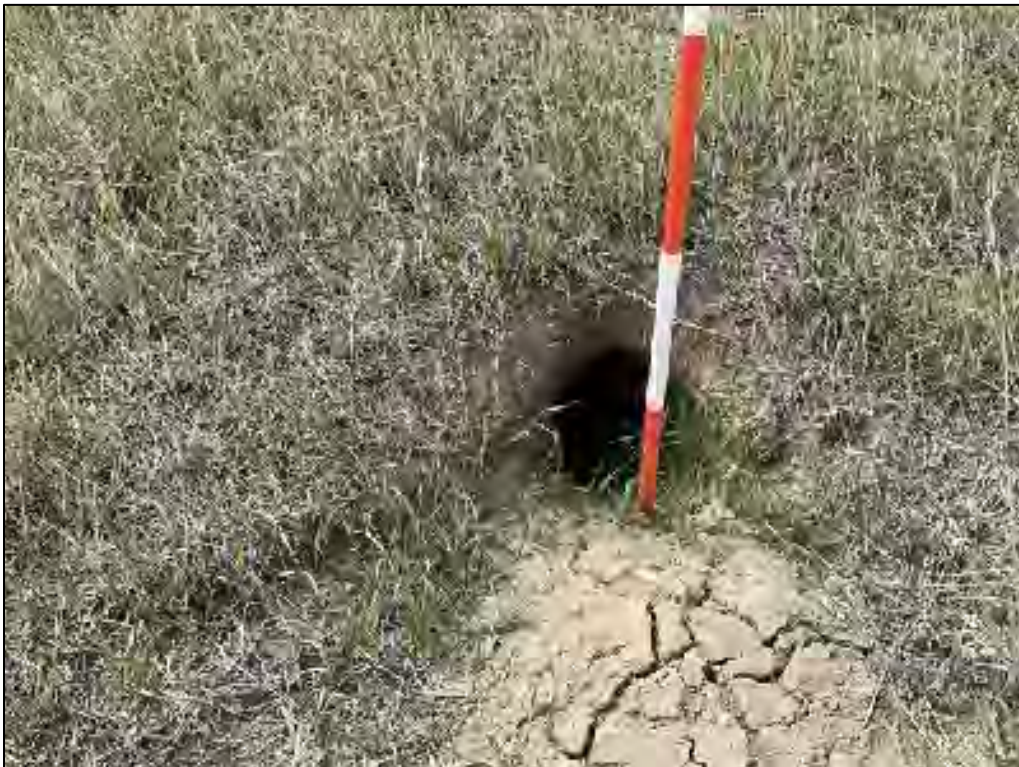
*PL-8. Larger Animal Burrow*

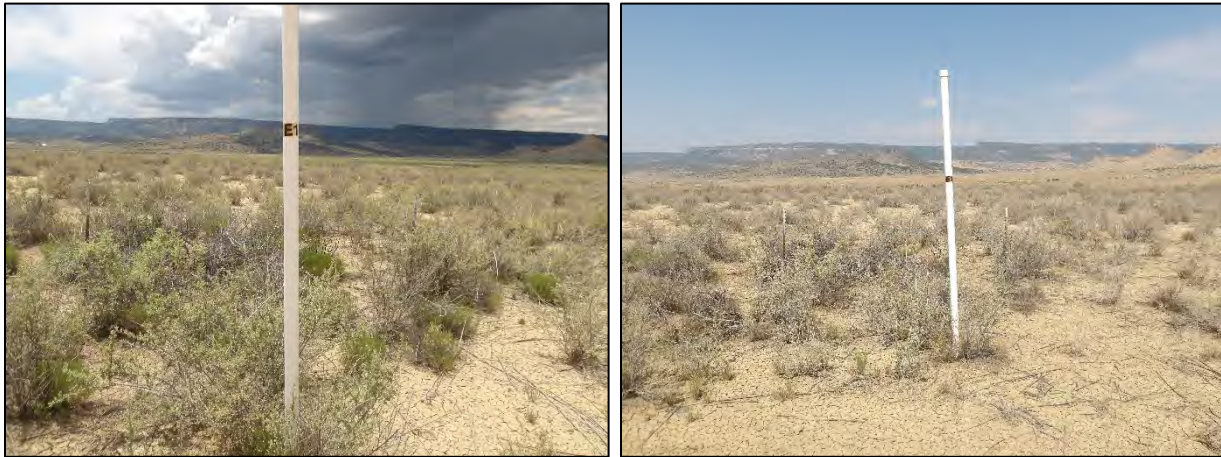
<sup>a</sup> A positive change indicates that the surface elevation at that monitoring point increased; a negative change indicates that the surface elevation at that location decreased. Negative changes were apparent in 2025.

Figure 3-12. Monitoring Location E1 in 2024 (Left) and 2025 (Right)

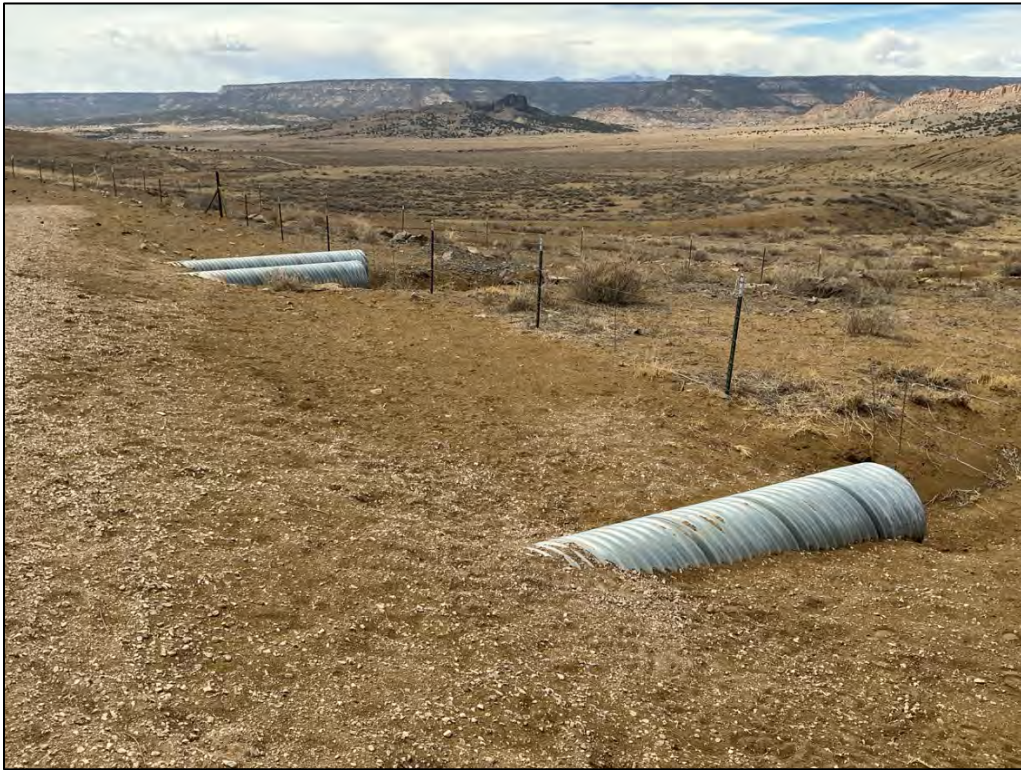
Interior roads used to access LM assets consist of two-track dirt roads with drainage culverts and low water crossings to convey stormwater in key locations. A gully that formed through headcutting on a side slope of the G3 channel was encroaching on the east site access road. Culverts were installed along the access road in 2016 to prevent washout of the road and to control erosion. Sediment was previously accumulating around one of the three culvert inlets, and erosion was also undercutting the outlets. Two of the three culverts are functioning as designed. The U.S. Army Corps of Engineers (USACE) conducted culvert cleanout and replacement in addition to cleanout of the adjacent sediment trap in October 2024 (PL-1). A silt fence placed by USACE east of the sediment trap has been damaged due to livestock. Repairs to the silt fence were conducted during the fall 2025 maintenance trip, and portions of the silt fence leading to the sediment trap were replaced with check dams.

*PL-1. Culverts*

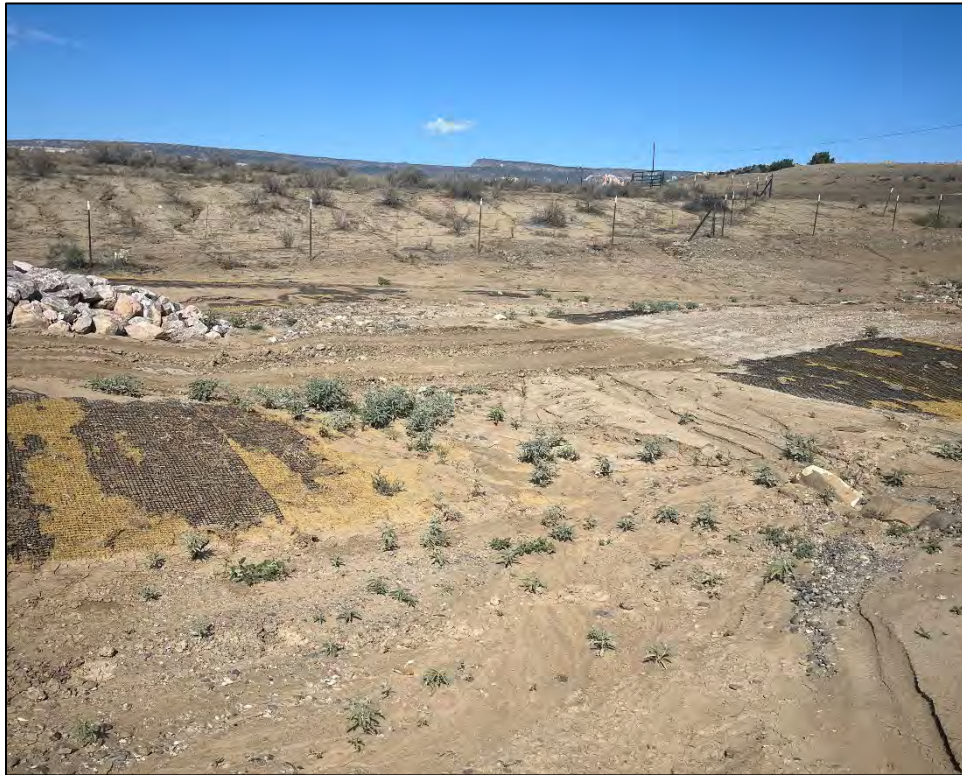
The sediment observed accumulating in low water crossing A is derived from significant erosion forming a roadside ditch first observed in June 2024 along the western edge of the access road leading from Marquez Road. Recent erosion has deepened the ditch and it is now better defined as an arroyo. The arroyo is most deeply incised north of the property line and has increased in depth since its discovery (PL-4). Downgradient, the road surface descends concurrently with the arroyo floor, resulting in a decrease of channel incision until the road elevation and bottom of the arroyo merge north of low water crossing A. This arroyo presents a safety issue presently as the edge of the access road inside and outside of the property line has begun to collapse into the arroyo, minimizing the access road width. Additionally, debris is being dumped into the deepest sections outside of the property line. Safety cones have been placed along the road and this new arroyo is being monitored and will most likely require corrective action in the future.

*PL-3. Low Water Crossing A*

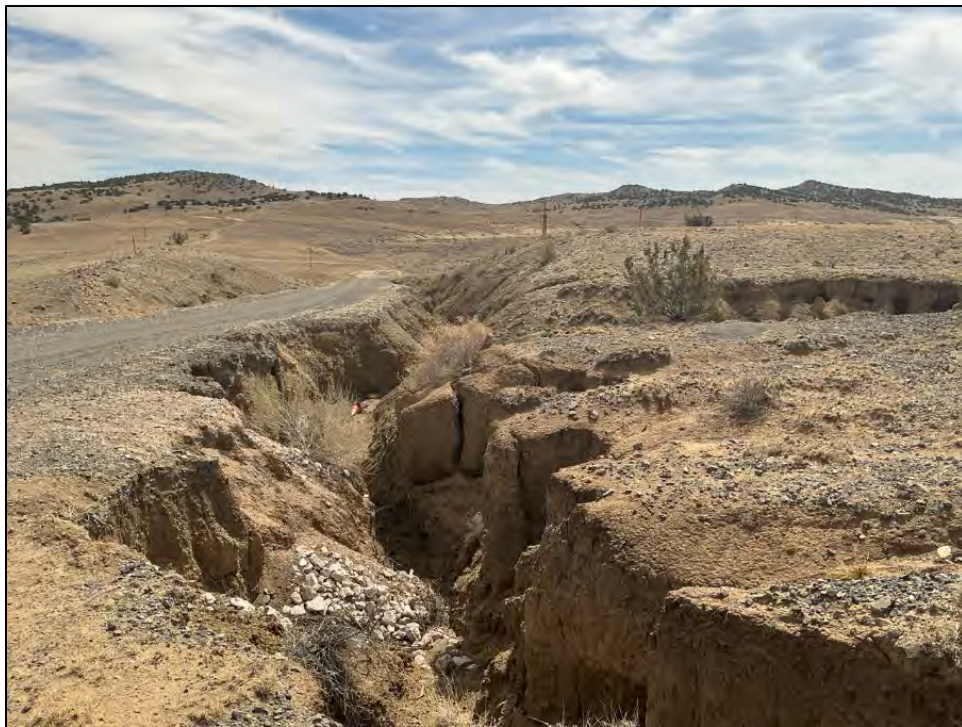
*PL-4. Road Arroyo*

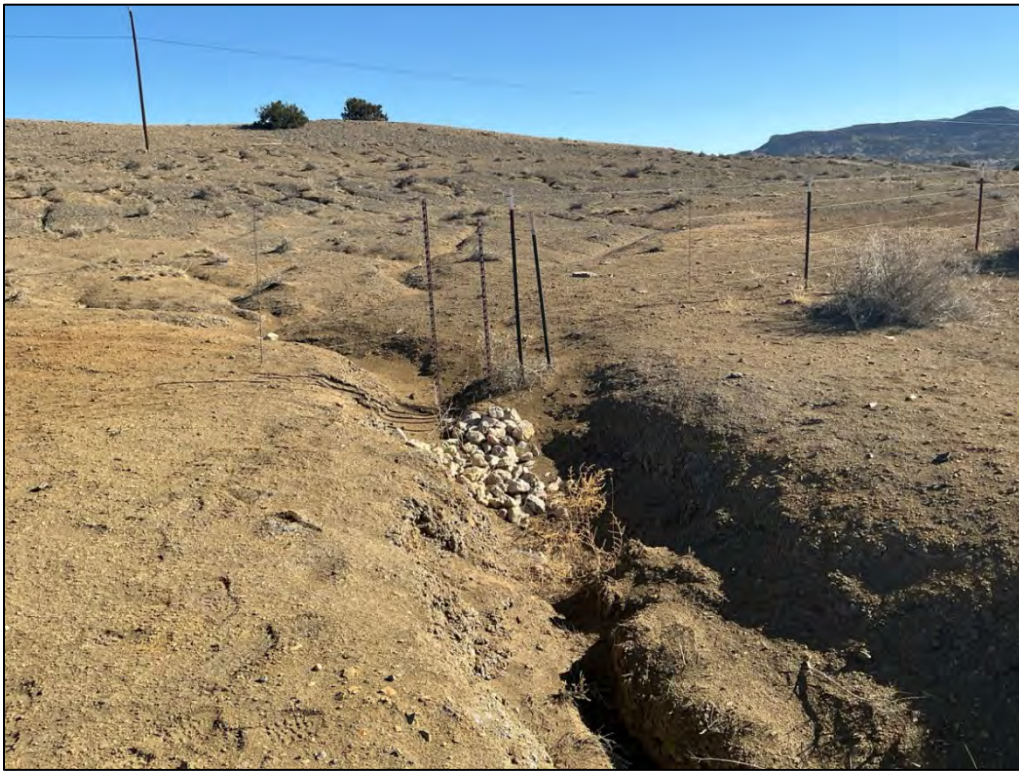
*PL-7. Check Dam*

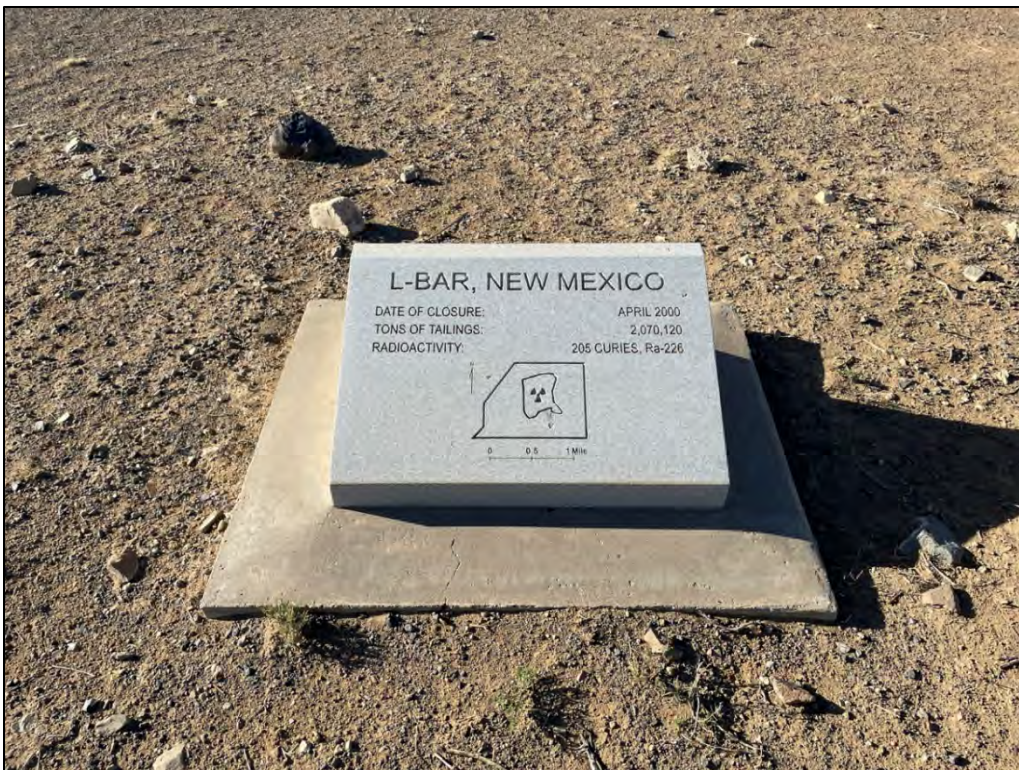
The site has one granite site marker north of the disposal cell, adjacent to the site access road. Bullet damage was observed on the site marker, but it remains legible (PL-10). No maintenance needs were identified.

*PL-10. Site Marker*

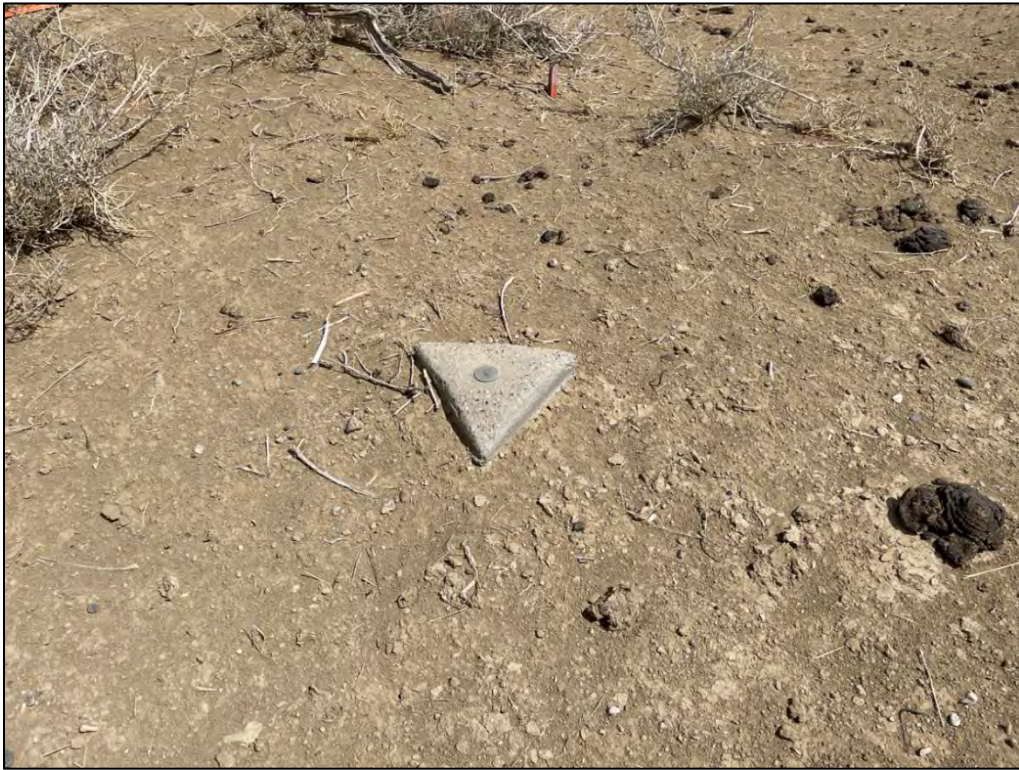
Eight boundary monuments define the site boundary (PL-11). All eight boundary monuments were observed during the 2025 inspection. No maintenance needs were identified.

*PL-11. Boundary Monument BM-8*

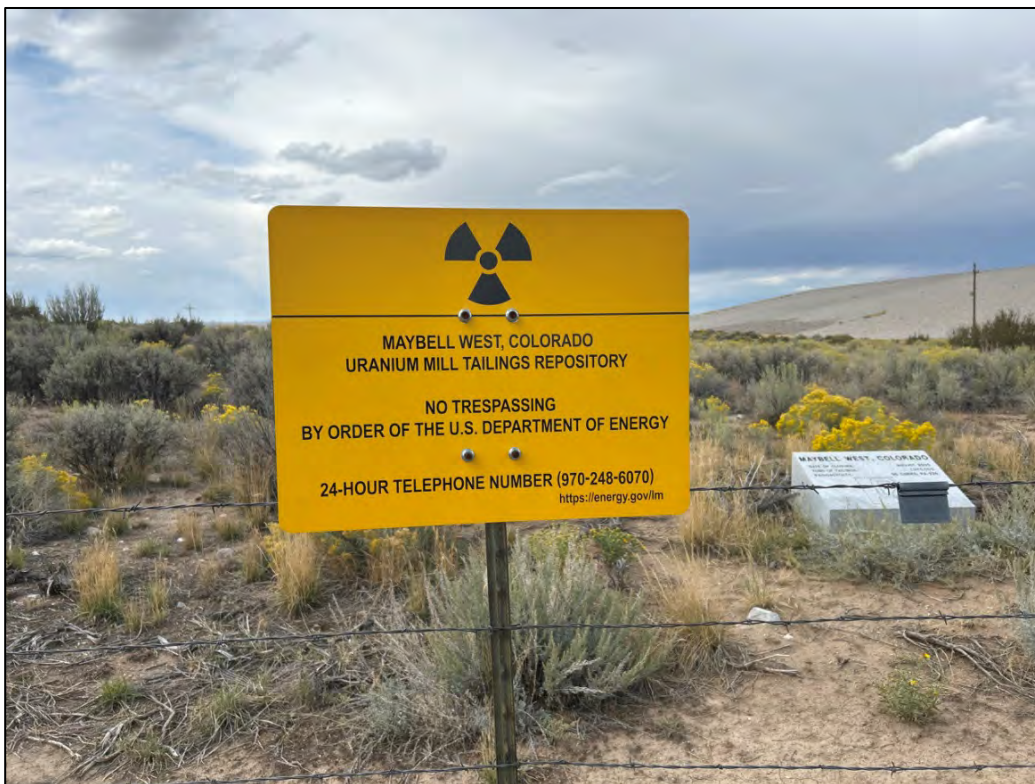
The entrance sign is mounted on a metal T-post directly south of the entrance gate (PL-2). Ten warning or perimeter signs are mounted on metal T-posts around the site. Perimeter sign P10 was faded and replaced during the maintenance trip (PL-3). Perimeter sign P8 is faded and perimeter sign P1 has bullet damage, but both remain legible. No other maintenance needs were identified.

*PL-2. Entrance Sign*

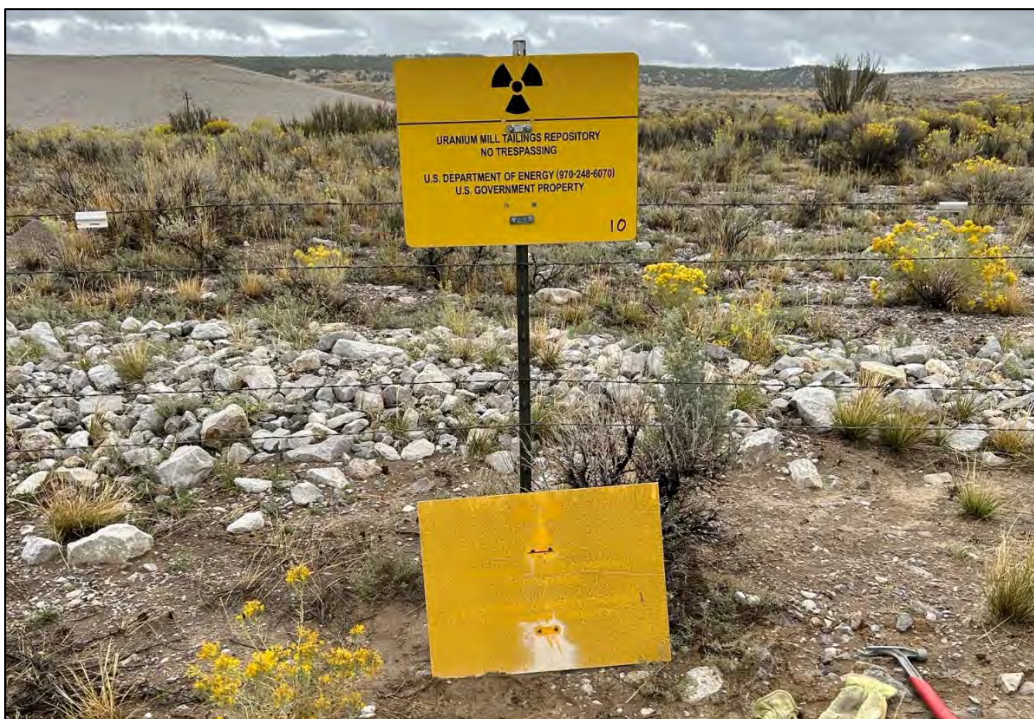
*PL-3. New Perimeter Sign P10*

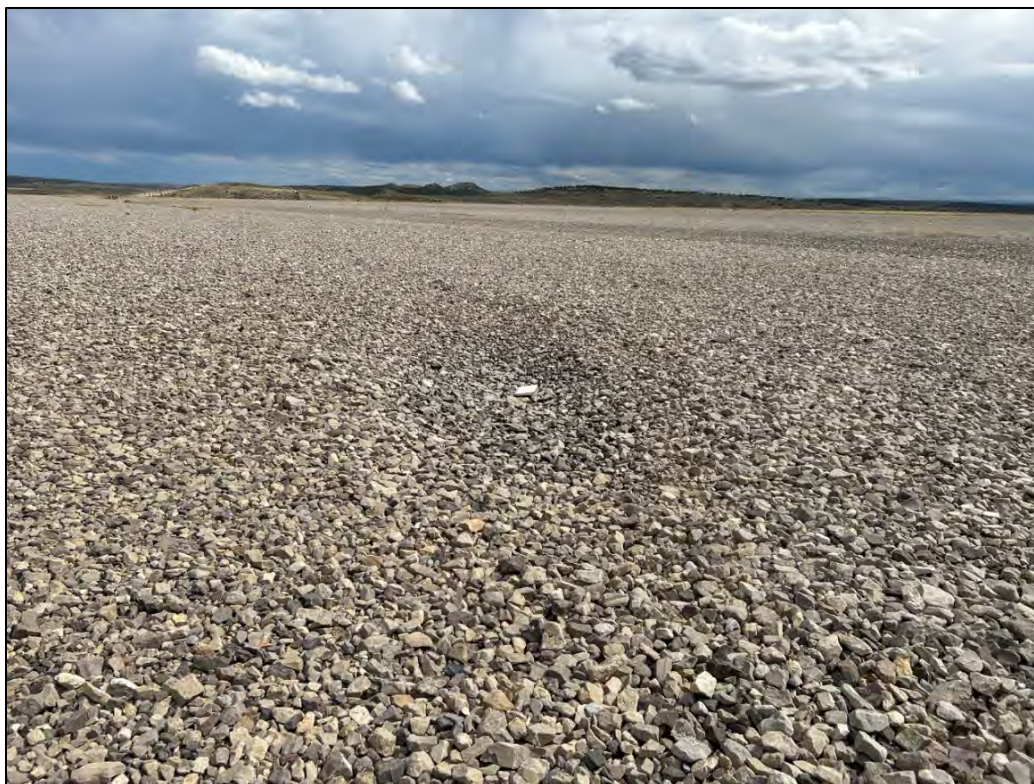
*PL-6. Shallow Depression 1*

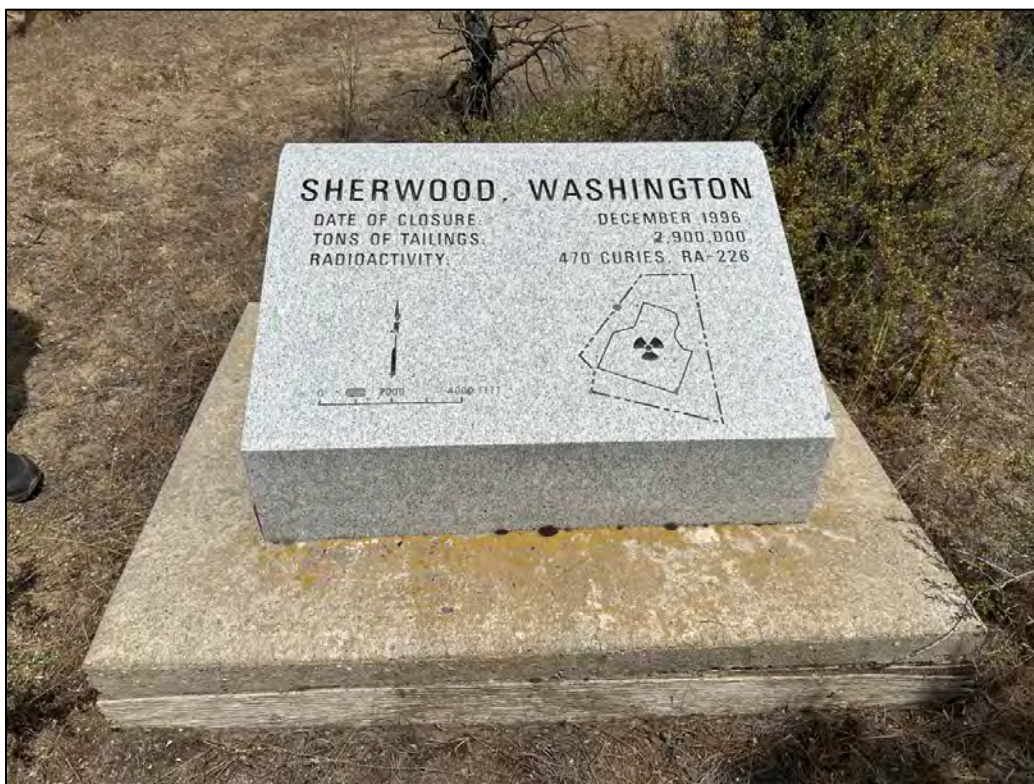
*PL-2. Site Marker*

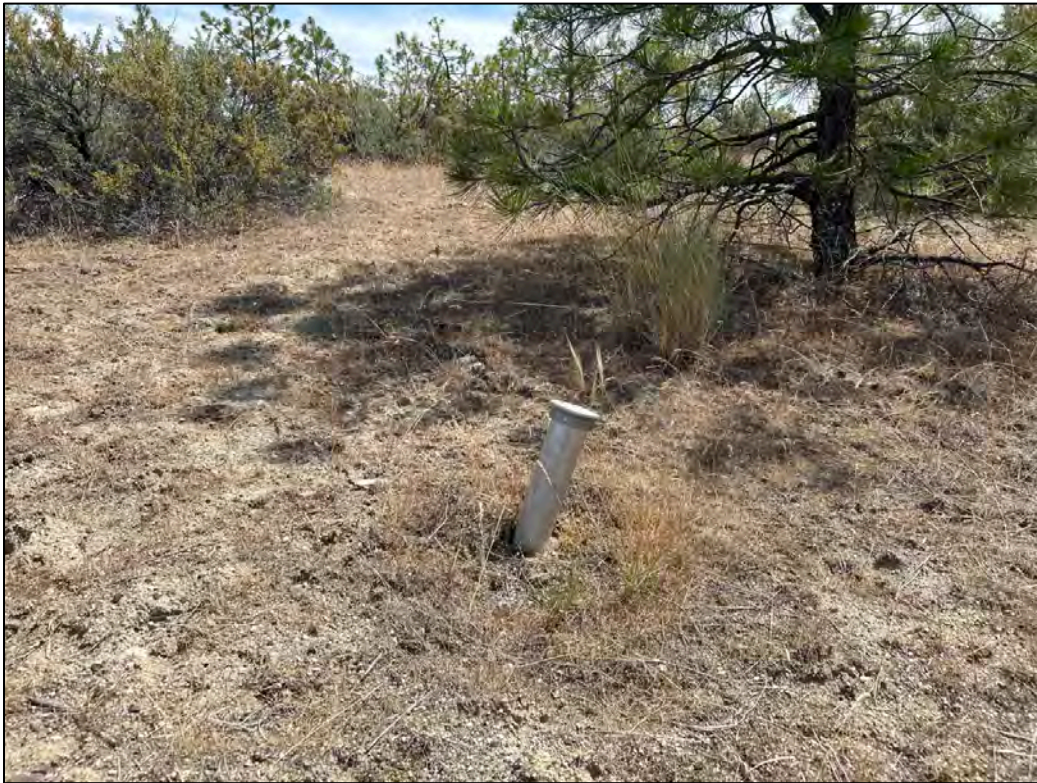
Six boundary monuments set in concrete define the site boundary. Because surrounding vegetation has made it difficult to locate some of the monuments, metal T-posts were installed at each boundary monument location. All boundary monuments were located during the inspection. Boundary monument BM-3A is bent but still visible and intact (PL-3). No maintenance needs were identified.

*PL-3. Bent Boundary Monument BM-3A*

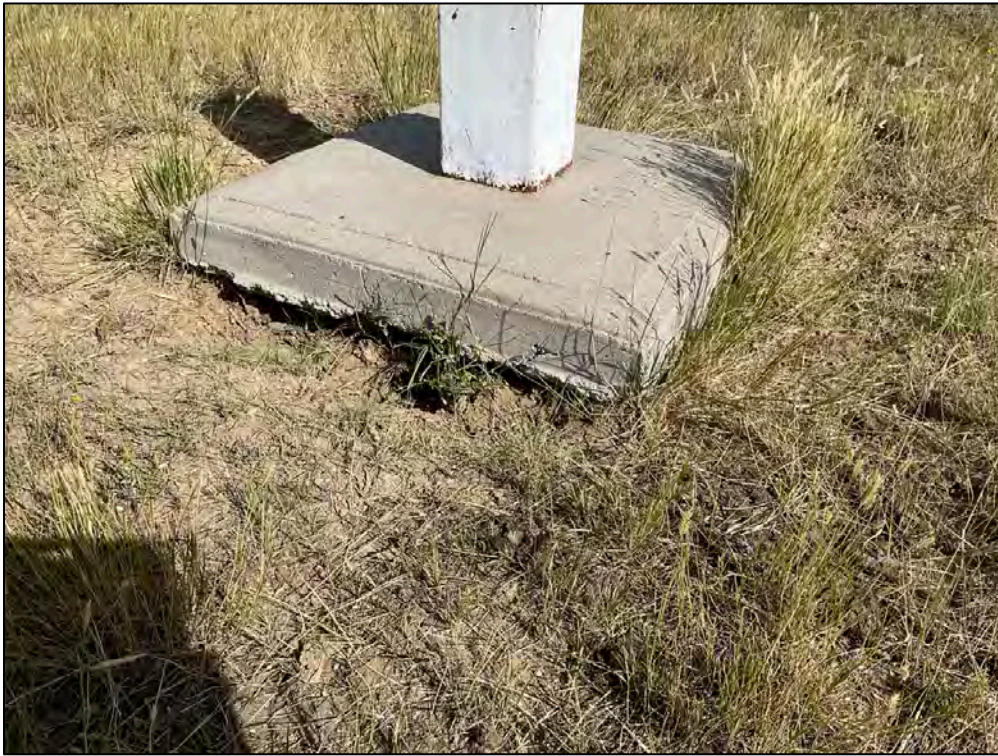
*PL-5. Animal Burrows Below Well 40-SC*

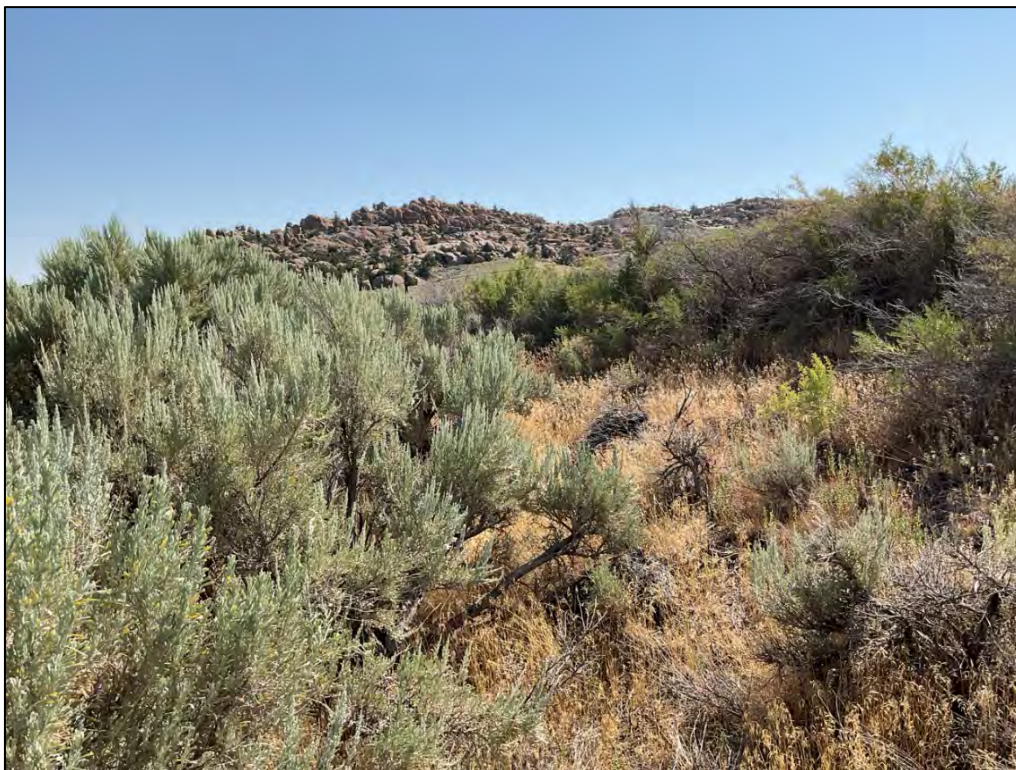
*PL-4. Vegetation Along Fence Line Off Ore Road*

- Repaired the fence along Ore Road
- Mowed along the fence on Ore Road and along the tertiary roads
- Installed 10 new perimeter signs
- Removed deep-rooted vegetation from the disposal cell
- Top-dressed the rills on the tertiary road with gravel

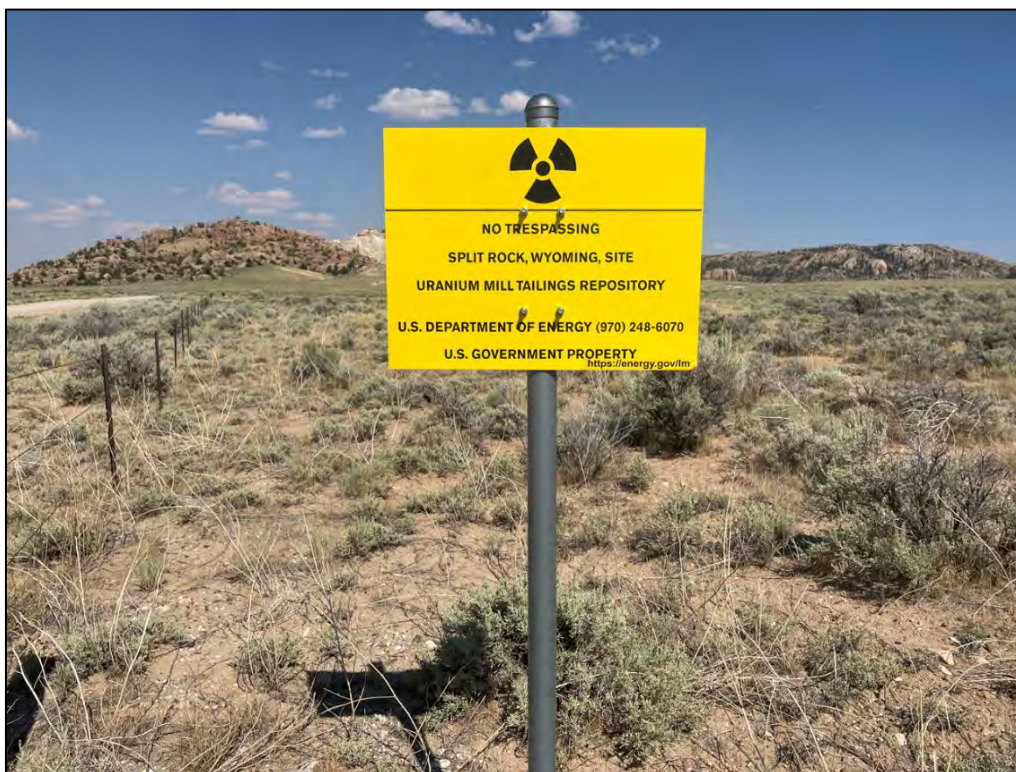
The entrance sign, identified in Figure 7-1, is on the main site access road near the site marker (PL-5). Before the site transitioned to LM, 40 additional steel signposts were placed around the

*PL-5. Entrance Sign*

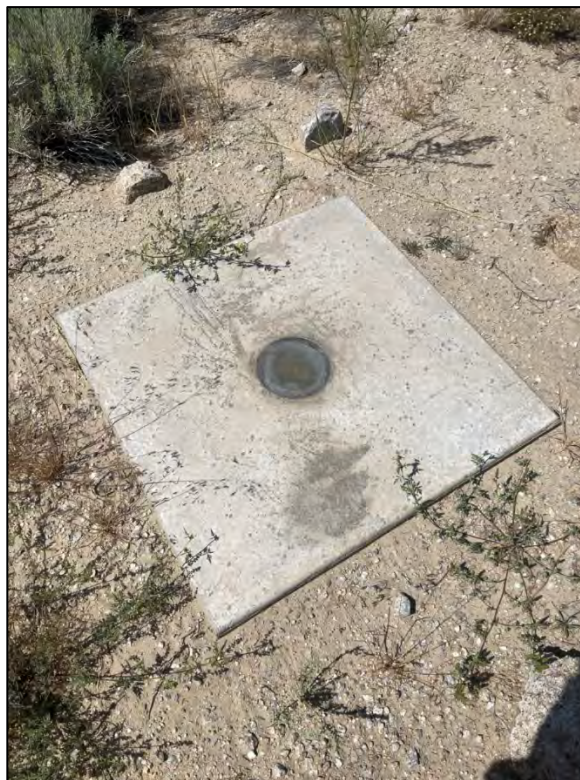
In August 2024, eight permanent quality control monuments were installed at the site in preparation for a September 2024 baseline aerial survey of the disposal cell (PL-8). Only five quality control monuments were visited during the 2025 inspection. The quality control monument locations are shown in Figure 7-1. No maintenance needs were identified.

*PL-8. Quality Control Monument QC-5*

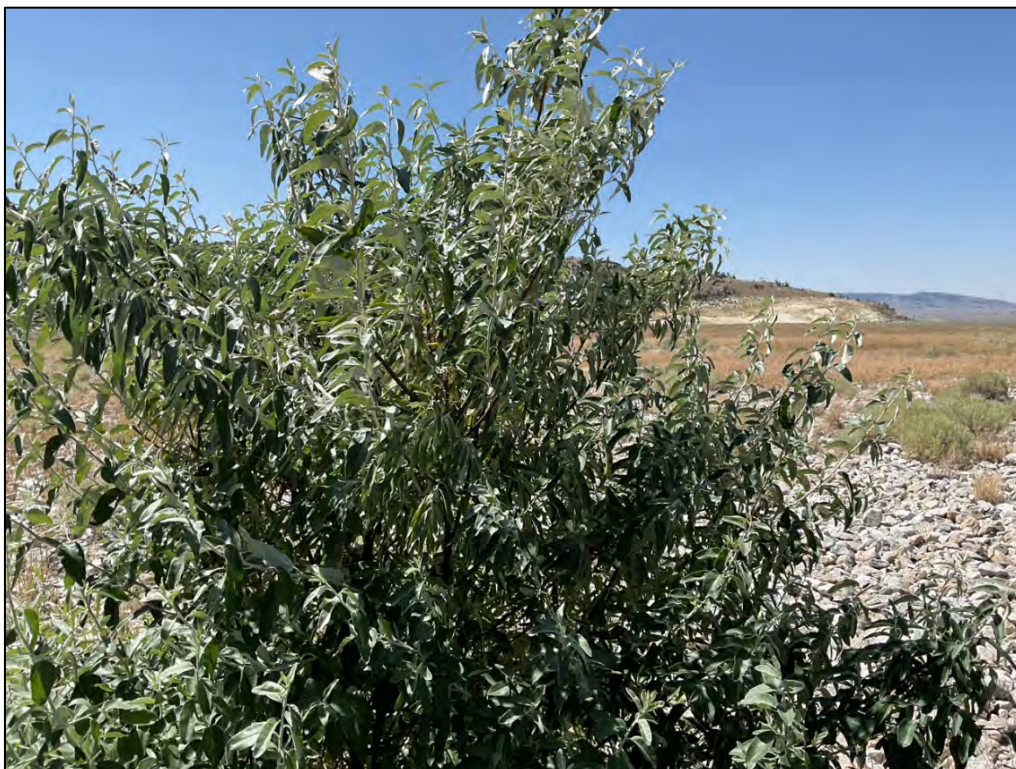
*PL-12. Russian Olive on Disposal Cell (Removed)*

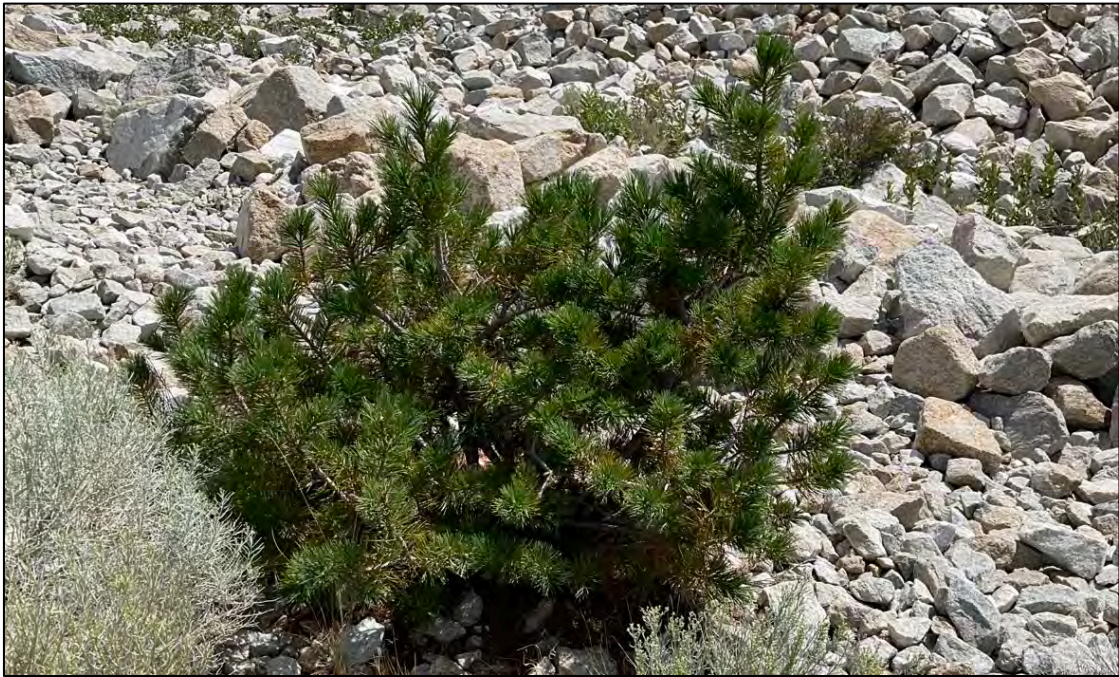
*PL-13. Limber Pine Tree on Disposal Cell (Removed)*

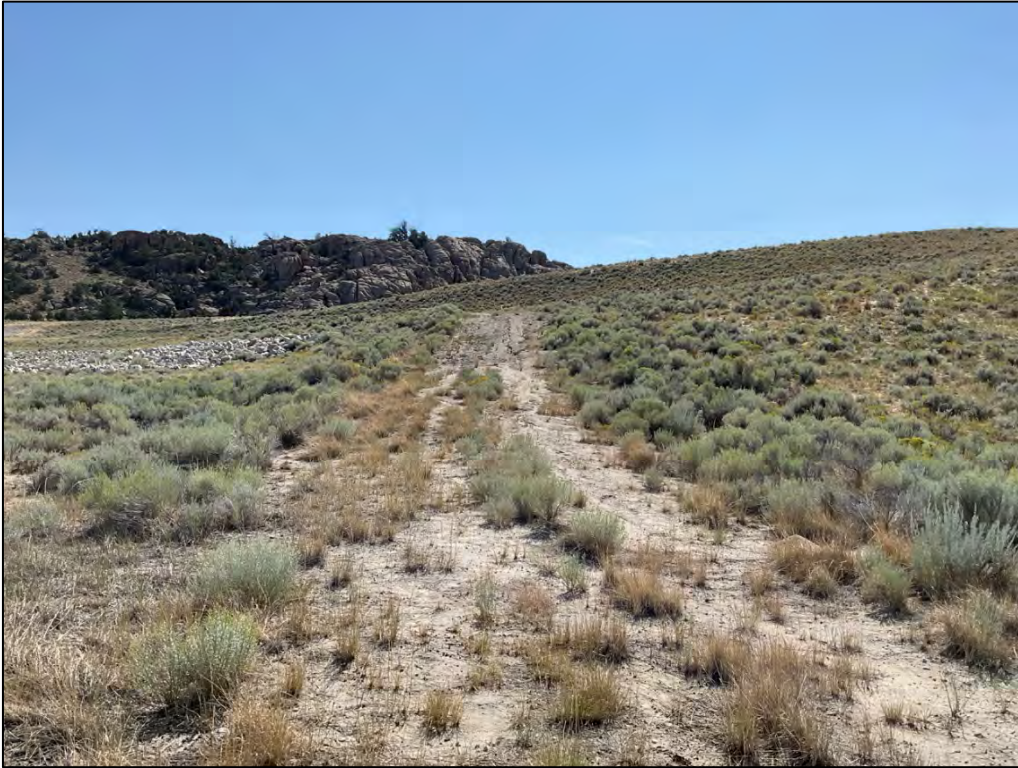
*PL-19. Rills in Tertiary Road*

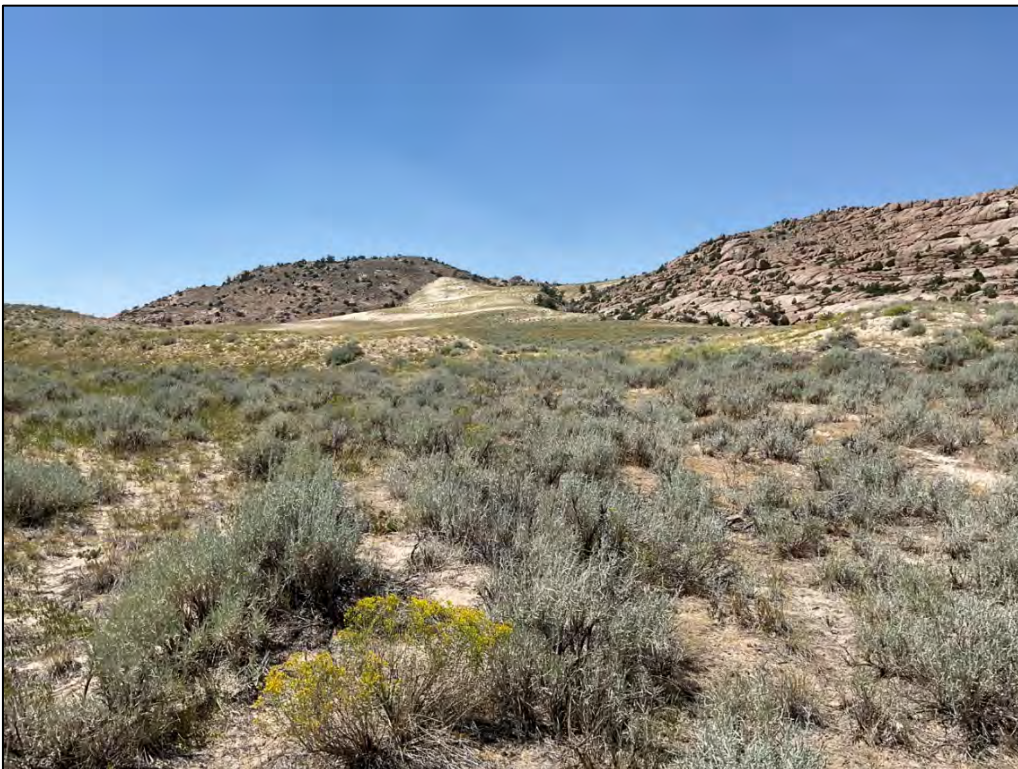
*PL-20. Sand Blowout Area*
