# Hooper Bay Housing Analysis and Energy Feasibility Report

Prepared for:  
Sea Lion Corporation  
Main Airport Road  
Hooper Bay, AK  
99604

December 30th, 2012

Prepared by:  
Cold Climate Housing Research  
Center  
1000 Fairbanks, AK 99708  
907.457.3454  
[www.cchrc.org](http://www.cchrc.org)

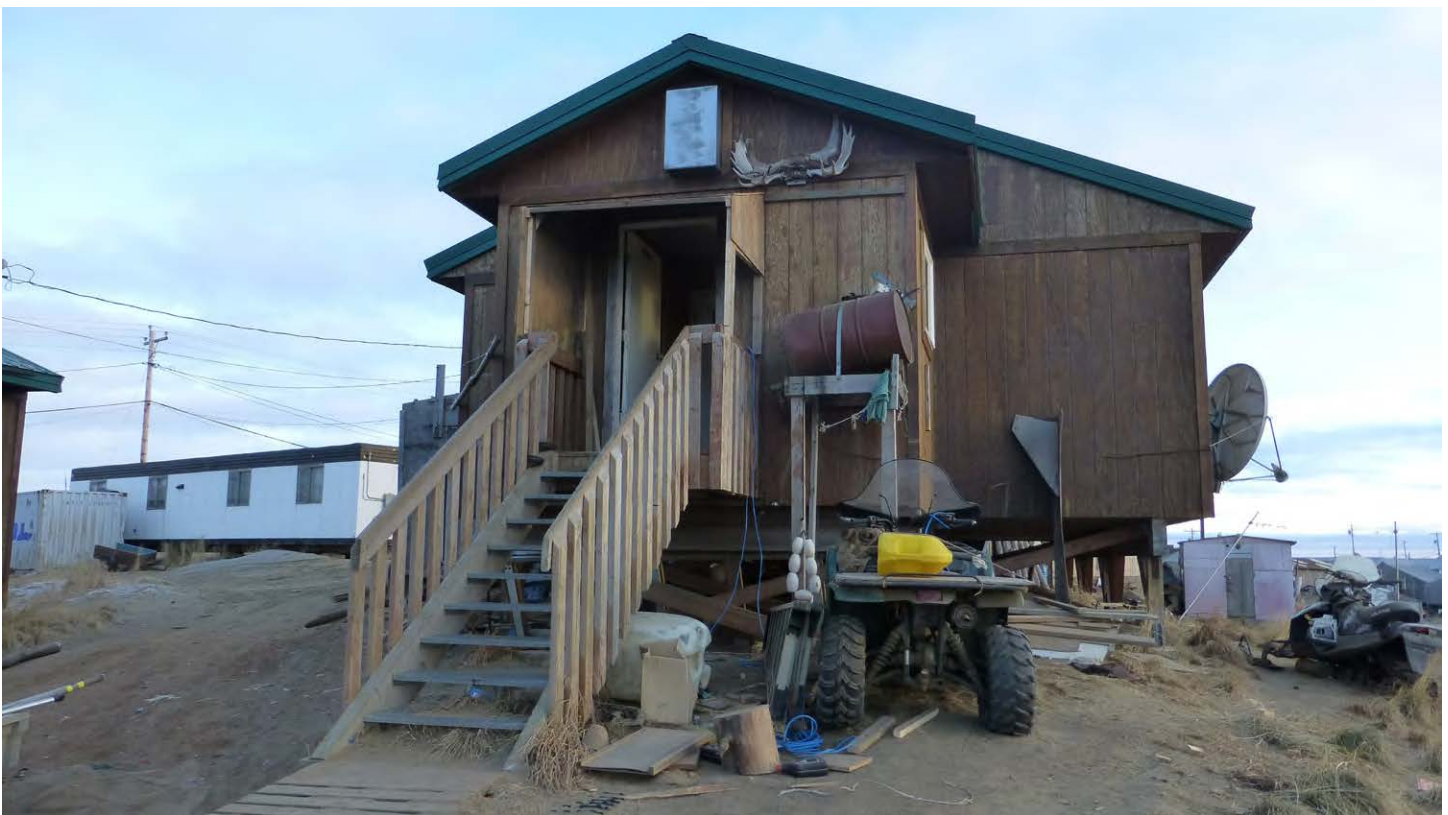
The house has experienced some settlement, but the foundation is not adjustable by occupant.

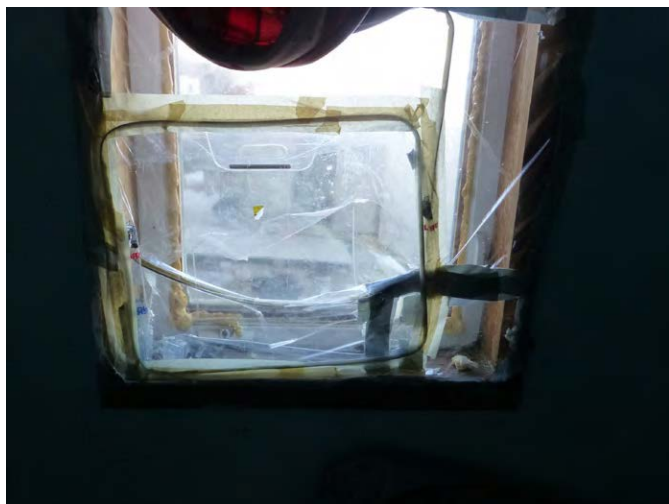
The windows are poorly caulked and drafty. The occupant covers them with plastic in the winters.

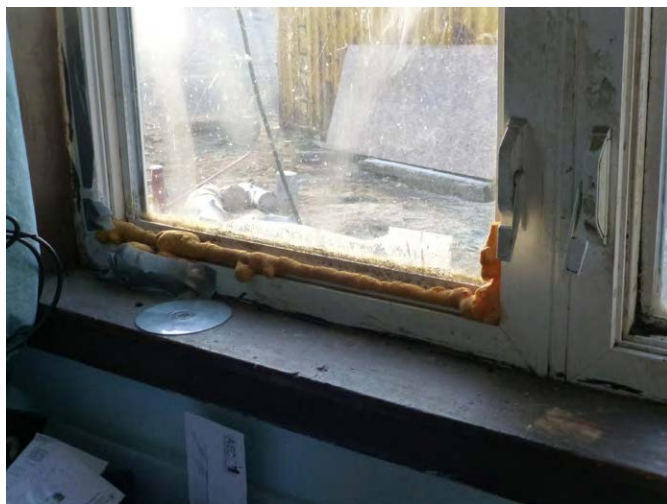
The windows are poorly caulked and drafty. The occupant covers them with plastic in the winters.

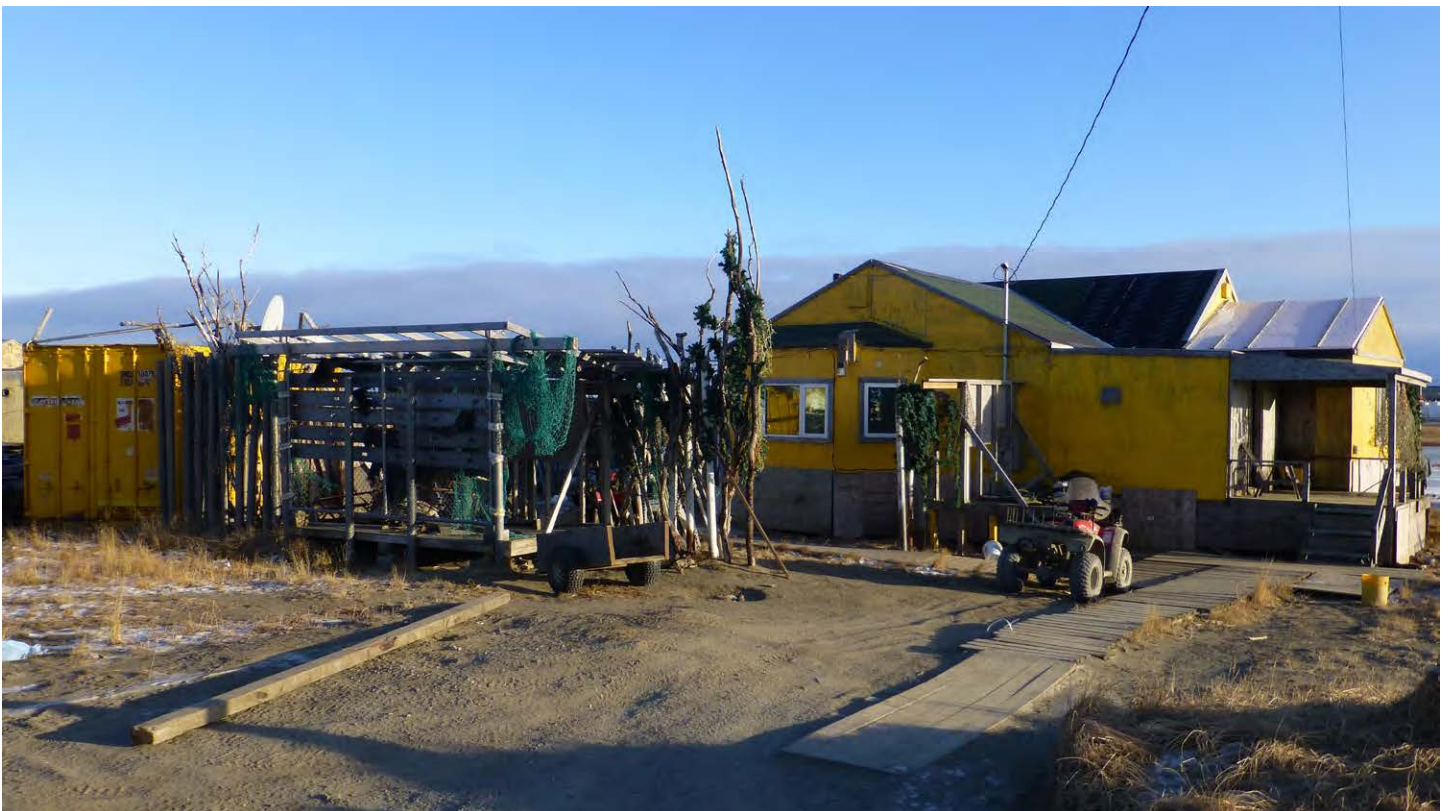
Ventilation system from a prior weatherization attempt has been disabled.

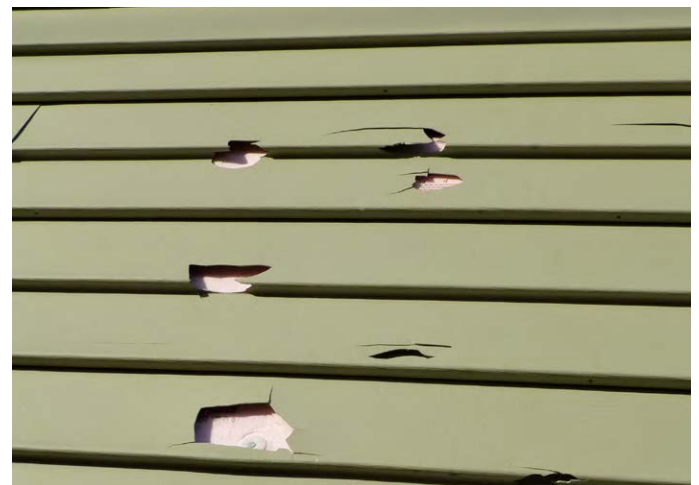
Moses Night House. Exterior rigid insulation was applied during a prior retrofit.

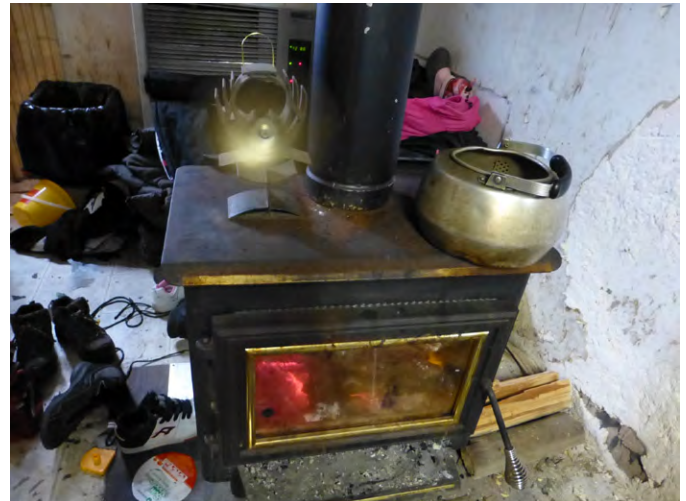
A passive fan atop the woodstove moves heat laterally into the living area.

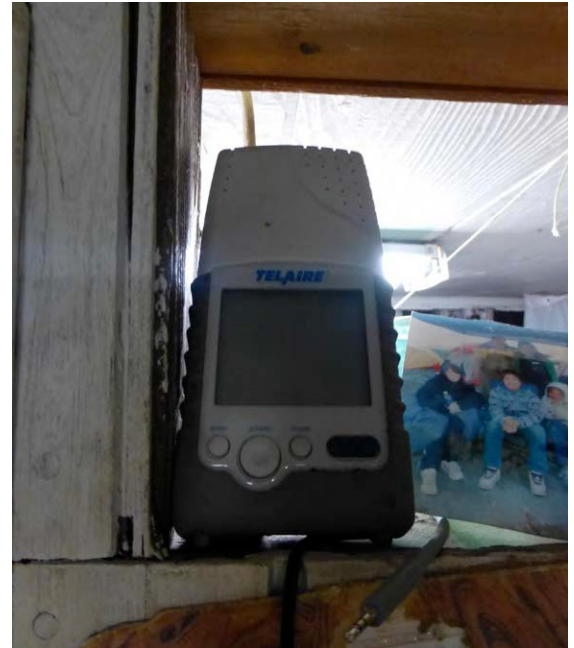
Glen Joe Sr. House. In a prior weatherization application the family was provided with a humidity monitor that beeps at them when humidity is high, and they turn the fan on to create air exchanges.

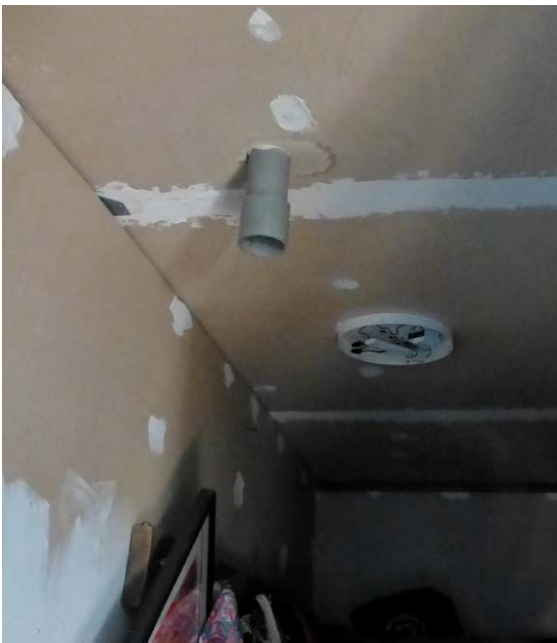
Henrietta Naneng House. A traditional passive vent has been installed in the closet for moist stale air to exit. The building depends on make-up air from the inherent lack of airtightness in the home.

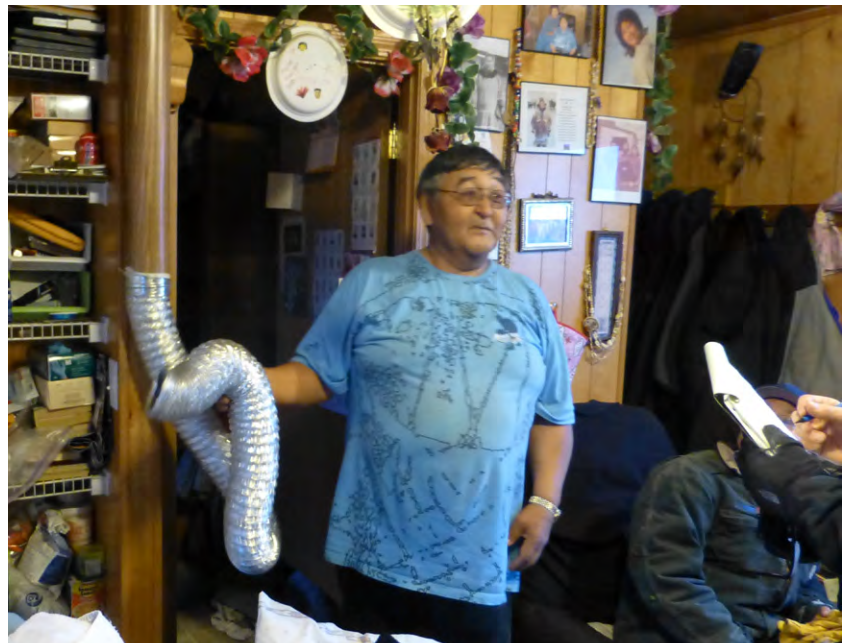
Harvey and Mary Tinker House. The resident has constructed a passive air exit vent that can be moved to the floor or higher in the home during the winter and summer, respectively. The intake air is through a Fresh 80 vent.
