U.S. Department of Energy Office of Environmental Management

Fire Forensic Analysis of the Radiological Release Event at the Waste Isolation Pilot Plant on February 14, 2014

April 6, 2015

**Prepared in Support of the U.S. DOE Accident Investigation
Board for the Radiological Release Event at the Waste
Isolation Pilot Plant on February 14, 2014**

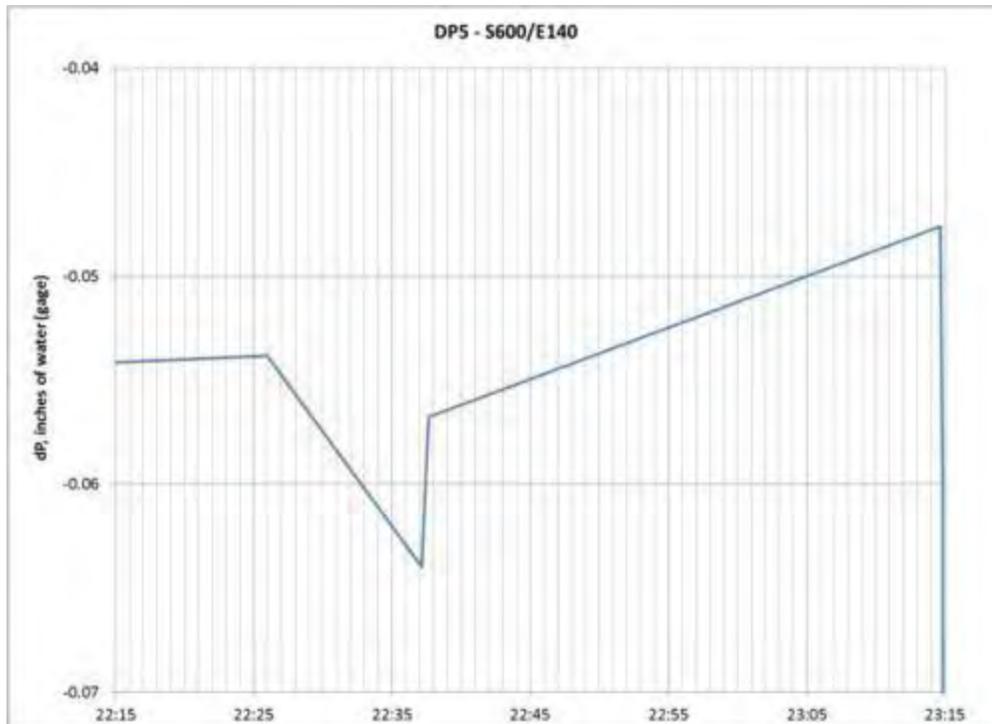
Two sensors, dP4 near the exhaust shaft, (Figure 5-41), and dP6 in S-1000 between the construction and disposal circuits (Figure 5-43), show fluctuations in the dP measurements throughout the pre-CAM timeframe with no noteworthy observations. The remaining four sensors: dP5 (Figure 5-42), dP8 (Figure 5-44), dP12 (Figure 5-45), and dP13 (Figure 5-46) do not show much variation in measurement throughout the pre-CAM timeframe.

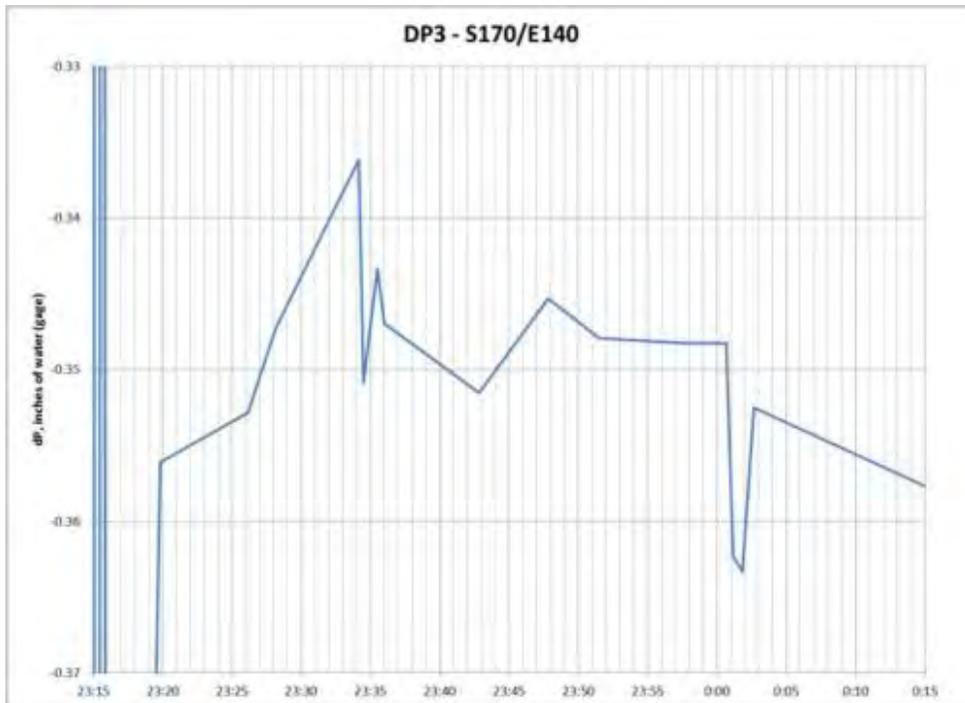
Differential pressure sensor dP2 reached a quasi-steady-state by about 2316 on February 14, 2014, (Figure 5-48) and did not change in value considerably after. Sensor dP3 reached an approximate steady-state by 2320 and showed some slight fluctuation (Figure 5-49), but nothing that stood out. An approximate steady-state was achieved by 2320 for sensor dP4, with the dP increasing slowly over the time observed in Figure 5-50. Figure 5-51 indicates that dP5 reached a quasi-steady-state by about 2321, with a slowly increasing trend in dP during the remaining timeframe analyzed.

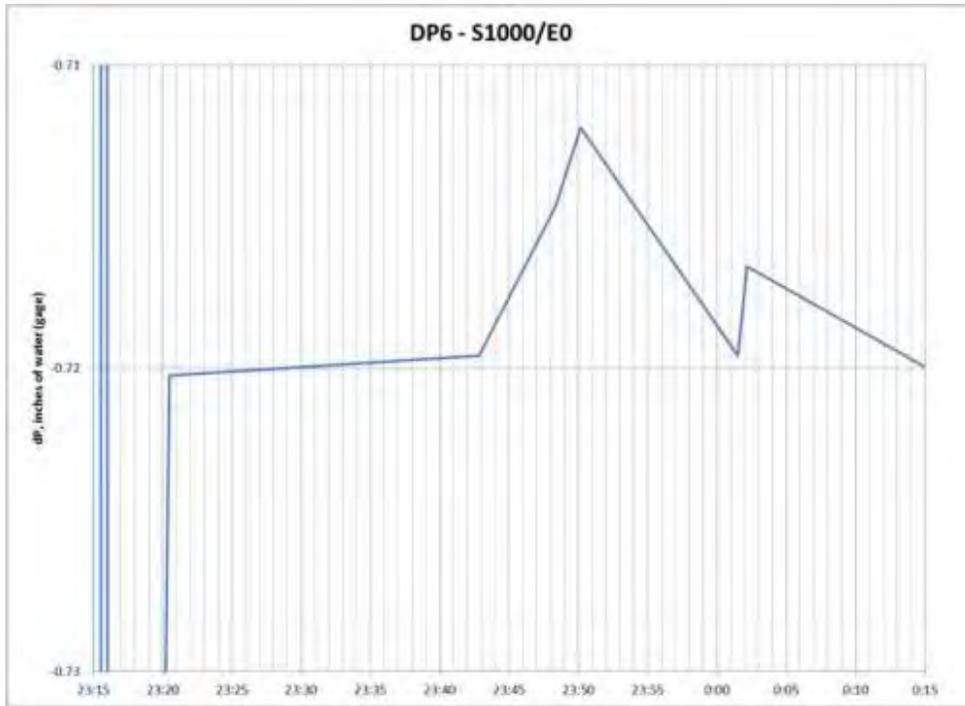
Two small peaks in dP data were observed in Figure 5-52 for dP6 during its steady-state regime after 2321. Figure 5-53 indicates that dP8 reached a steady-state by 2317 and had a slight increasing trend in dP for the remainder of the hour following the release event. Sensor dP12 began to settle down to a steady-state reading by 2320 (Figure 5-54), with steady ups and downs in its readings. Sensor dP13 (Figure 5-55) began to settle at 2322 and dP-WHT (Figure 5-56) stopped its large oscillations due to the change in flow regimes at 2321.

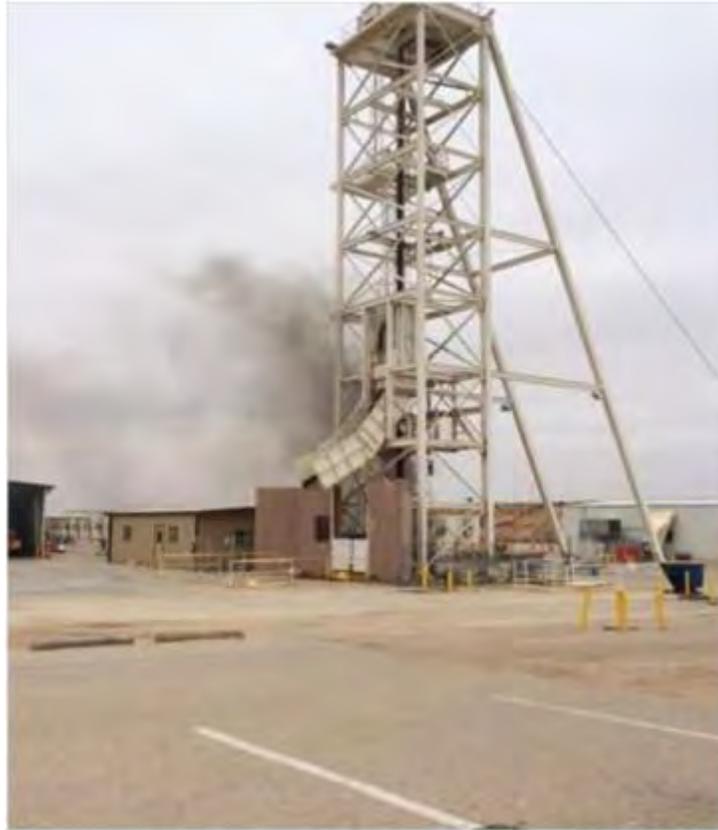
**Figure 6-10: Upcasting Observed at the Salt Shaft
on February 5, 2014**

The result places the height of the plume exiting the SHS in the range of 24 feet to 35 feet. In Figure 6-10, the observed plume height is estimated at about 40 feet, which is greater than the predicted range. The difference is within the accuracy of the analysis.

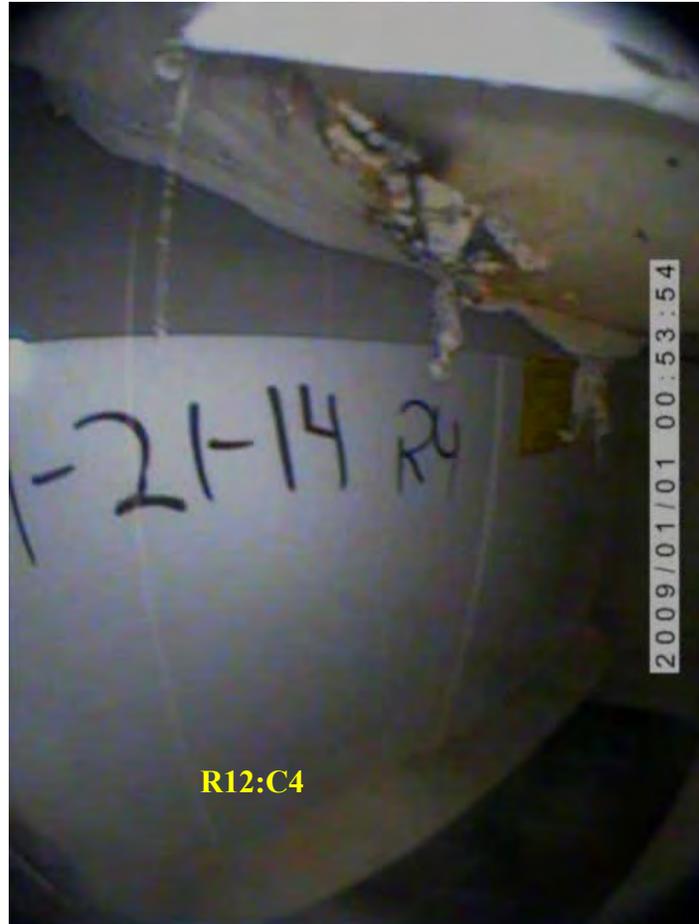
AIB-FST-02004: R12:C4 – Top Tier – Array face (west) view

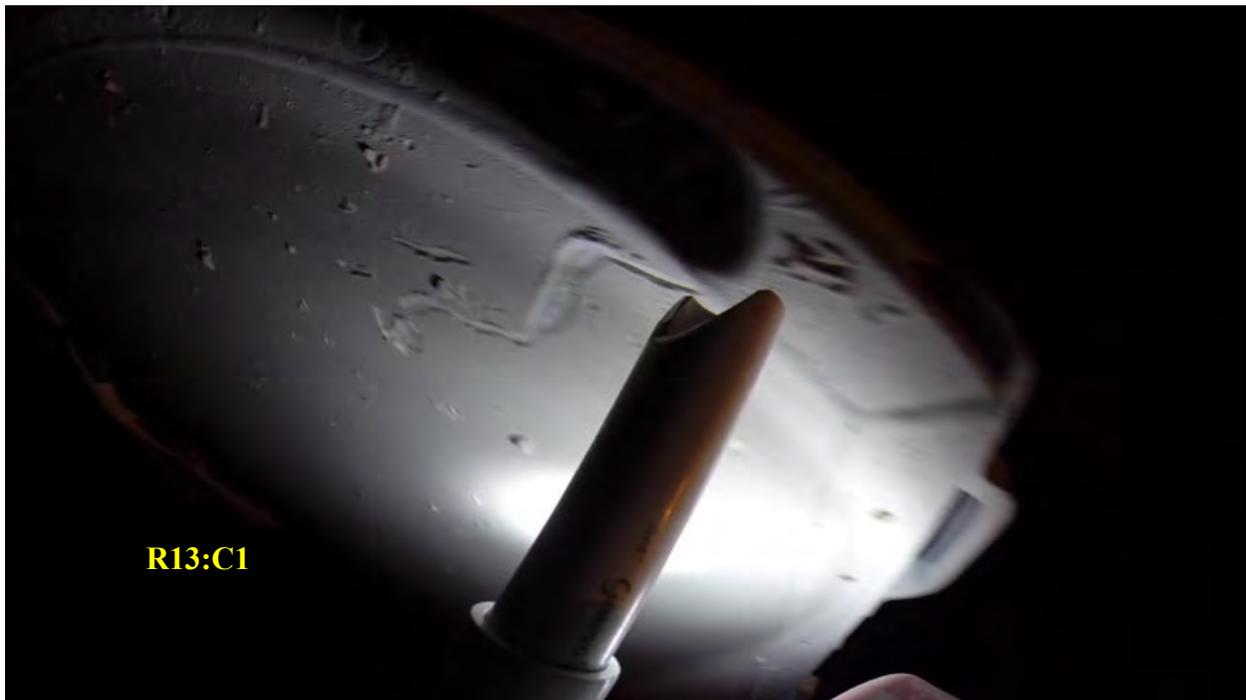
AIB-FST-02009: R13:C1 – Demonstration of dust layer

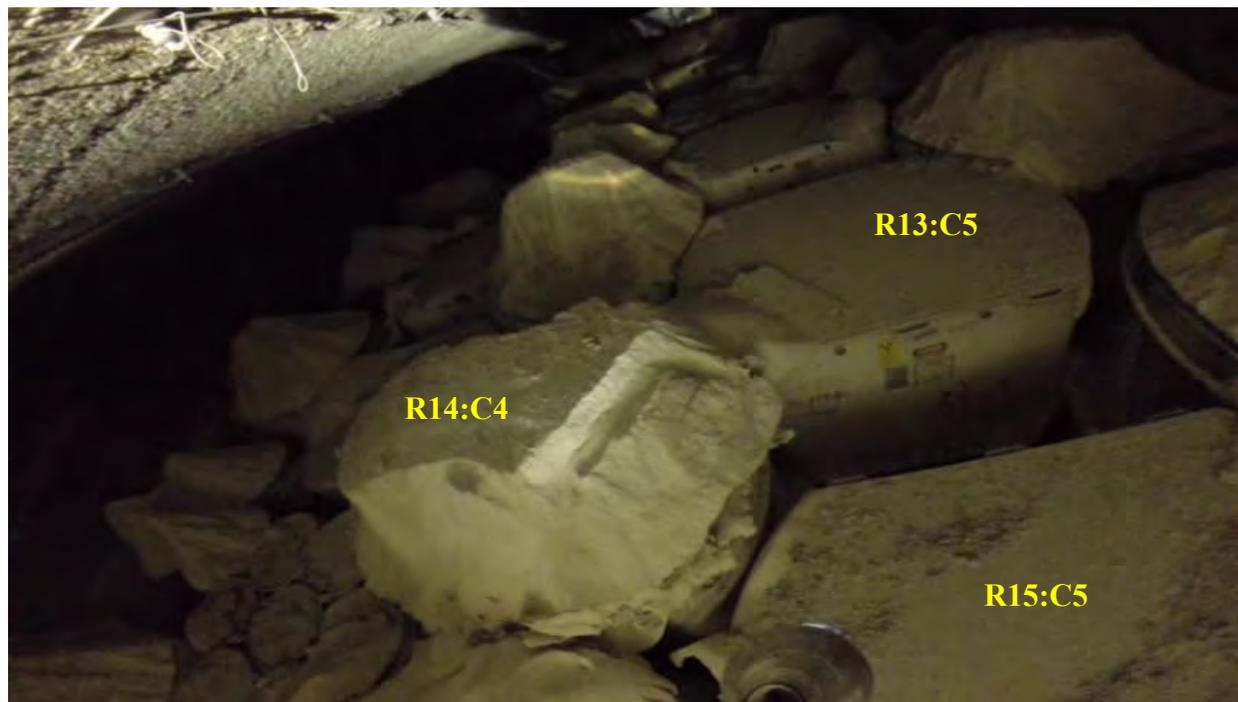
AIB-FST-02026: R14:C4 – Residual Mg

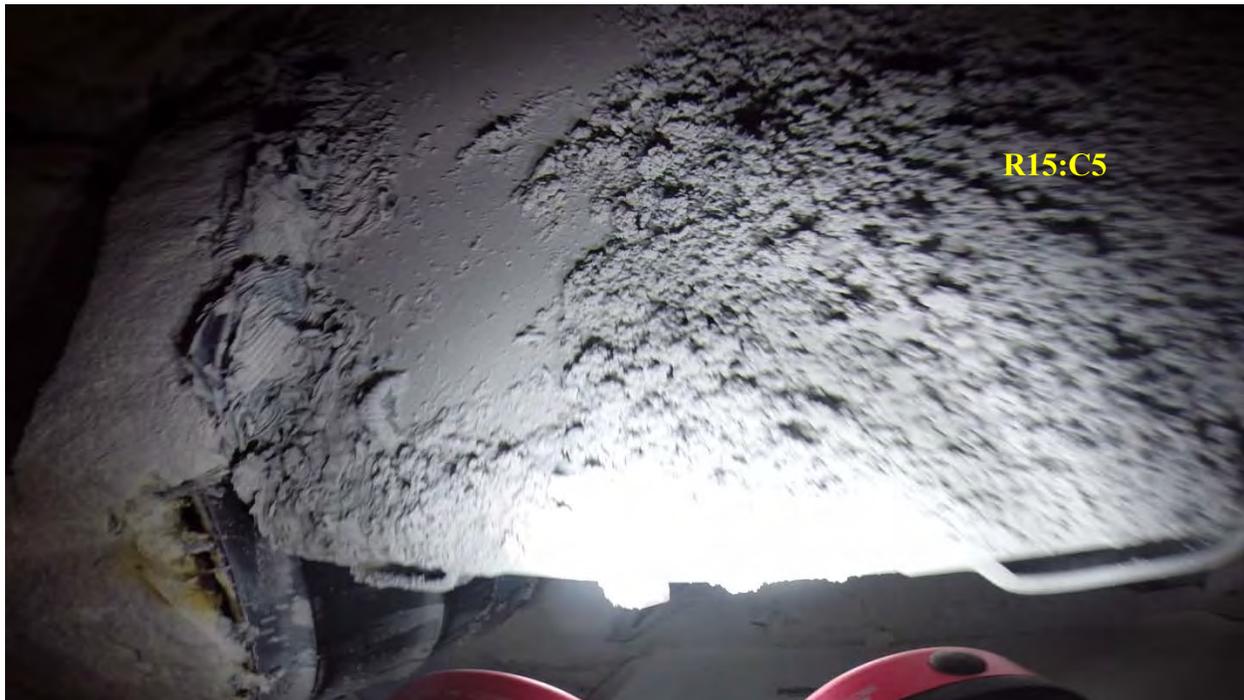
AIB-FST-02047: R15:C5 – SWB lid debris

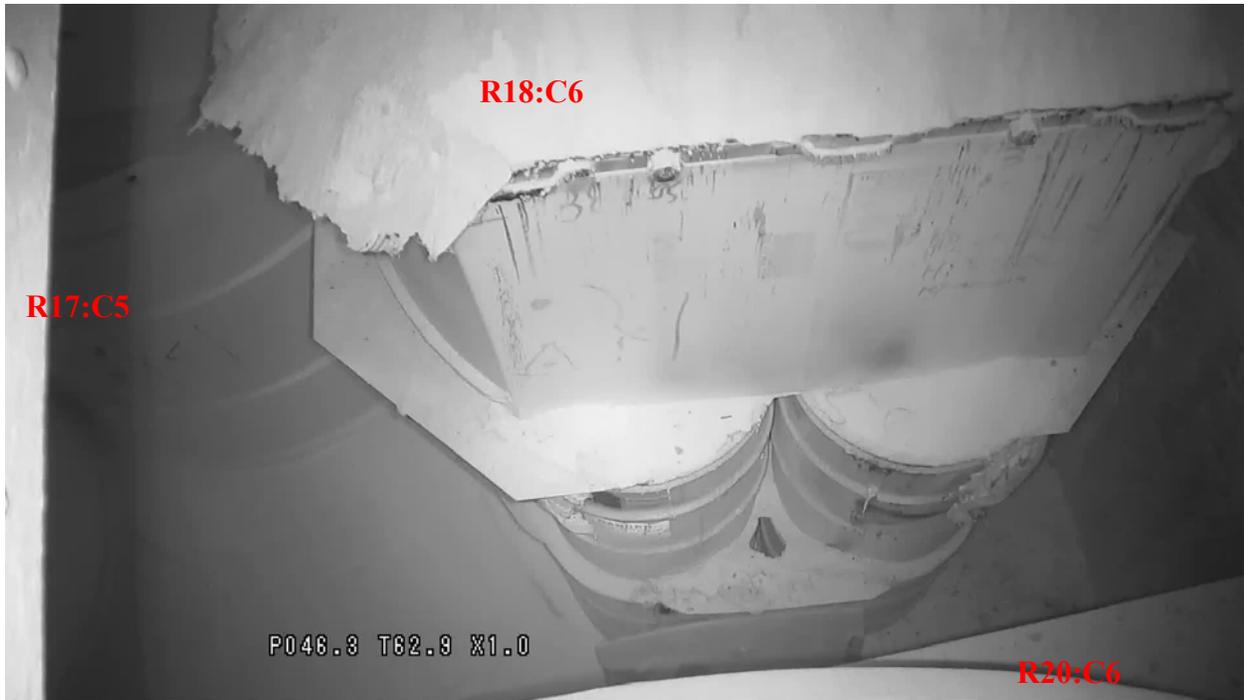
AIB-FST-10001 – Face (west) view of R18:C6

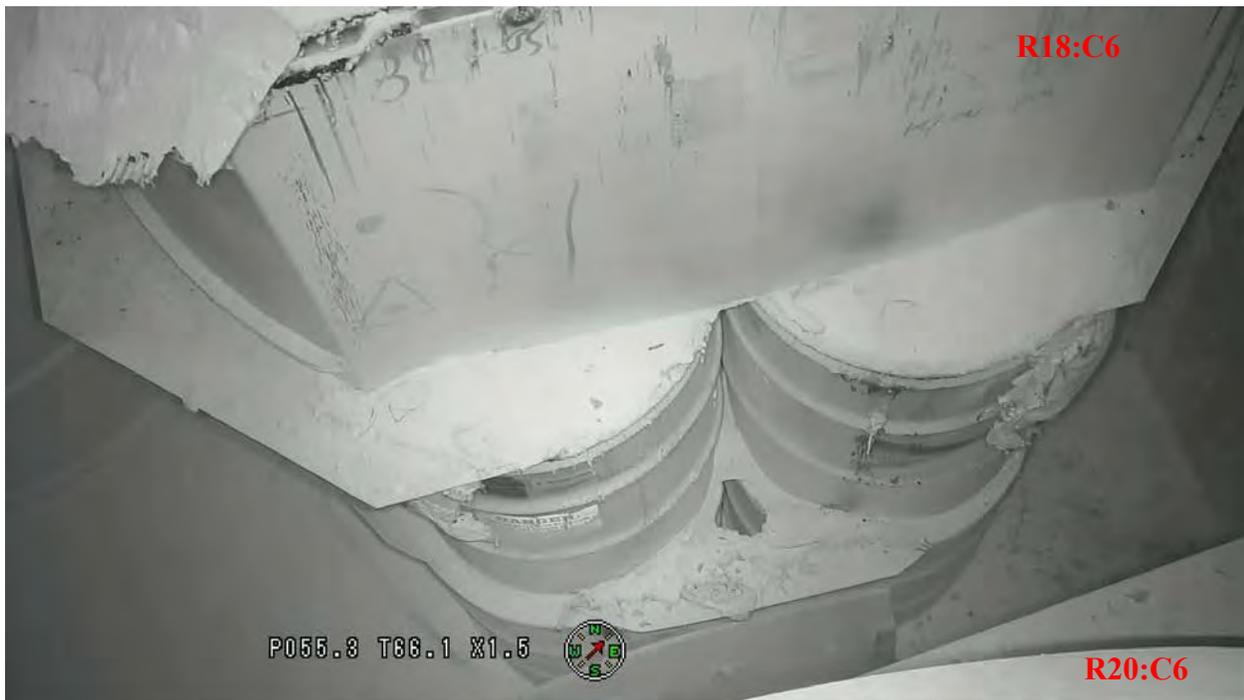
AIB-FST-10002– Face (west) view of R18:C6

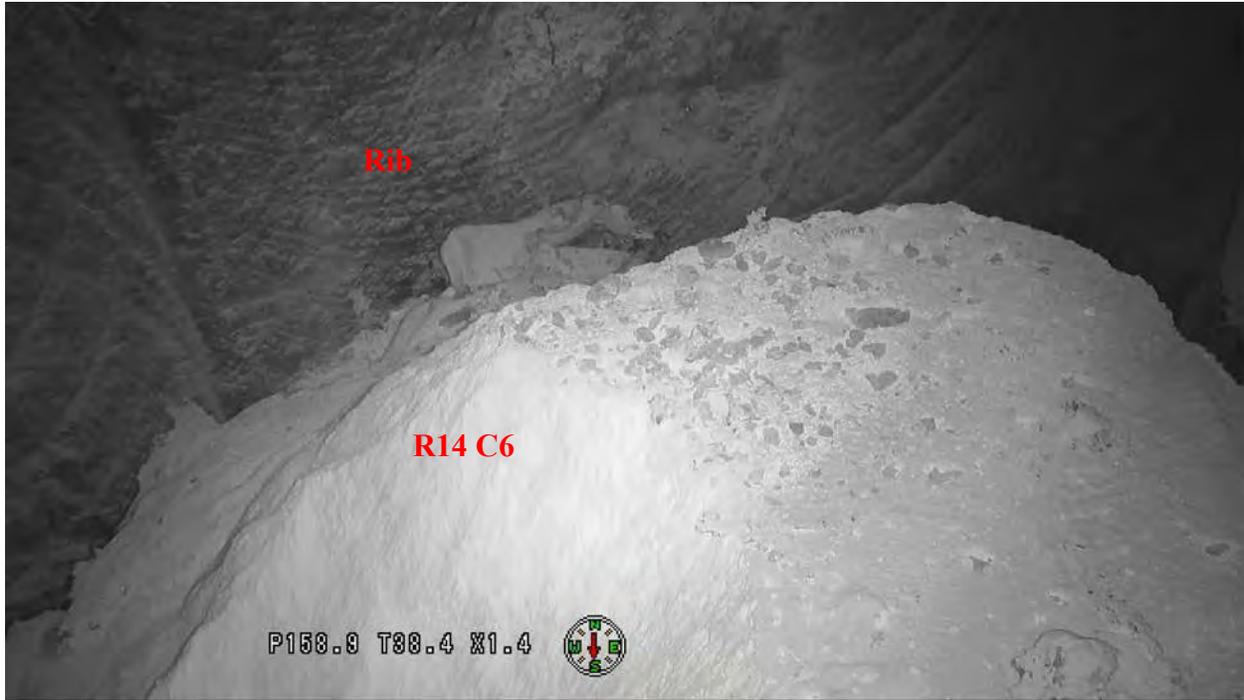
AIB-FST-10028: R14:C6 – Residual Mg

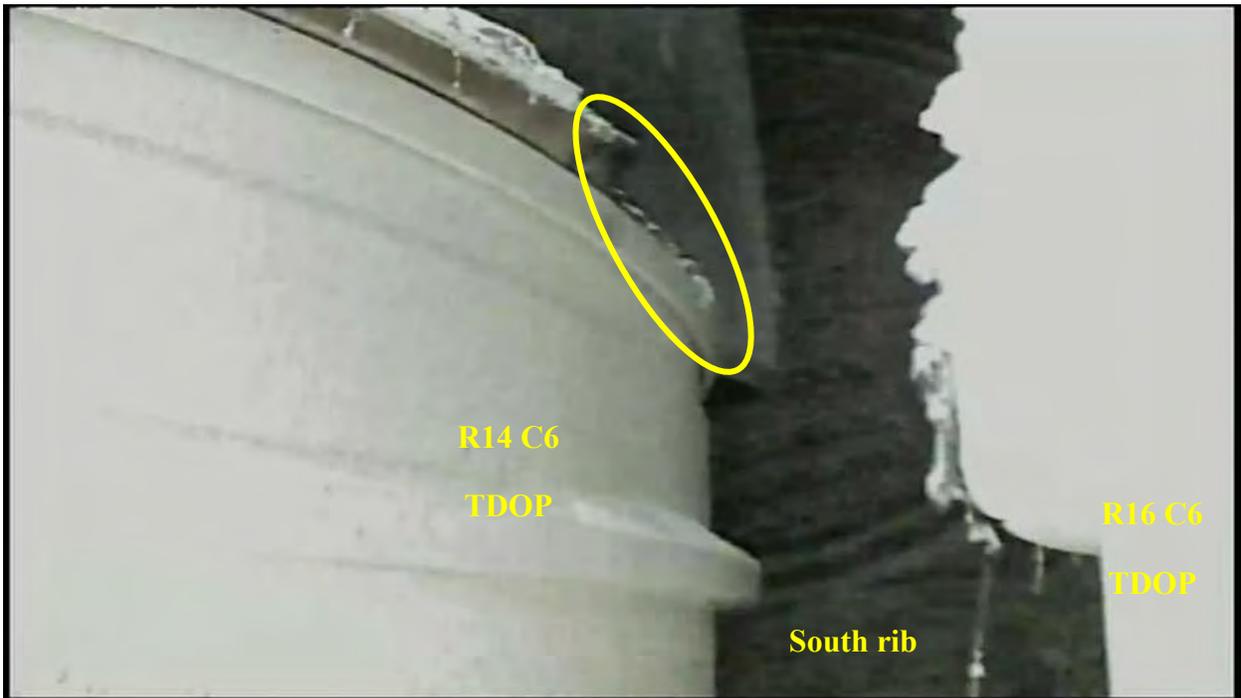
AIB-FST-10031: R14:C6 and R16:C6 - Charred edge of SWB slip sheet

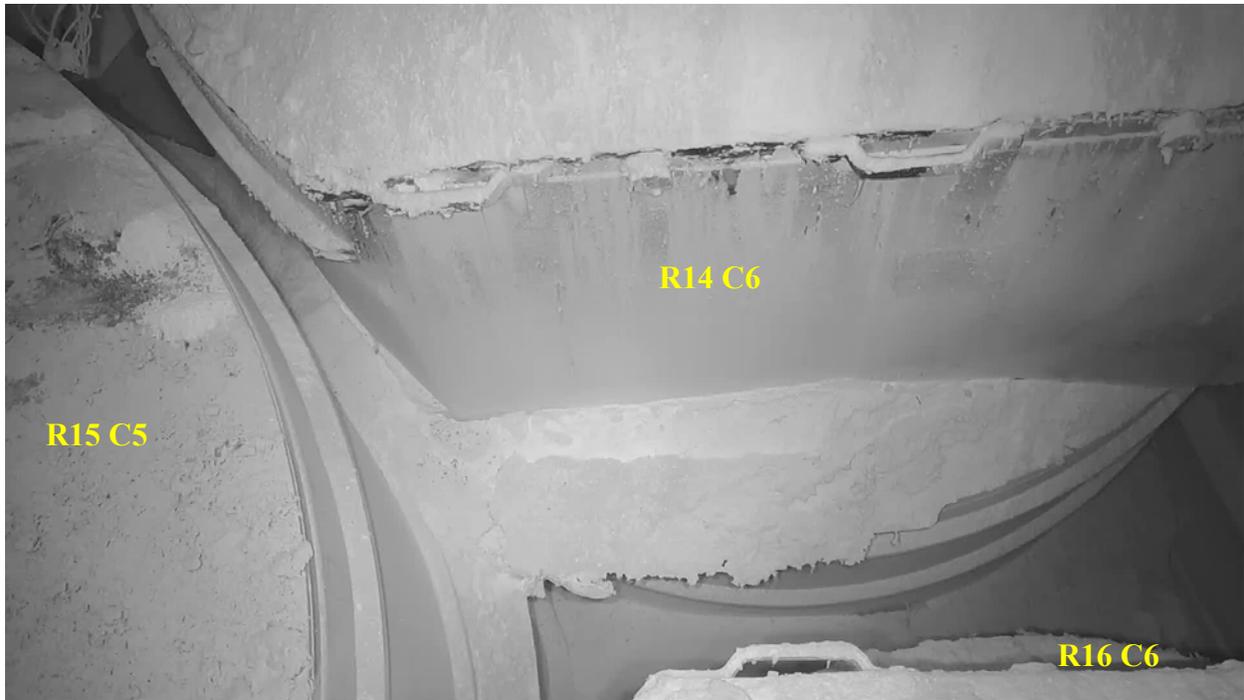
AIB-FST-10038 - R14:C6 show lip/slip sheet with Mg piled on slip sheet and top of TDOP

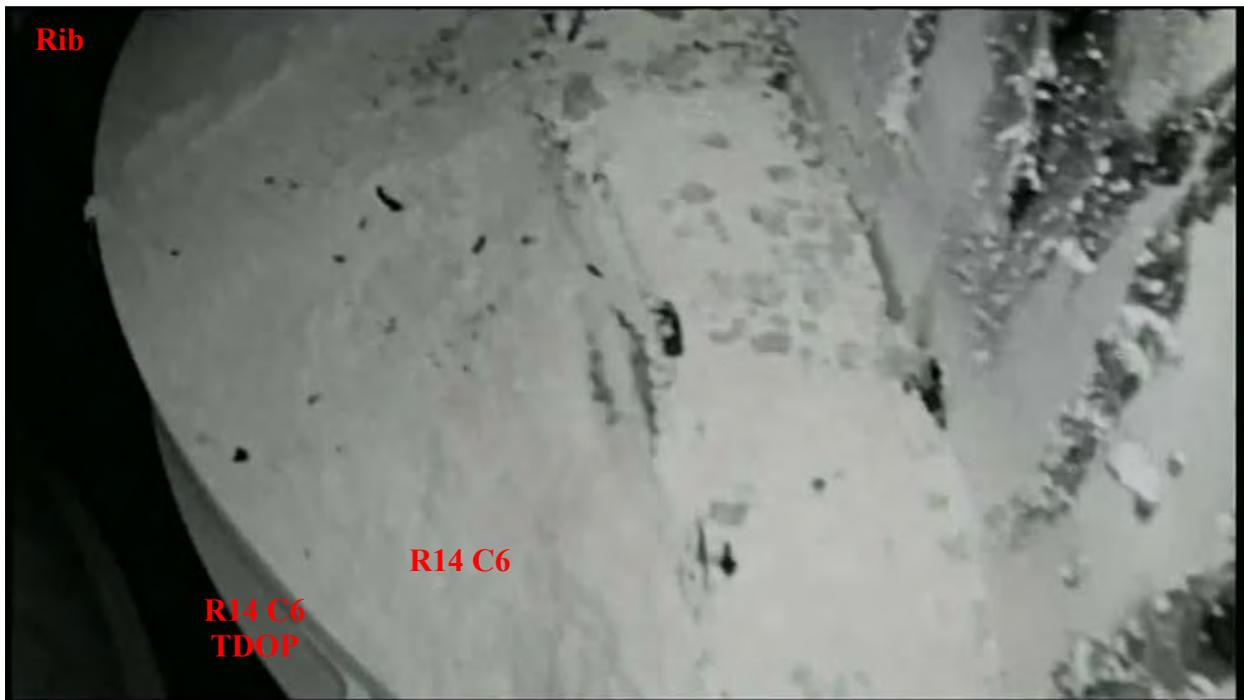
AIB-FST-10040: R14:C6 – Bulkhead (east) view

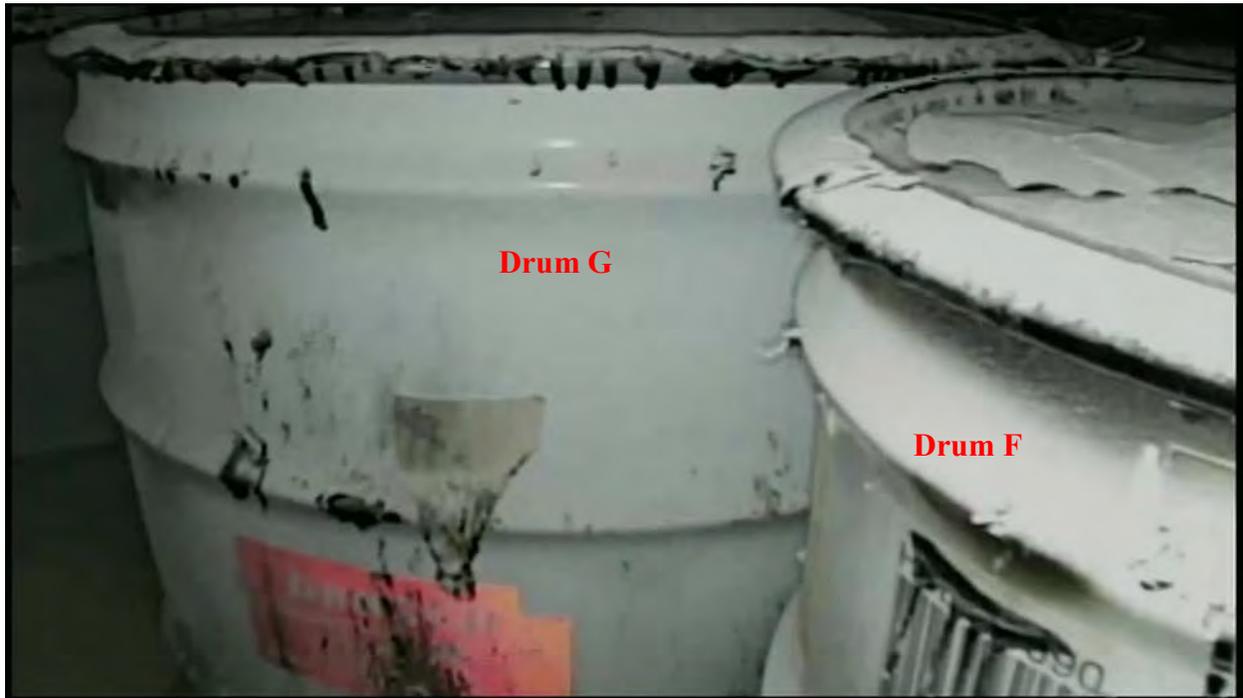
AIB-FST-10067: R9:C5 – Drum F and Drum G

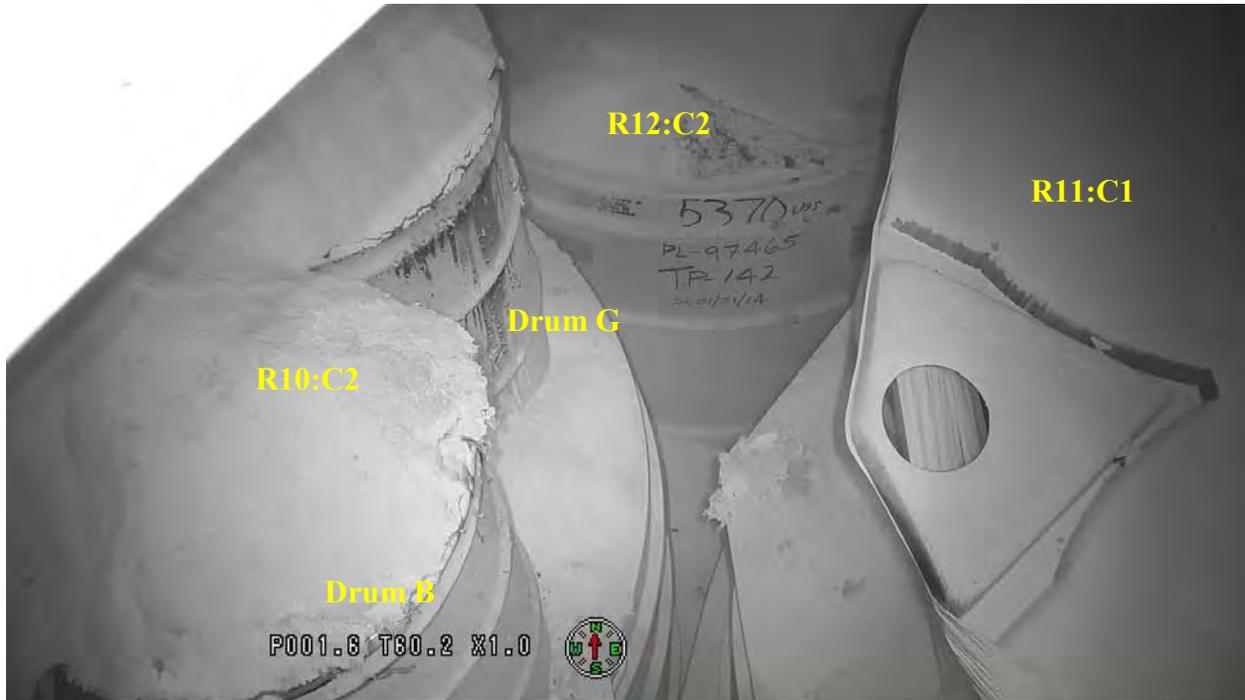
AIB-FST-10111: R10:C2 – Drum B

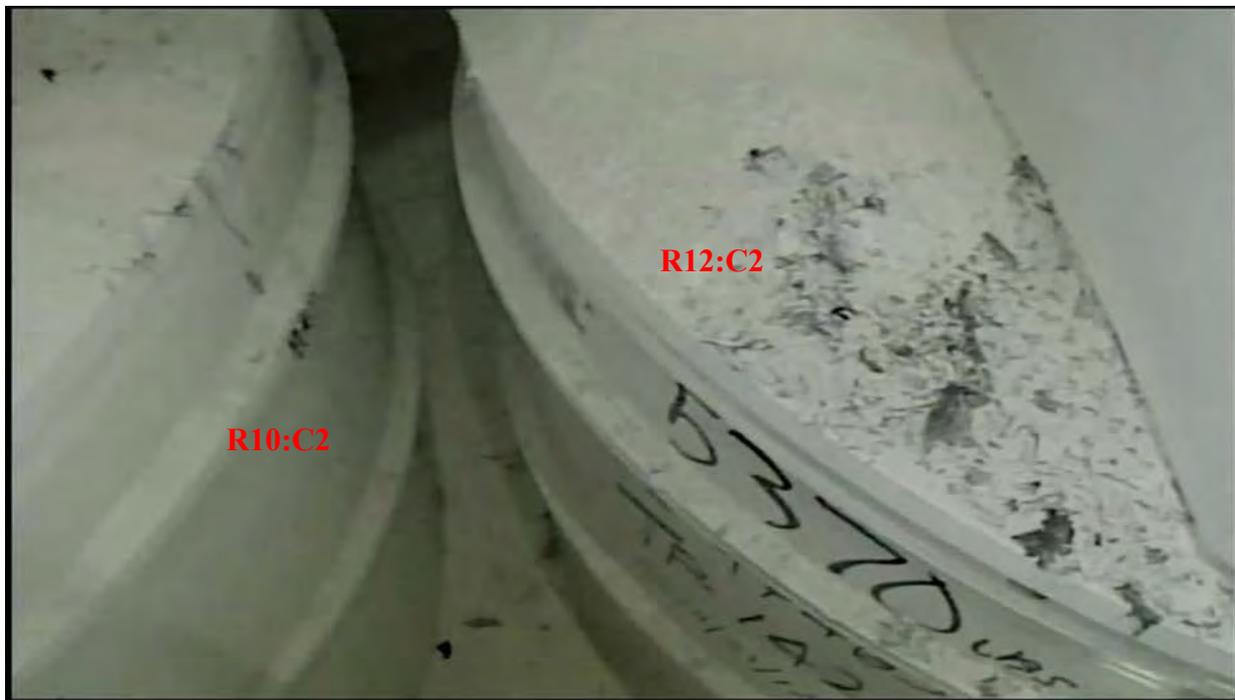
AIB-FST-10113: R10:C2 – Drum G dunnage label

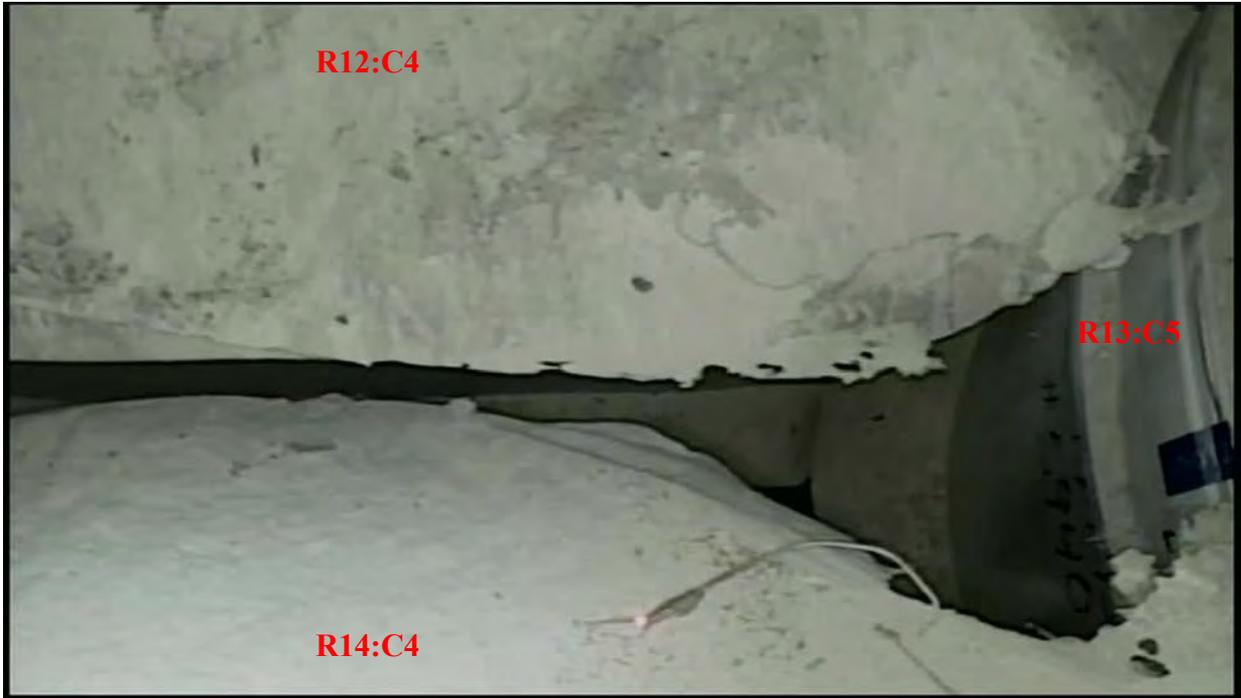
AIB-FST-10123: R13:C5 and R14:C6 – Damage to slip sheet

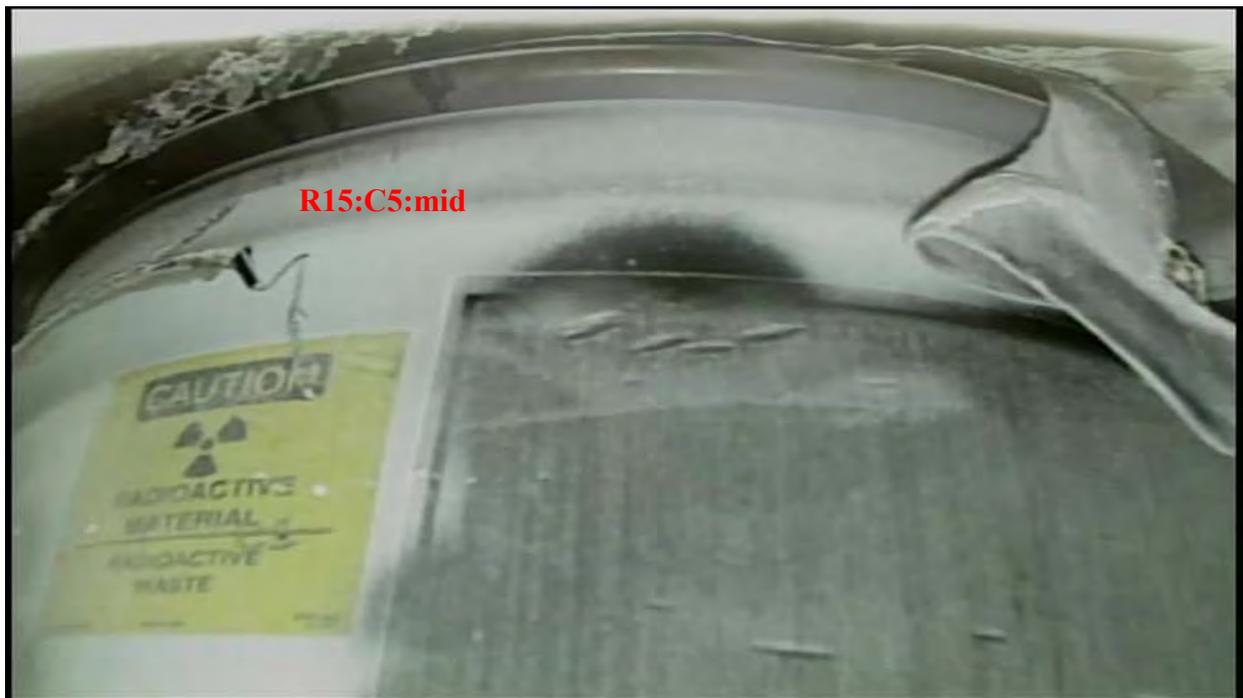
AIB-FST-10128: R13:C5 – Charred stiffener on SWB lid

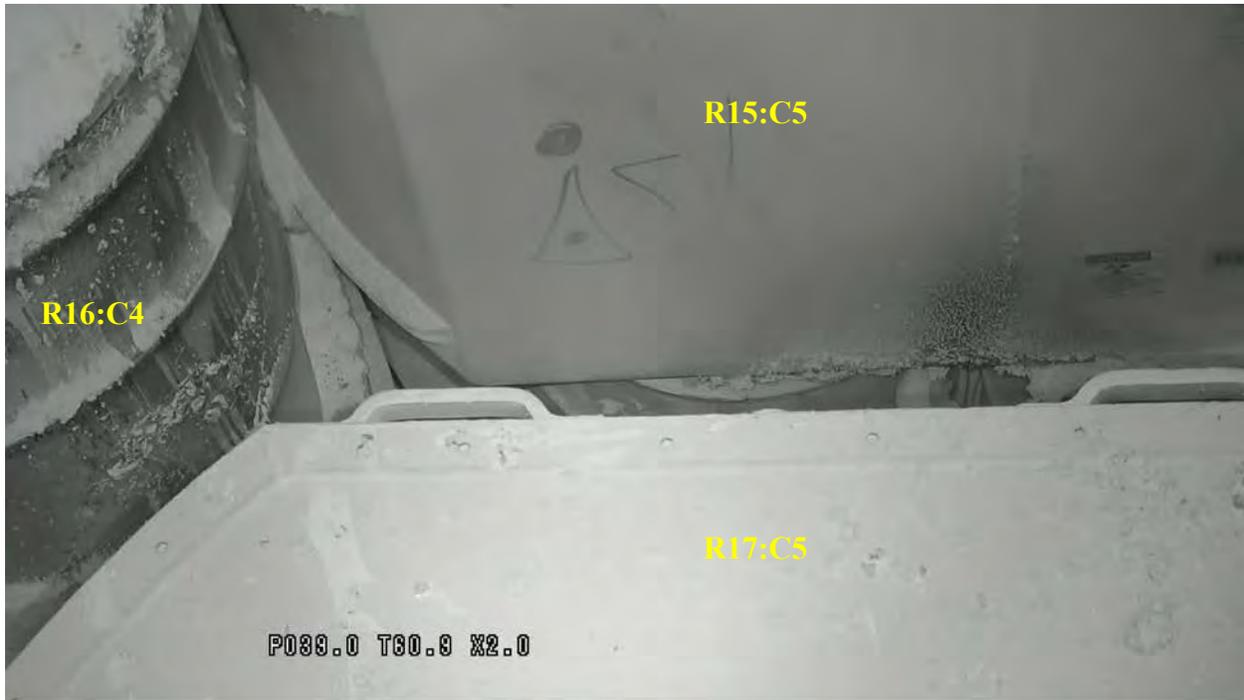
AIB-FST-10167: R15:C5 and R16:C4 – Debris on SWB lid

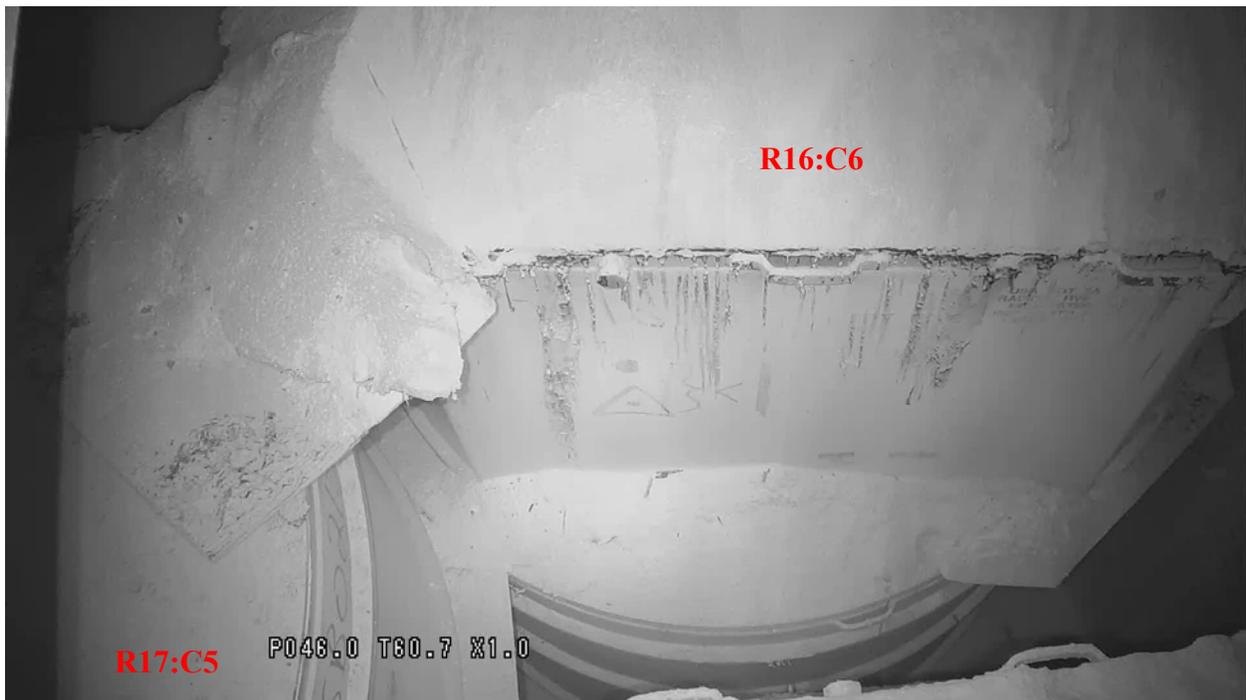
AIB-FST-10201: R16:C6 - Mg slumped against south rib

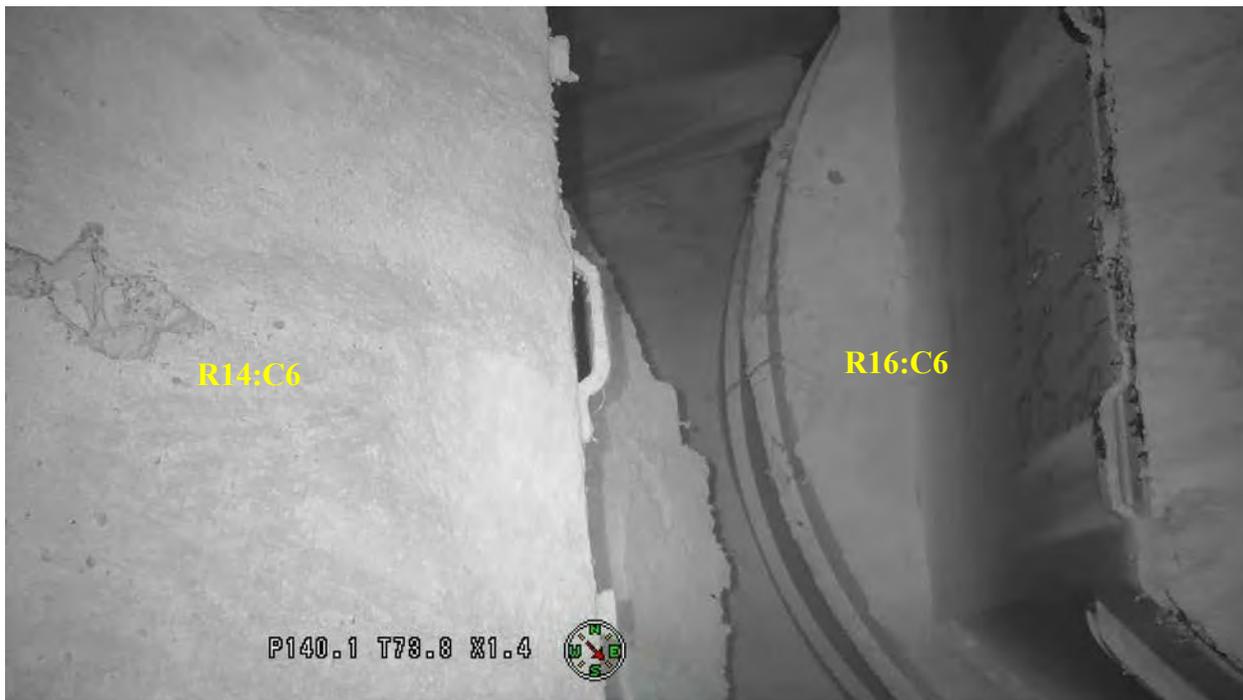
AIB-FST-10207: R15:C5, R16:C6, and R17:C5 – Mg buildup on floor

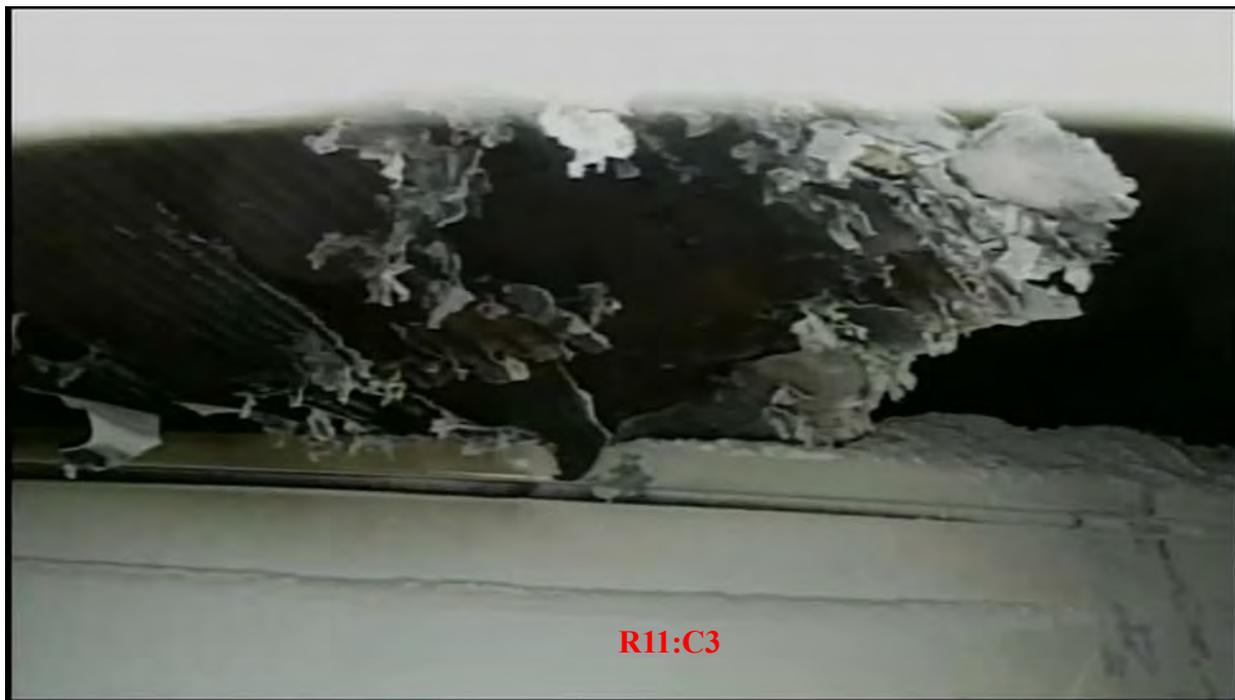
AIB-FST-10221: R11:C3 and R12:C4 – Underside of cardboard stiffener bridge

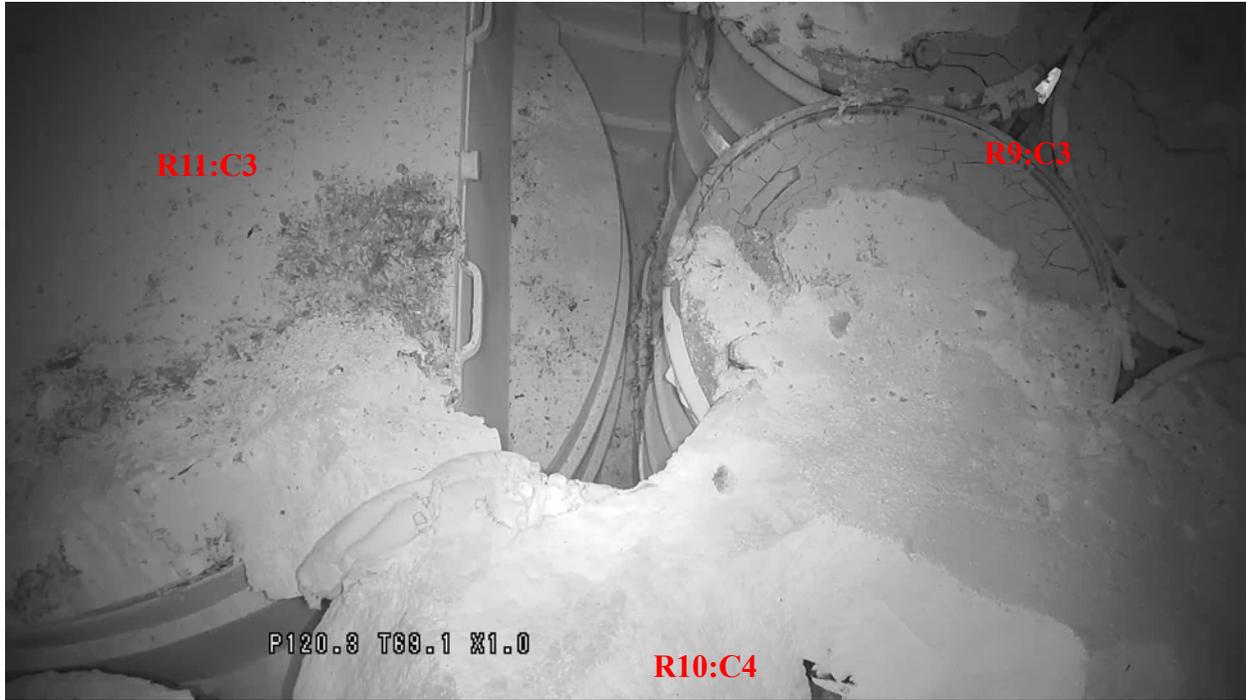
AIB-FST-10226: R10:C4, R11:C3 and R12:C4 – Mg buildup on floor

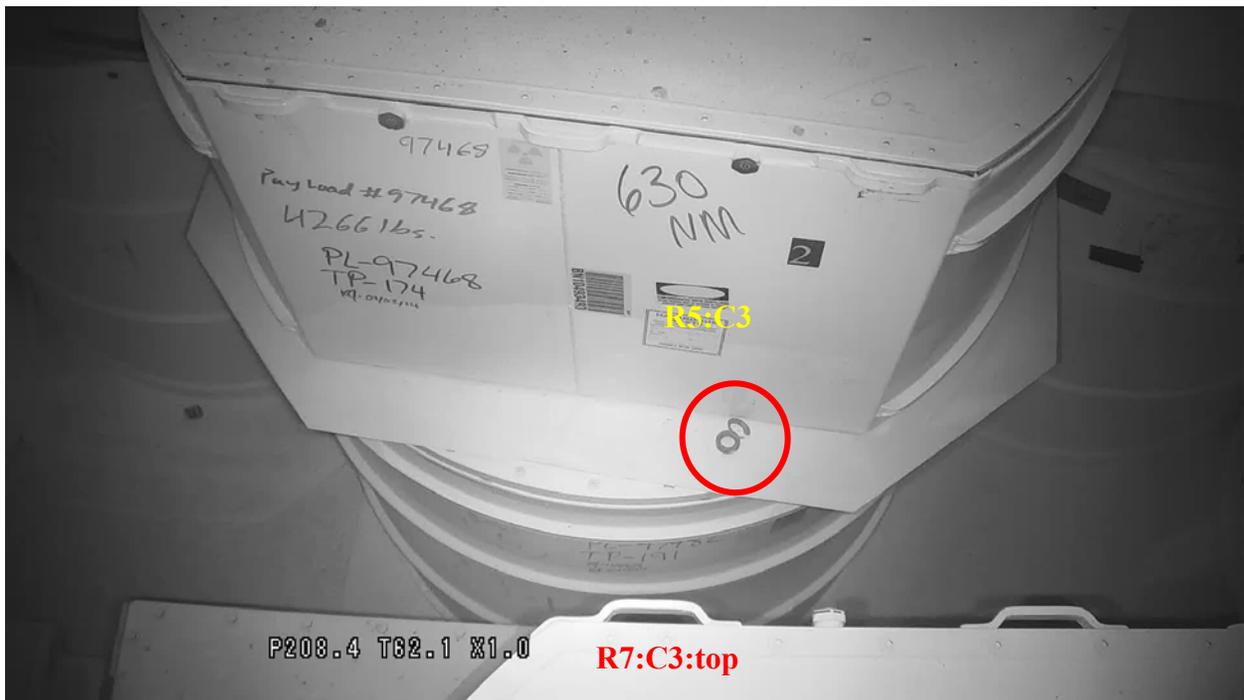
AIB-FST-10238: R5:C3 – Rock bolt retaining rings

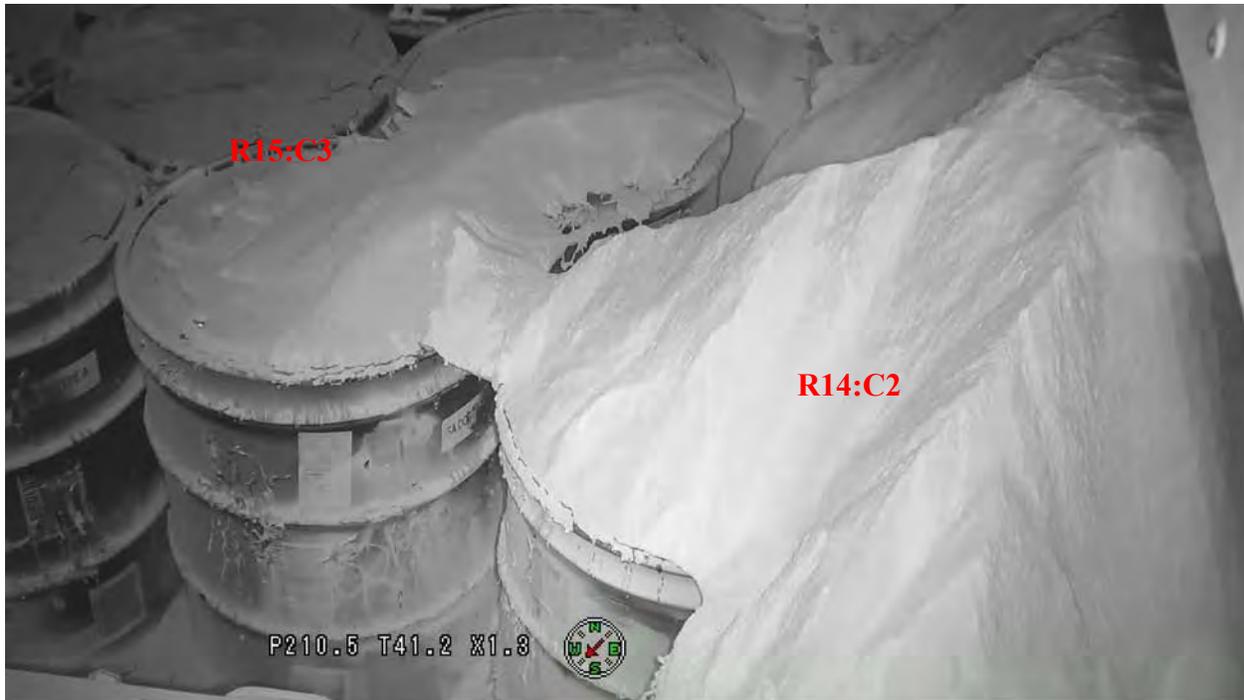
AIB-FST-10253: R14:C2 and R15:C3 – Cardboard stiffener bridge
