U.S. Department of Energy Office of Environmental Management

Fire Forensic Analysis of the Radiological Release Event at the Waste Isolation Pilot Plant on February 14, 2014

April 6, 2015

**Prepared in Support of the U.S. DOE Accident Investigation
Board for the Radiological Release Event at the Waste
Isolation Pilot Plant on February 14, 2014**

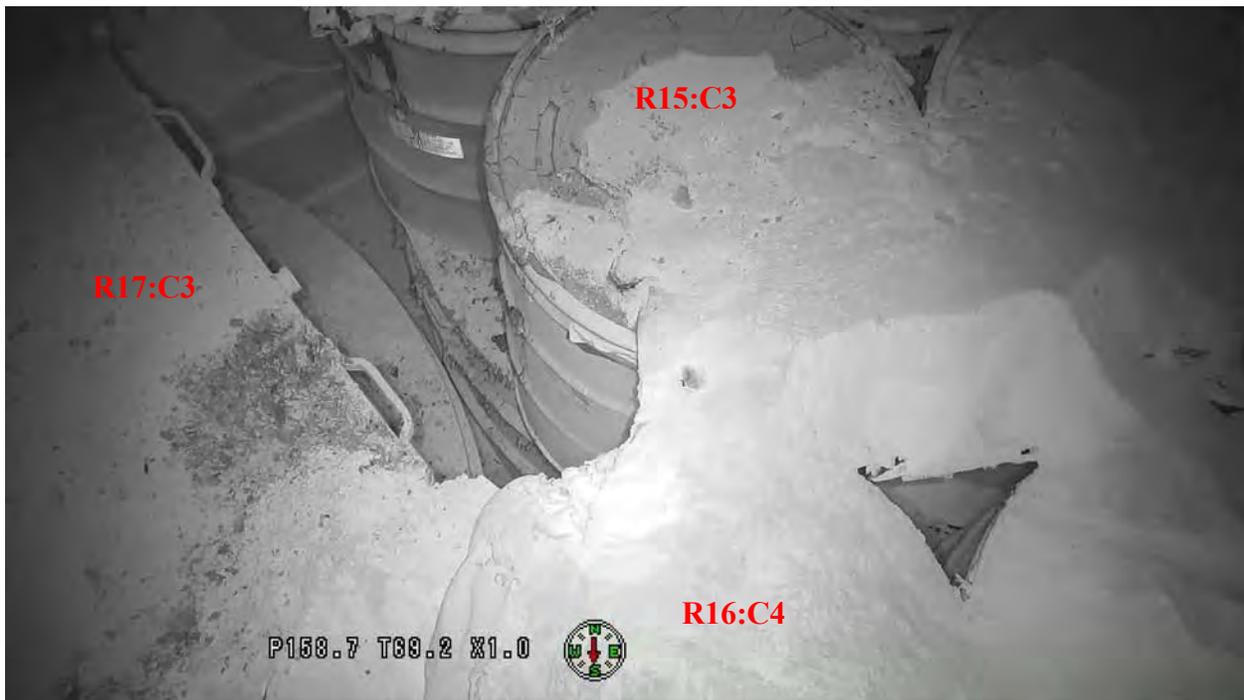
AIB-FST-10256 – R15:C3 and R16:C4 – Cardboard stiffener bridge

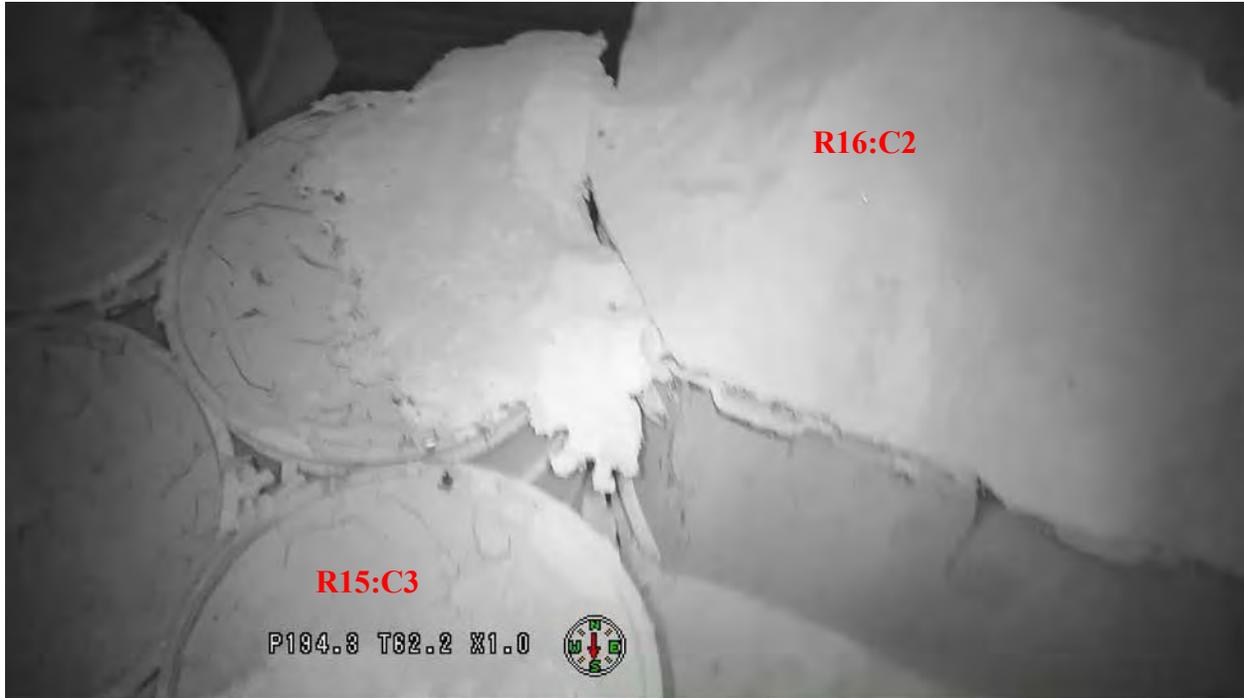
AIB-FST-10257: R15:C3 and R16:C2 – Cardboard stiffener bridge

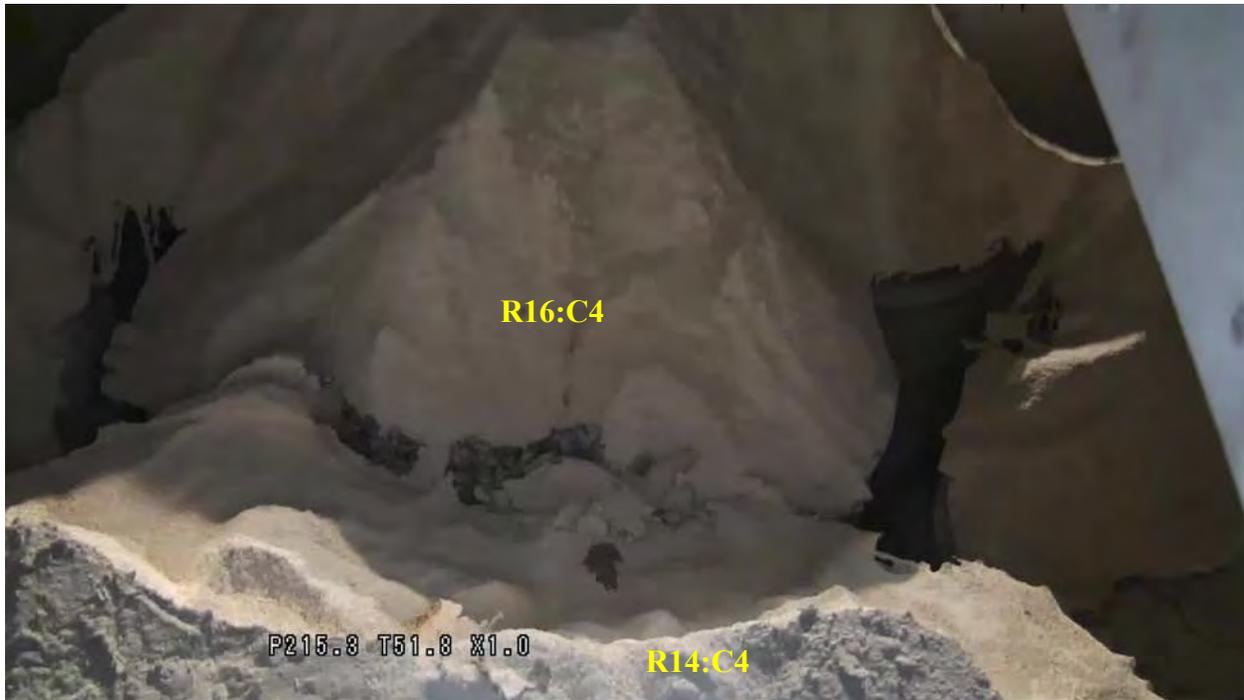
AIB-FST-10273: R13:C5 and R14:C4 – Cardboard stiffener bridge

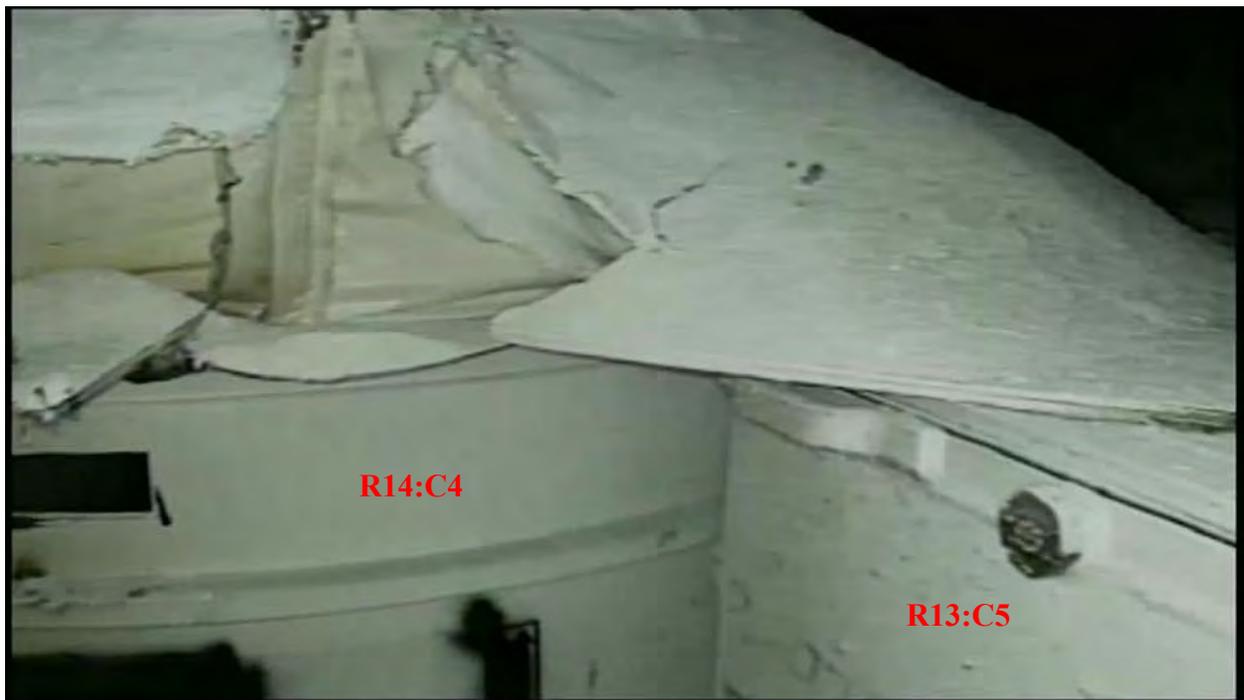
AIB-FST-10278: R13:C5 and R14:C4 – Cardboard stiffener bridge

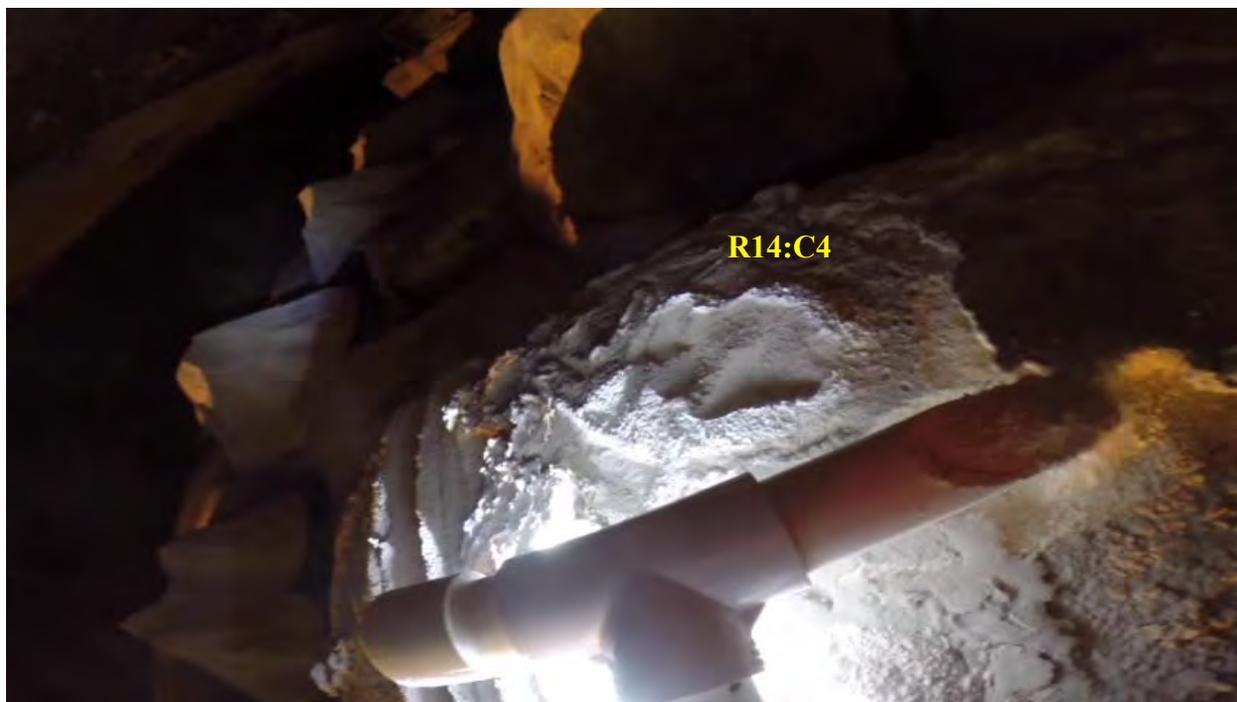
AIB-FST-10279: R14:C4 – Sample tool over residual MgO

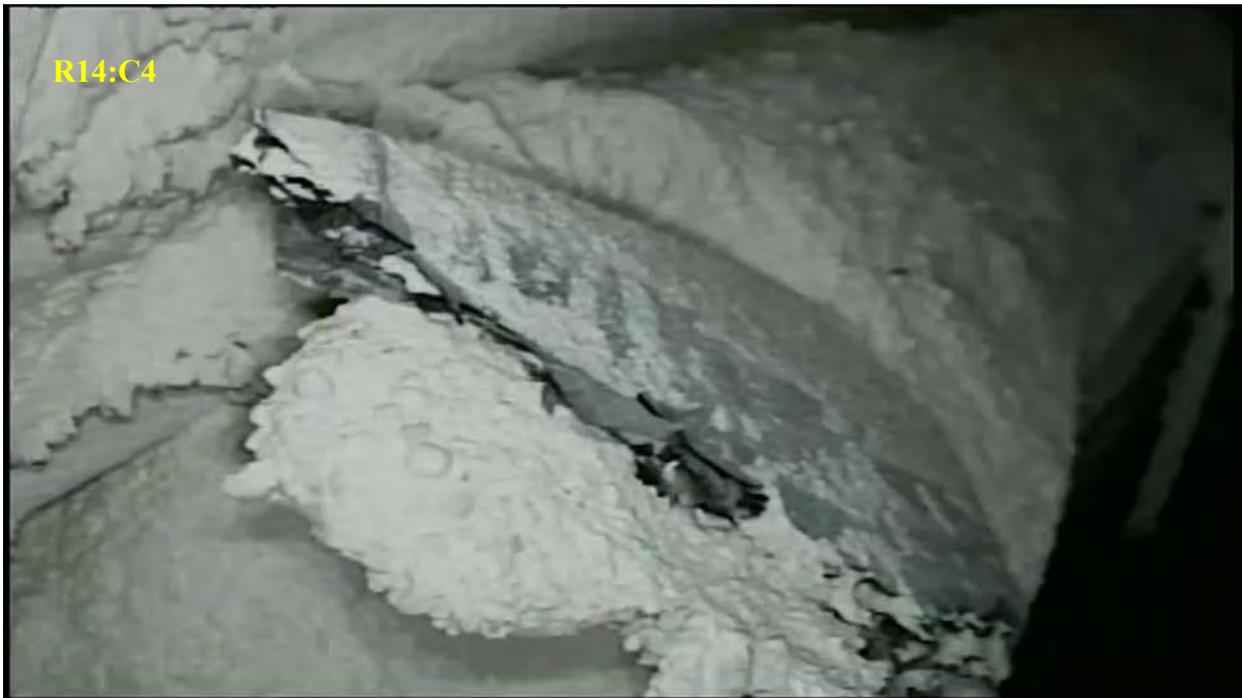
AIB-FST-10284: R14:C4 – Charred stiffener

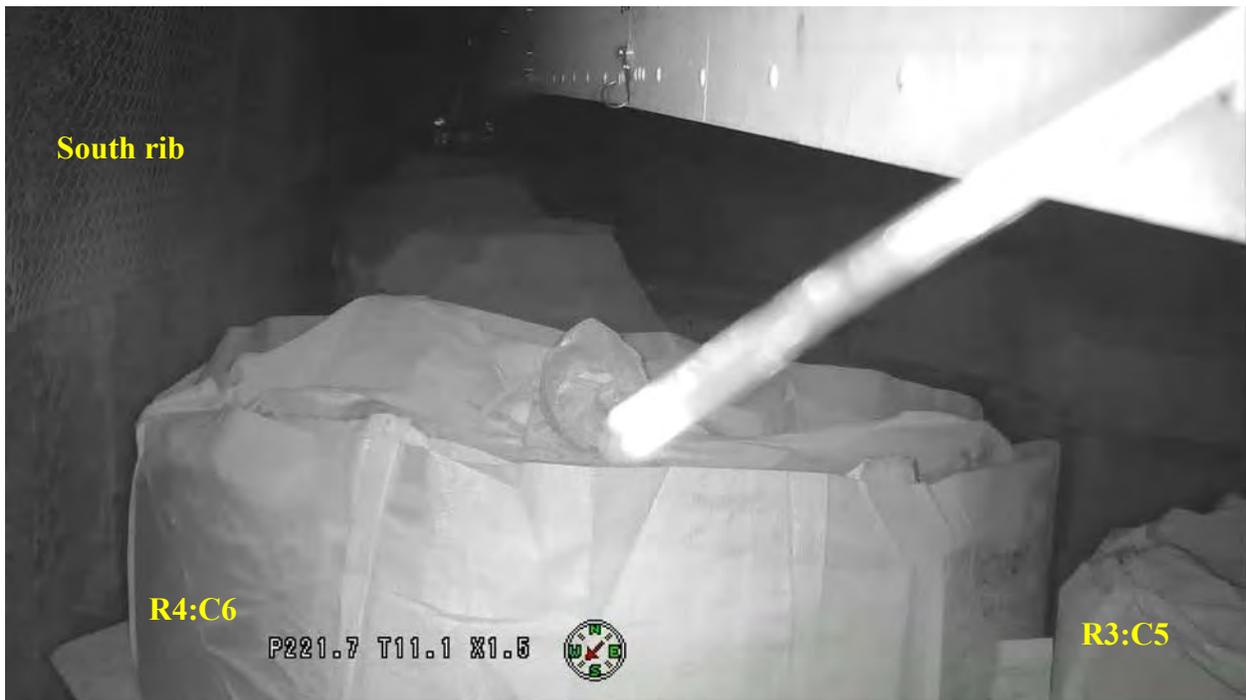
AIB-FST-10310: R4:C6 - Top of MgO super sack

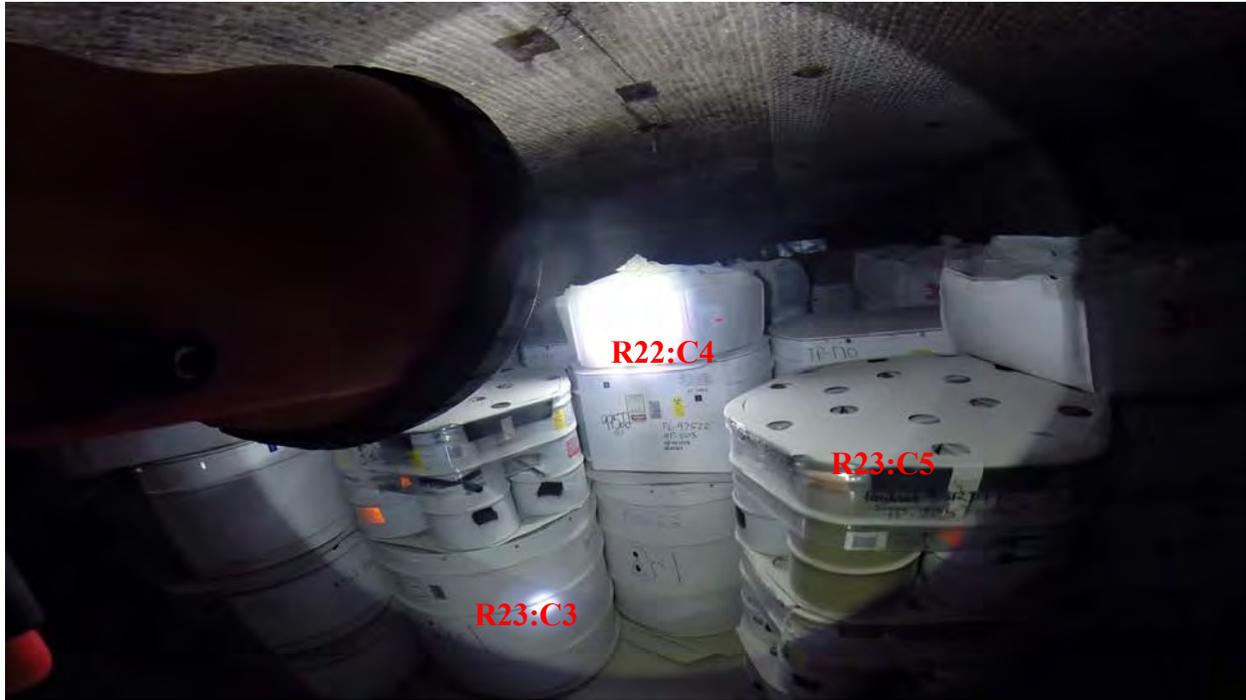
AIB-FST-10319: R20:C4, R21:C5 and R22:C4 – MgO buildup on floor,

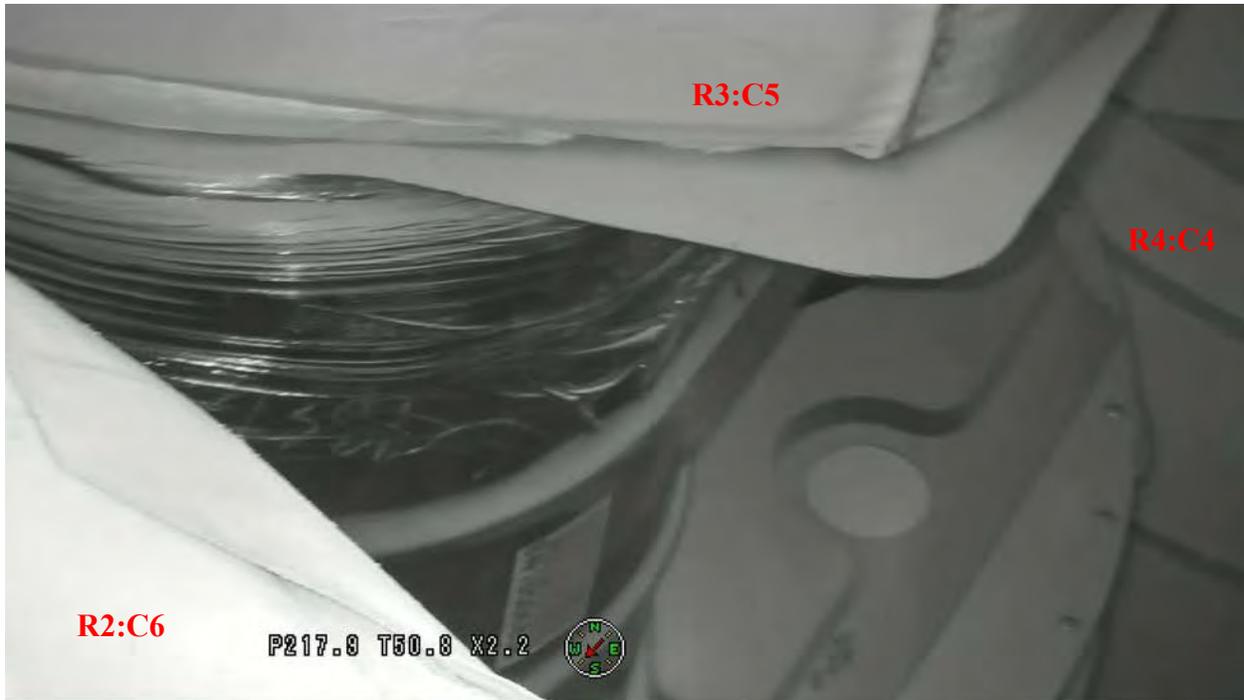
AIB-FST-10339: Top of MgO super sack showing tied closure.

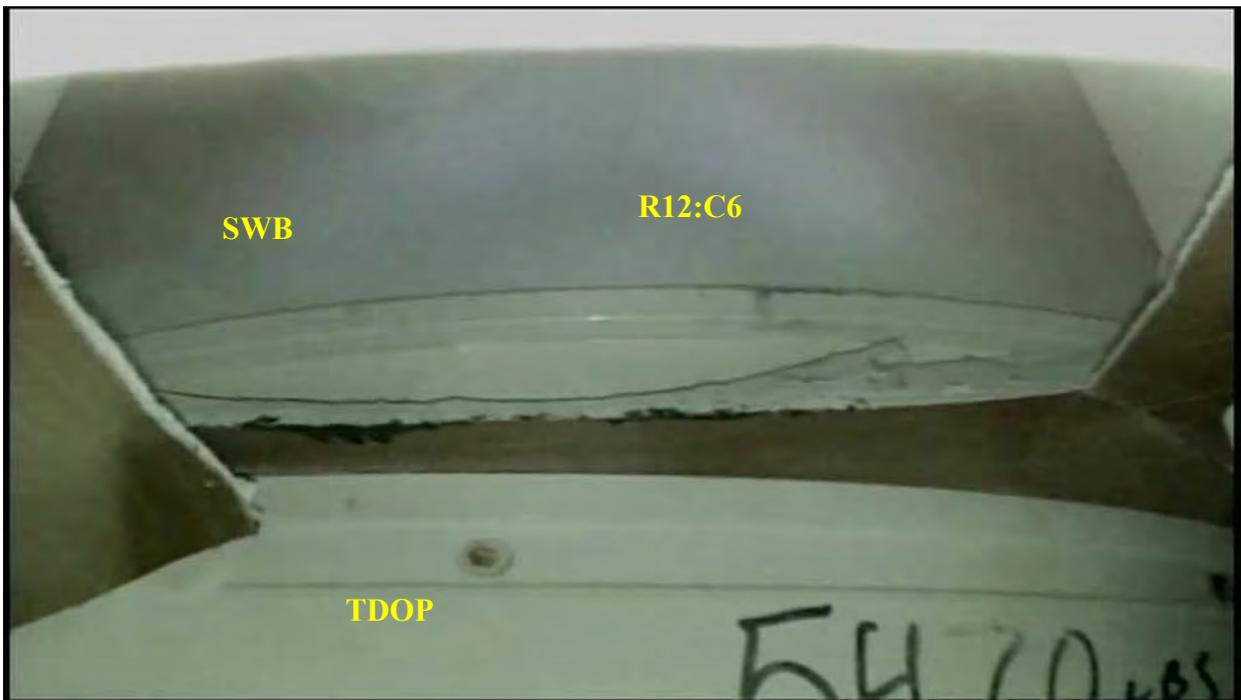
AIB-FST-10408: R11:C5 – Cardboard stiffener from R12:C6

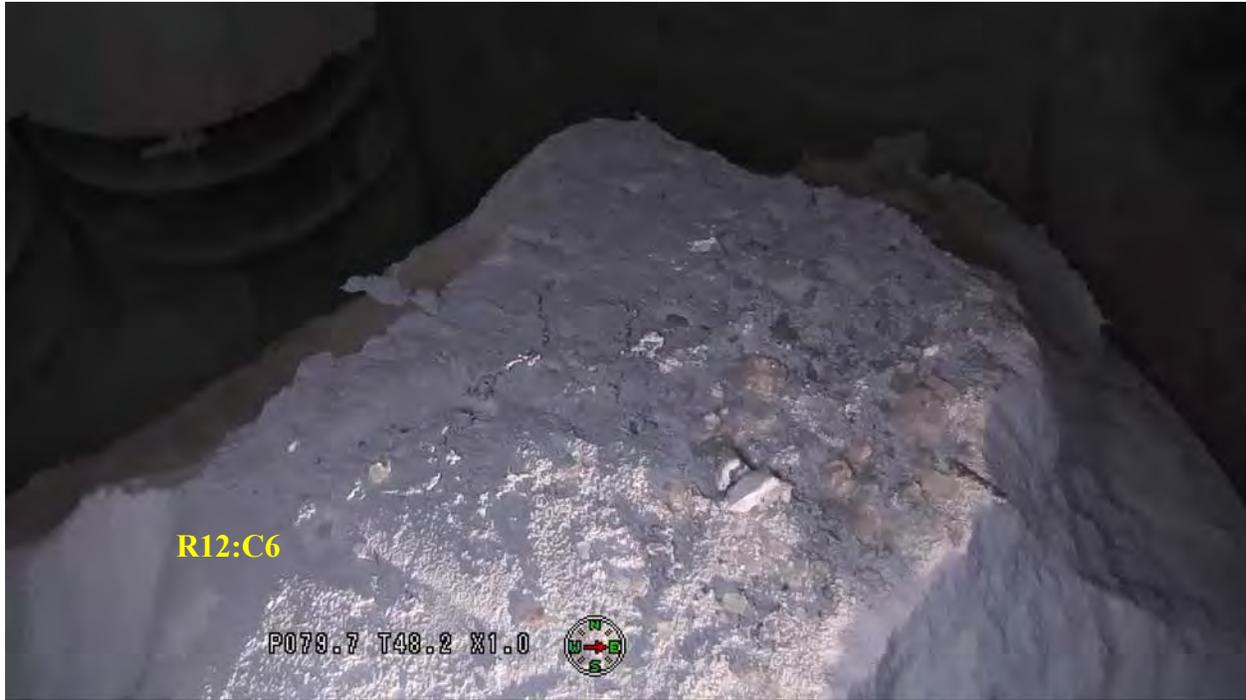
AIB-FST-10413: R10:C6 and R12:C6 - Remnant super sack

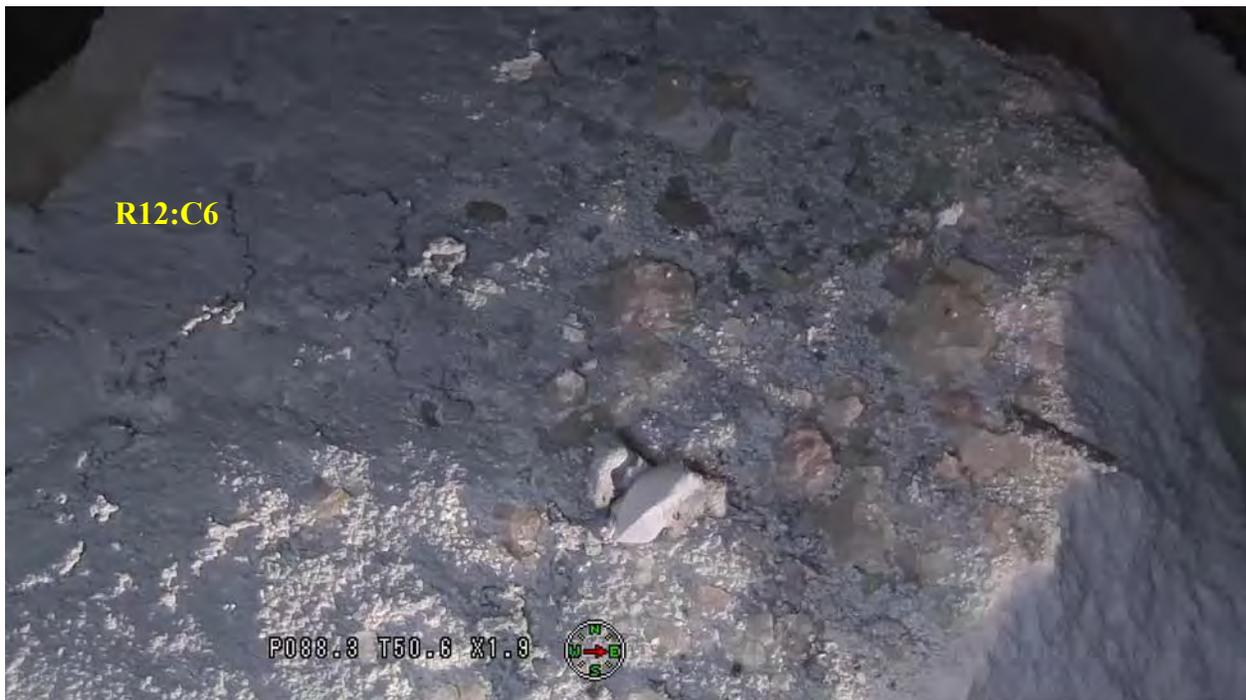
AIB-FST-10414: R12:C6 – Debris on residual MgO pile

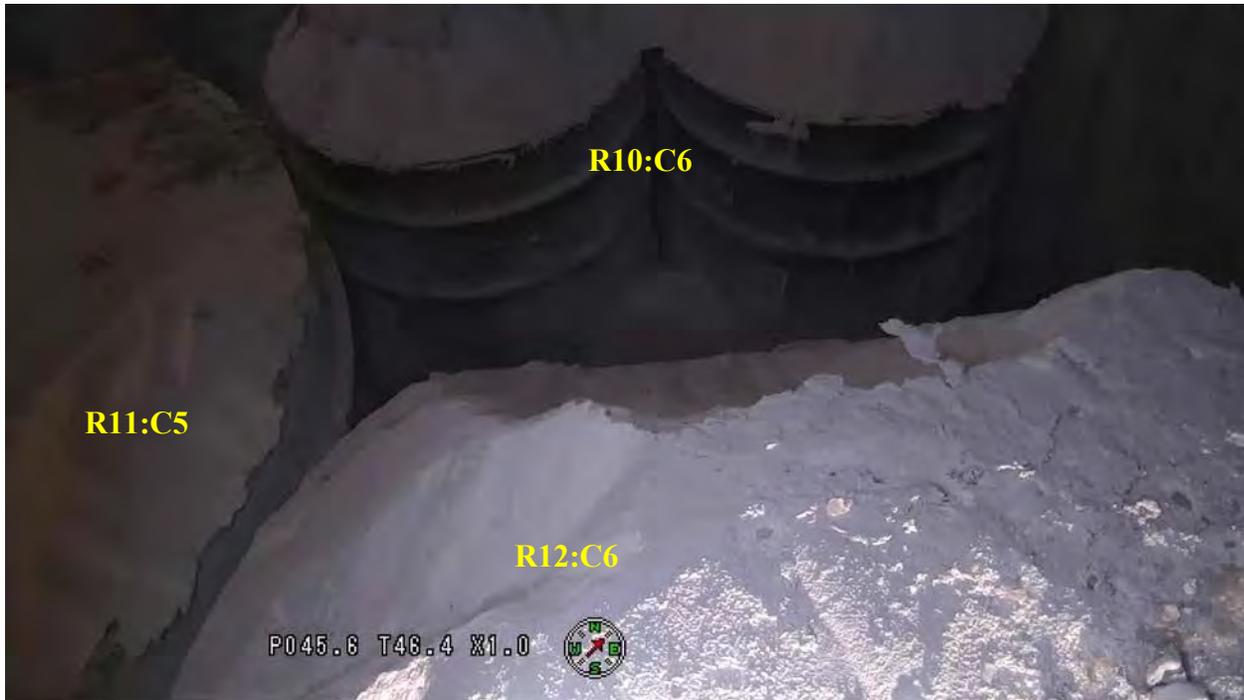
AIB-FST-10415: R12:C6 – Debris on residual MgO pile

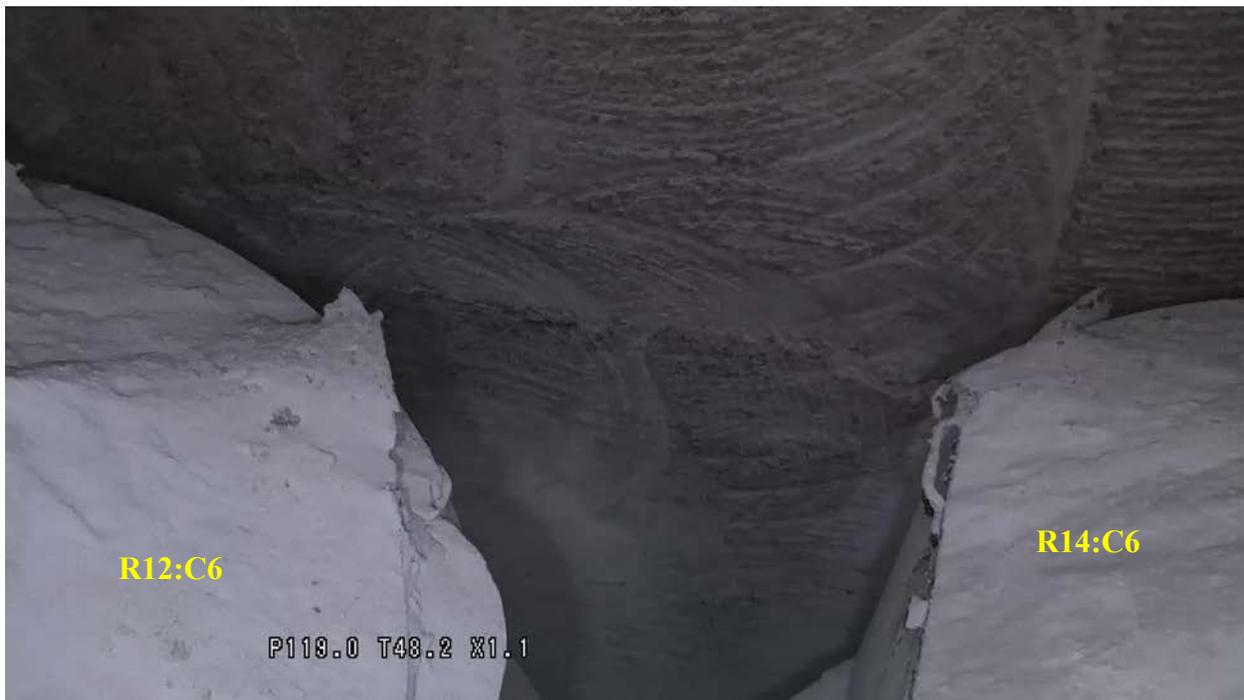
AIB-FST-10416: R12:C6 – Melted fabric remnants on residual MgO pile

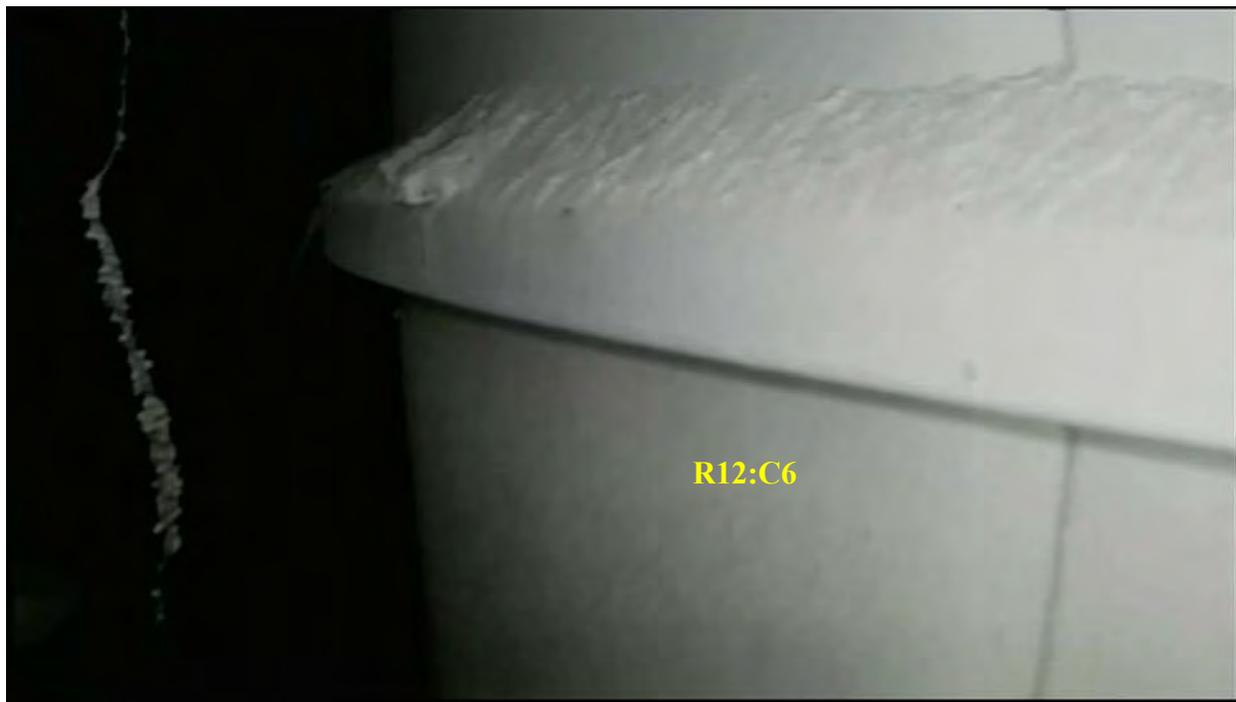
AIB-FST-10420: R12:C6 – Bulkhead (east) view - Crease in TDOP wall below top bumper

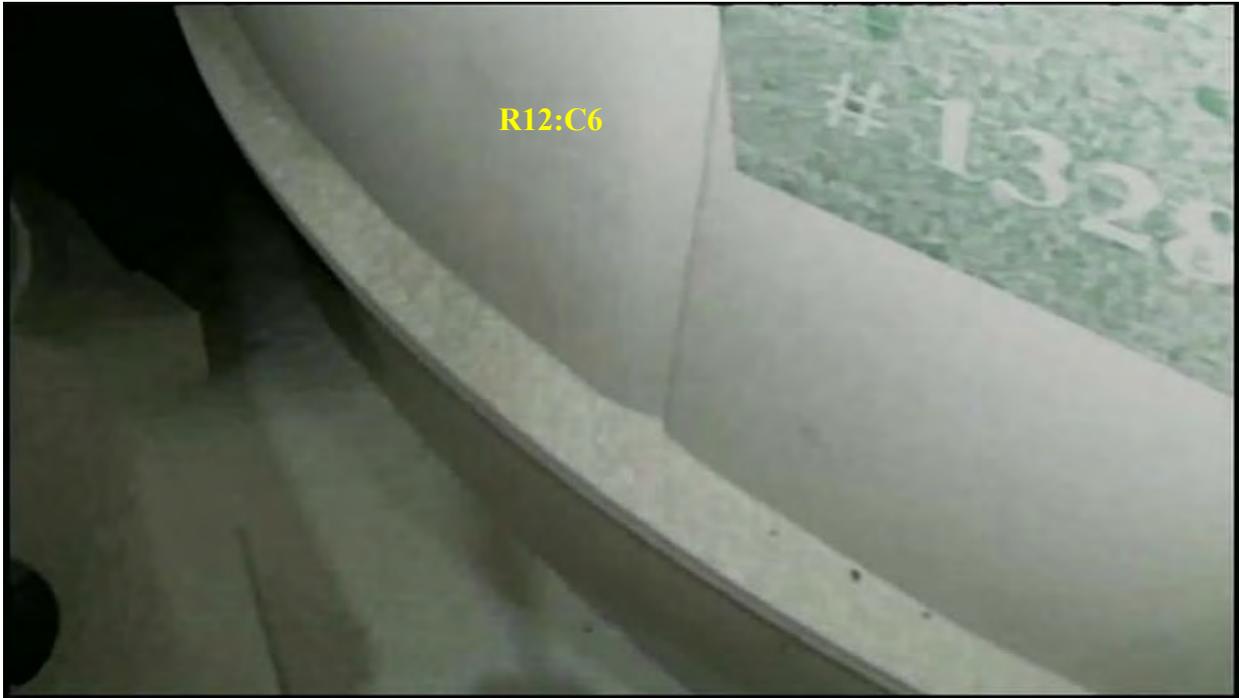
AIB-FST-10421: R12:C6 – Bulkhead (east) view - Crease in TDOP wall at middle bumper

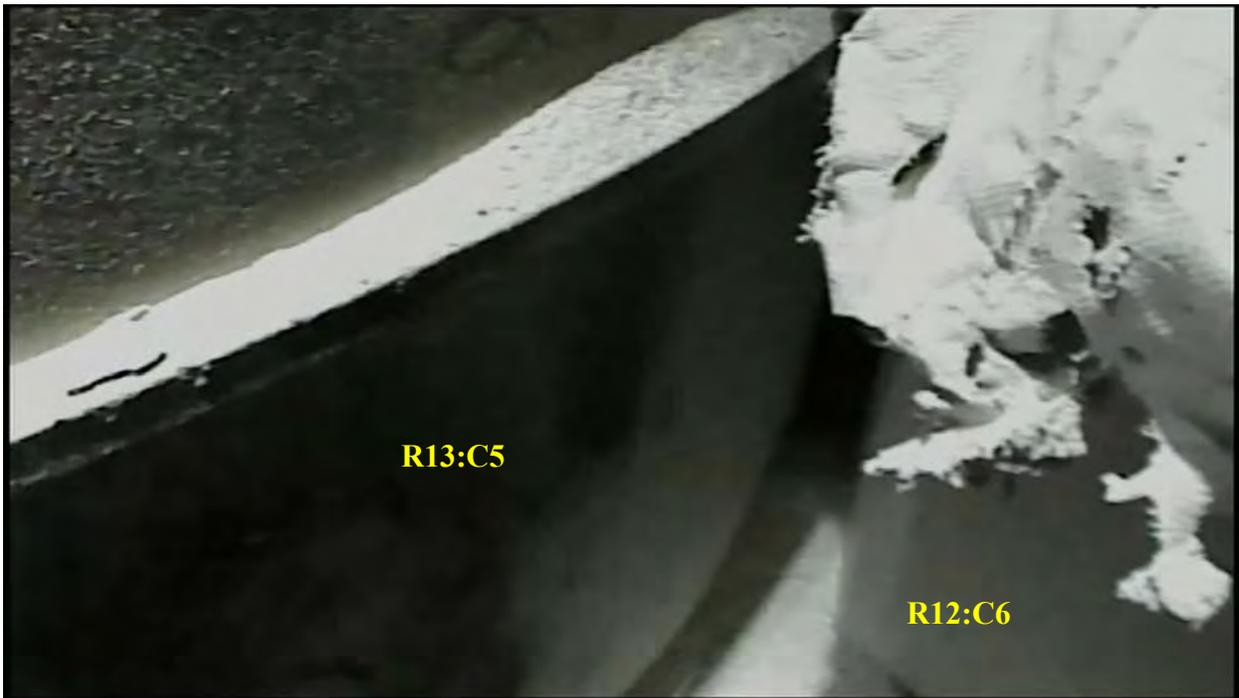
AIB-FST-10422: R12:C6 – Bulkhead (east) view - Crease in TDOP wall at bottom bumper

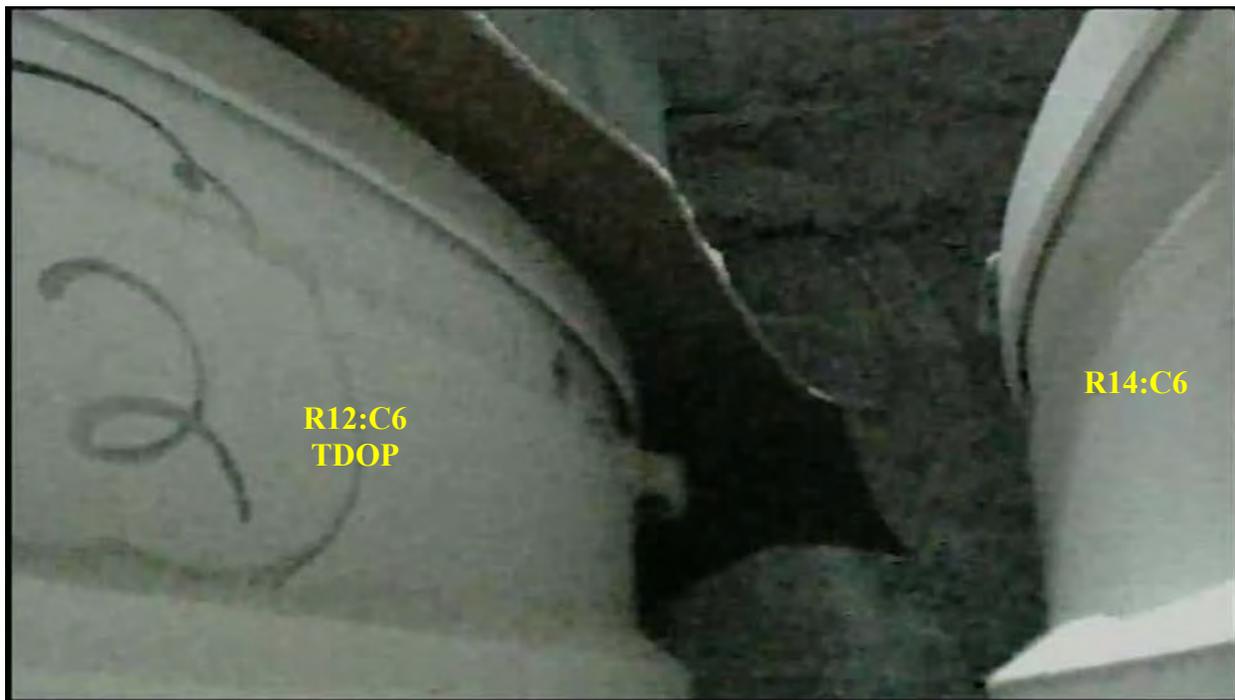
AIB-FST-10424: R12:C6 and R13:C5 – Underside of SWB slip sheet

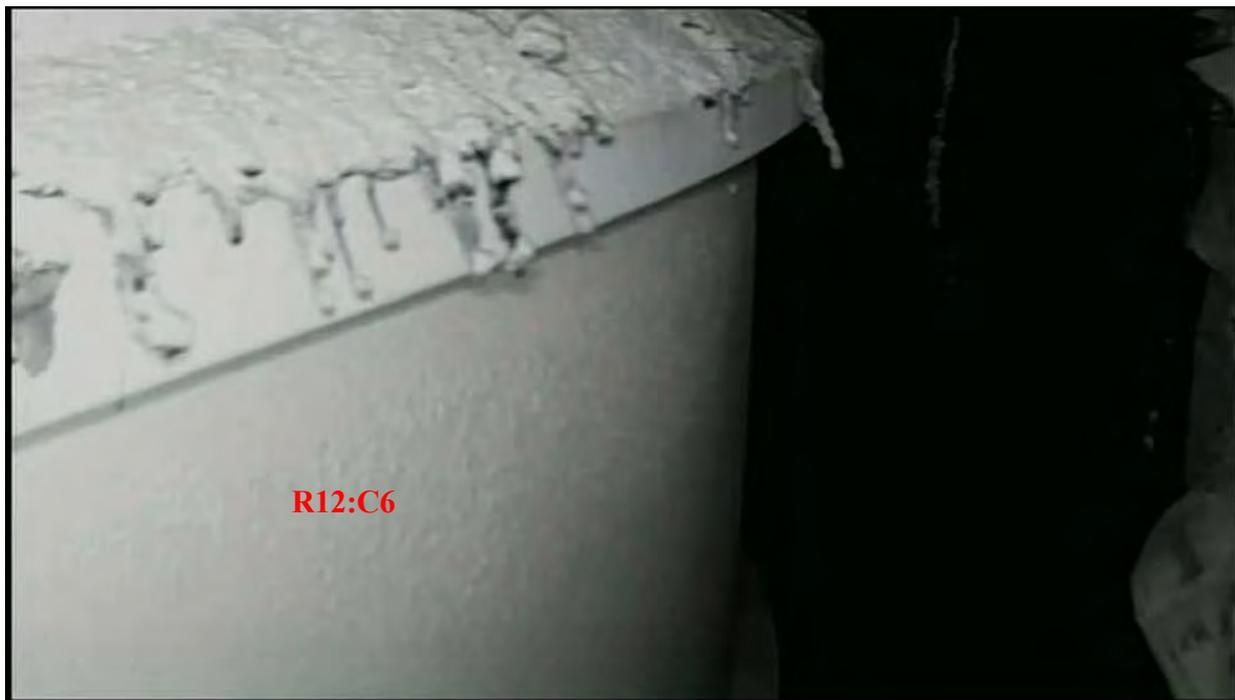
AIB-FST-10430: R12:C6 – South view of SWB slip sheet

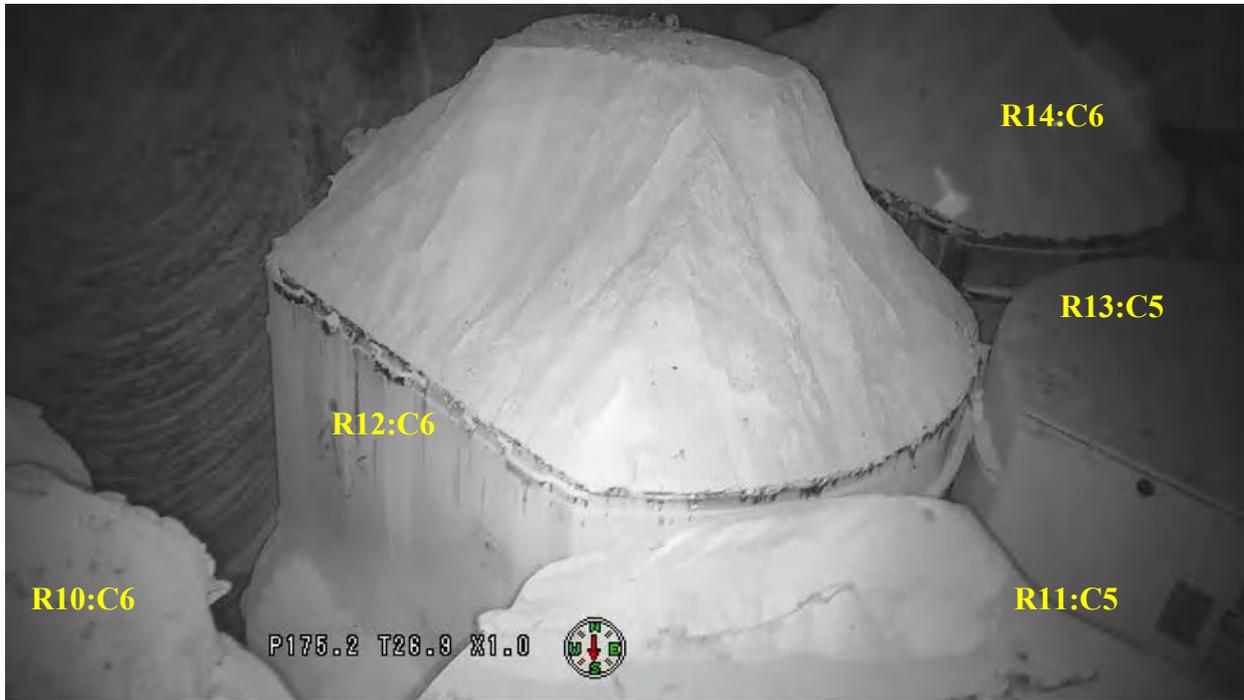
AIB-FST-10431: R12:C6 – Bulkhead face (east) view

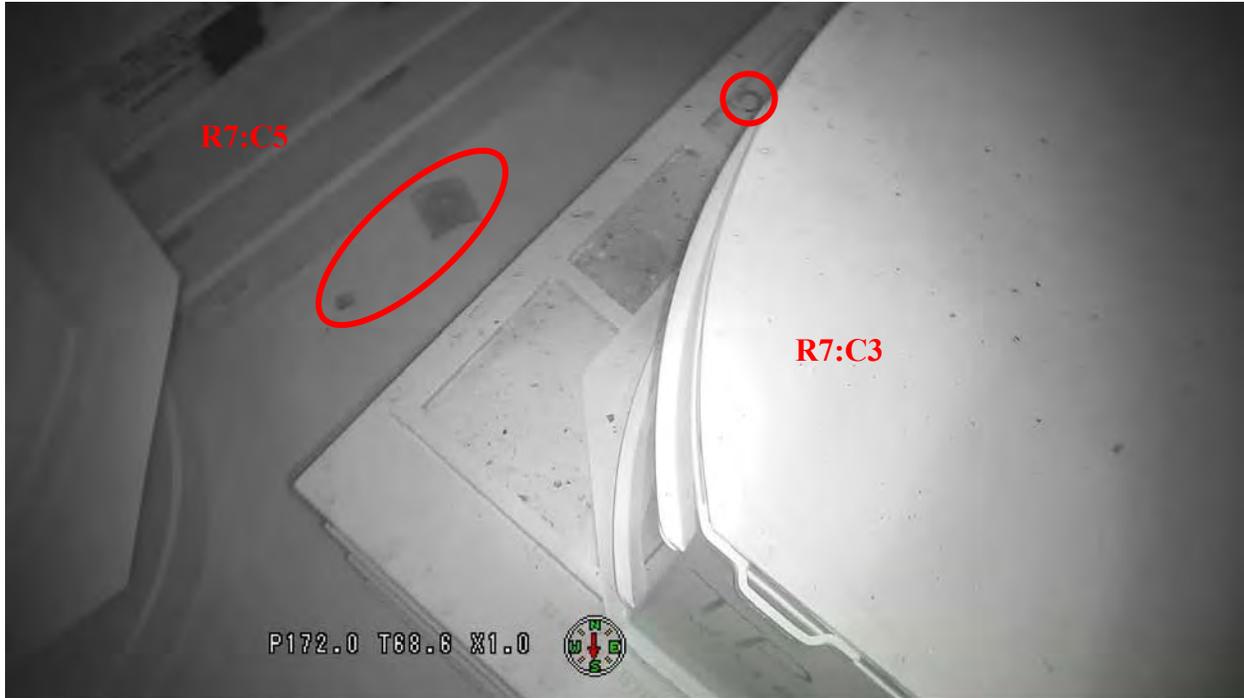
AIB-FST-10433: R7:C3 and R7:C5 – Rock bolt debris on SLB2 and floor

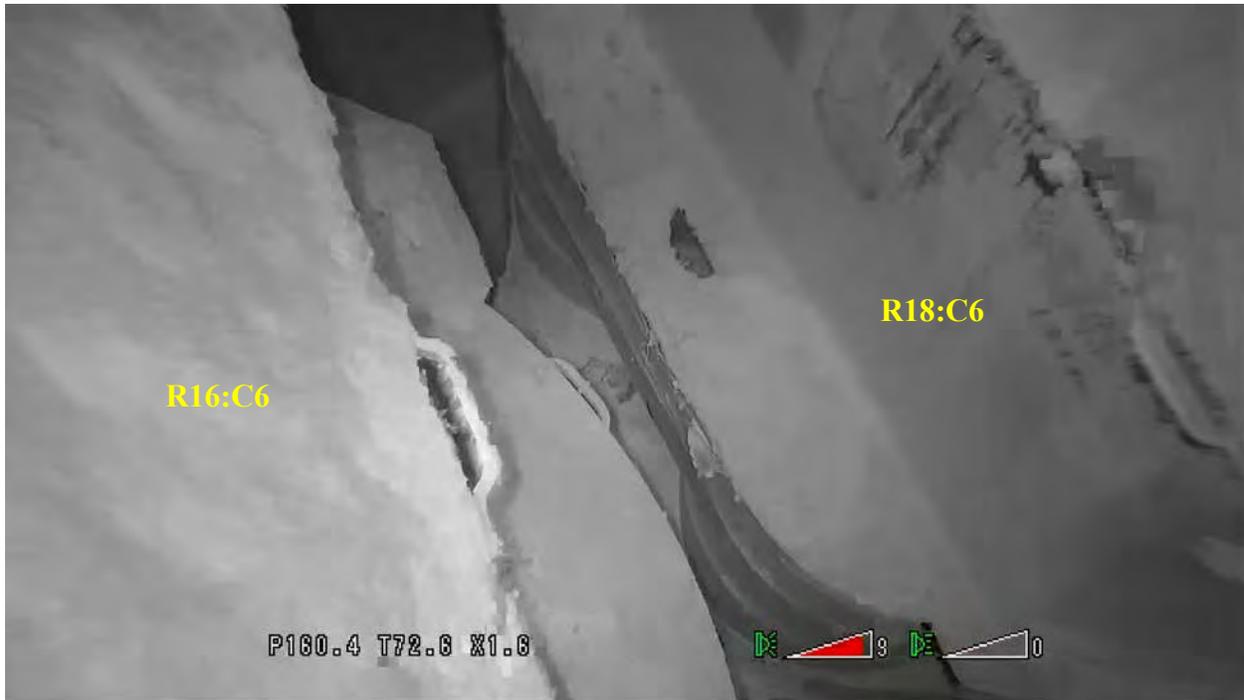
AIB-FST-10449: R18:C6 – Dark area on south rib

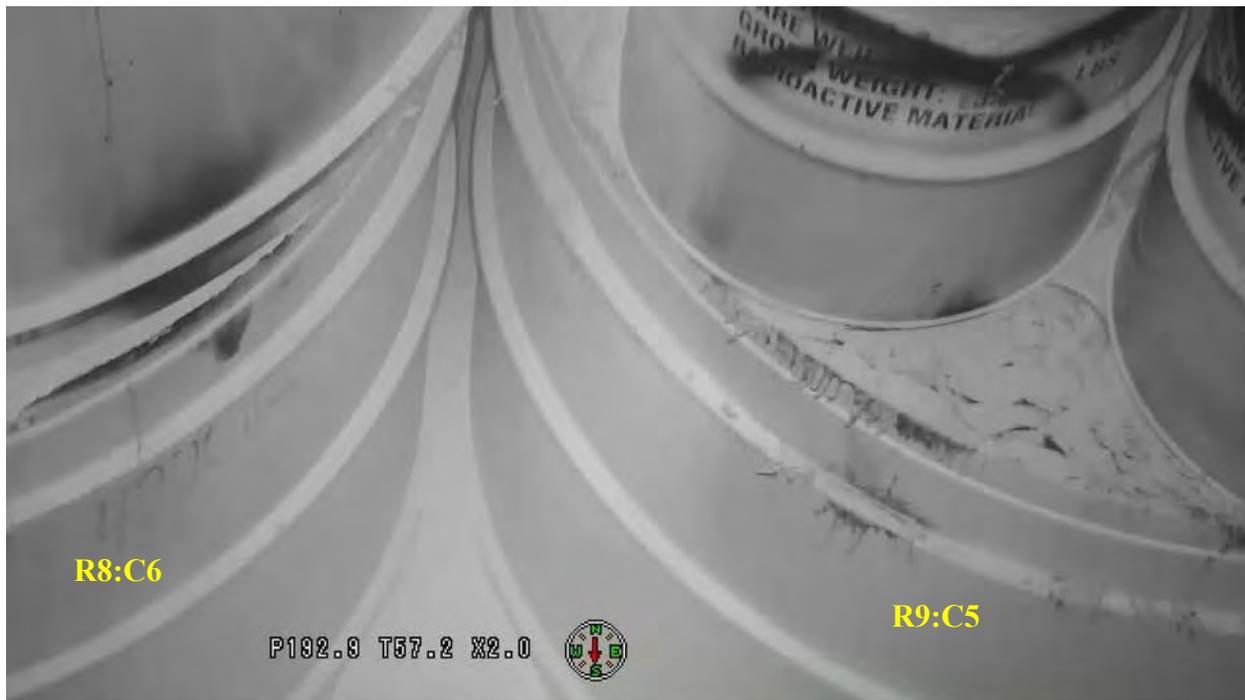
AIB-FST-10479: R8:C6 – Bulkhead (east) view – Damaged Mg super sack fabric

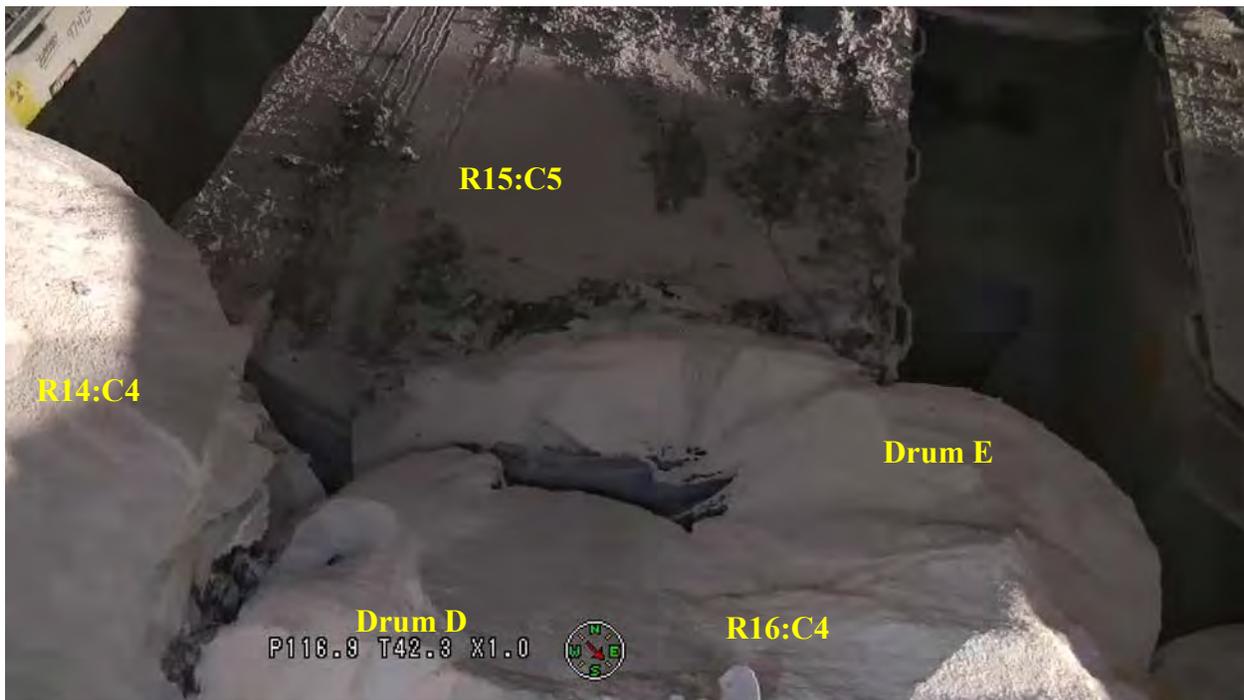
AIB-FST-10522: R16:C4 – Residual Mg

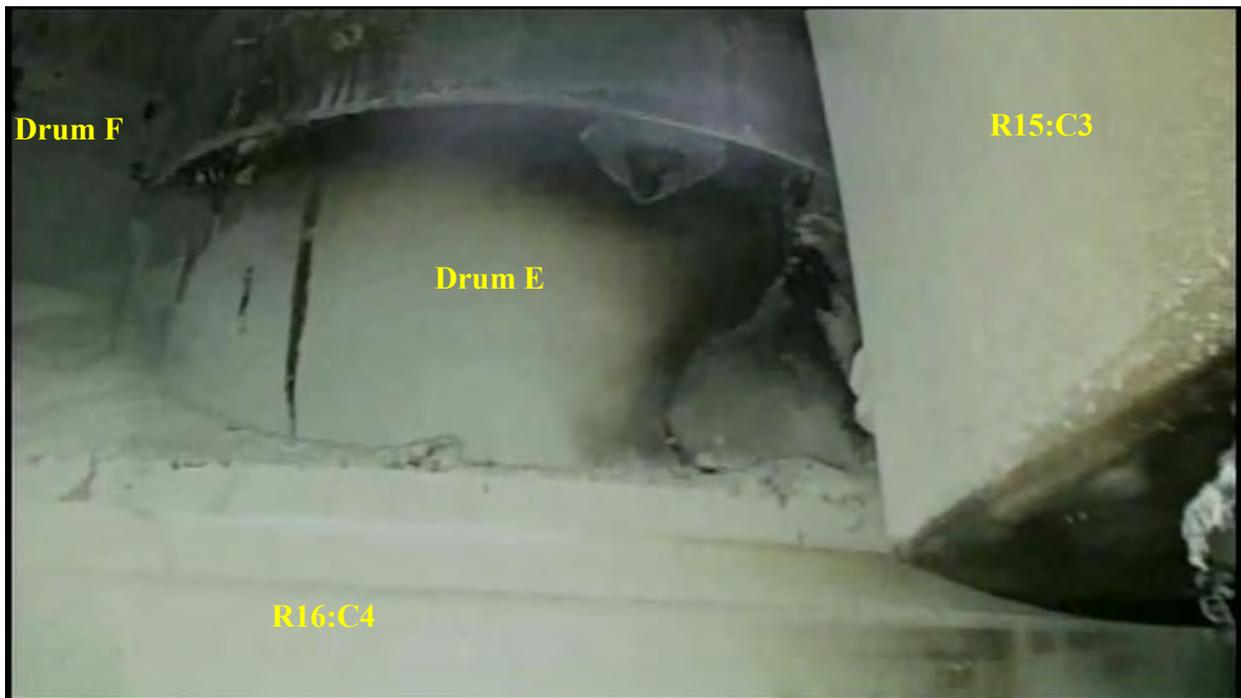
AIB-FST-10529: R16:C4 – Waste drum 68660 – Clean burn area

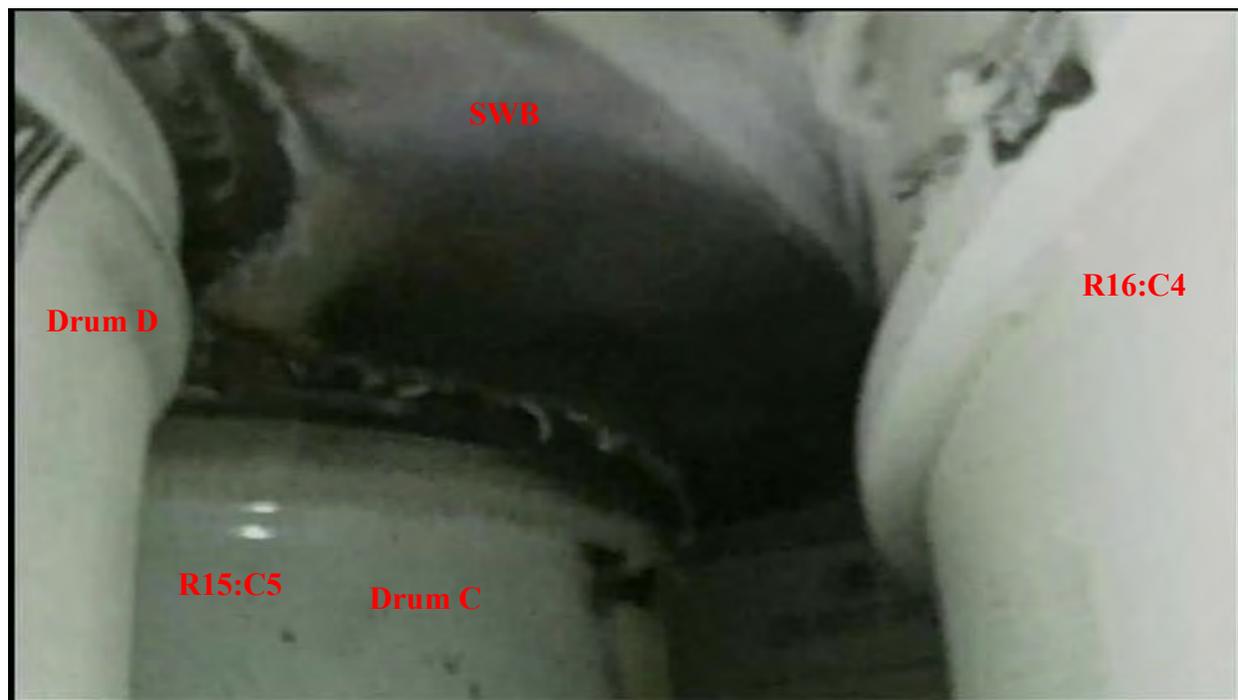
AIB-FST-10535: R16:C4 – Base of drum D
