U.S. Department of Energy Office of Environmental Management

Fire Forensic Analysis of the Radiological Release Event at the Waste Isolation Pilot Plant on February 14, 2014

April 6, 2015

**Prepared in Support of the U.S. DOE Accident Investigation
Board for the Radiological Release Event at the Waste
Isolation Pilot Plant on February 14, 2014**

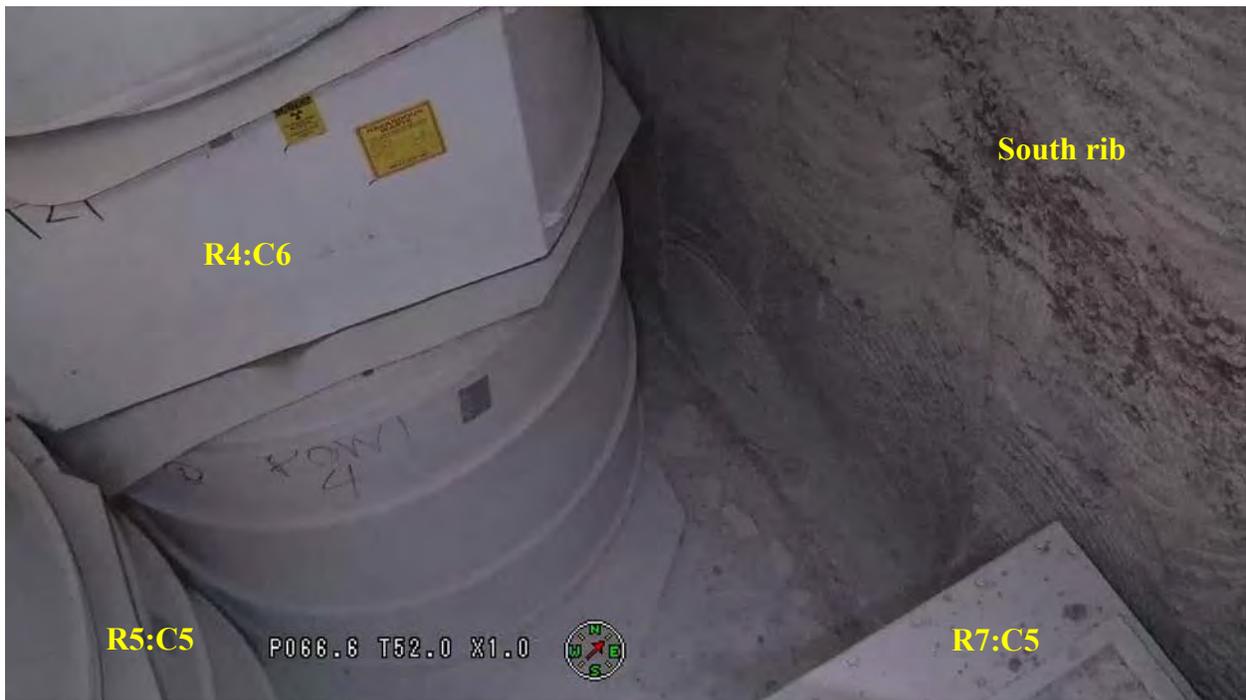
AIB-FST-10554: South rib near row 7 - Formation coloration

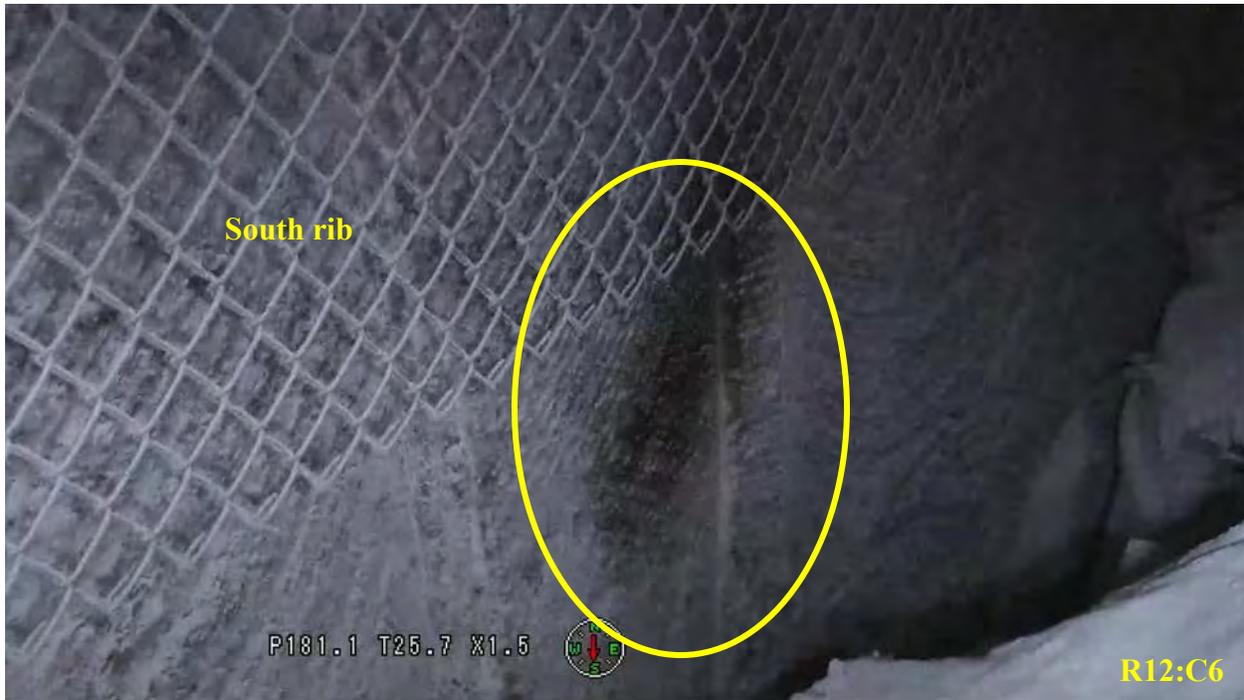
AIB-FST-10557: South rib near row 12 and 13 – Fire evidence

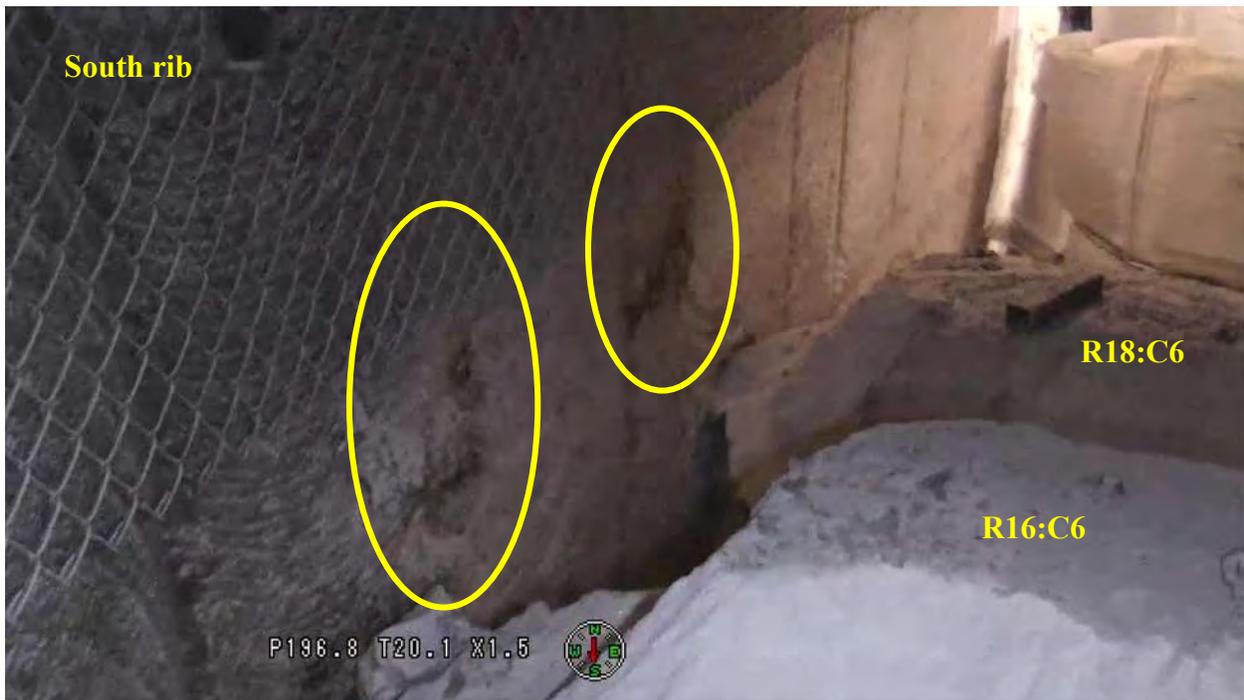
AIB-FST-10558: South rib near row 16 and 18 – Fire evidence

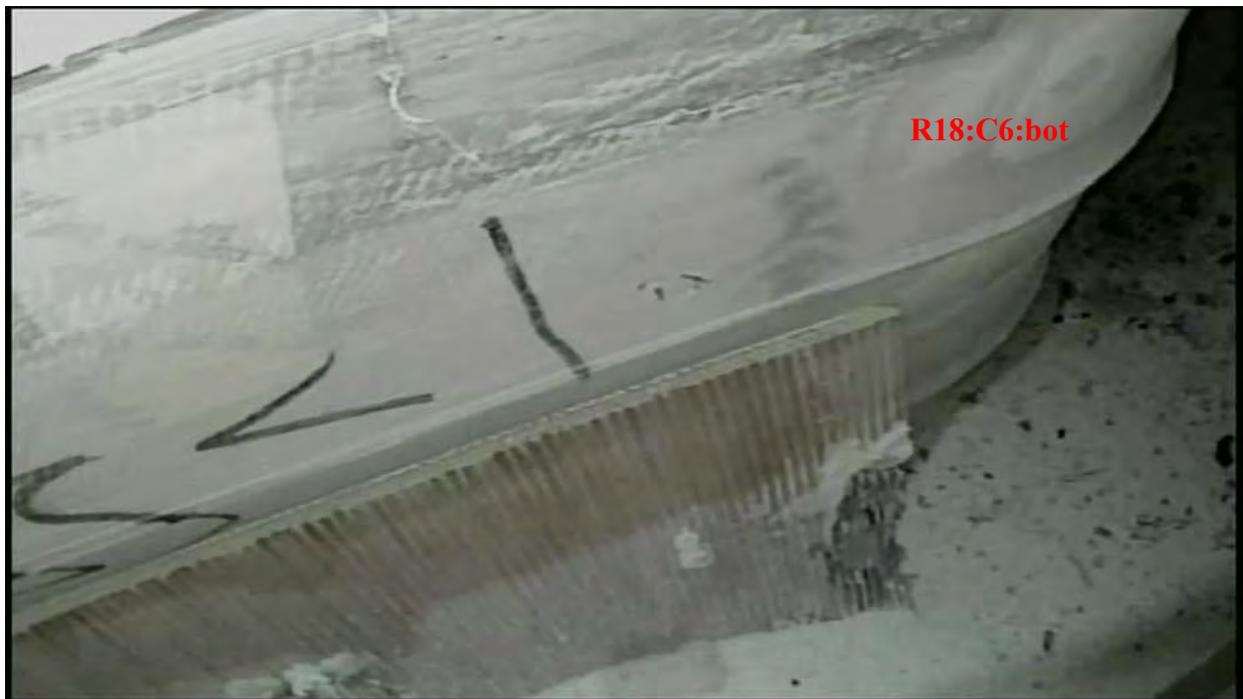
AIB-FST-10619: R18:C6 and R20:C6 – Debris at base of stacks

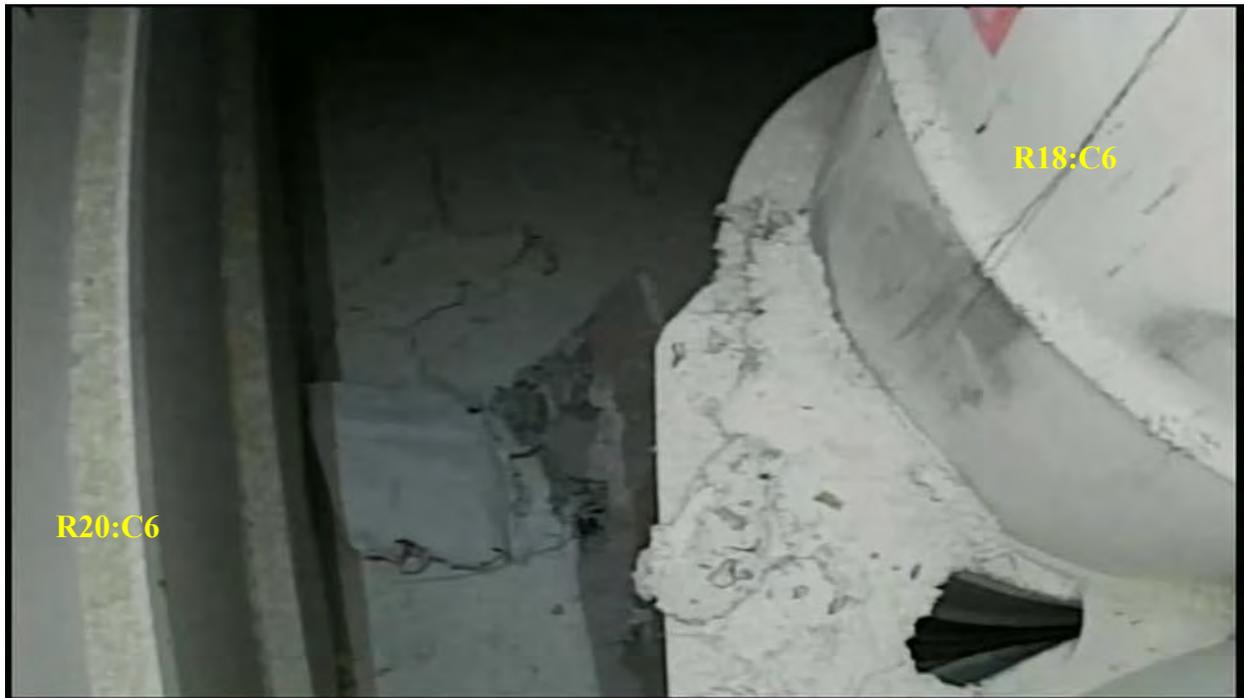
AIB-FST-10623: R18:C6 and R20:C6 – Damaged cardboard stiffener

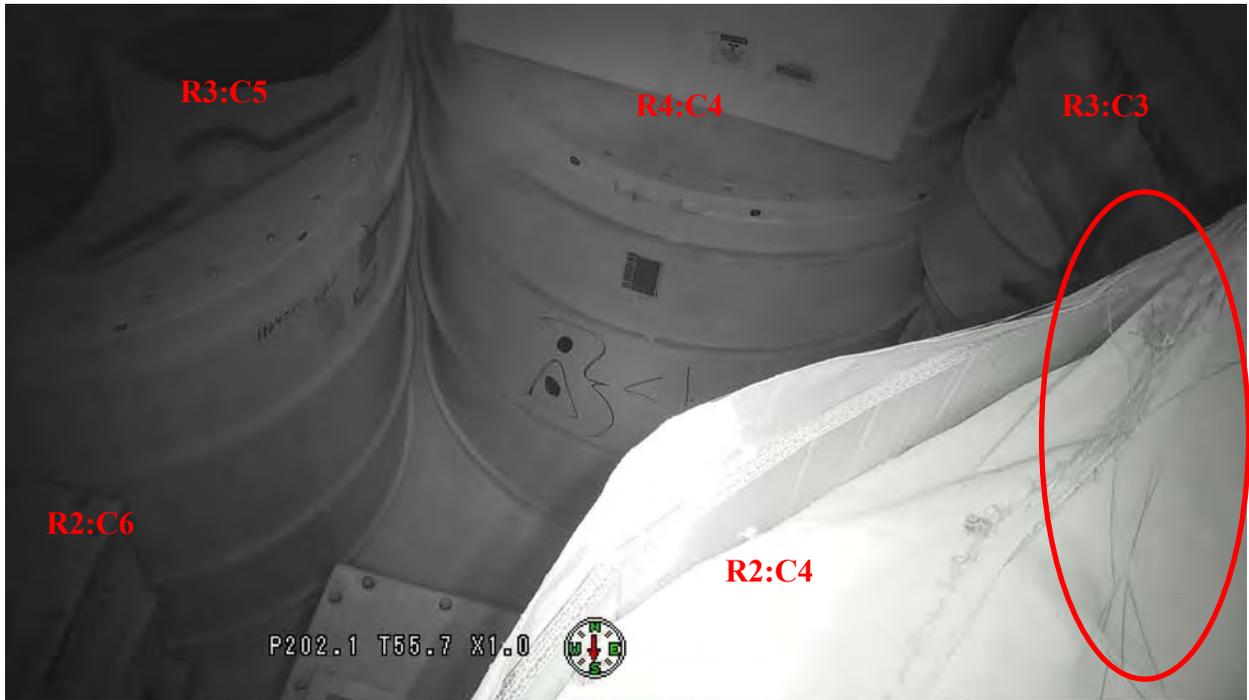
AIB-FST-10642: R2:C4 - Web-like accumulation

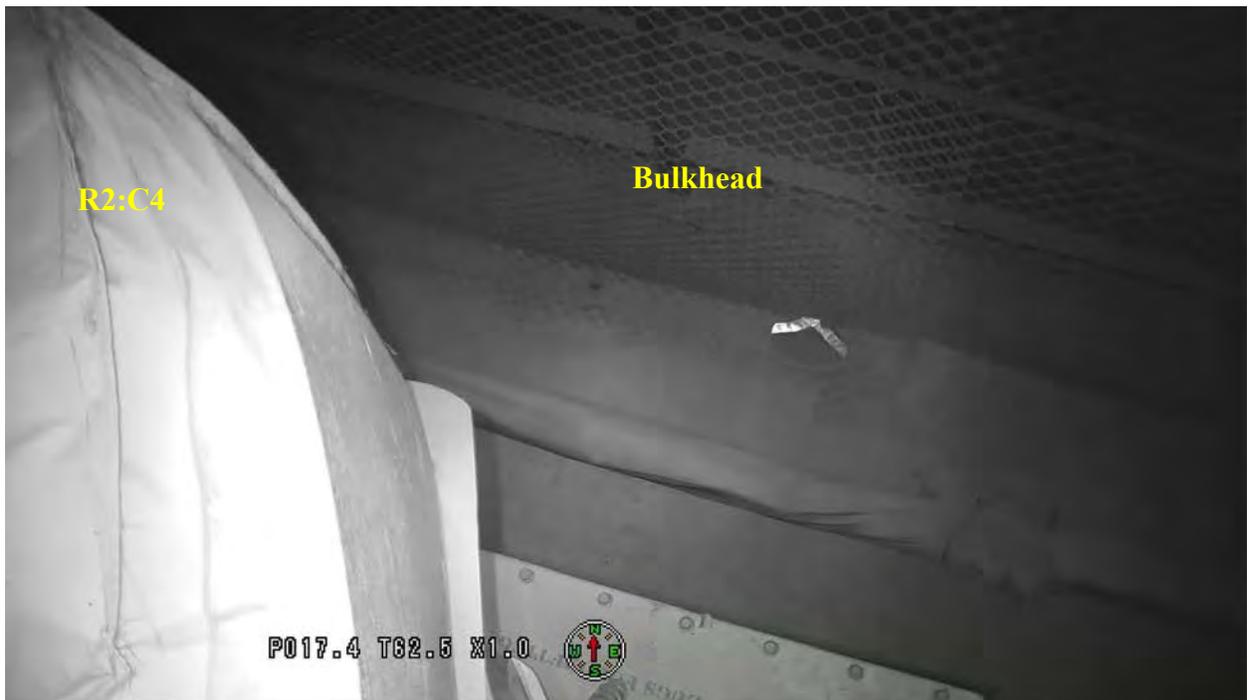
AIB-FST-10643: R2:C4 - Web-like accumulation

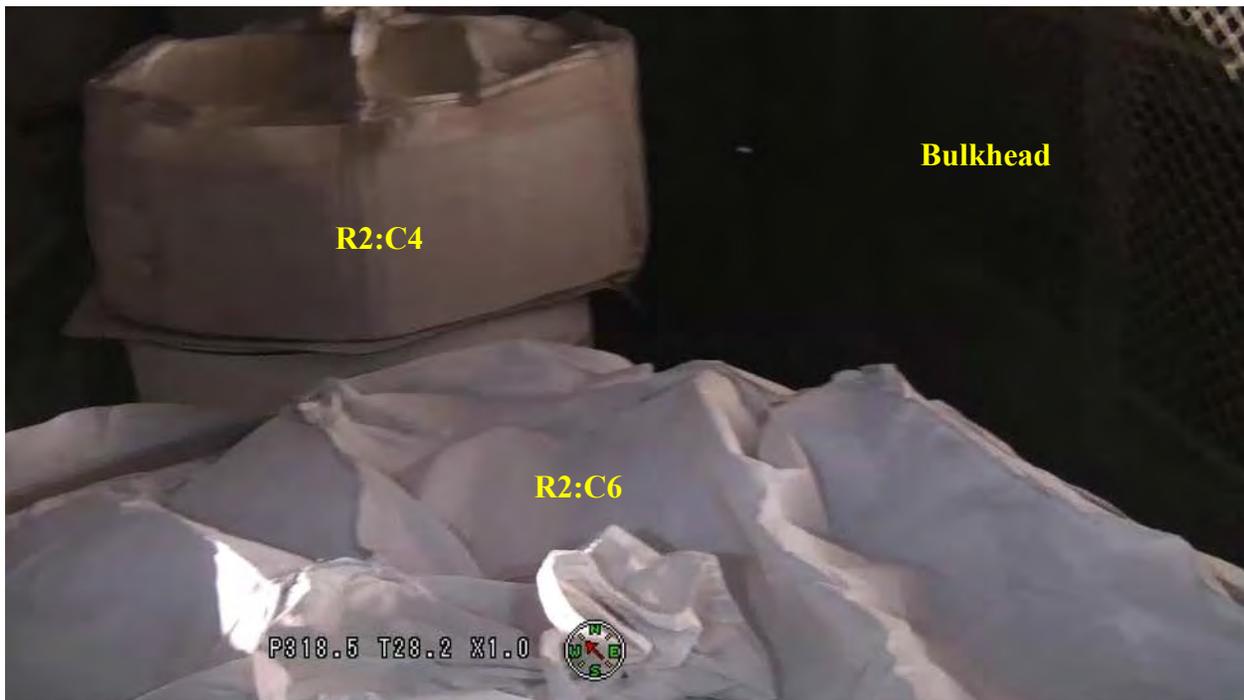
AIB-FST-10645: R2:C4 - Web-like accumulation

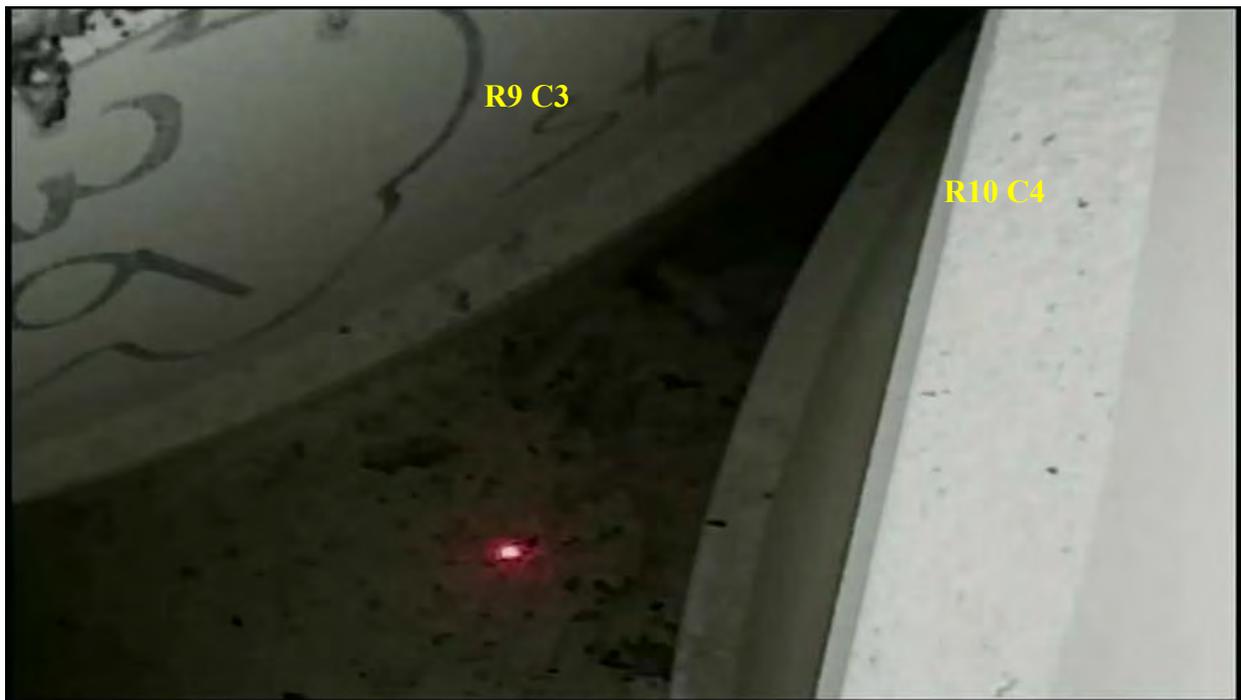
AIB-FST-10677: R9:C3 – Damaged slip sheet below drum G

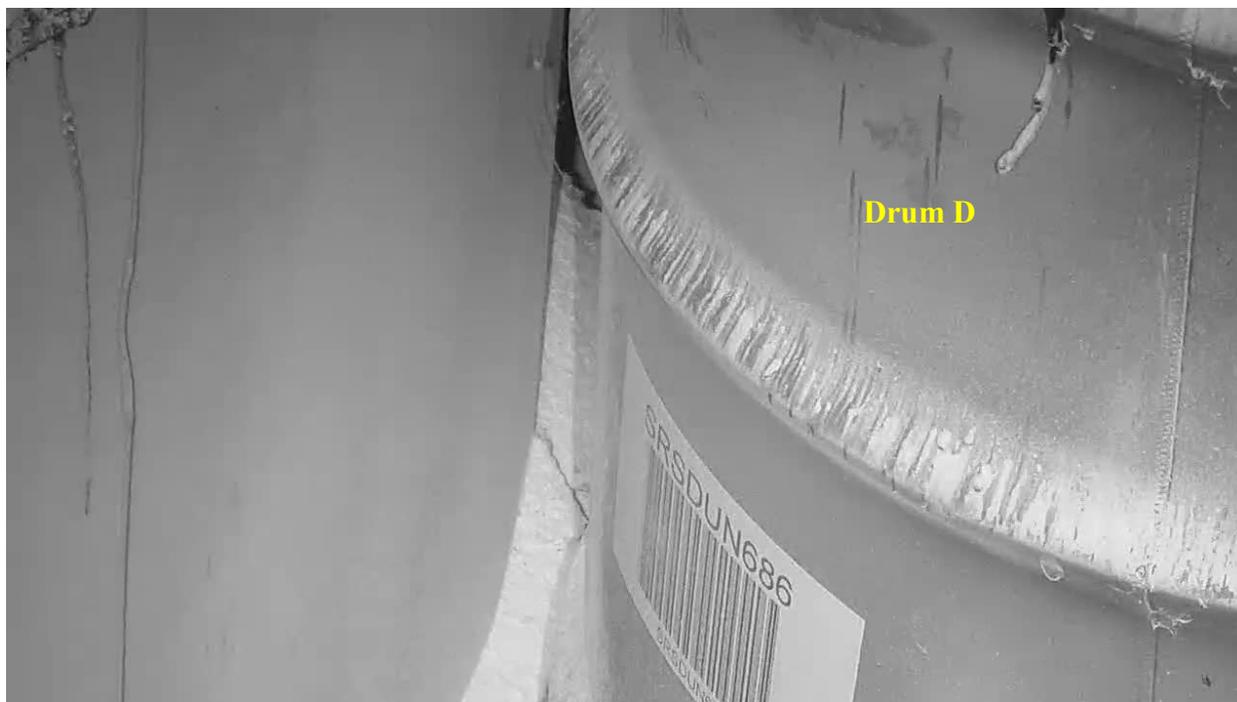
AIB-FST-10681: R9:C3 – Drum D lid

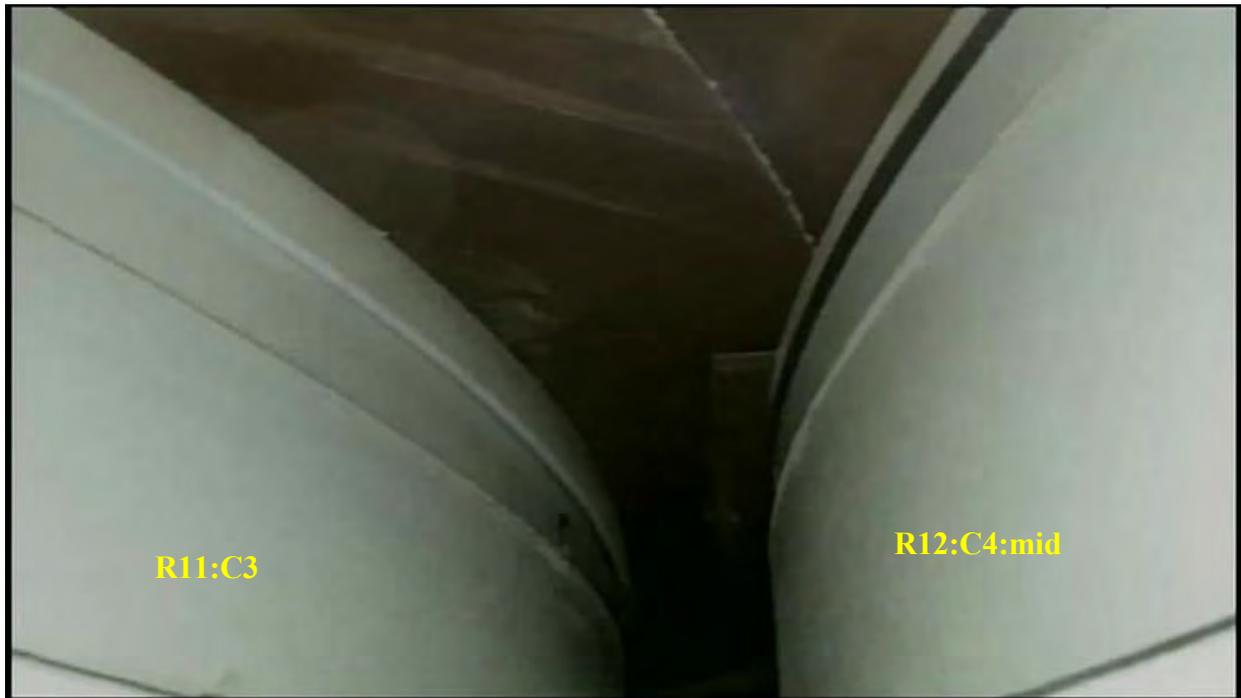
AIB-FST-10766: R11:C3 and R12:C4 – Cantilevered material

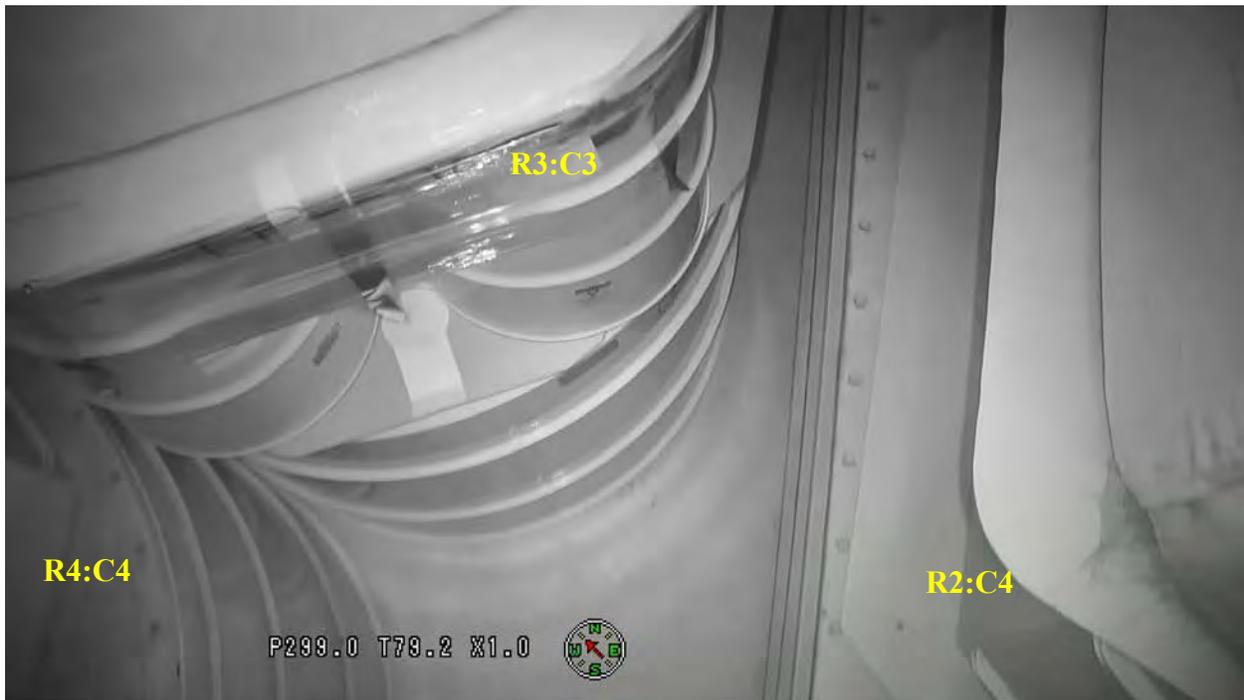
AIB-FST-10775: R3:C3 – Web-like accumulation

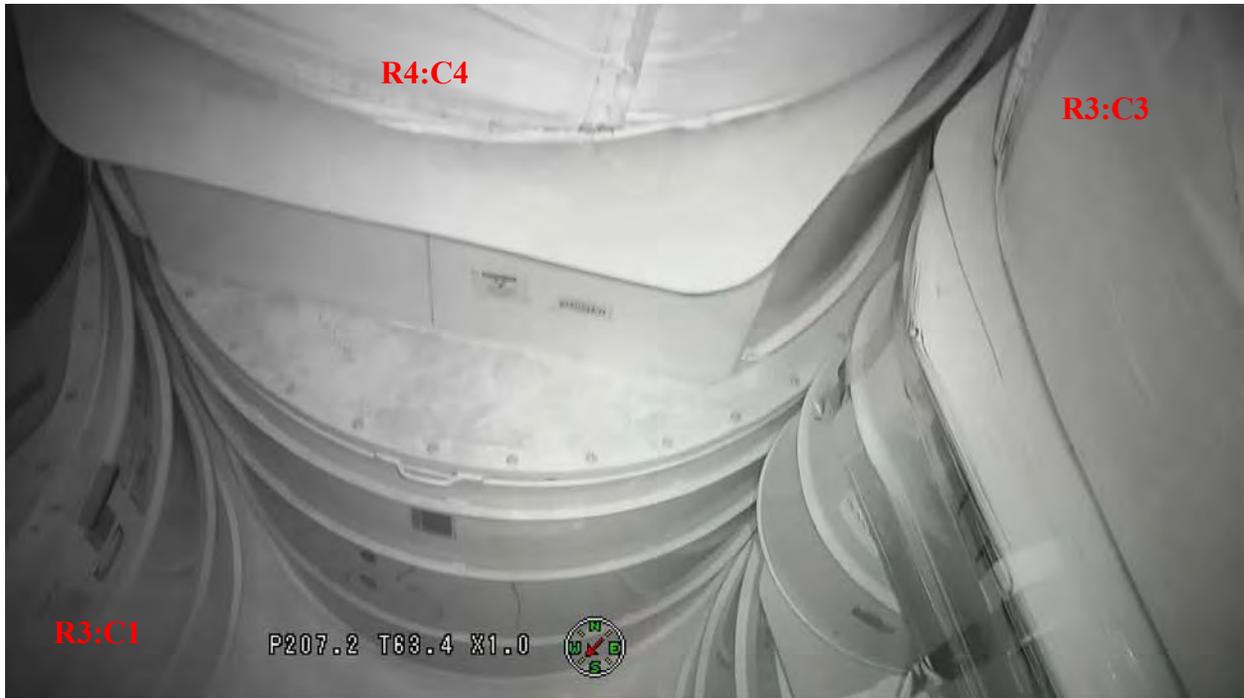
AIB-FST-10776: R3:C3 and R2:C4 – Web-like accumulation

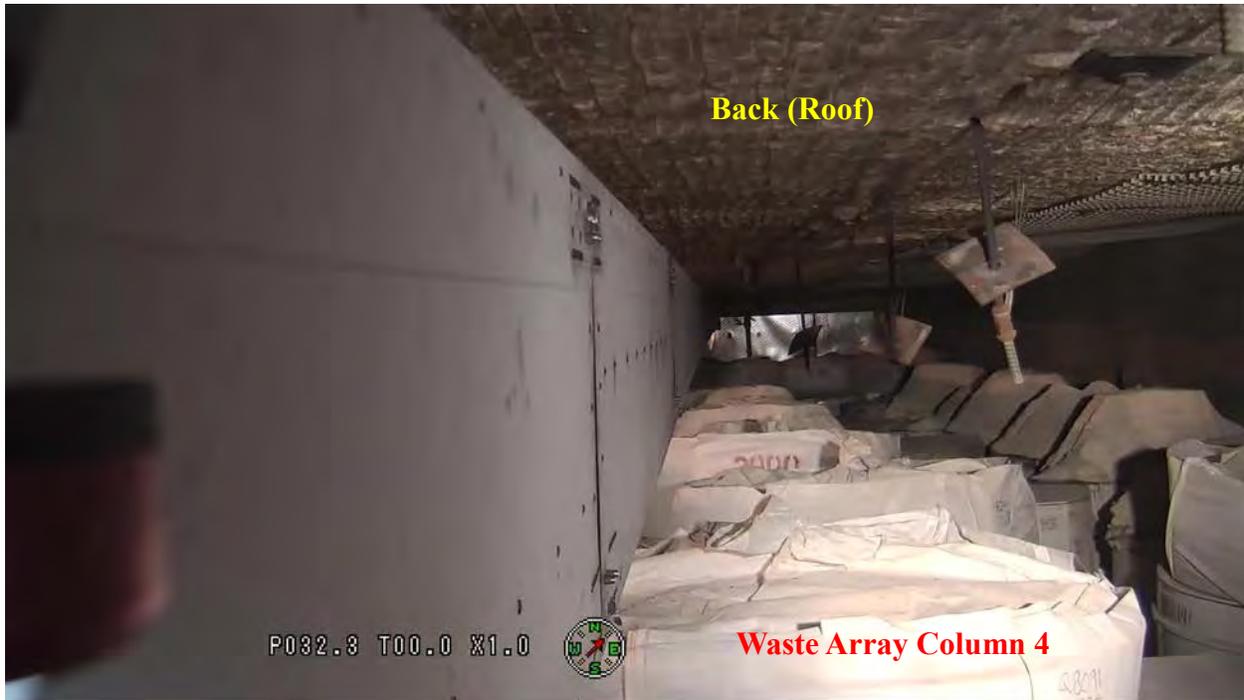
AIB-FST-10809: North side of beam looking east toward bulkhead

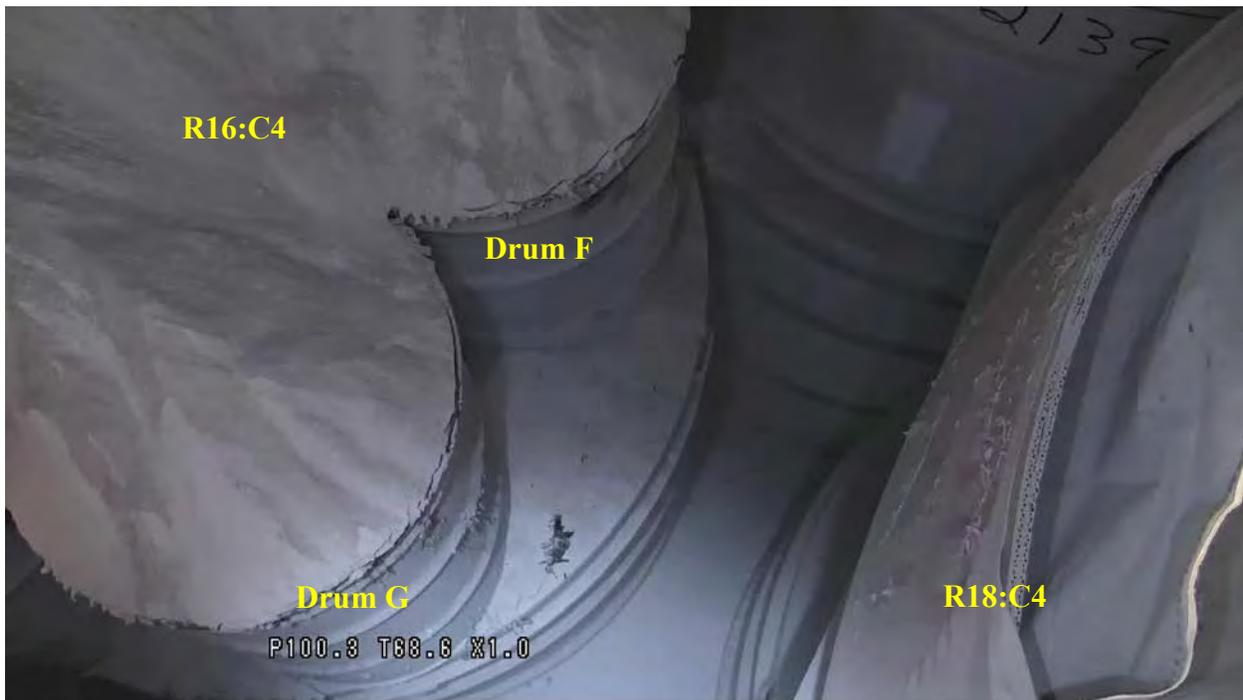
AIB-FST-10945: R14:C4 and R16:C4 – Drum C overhanging TDOP

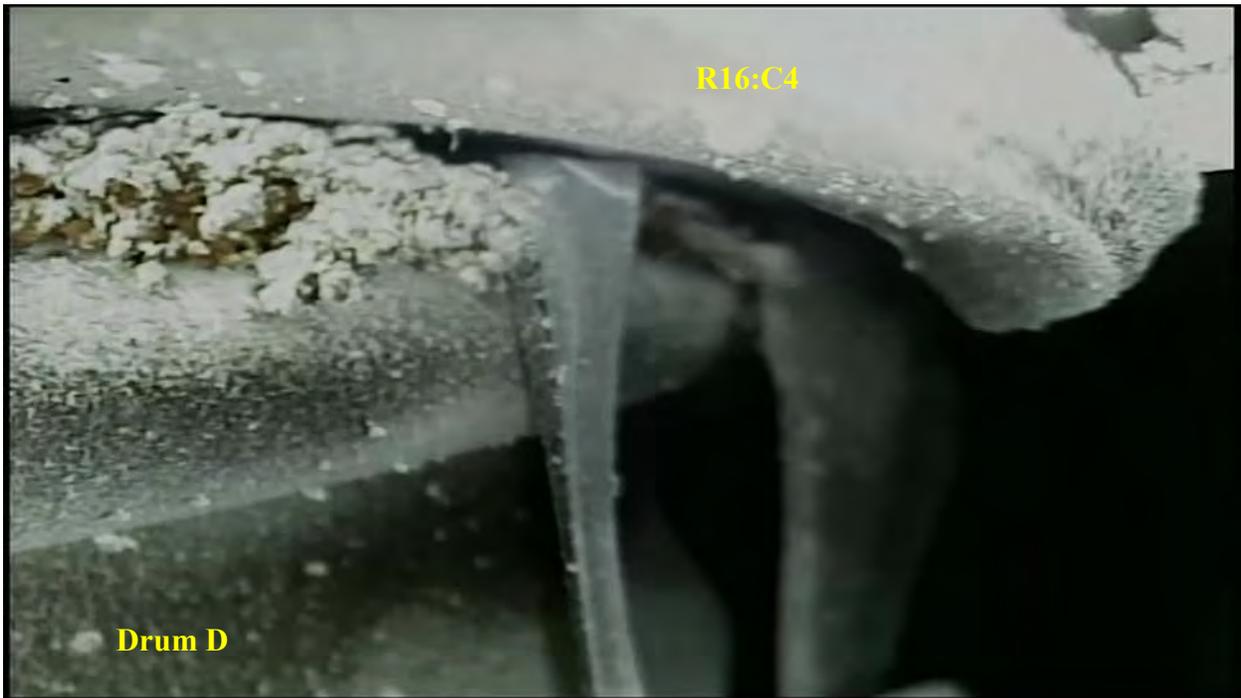
AIB-FST-10949: R16:C4 - Gap between dunnage drum lid and reinforcing plate

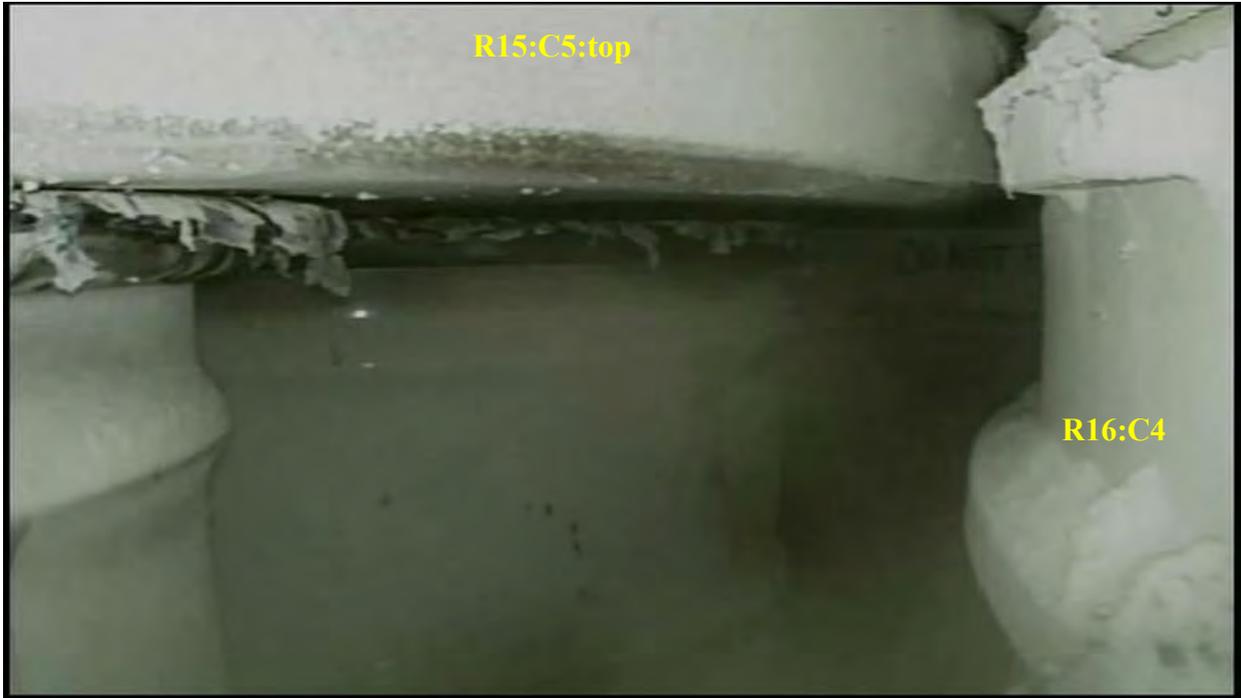
AIB-FST-10950: R16:C4 – Orange material above drum D

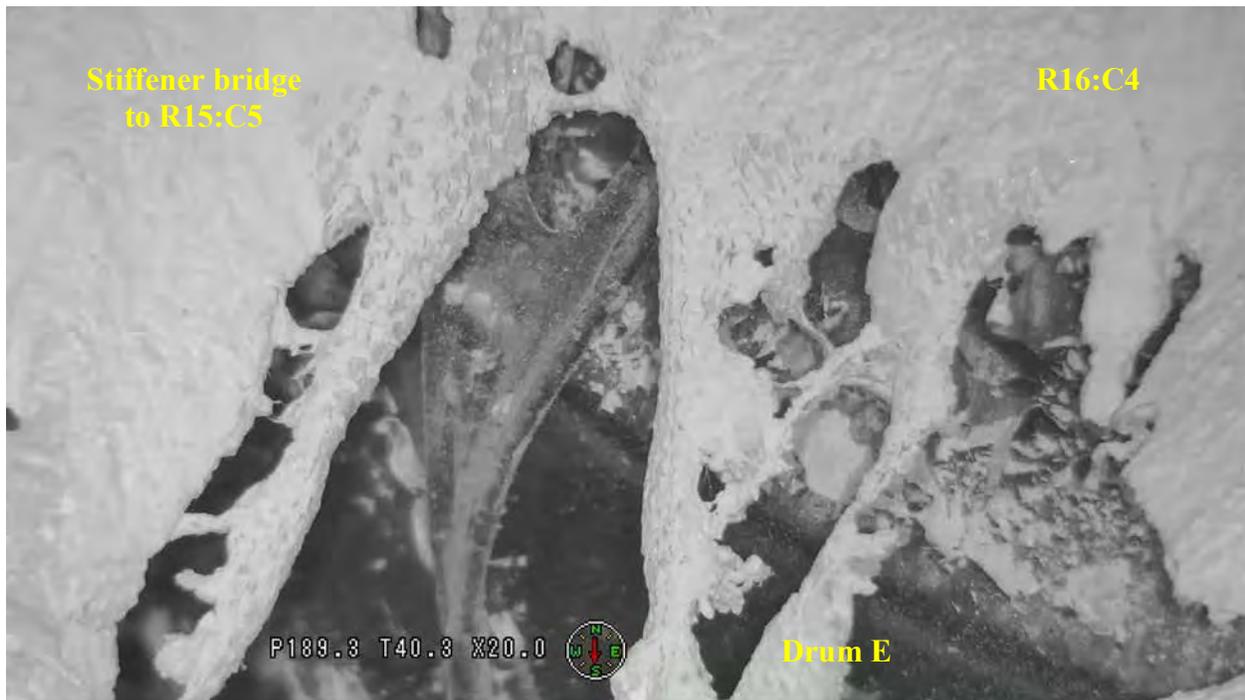
AIB-FST-10955: R15:C5 and R16:C4 – Drum E breach – Bulkhead (east) view

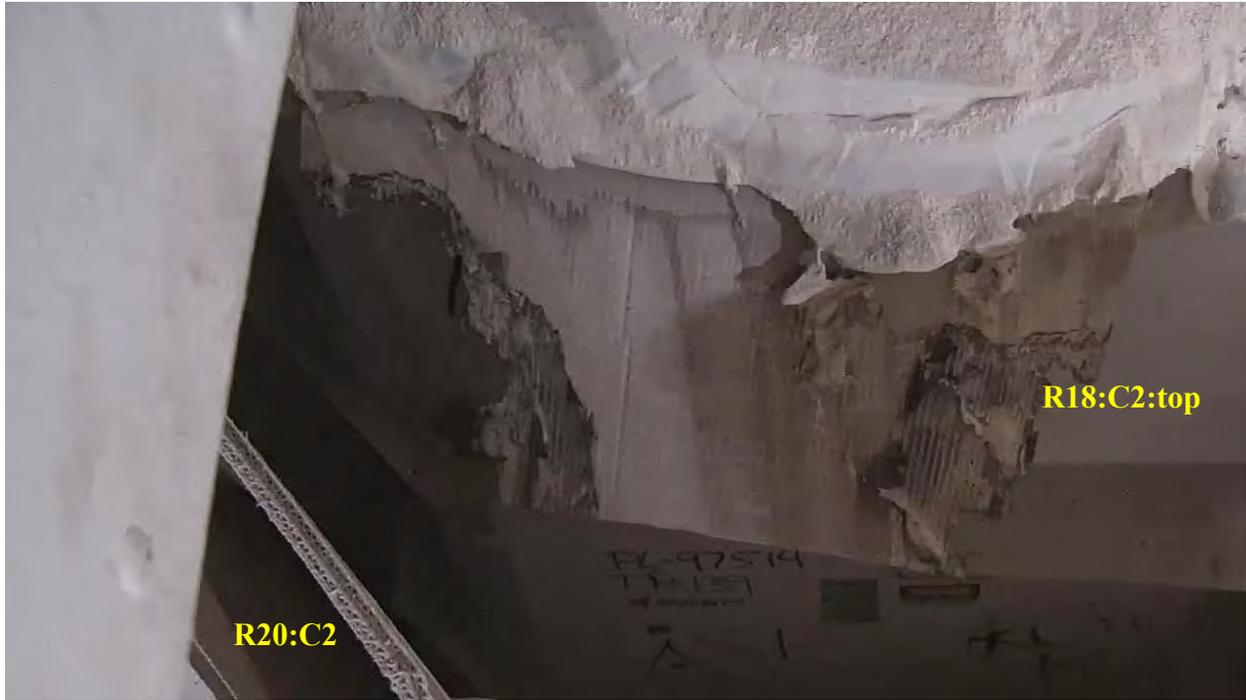
AIB-FST-11164: R18:C2 and R19:C3 – Cardboard stiffener bridge

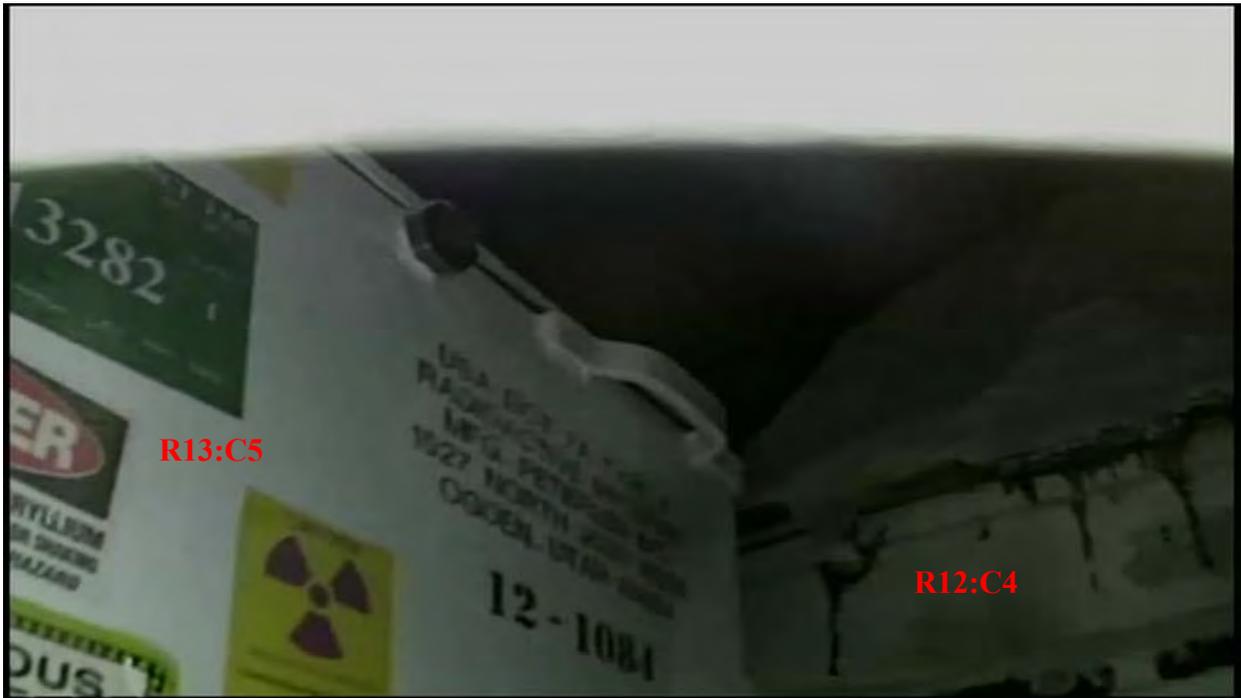
AIB-FST-11200: R13:C5:top - Bulkhead (east) view

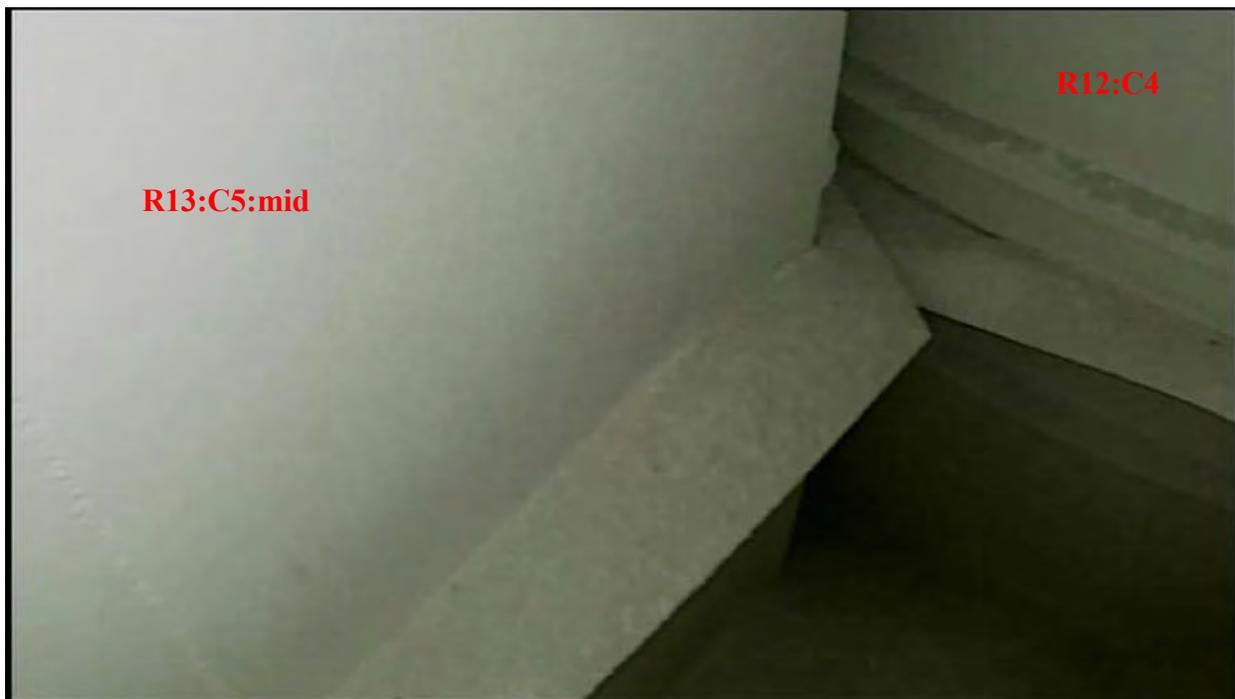
AIB-FST-11206: R13:C5:top - Bulkhead (east) view

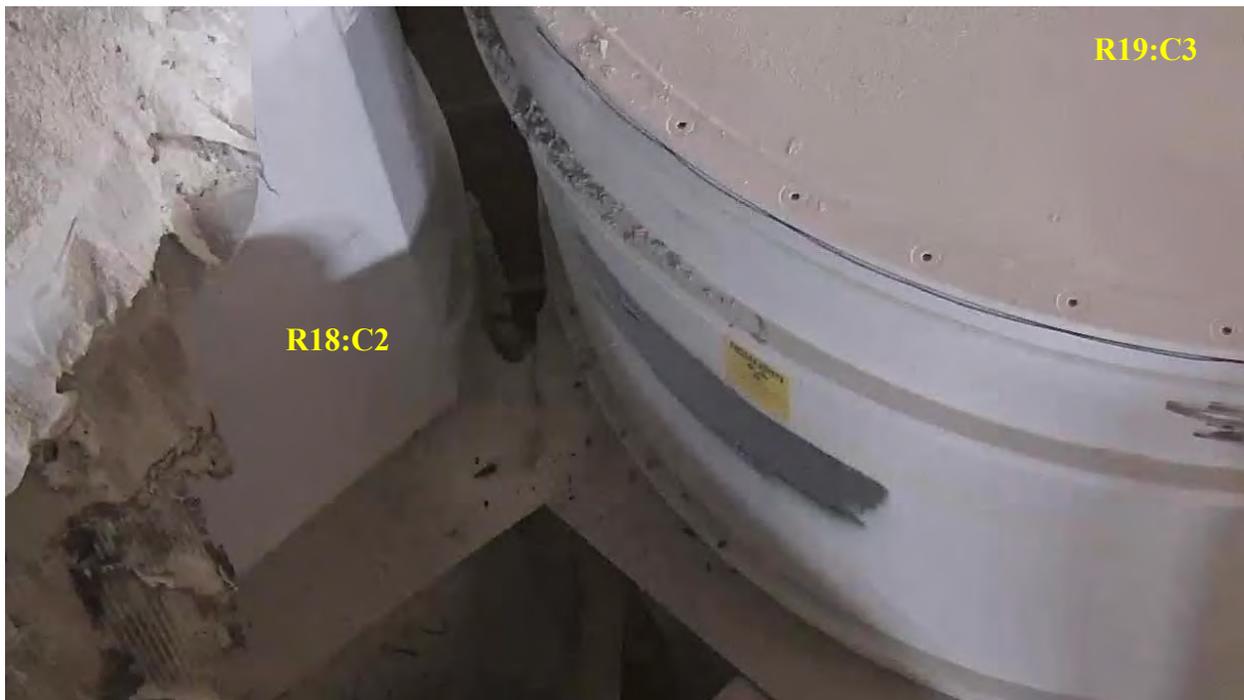
AIB-FST-11344: R18:C2 and R19:C3 – Cardboard stiffener bridge
