### LONG-TERM MONITORING INSPECTION REPORT YEAR 2, Quarter 1 INSPECTION #5

### LOS ALAMOS COUNTY AIRPORT LANDFILL COVER REPLACEMENT

Inspection Date:	August 31,	2017
Report Date:	October 5,	2017

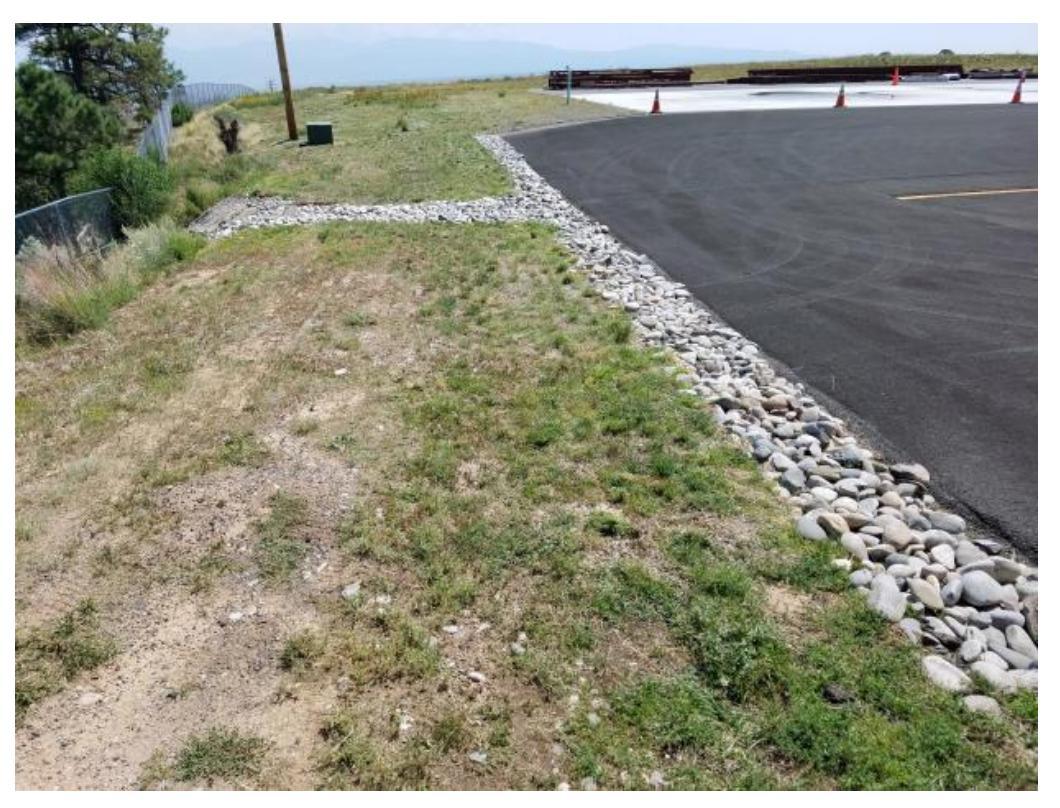
Picture 9. Reseeded Disturbed Area North of New Hangar Pad

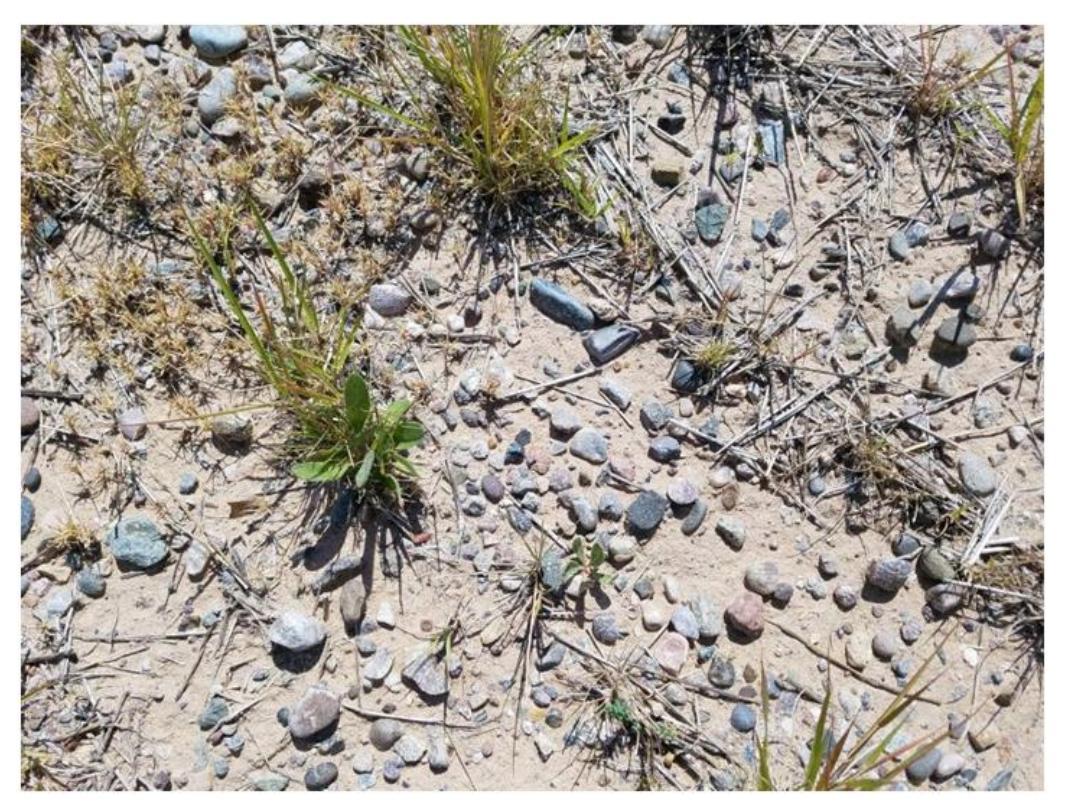
Picture 17. 'Desert Pavement' and Emerging Vegetation - Surface of ET Cover

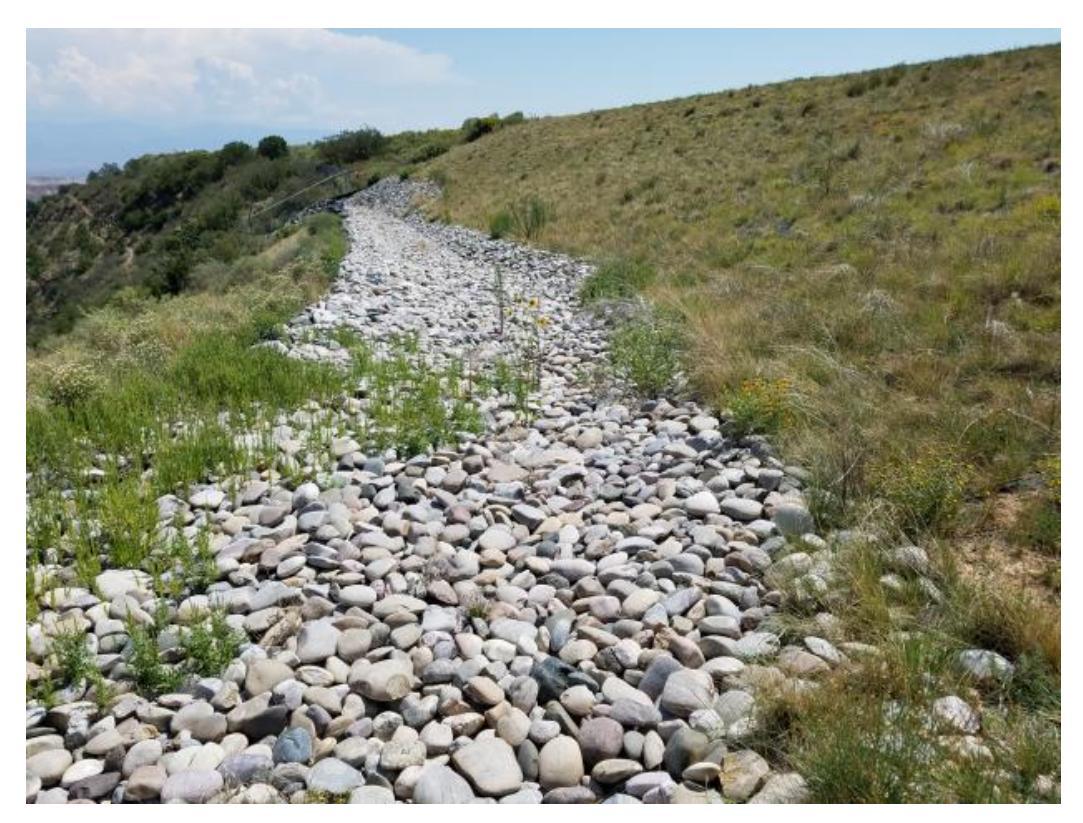
Picture 18. SE Berm - Adjacent to Airport Taxiway

1. Rip Rap Berm near Retaining Wall:	The Rip Rap drainage on side slope is in good condition
Functional Yes (X) No () if no, describe locations	(Pictures 18 and 19).
Damage or degradation: Yes ( ) No ( X )	
Description of damage: NA	
Repairs Necessary Yes ( ) No ( X ) If yes, explain

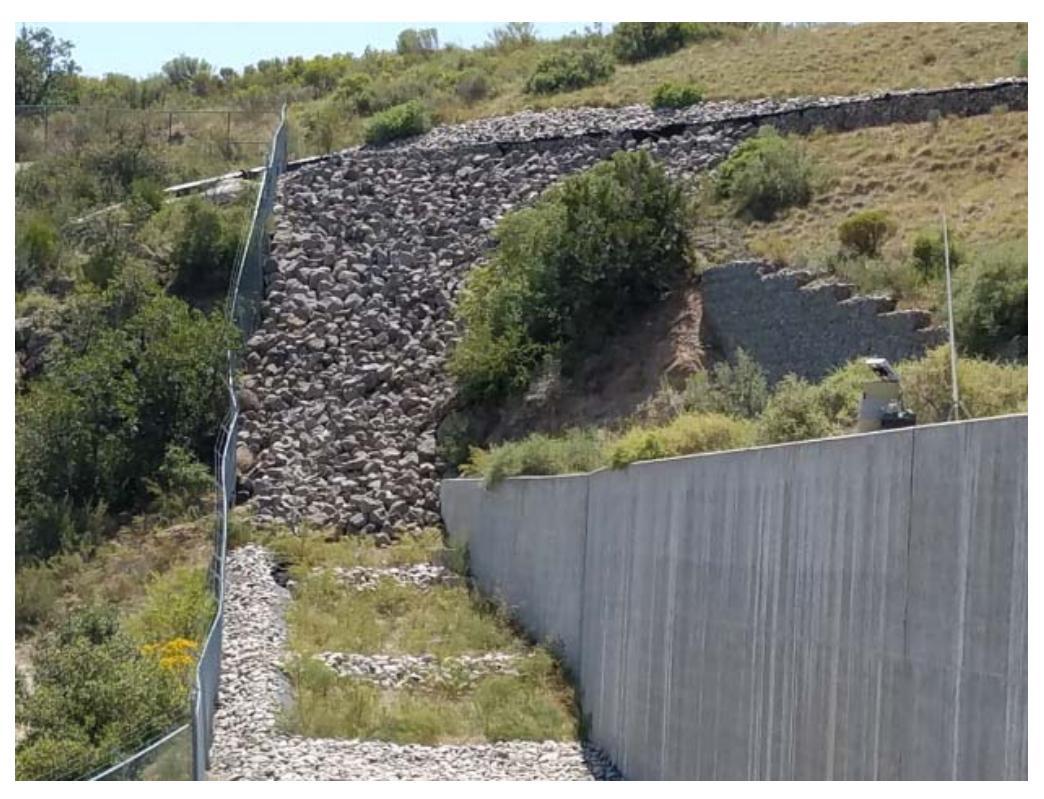
Picture 23. Large Rip Rap Slope - East End of Landfill Site

4. Drainage Channels adjacent to Retaining Wall:	The drainage channels adjacent to the retaining wall
Functional Yes (X) No () if no, describe locations	appear in good condition (Pictures 23 to 26). Drainage
Damage, adjunct erosion, slope problem, or other damage/degradation: Yes ( ) No ( X )	rainstorm that occurred during this inspection.
Description of damage: NA	
Repairs Necessary Yes ( ) No ( X ) If yes, explain

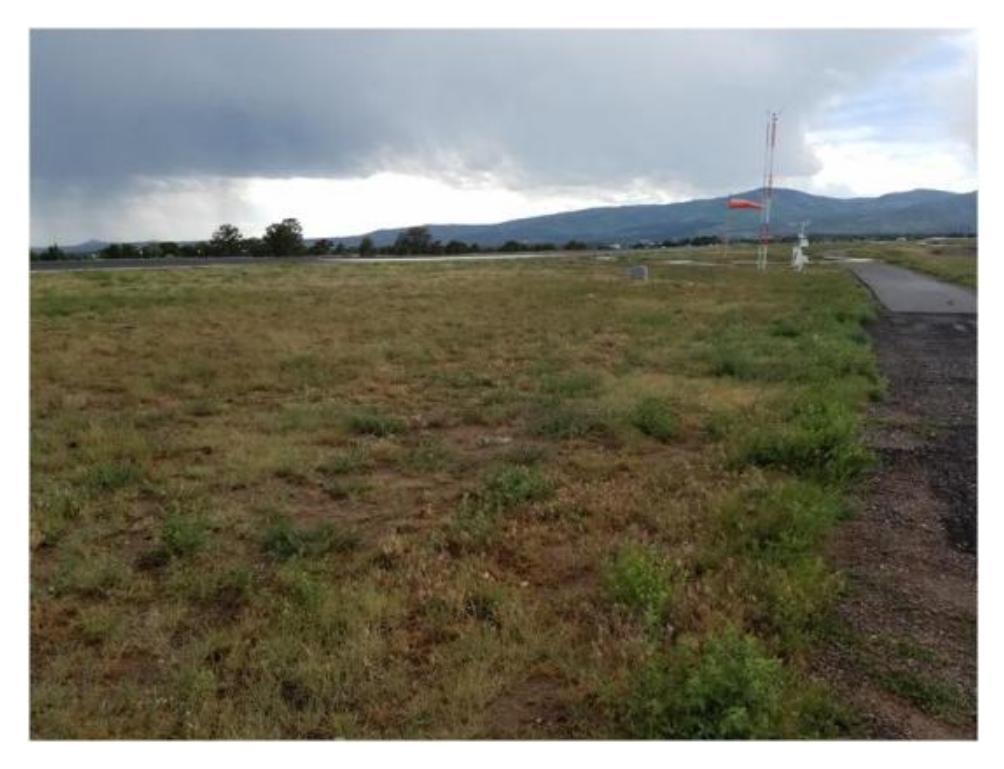
Picture 27. Debris Disposal Area

1. Access Restrictions:	The site has controlled access with a security fence and
Yes ( X ) No ( )	locked gates.
Description: Secured fence with keyed lock	
Repairs Necessary Yes ( ) No ( X ) If yes, explain	
Debris Dispos	al Area (DDA)
Debris Disposal Area Condition	The DDA area is in good condition. There is no
Good Condition ( X ) Poor Condition ( )	observed degradation of the site. The vegetation on the site is in good condition (Picture 27).
Ger	neral

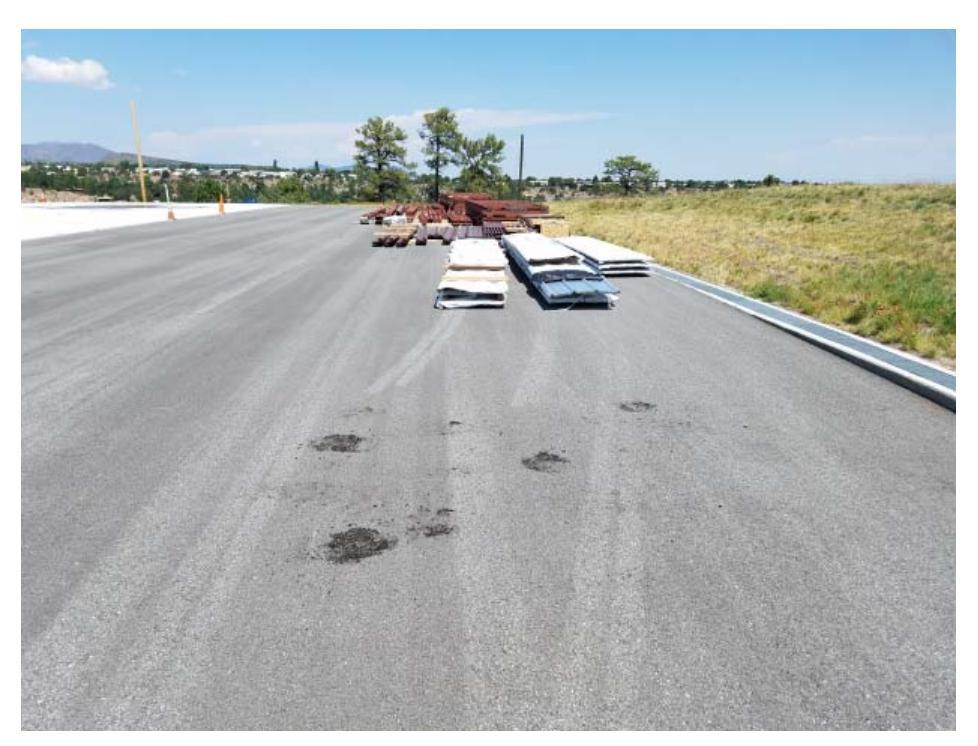
Picture 28. Materials Stockpiled for Construction of New Hangar West of Landfill

2. Materials have been stockpiled on the new asphalt adjacent to the new concrete hangar foundation west of the landfill (Picture 28). The materials are for erection of the new LA County Airport Hangar.

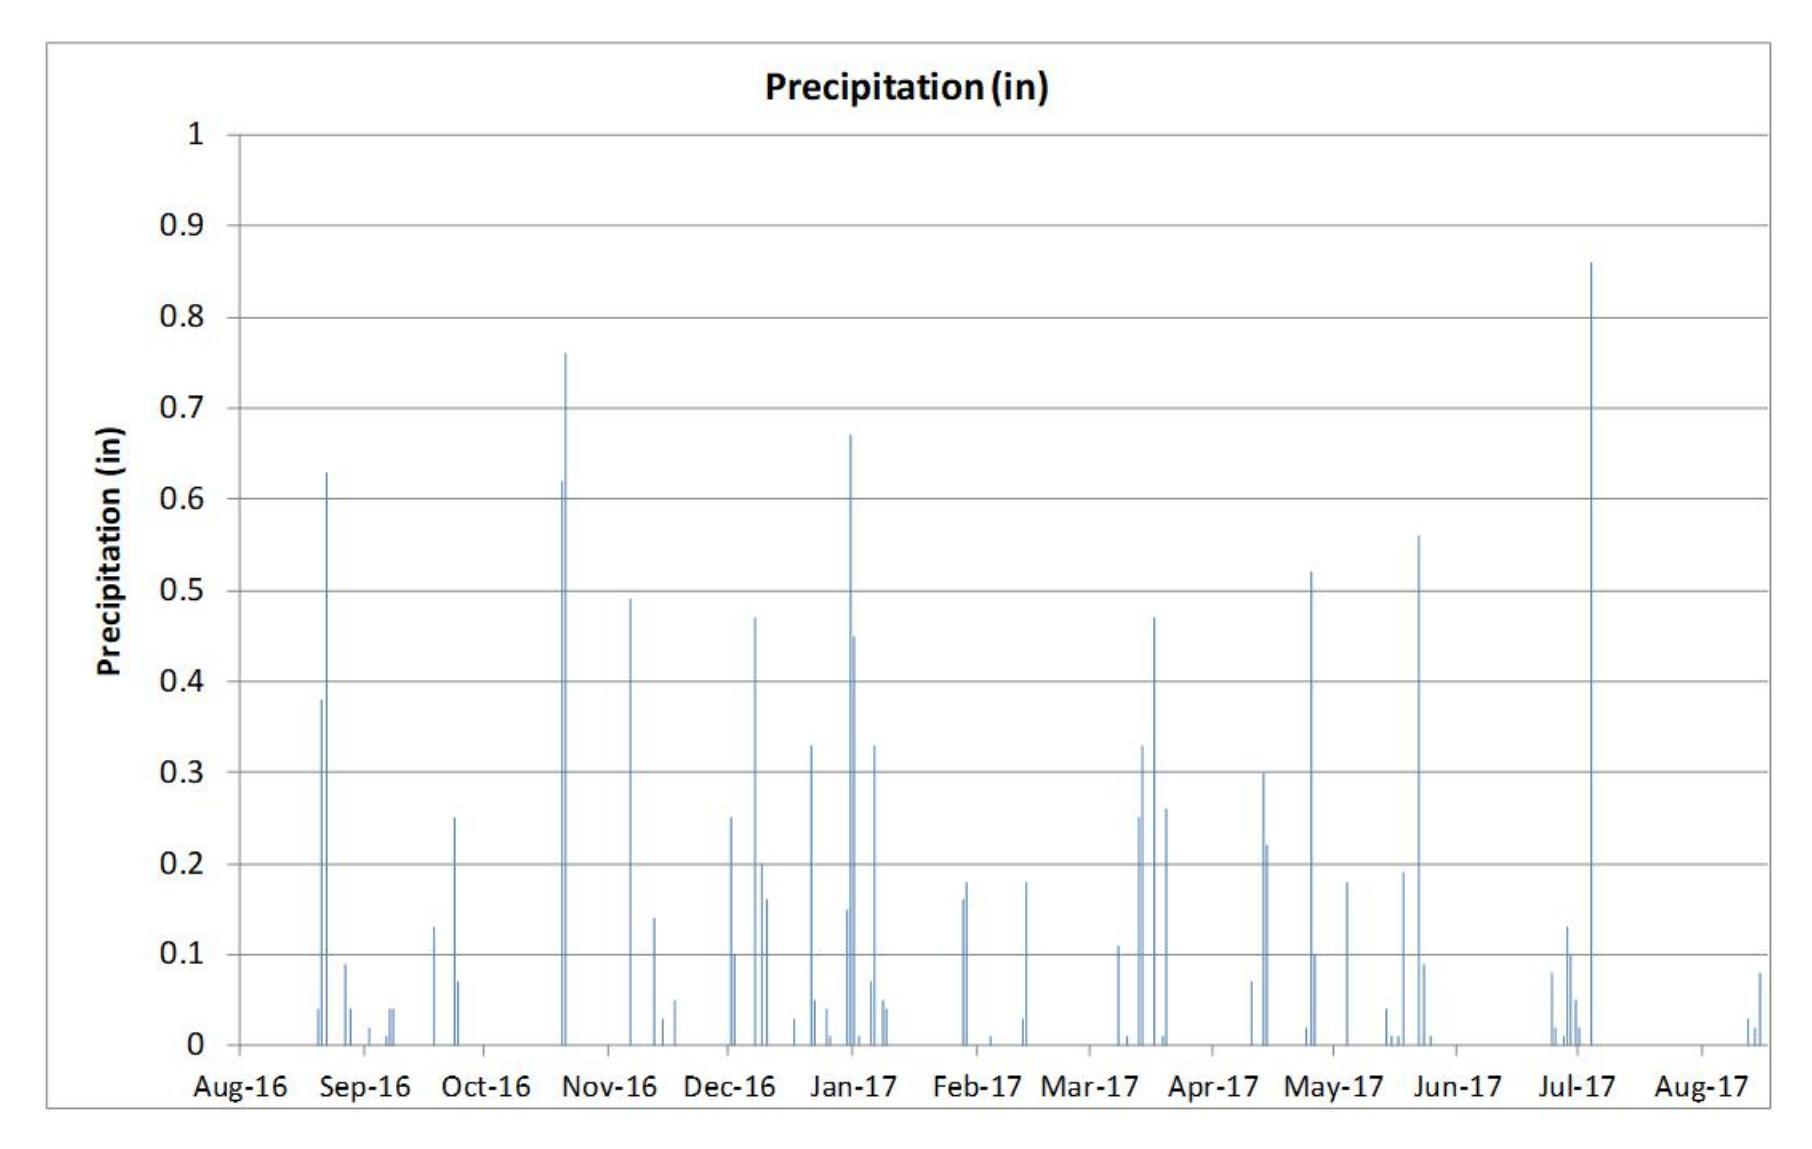
Figure 3. Precipitation (Sept 2016 to Aug 2017

The moisture content probes data was collected and summarized in this inspection report (Figures 1 and 2). The probes were installed on August 29, August 30, and September 4, 2016. The data collected to date is summarized and presented in Figures 1 to 2. Figure 3 contains the available daily precipitation events for comparison of the response to the moisture probe data.

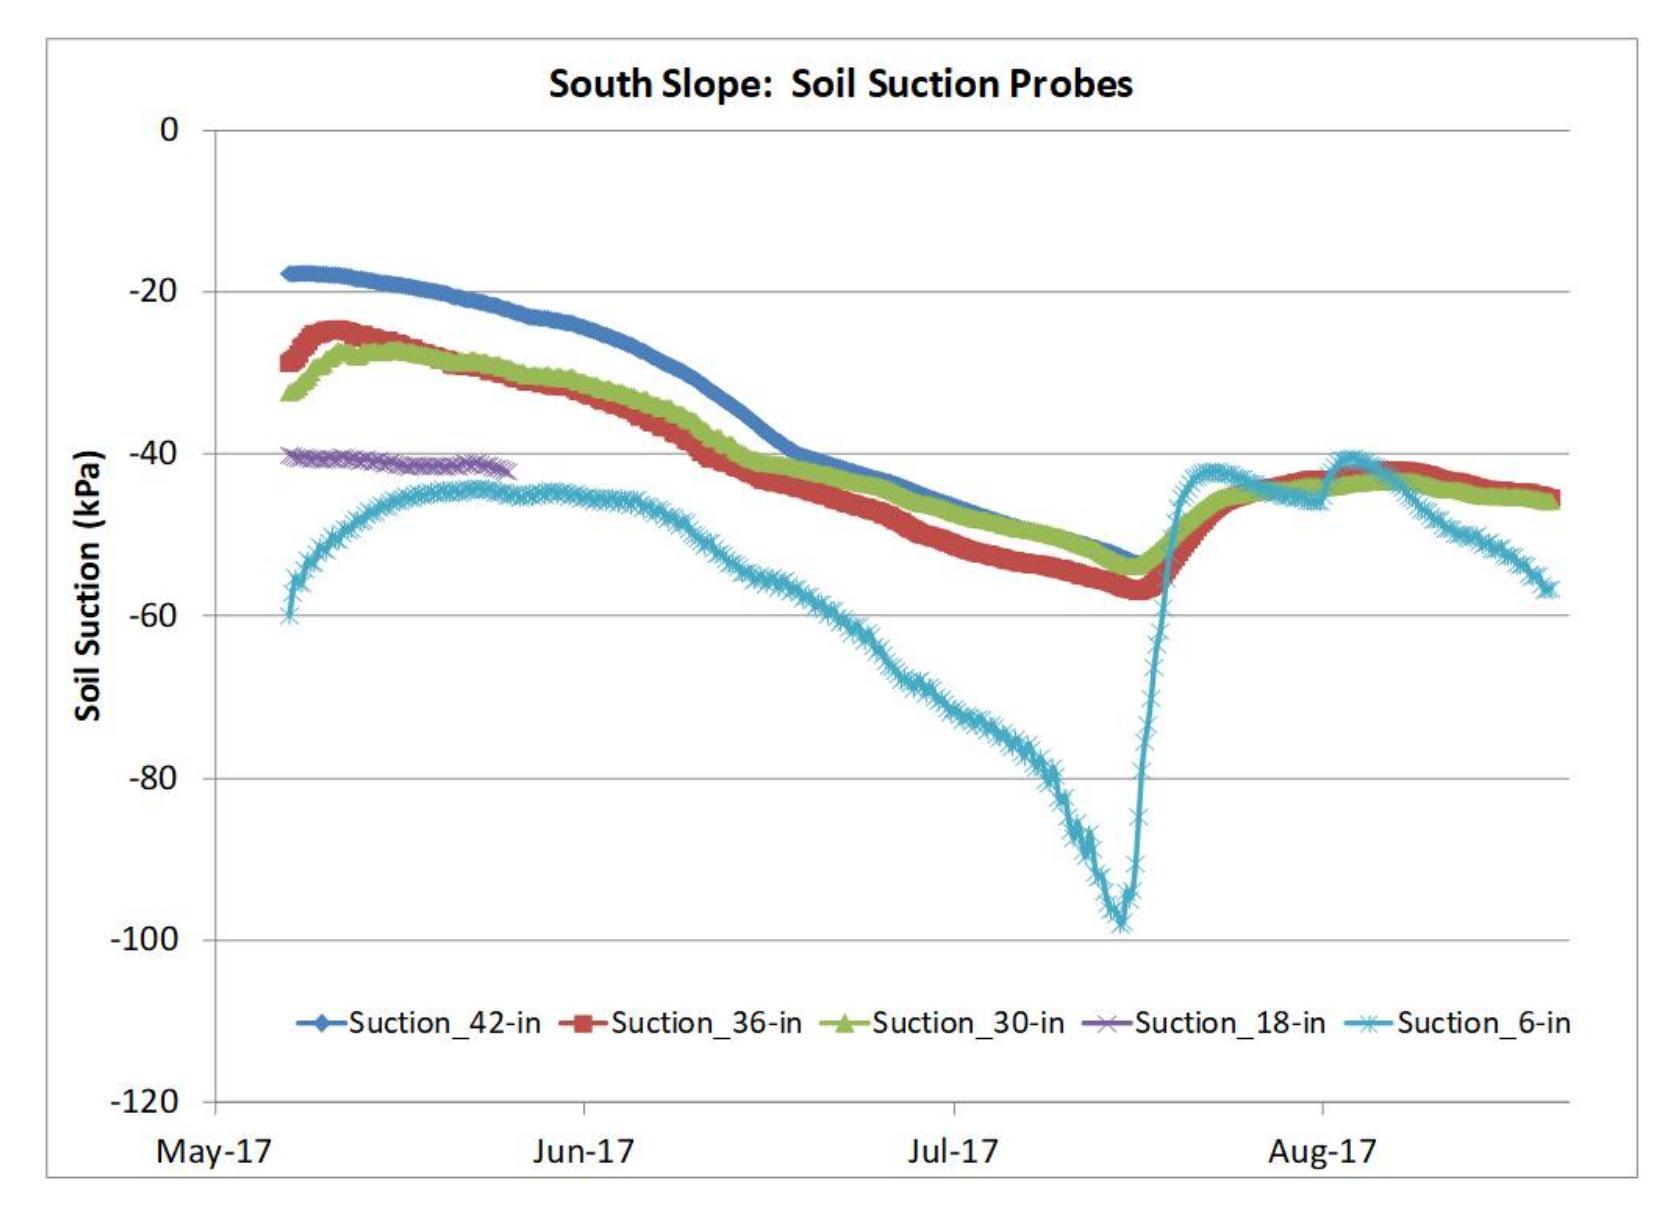
Figure 4. HDU Data (May 2017 to Aug 2017) - ET Cover South Slope

Heat dissipation units (HDU) were replaced on May 18, 2017. These probes measure the matric potential or soil suction in the soil cover system at various depths. The new probes are the most advanced available to date through Decagon Corp. Collected data to date is shown in Figures 4 and 5. Figure 6 contains the available daily precipitation events for comparison to response of the soil suction data. Figure 7 shows the monitoring point locations.

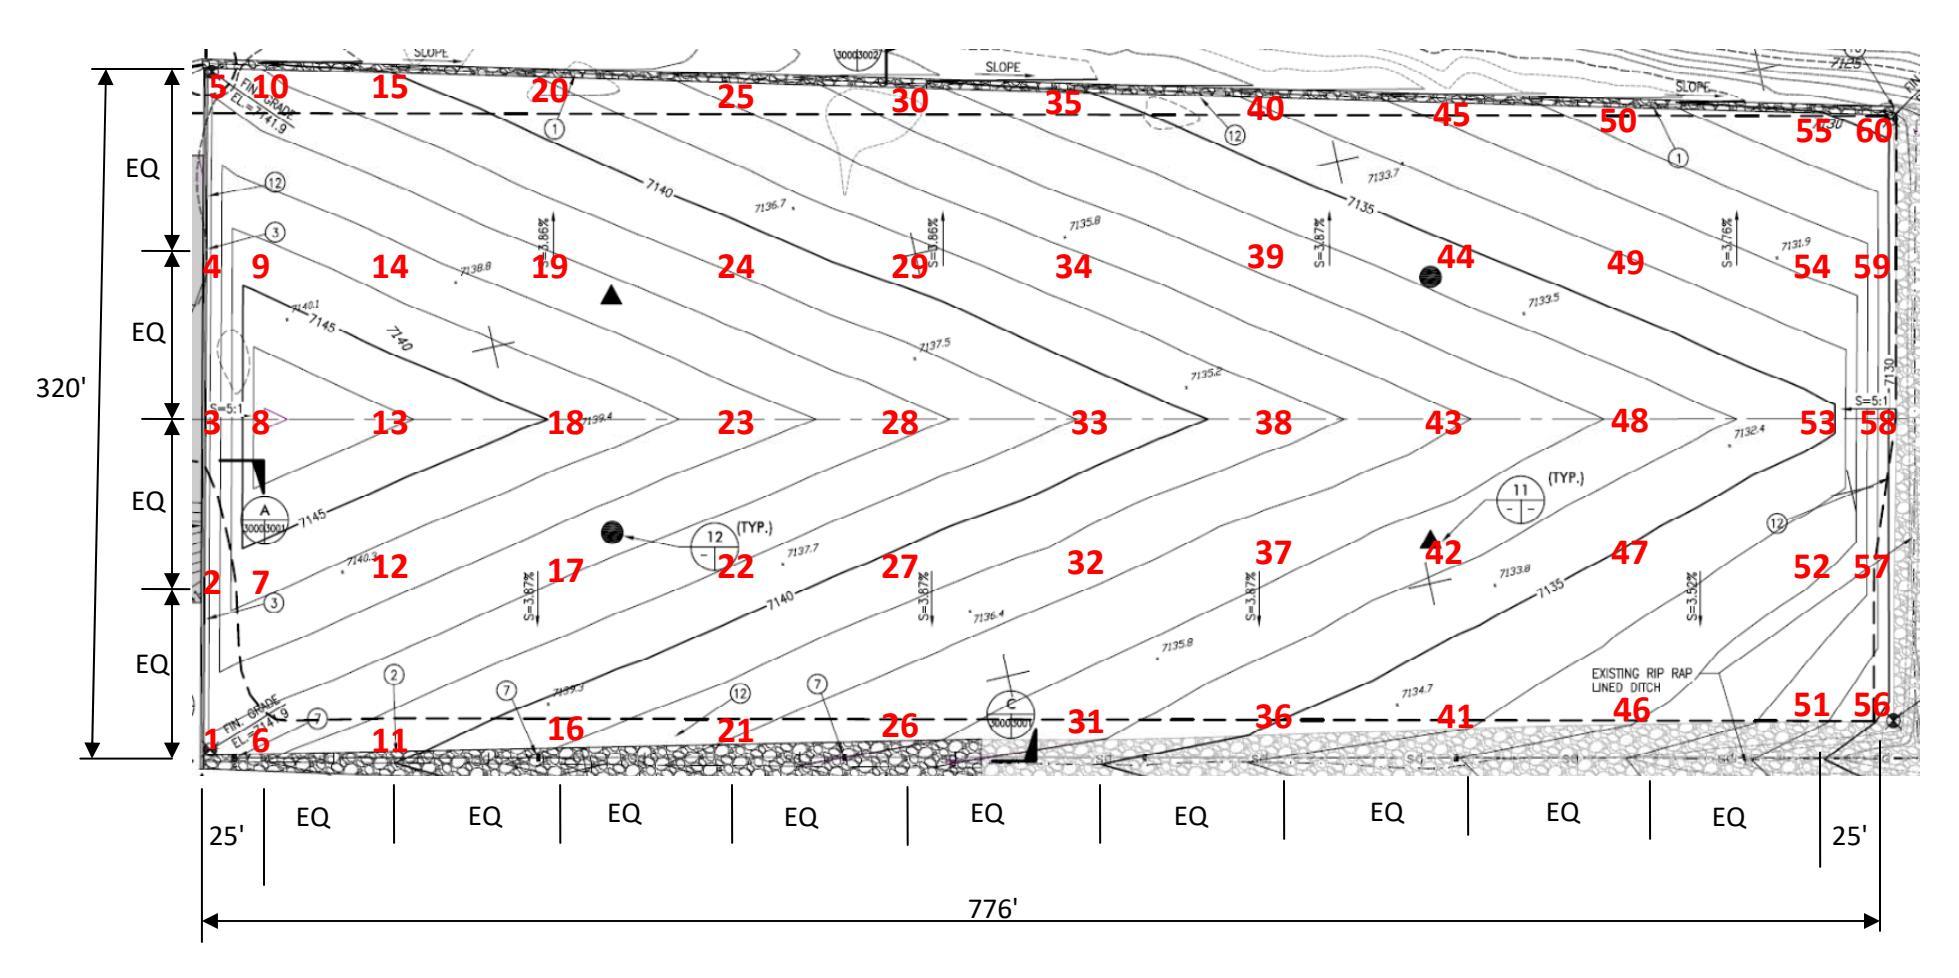
**Figure 8. Survey Point Locations**

Table 3 provides a summary of the initial elevation measurements for the identified survey points to monitor any differential settlement in the landfill. Figure 8 shows the settlement survey locations.

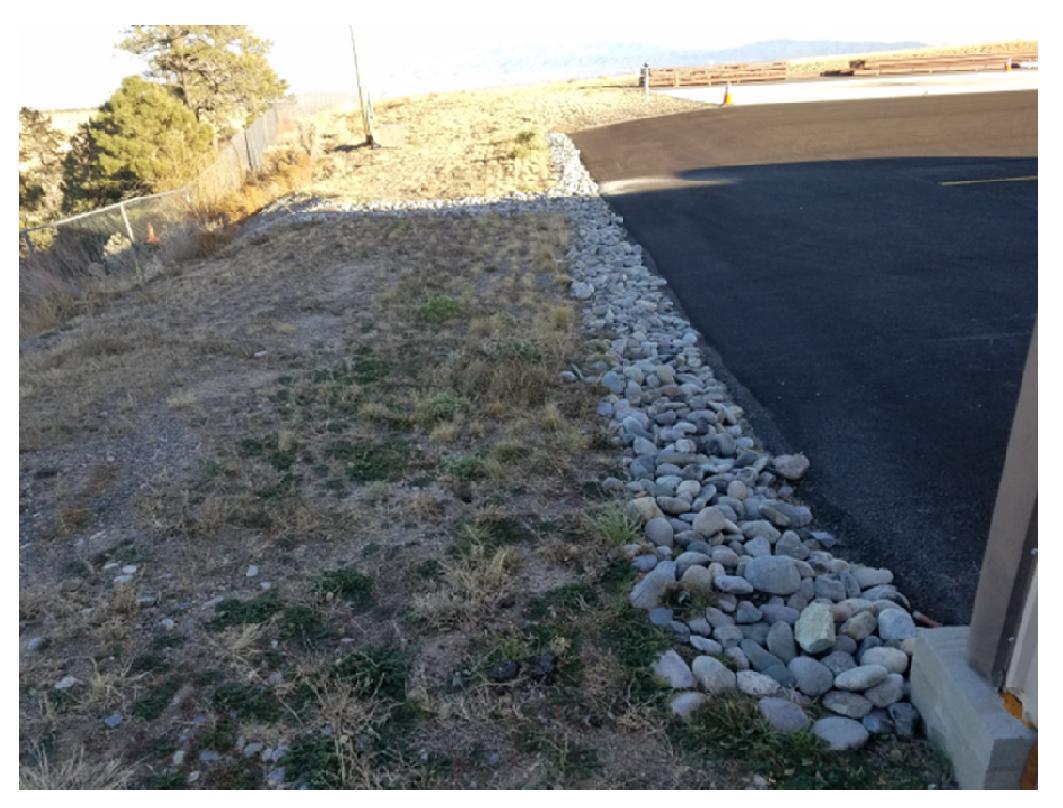
Picture 9. Reseeded Disturbed Area North of New Hangar Pad

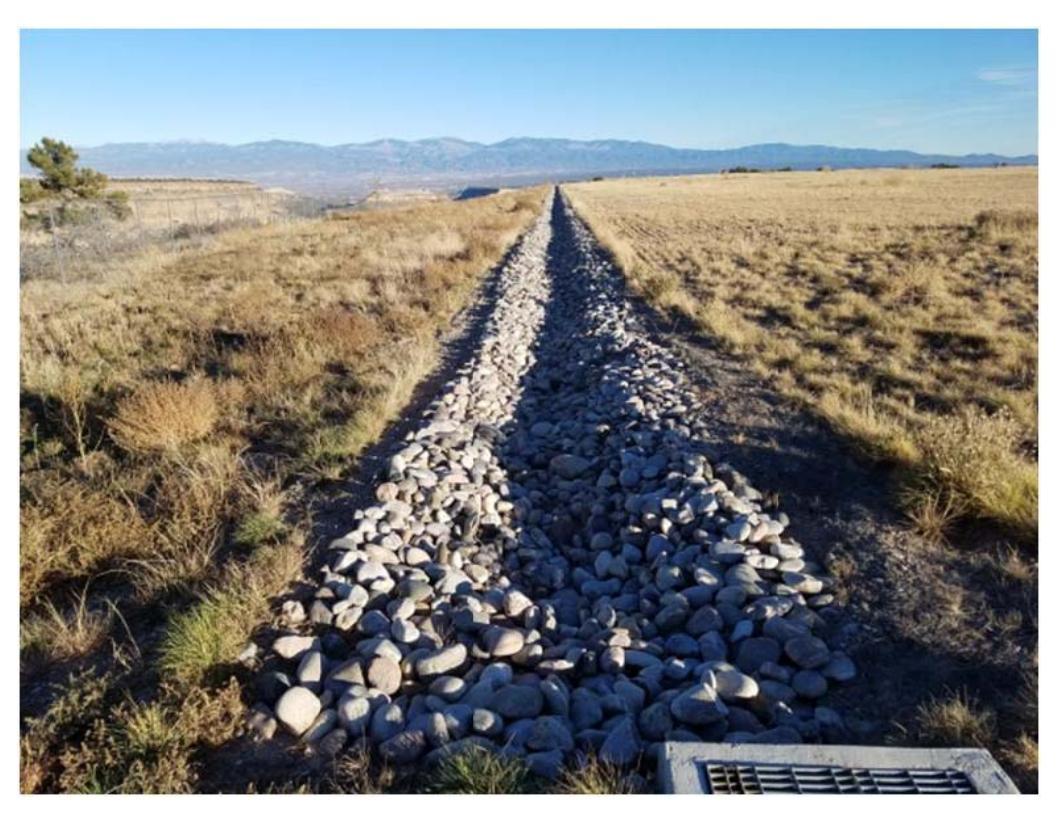
Picture 10. Drainage Channel - North Perimeter of ET Cover

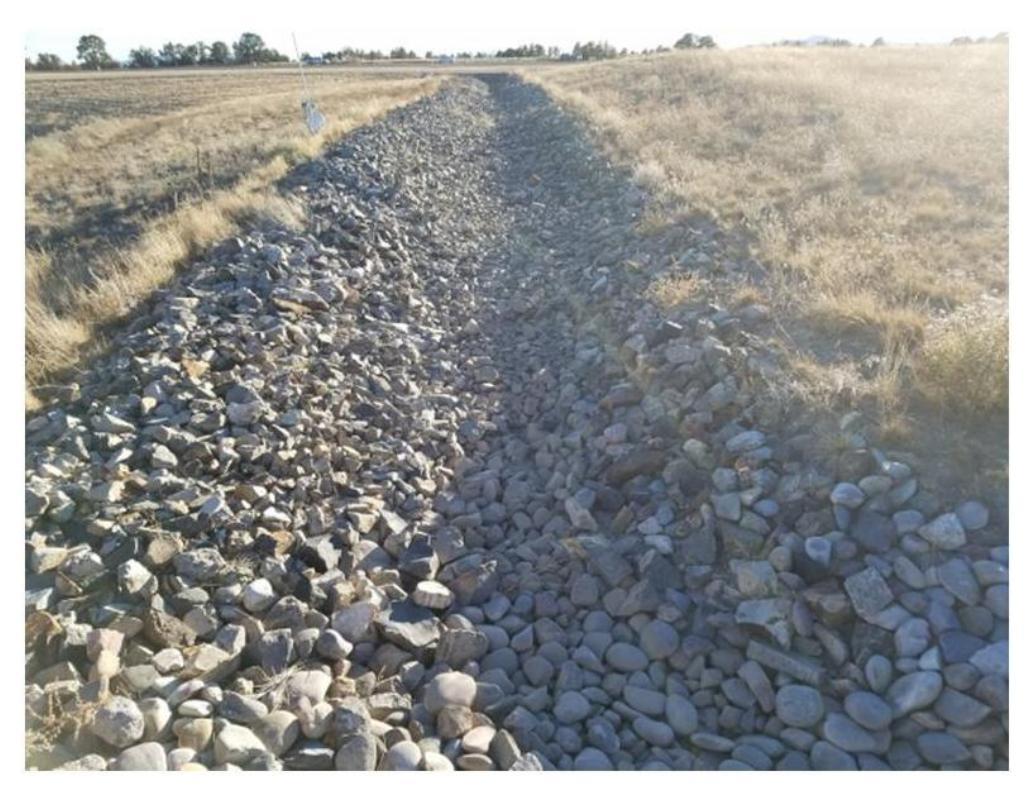
Picture 11. Drainage Channel - East Perimeter of ET Cover

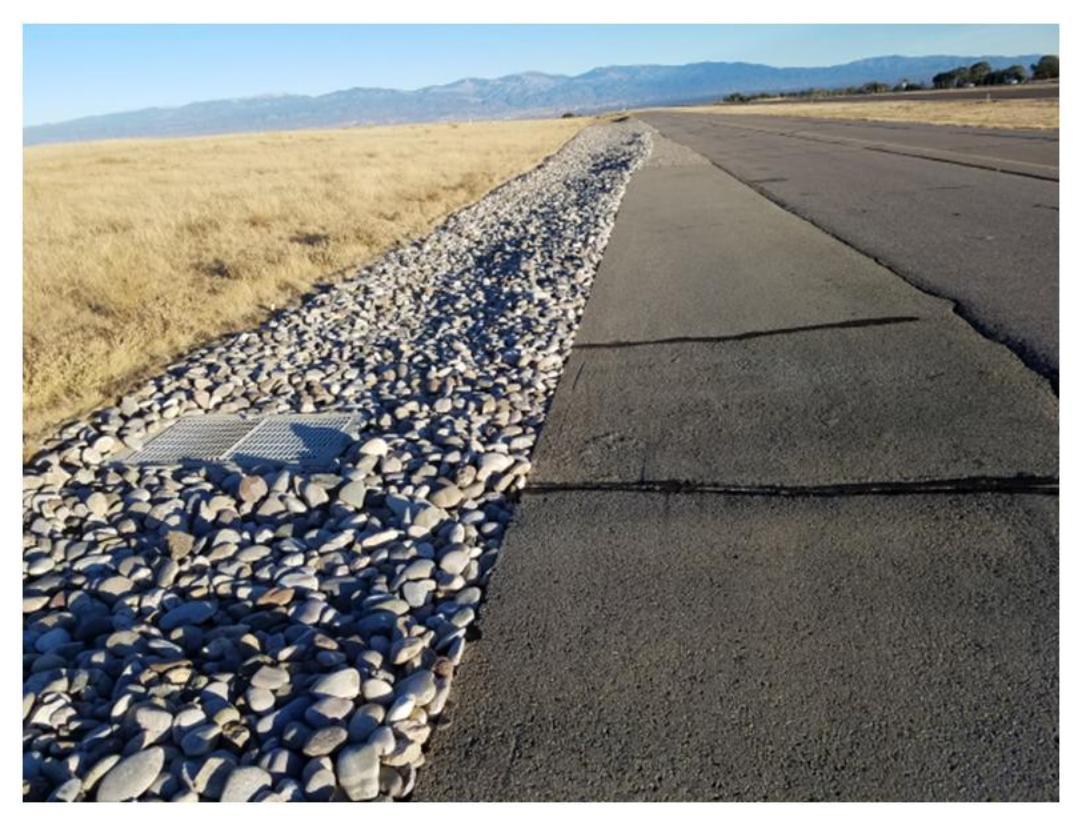
Picture 12. Drainage Channel - South Perimeter of ET Cover

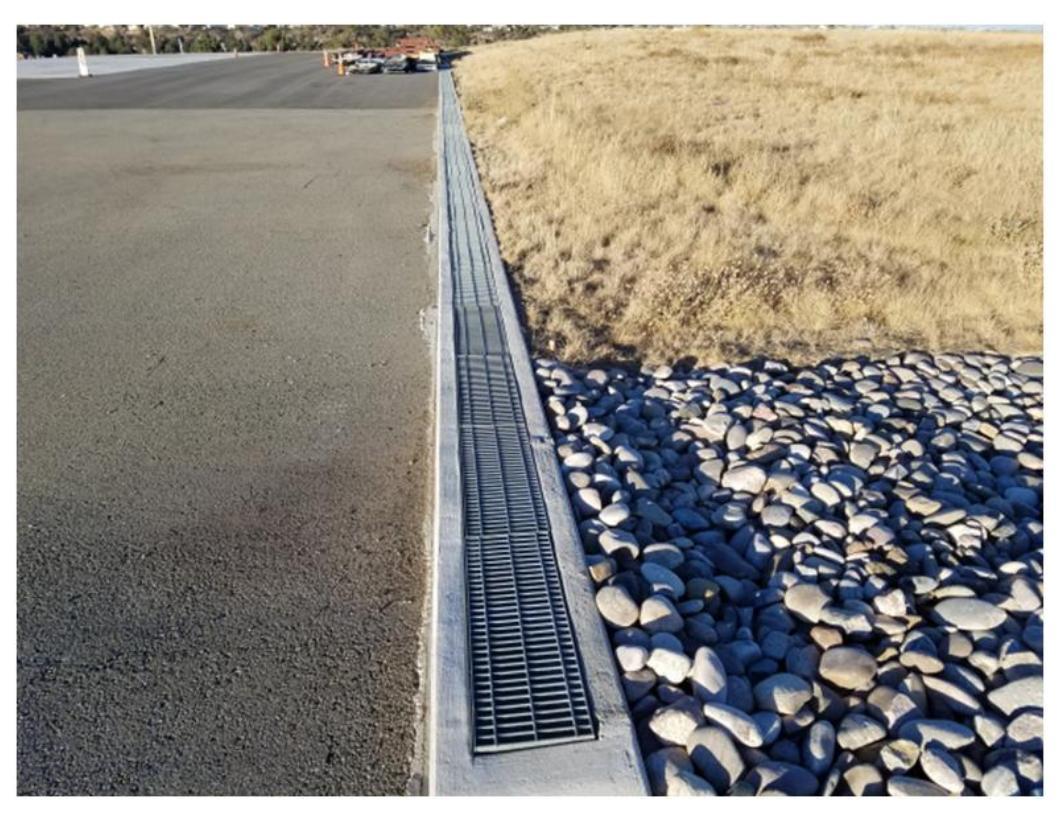
Picture 13. Concrete Culvert - West Perimeter of ET Cover

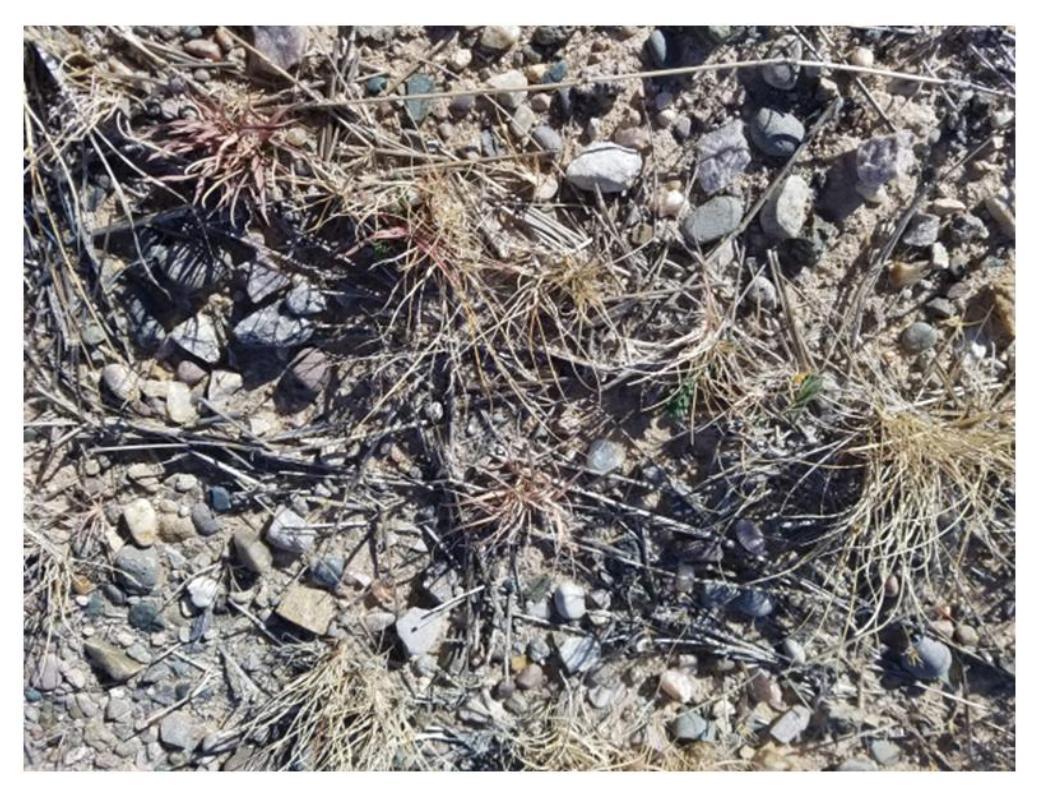
Picture 17. 'Desert Pavement' and Emerging Vegetation - Surface of ET Cover

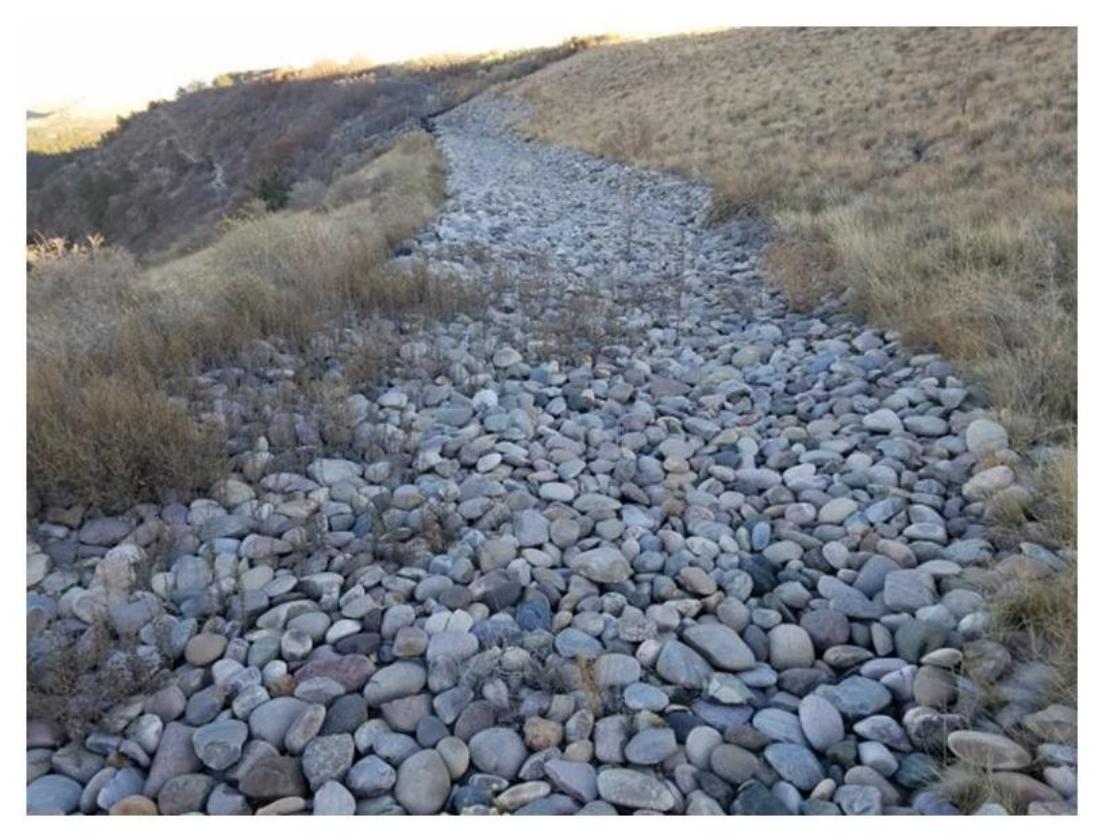
Picture 18. SE Berm - Adjacent to Airport Taxiway

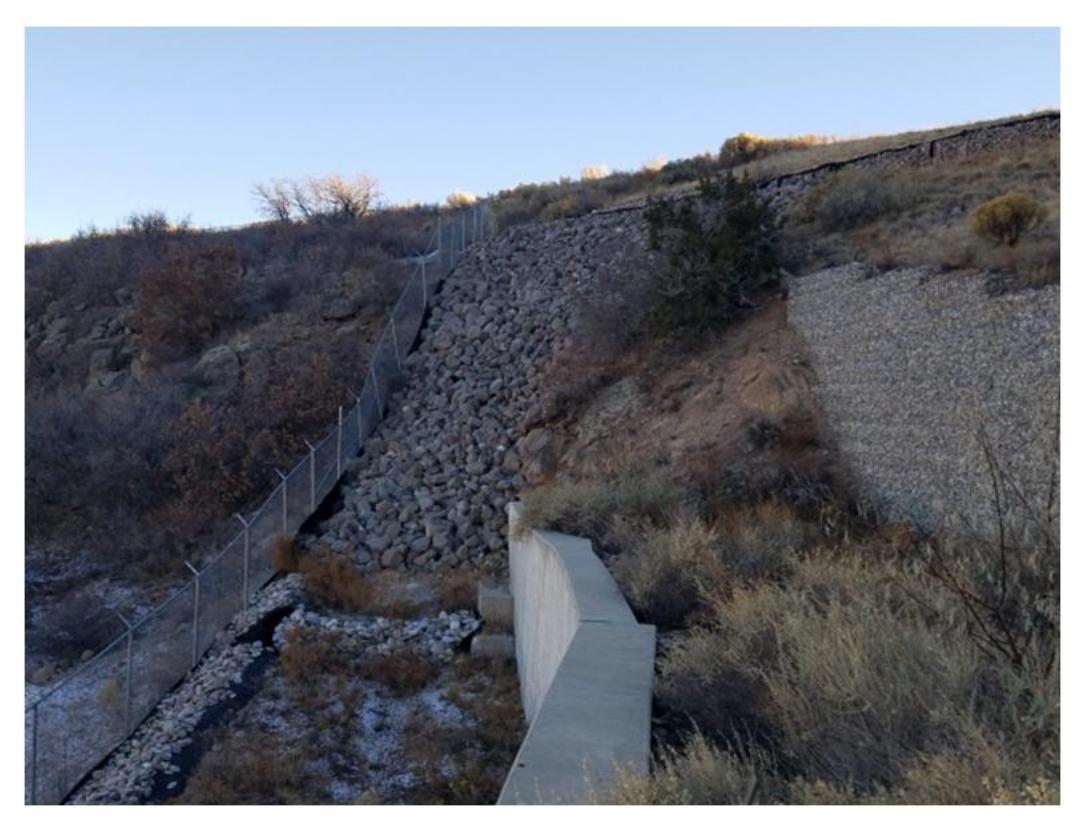
4. Drainage Channels adjacent to Retaining Wall:	The drainage channels adjacent to the retaining wall
Functional Yes (X) No () if no, describe locations	appear in good condition (Pictures 23 to 26). Drainage
Damage, adjunct erosion, slope problem, or other damage/degradation: Yes ( ) No ( X )	channels appear to be working properly.
Description of damage: NA	
Repairs Necessary Yes ( ) No ( X ) If yes, explain

Picture 23. Large Rip Rap Slope - East End of Landfill Site

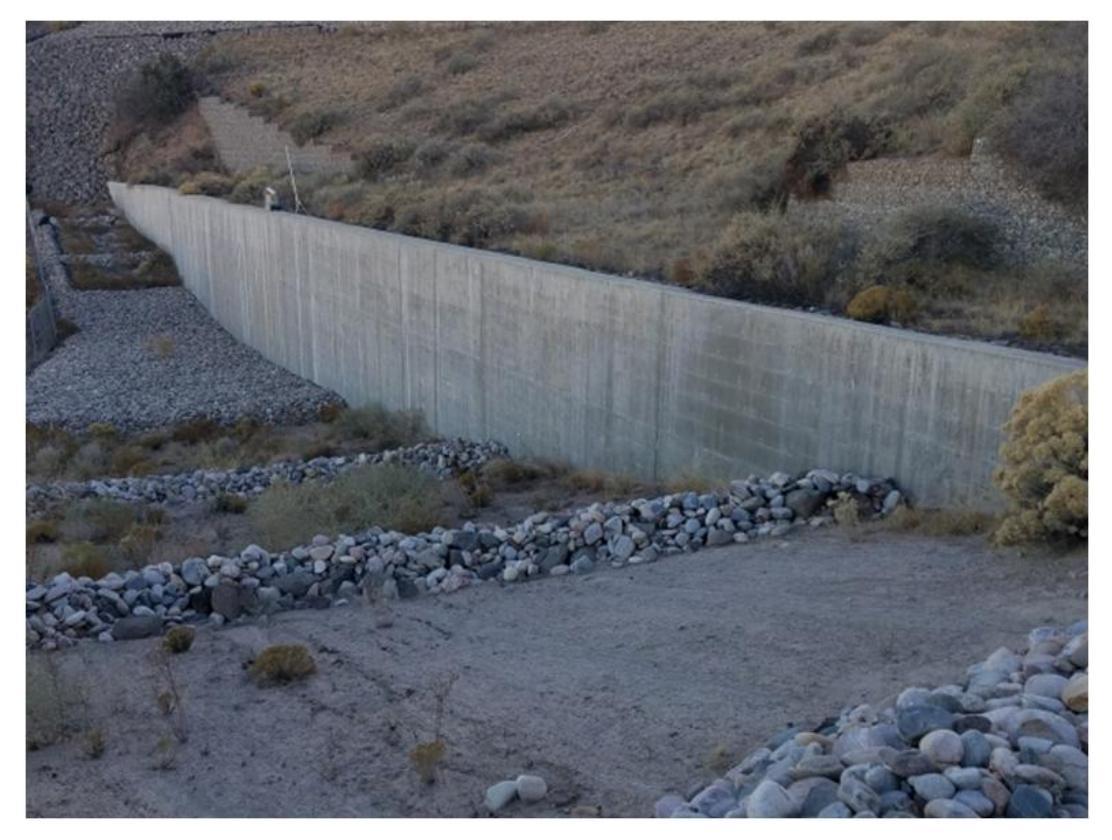
Picture 24. Concrete Retaining Wall - East End of Landfill

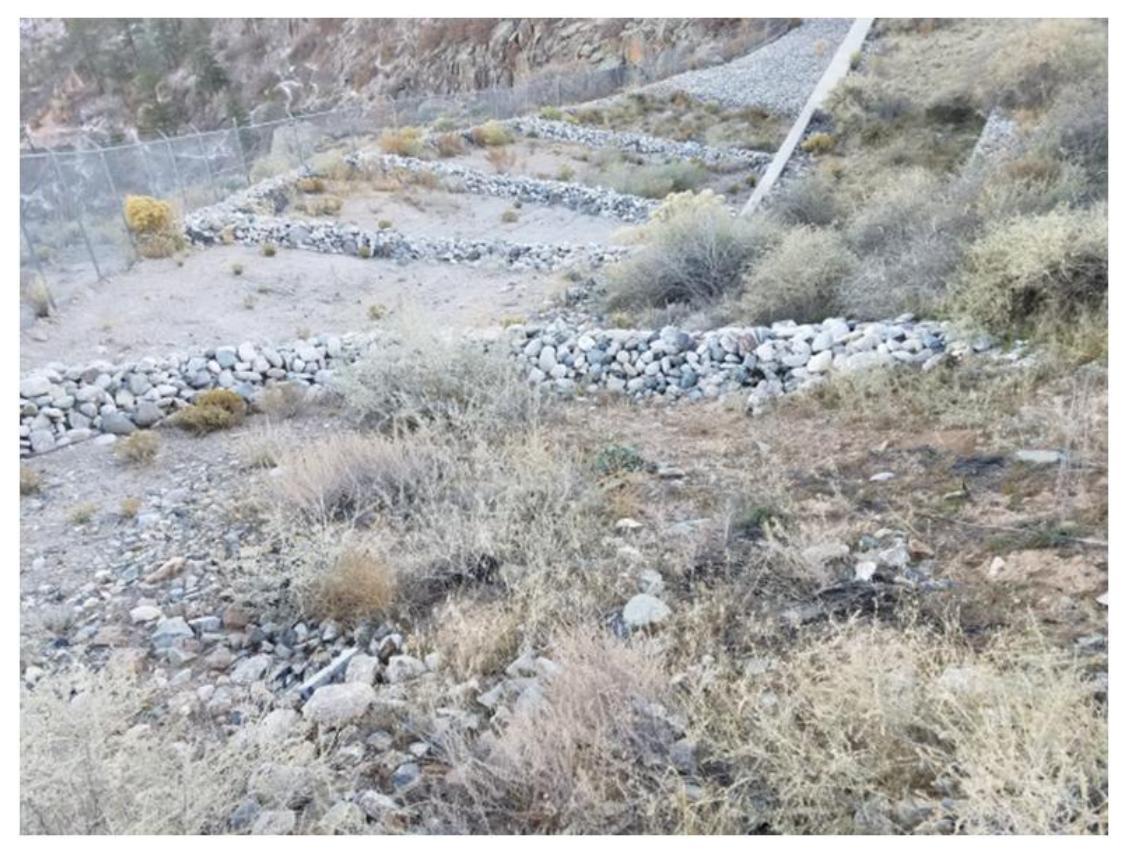
Picture 25. Concrete Retaining Wall - NE End of Landfill

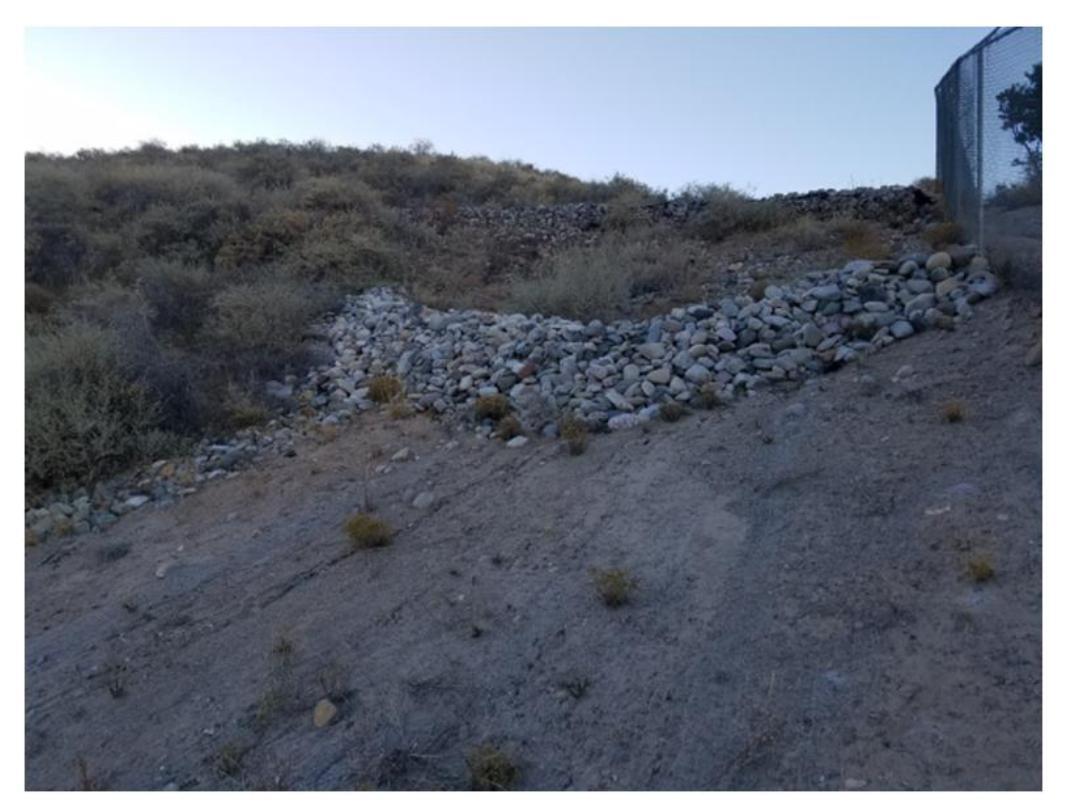
Picture 26. Rock Check Dams - Erosion Control East End of Landfill

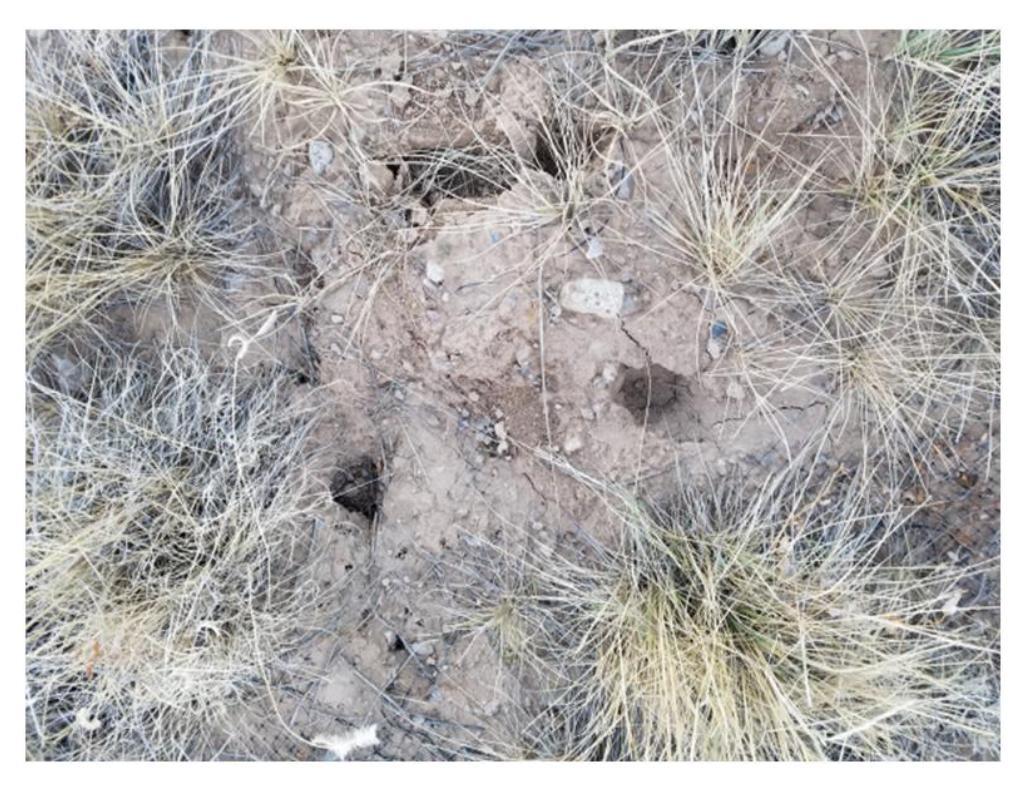
Picture 28. Burrow Holes on Side Slope of Older Landfill Cover
