### LONG-TERM MONITORING INSPECTION REPORT YEAR 2, Quarter 1 INSPECTION #5

### LOS ALAMOS COUNTY AIRPORT LANDFILL COVER REPLACEMENT

Inspection Date:	August 31,	2017
Report Date:	October 5,	2017

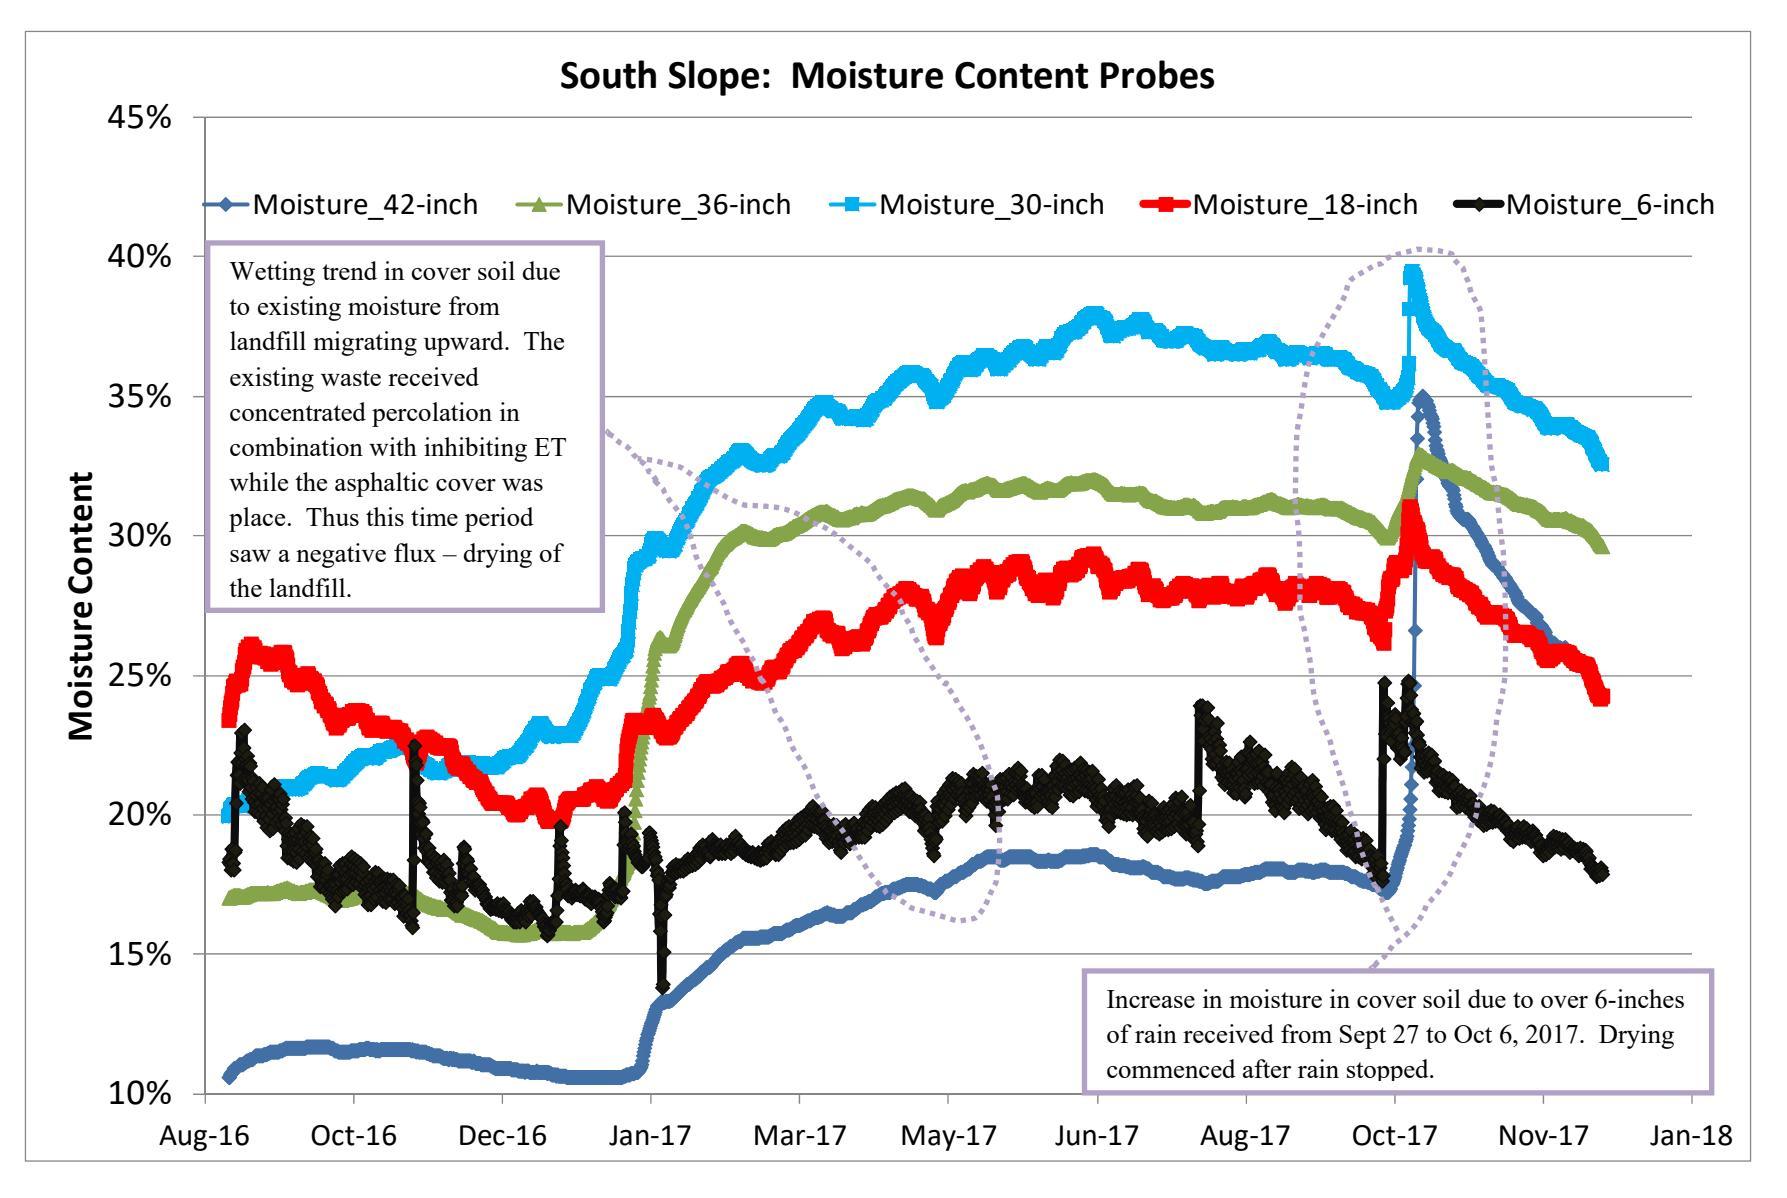
The moisture content probes reveal that infiltrated moisture due to precipitation quickly dries shortly after (Figures 1 and 2). There was a considerable amount of precipitation at the site from September 27 to October 6, 2017– about 6.04-inches. The probes showed that the moisture infiltrated the cover during that period and took several weeks to dry via Evapotranspiration (ET). There also appears to be some sensitivity of the moisture content measurements to soil temperature. This data is in early in the data acquisition process and it will take multiple seasons of data to analyze the data and better reflect understand the water balance trends in the cover system.

Figure 1. Moisture Probe Data (September 2016 to Dec 2017) - ET Cover South Slope

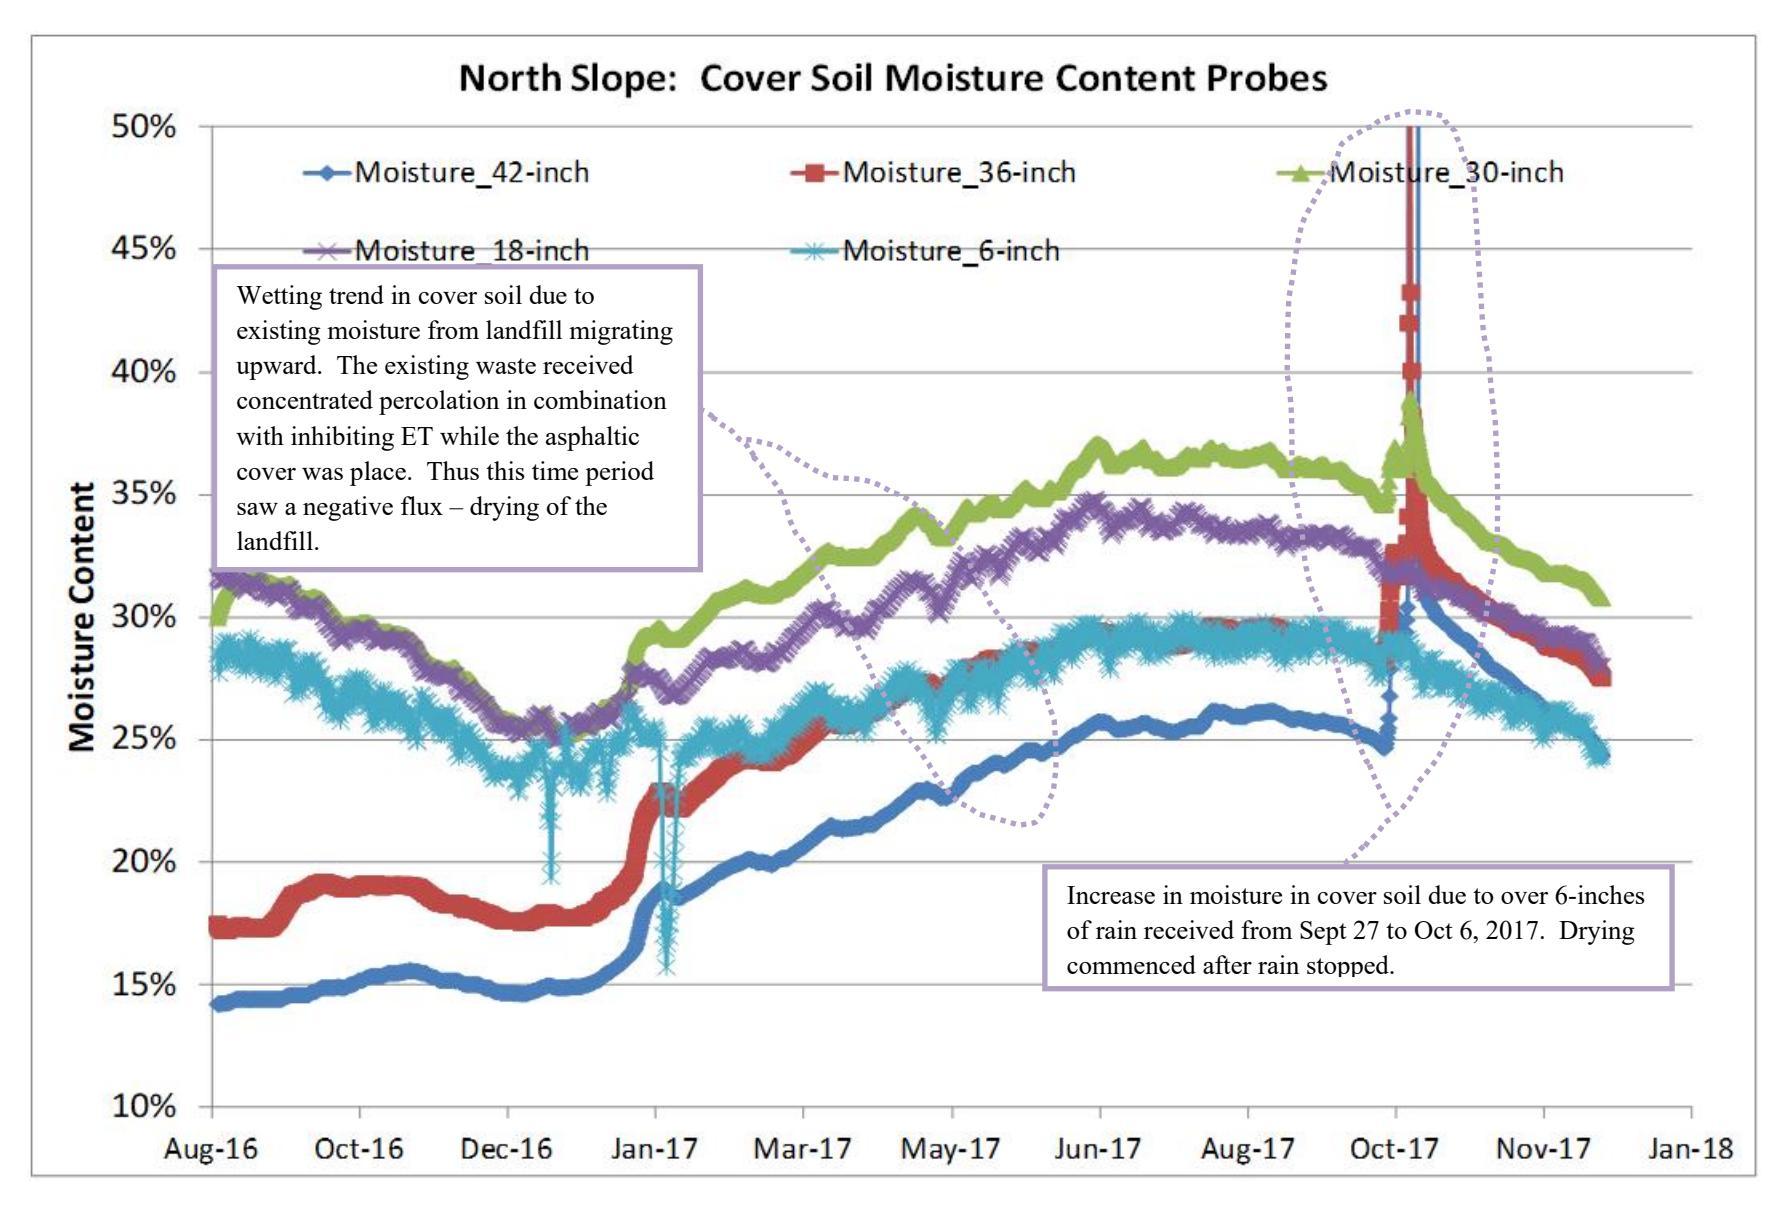
Figure 2. Moisture Probe Data (September 2016 to Dec 2017) - ET Cover North Slope

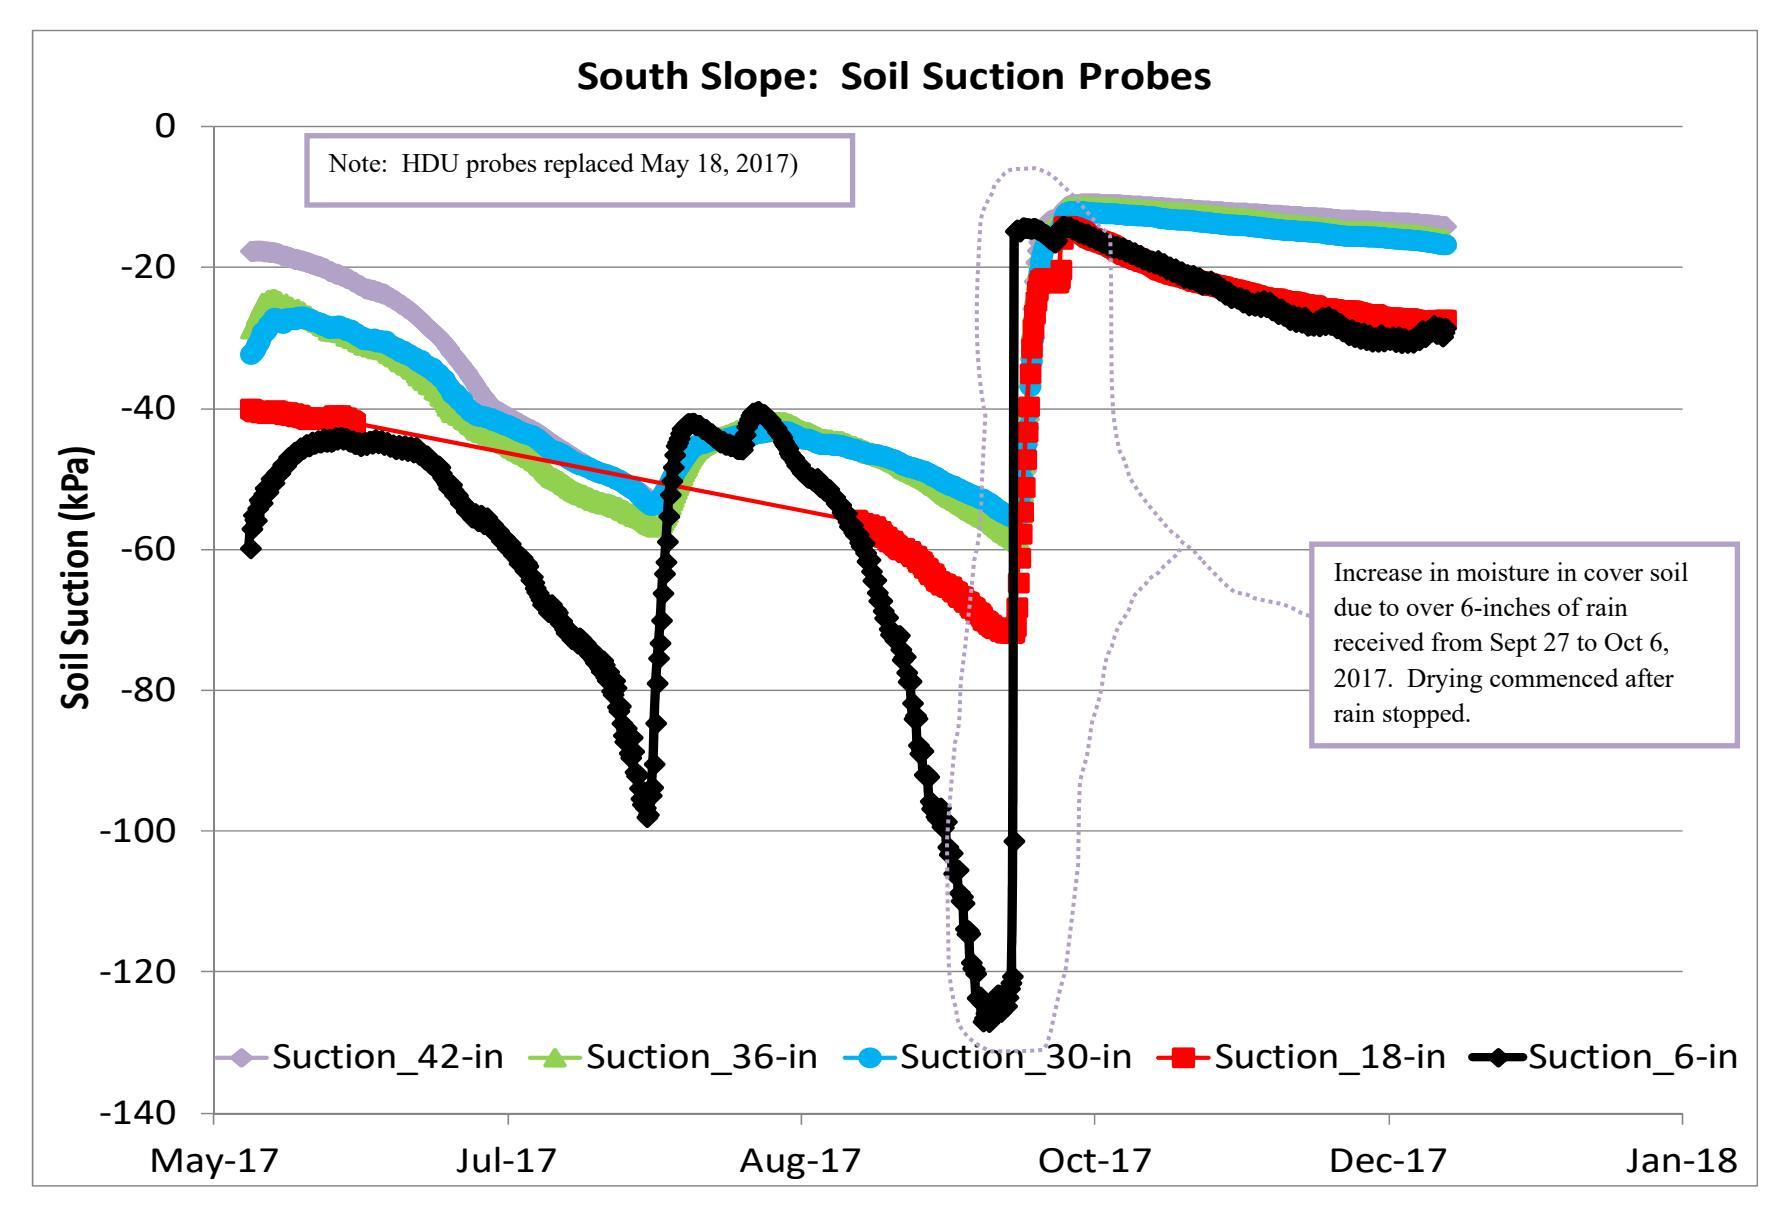
Heat dissipation units (HDU) were replaced on May 18, 2017. These probes measure the matric potential or soil suction in the soil cover system at various depths. The new probes are the most advanced available to date through Decagon Corp. Collected data to date is shown in Figures 4 and 5. Figure 6 contains the available daily precipitation events for comparison to response of the soil suction data. Figure 7 shows the monitoring point locations. The infiltration of water due to the excessive rain the site received (September 27 to October 6, 2017– about 6.04-inches) is reflected in the HDU probes whereby the soil suction was reduced when the moisture infiltrated and has been drying since. Despite this extreme amount of precipitation, there was no saturation recorded in the cover reflecting the ET Cover is working as designed. Saturation of the soil is equivalent to a zero soil suction value.

Figure 4. HDU Data (May 2017 to Dec 2017) - ET Cover South Slope

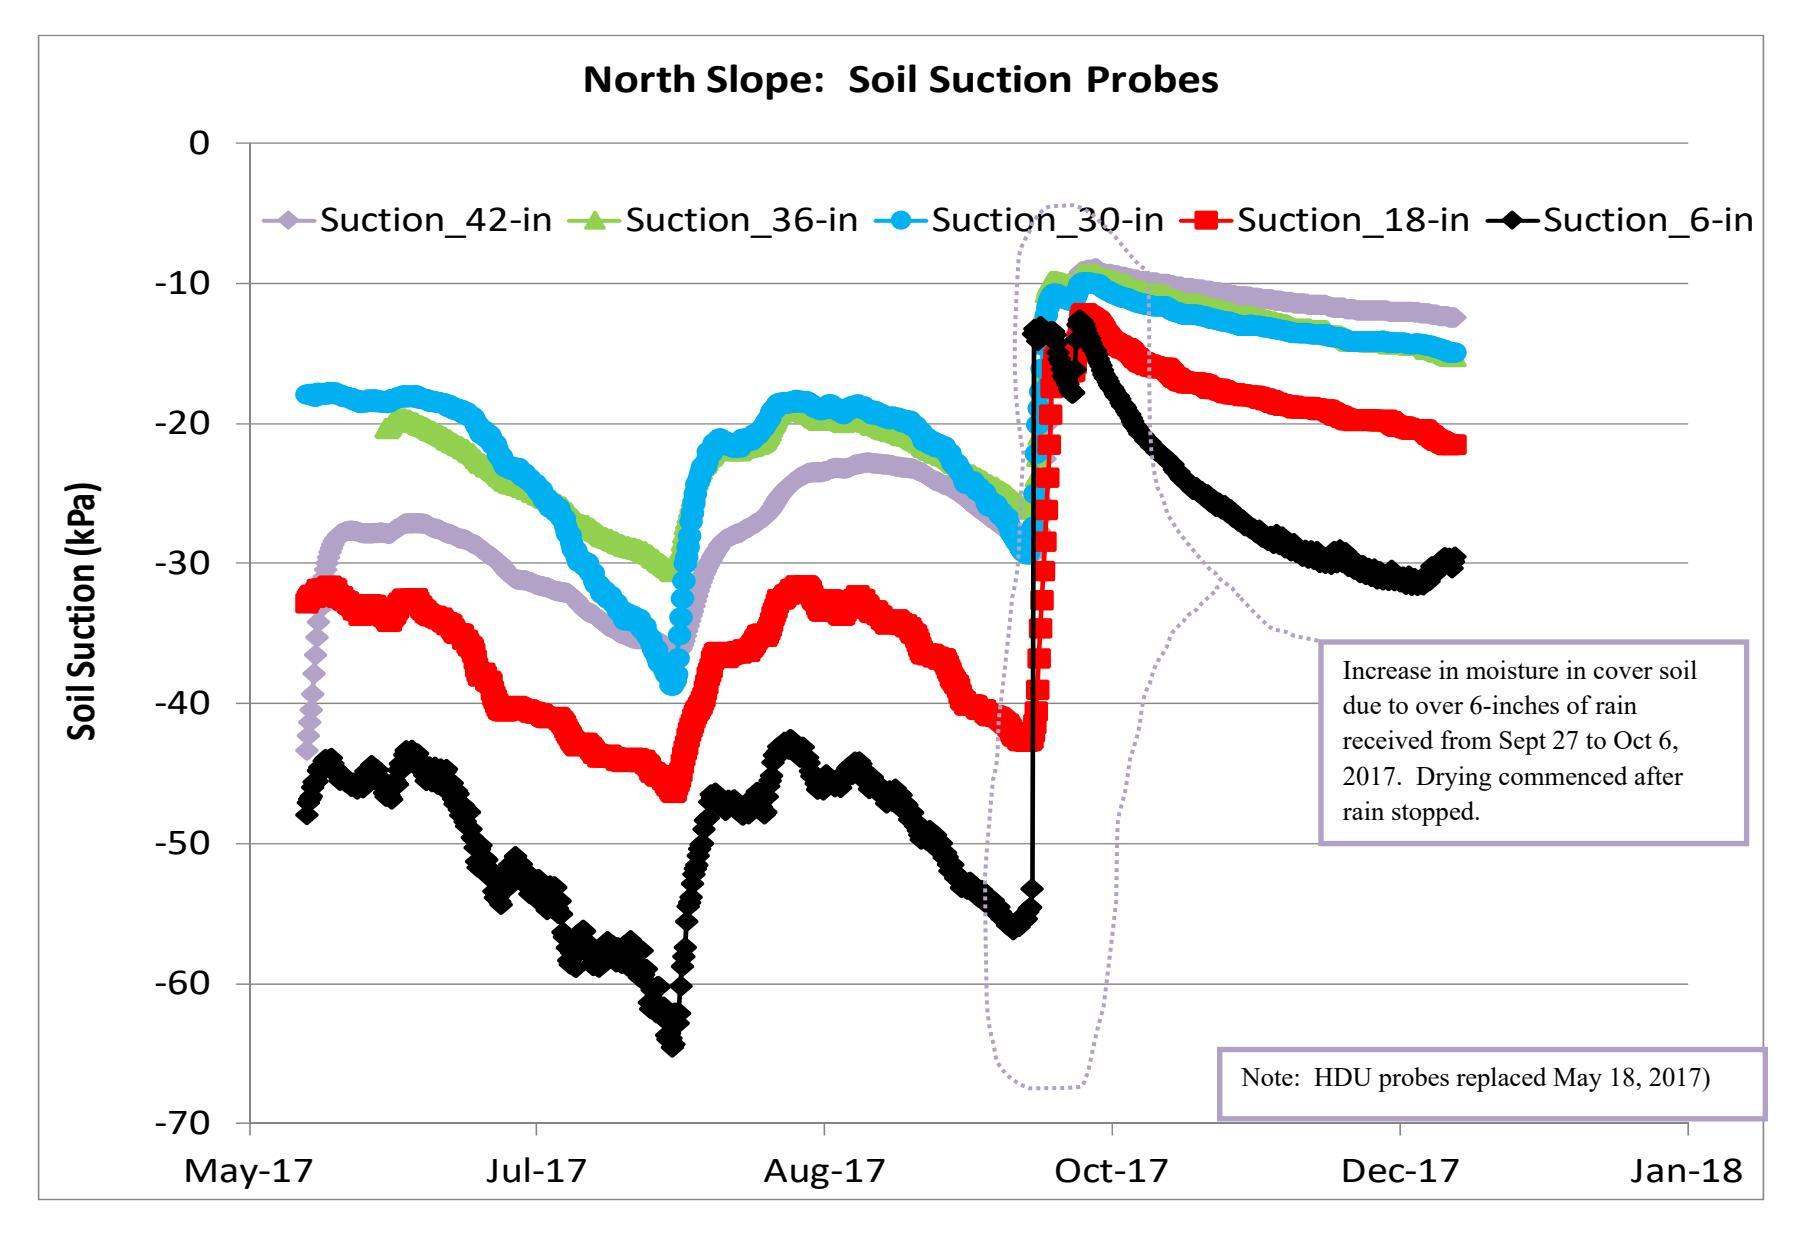
Figure 5. HDU Data (May 2017 to Dec 2017) - ET Cover North Slope

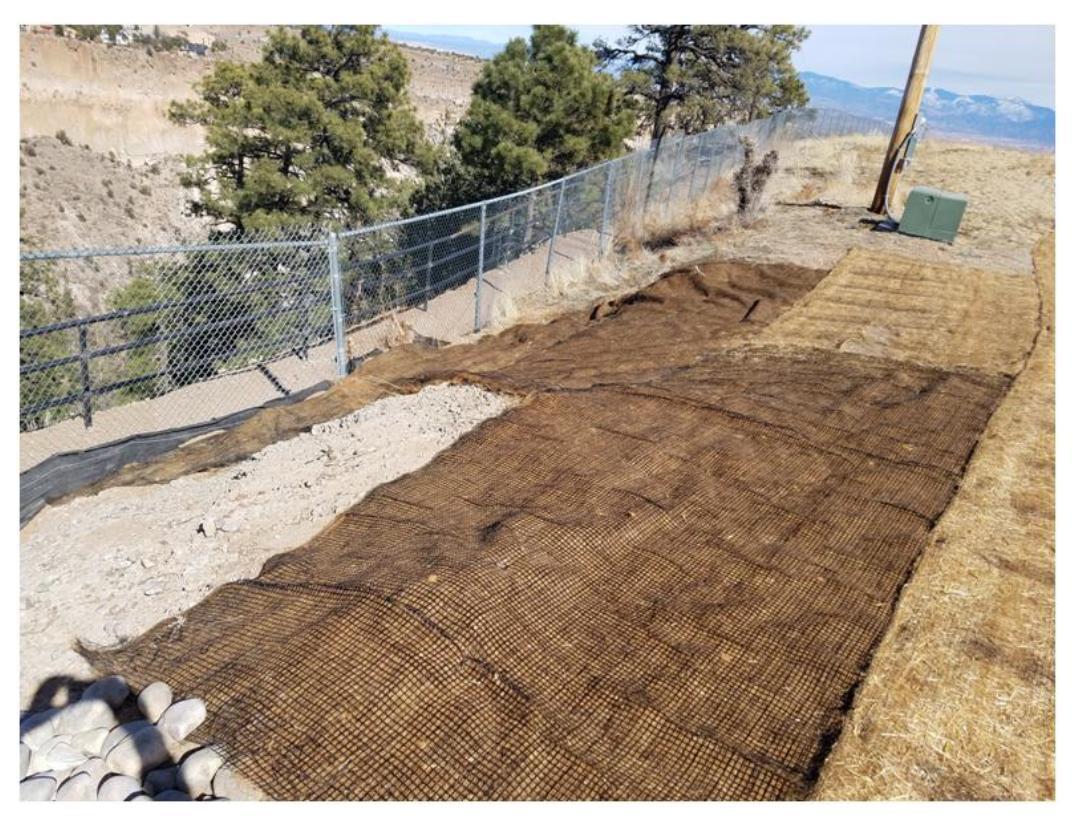
Picture 7. Recent Placement of Erosion Matting by Los Alamos County North of New Hangar Pad

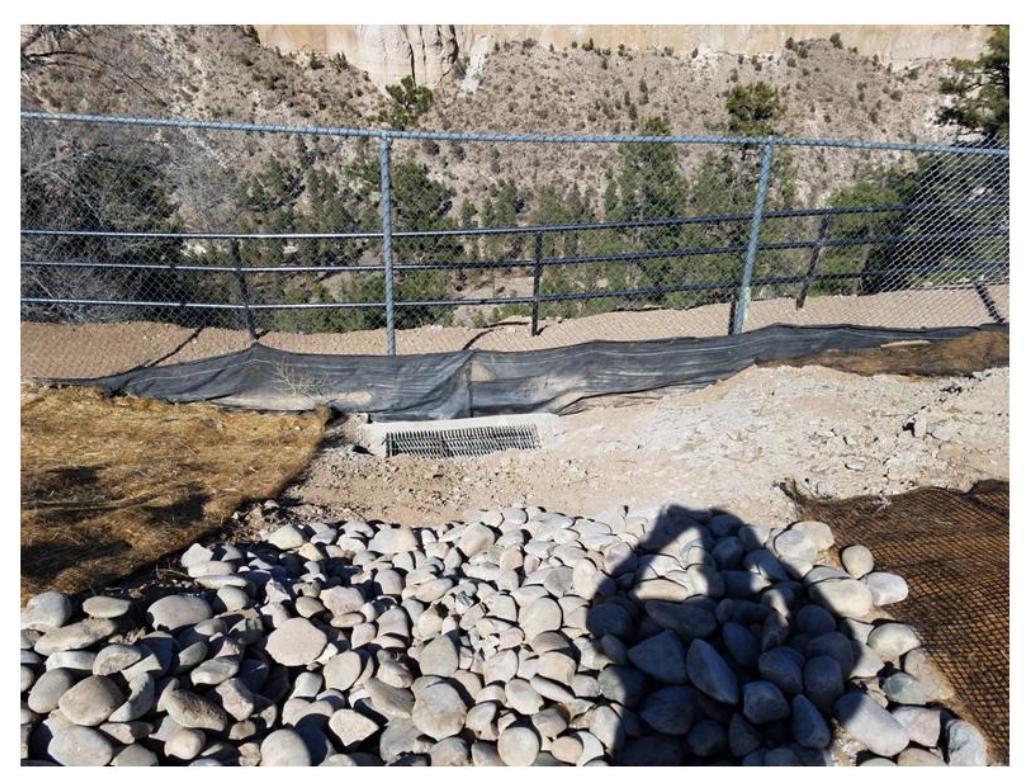
Picture 9. New Drop Inlet Structure Installed by Los Alamos County North of New Hangar Pad

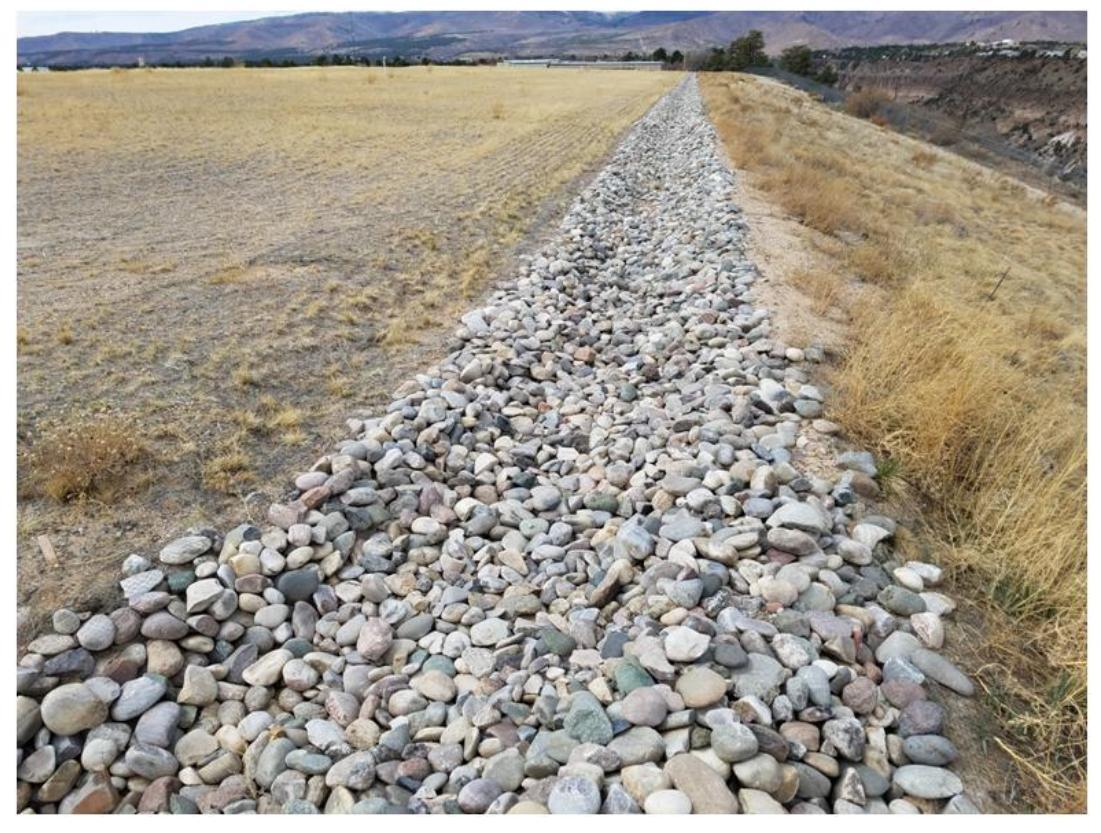
2. Material Degradation:	No material degradation noted to date (Pictures 10, 11,
Yes ( ) No ( X )	and 12).
Material Type: Rock, geotextile, geomembrane

Picture 10. Drainage Channel - North Perimeter of ET Cover

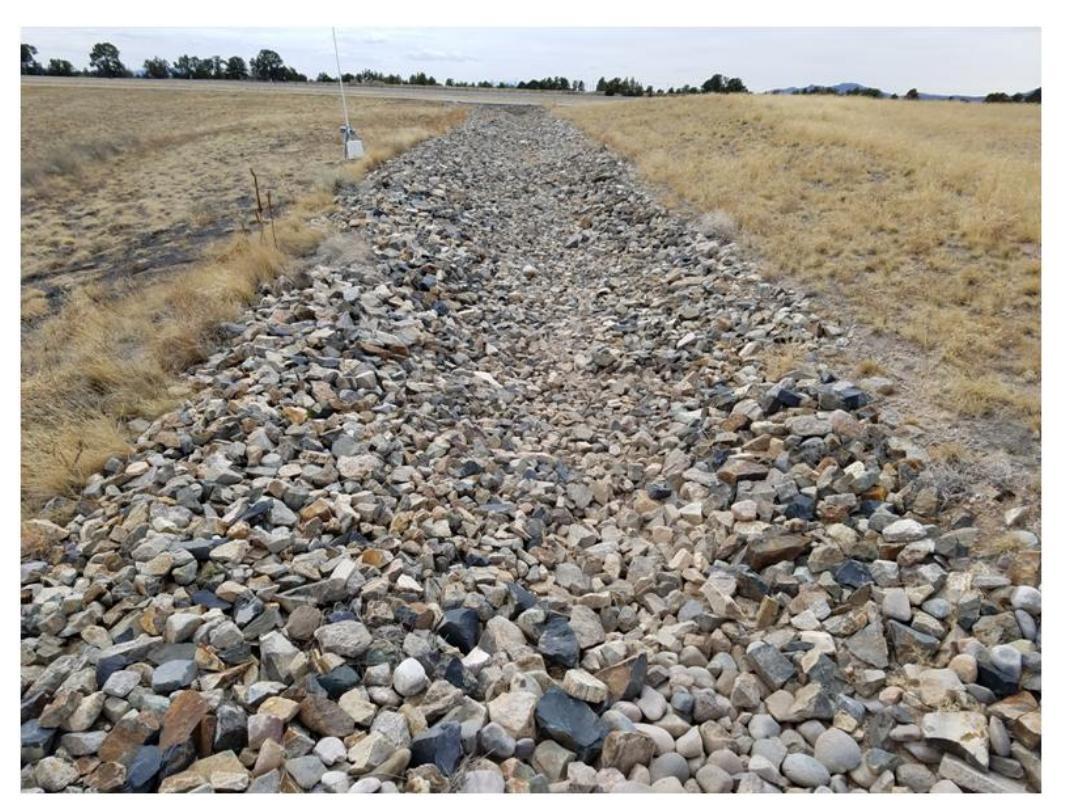
Picture 11. Drainage Channel - East Perimeter of ET Cover

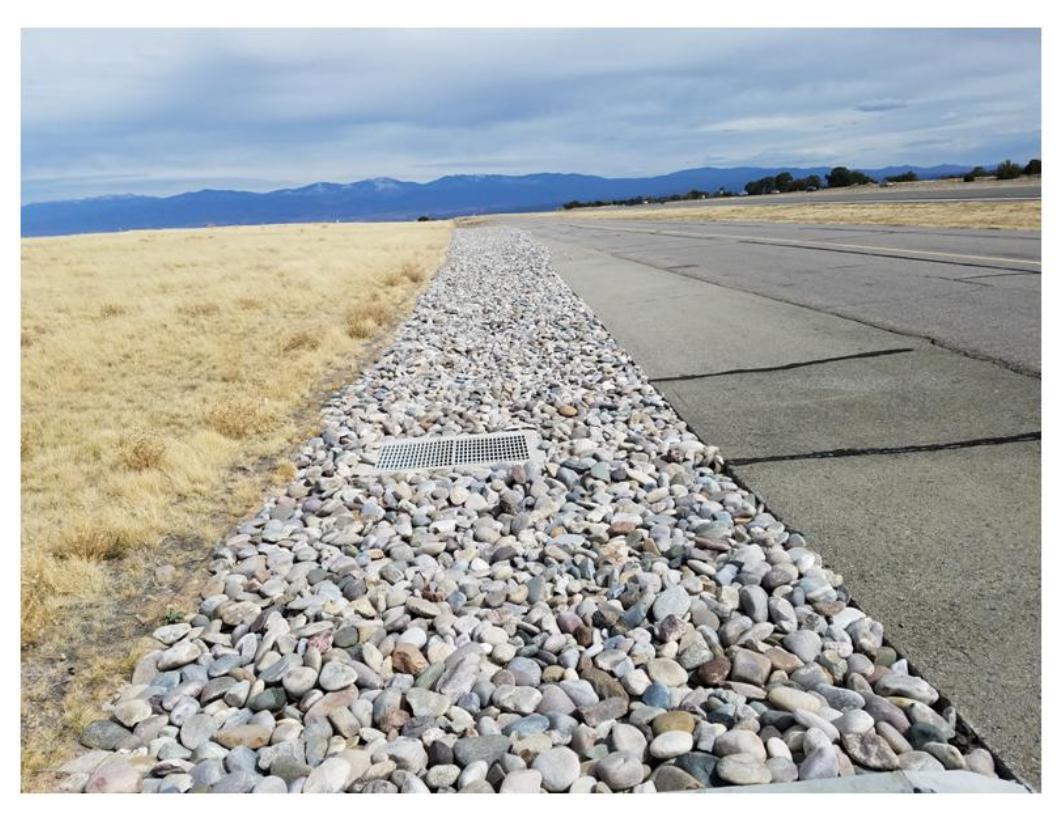
8. Drop Inlet Structures:	Drop inlet structures are in good condition (Picture 12).
Working Properly	
Yes ( X ) No ( )	
Condition: good	
Extent of Damage: NA	
Repairs Necessary Yes ( ) No ( X ) If yes, explain	
Concrete	e Culvert

Picture 12. Drainage Channel - South Perimeter of ET Cover

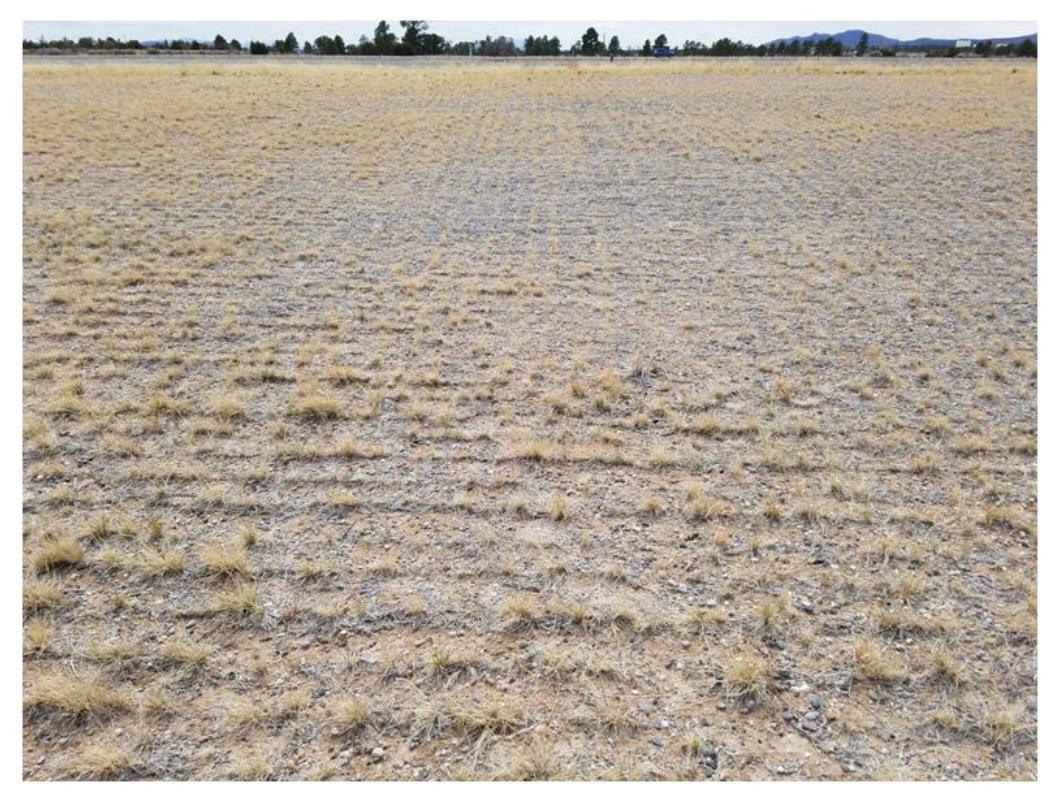
Picture 14. ET Cover - South View

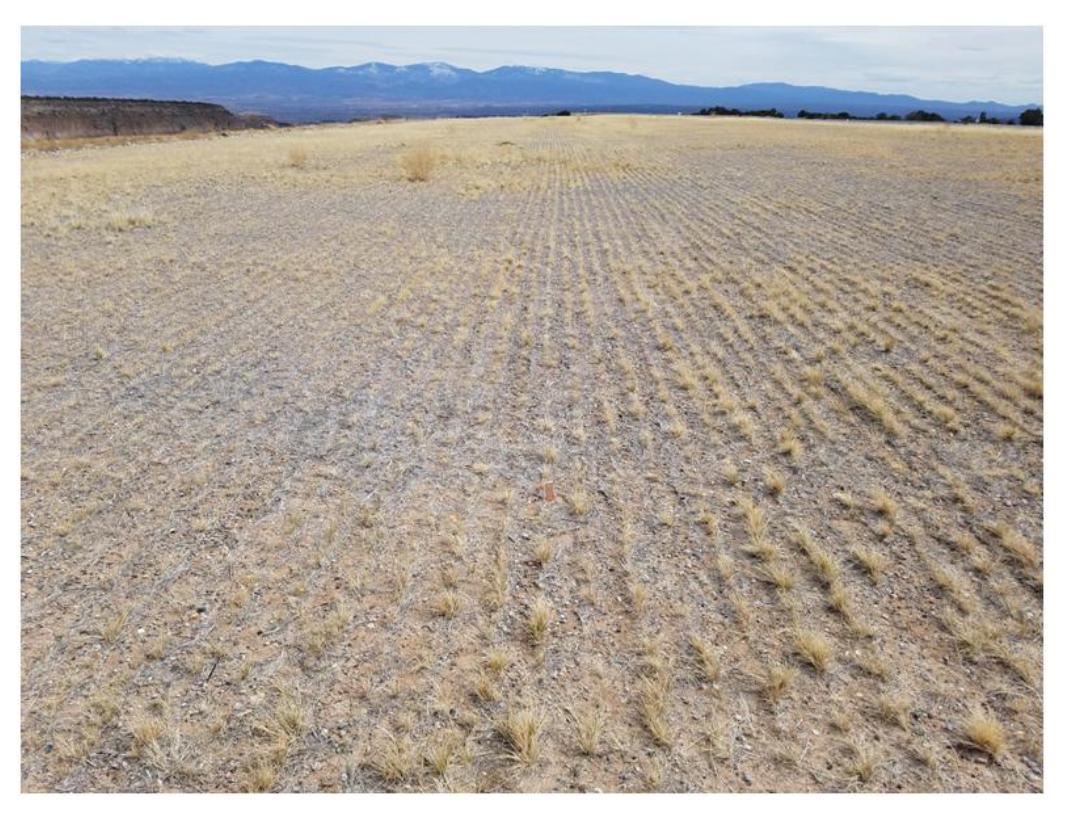
Picture 15. ET Cover - East View

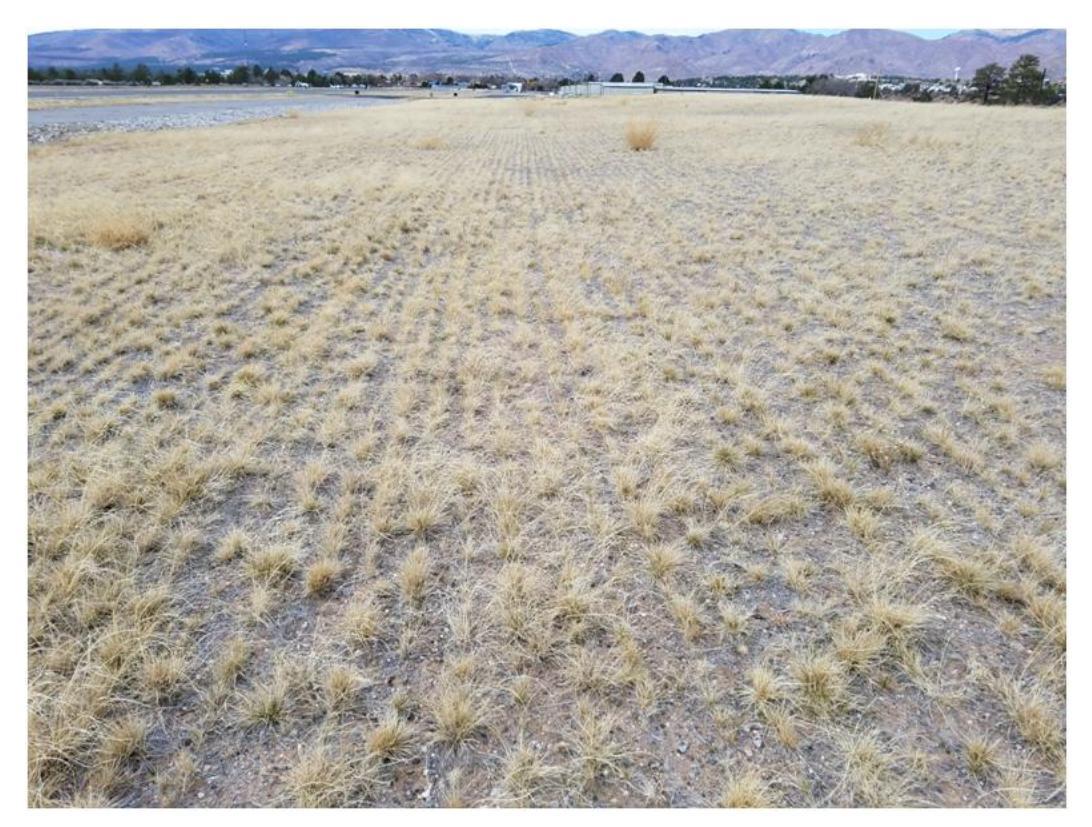
Picture 16. ET Cover - West View

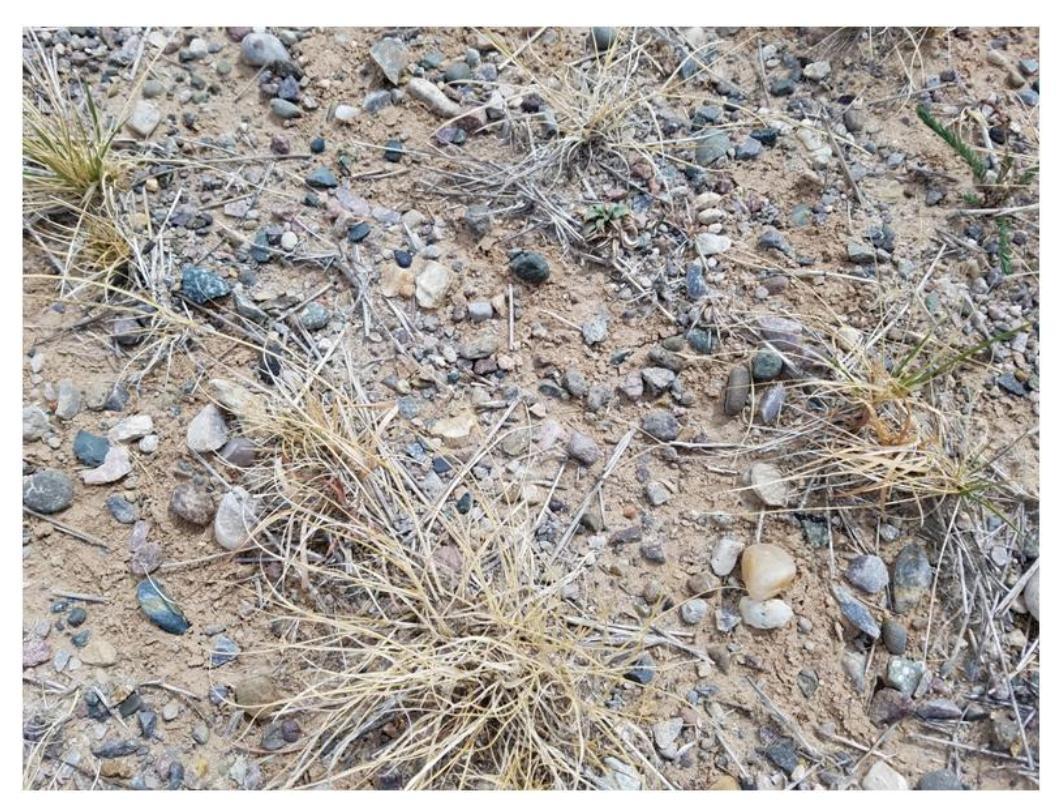
Picture 17. 'Desert Pavement' and Emerging Vegetation - Surface of ET Cover

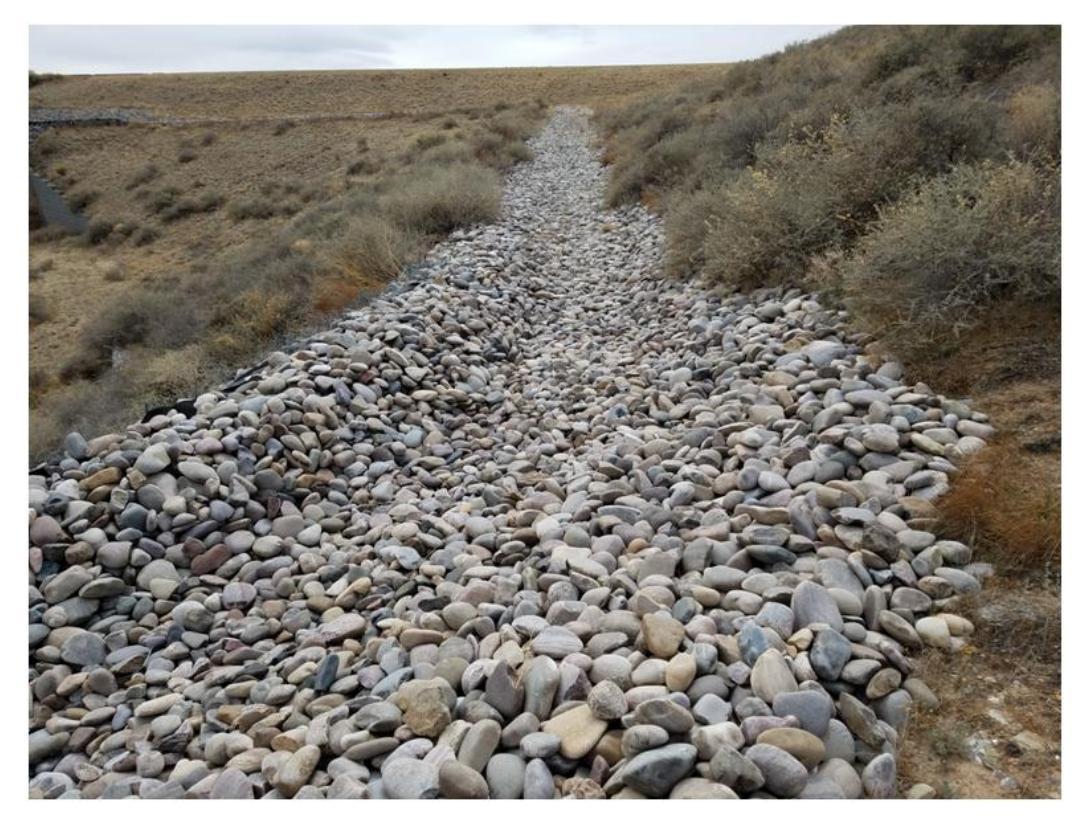
Picture 18. Eastern Berm on Sideslope East of Landfill

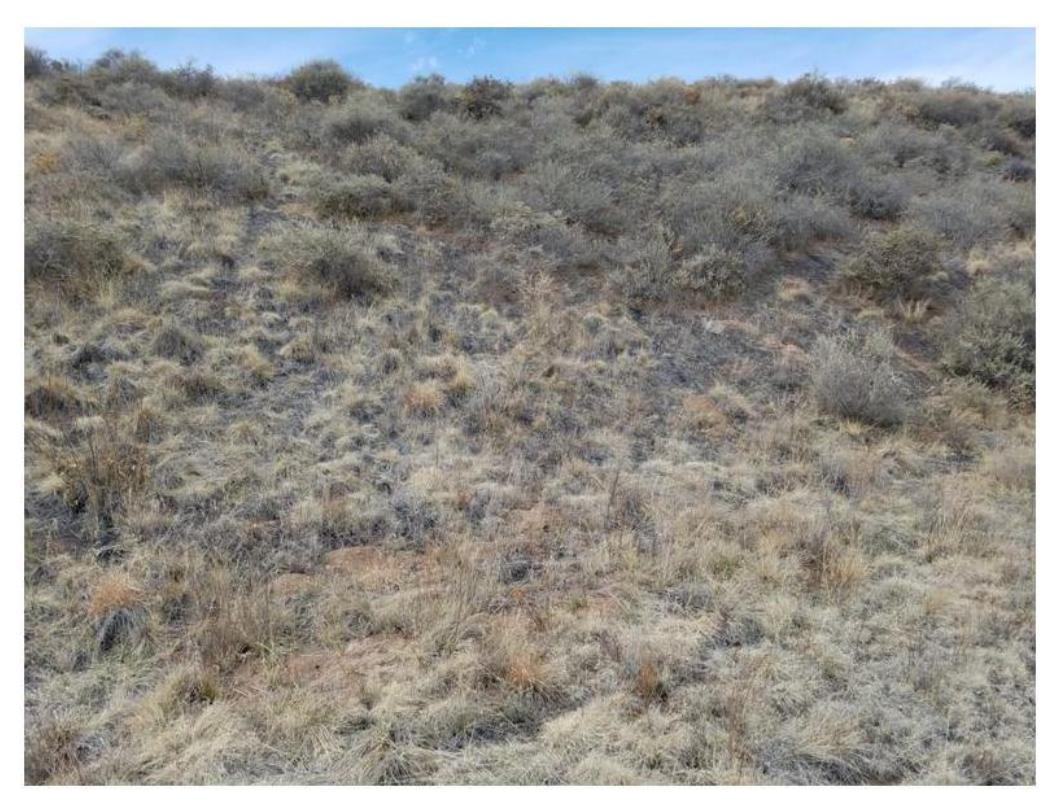
Picture 20. Eastern Side Slope of Landfill

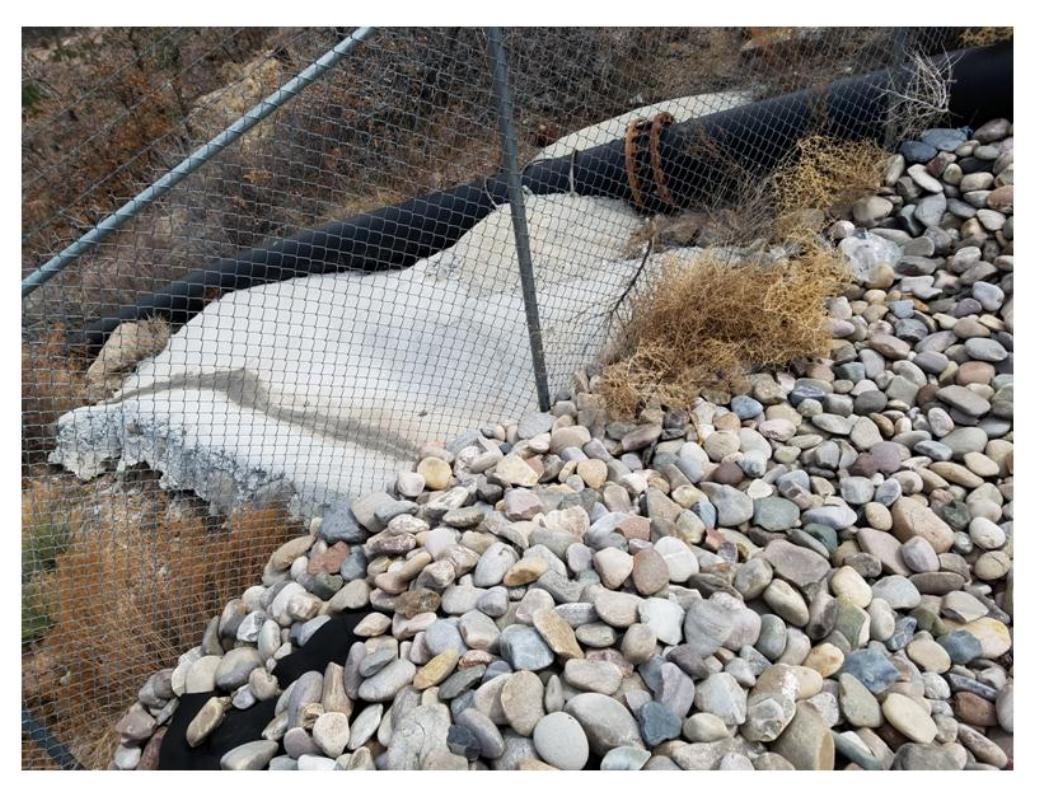
Picture 21. Concrete Drainage - East End of SE Berm

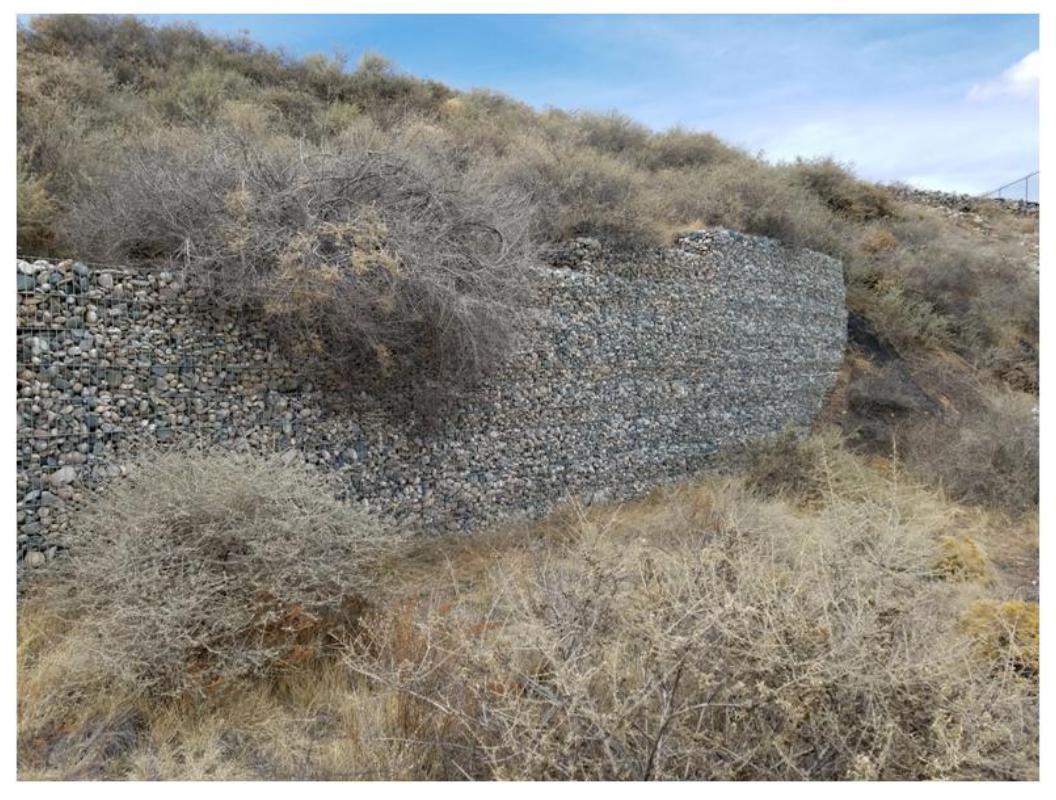
Picture 22. Gabion Retaining Structure - East End of Landfill

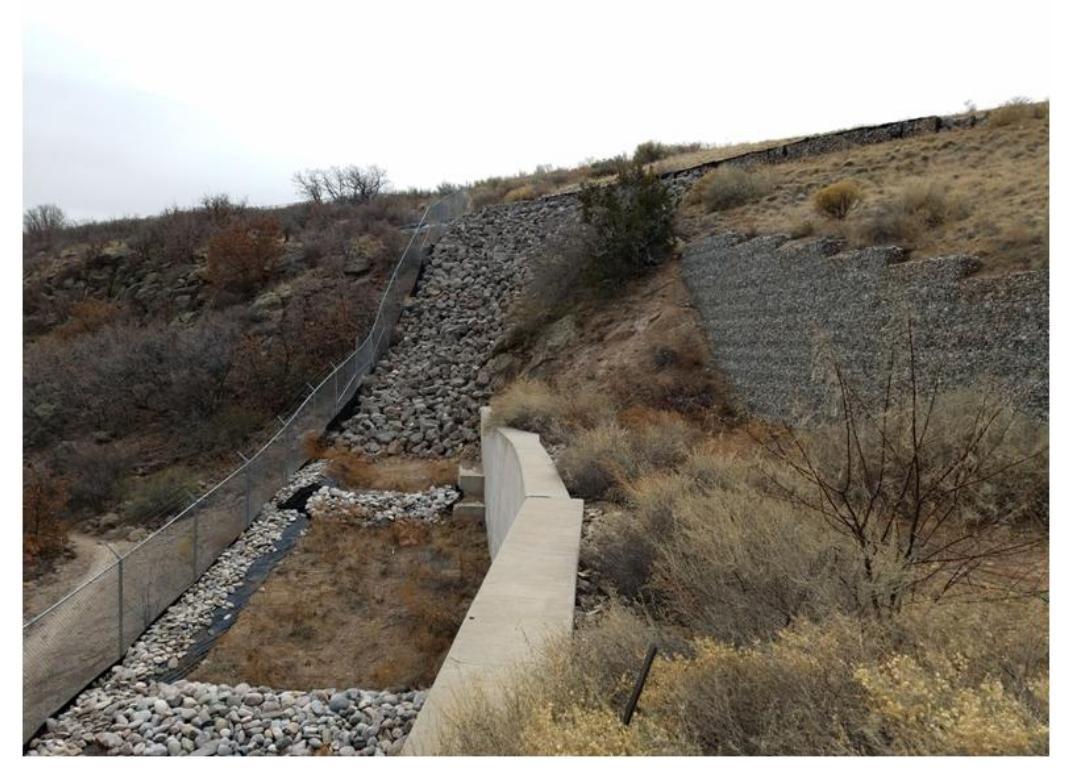
Picture 23. Large Rip Rap Slope and Gabion Retainment Wall - East End of Landfill Site

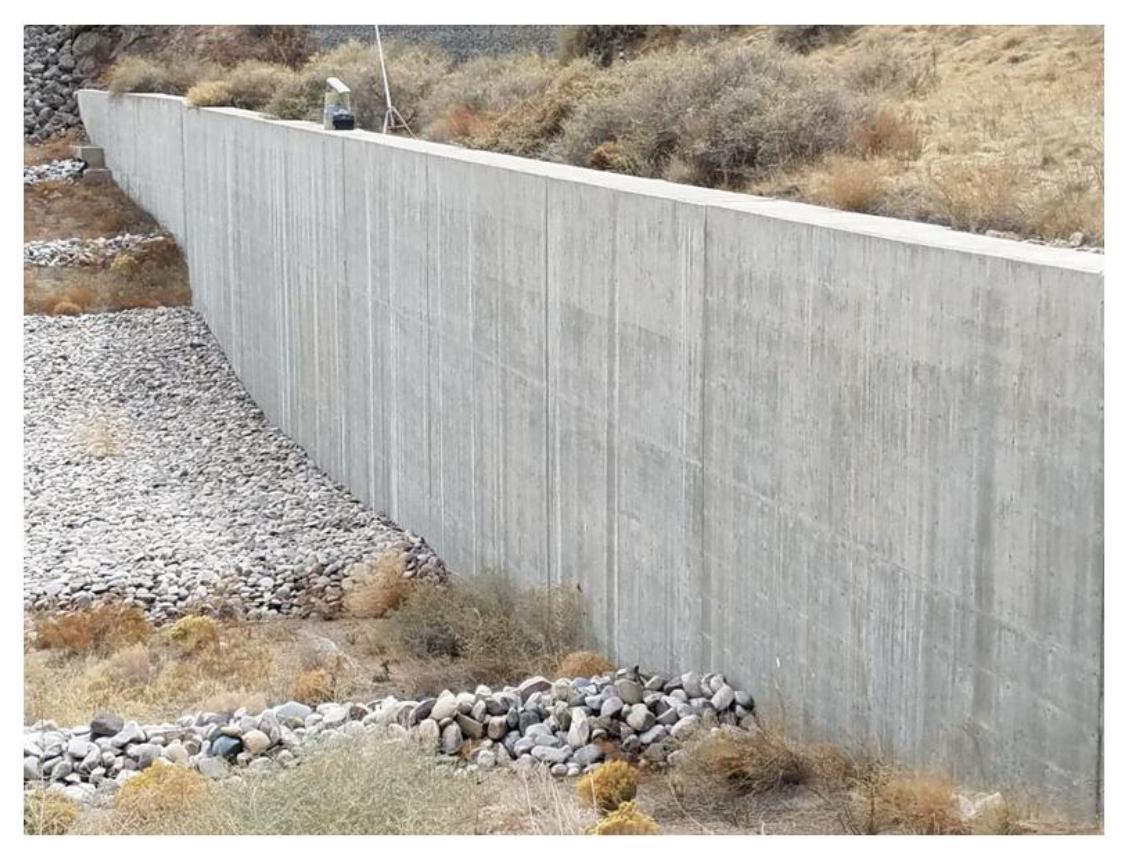
Picture 24. Concrete Retaining Wall - East End of Landfill
