### LONG-TERM MONITORING INSPECTION REPORT YEAR 2, Quarter 1 INSPECTION #5

### LOS ALAMOS COUNTY AIRPORT LANDFILL COVER REPLACEMENT

Inspection Date:	August 31,	2017
Report Date:	October 5,	2017

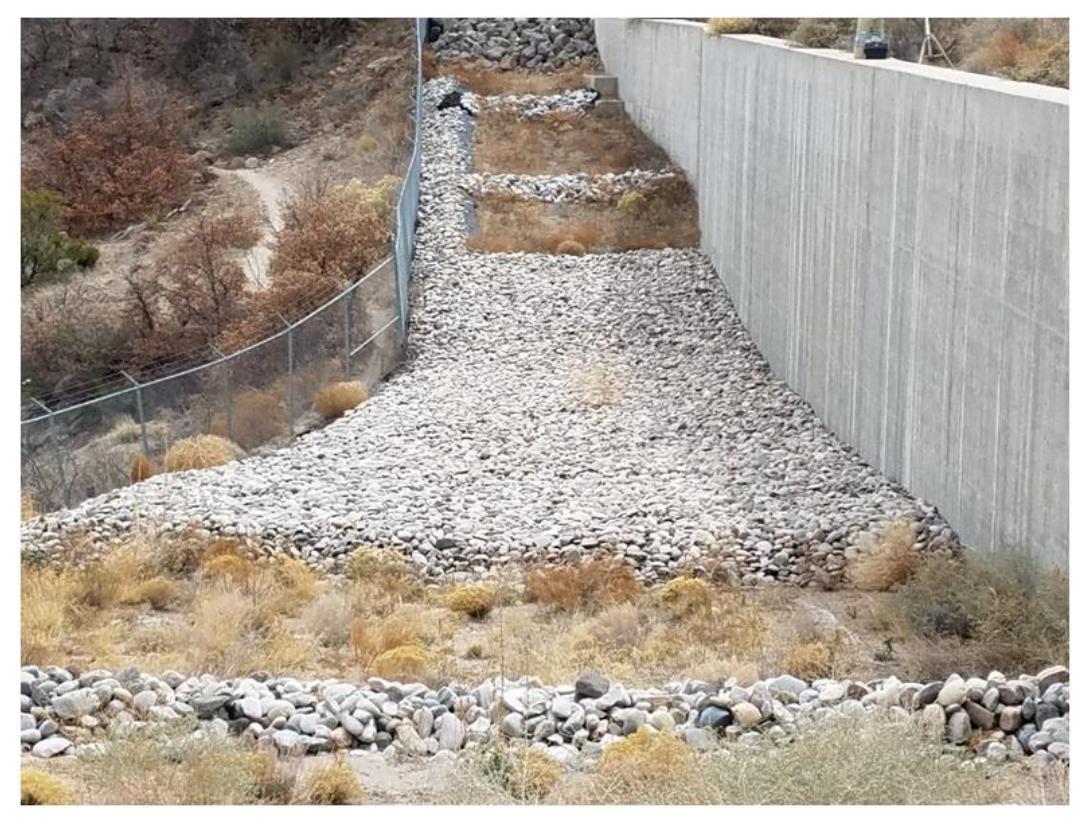
Picture 25. Erosion Control below Concrete Retaining Wall - NE End of Landfill

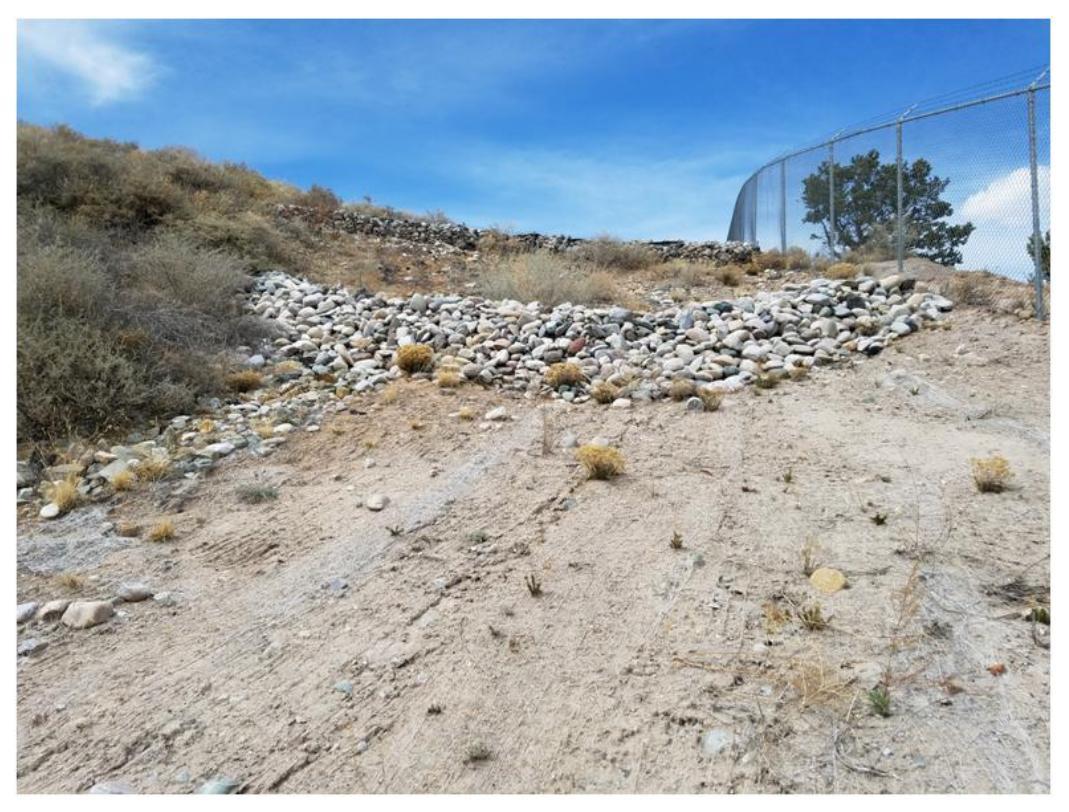
Picture 26. Rock Check Dams - Erosion Control East End of Landfill

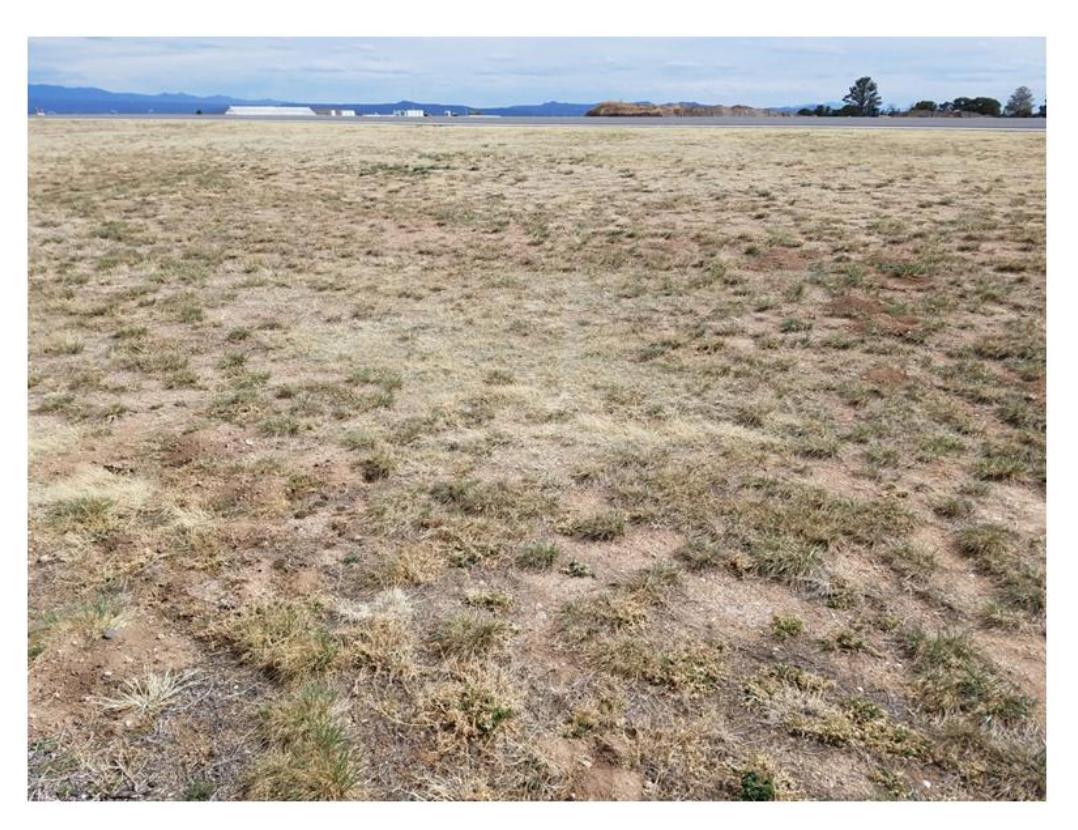
Picture 27. Debris Disposal Area

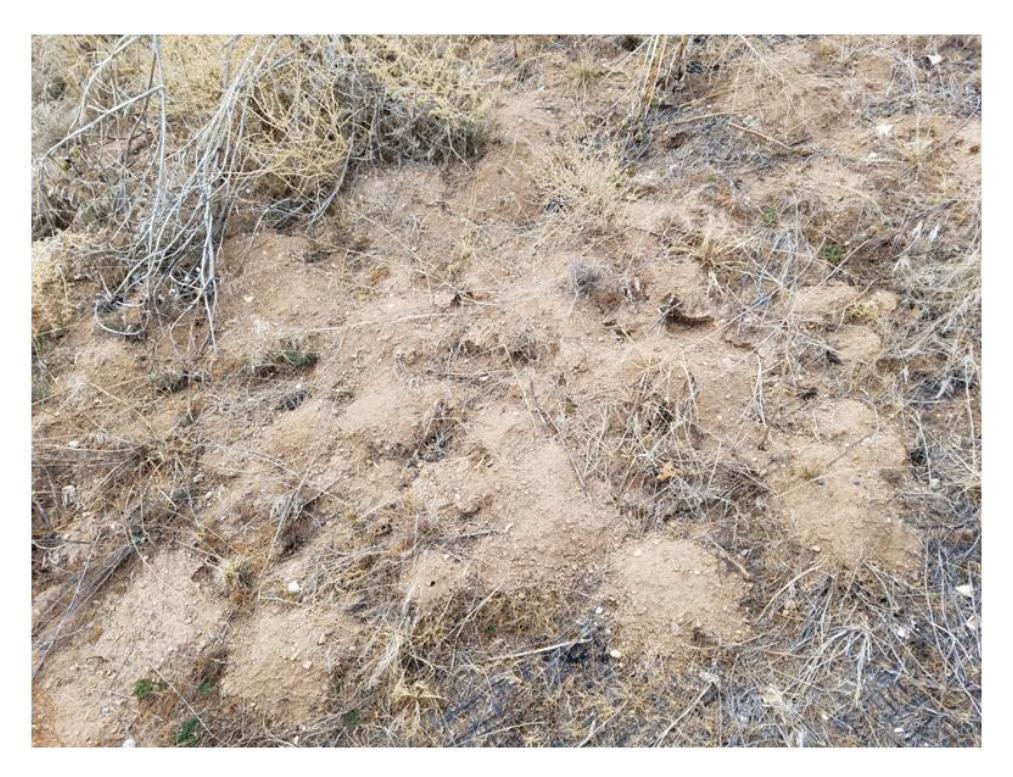
Picture 28. Burrow Holes on Side Slope of Older Landfill Cover

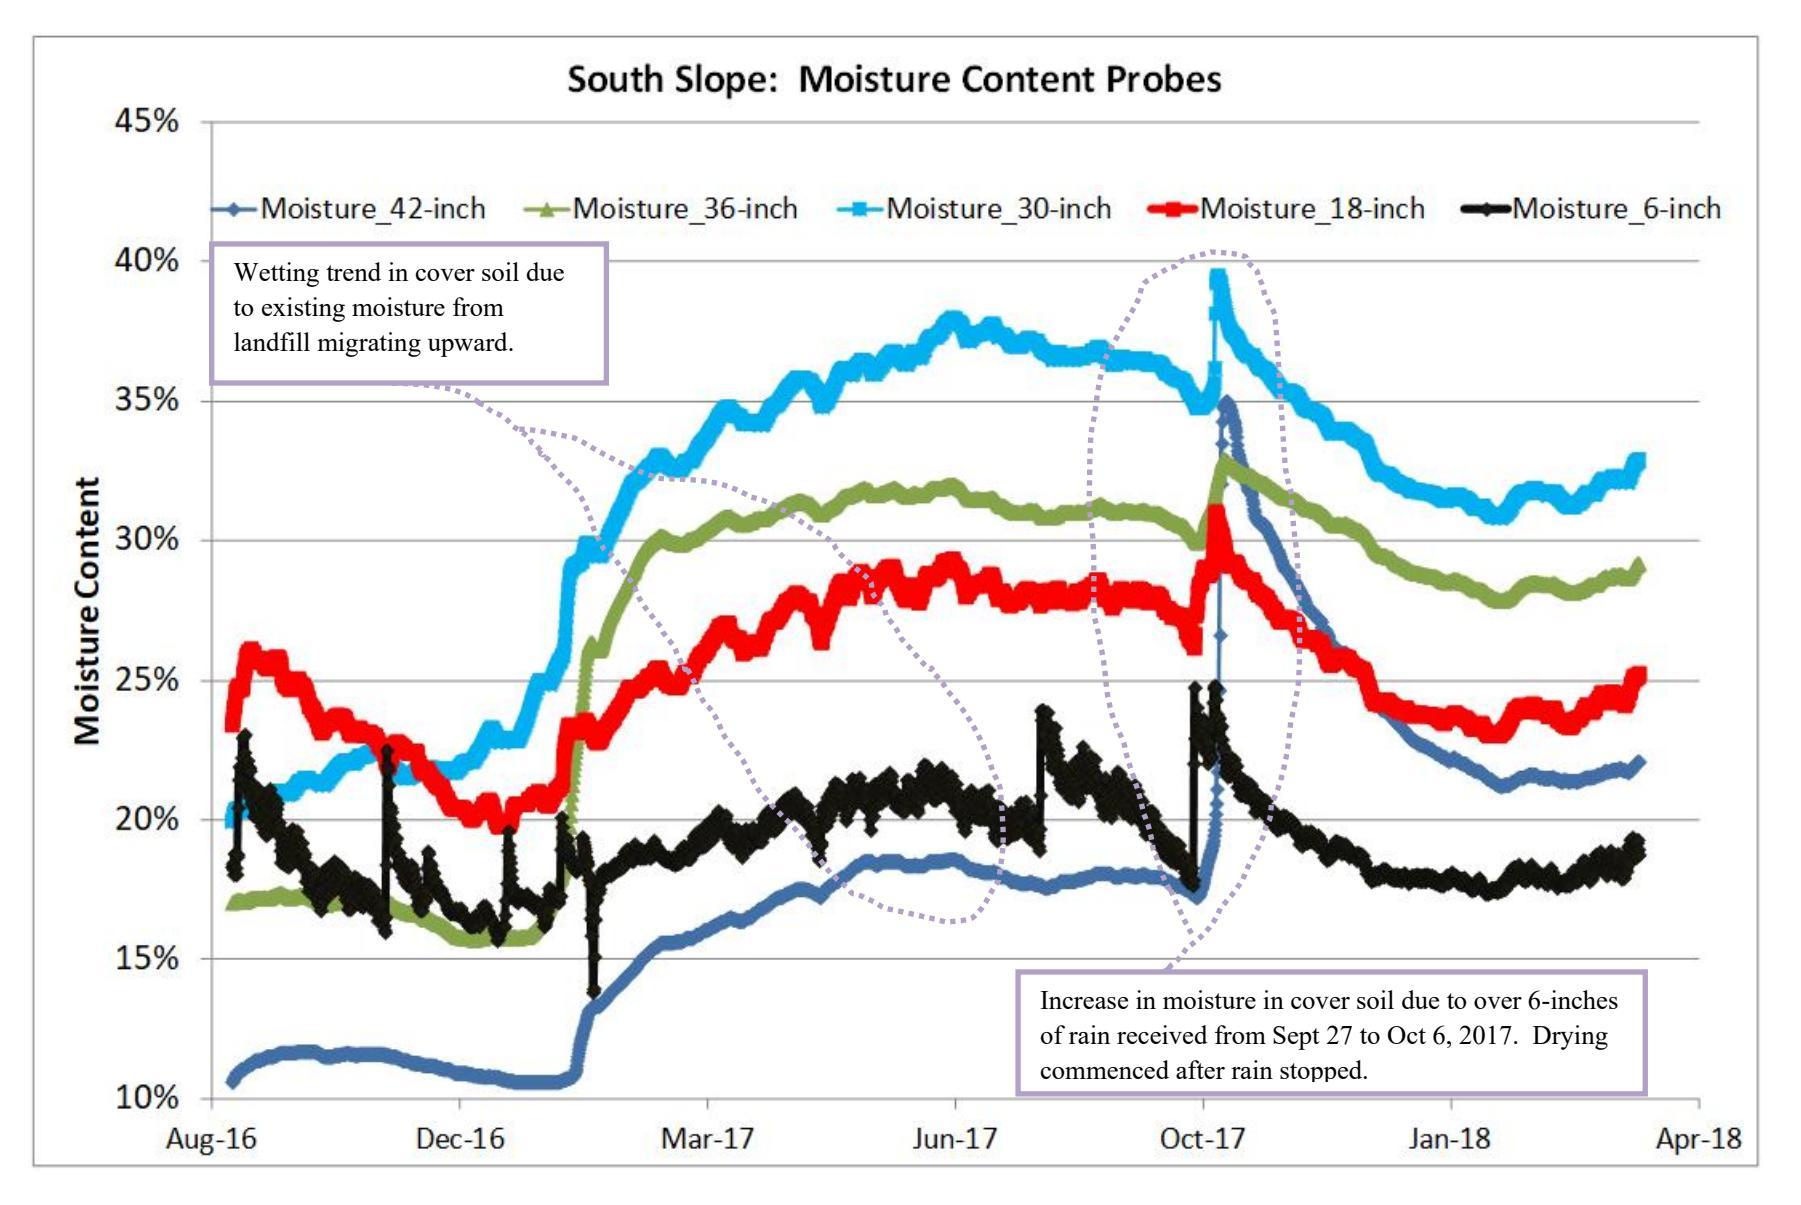
The moisture content probes reveal that infiltrated moisture due to precipitation quickly dries shortly after (Figures 1 and 2). There also appears to be some sensitivity of the moisture content measurements to soil temperature. This data will take multiple seasons to analyze and better understand the water balance trends in the cover system.

Figure 1. Moisture Probe Data (September 2016 to March 2018) - ET Cover South Slope

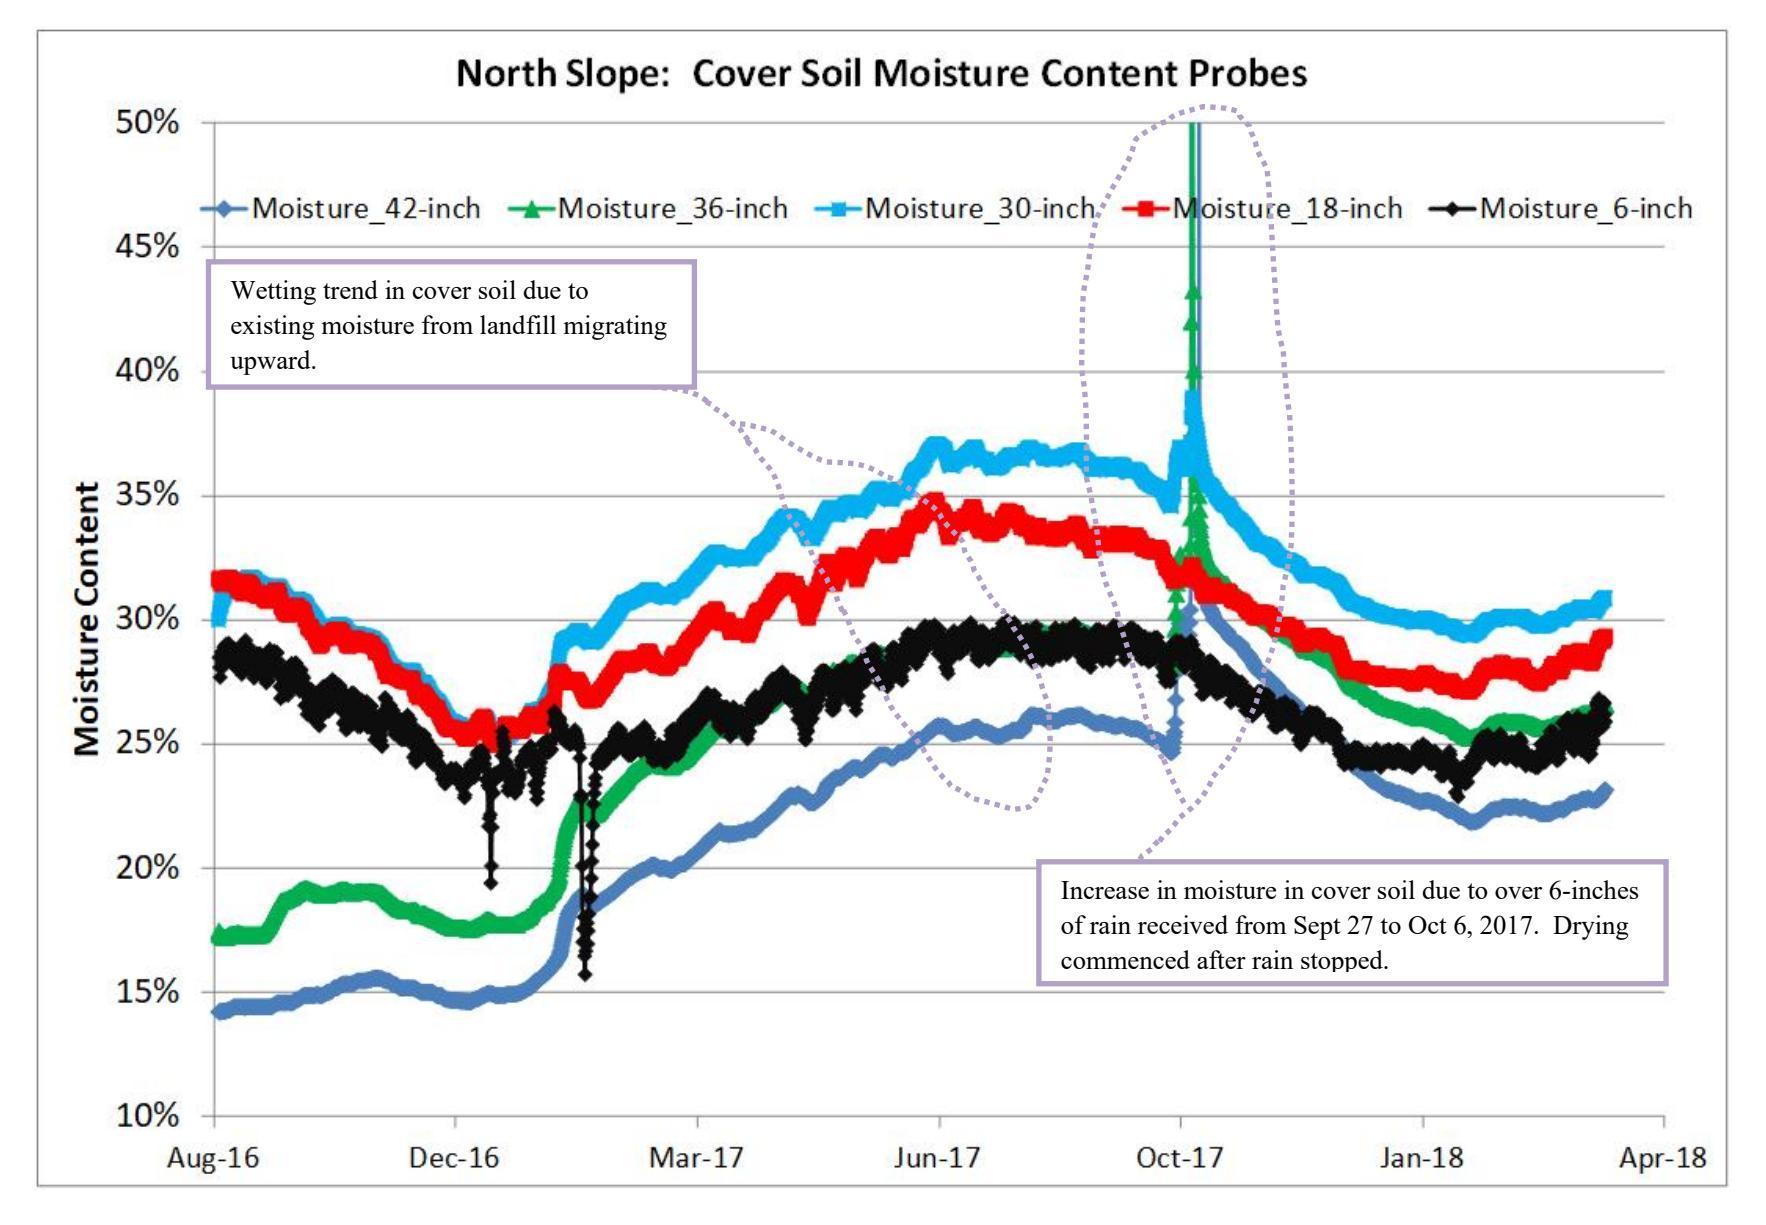
Figure 2. Moisture Probe Data (September 2016 to March 2018) - ET Cover North Slope

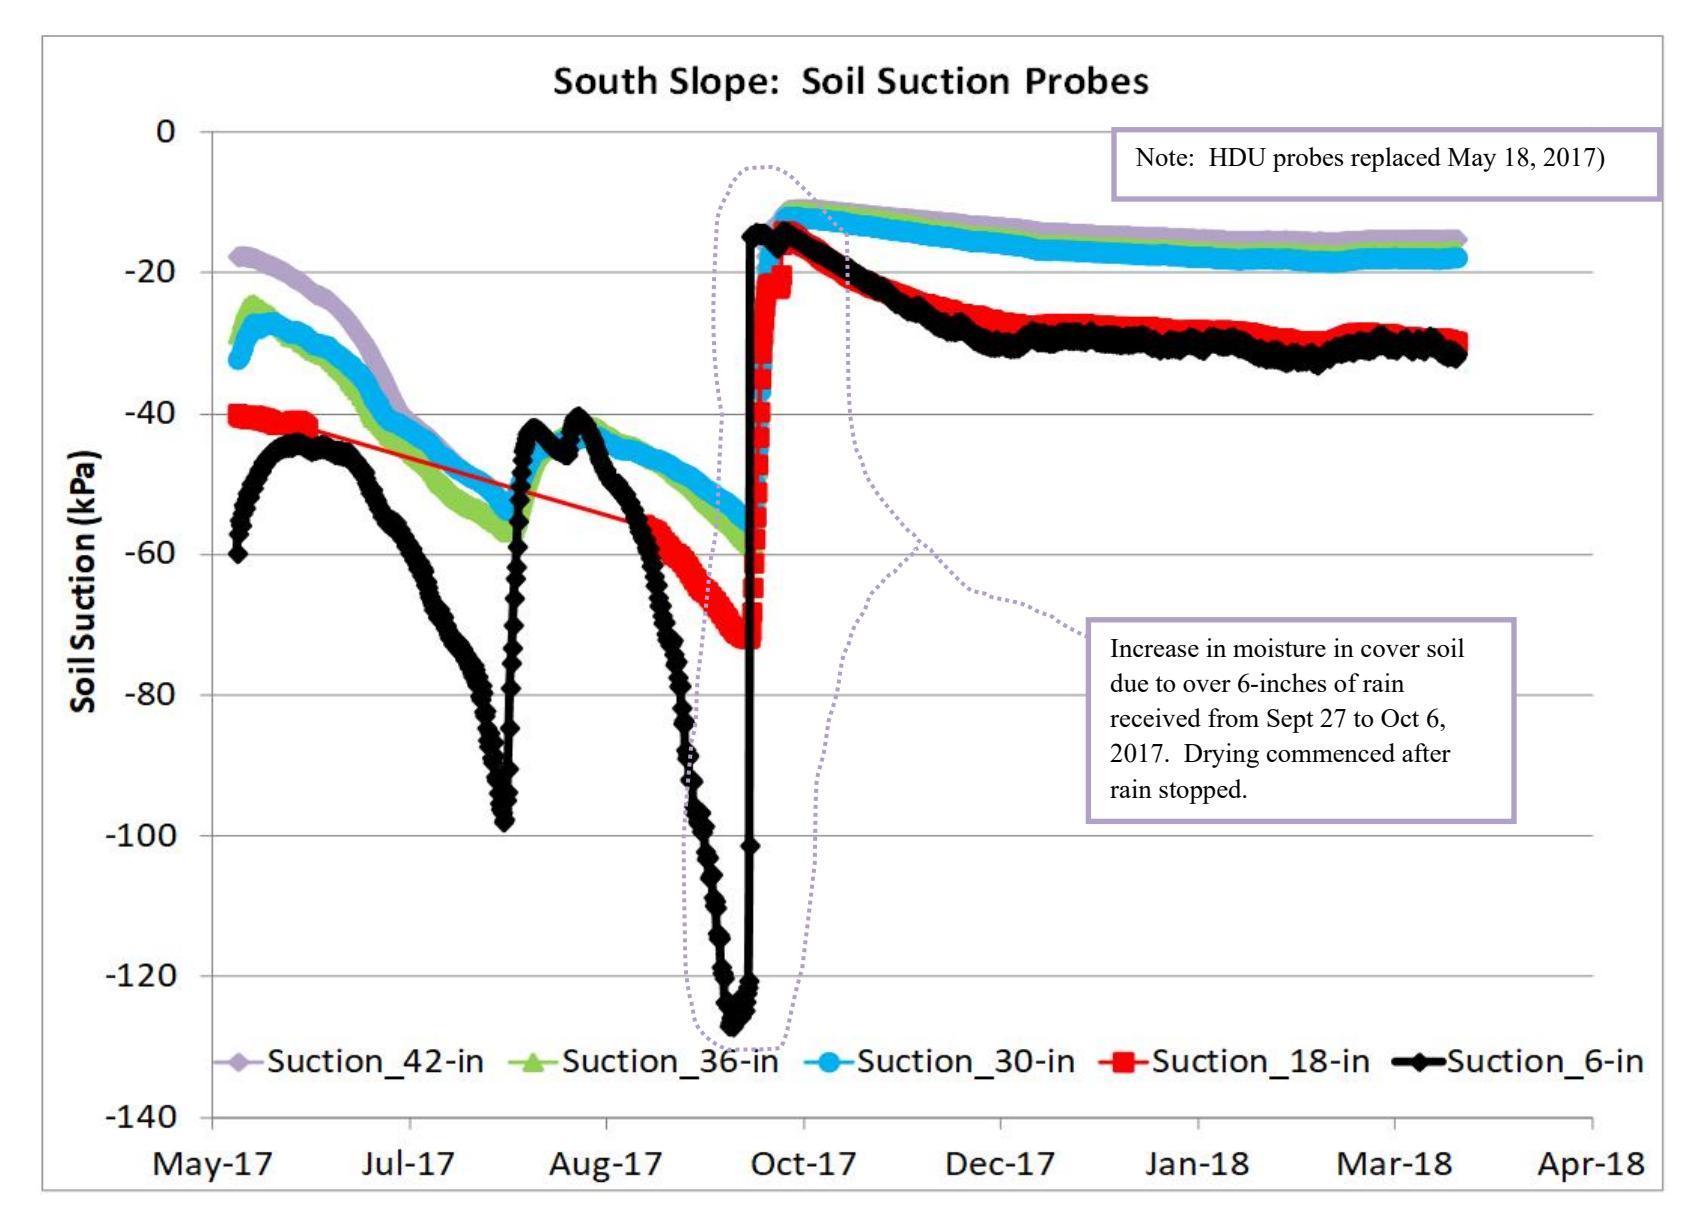
Figure 4. HDU Data (May 2017 to March 2018) - ET Cover South Slope

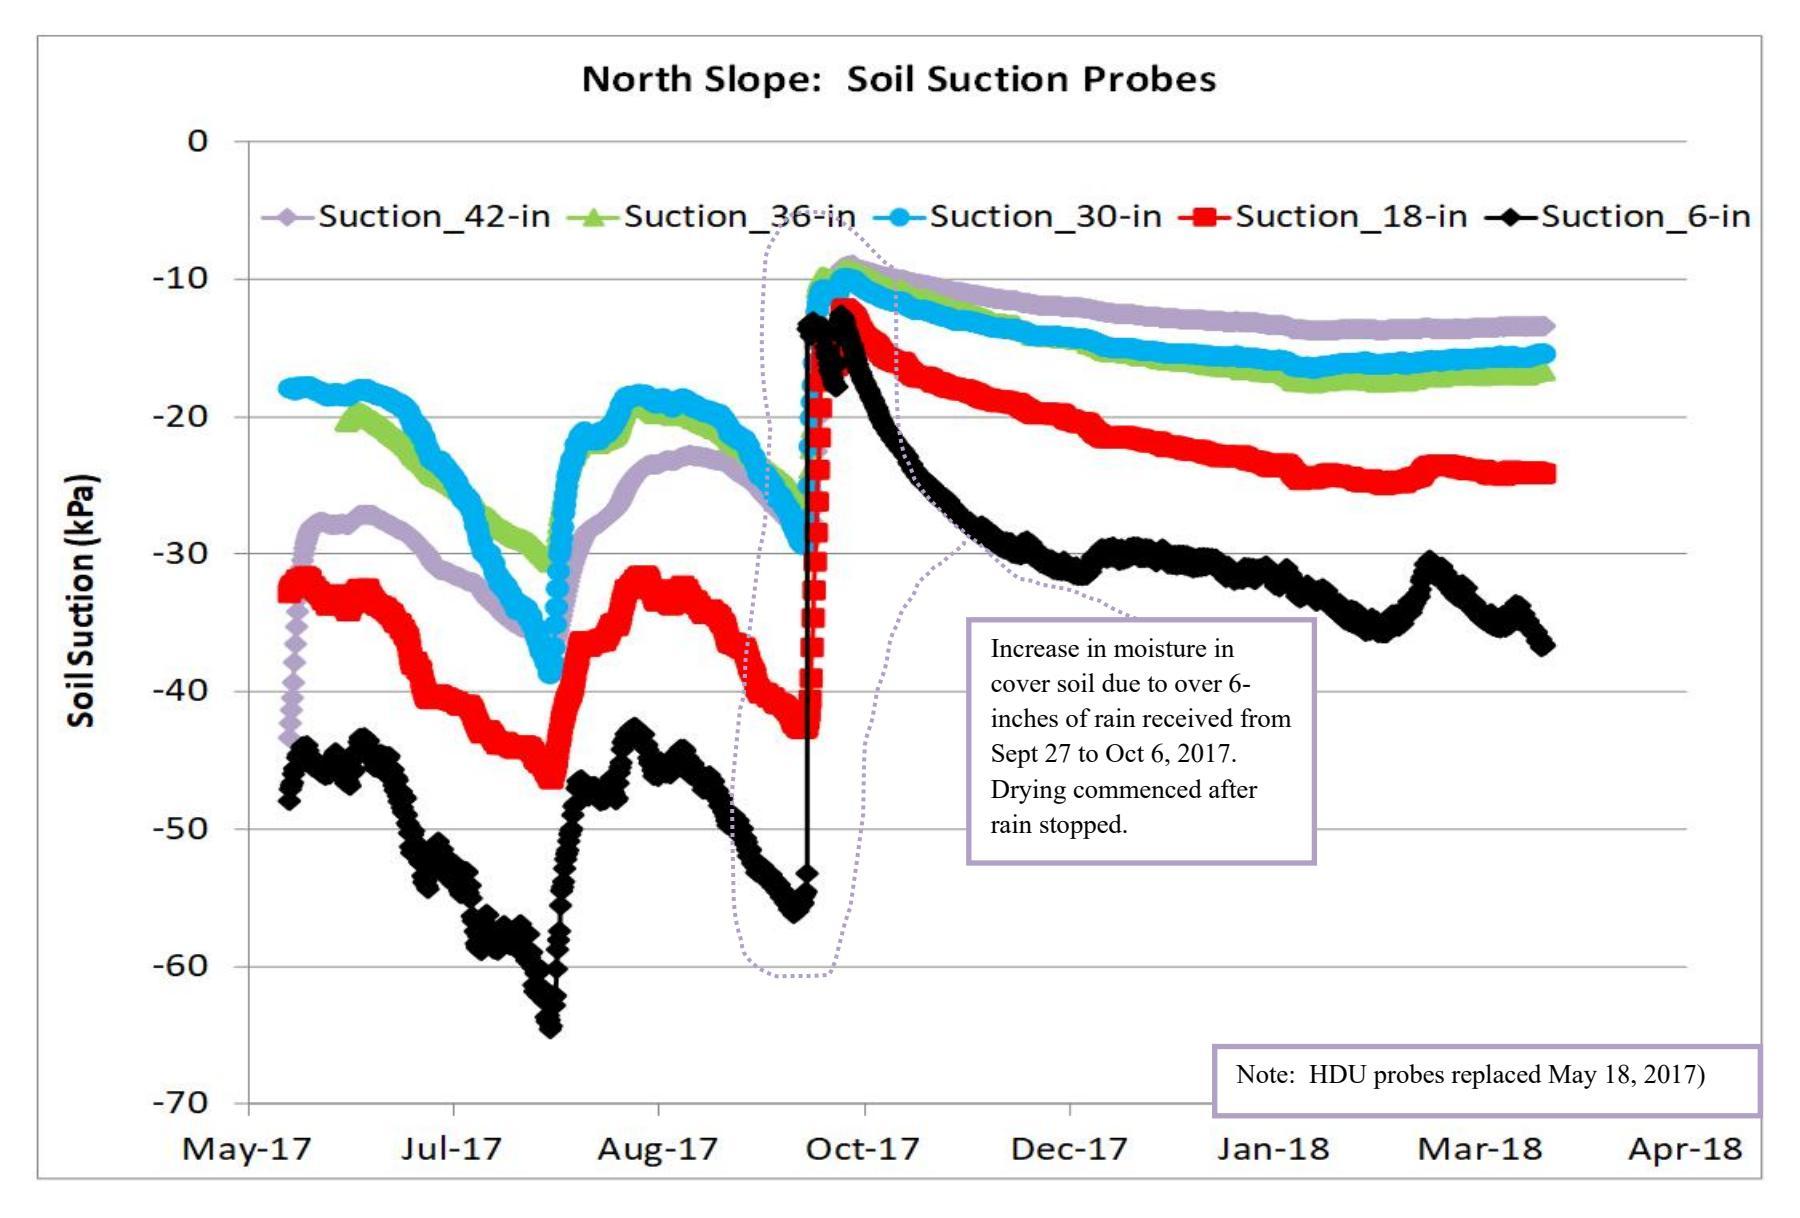
Figure 5. HDU Data (May 2017 to March 2018) - ET Cover North Slope

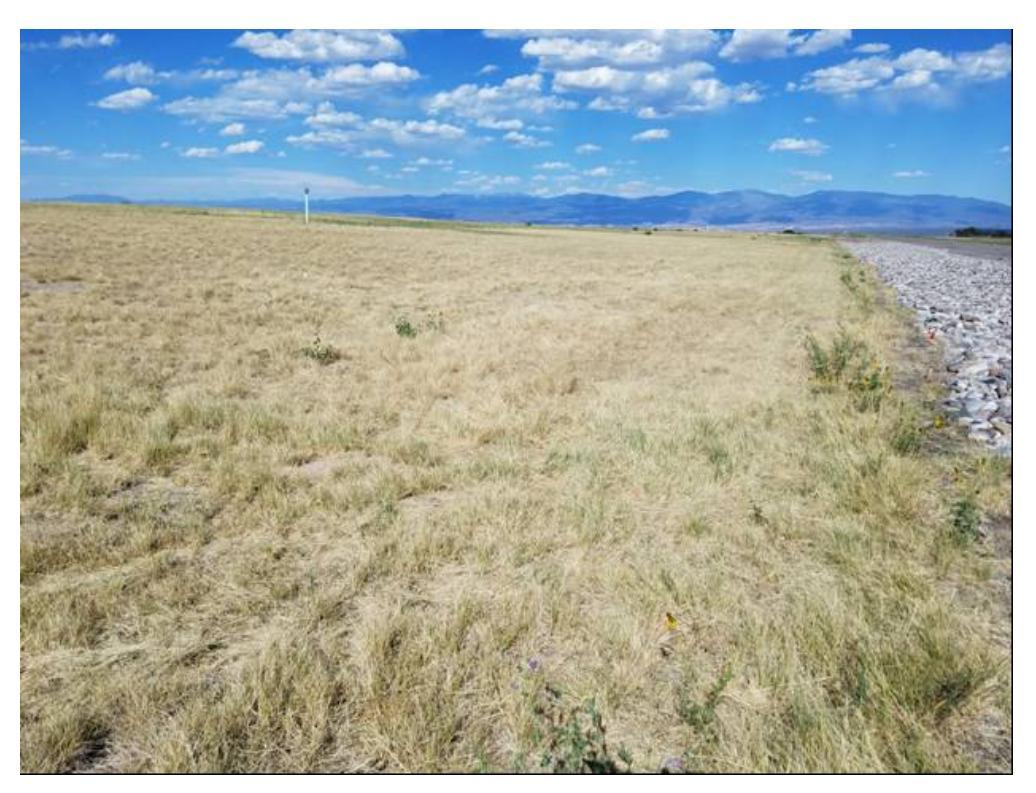
**Picture 1. Cover East View**

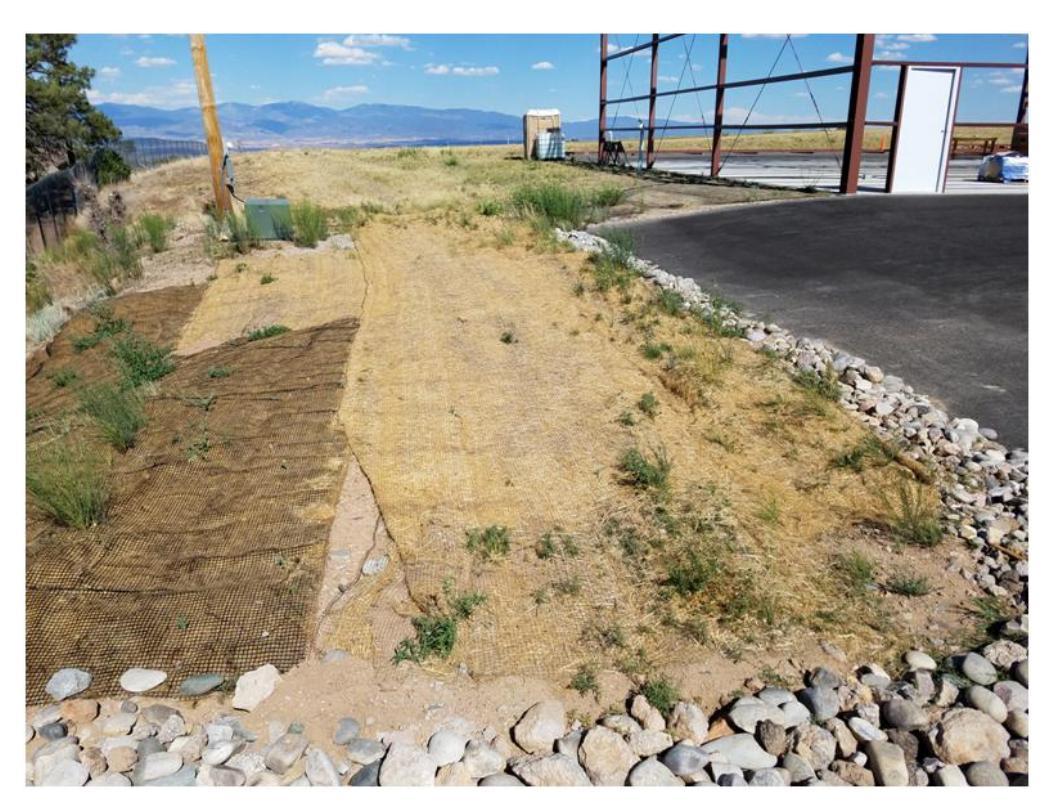
Picture 7. Recent Placement of Erosion Matting by Los Alamos County North of New Hangar Pad

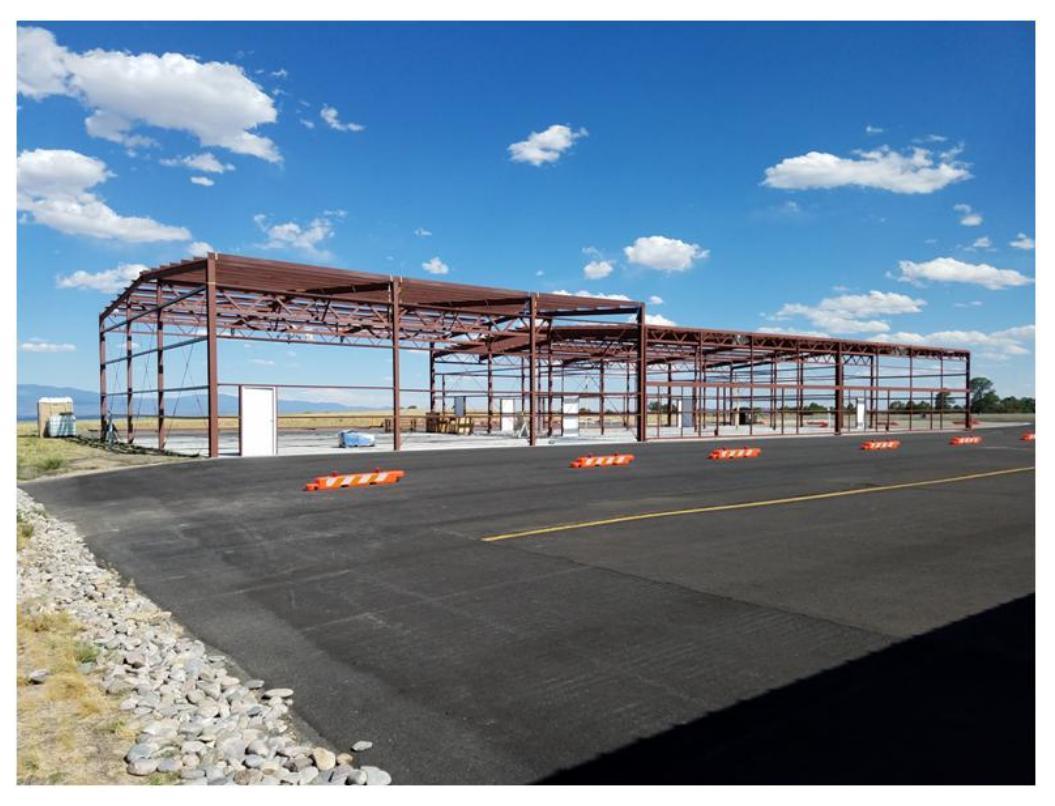
Site Name: Los Alamos County Airport Landfill Cover Replacement	Date of Inspection: June 22, 2018
City: Los Alamos	Weather: hot, sunny, windy
State: New Mexico	Temperature: 90s
Agency: Department of Energy	Inspector: Stephen F Dwyer, PhD, PE
Site Element	Remarks
<ol> <li>Materials have been stockpiled on the new asphalt adjacent to the new concrete hangar foundation west of the landfill. The materials are for continued erection of the new LA County Airport Hangar. This is west of the footprint of the landfill.</li> <li>The area directly north of the new airport hangar pad was disturbed by Los Alamos County utility work activities. This area is outside of the footprint of the landfill and has no impact on the landfill. The disturbed area appeared to be seeded and then covered with a temporary erosion blanket (Picture 7). Additionally, a concrete drop inlet structure was installed to capture surface water from the hangar area (Picture 9).</li> </ol>	1. Erection of the hangar has progressed whereby the metal frame is complete (Pictures 2, 3, 4, and 8).

Picture 8. New Asphalt and Hangar Under Construction - West of Landfill

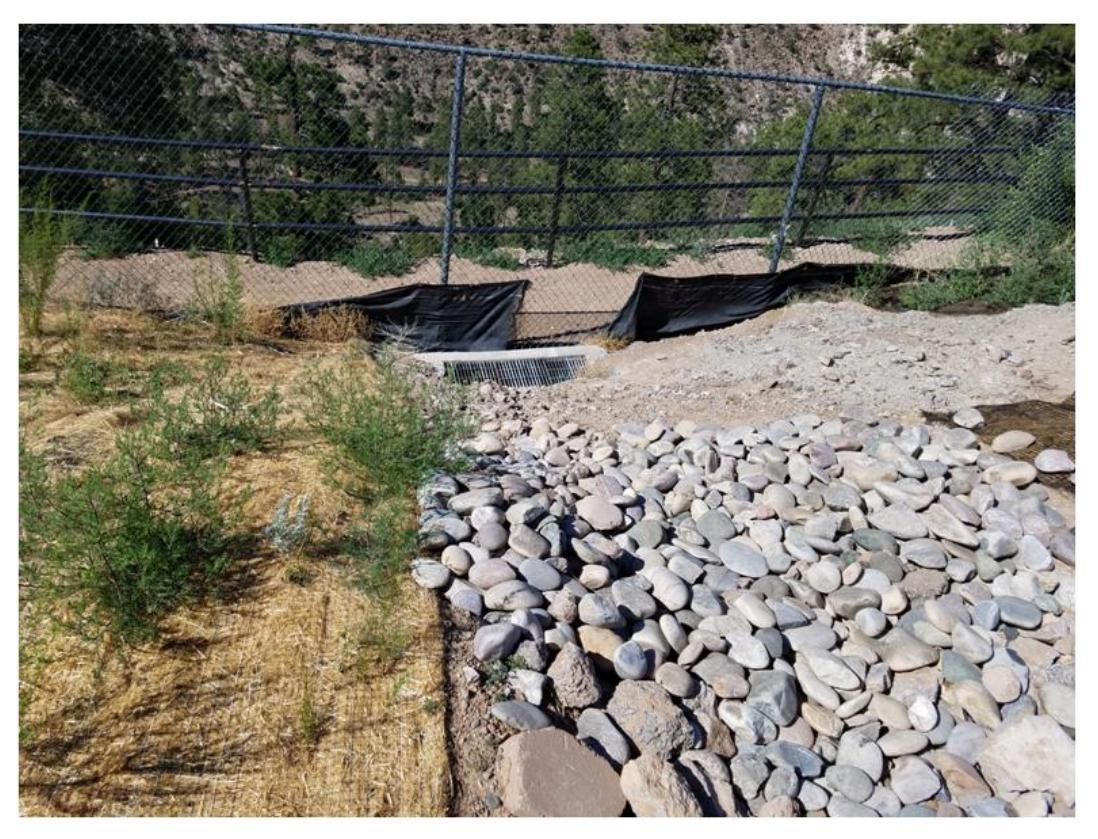
1. Airport Fence Adjacent to Landfill:	Airport fencing is in good condition and securing the		
bent posts: Yes ( ) No (X)	site (Pictures 9, 21, 23, 25 and 26). This fencing is		
loose posts: Yes ( ) No ( X )	maintained by the County of Los Alamos.

Picture 9. New Drop Inlet Structure Installed by Los Alamos County North of New Hangar Pad

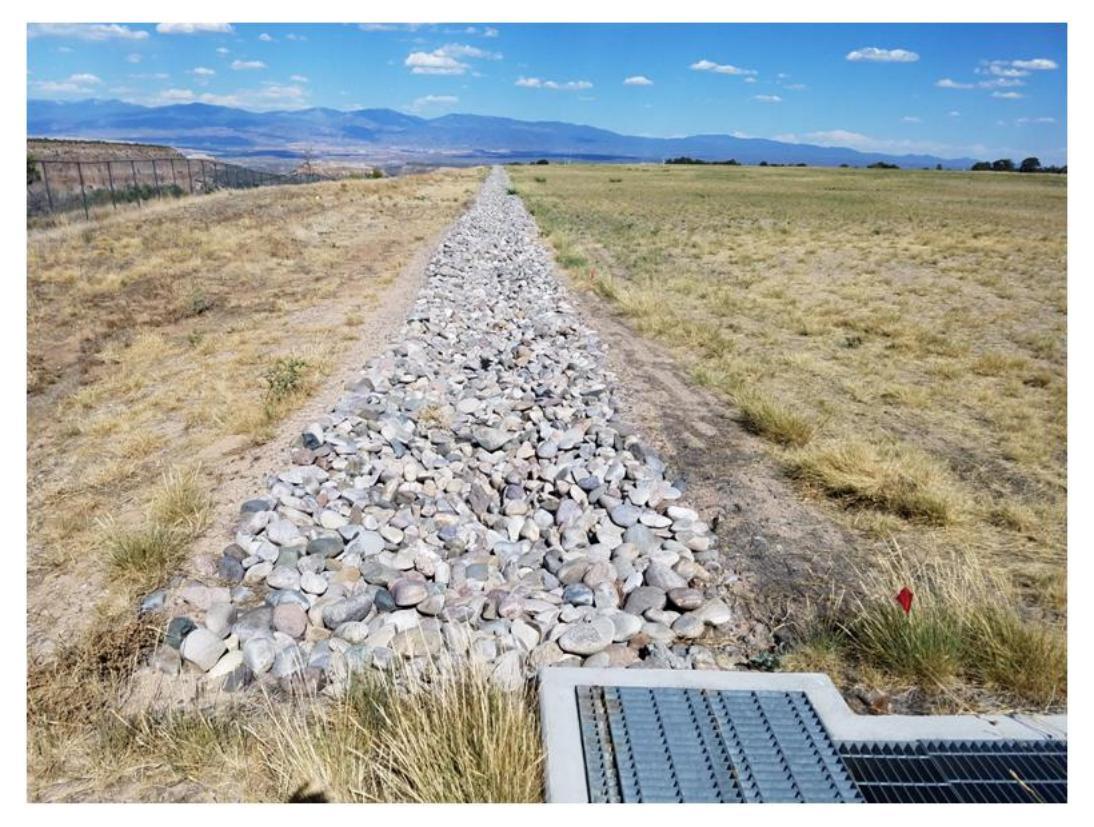
2. Material Degradation:	No material degradation noted to date (Pictures 10, 11,	
Yes ( ) No ( X )	and 12).	
Material Type: Rock, geotextile, geomembrane (polyethylene)

Picture 10. Drainage Channel - North Perimeter of ET Cover

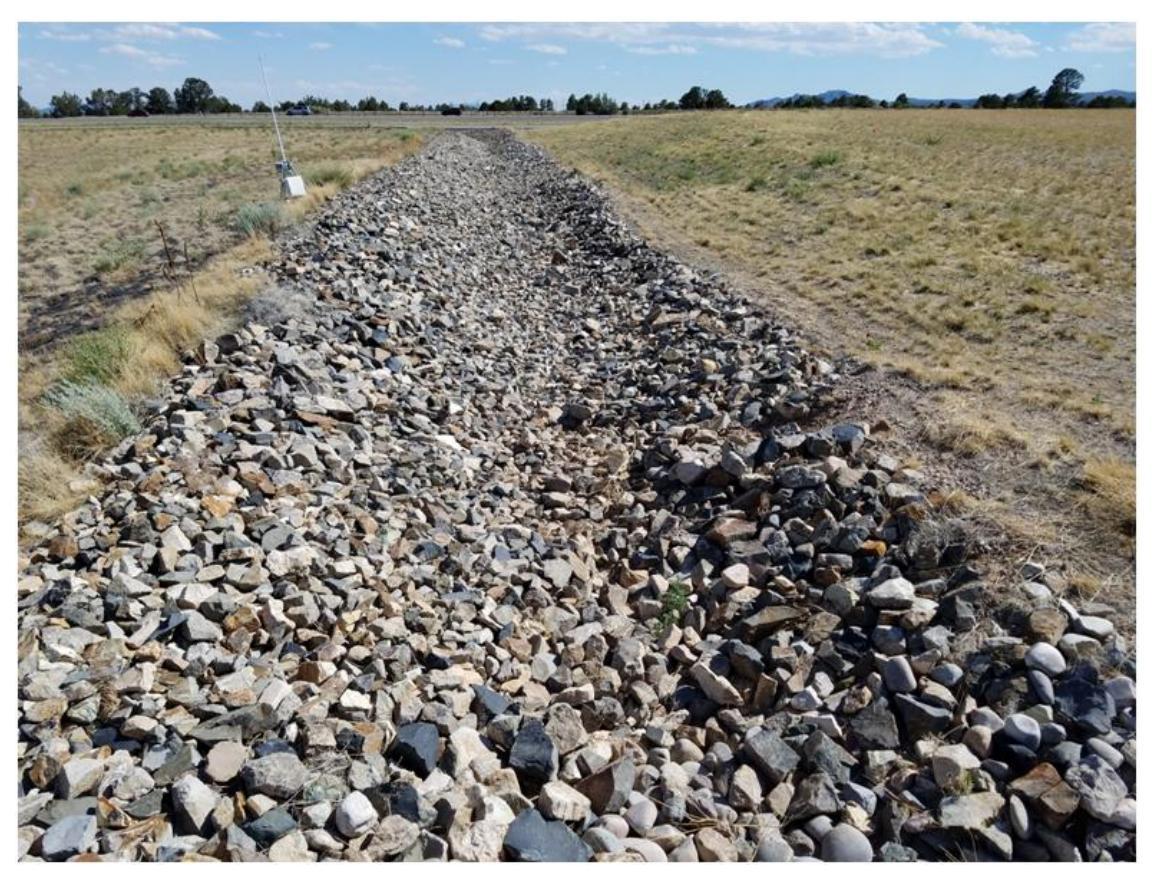
Picture 11. Drainage Channel - East Perimeter of ET Cover

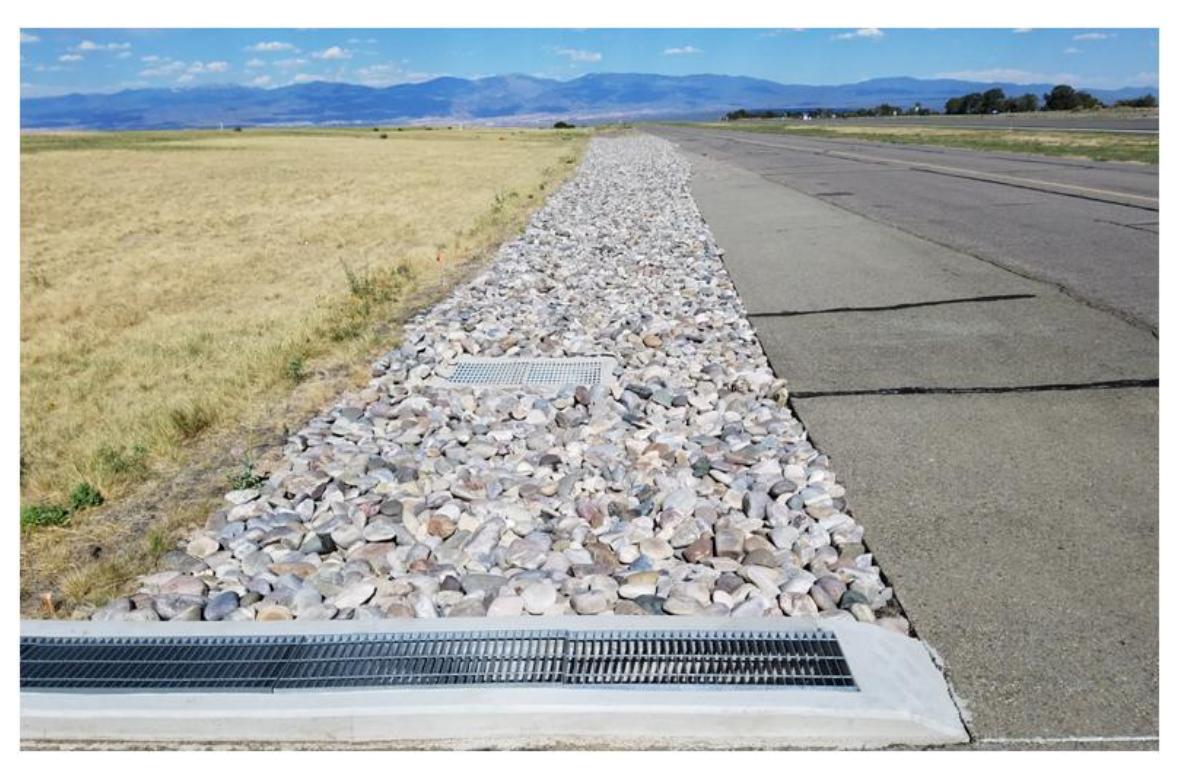
8. Drop Inlet Structures:	Drop inlet structures are in good condition (Picture 12).		
Working Properly			
Yes ( X ) No ( )			
Condition: good			
Extent of Damage: NA			
Repairs Necessary Yes ( ) No (X) If yes, explain			
Concre	Concrete Culvert

Picture 12. Drainage Channel - South Perimeter of ET Cover

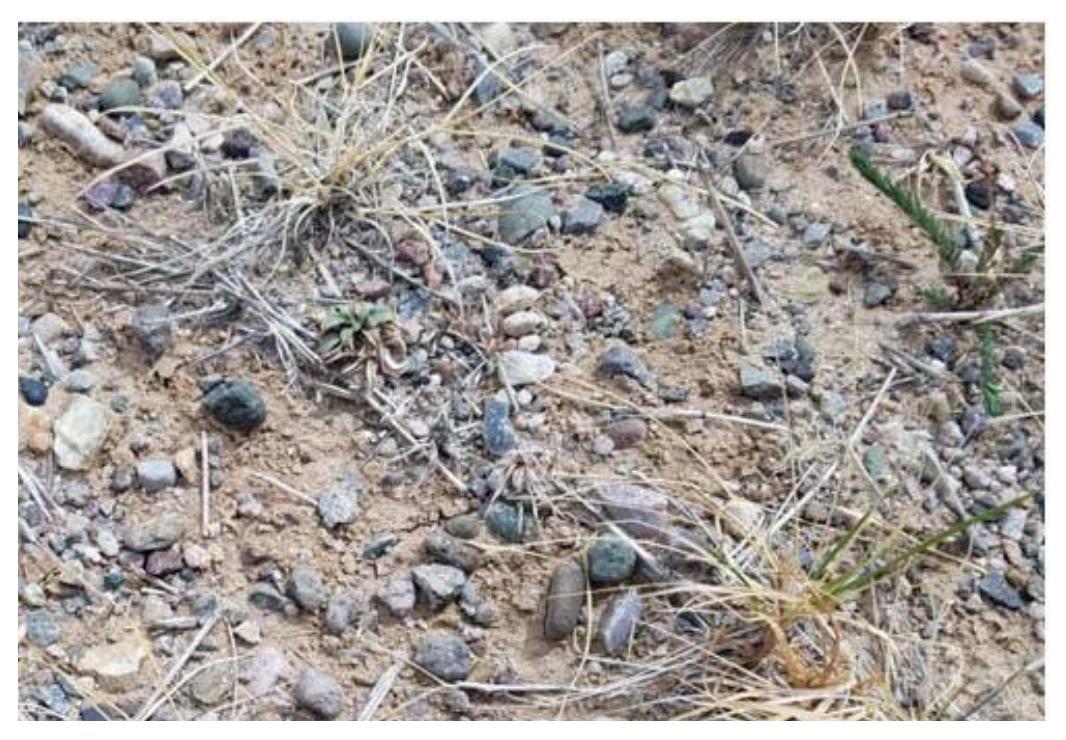
Picture 17. 'Desert Pavement' and Emerging Vegetation - Surface of ET Cover

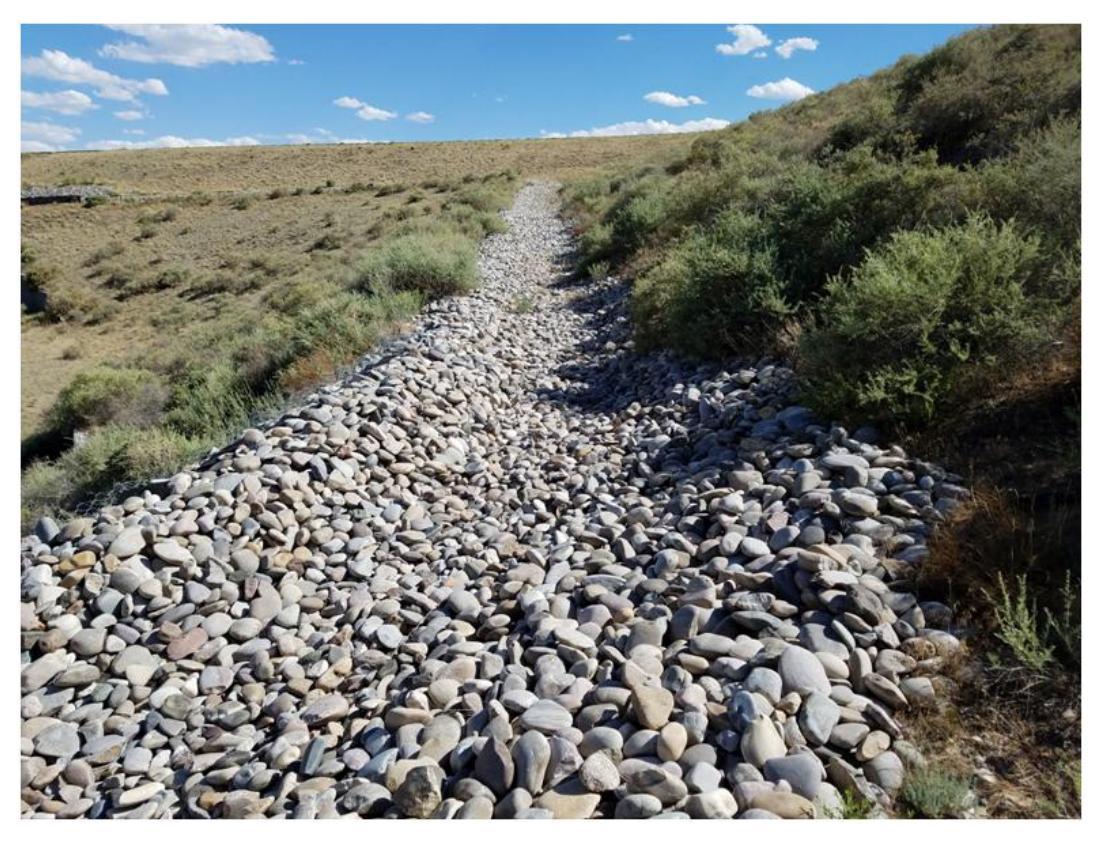
1. Rip Rap Berm near Retaining Wall:	The Rip Rap drainage on side slope is in good condition
Functional Yes (X) No () if no, describe locations	(Picture 18).
Damage or degradation: Yes ( ) No ( X )	
Description of damage: NA	
Repairs Necessary Yes ( ) No (X) If yes, explain

Picture 18. Eastern Berm on Sideslope East of Landfill

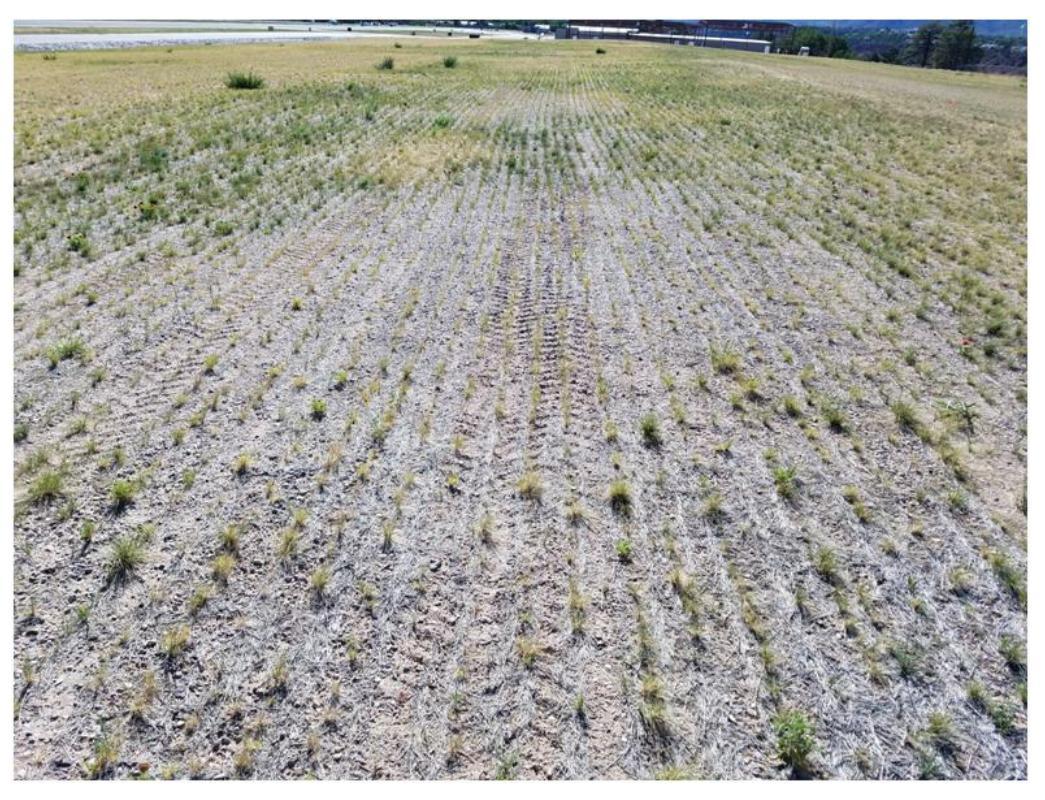
Picture 19. Area of Cover with Slower Vegetation Establishment

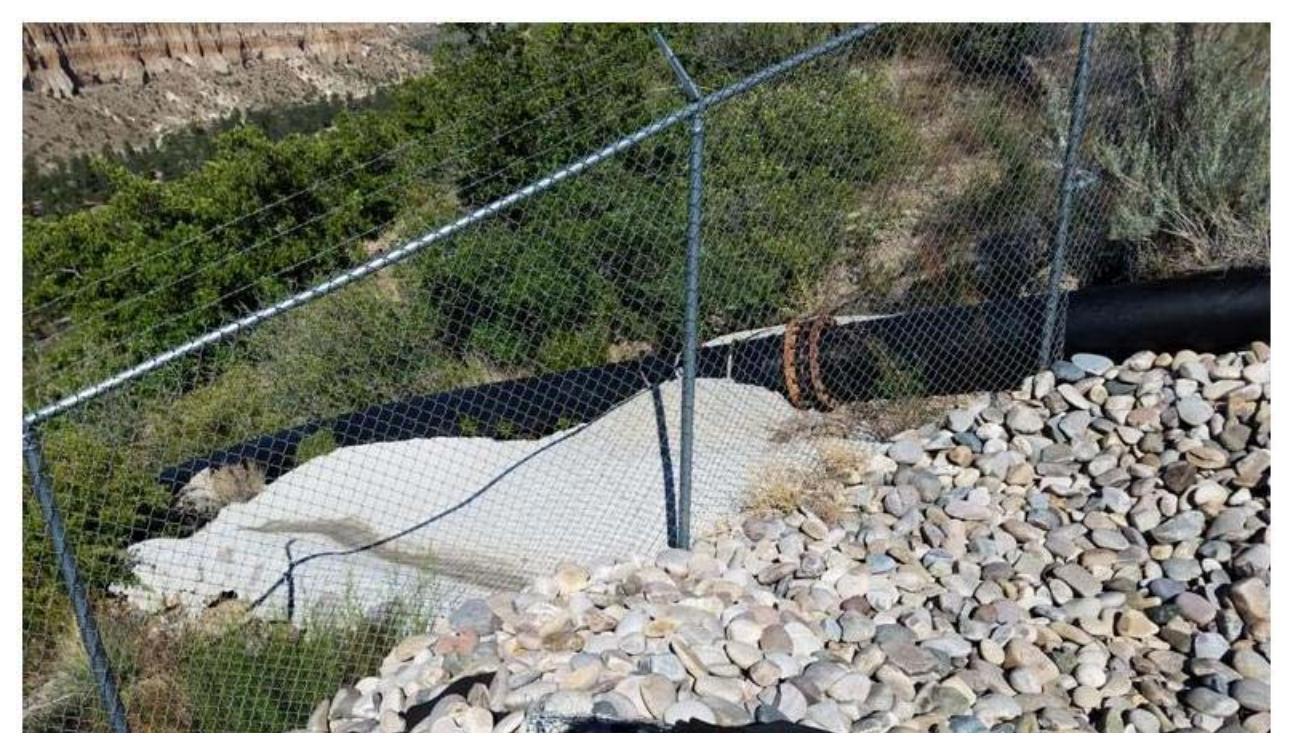
Picture 20. Eastern Side Slope of Landfill
