### LONG-TERM MONITORING INSPECTION REPORT YEAR 2, Quarter 1 INSPECTION #5

### LOS ALAMOS COUNTY AIRPORT LANDFILL COVER REPLACEMENT

Inspection Date:	August 31,	2017
Report Date:	October 5,	2017

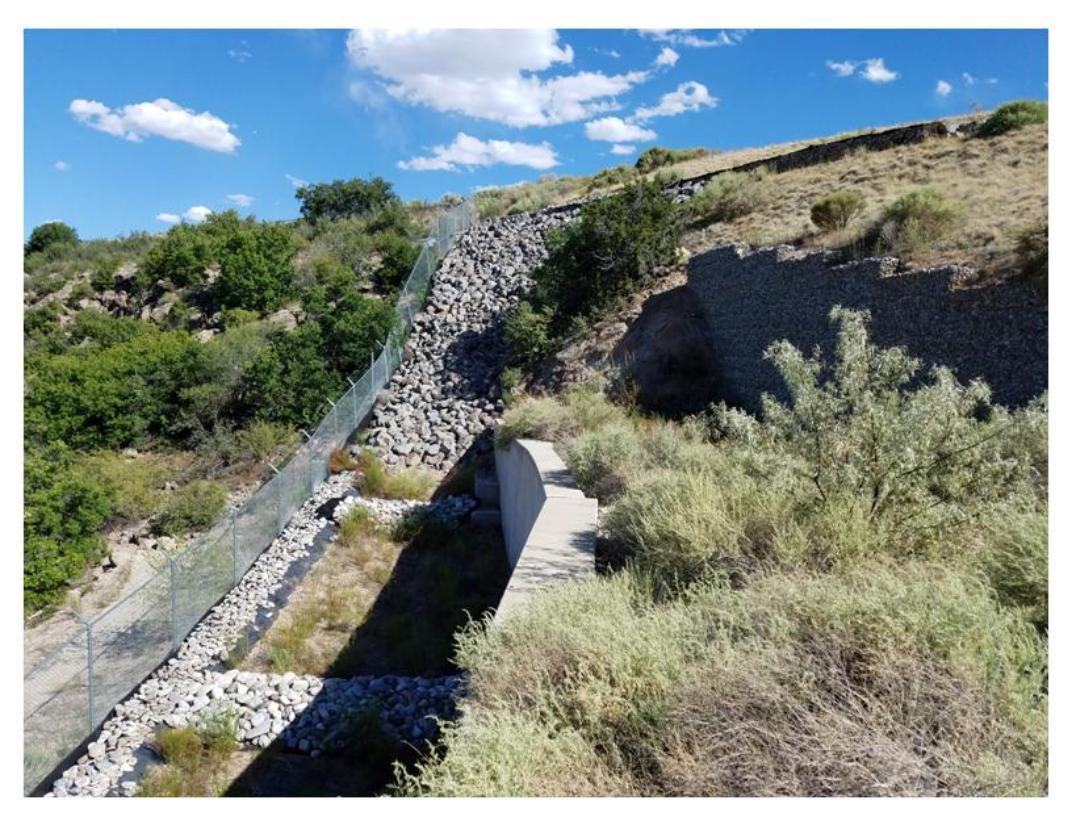
Picture 22. Gabion Retaining Structure - East End of Landfill

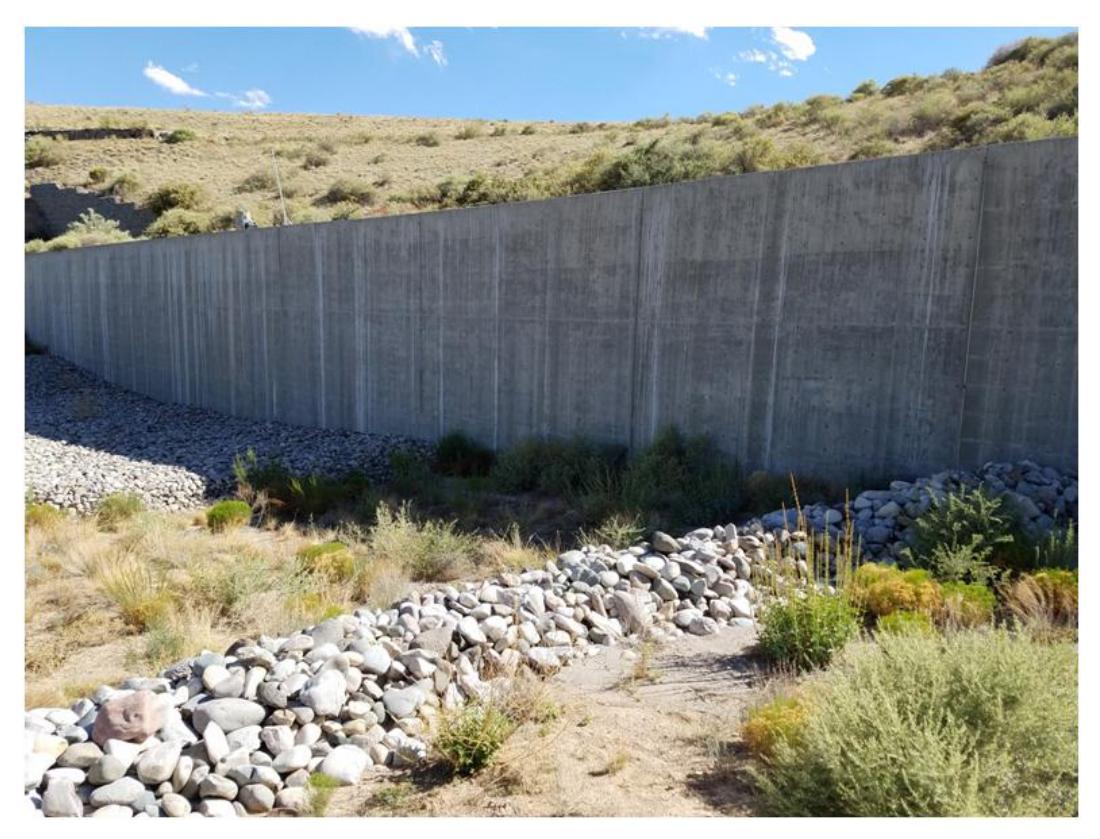
2. Rock Check Dams near Retaining Wall:	The rock check dams are in good condition (Pictures 23

4. Drainage Channels adjacent to Retaining Wall:	The drainage channels adjacent to the retaining wall
Functional Yes (X) No () if no, describe locations	appear in good condition (Pictures 23 to 26). Drainage
Damage, adjunct erosion, slope problem, or other damage/degradation: Yes ( ) No ( X )	channels appear to be working property.
Description of damage: NA	
Repairs Necessary Yes ( ) No (X) If yes, explain

Picture 23. Large Rip Rap Slope and Gabion Retainment Wall - East End of Landfill Site

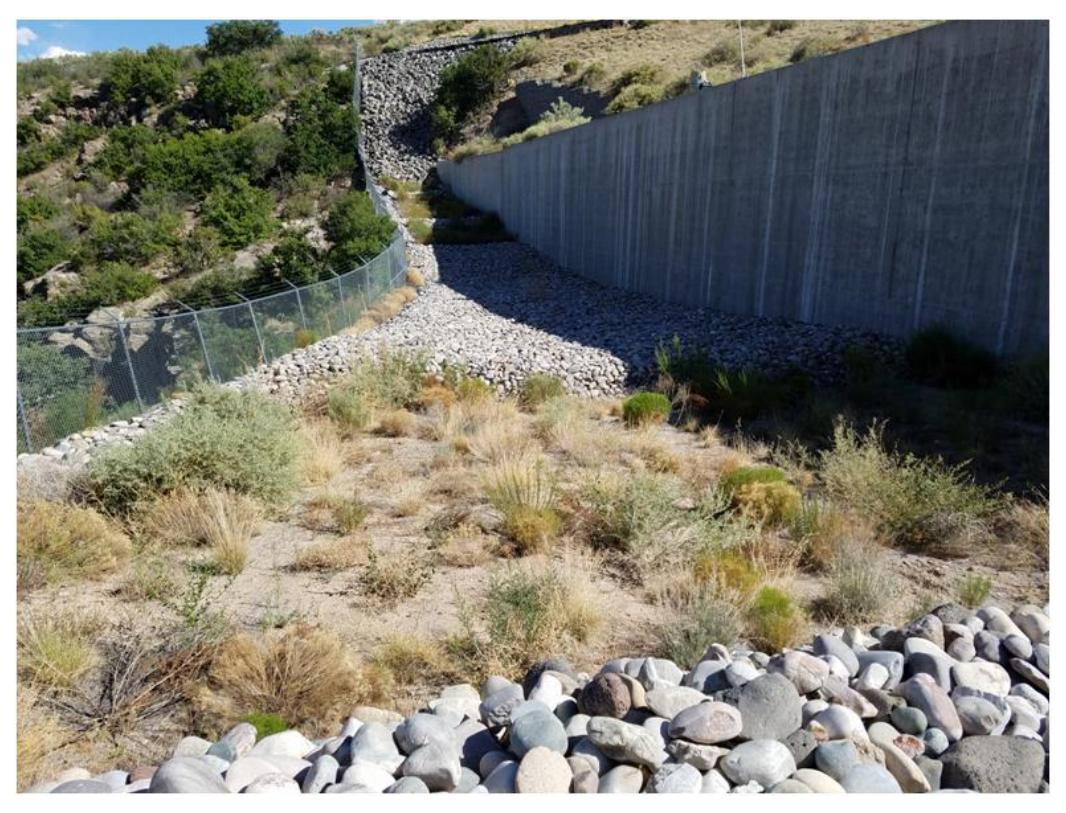
Picture 24. Concrete Retaining Wall - East End of Landfill

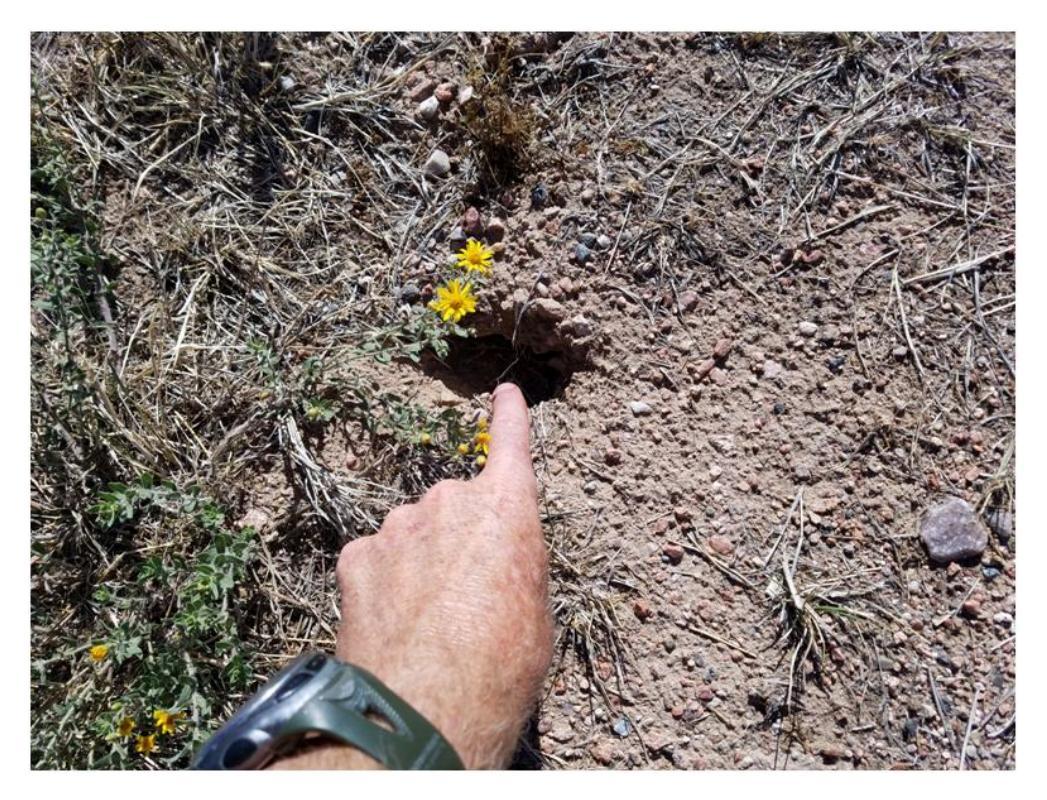
2. Surface Cracks: Yes ( ) No ( X ) Length: NA Width: NA Depth: NA	The surface crack noted in the previous inspection was not visible during this inspection. No other cracks were identified.
Repairs Necessary Yes ( ) No (X) If yes, explain <b>3. Erosion:</b> Yes ( ) No (X) Areal Extent: NA Depth: NA Repairs Necessary Yes ( ) No (X) If yes, explain	No significant erosion noted to date. The gravel/soil top admixture top layer (6-inches thick) referred to as a 'desert pavement' is developing well and appears to be working as designed to minimize erosion (Picture 17).
<ul> <li>4. Biointrusion Holes:</li> <li>Yes (X) No ()</li> <li>Areal Extent: minimal</li> <li>Depth: approx. 12-inches</li> </ul>	No biointrusion noted on the new ET Cover. There was minimal biointrusion (small animal burrow holes) noted on the side slopes of the prior cover system (Picture 28). The biointrusion noted is within expected tolerances to date.

Picture 27. Debris Disposal Area

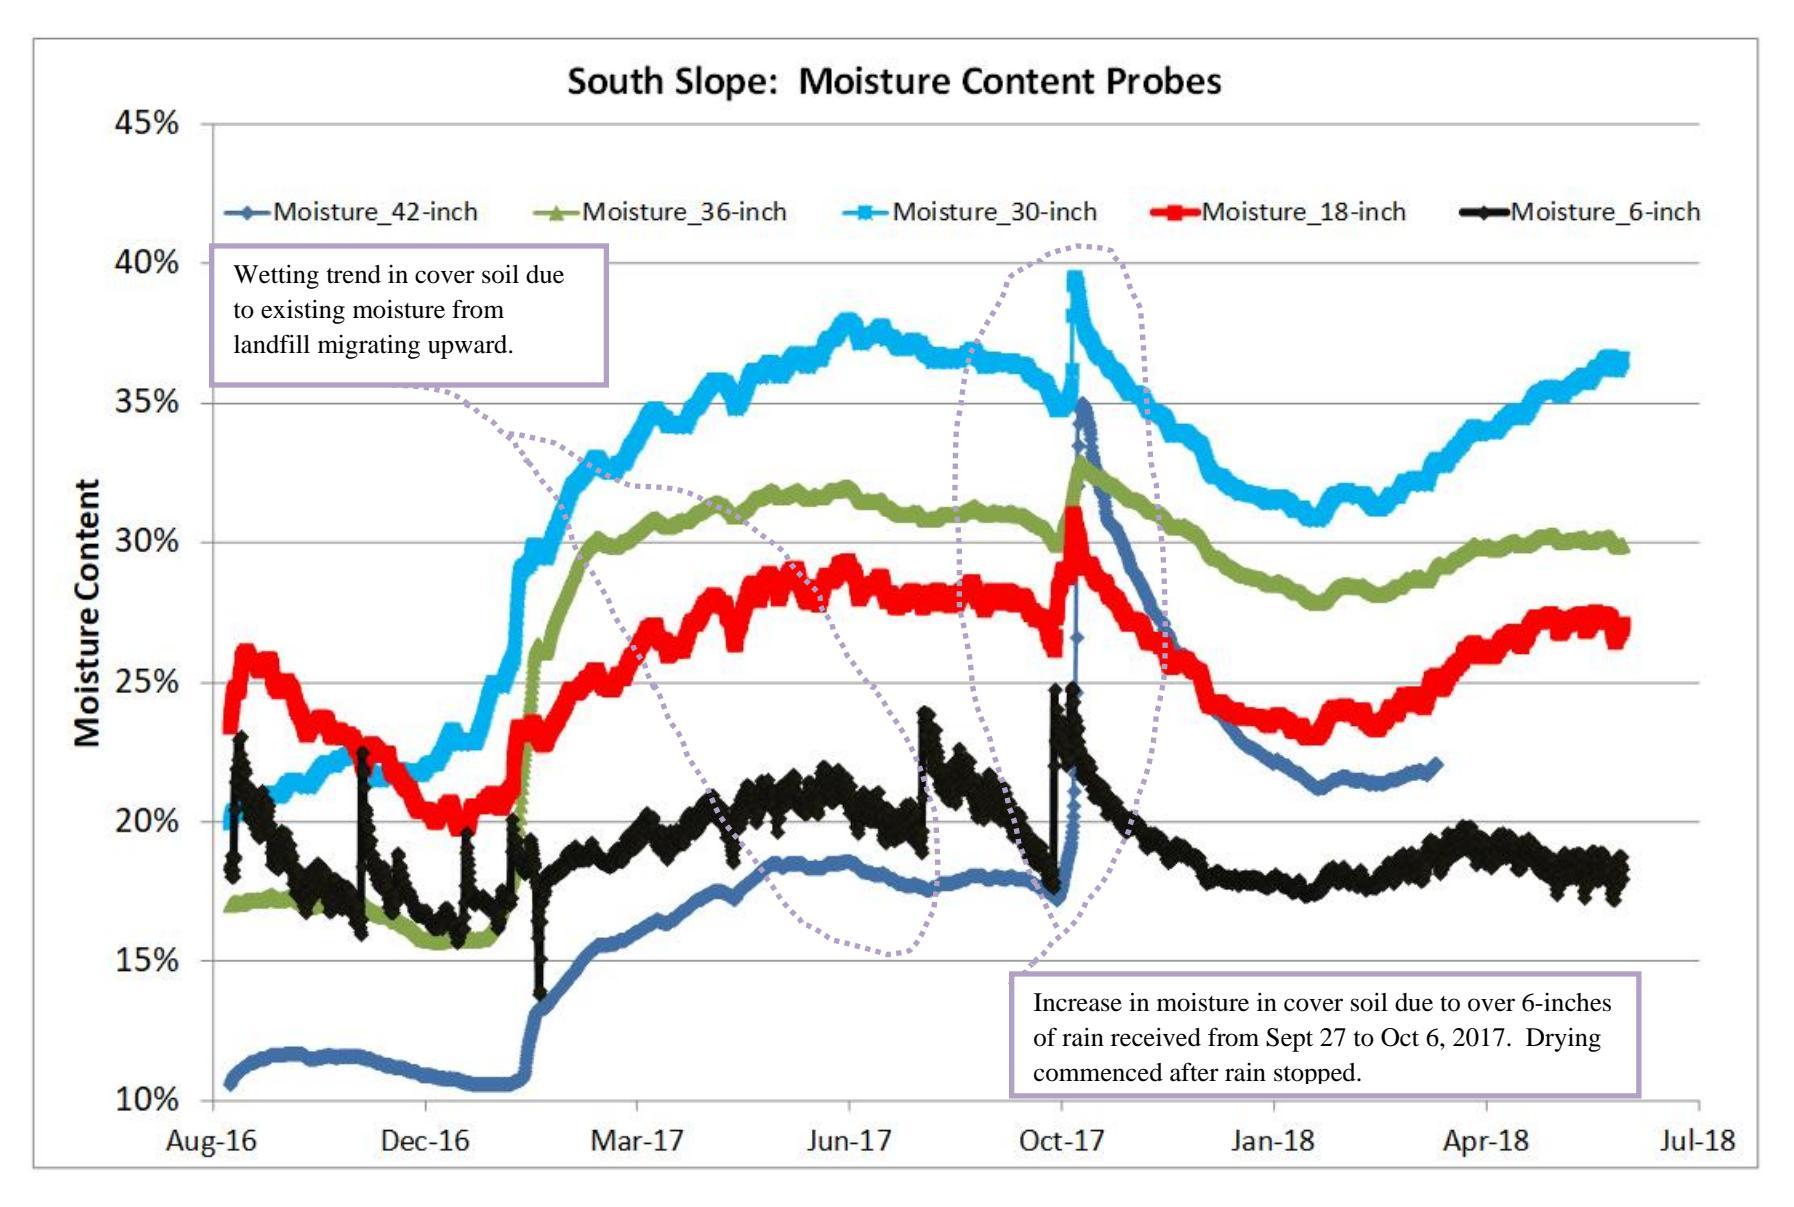
The moisture content probes reveal that infiltrated moisture due to precipitation quickly dries shortly after (Figures 1 and 2). There also appears to be some sensitivity of the moisture content measurements to soil temperature (especially noted in variation of winter and summer months). This data will take multiple seasons to analyze and better understand the water balance trends in the cover system.

Figure 1. Moisture Probe Data (September 2016 to June 2018) - ET Cover South Slope

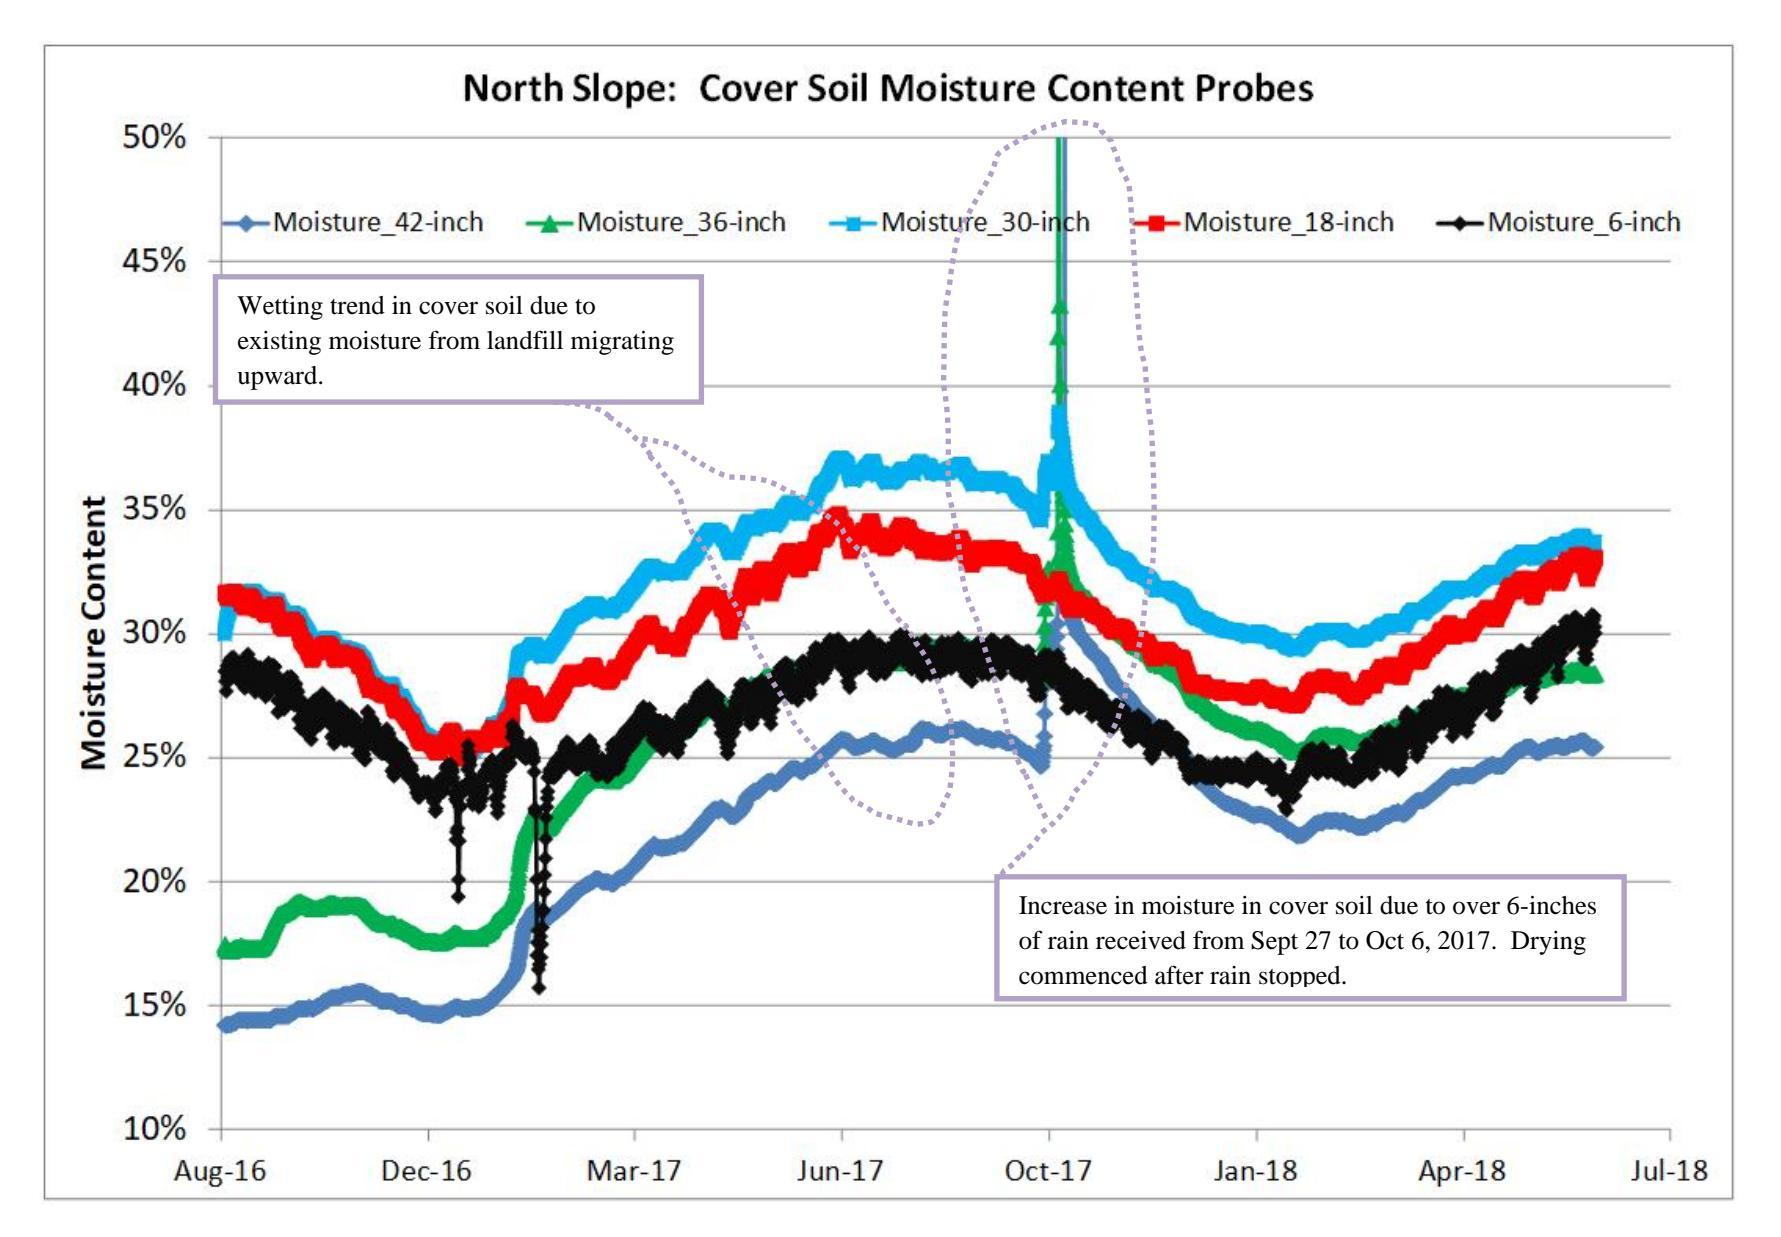
Figure 2. Moisture Probe Data (September 2016 to June 2018) - ET Cover North Slope

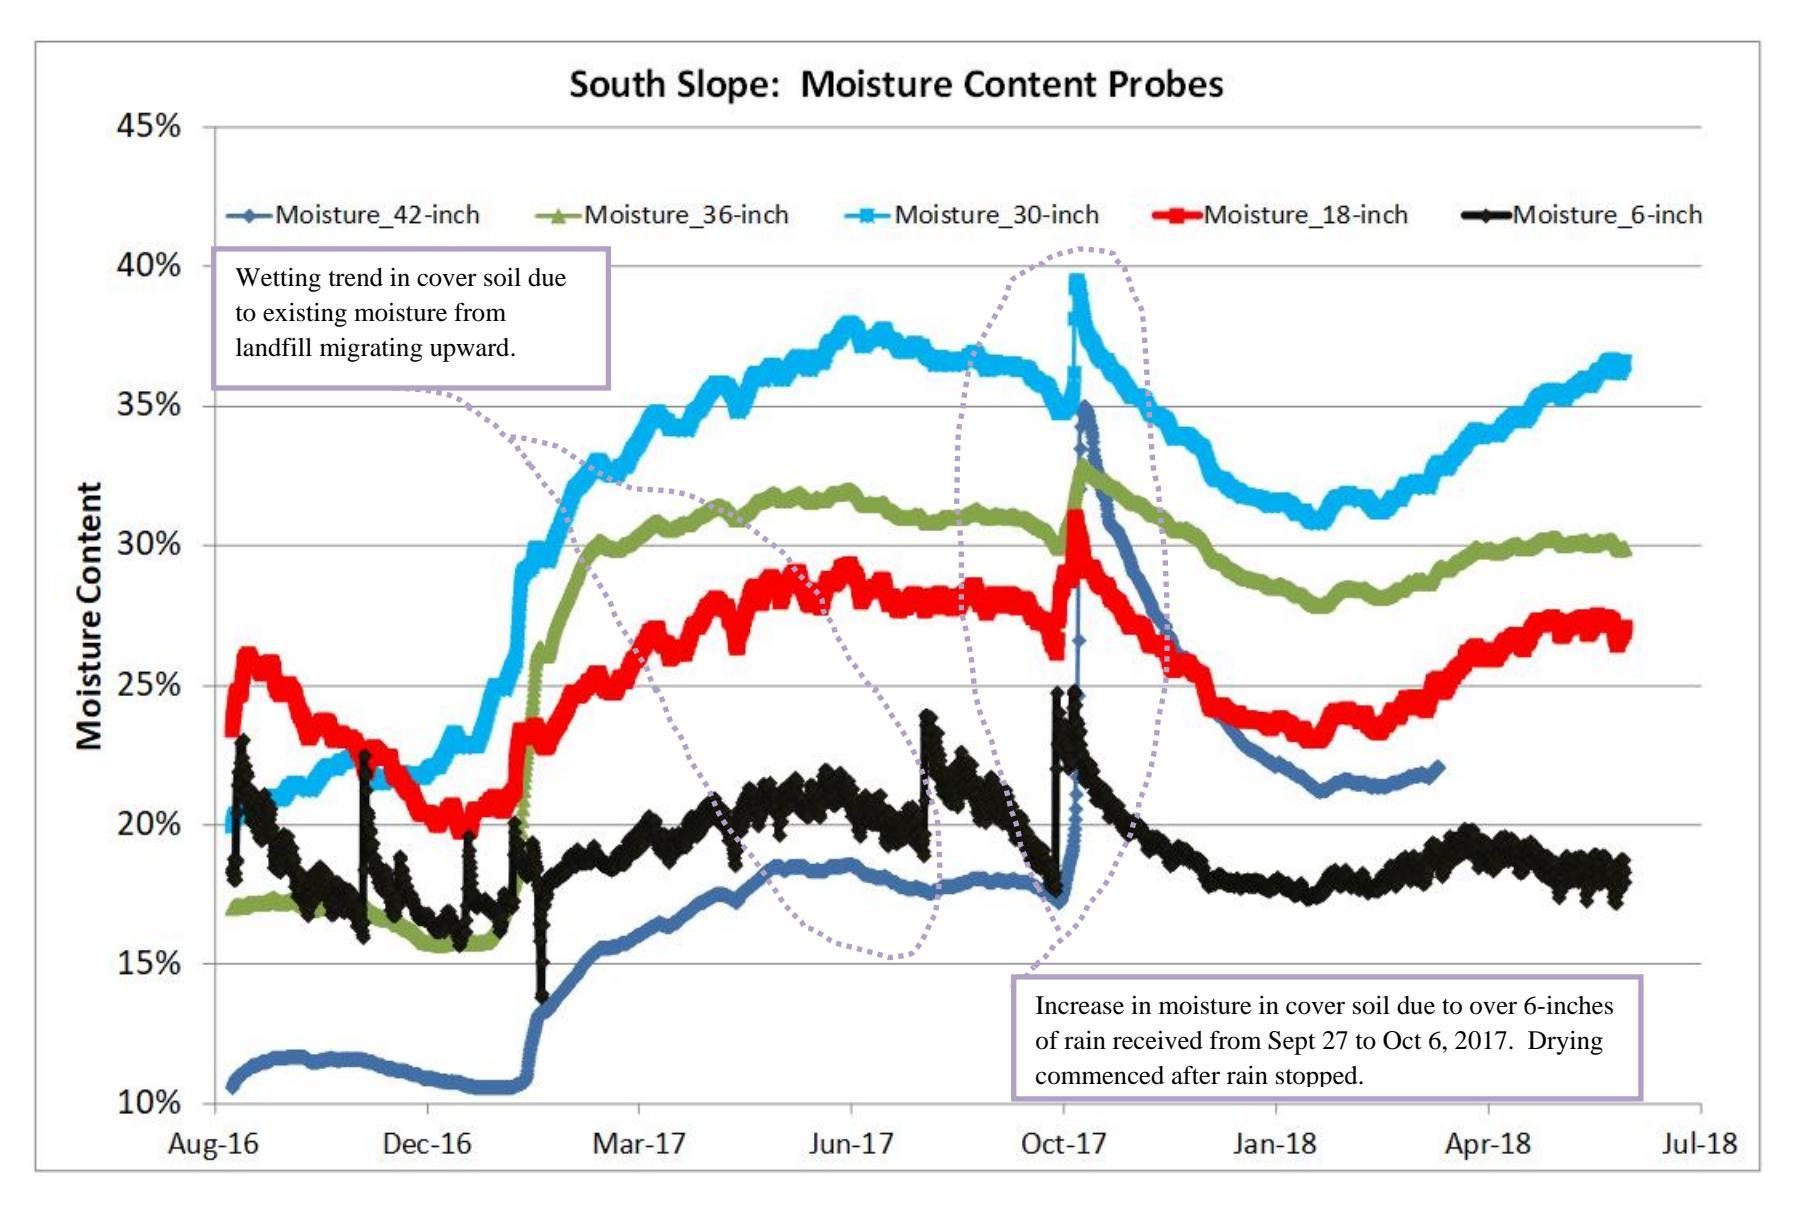
The moisture content probes reveal that infiltrated moisture due to precipitation quickly dries shortly after (Figures 1 and 2). There also appears to be some sensitivity of the moisture content measurements to soil temperature (especially noted in variation of winter and summer months). This data will take multiple seasons to analyze and better understand the water balance trends in the cover system.

Figure 1. Moisture Probe Data (September 2016 to June 2018) - ET Cover South Slope

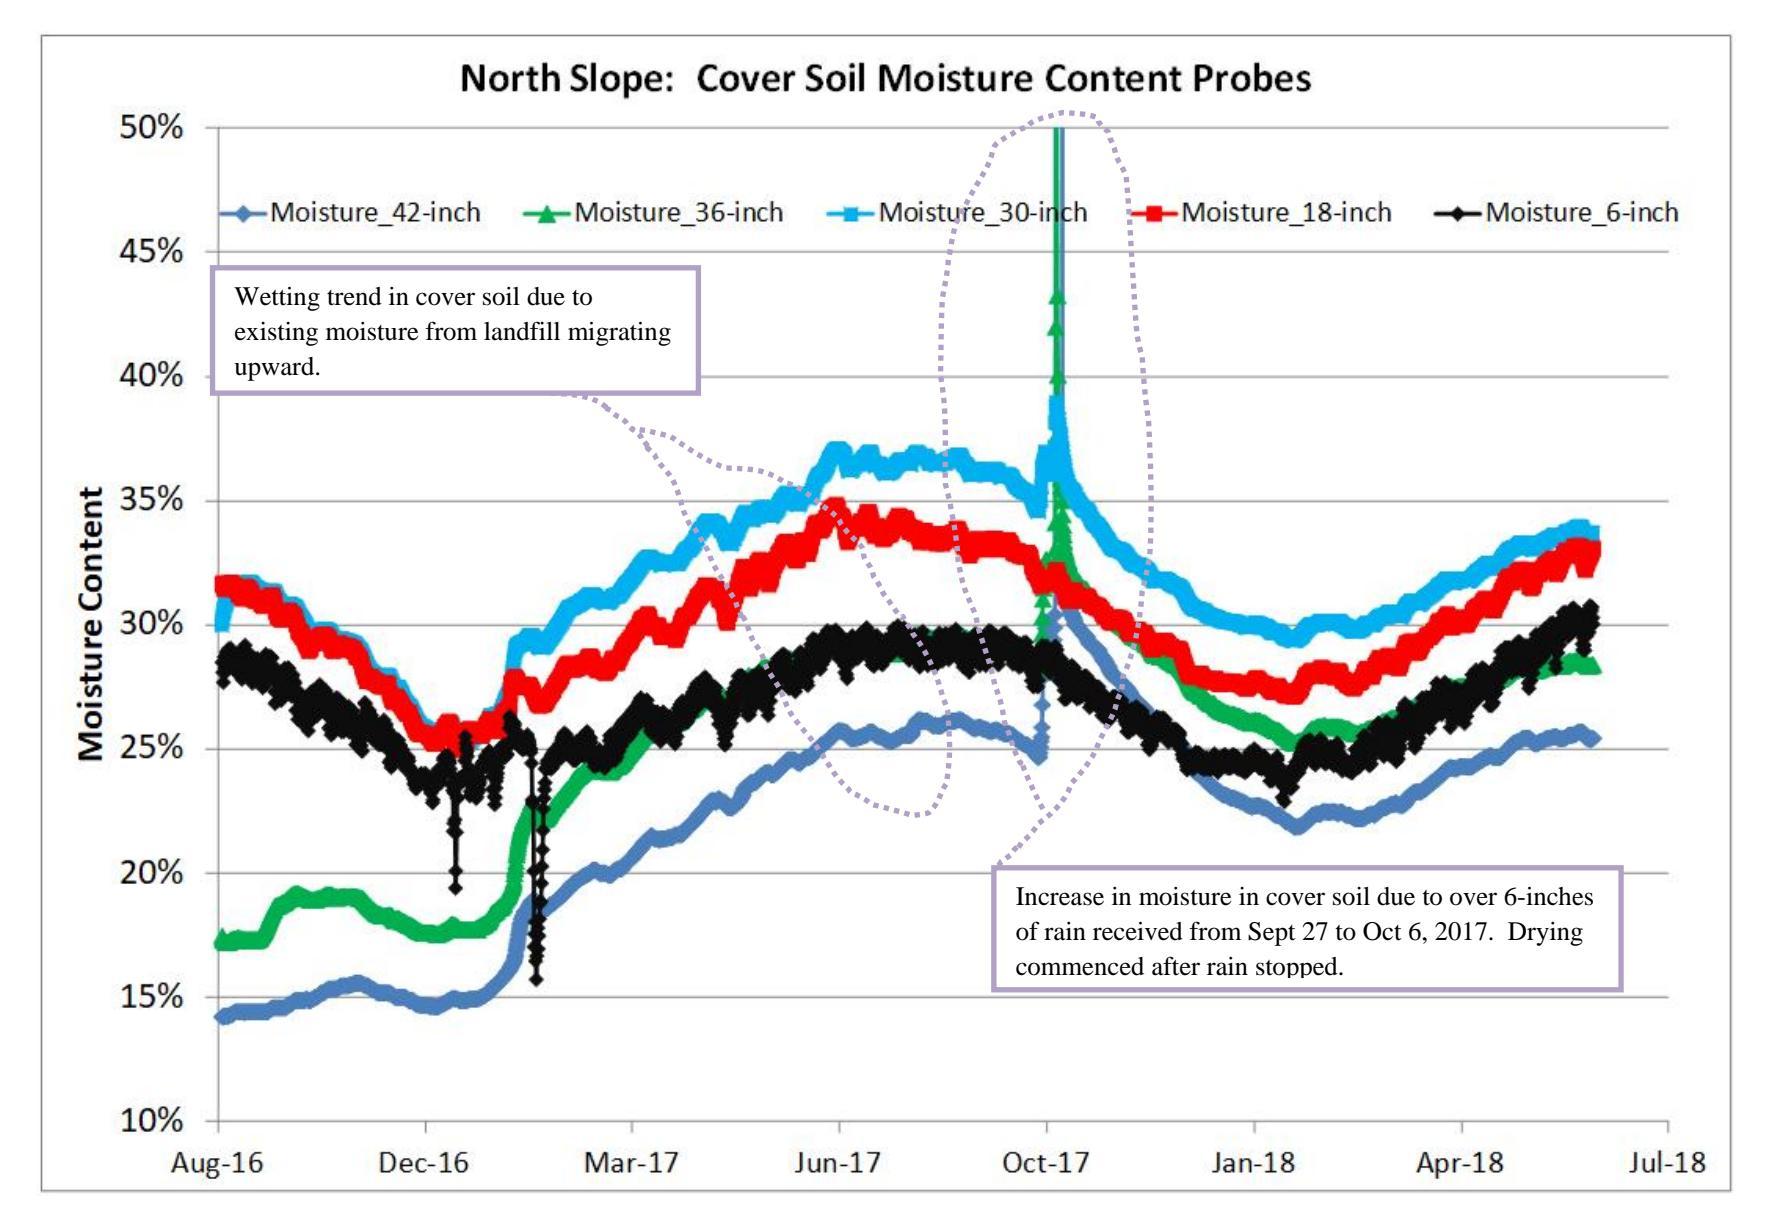
Figure 2. Moisture Probe Data (September 2016 to June 2018) - ET Cover North Slope
