# Deep Dive into Marine Energy Composites and Manufacturing

# Crevice Corrosion in Seawater Using CFRP Composite as Part of a Novel Crevice Former

F. Presuel-Moreno\*, B. A. Hernandez-Sanchez\*\*,

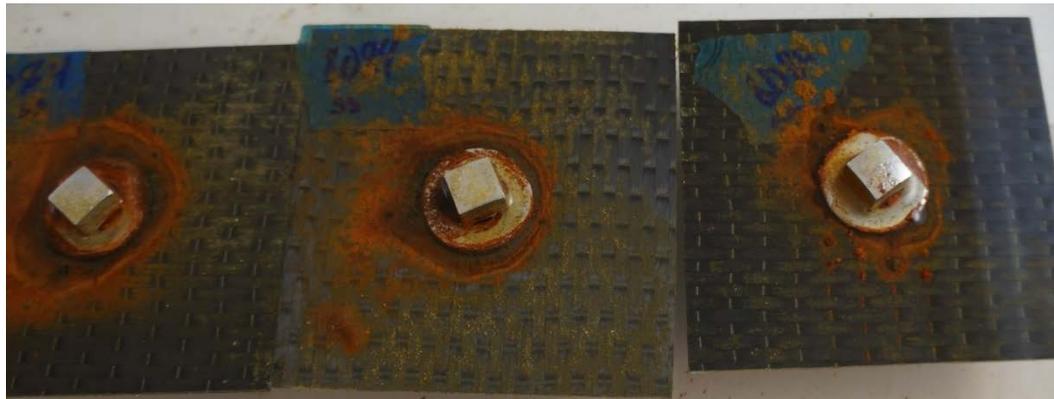
Elevated Temperature  
after 55 days of immersion

# Stainless Steel/CFRP composite fastened samples

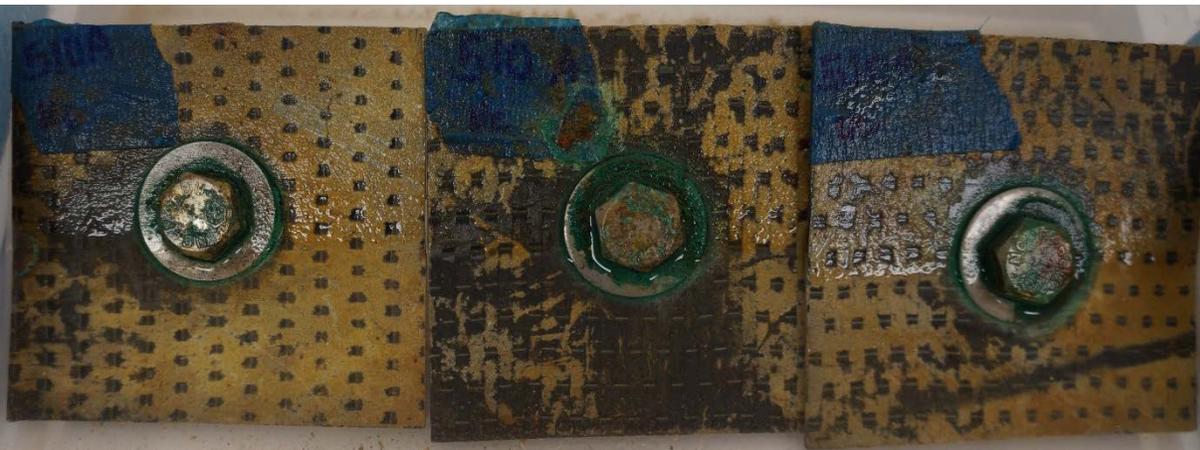
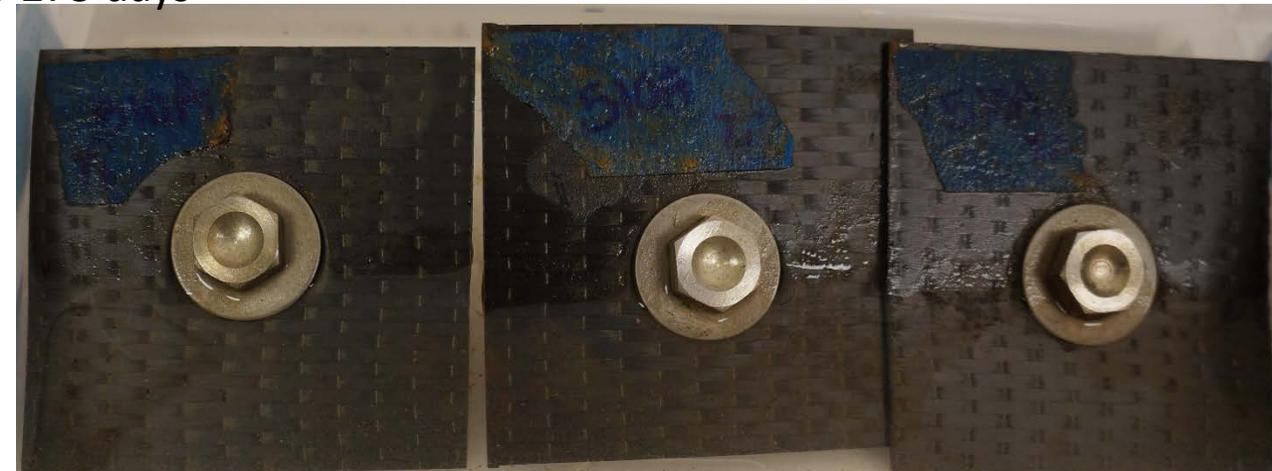
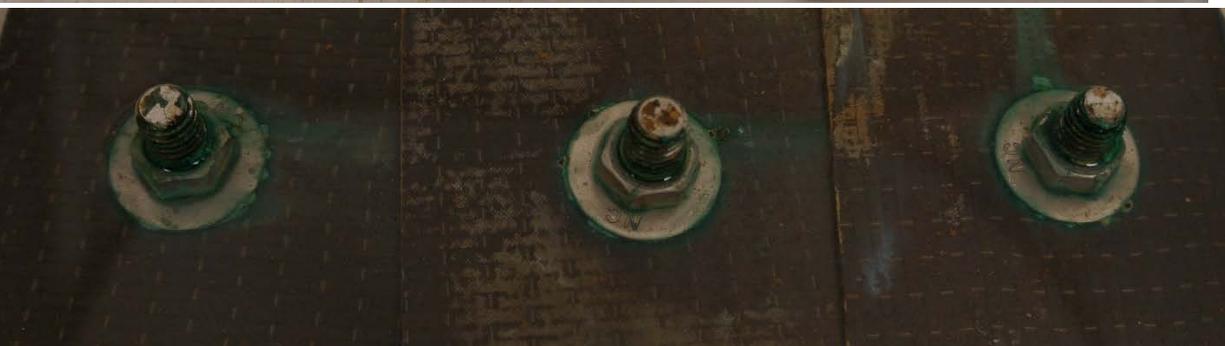
immersed for 273 days

No corrosion took place on the Titanium washers within the time monitored

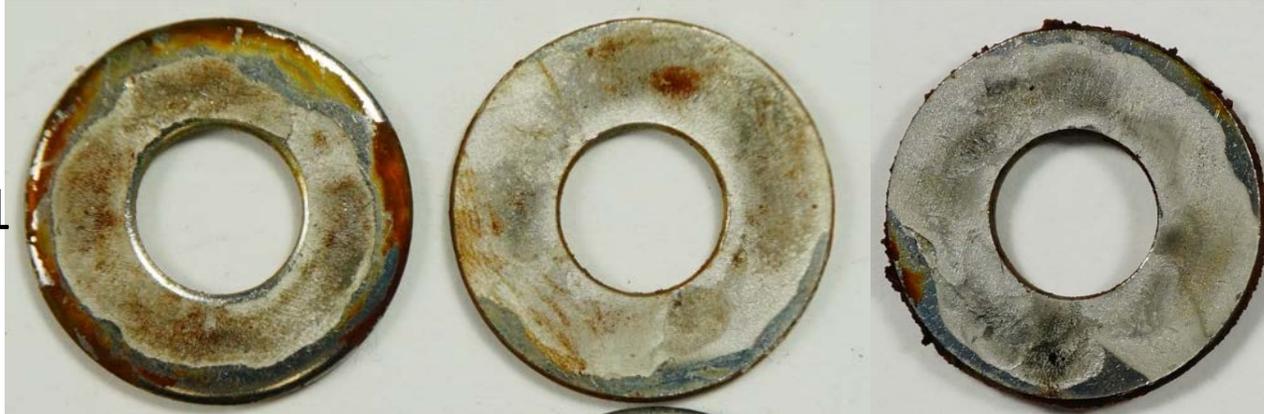
Stainless Steel Washers in contact with the CFRP composite, top row smooth side, bottom row rough side

C1 corrosion occurred with large surface coverage on stainless steel, and most corrosion products leached out.

C2 corrosion occurred as different sizes of pits on stainless steel and as brown corrosion products that flaked easily on Monel washers.

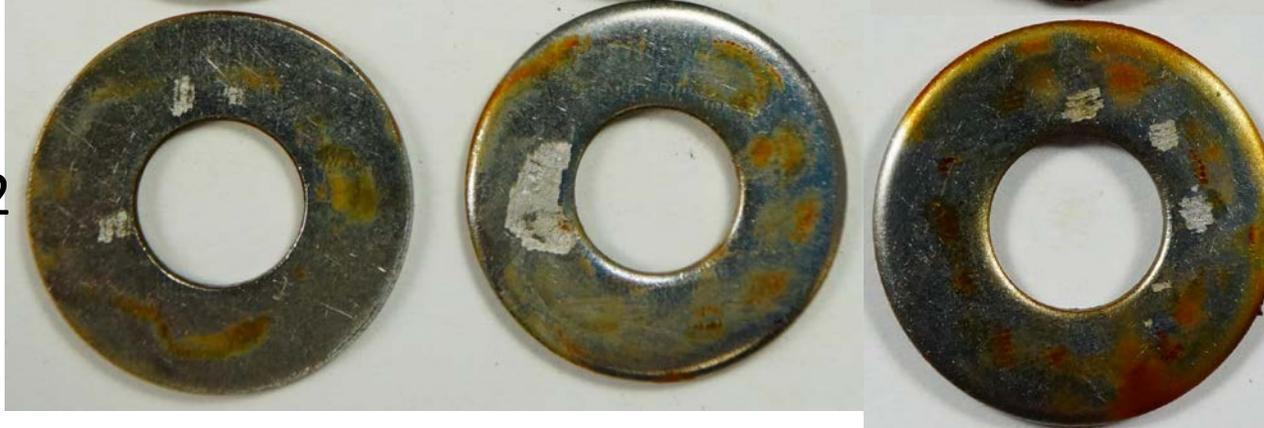
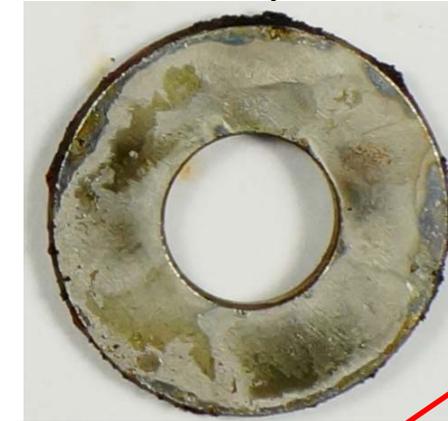
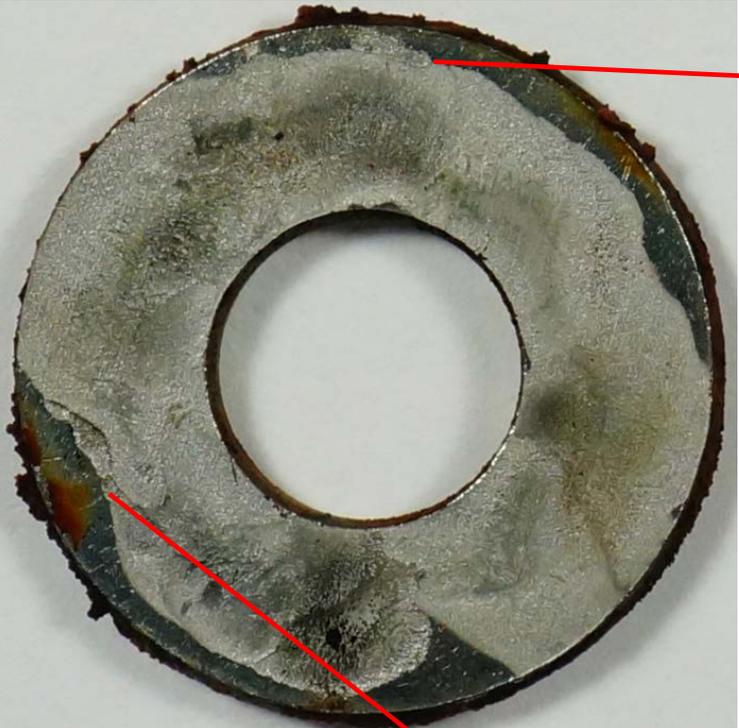
Crevice Corrosion of type C1 and C2 were observed on Monel and Stainless steel washers.

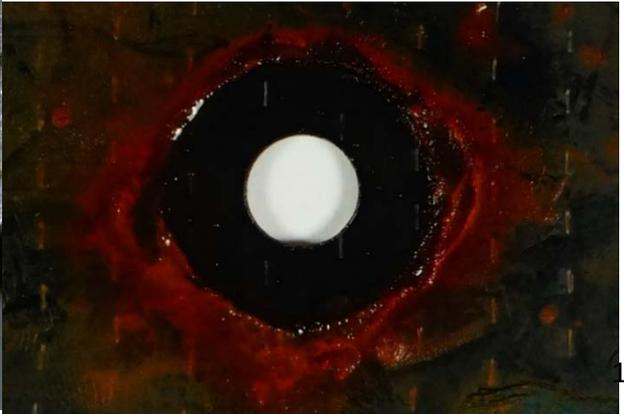
806 days  
Washer in contact with  
smooth composite

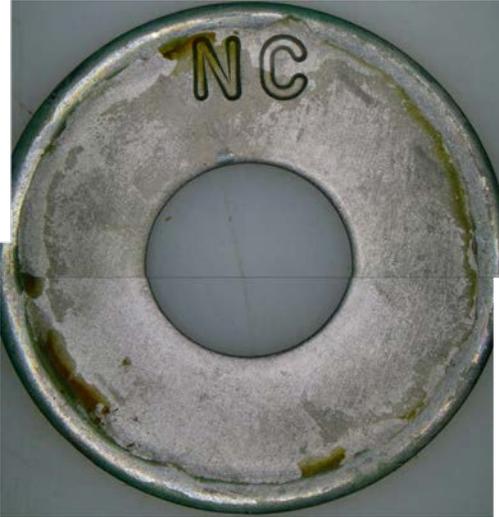
365 days

Monel washer surfaces in contact with the CFRP composite, top row smooth side, bottom row rough side

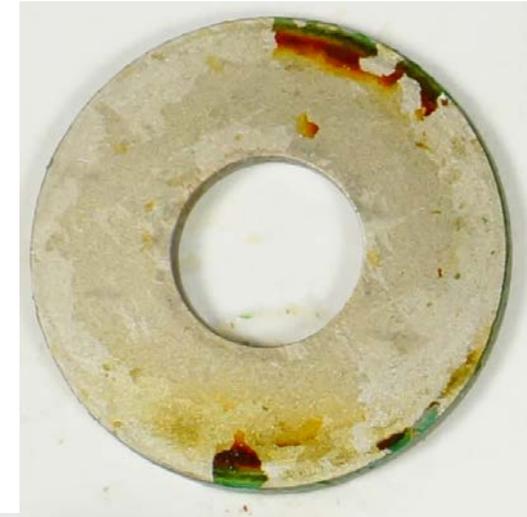
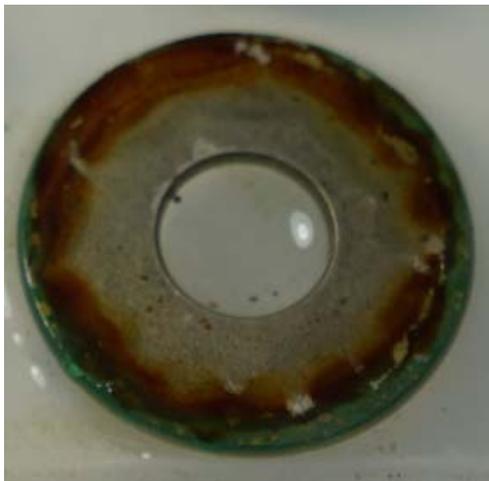
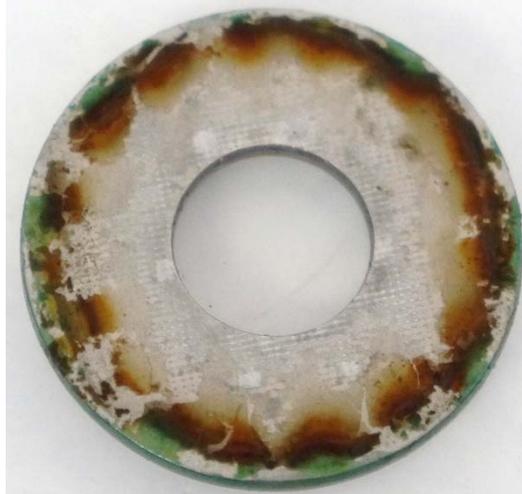
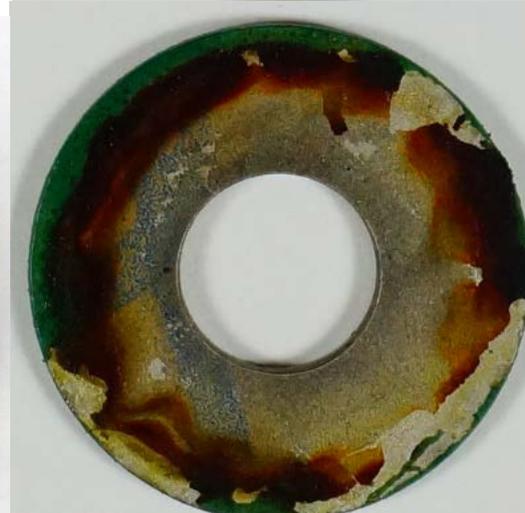
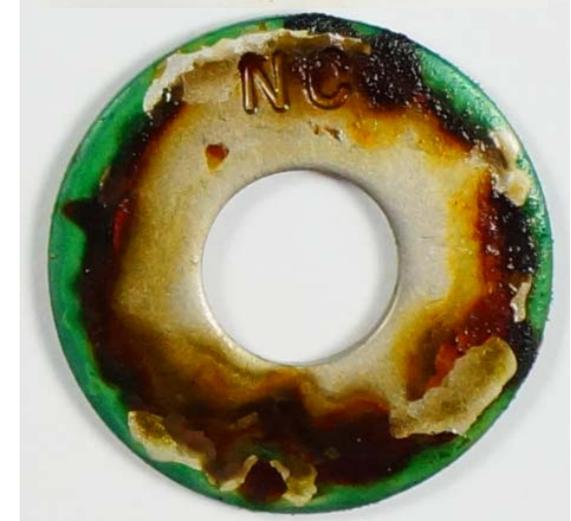
806 days

799 days, on the left in contact with smooth CFRP composite,  
below in contact with rougher CFRP composite surface

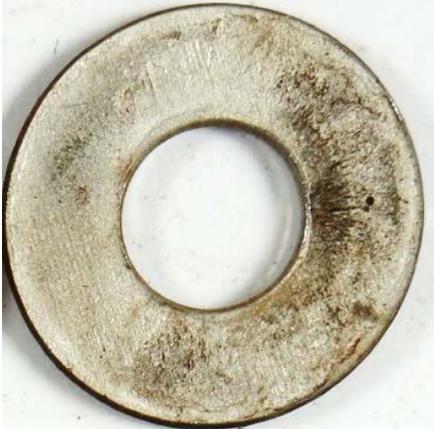
273 days

Stainless Steel Washers in contact with the CFRP composite, top row smooth side, bottom row rough side

Crevice corrosion appears to be more pronounced on samples exposed in the elevated temperature seawater

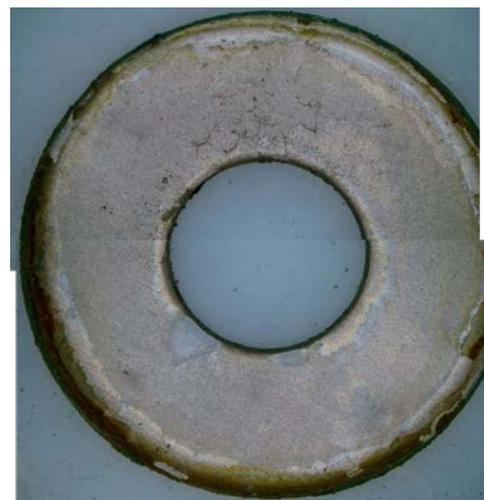
288 days

Monel Washers in contact with the CFRP composite, top row smooth side, bottom row rough side

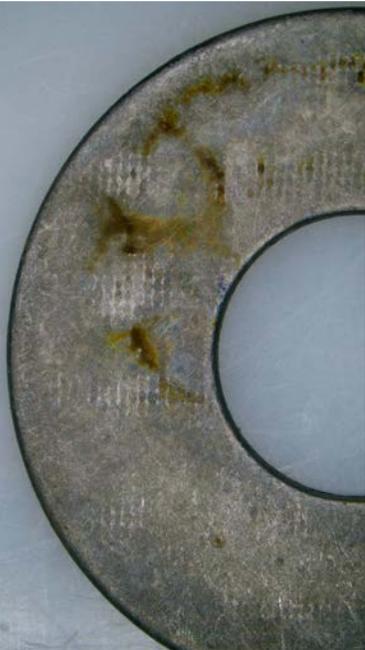
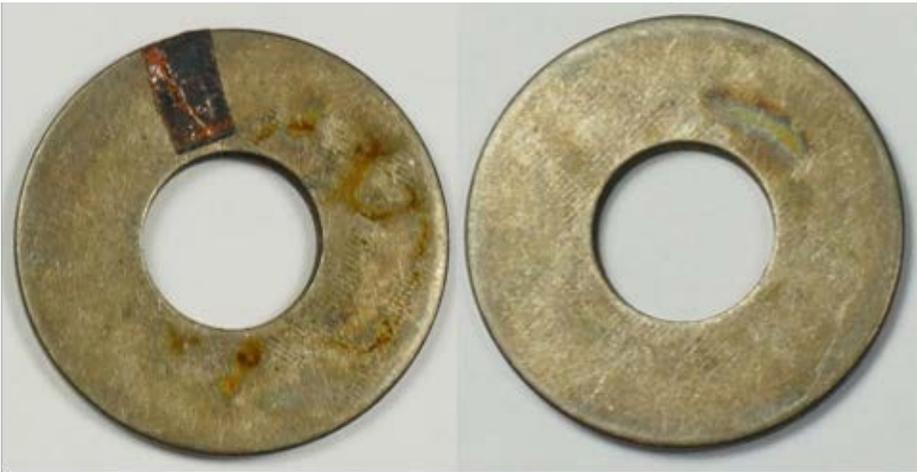
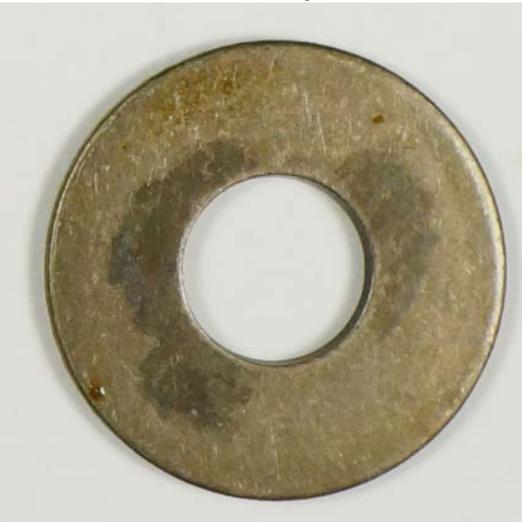
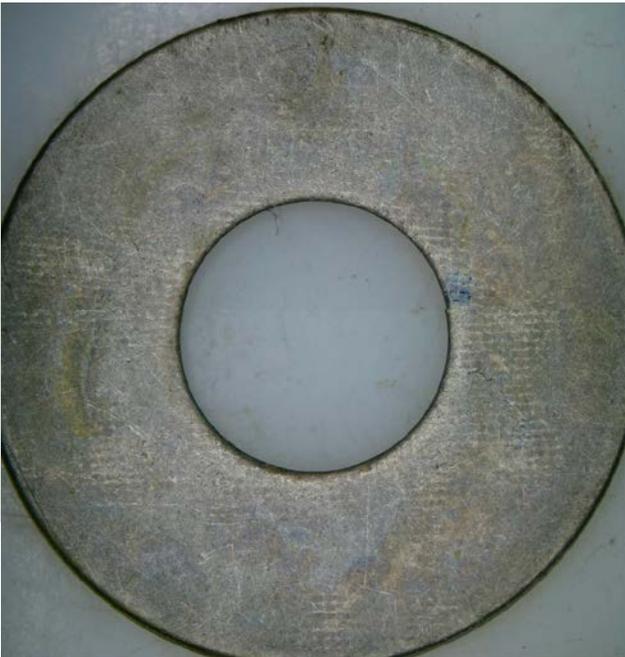
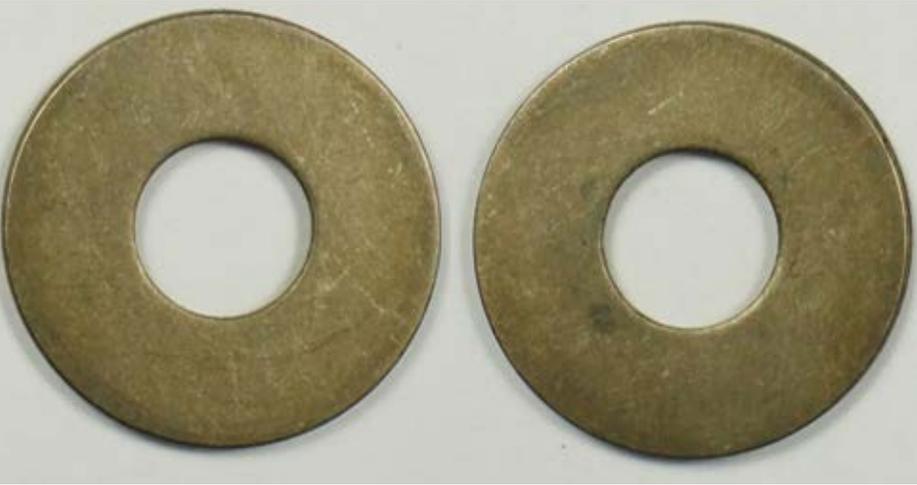
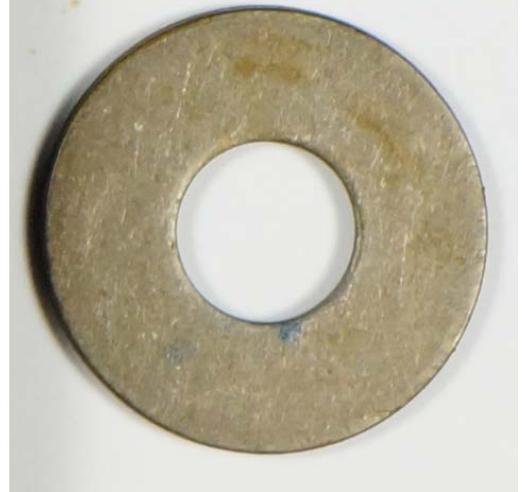
Titanium washers in contact with the CFRP composite, top row - smooth side, bottom row - rough side

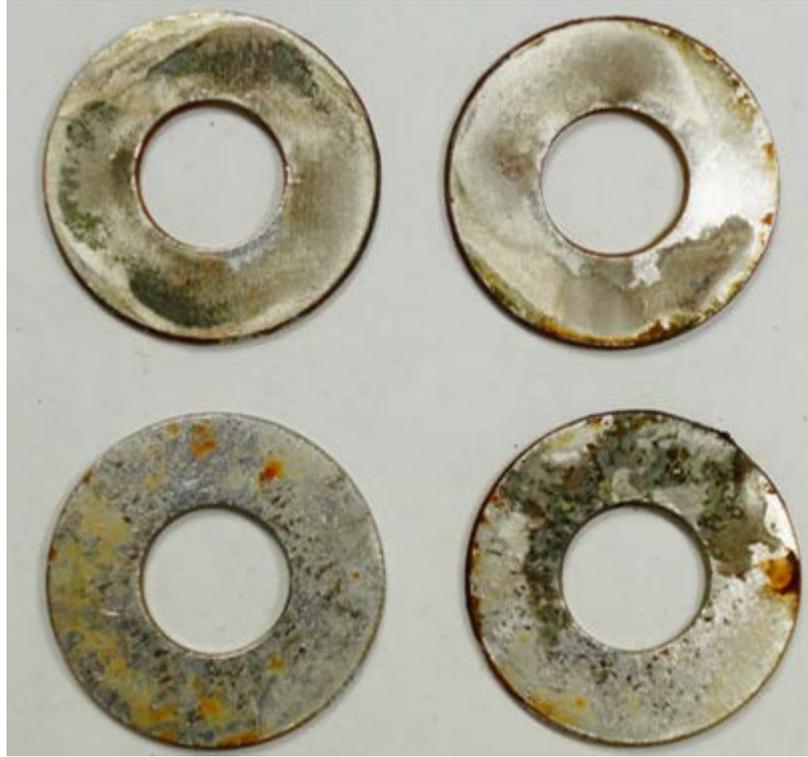
Stainless Steel

Washers in contact with the Hybrid composite, top row - smooth side, bottom row - rough side

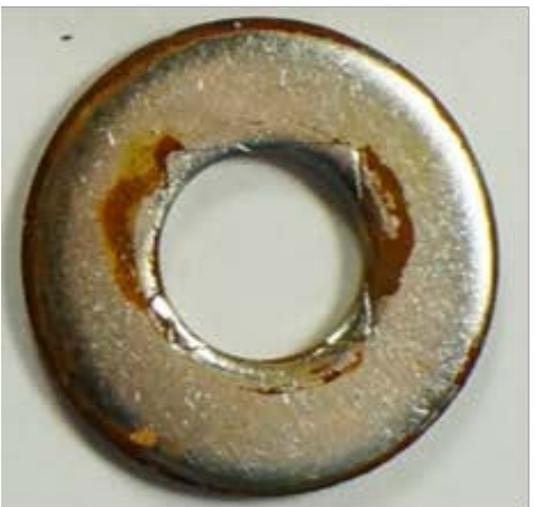
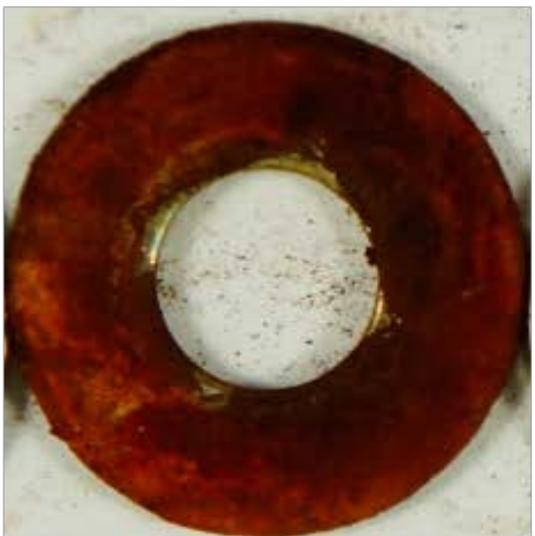
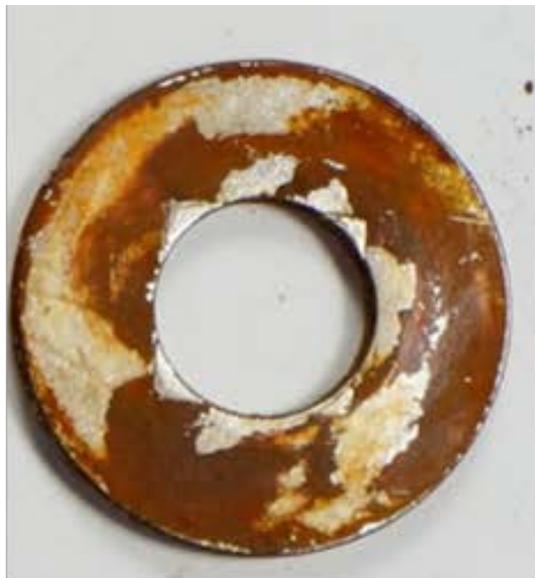
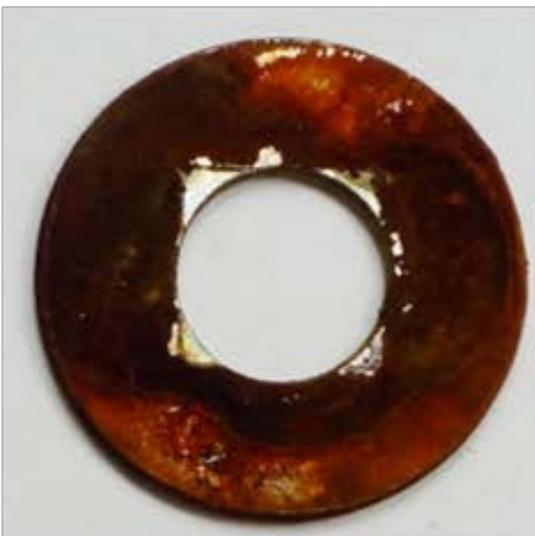
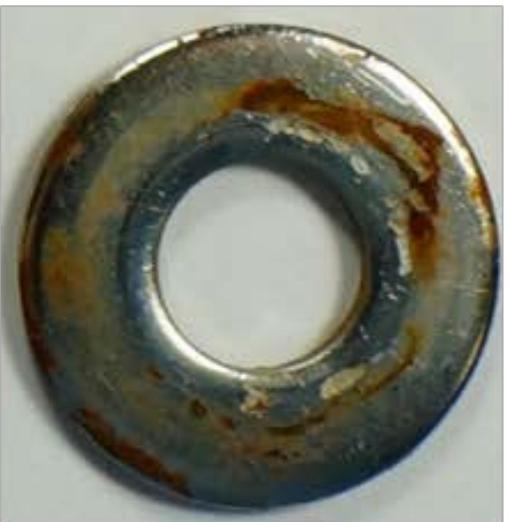
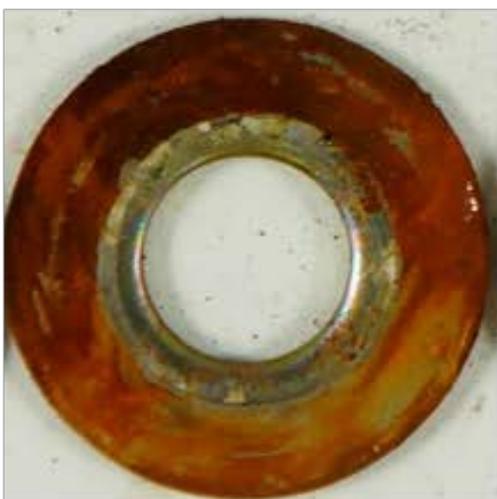
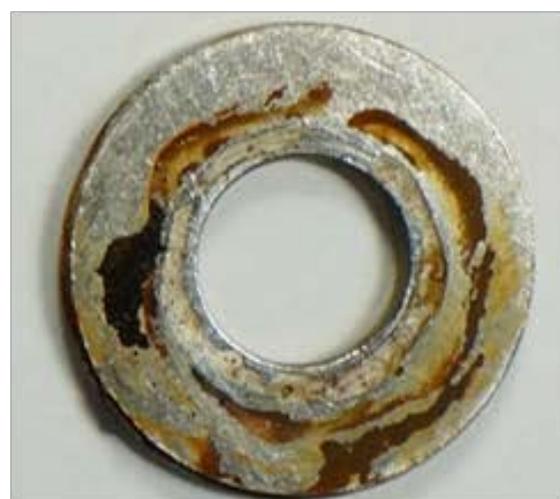
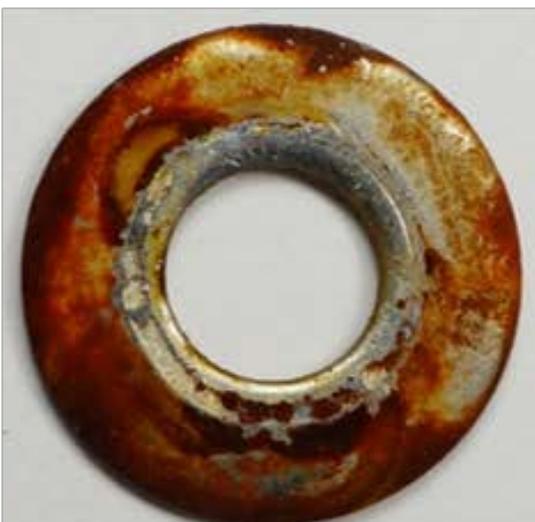
# Elevated Temperature – Stainless Steel

Stainless Steel Washers in contact seawater, top row bolt side, bottom row nut side

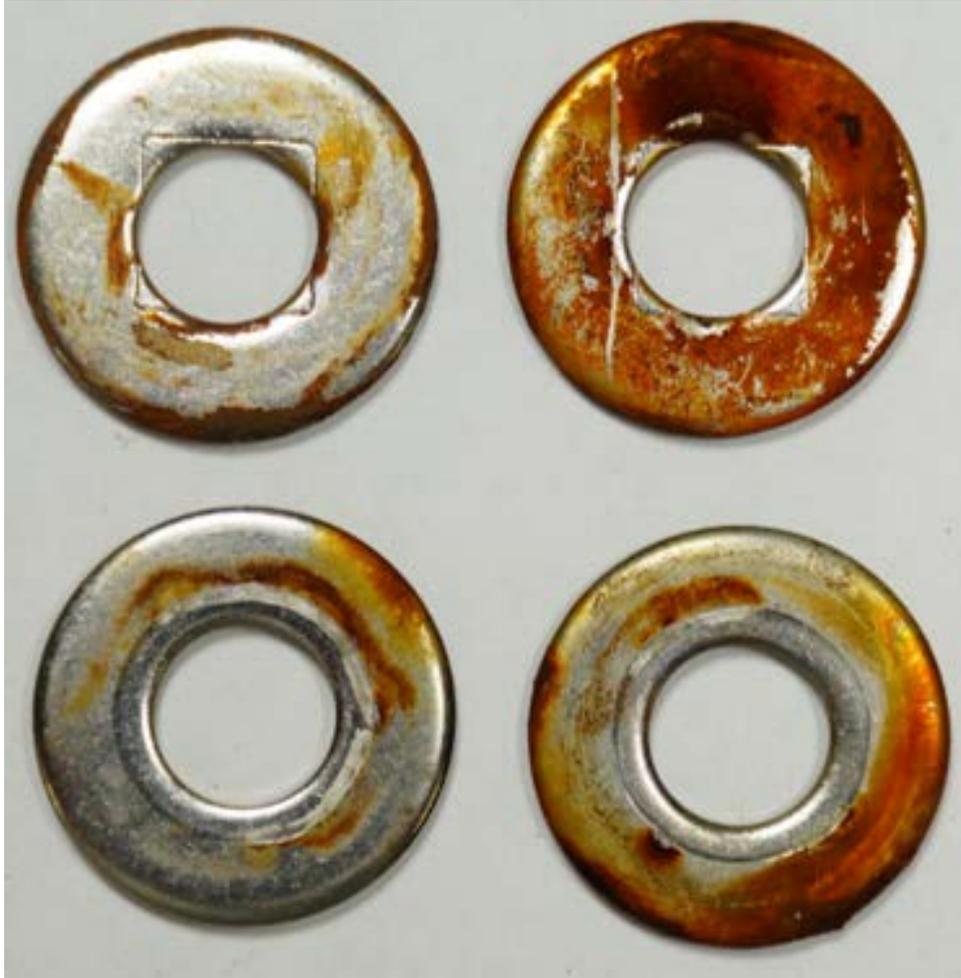
# Elevated Temperature

Washers in contact with the Hybrid composite, top row – bolt side, bottom row – nut side

316 days

708 days

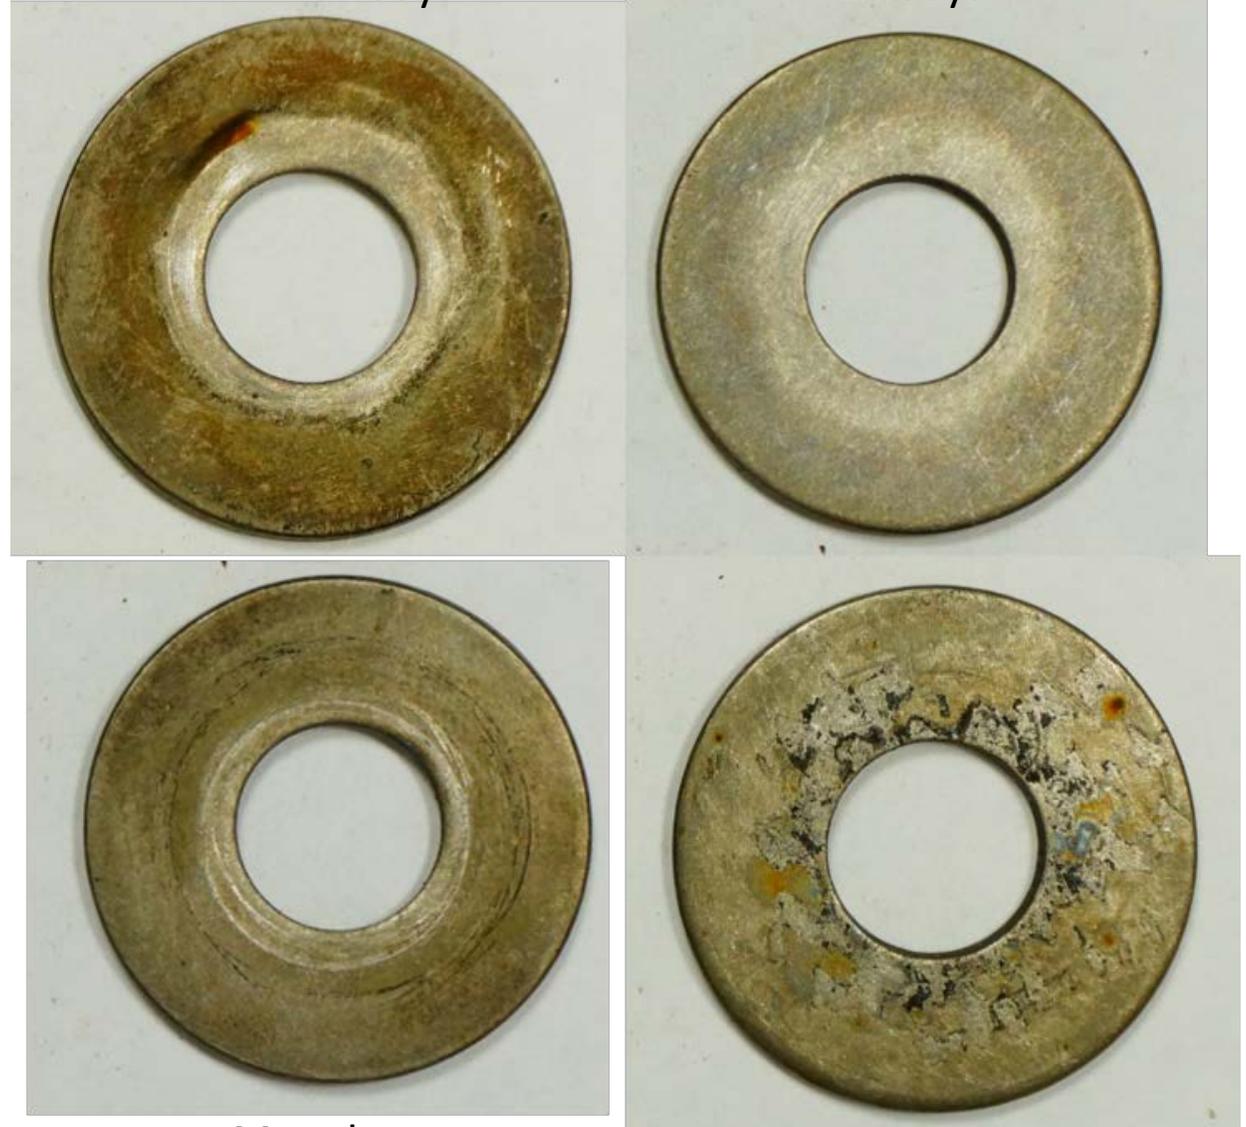
704 days

713 days

Example of a C3 site (crevice corrosion between nut and washer surfaces)
