U.S. DEPARTMENT OF
ENERGY

Legacy
Management

2020 Annual Site Inspection and Monitoring Report for Uranium Mill Tailings Radiation Control Act Title I Disposal Sites

March 2021

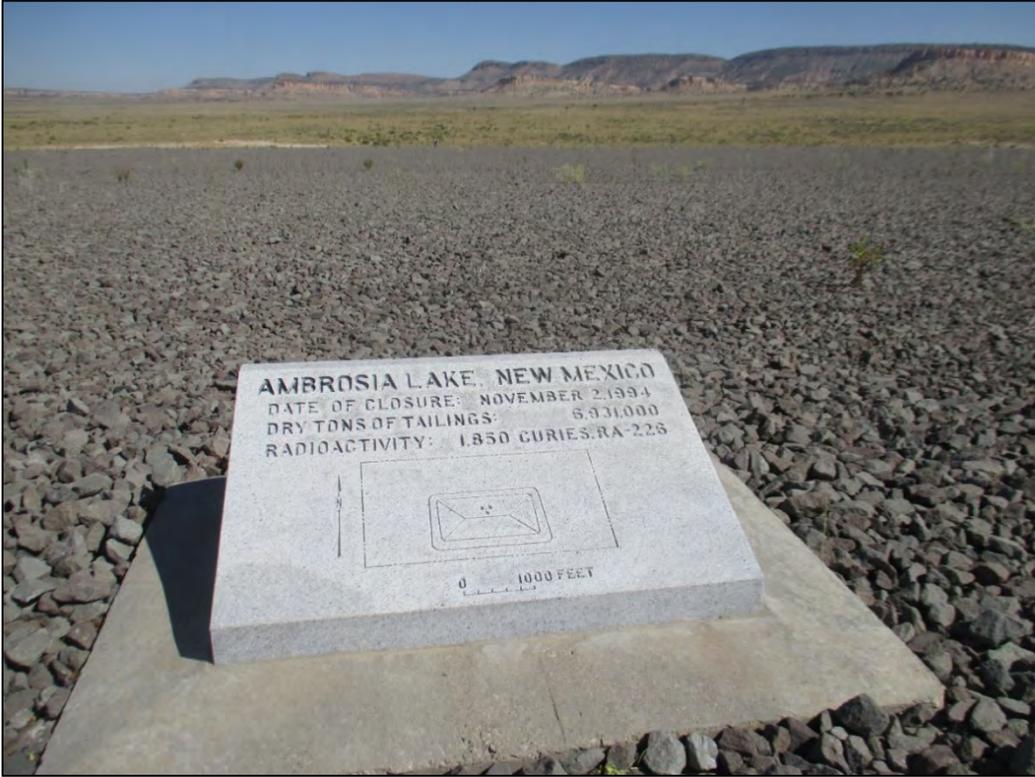
PL-3. Site Marker SMK-2

The site has two granite site markers. Site marker SMK-1 is just inside the site entrance, and site marker SMK-2 is on the top slope of the disposal cell (PL-3). No maintenance needs were identified.

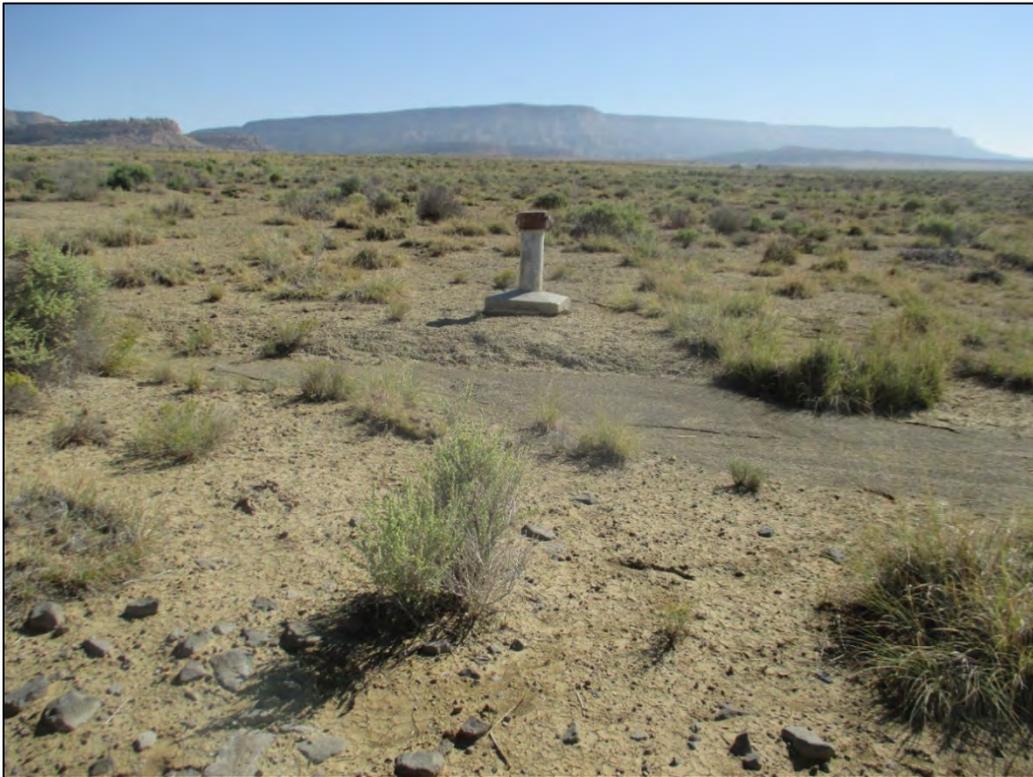
PL-6. Erosional Gully near Monitoring Well 0678

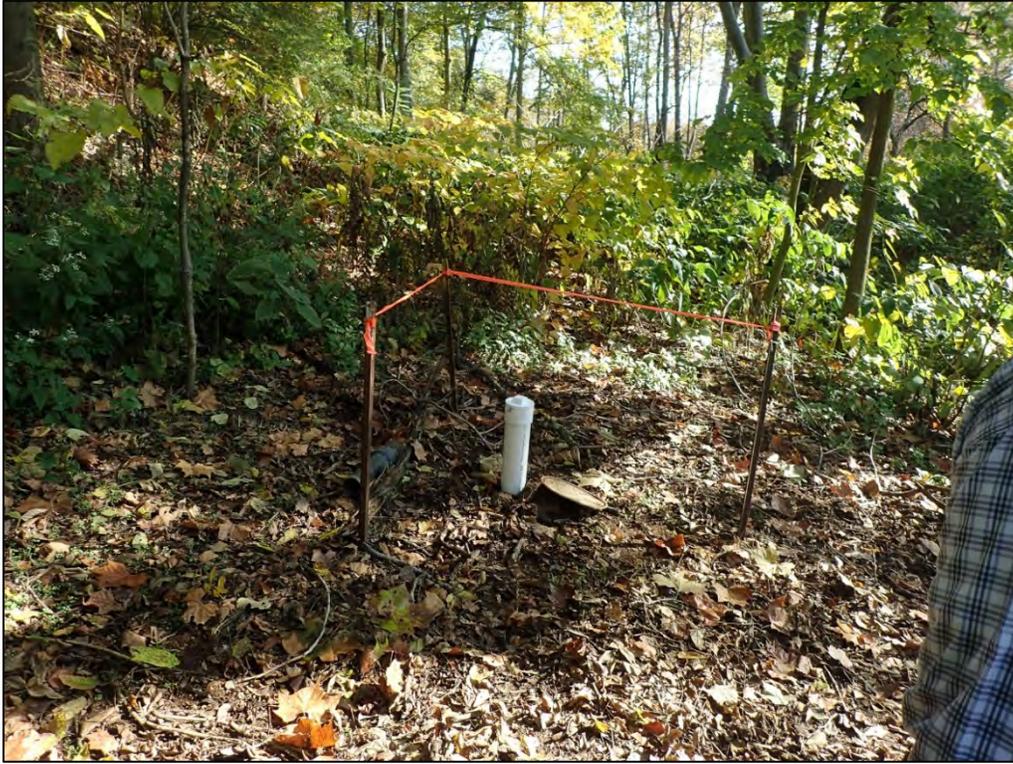
PL-3. New Pipe Installed at Boundary Monument BM1

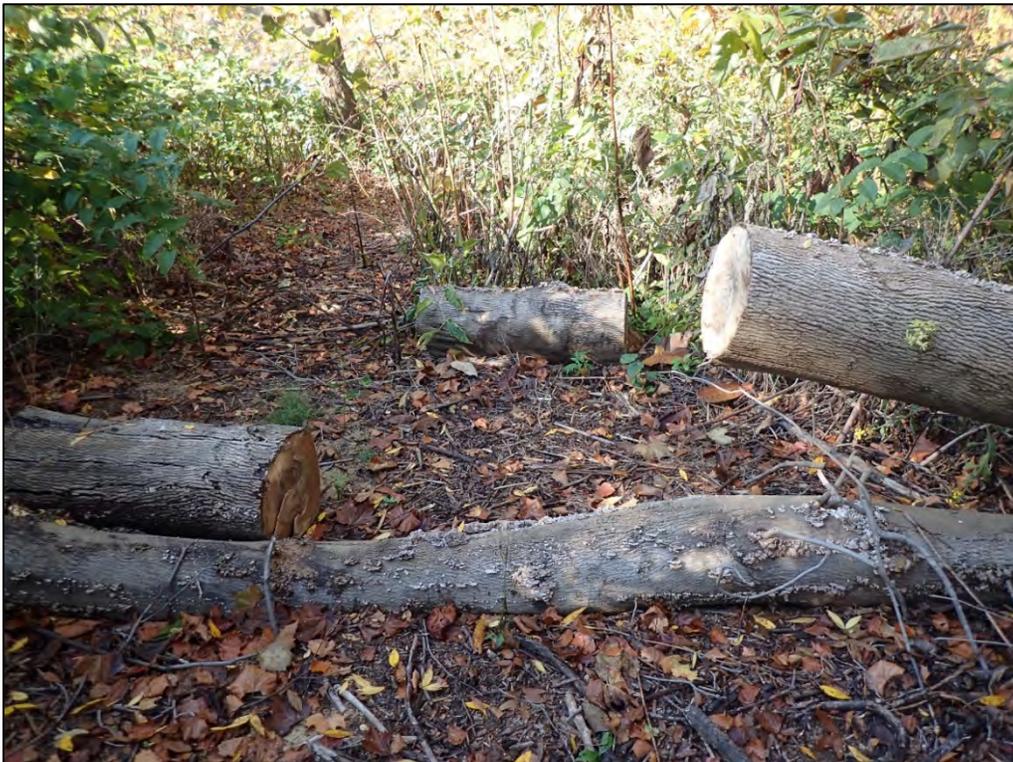
PL-4. Cleared Tree on Path to Boundary Monument BM1

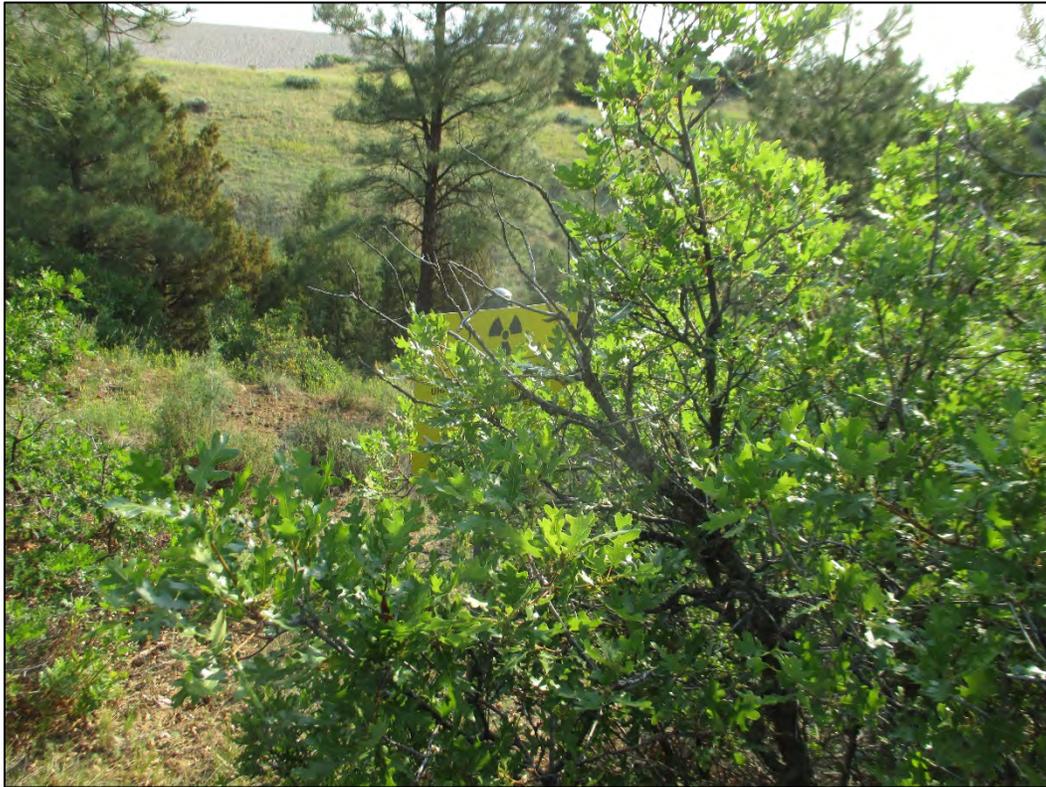
PL-3. Vegetation Surrounding Perimeter Sign P4

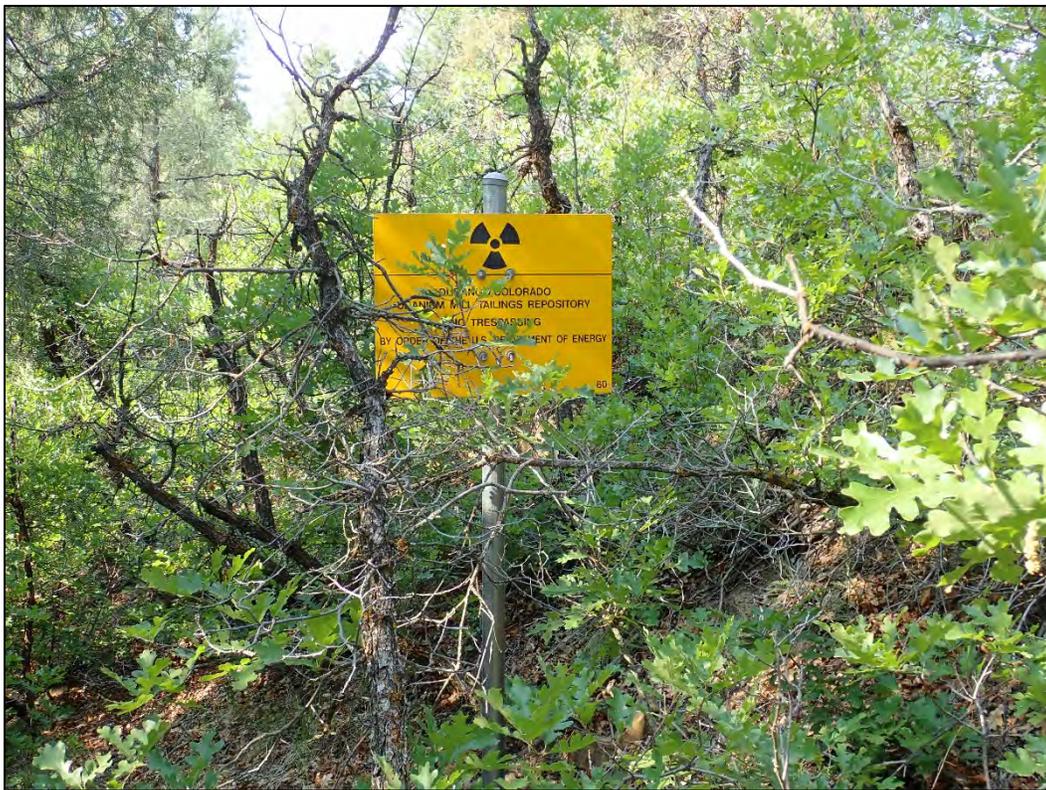
PL-4. Vegetation Around Perimeter Sign P60

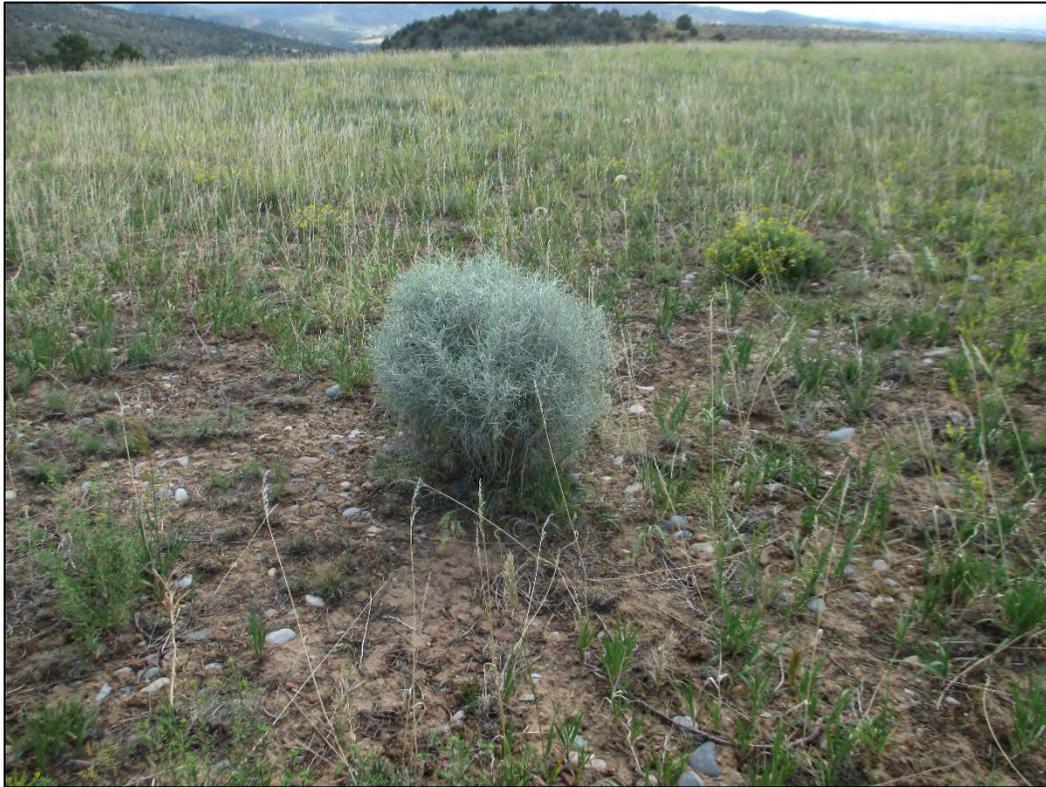
PL-7. Rabbitbrush on Cell Top Slope

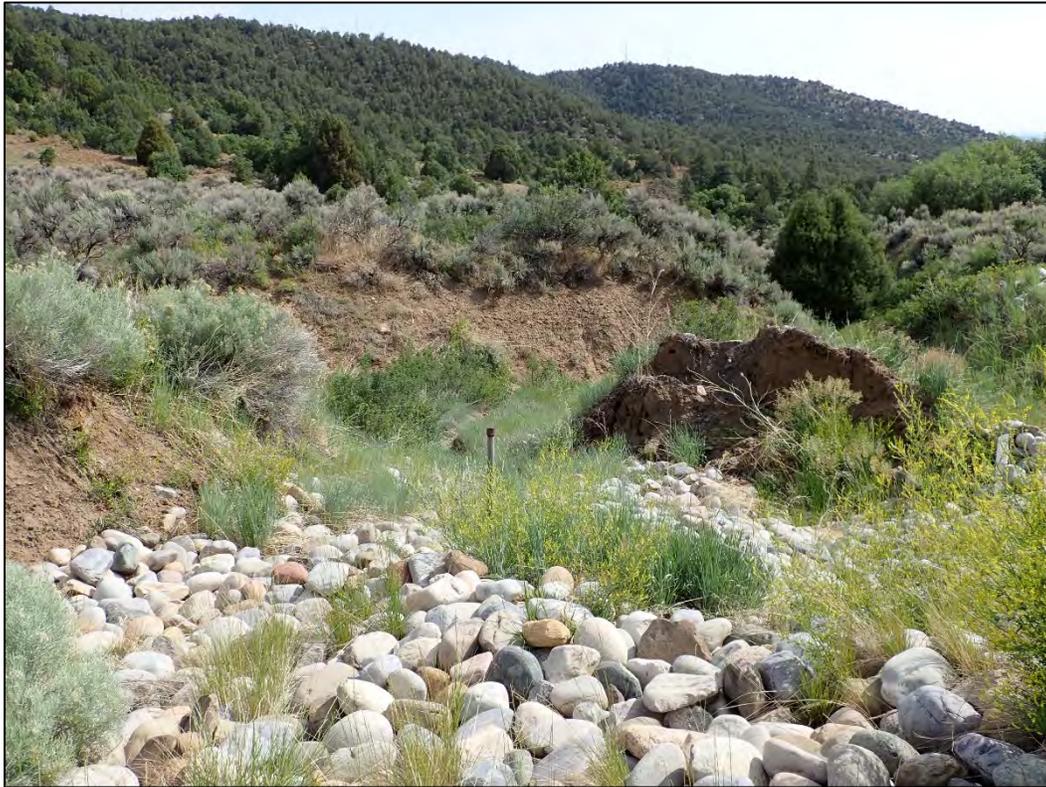
PL-9a. Northeast Outflow in 2020

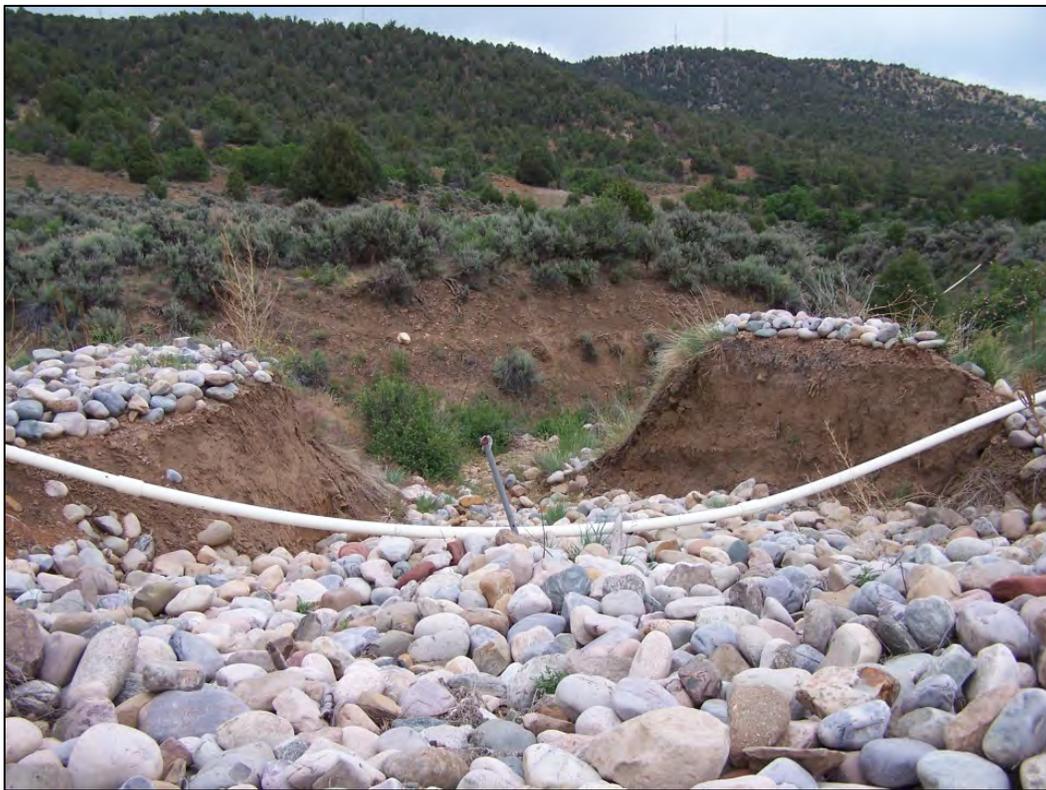
PL-9b. Northeast Outflow in 2006

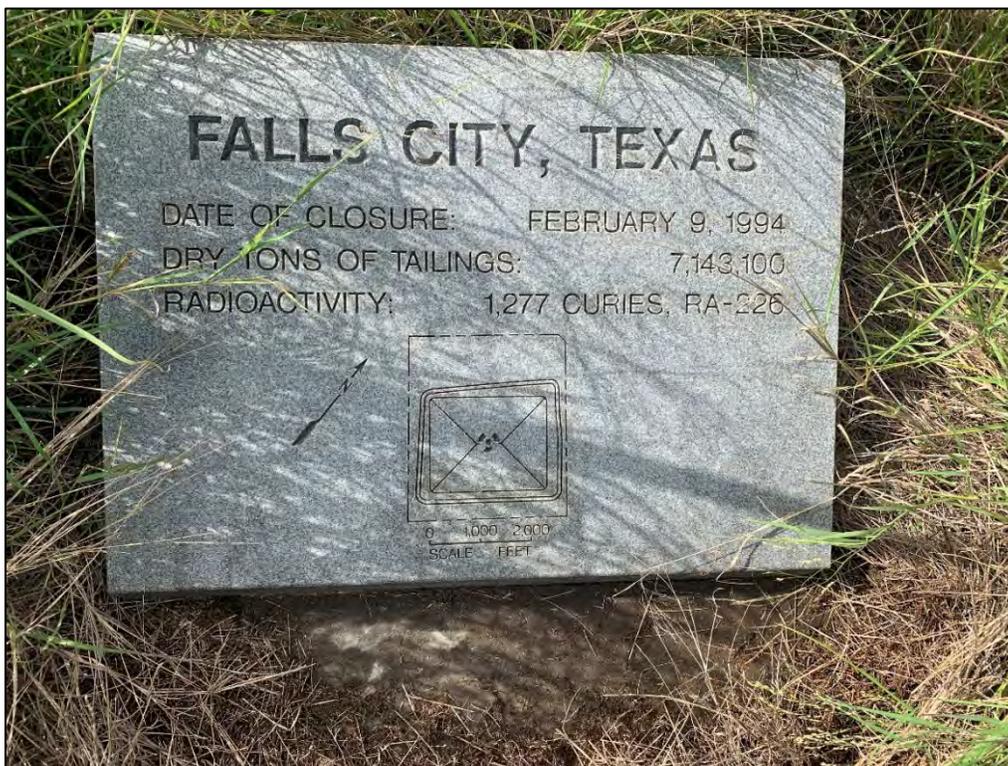
PL-1. Site Marker SMK-1

The site has two site markers. Site marker SMK-1 is just inside the entrance gate (PL-1). The corners of the concrete base around the marker are cracked. The cracks consistently are unchanged and repairs are not needed. Site marker SMK-2 is on the top slope of the disposal cell. No maintenance needs were identified.

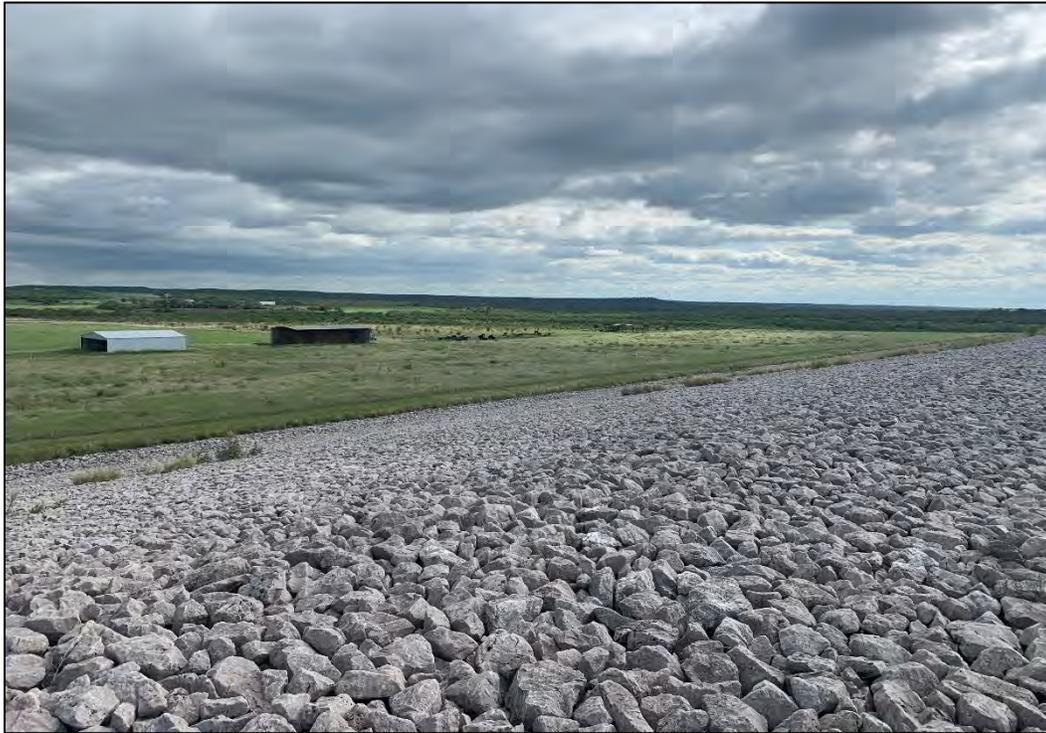
The disposal cell side slopes and a transition zone where the top slope meets the side slopes are armored with riprap (PL-3). LM has monitored several small depressions on the northwest side slope of the disposal cell since 2010. These depressions do not compromise the protectiveness of the riprap side slope, and no changes have been observed since 2010. Inspectors will continue to monitor these areas.

Fractured riprap has been observed on the disposal cell side slopes since it was completed. Pieces of riprap are fractured in place, indicating that the fracturing occurred after placement. Fracturing is likely a consequence of mechanical placement or thermal expansion and contraction; the riprap condition appears stable. LM periodically takes photos of riprap at the base of T-post 4 on the west corner of the disposal cell. On the basis of a qualitative evaluation of the photos in 2018, there is no indication that the riprap is degrading, but its durability will continue to be monitored. If the number of fractured rocks appears to be increasing, LM will establish a more quantitative monitoring program.

PL-3. South Side of Disposal Cell Side Slope

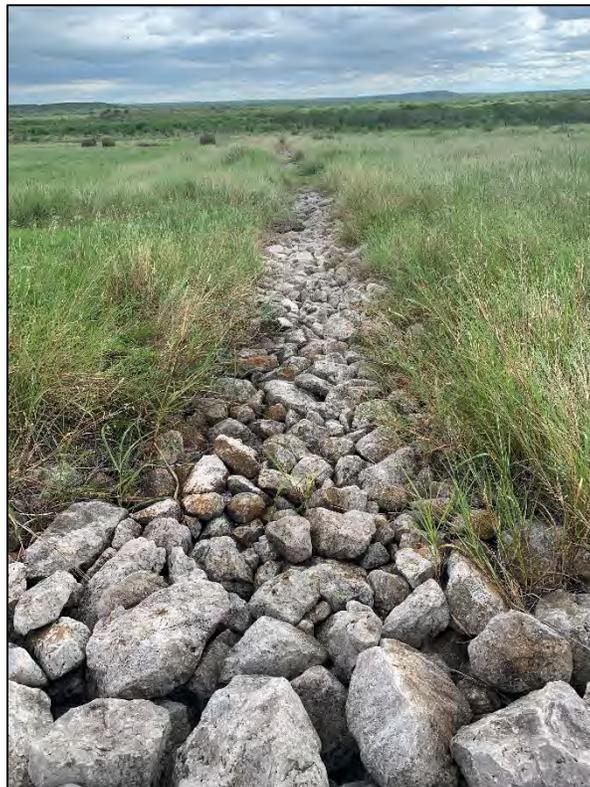
No water was flowing in the south rock drain during the inspection (PL-4). Willows that grow along the south drain are periodically removed by the maintenance subcontractor. No water was observed in the north rock drain. Vegetation is left uncut at the outlets of the rock drains to help dissipate the energy of stormwater runoff and to reduce soil erosion. Vegetation in the apron outfall, midway along the northeast side slope, was cut back before the 2020 inspection. No maintenance needs were identified.

PL-4. Rock Drain on South Corner of Disposal Cell

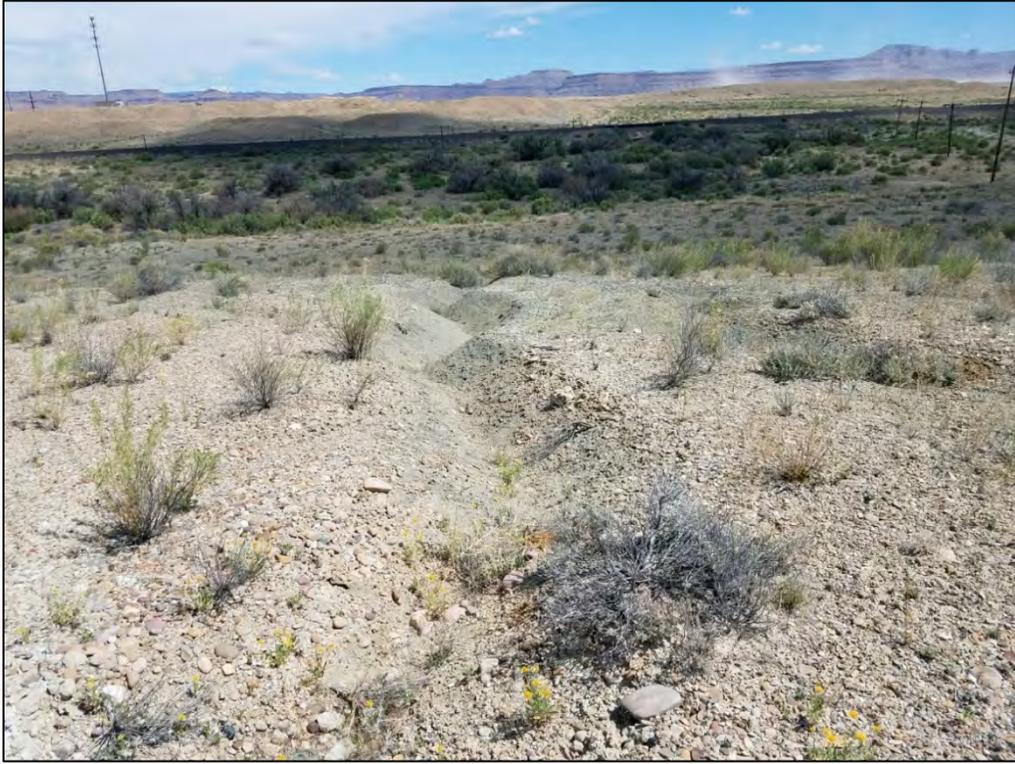
PL-9. Gullies Near Boundary Monument BM-8

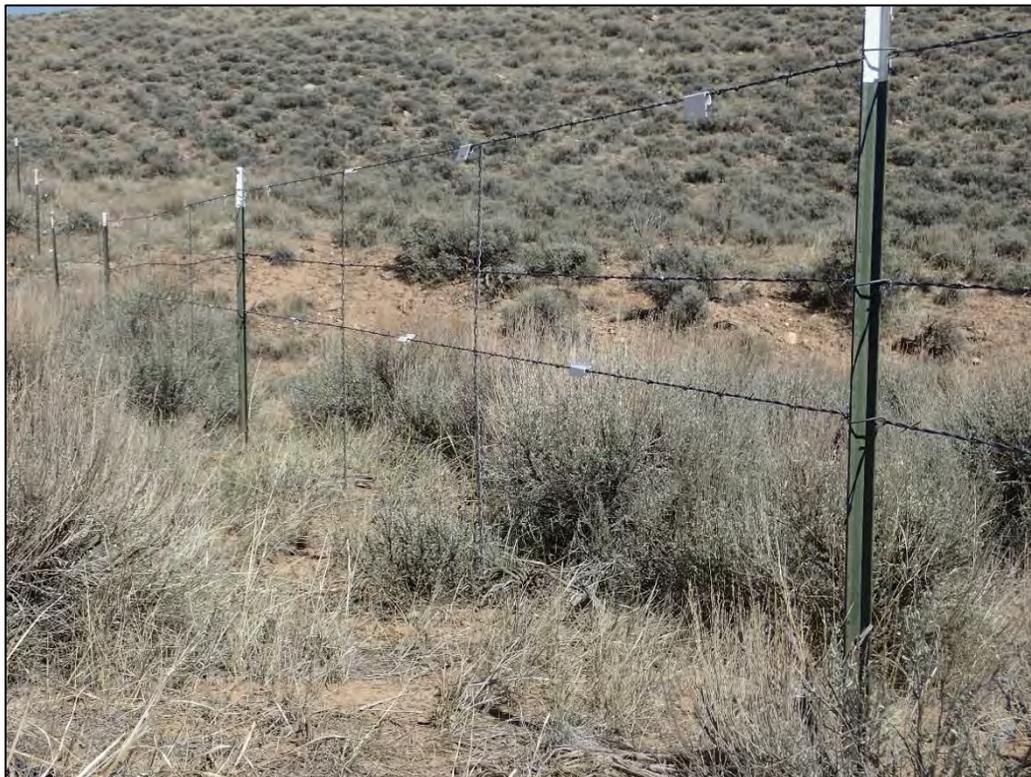
PL-2. Fence Flagging on East Fence Line

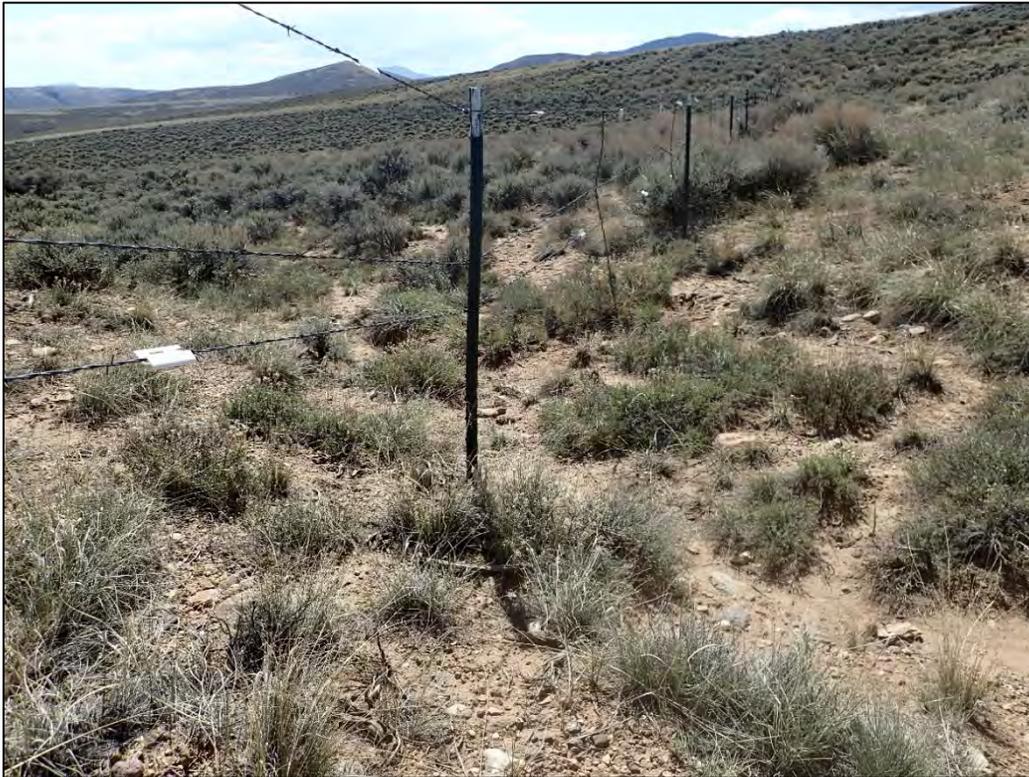
PL-3. Fence Flagging on East Fence Line

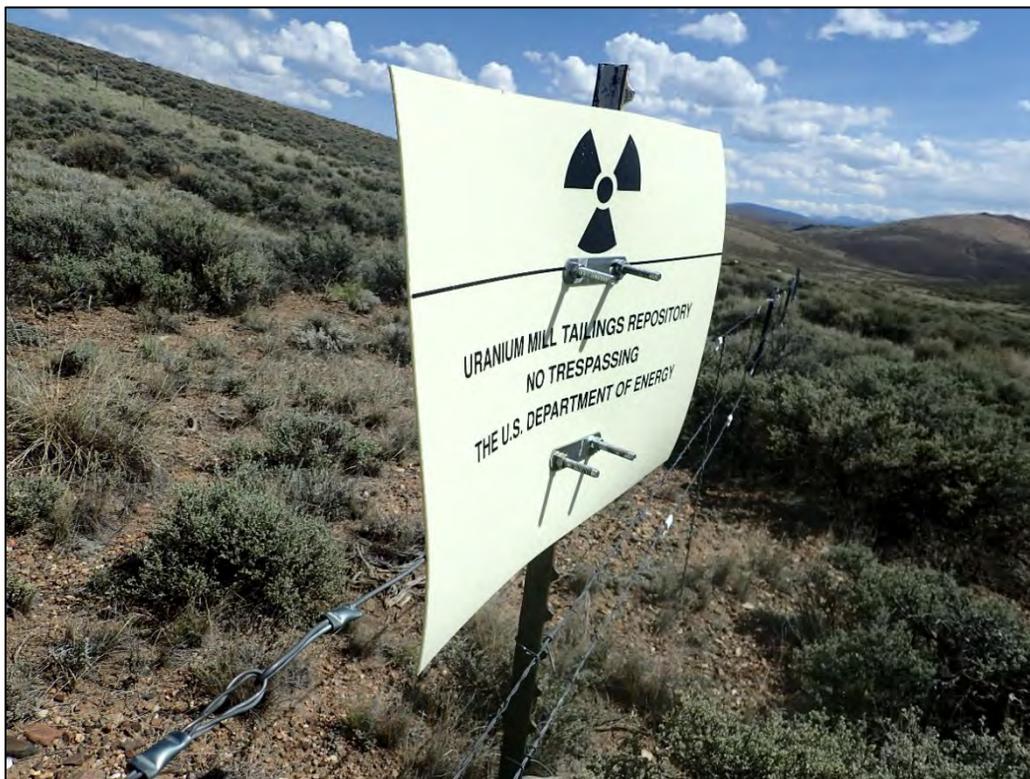
There are 45 perimeter signs bolted to the perimeter fence posts. Several perimeter signs have bullet damage but remain legible. In 2020, perimeter signs P4–P13 along the west perimeter fence were replaced. Perimeter signs P36, P37 (PL-4), P38, and P41 are constructed of plastic and are faded and curling. The plastic signs have been rescheduled for replacement with metal signs in 2021. All new signs will include the words “Gunnison Site.” Other perimeter signs that are damaged and showing wear will be replaced over the next 2 years. No other maintenance needs were identified.

PL-4. Perimeter Sign P37

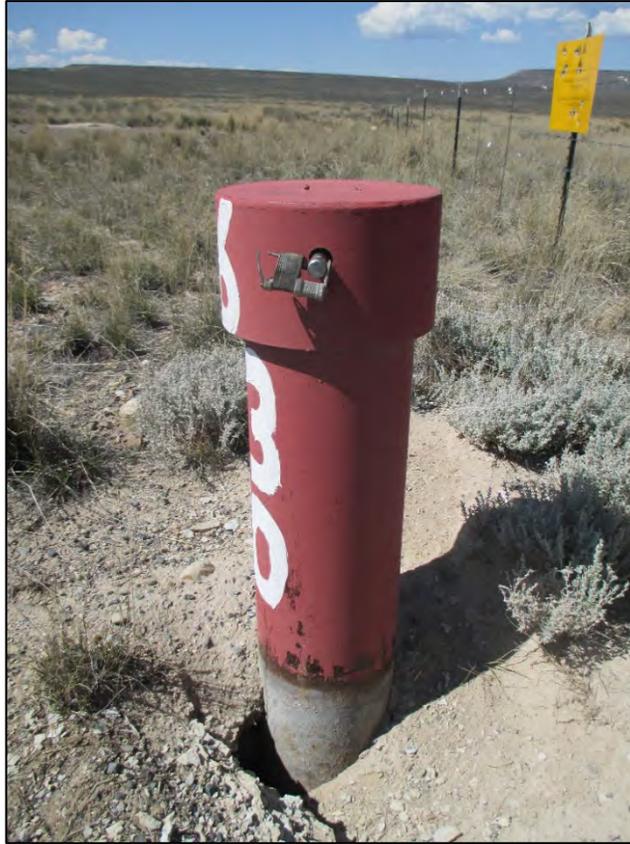
The site has 16 groundwater monitoring wells. The wellhead protectors were locked and properly labeled. Bullet damage is present on the locks of monitoring wells 0630 (PL-5) and 0712 and on the wellhead protector of monitoring well 0634. Both wells are secure, though new locks will be installed on both monitoring wells. Gunnison County landfill operators have placed concrete barriers to protect monitoring well 0716, which is on landfill property, from landfill activities. The edge of an adjacent spoil pile, although close to the concrete barriers, does not impair access to monitoring well 0716. The base of monitoring well 0709 is cracked but remains stable. Inspectors will continue to monitor these features. No maintenance needs were identified.

PL-5. Well 0630

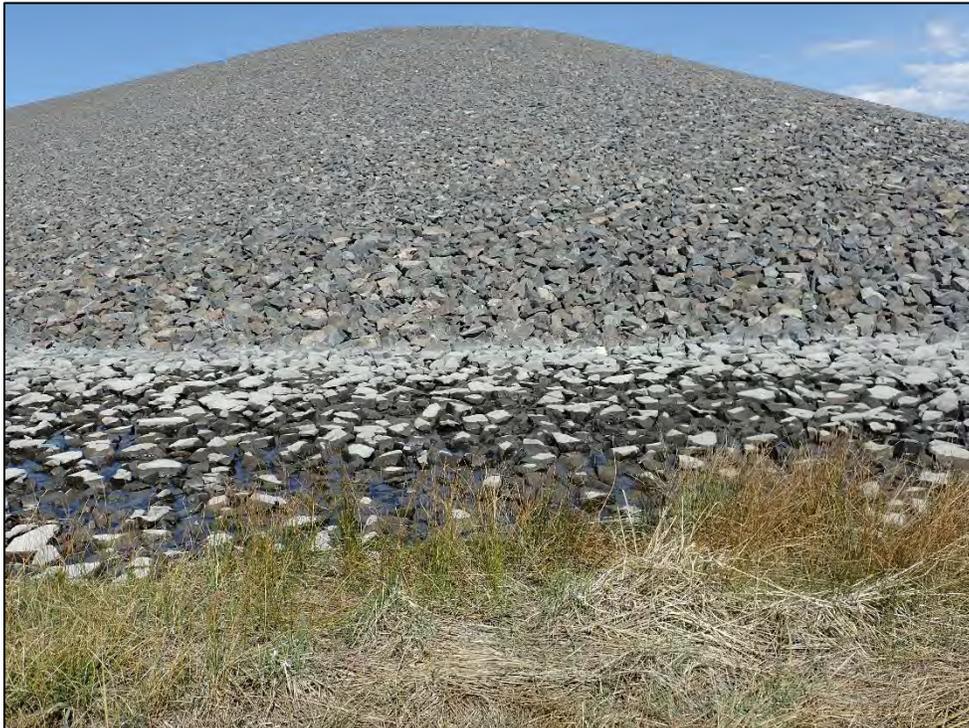
PL-6. Water in Cell Apron, Southeast Corner

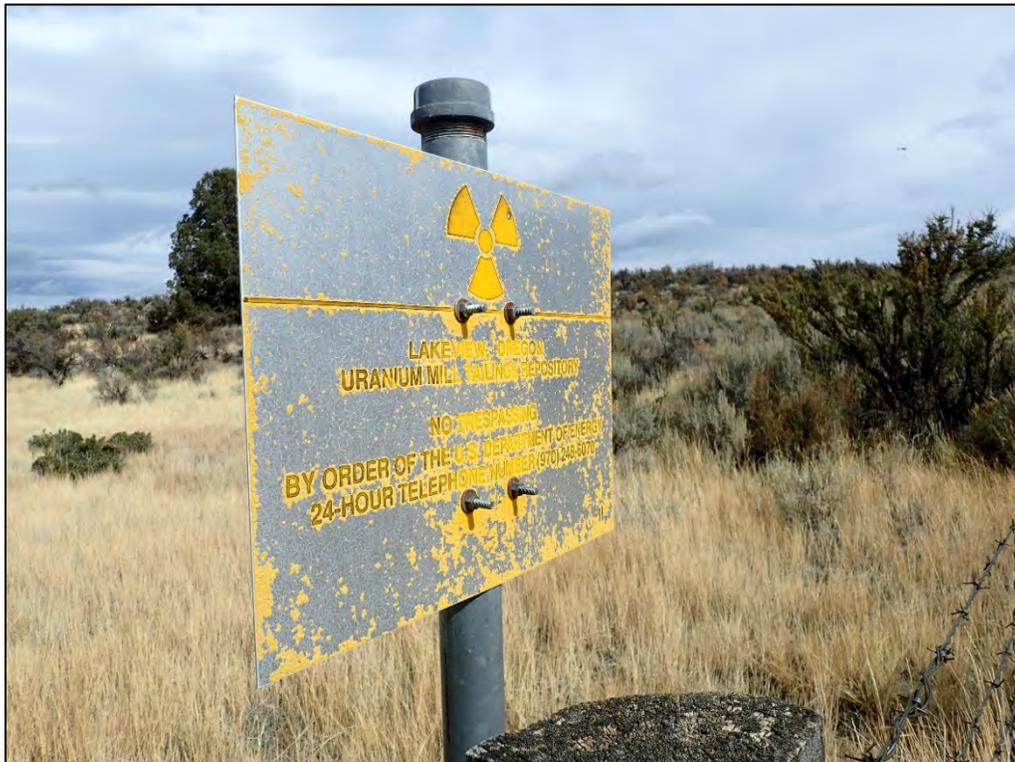
PL-2. Faded Perimeter Sign P11

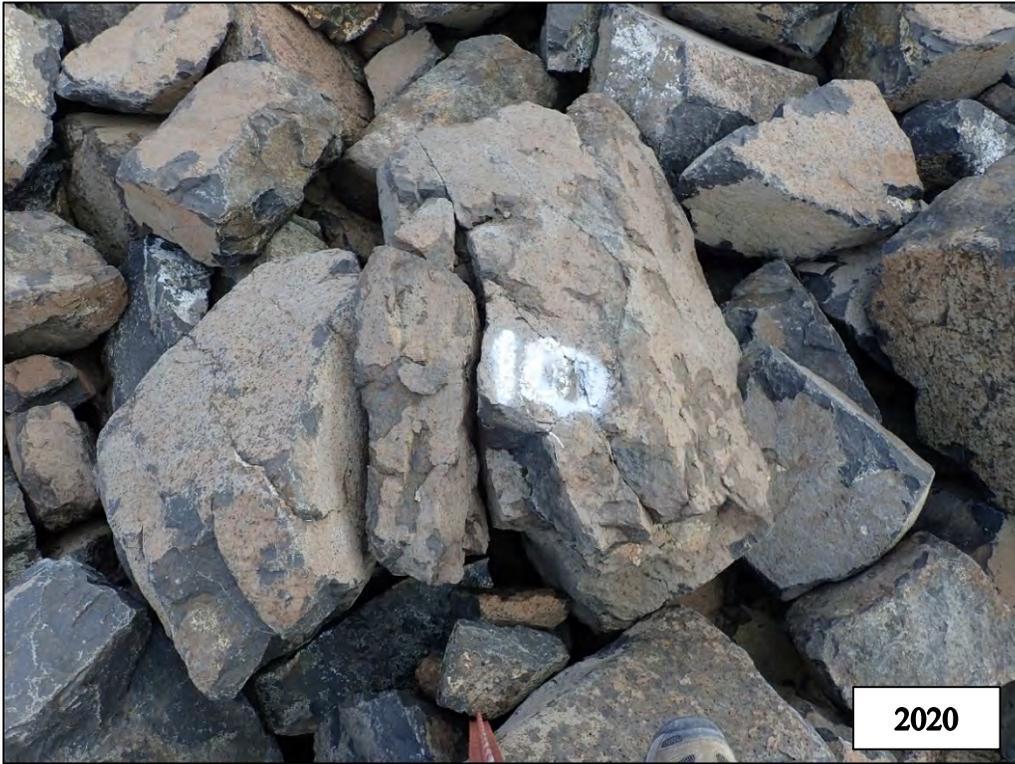
PL-9a. Riprap Monitoring Location Number 10 in Energy Dissipation Area–2020

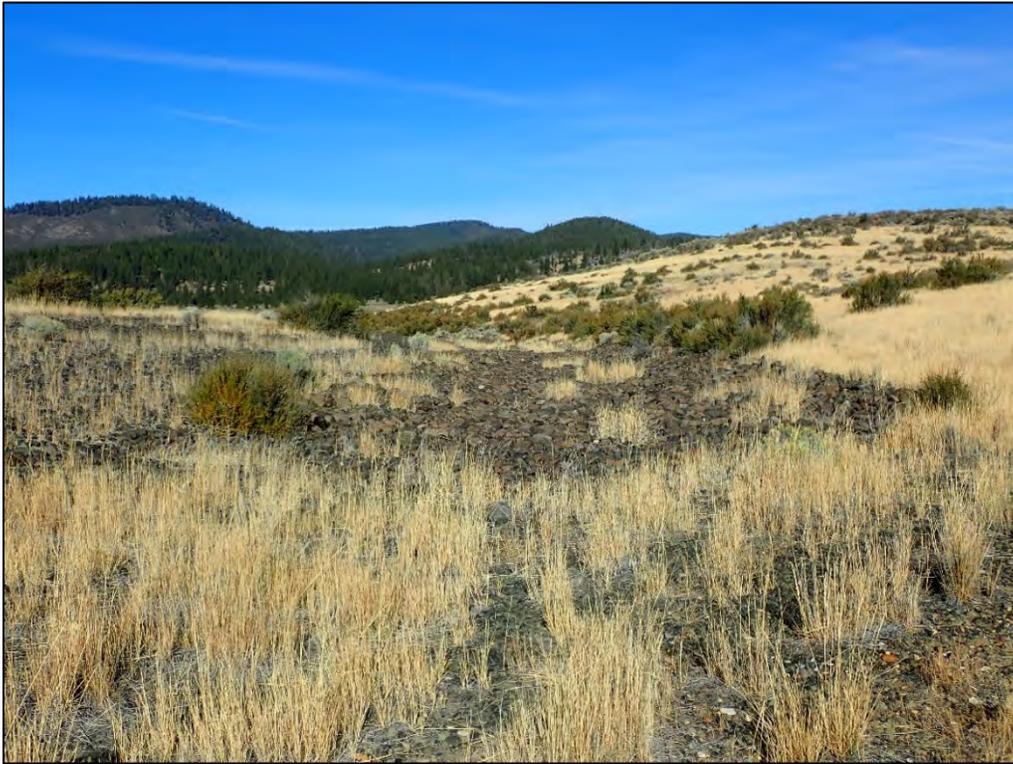
PL-10. Drainage Channel with Encroaching Vegetation

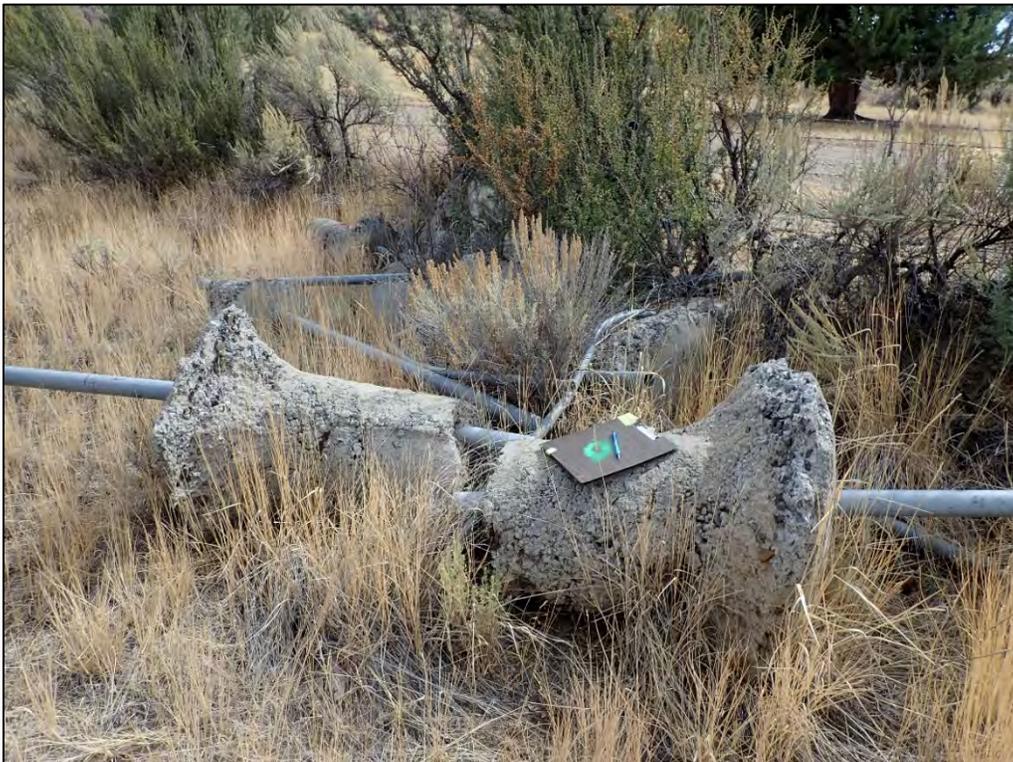
PL-11. Old Fence Posts with Concrete Bases

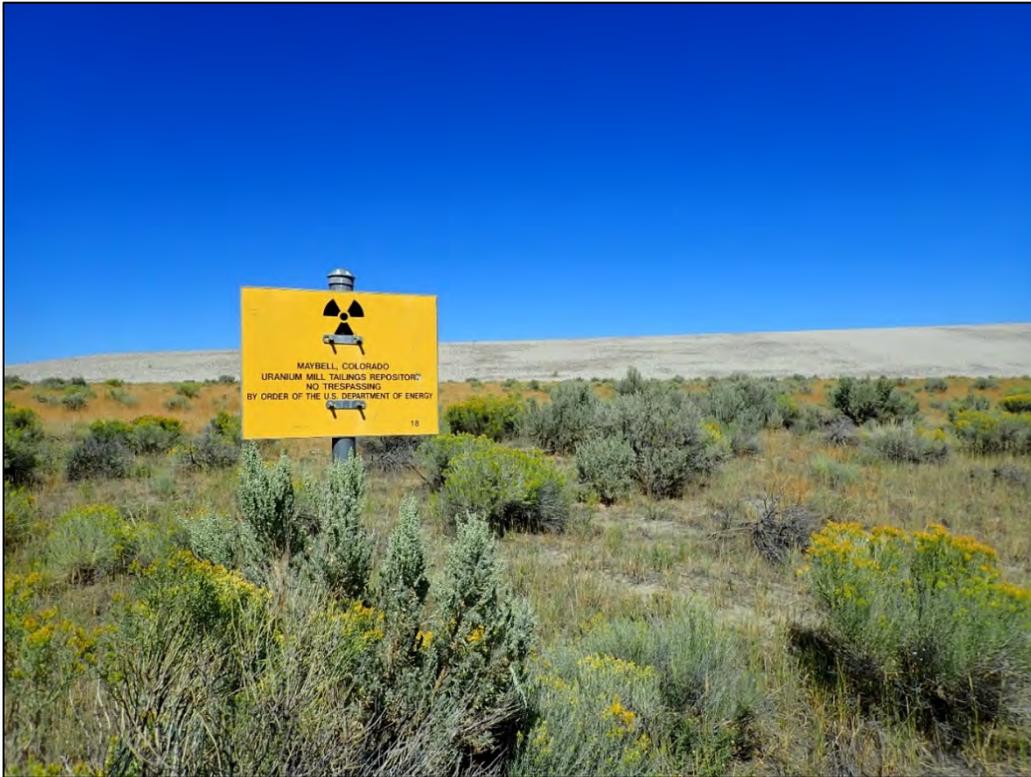
PL-3. Perimeter Sign P18

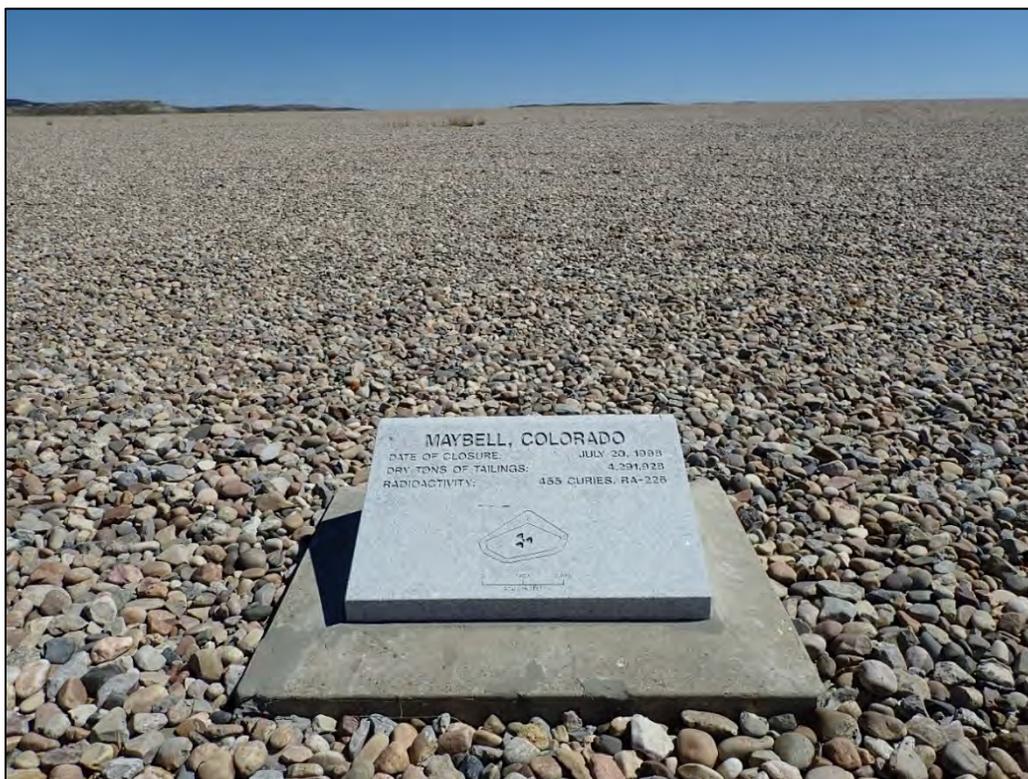
PL-5. Site Marker SMK-2

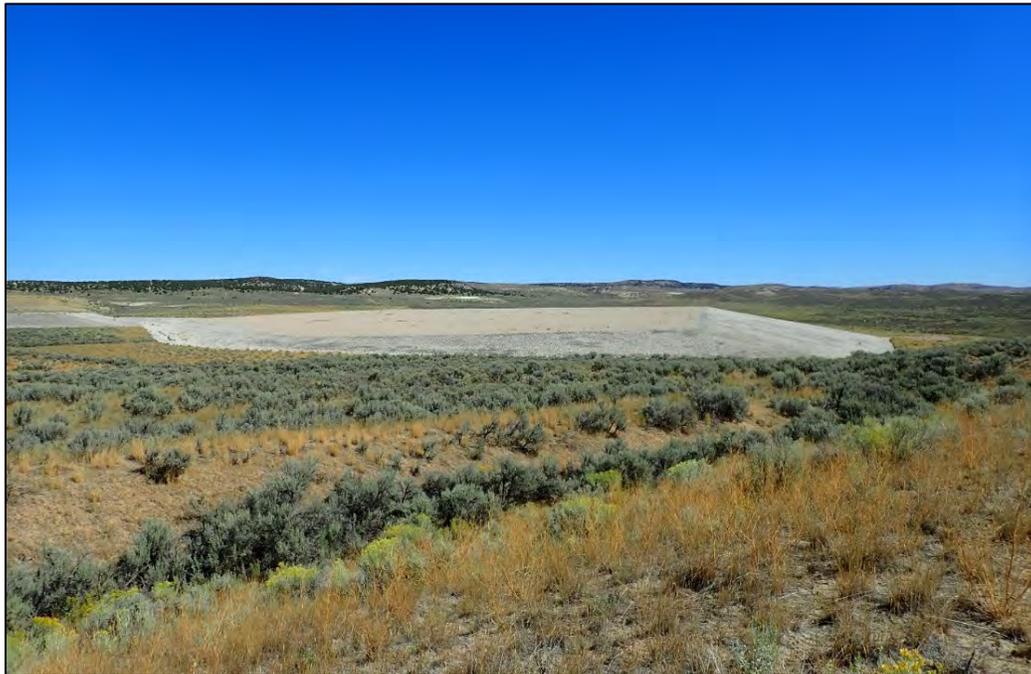
The disposal cell, completed in 1998, occupies 66 acres. The disposal cell is armored with riprap to control erosion and deter animal and human intrusion (PL-8). There was no evidence of erosion, settling, slumping, rock degradation, or other modifying processes that might affect the integrity of the disposal cell. Scattered shallow-rooted plants continue to establish on the disposal cell top and side slopes (PL-9); these plants do not affect the integrity of the cell. Deep-rooted plants and noxious weeds are controlled as required by the LTSP.

PL-8. Disposal Cell

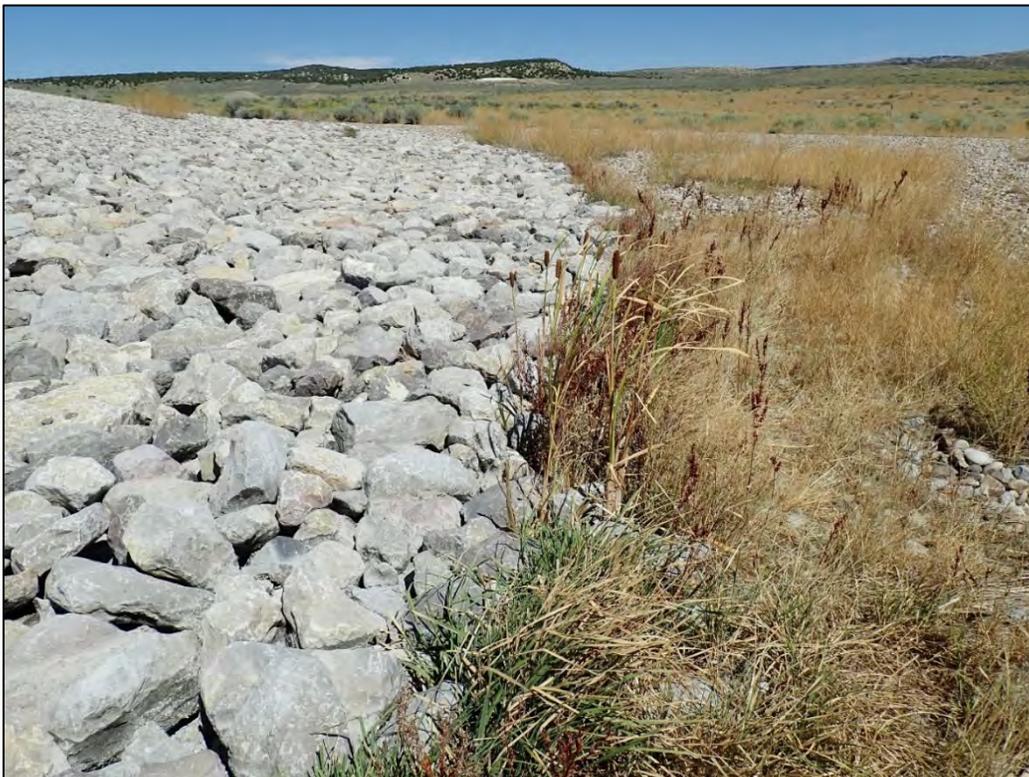
PL-10. Cattails Adjacent to Disposal Cell Toe Slope and Apron

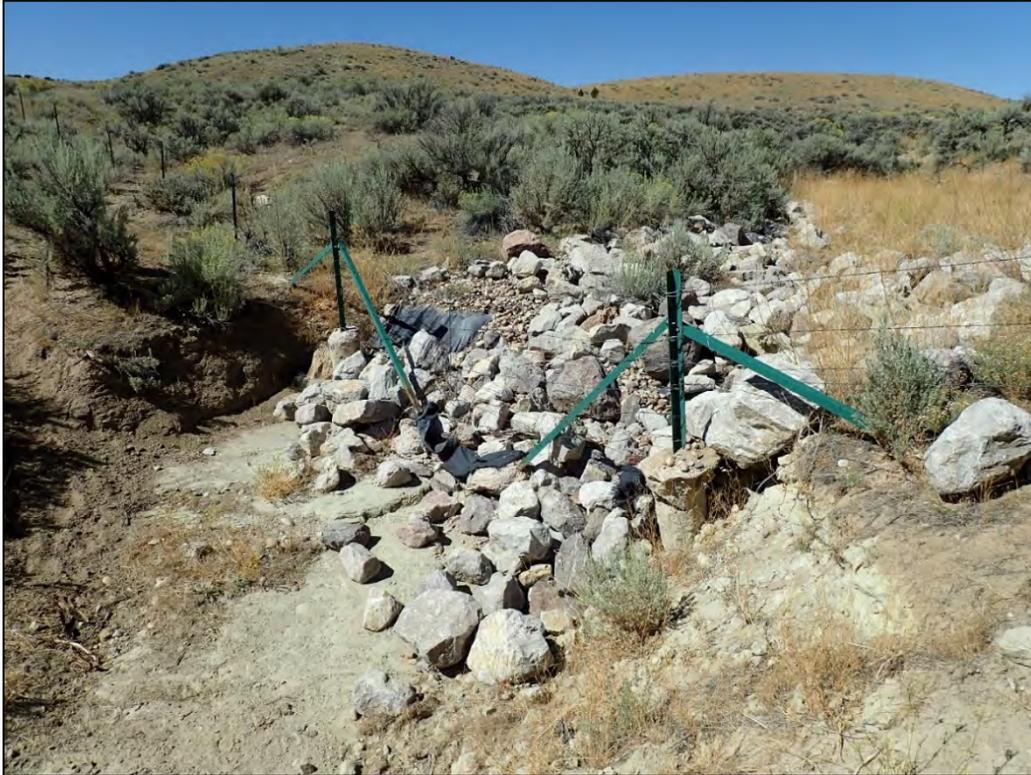
PL-13. Perimeter Fence near Outlet to Diversion Channel No.1

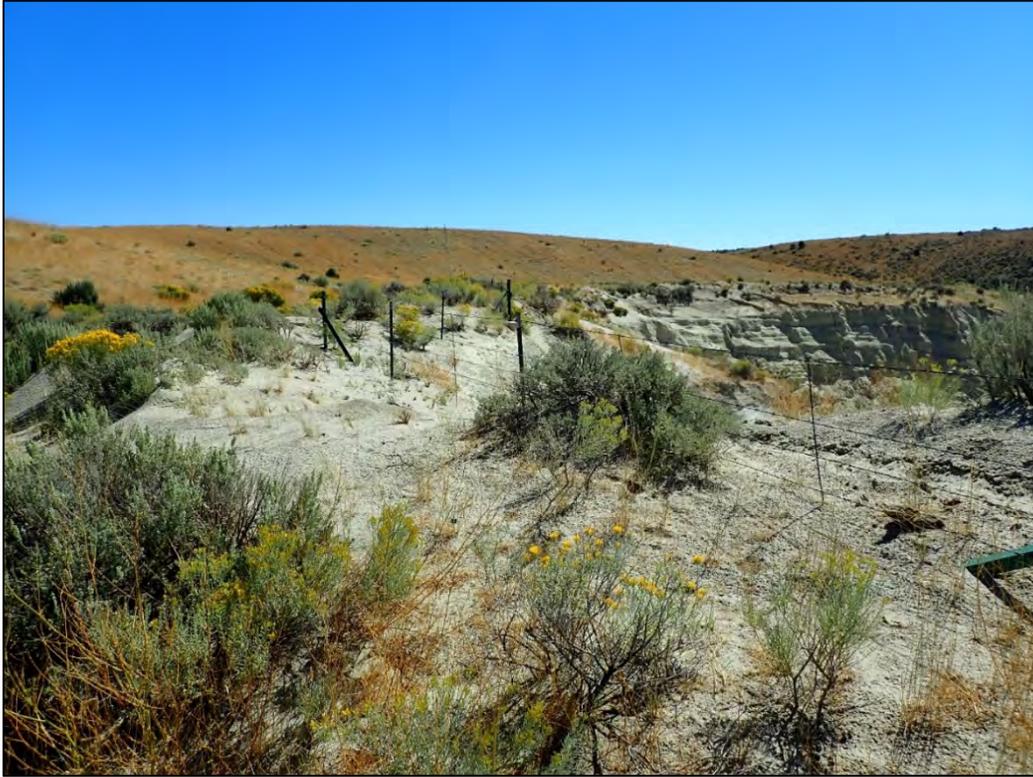
PL-15. Sand Accumulation Around Perimeter Fence near Johnson Pit
