U.S. DEPARTMENT OF
ENERGY

Legacy
Management

2020 Annual Site Inspection and Monitoring Report for Uranium Mill Tailings Radiation Control Act Title I Disposal Sites

March 2021

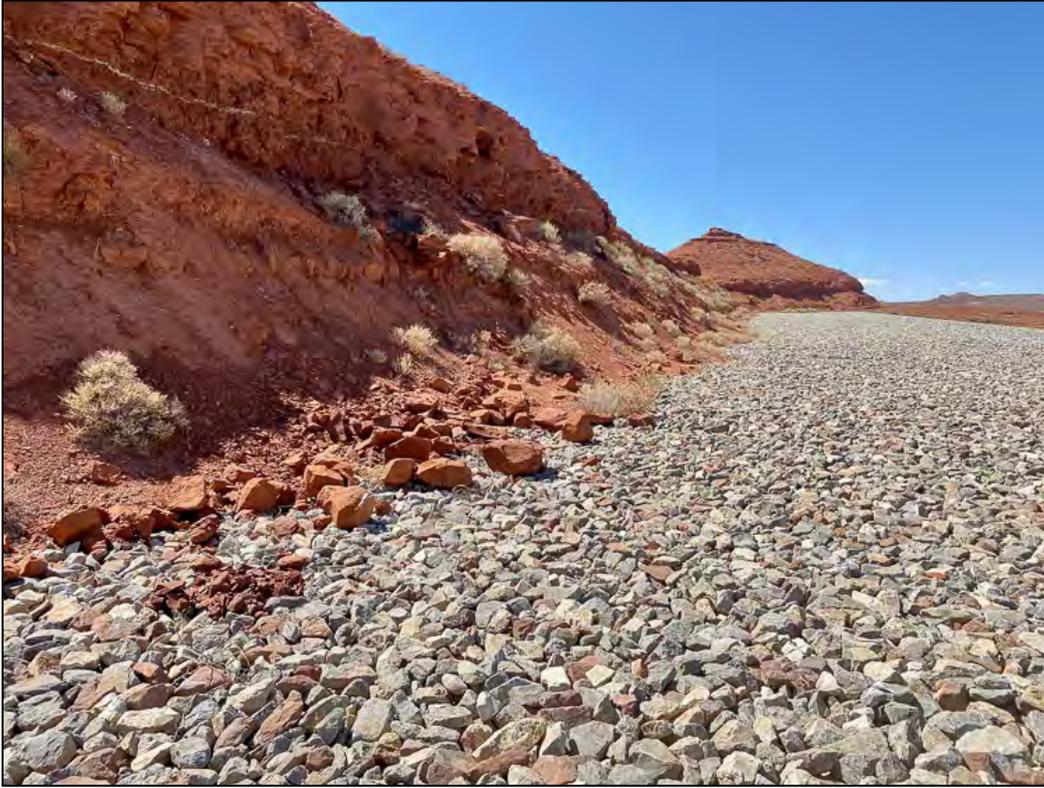
PL-9. Sloughed Rock Area on South Apron

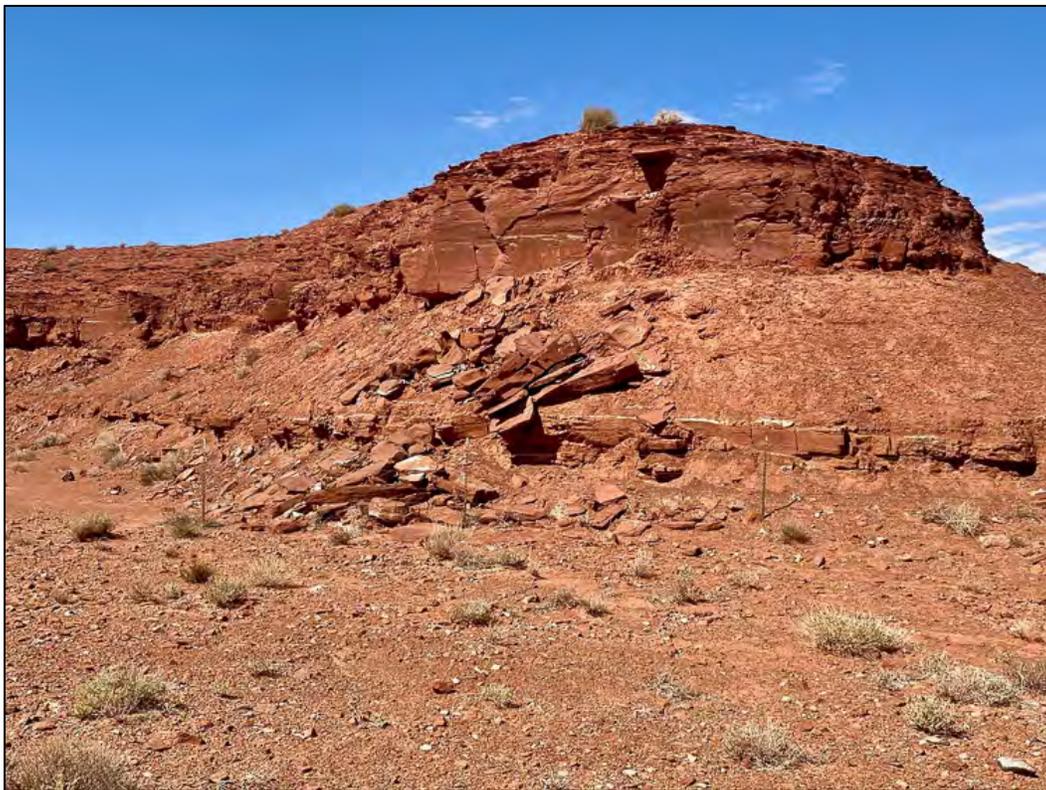
PL-12. Sloughed Rock Approaching Fence

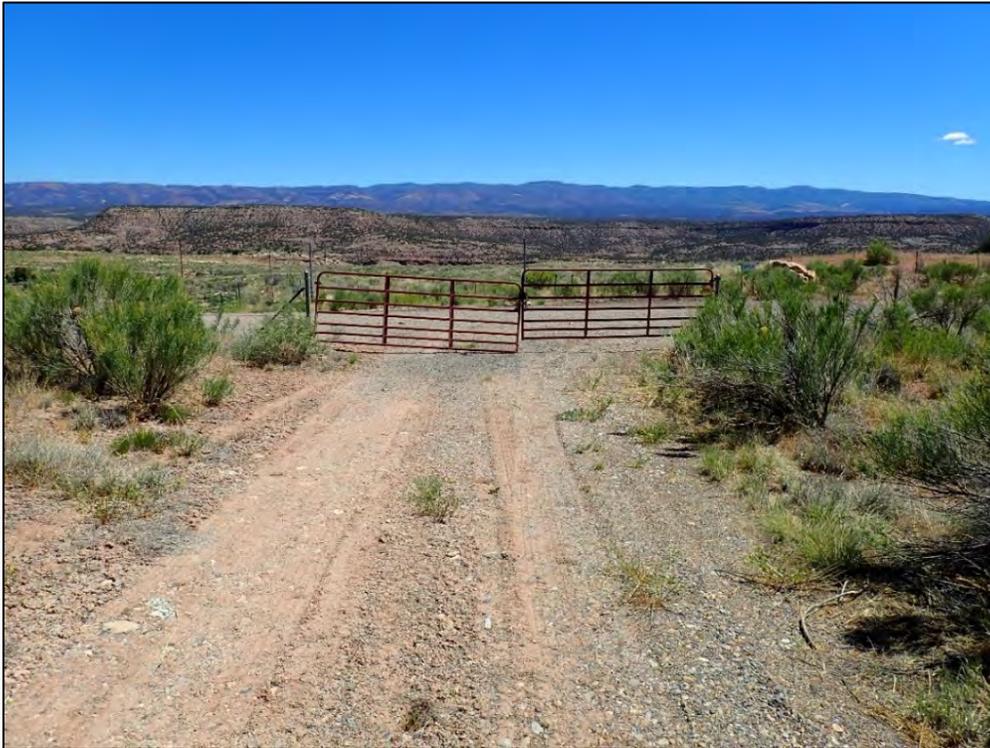
PL-1. Site Entrance Gate with Detached Hinge

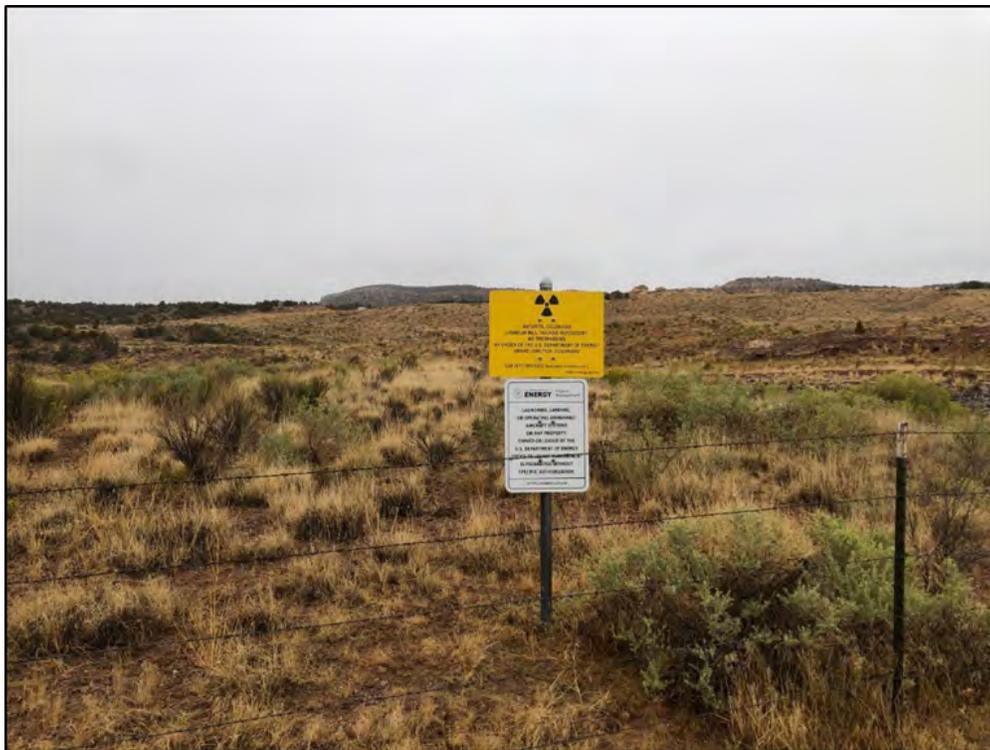
PL-2. New Entrance Sign with Unmanned Aircraft System Sign

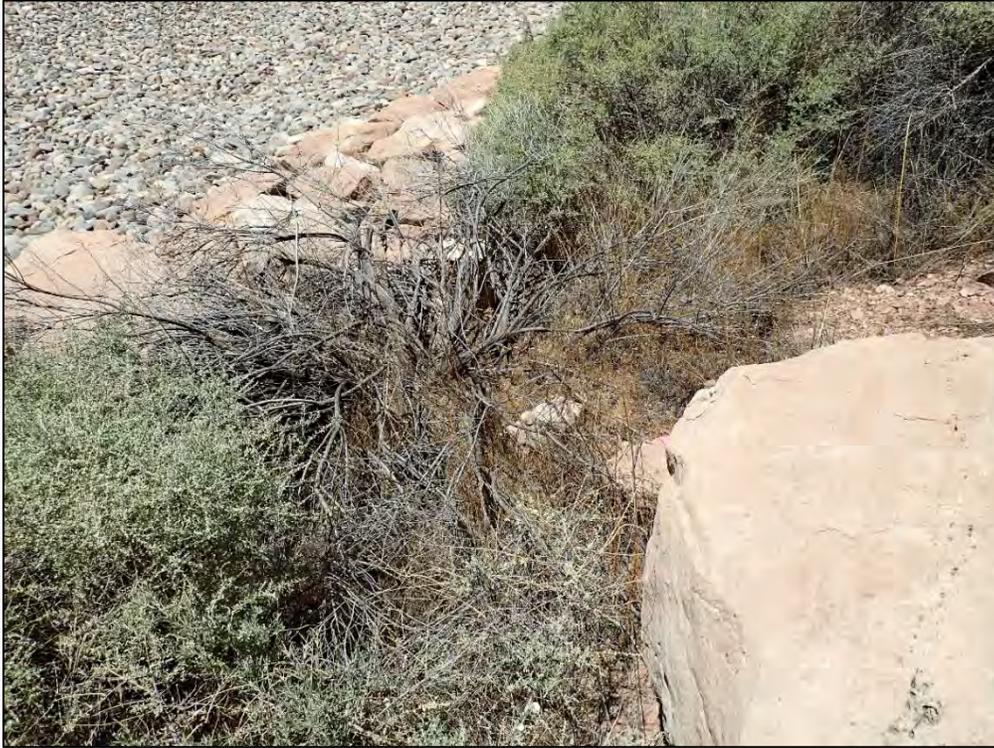
PL-6. Overgrown Vegetation Around Well CM93-1

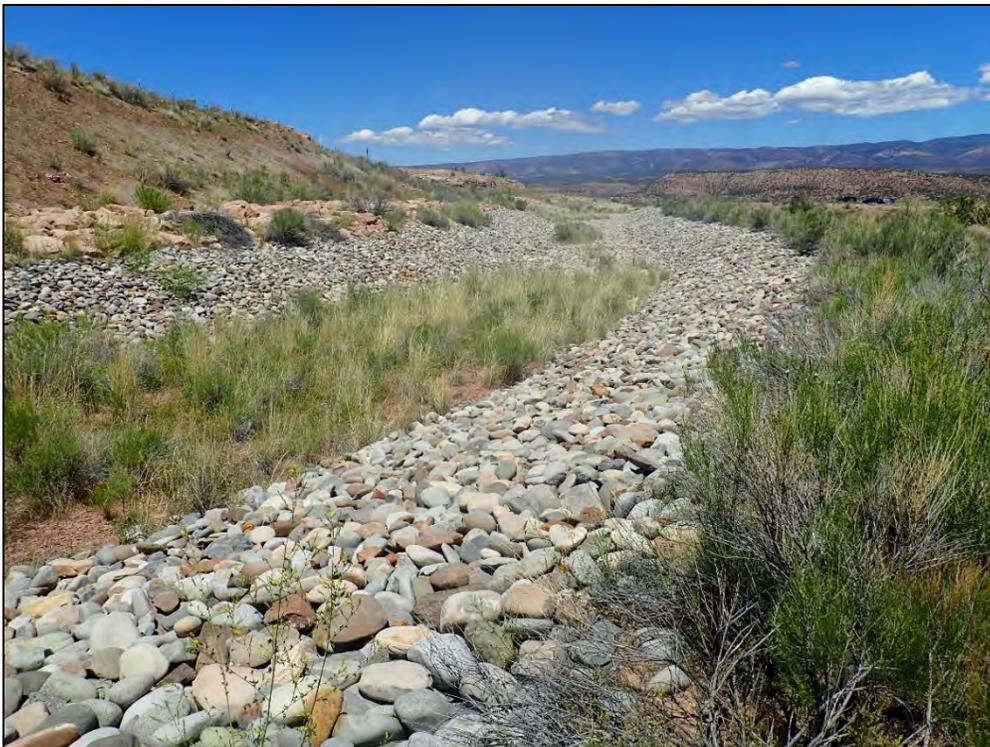
PL-9. Spillway Above Interceptor Channel

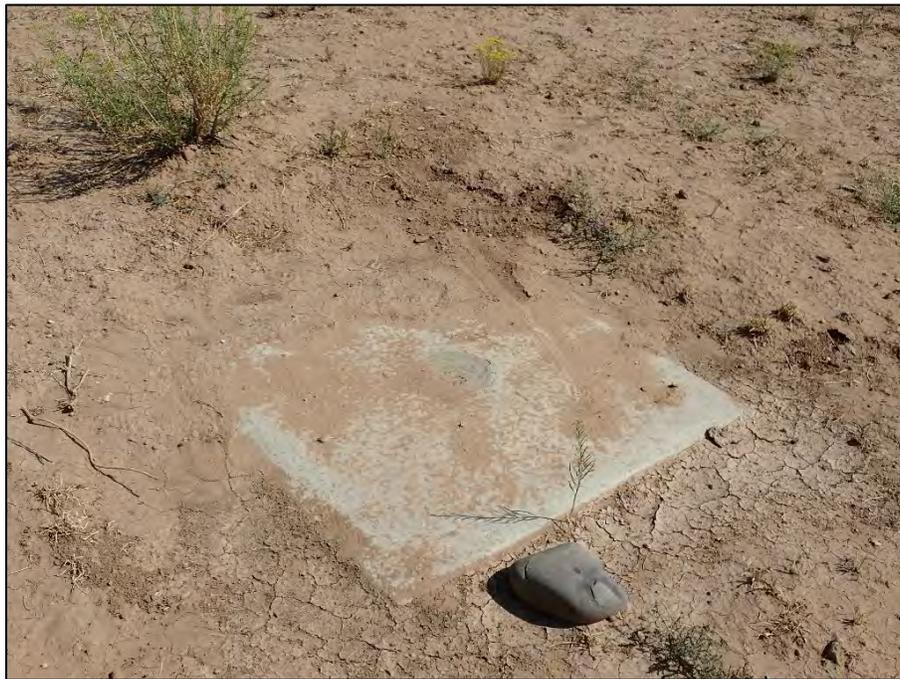
Nine aerial survey quality control monuments installed in 2019 were inspected during the 2020 annual inspection. Inspectors noted sediment accumulation on quality control monument QC8 and vegetation growth around quality control monument QC9, obstructing their visibility (PL-4 and PL-5). T-posts will be installed to help locate the quality control monuments. No other maintenance needs were identified.

PL-4. Quality Control Monument QC8 Covered with Sediment

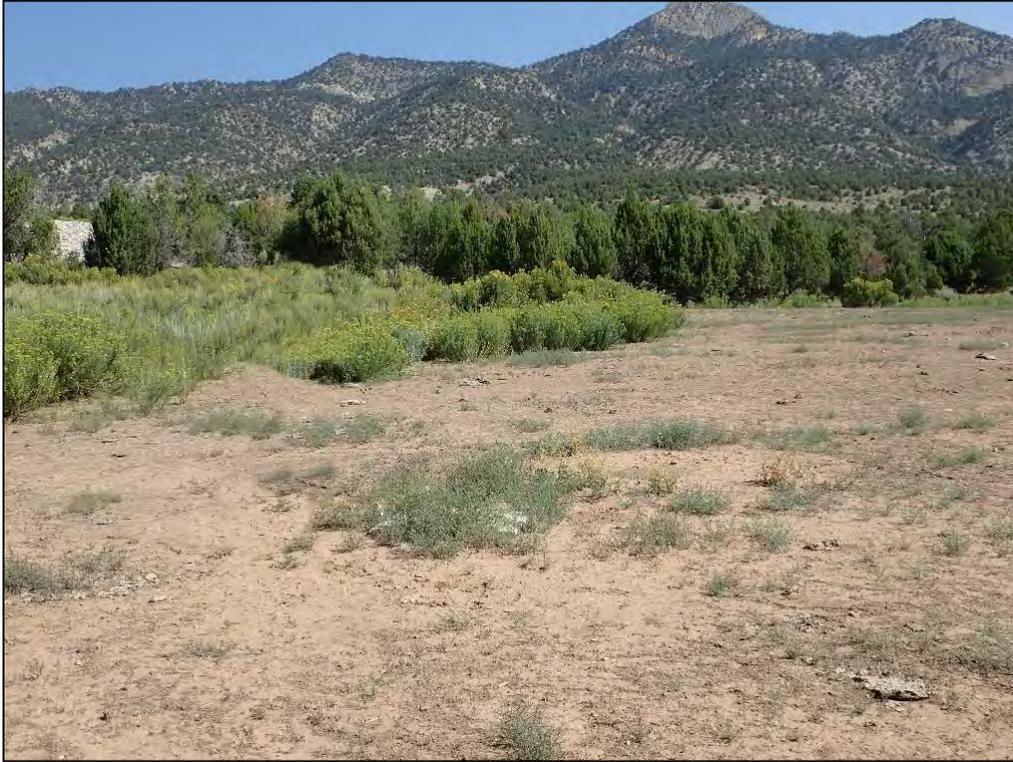
PL-5. Quality Control Monument QC9 Obscured by Vegetation

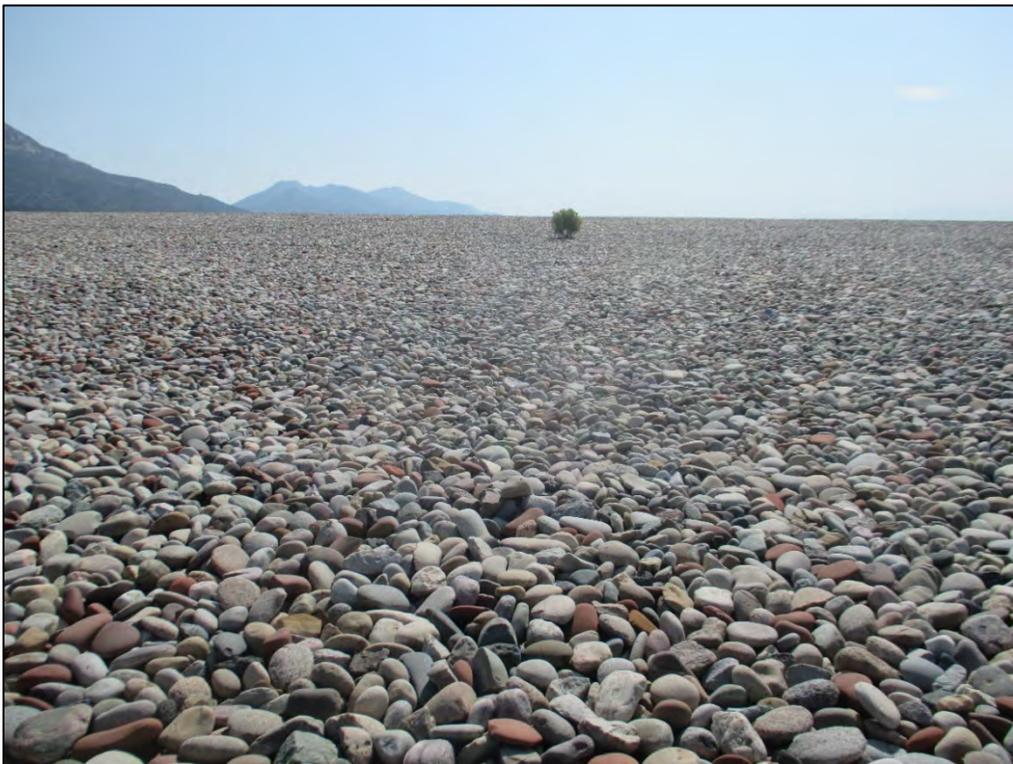
PL-6. Deep-Rooted Woody Plant—Rabbitbrush—on Cell Cover

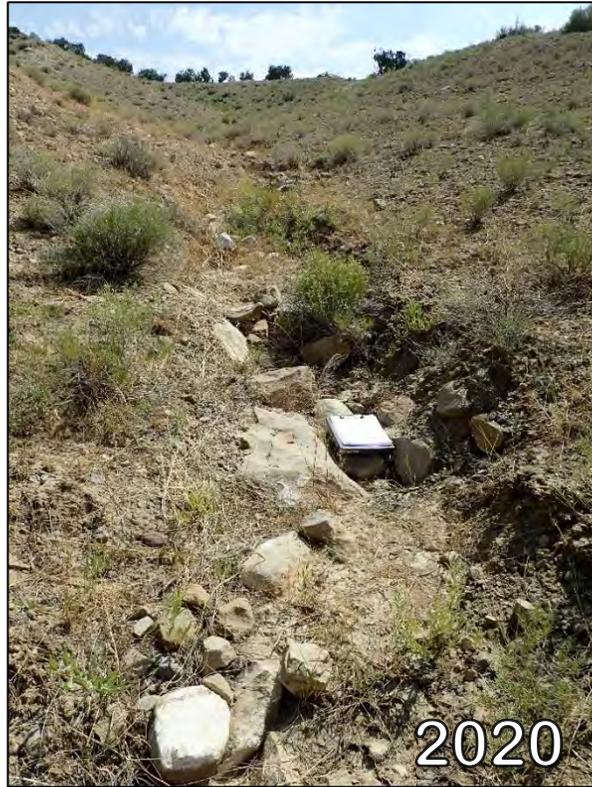
PL-7a. Minor Gully Erosion at Interceptor Trench in 2020

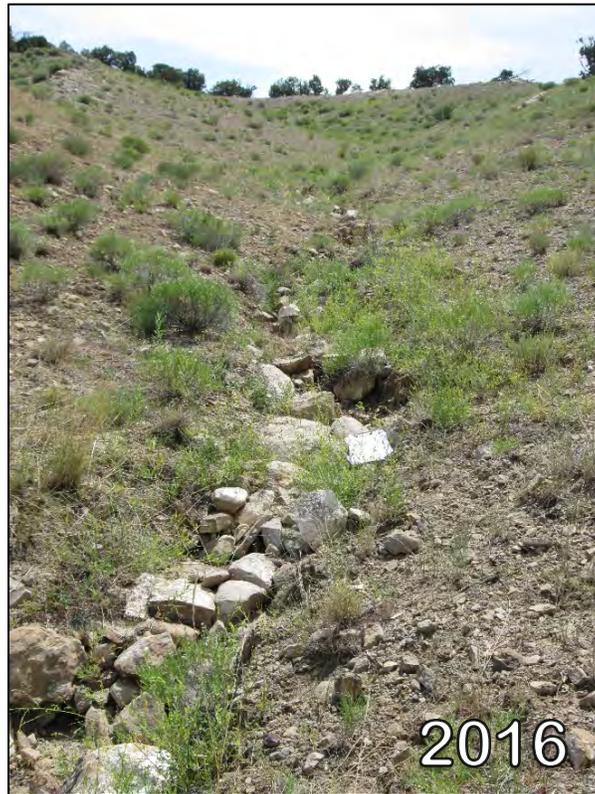
PL-7b. Minor Gully Erosion at Interceptor Trench in 2016

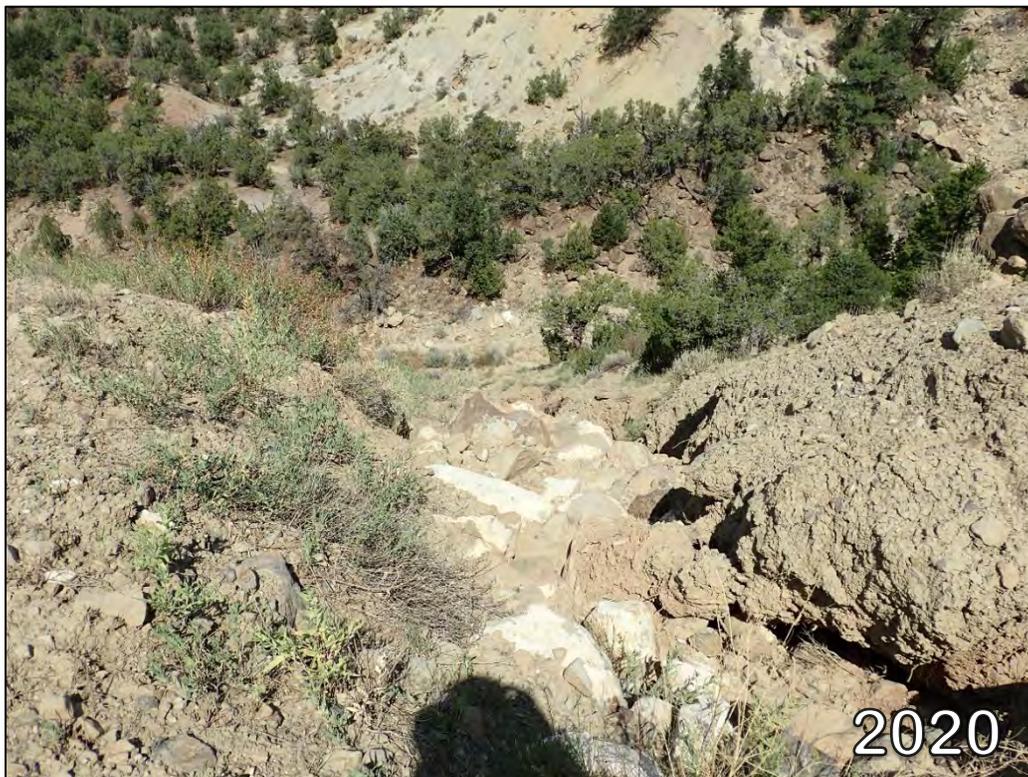
PL-8a. Major Gully Erosion in Interceptor Trench Outfall in 2020

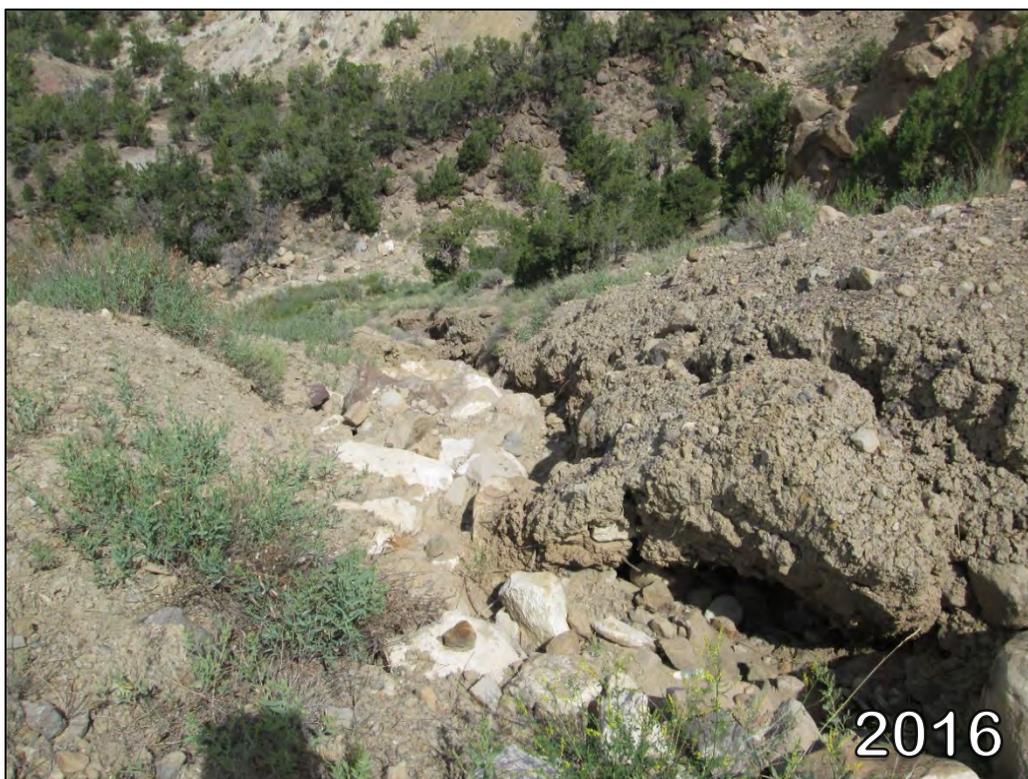
PL-8b. Major Gully Erosion in Interceptor Trench Outfall in 2016

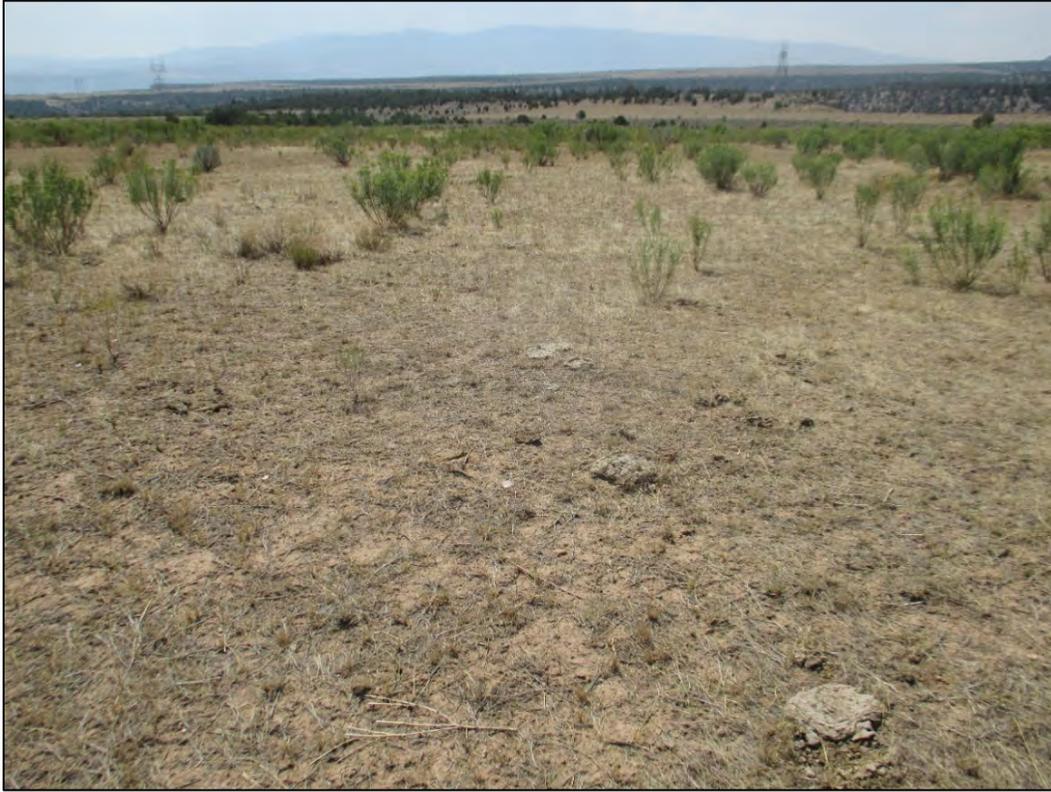
PL-9. Heavily Grazed Vegetation

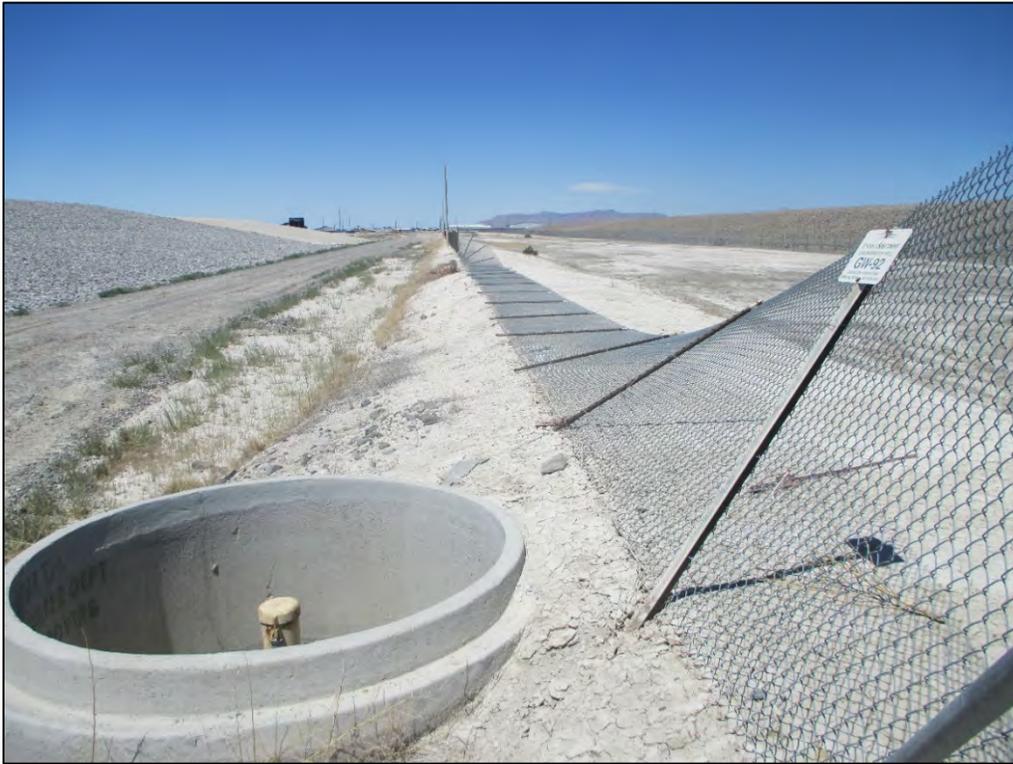
PL-1. EnergySolutions Fence Down

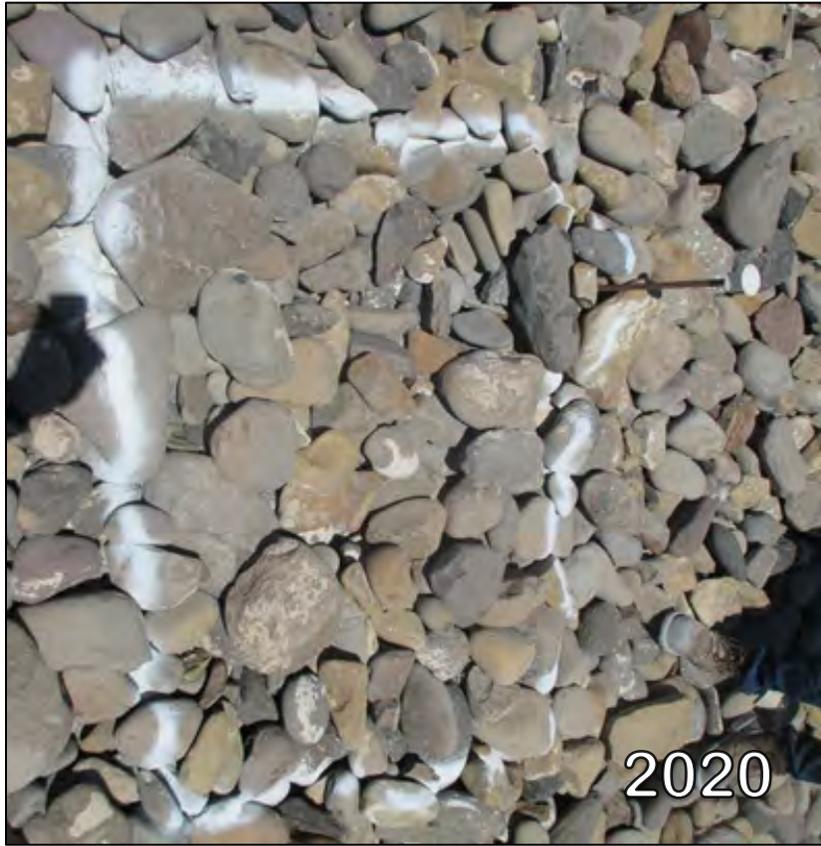
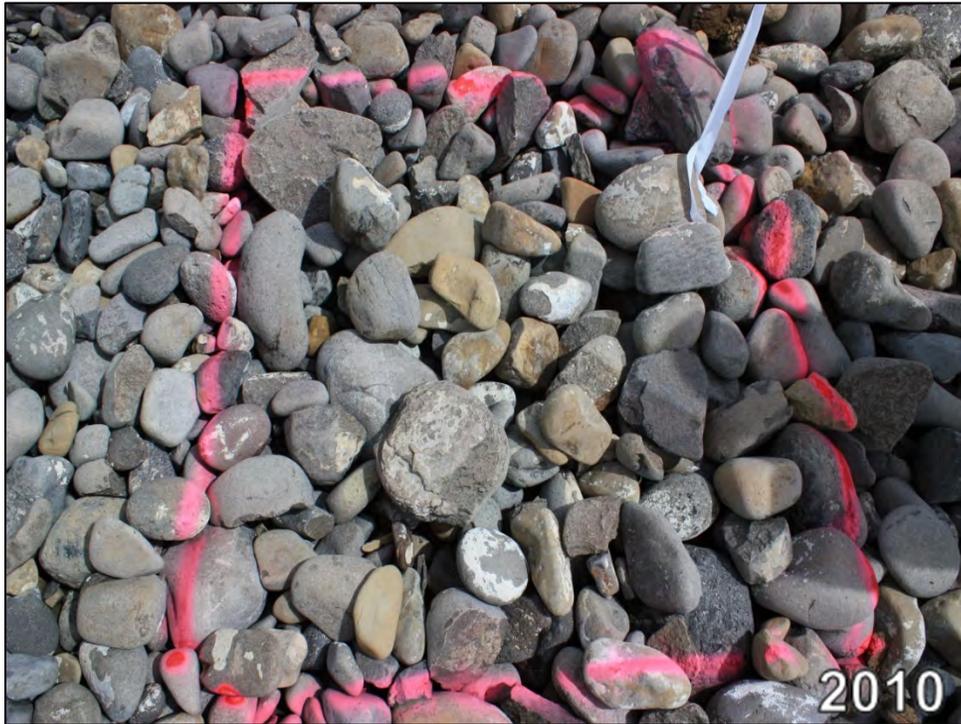
One of several types of rock used for the disposal cell erosion-protection riprap layer has exhibited minor degradation since the disposal cell was constructed. As a result, eight rock-quality monitoring plots, each measuring 1 square meter (indicated by Roman numerals I–VIII in Figure 15-1), were established in 2010 to monitor for continued rock degradation.

PL-7. (a) Rock Quality Plot No. 1—2020

PL-7. (b) Rock Quality Plot No. 1—2010 Photo for Comparison

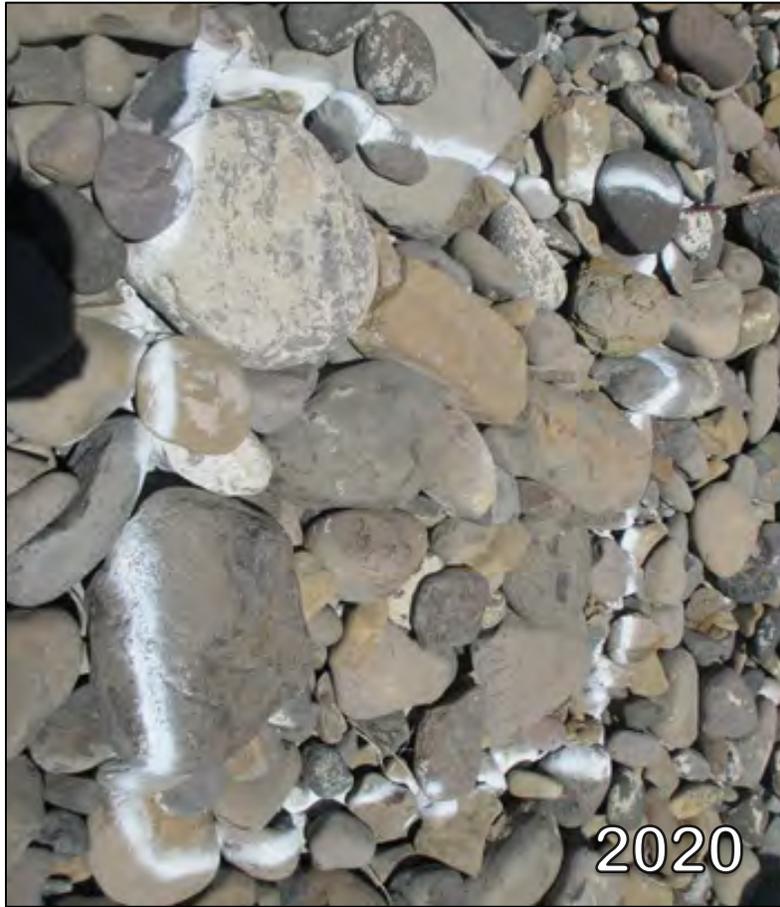
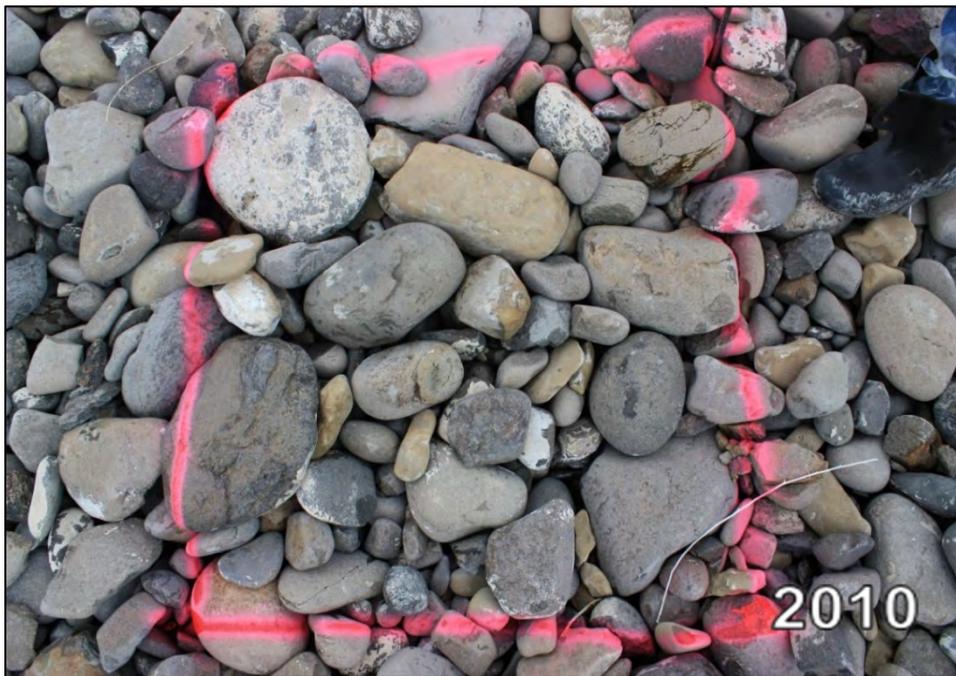
PL-8. (a) Rock Quality Plot No. II—2020

PL-8. (b) Rock Quality Plot No. II—2010 Photo for Comparison

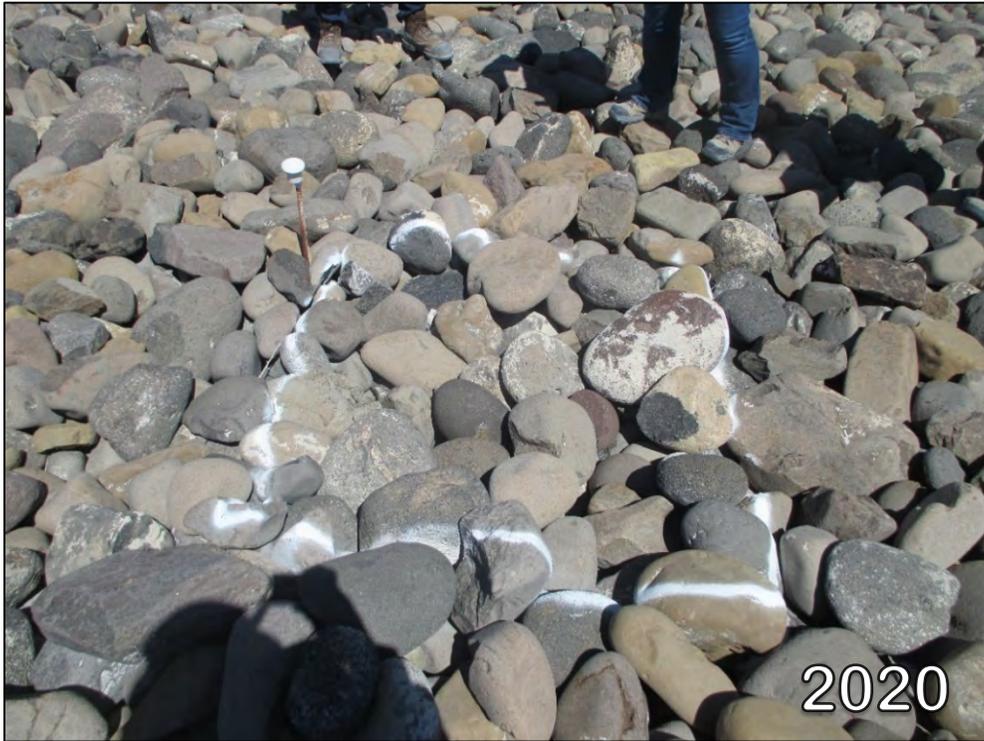
PL-9. (a) Rock Quality Plot No. III—2020

PL-9. (b) Rock Quality Plot No. III—2010 Photo for Comparison

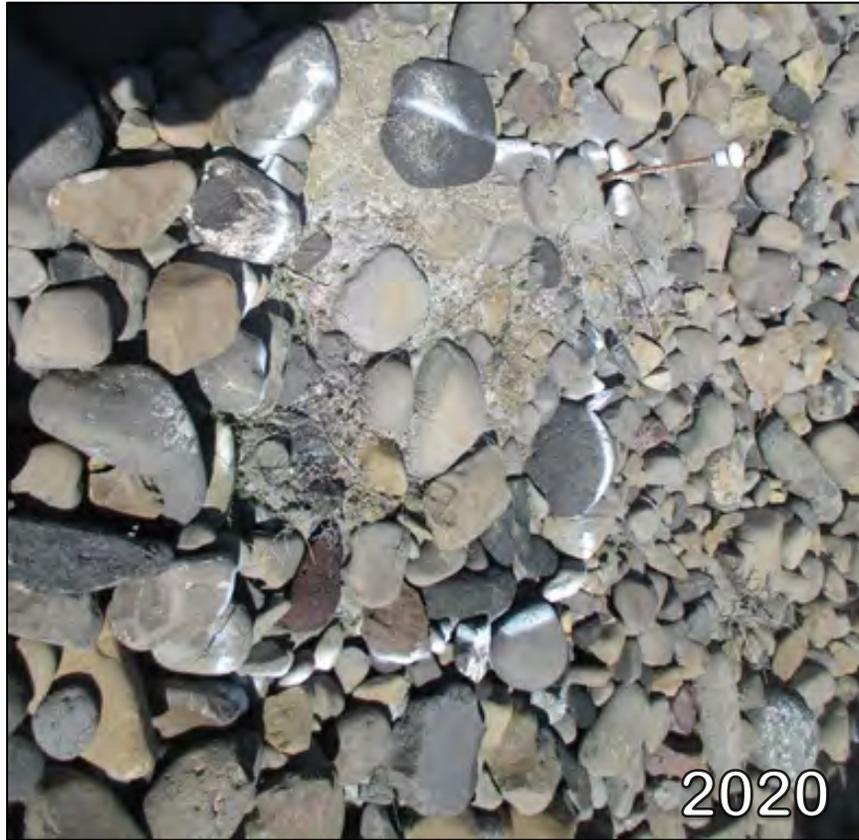
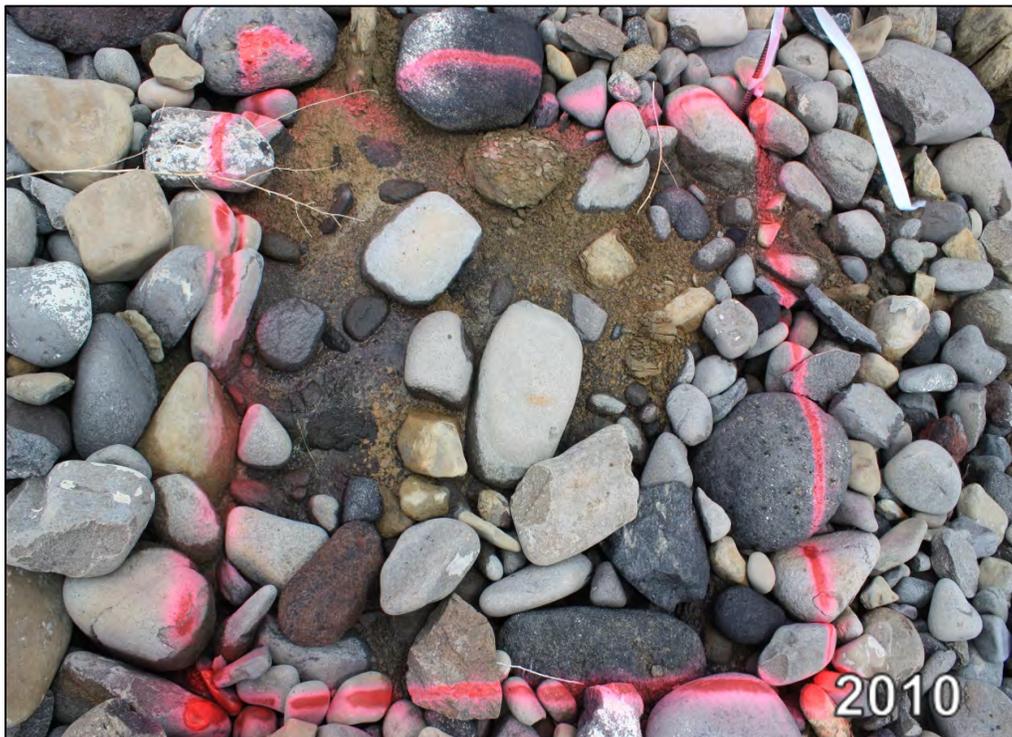
PL-10. (a) Rock Quality Plot No. IV—2020

PL-10. (b) Rock Quality Plot No. IV—2010 Photo for Comparison

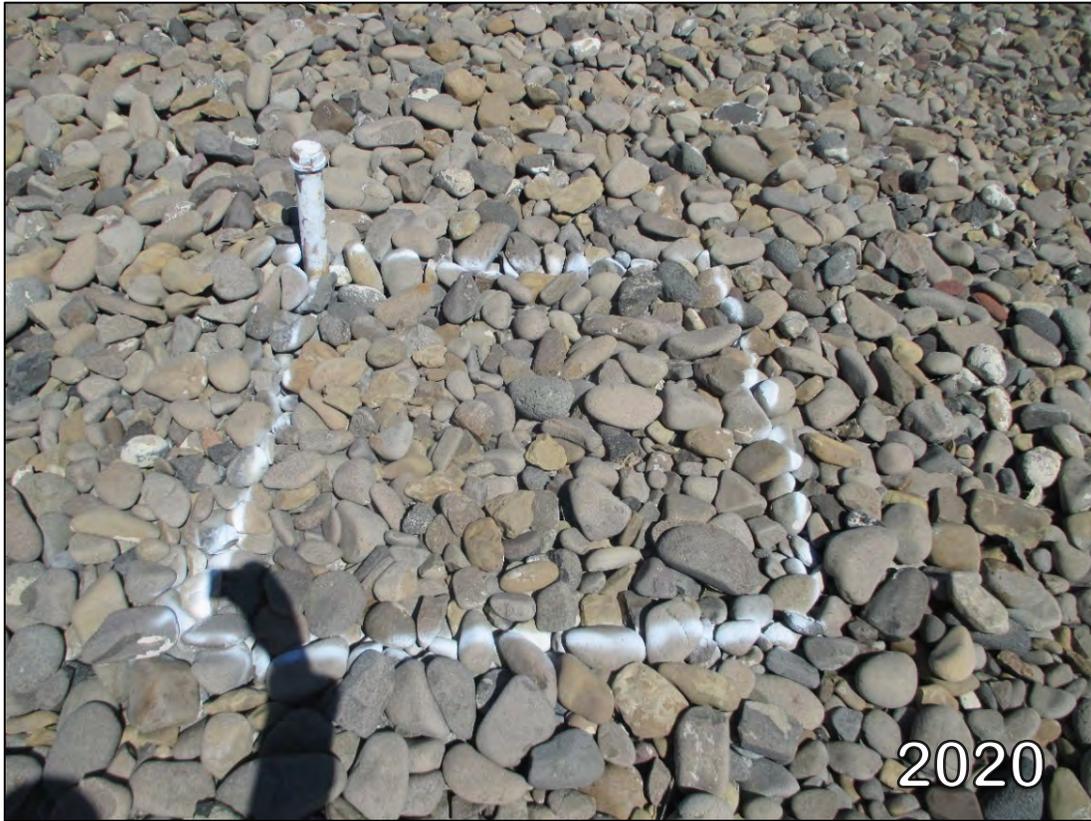
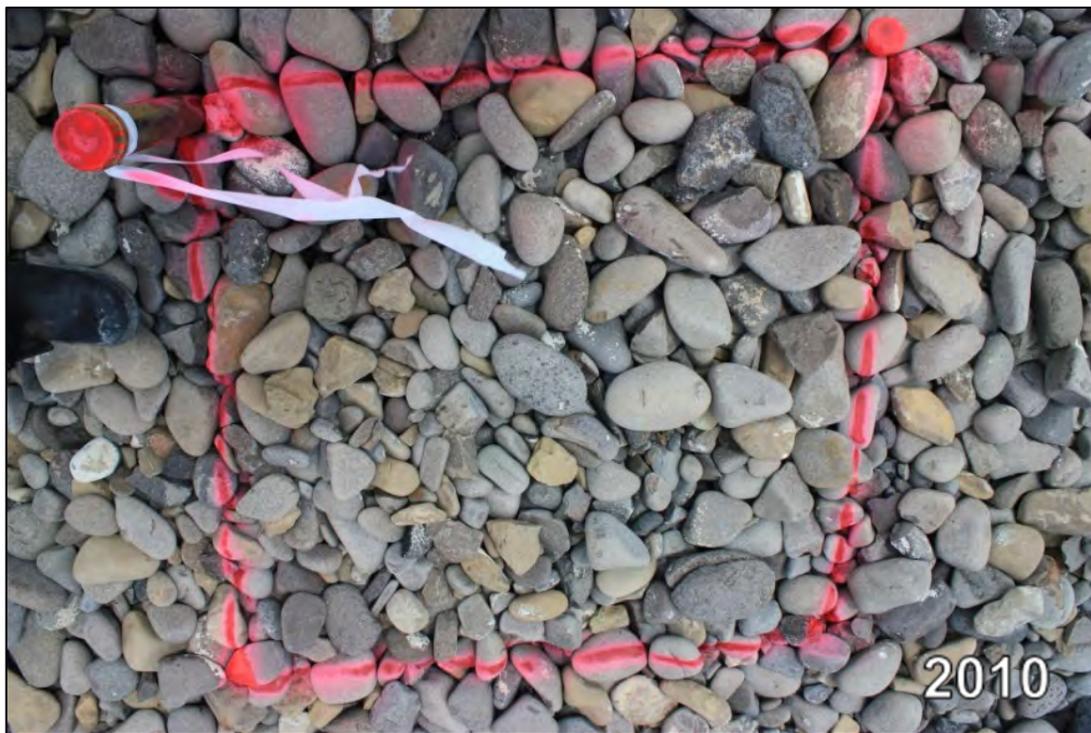
PL-11. (a) Rock Quality Plot No. VII—2020

PL-11. (b) Rock Quality Plot No. VII—2010 Photo for Comparison

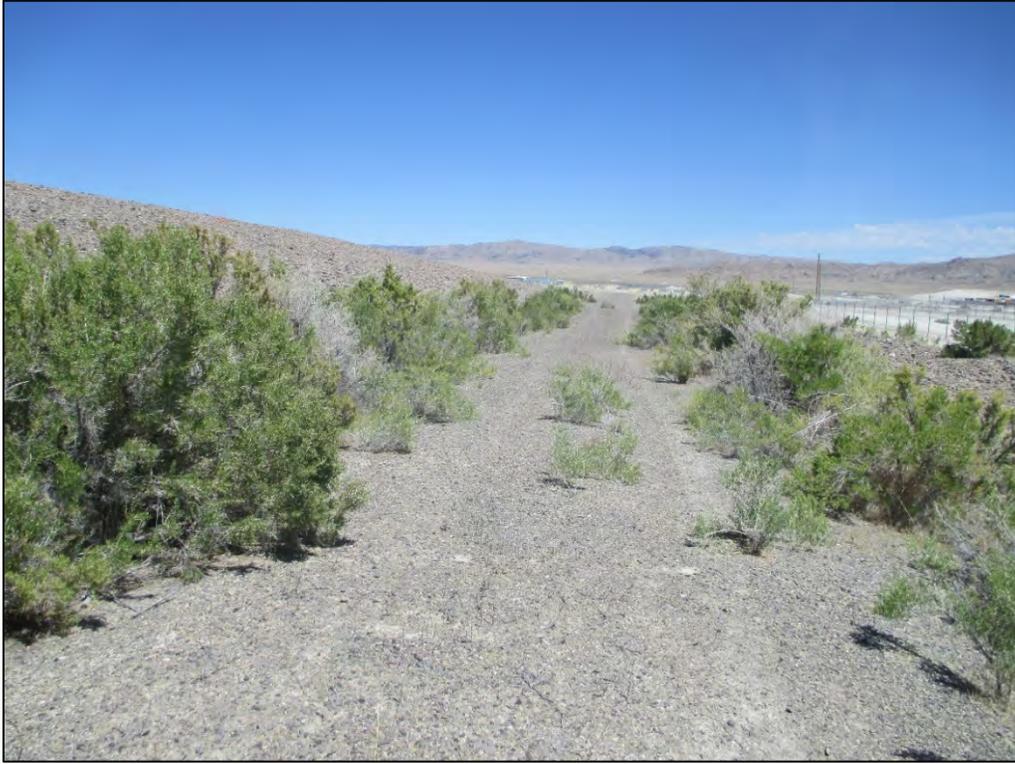
PL-12. Vegetation on Cell Perimeter Road

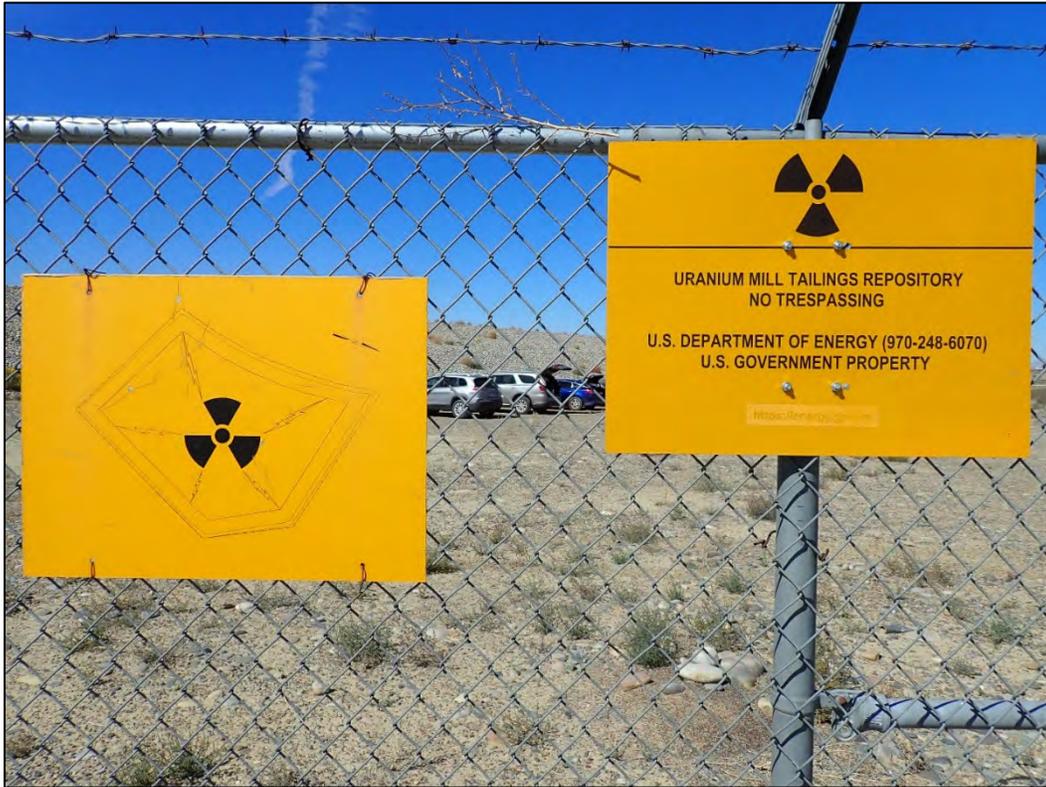
PL-1. Pictorial Sign and Perimeter Sign P2 with Faded Information

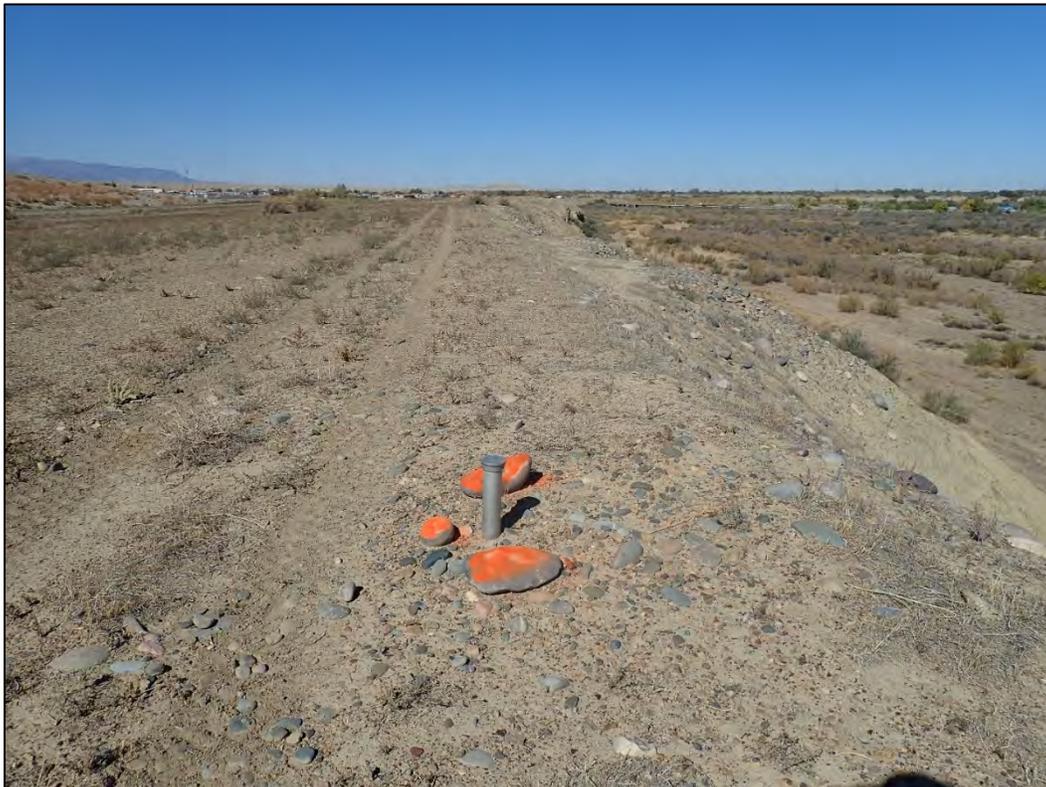
PL-4. Erosion Control Marker E-2

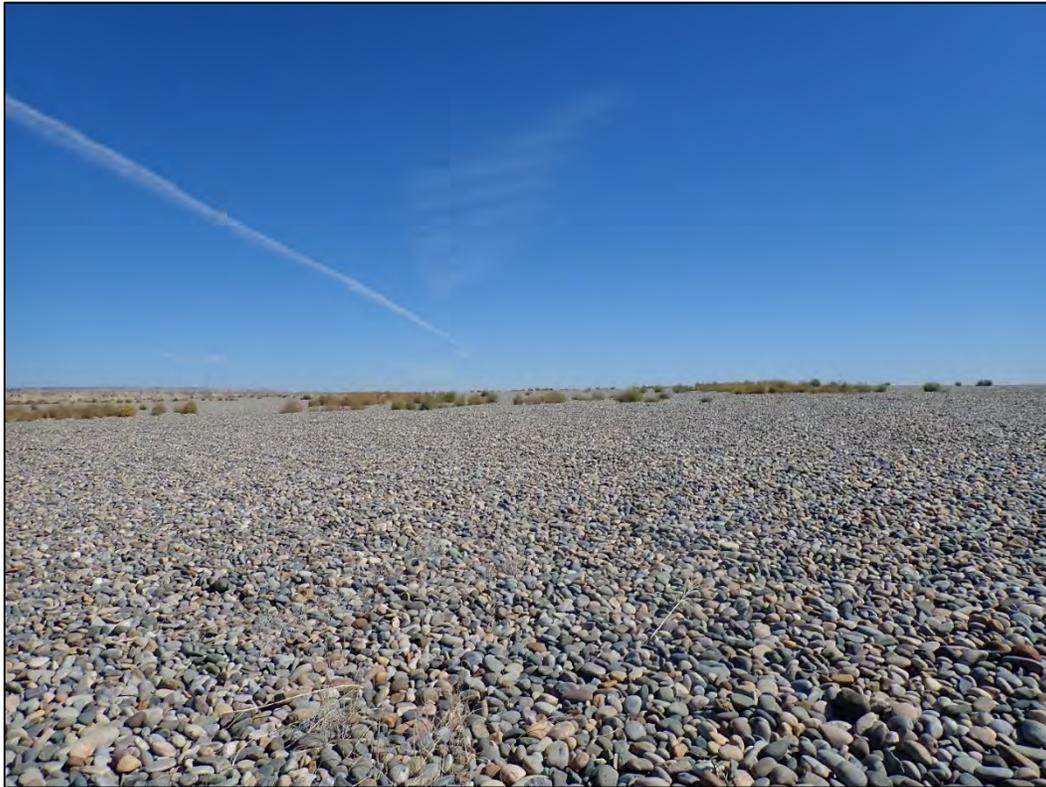
PL-5. Disposal Cell Top Slope

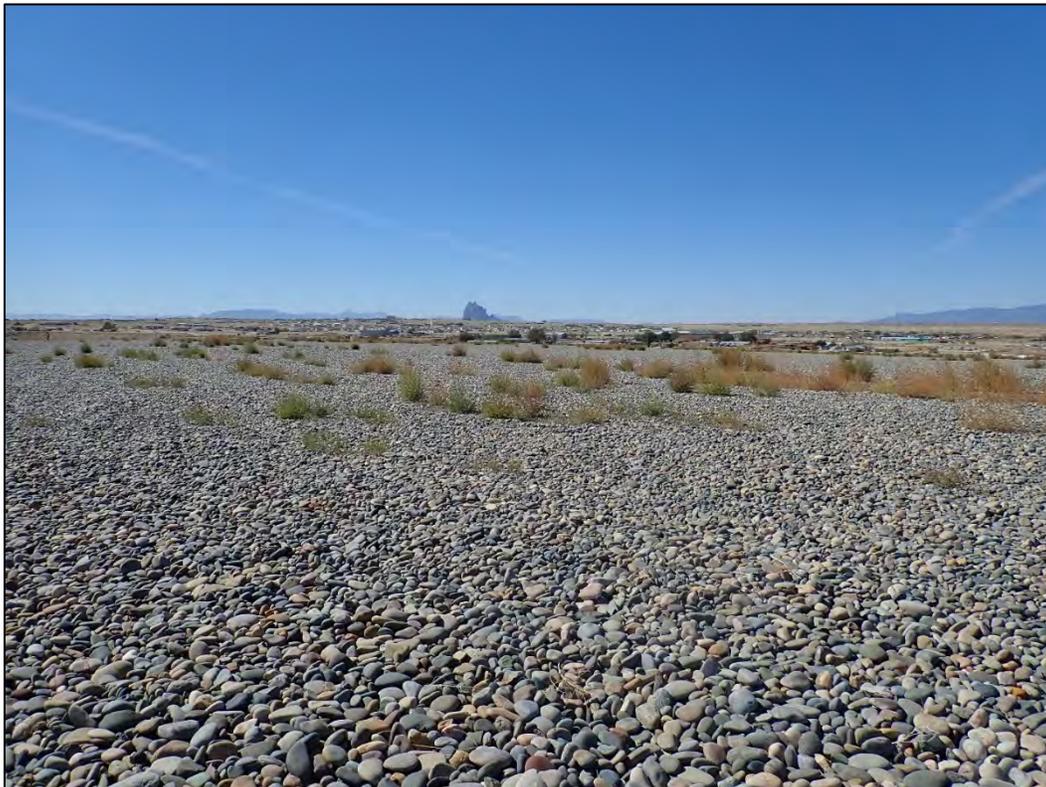
PL-6. Disposal Cell Top Slope with Growing Vegetation

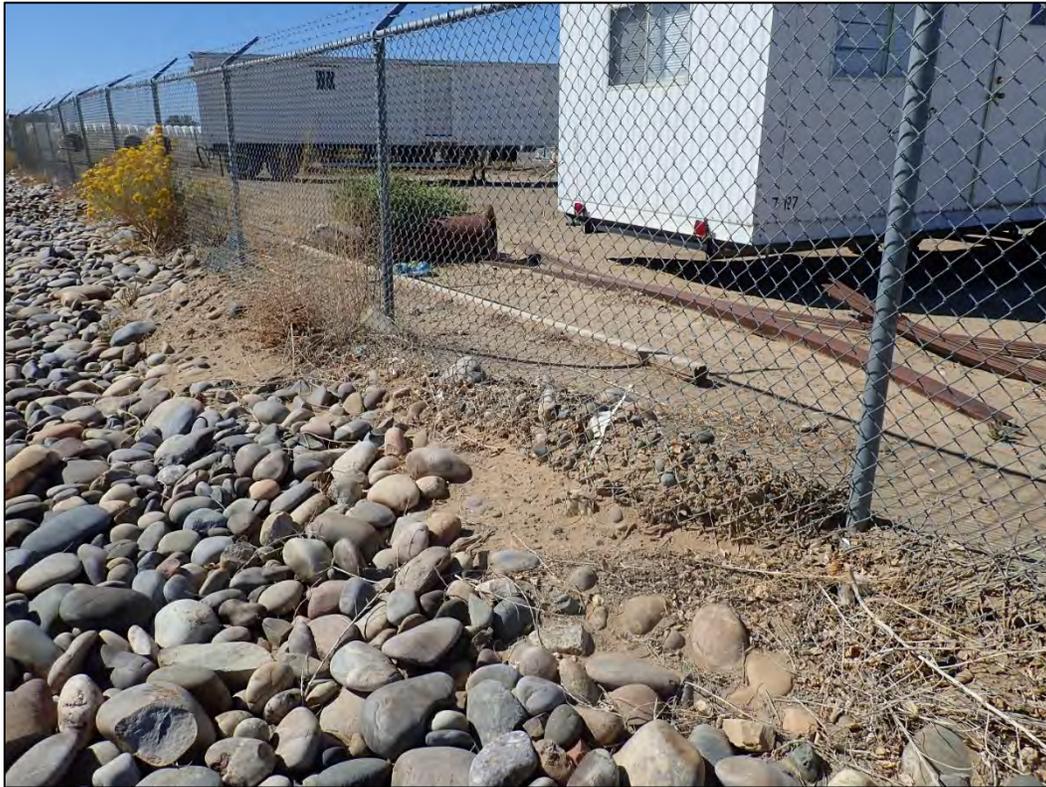
PL-7. Sediment Accumulation Near Southwest Fence Line
