U.S. DEPARTMENT OF
ENERGY

Legacy
Management

2020 Annual Site Inspection and Monitoring Report for Uranium Mill Tailings Radiation Control Act Title I Disposal Sites

March 2021

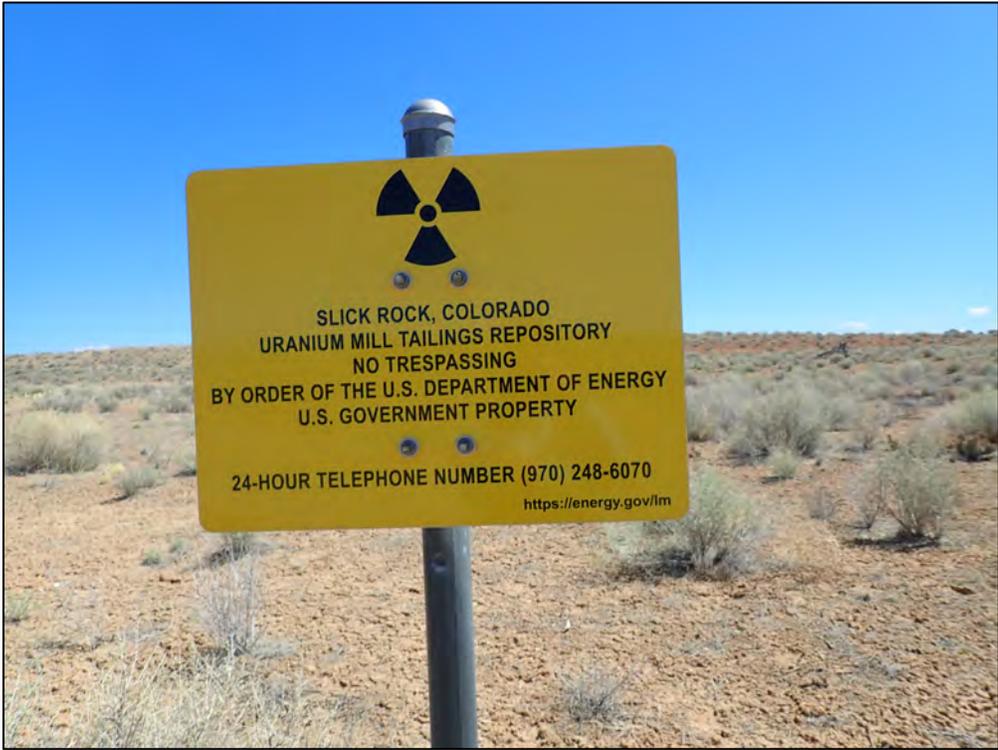
Access to the site is from San Miguel County Road T11. Entrance to the site is through a chained and locked gate. The wire entrance gate was locked and is worn but remains functional. The entrance sign is next to the gate (PL-1). No maintenance needs were identified.

PL-1. Entrance Sign

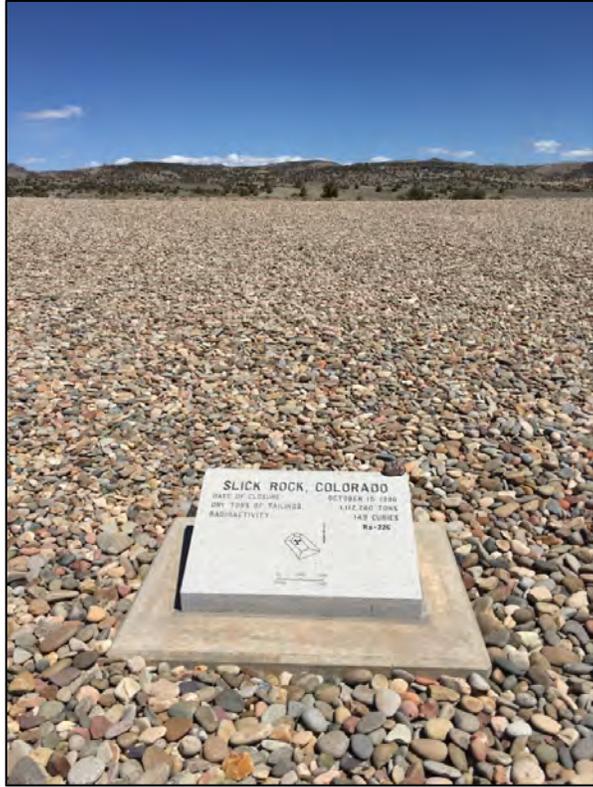
The site has two granite site markers. Site marker SMK-1 is just inside the entrance gate, and site marker SMK-2 is on top of the disposal cell (PL-2). Erosion near site marker SMK-1 is being monitored and will be repaired if it threatens the integrity of the marker. No immediate maintenance needs were identified.

PL-2. Site Marker SMK-2

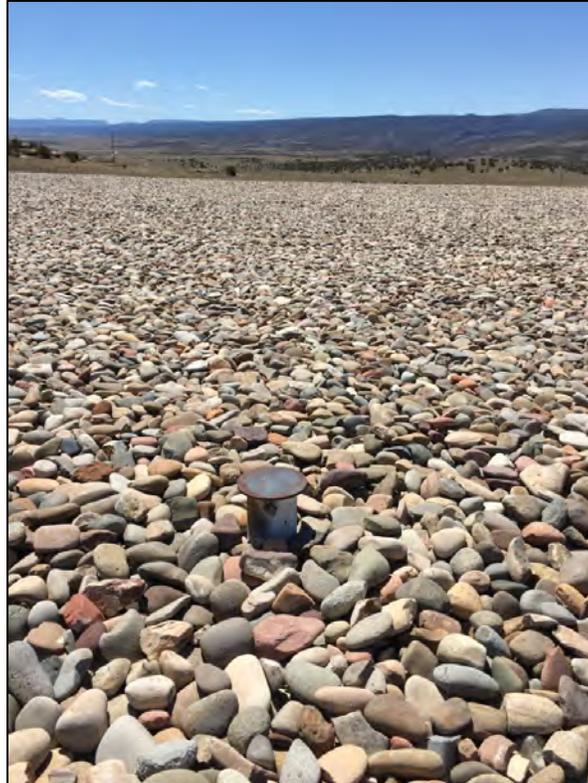
The disposal cell, completed in 1996, occupies 12.9 acres and is armored with riprap, consisting of rounded, cobble-sized river rock to control erosion and deter animal and human intrusion (PL-4). The inspection found no evidence of erosion, settling, slumping, rock degradation, or other modifying processes that might affect the integrity of the disposal cell. No other maintenance needs were identified.

PL-4. Settlement Plate on Disposal Cell

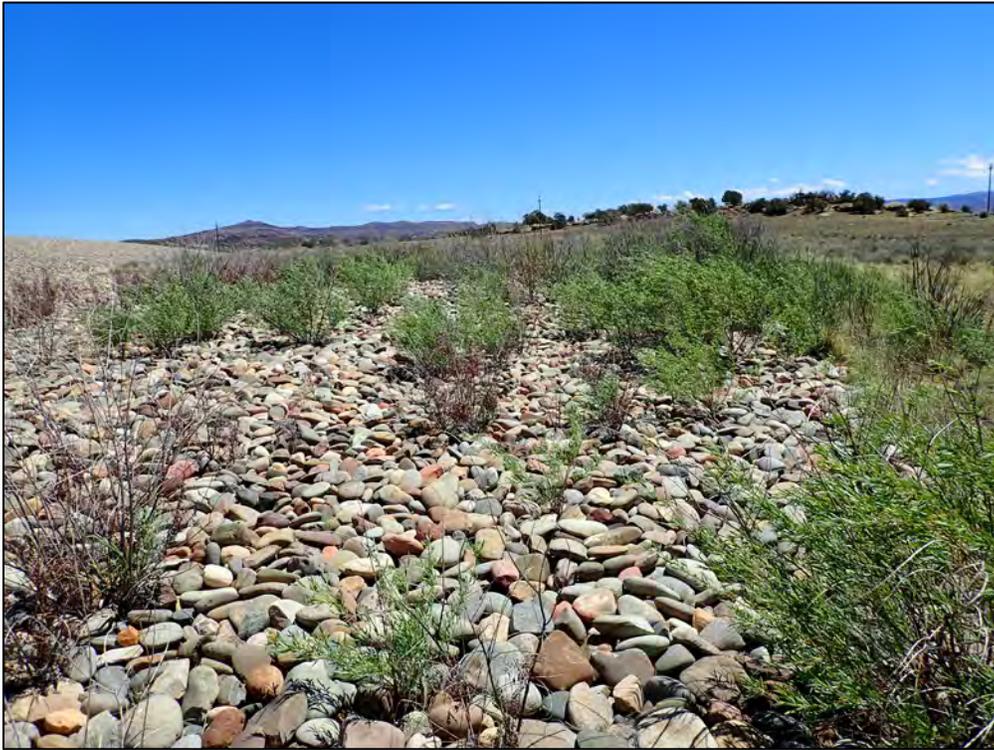
PL-5. Willows on Disposal Cell Toe

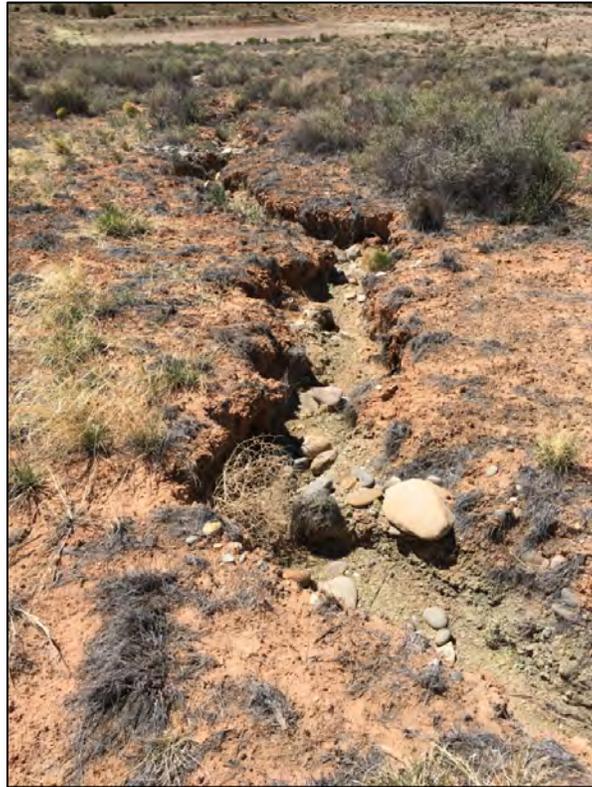
PL-7. Deep Erosional Gully

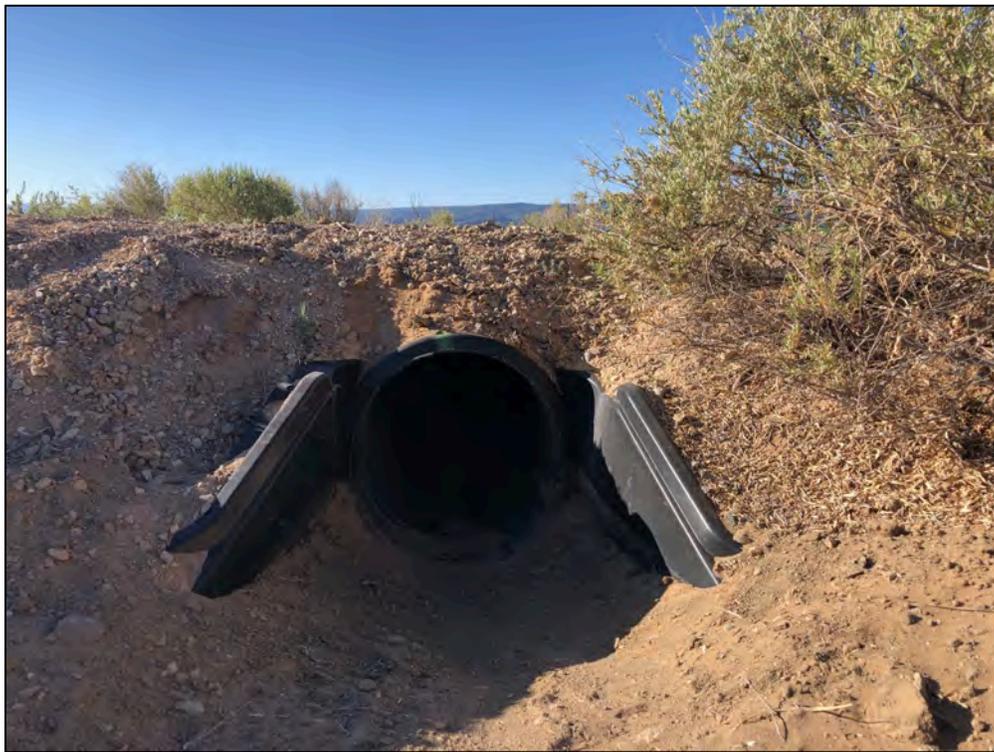
PL-8. Cleaned-Out Culvert

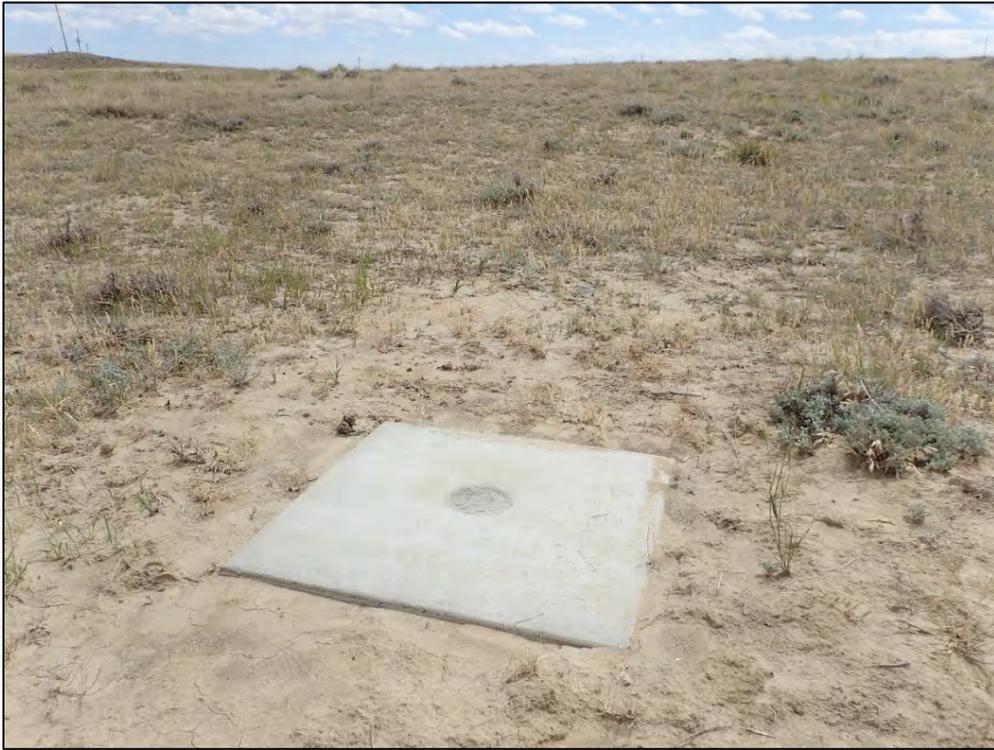
Four aerial survey quality control monuments were installed in 2019 following the site inspection (PL-5). The quality control monument locations are shown in Figure 18-1. No maintenance needs were identified.

PL-5. Quality Control Monument QC3

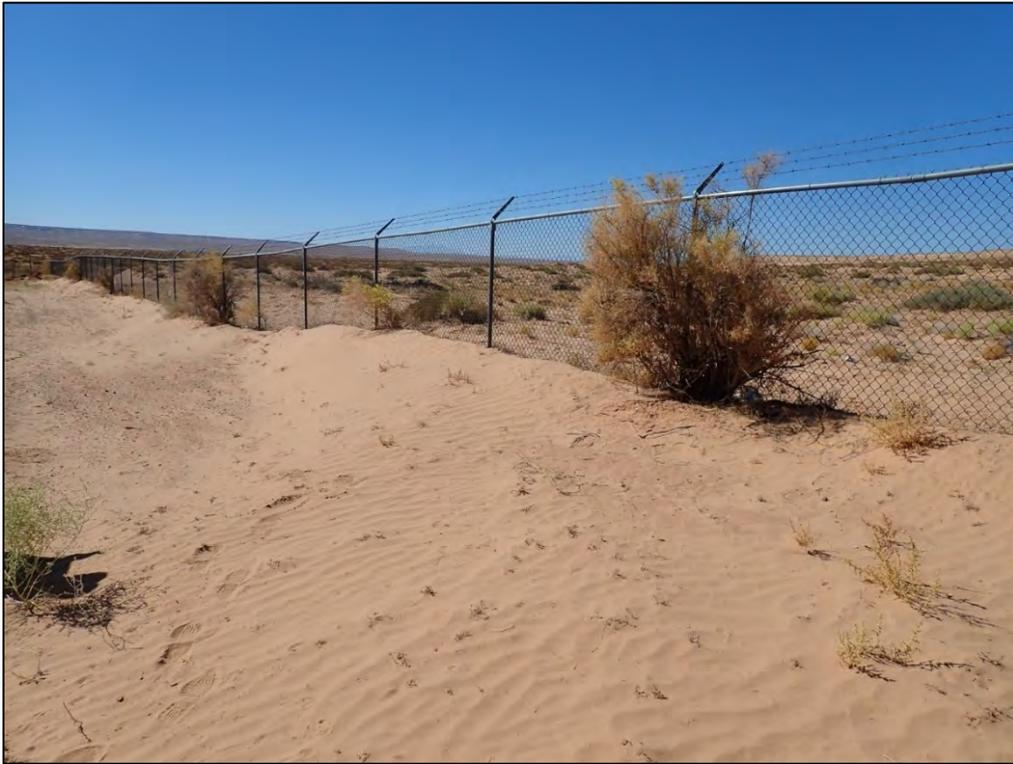
PL-1. Sand Accumulation and Treated Woody Vegetation Along West Fence

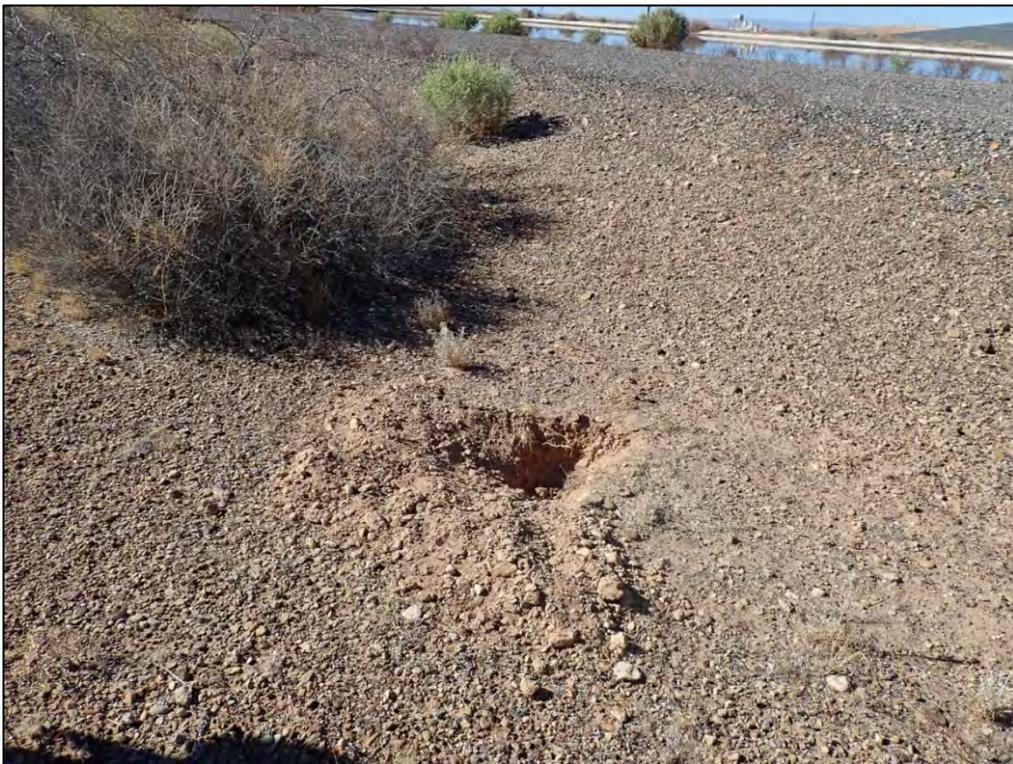
PL-2. Animal Burrow

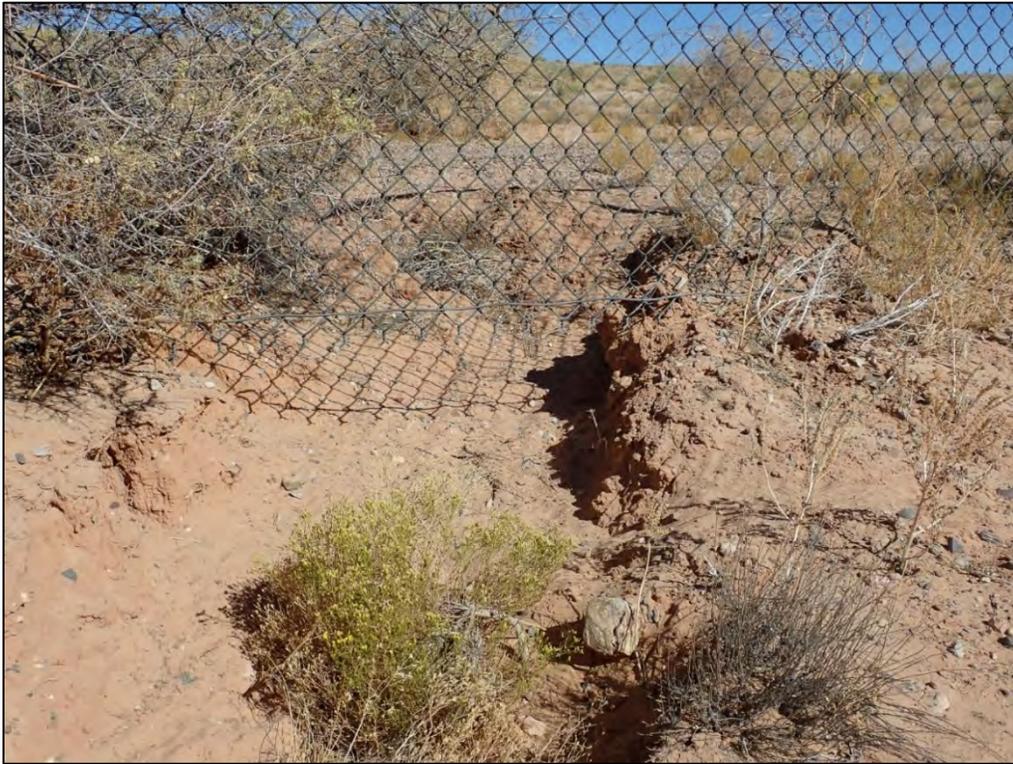
PL-3. Erosion Under Fence

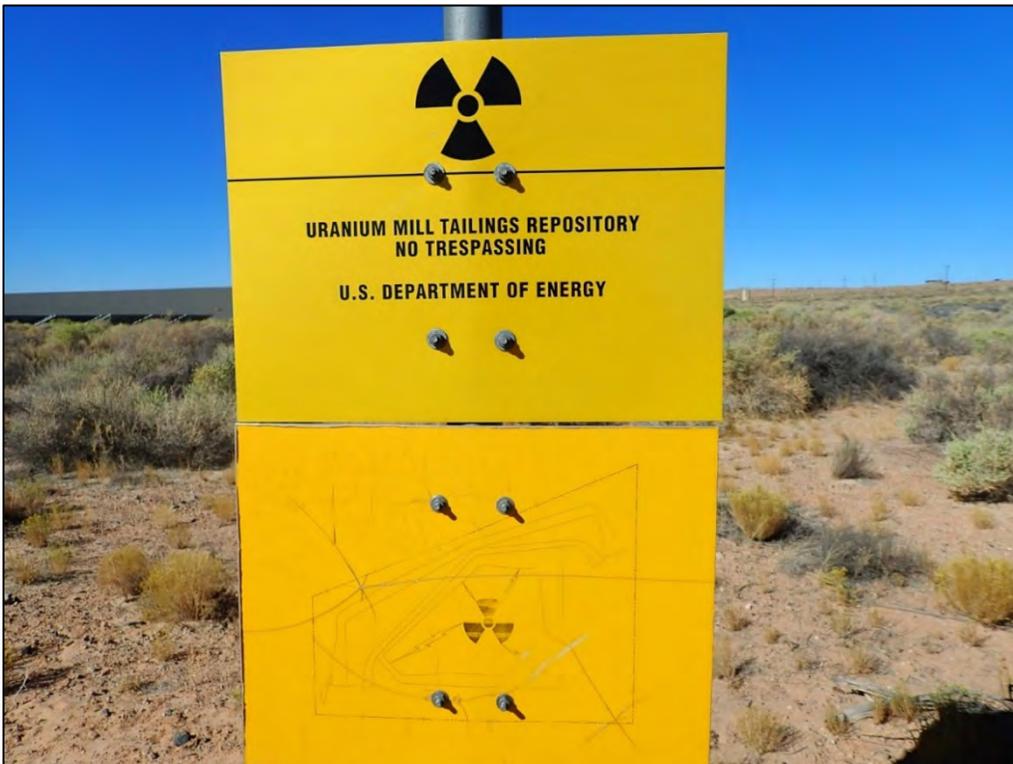
PL-4. Faded Pictorial Perimeter Sign P24

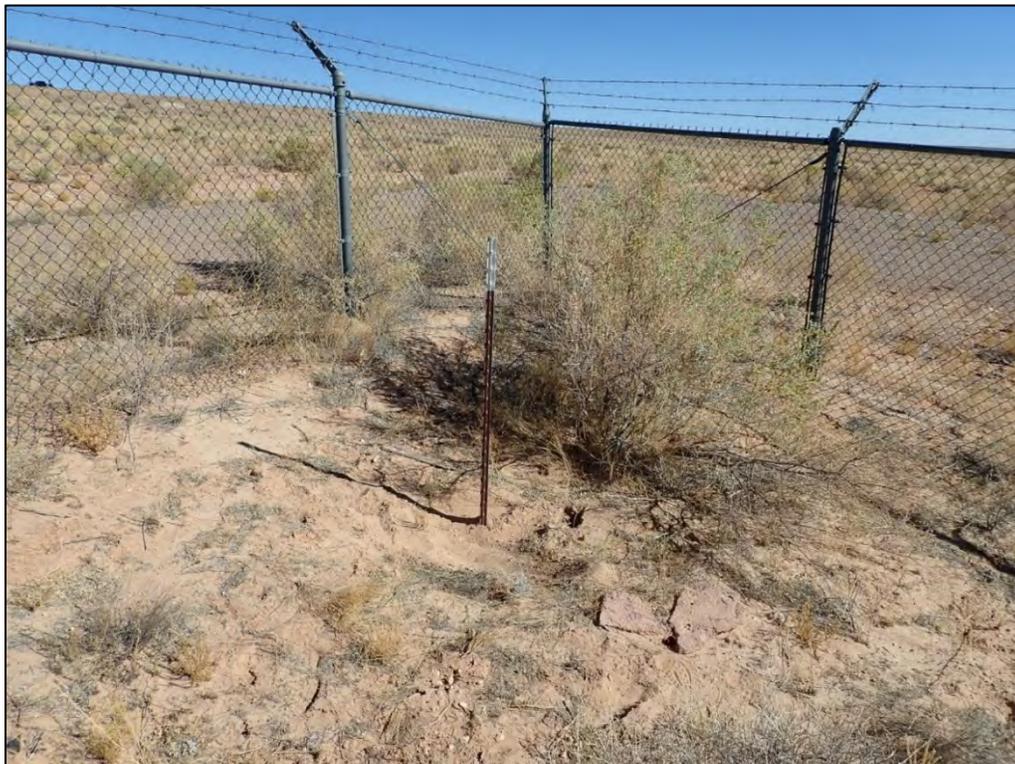
PL-6. Survey/Boundary Monument SM/BM-3 with Sand Accumulation

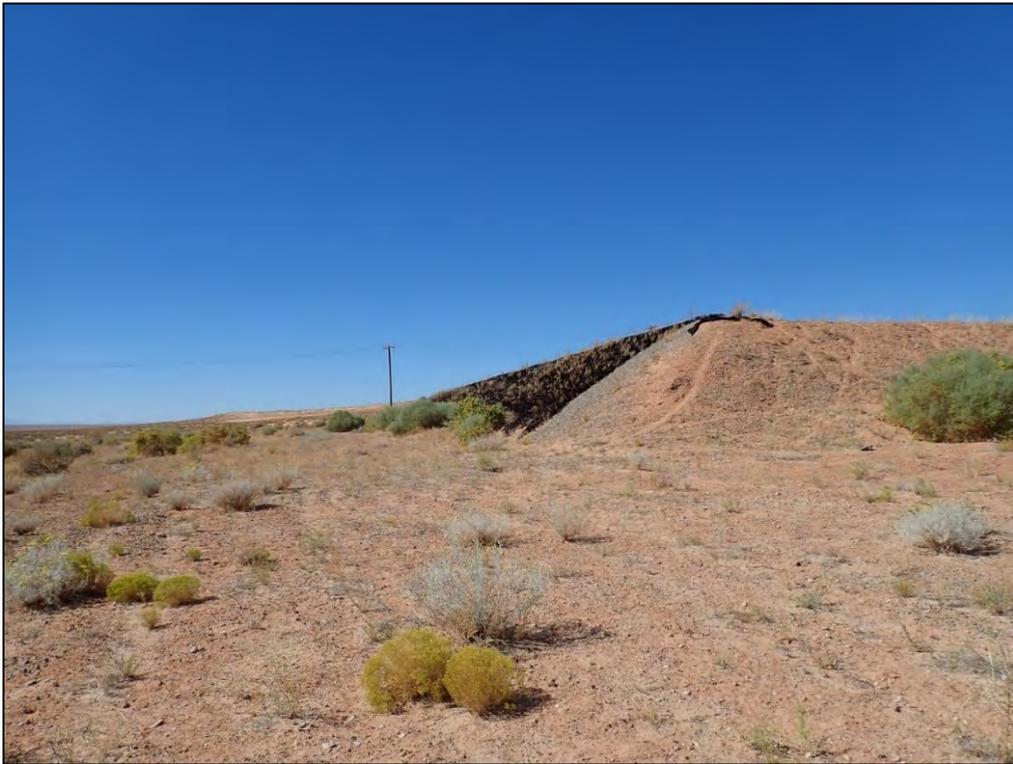
PL-10. Exposed Geofabric on South Side of Inactive, Lined Evaporation Pond

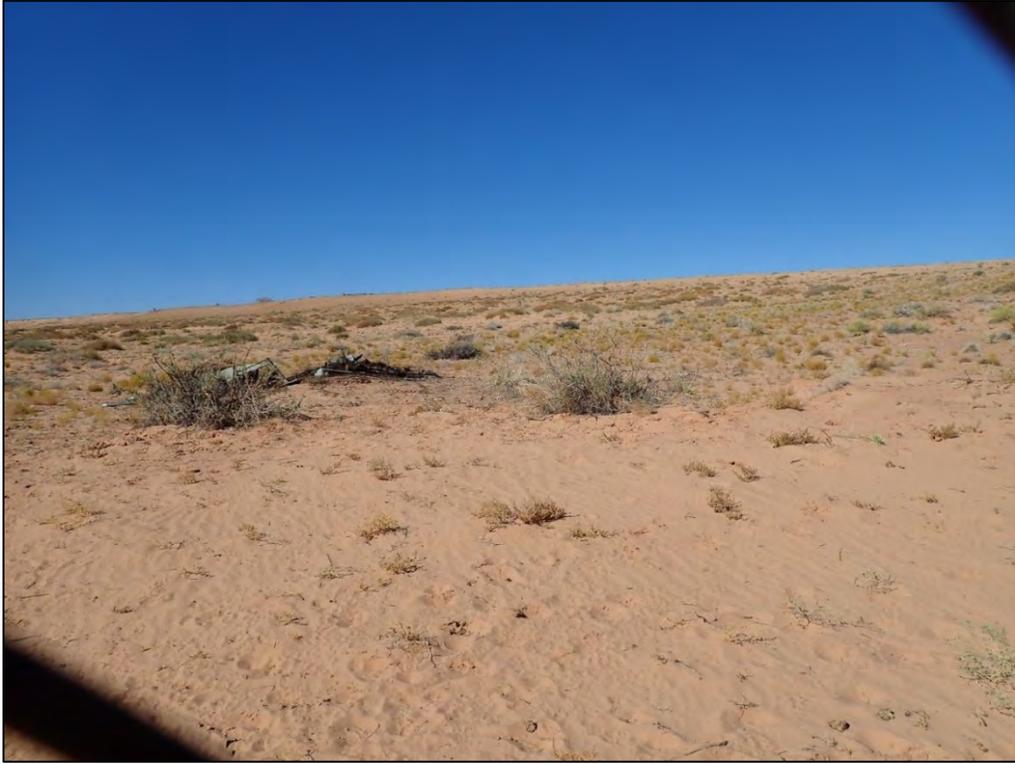
PL-11. Offsite Trash and Debris Pile
