U.S. DEPARTMENT OF
ENERGY

Legacy
Management

2022 Annual Site Inspection and Monitoring Report for Uranium Mill Tailings Radiation Control Act Title I Disposal Sites

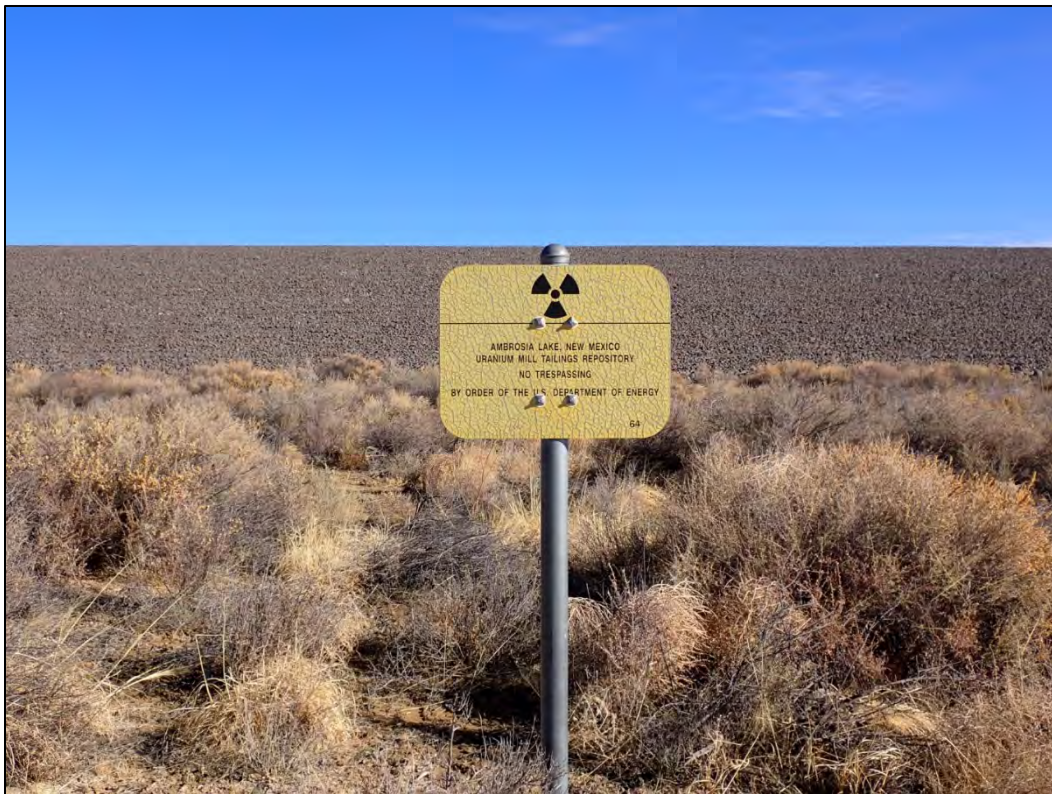
There are 70 perimeter signs, attached to steel posts set in concrete, positioned along the unfenced property boundary (PL-2). Posts for perimeter signs P1 through P15 include additional warning signs about mining restrictions. Many of the perimeter signs were cracked and weathered but remain legible. Erosion has occurred around the base of perimeter signs P12 (PL-3) and P41, but both perimeter signs are stable. Prairie dog colonies were identified near perimeter signs P17 and P18 during the 2021 inspection and observed again in 2022 (PL-4). The colony does not threaten the integrity of either of the perimeter signs, therefore, no additional action is needed. No maintenance needs were identified.

PL-2. Perimeter Sign P64

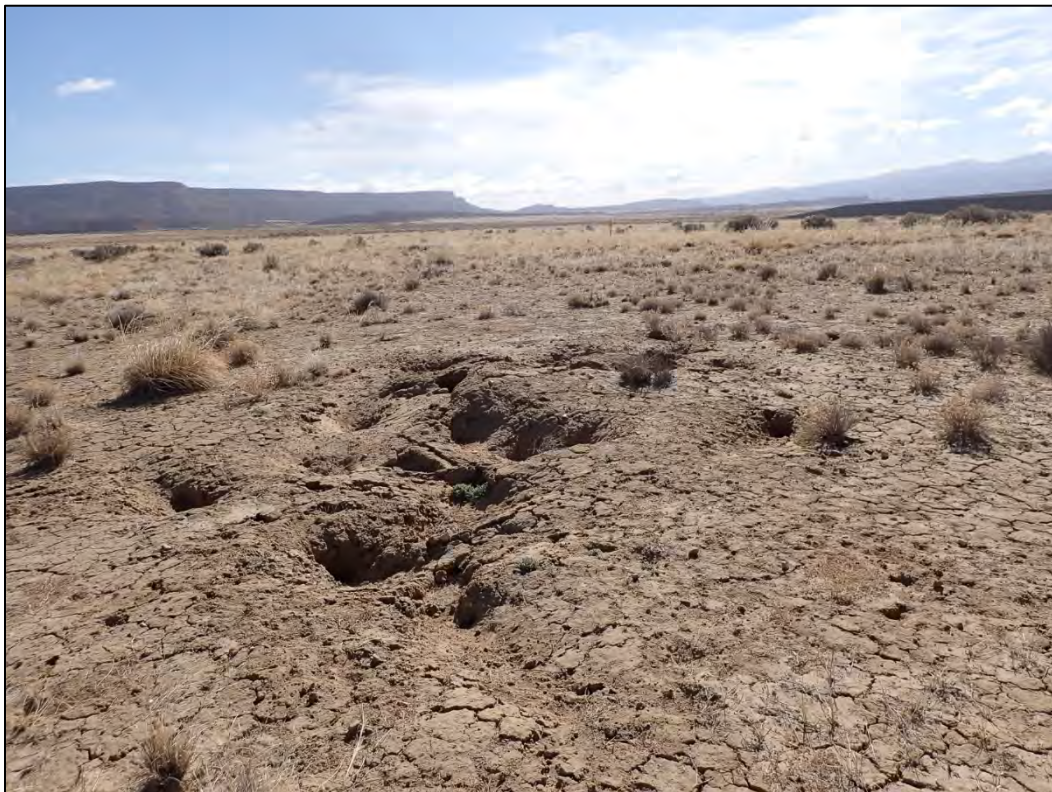
PL-4. Prairie Dog Colony near Perimeter Sign P17

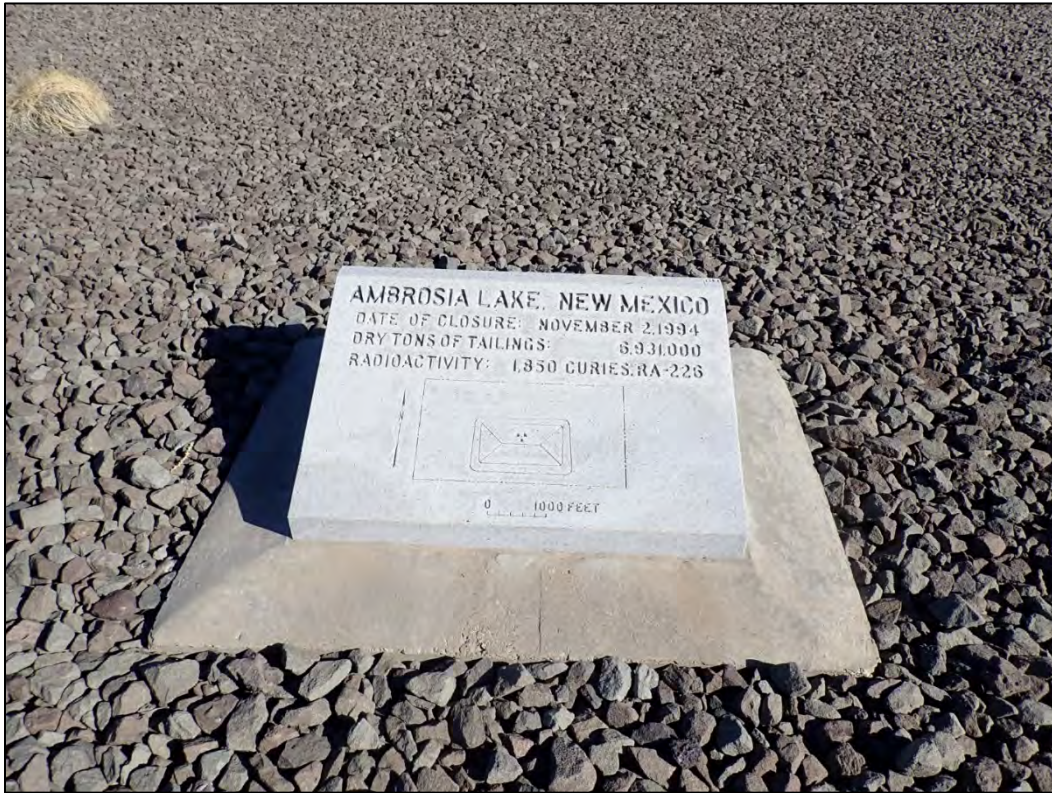
The site has two granite site markers. Site marker SMK-1 is just inside the site entrance, and site marker SMK-2 is on the top slope of the disposal cell (PL-5). No maintenance needs were identified.

PL-5. Site Marker SMK-2

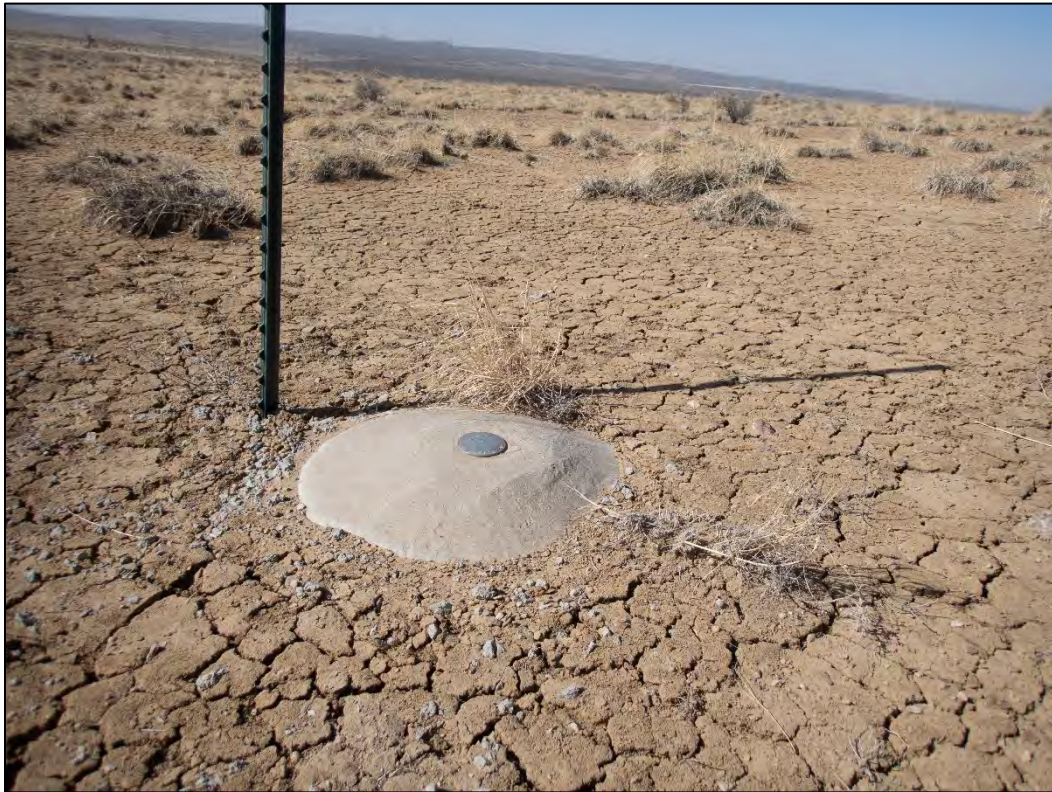
Three combined survey and boundary monuments and five additional boundary monuments delineate the property corners and boundary (PL-6). Steel T-posts were installed next to boundary monuments to help inspectors locate them. Erosion has occurred around the base of boundary monument BM-8, but the monument is stable. Prairie dog colonies were observed near boundary monuments BM-4 in 2021 (PL-7) and near BM-8 during the 2022 inspection. No maintenance needs were identified.

PL-6. Combined Survey and Boundary Monument BM-2

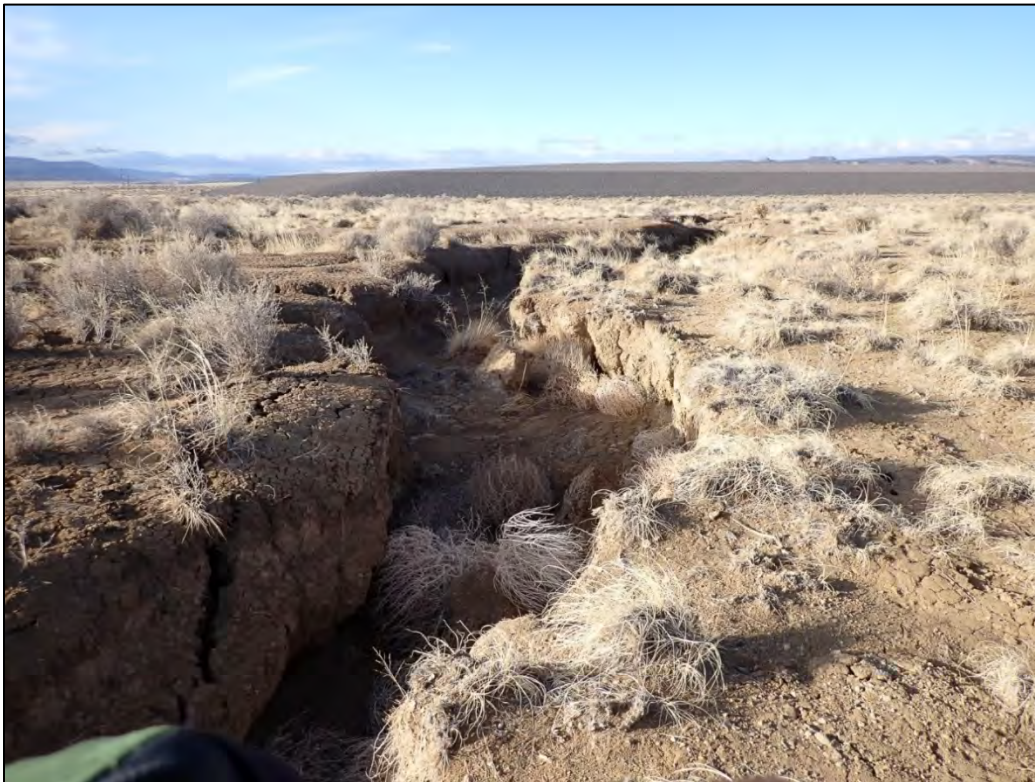
PL-12. Main Channel of Deep Gully

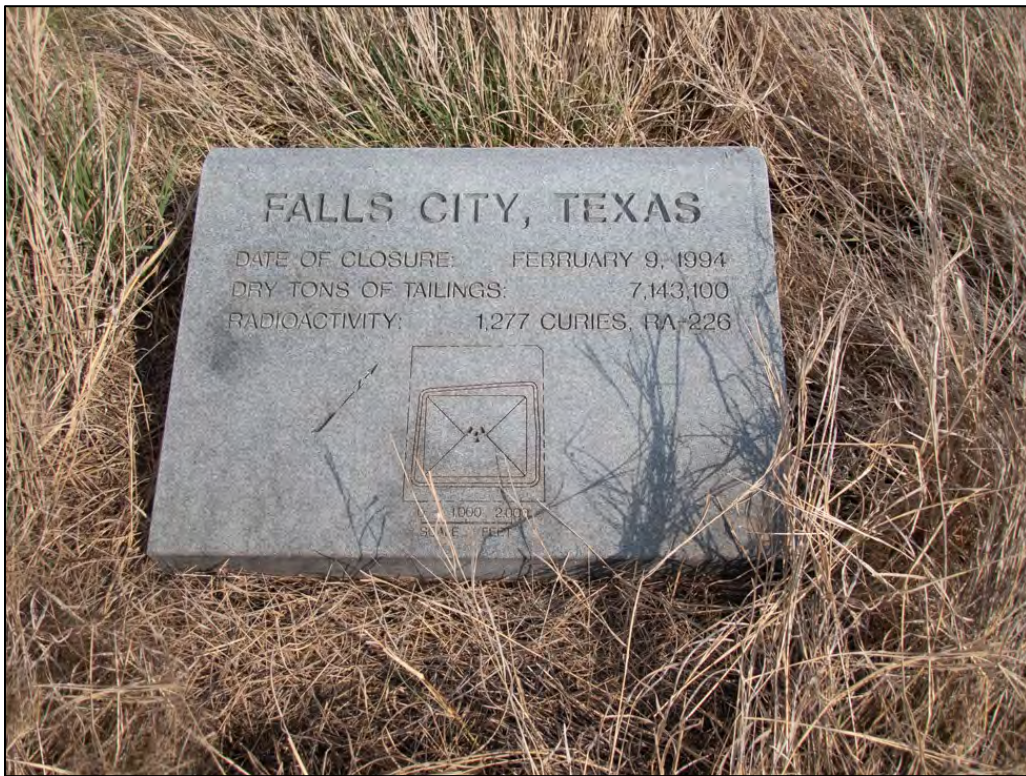
PL-4. Site Marker SMK-2

inspection, and repairs are not needed at this time. Site marker SMK-2 is on the top slope of the disposal cell (PL-4). No maintenance needs were identified.

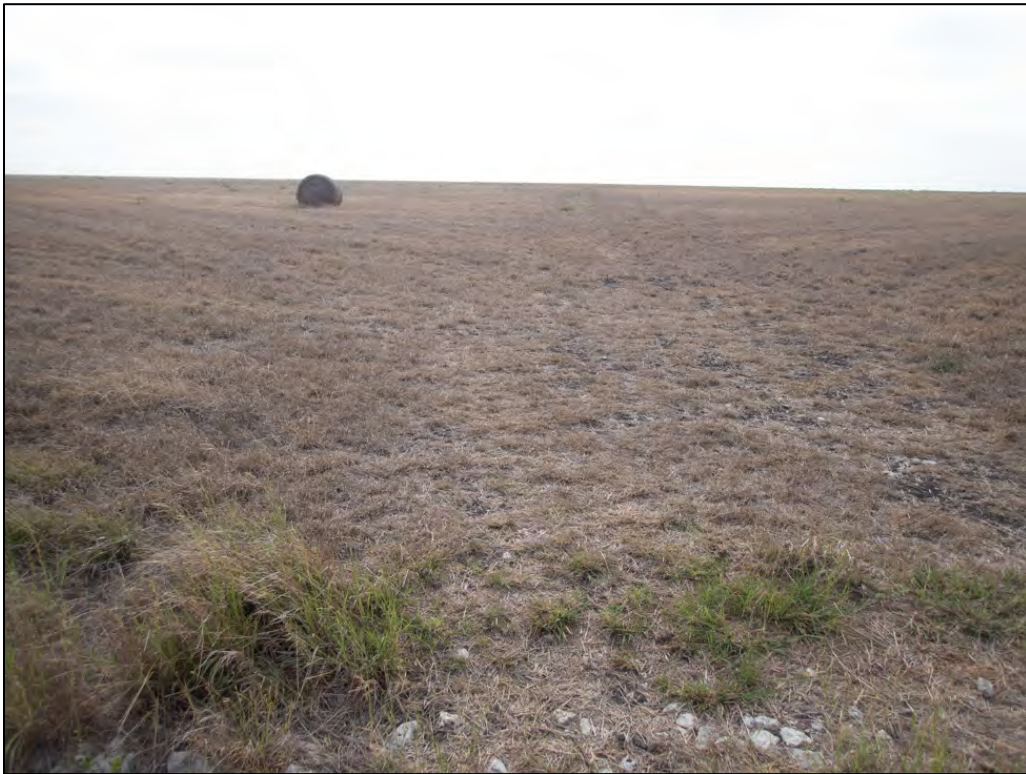
Desiccation cracks were observed in the soil on the top of the disposal cell (PL-7). There was no evidence of erosion, settling, slumping, or other modifying processes that might affect the integrity of the disposal cell. No areas of ponded water or areas of settlement were observed on top of the disposal cell during the 2022 inspection.

PL-7. Soil Desiccation Cracks on Top Slope of Disposal Cell

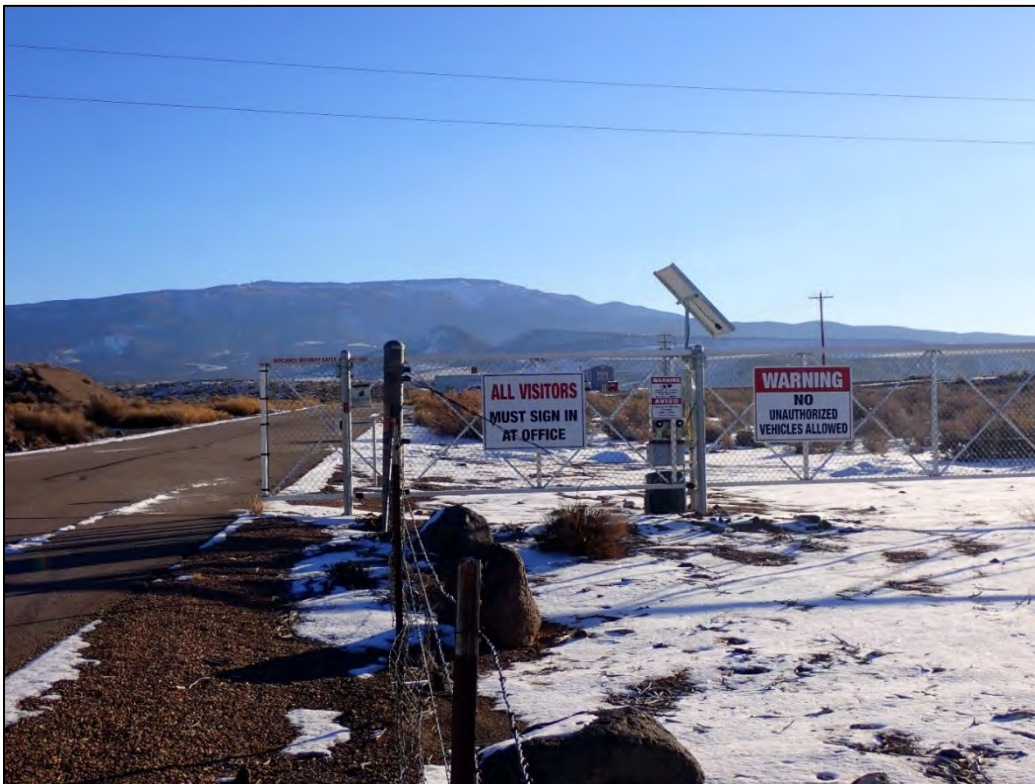
PL-2. Site Entrance Gate

The solar-powered site entrance gate is secured by an electronic locking device that requires entry of a keypad code to open the gate. The entrance gate was functional at the time of the inspection (PL-2). Site entrance signs on and next to the entrance gate were in good condition. No maintenance needs were identified.

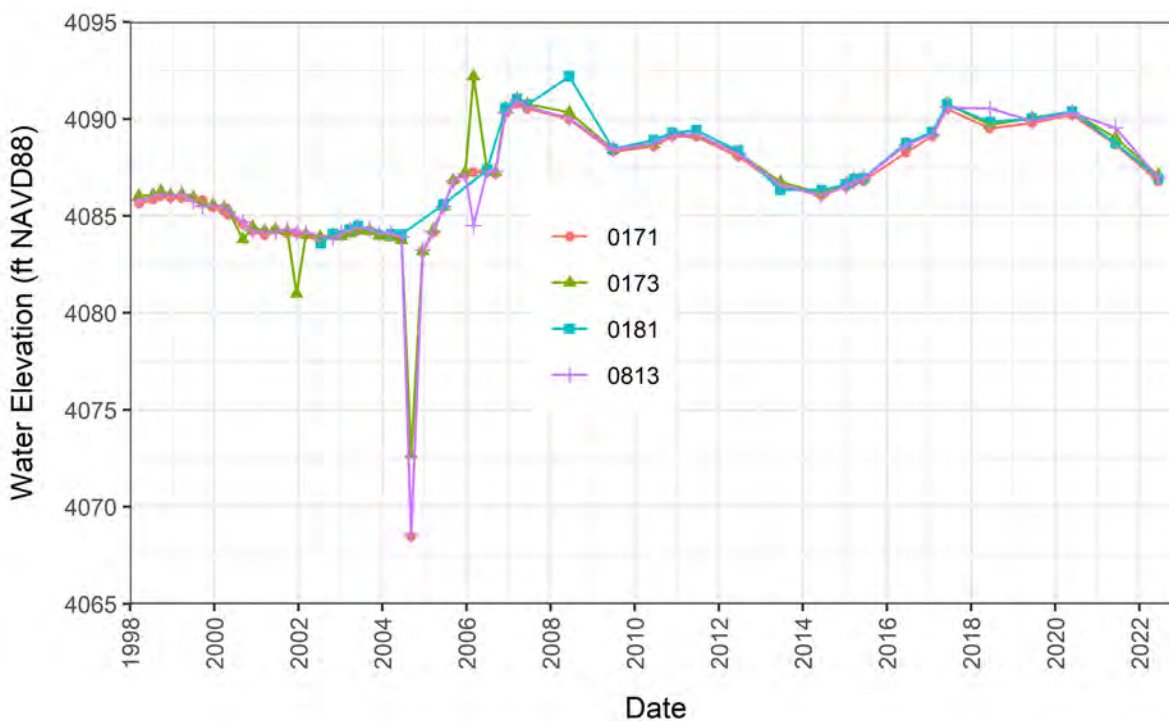
Figure 7-3. Groundwater Elevations at the Green River, Utah, Disposal Site, 1998–2022

Water levels in the POC wells have been measured manually every year since 1991. As shown in Figure 7-3, groundwater elevations measured from 1998 through 2022 have been generally consistent across the four POC wells, with few exceptions ranging from approximately 4083 to 4093 ft.

The sharp (11–15 ft) drop in water levels in wells 0171, 0173, and 0813 recorded in September 2004 (Figure 7-3) may have been due to instrument error or human error in recording the original field record. However, there is no definitive evidence of error and the data as shown are consistent with available documentation. The three other water level measurements taken in these wells in 2004 (in March, June, and December) are consistent with previous and subsequent nonoutlier water elevations. To provide greater resolution on the historical groundwater elevation data, Figure 7-4 plots the same results as those shown in Figure 7-3 but excludes the three outliers discussed above. In contrast with the initial line plot, Figure 7-4 was developed using a faceting approach, whereby data are partitioned into a matrix of panels, with each panel plotting data for a single well. In each facet plot, a nonparametric smoothing method—locally estimated scatterplot smoothing (LOESS)—is used. The surrounding shaded area represents the 95% pointwise confidence interval. Using this approach, overall trends in the data are more apparent and not obscured by “noise” or random variation.

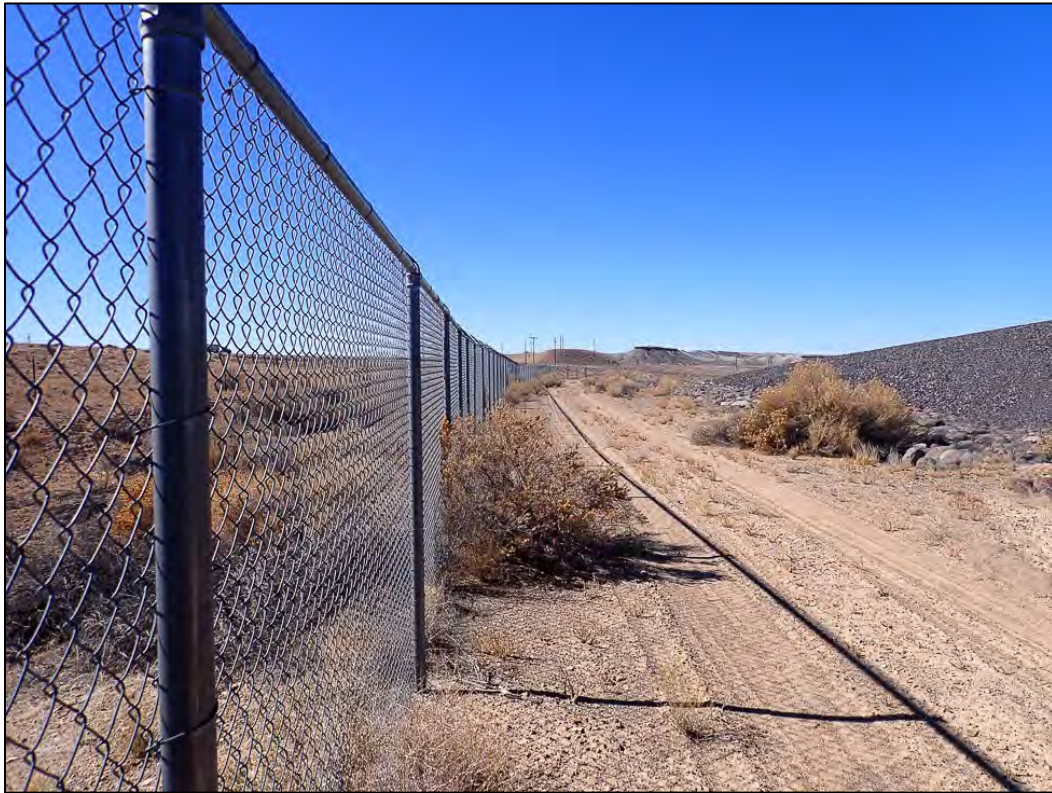
PL-1. Vegetation Along Chainlink Security Fence

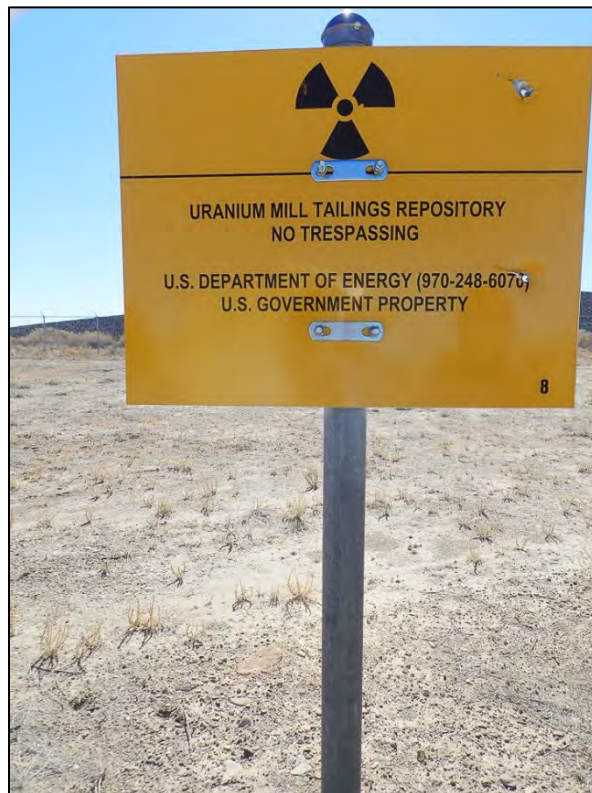
PL-2. Perimeter Sign P8 with Bullet Holes

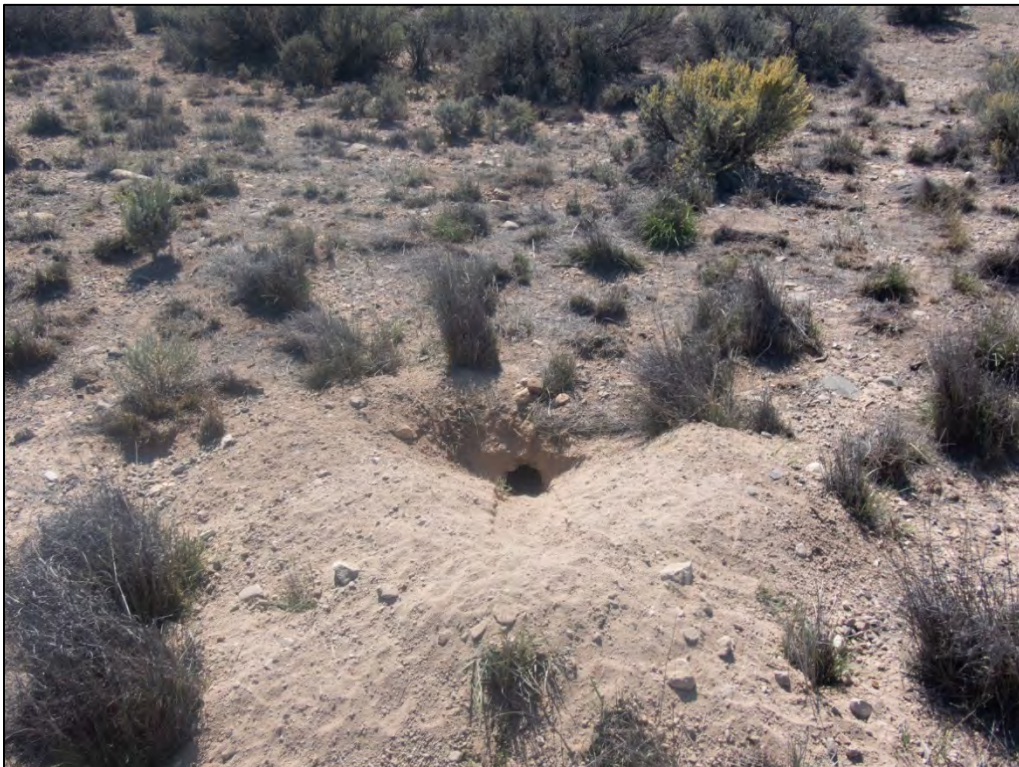
PL-4. Prairie Dog Hole near Perimeter Sign P2

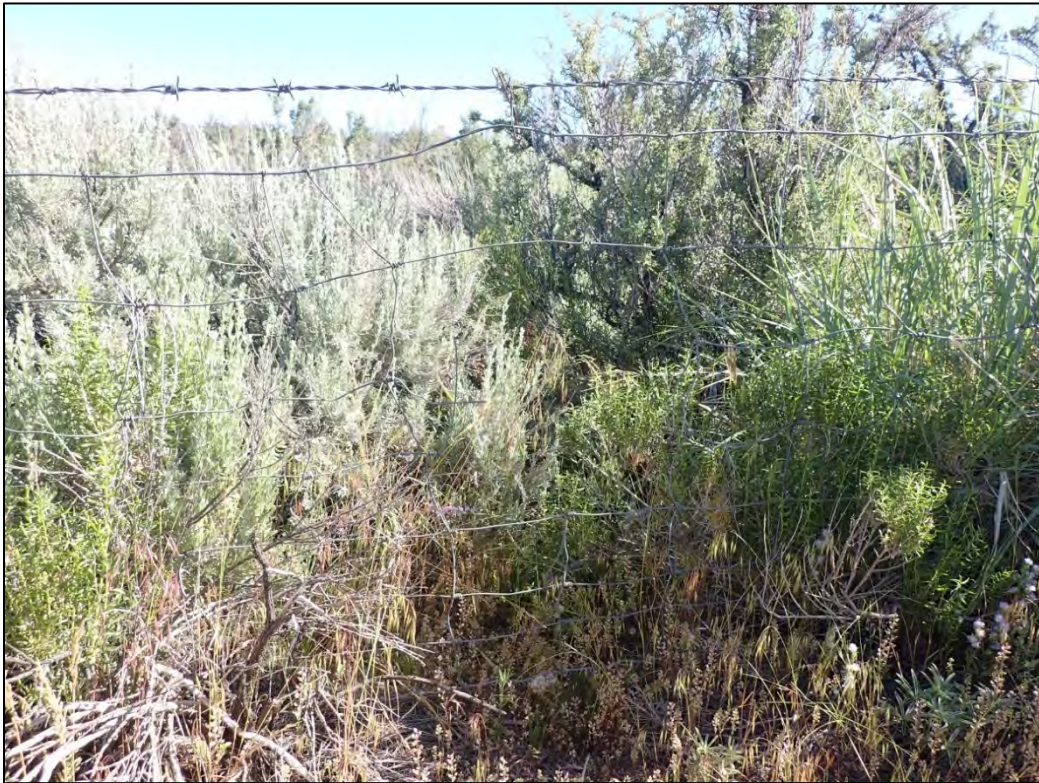
PL-3. Hole in Sheep Fence

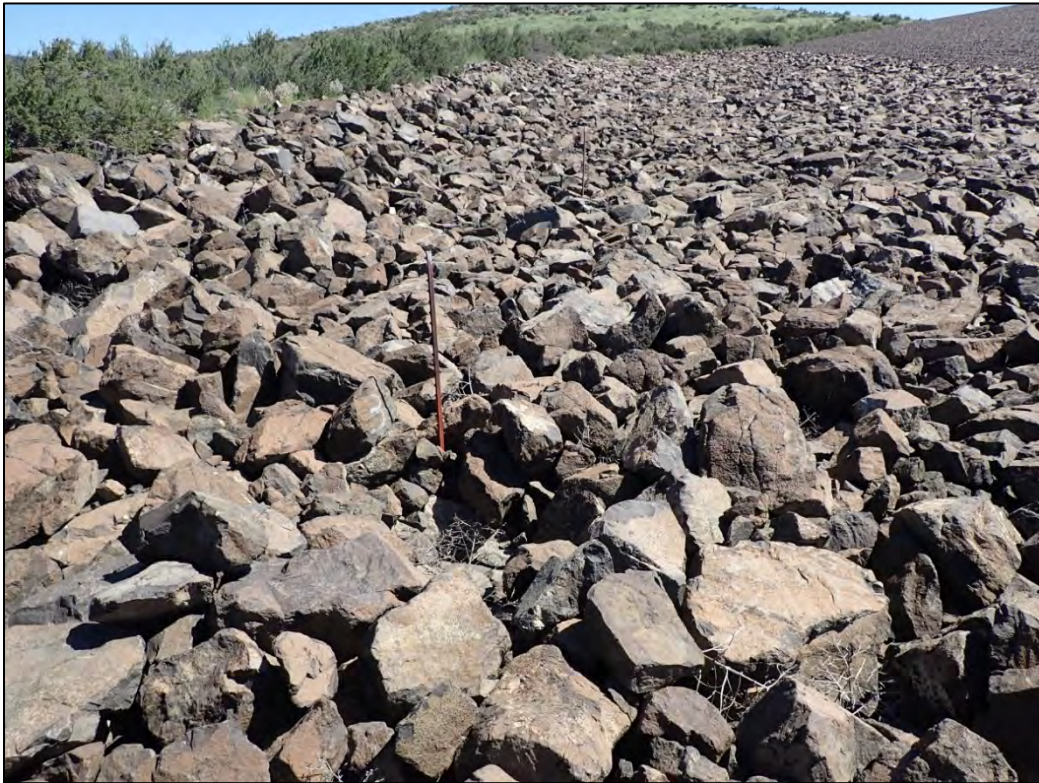
PL-10. Dry Depression in EDA

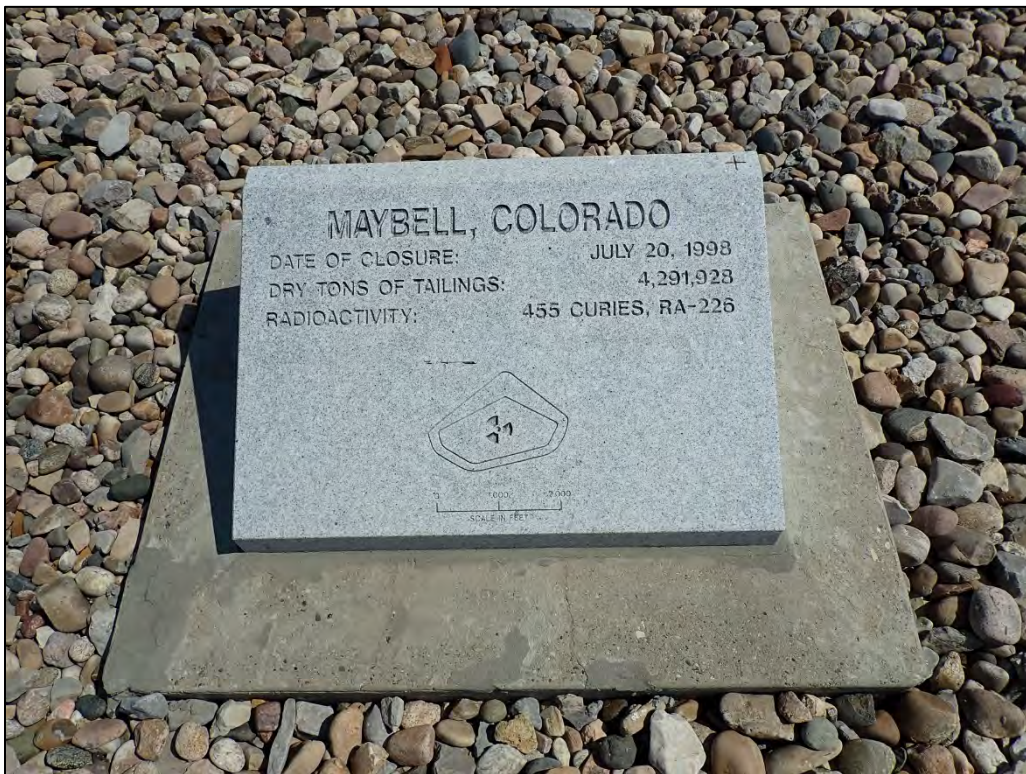
PL-4. Site Marker SMK-2 on Disposal Cell

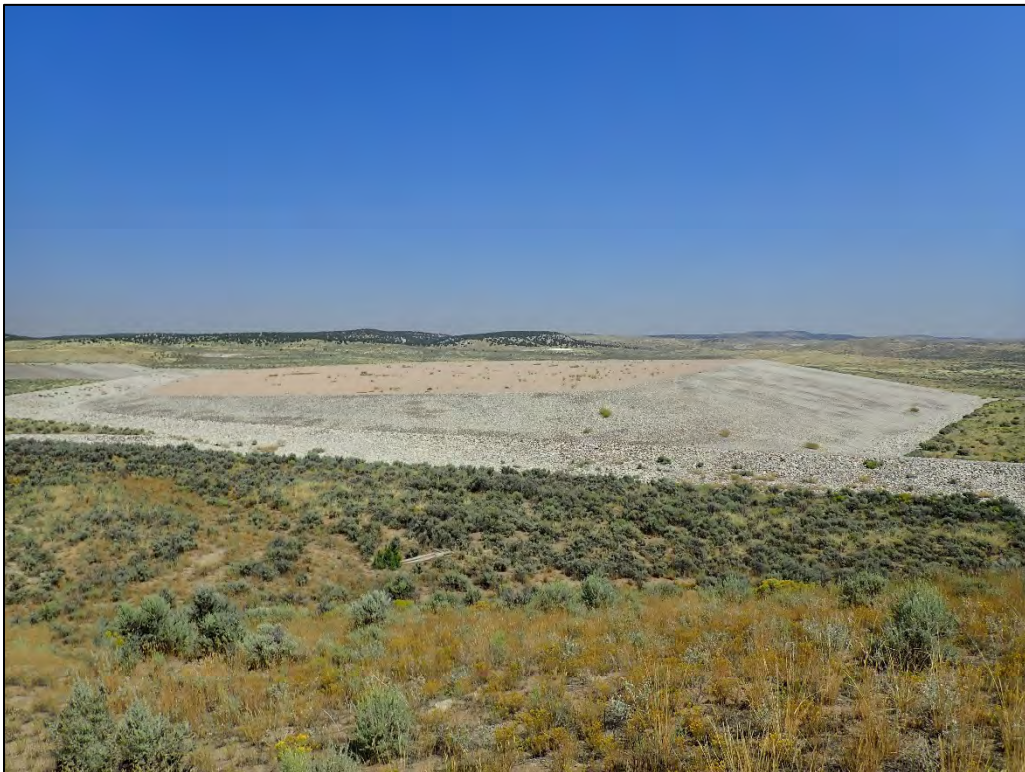
The disposal cell, completed in 1998, occupies 66 acres; it is armored with riprap to control erosion and deter animal and human intrusion (PL-8). There was no evidence of erosion, settling, slumping, rock degradation, or other modifying processes that might affect the integrity of the disposal cell. Scattered plants continue to establish on the disposal cell top slope, but they are not affecting the integrity of the disposal cell.

PL-8. Disposal Cell Overview

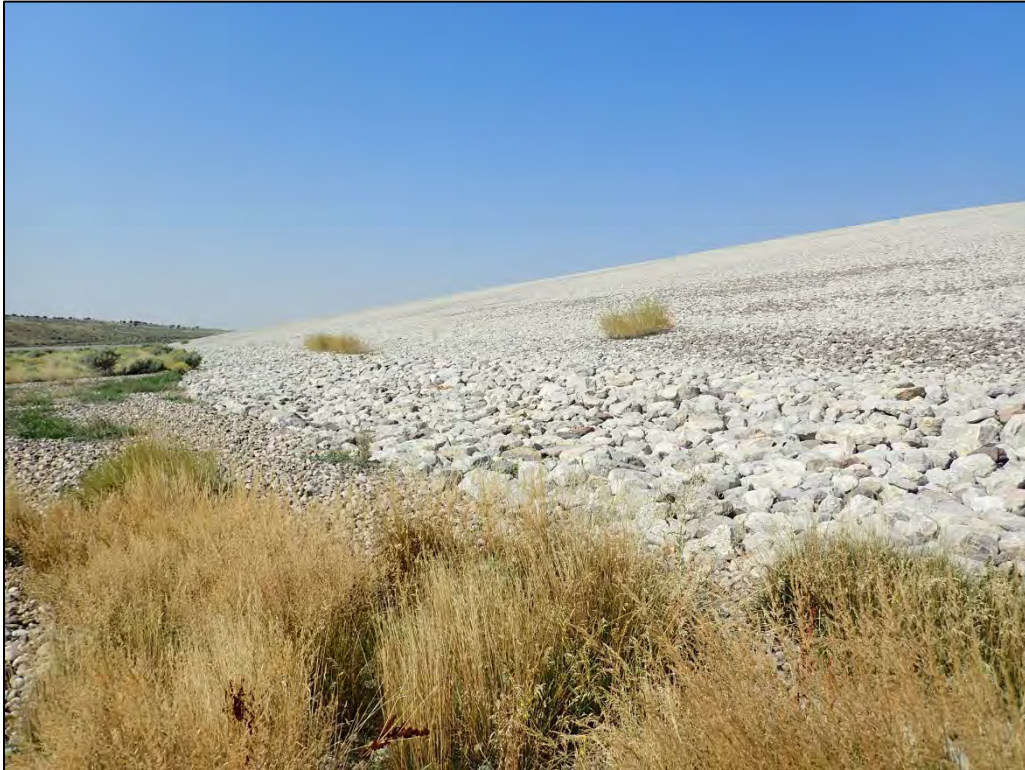
Stormwater runoff from the disposal cell discharges at this location. Cattails are present in this area indicating regular pooling of water (PL-9). During the 2021 inspection, standing water was observed in the easternmost portion of the disposal cell toe slope apron upgradient of the cobble blanket. This area was dry during the 2022 inspection. No other maintenance needs were identified.

PL-9. Cattails Along Eastern Side Slope Apron

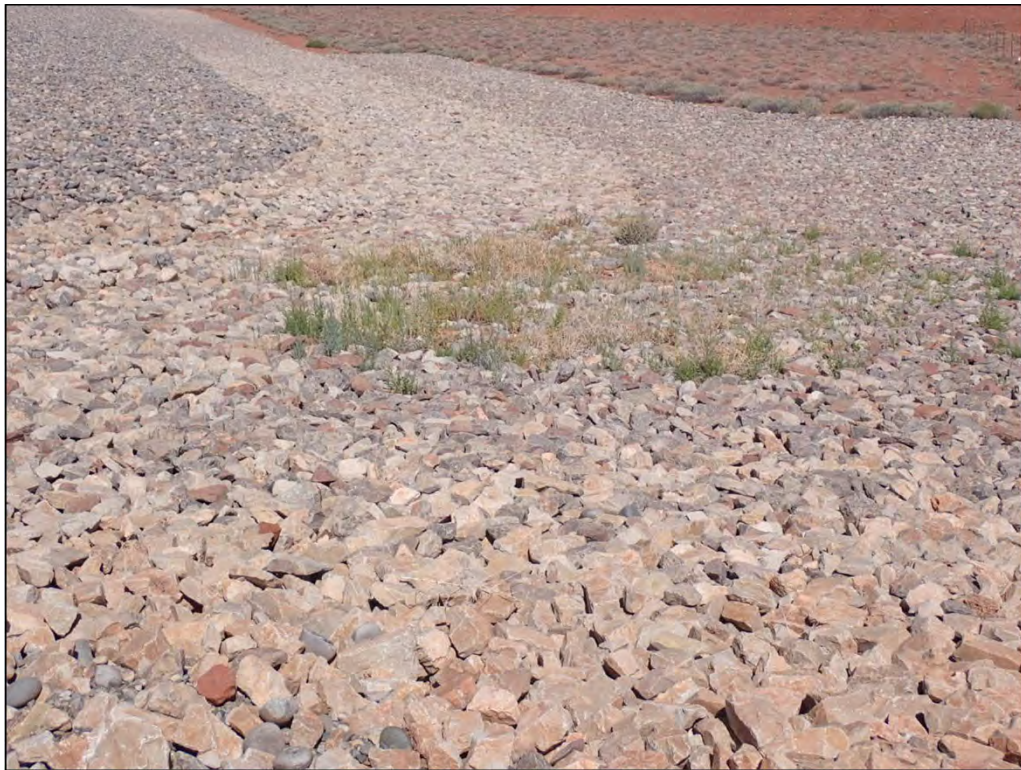
PL-8. Vegetation Growth in the West Diversion Channel

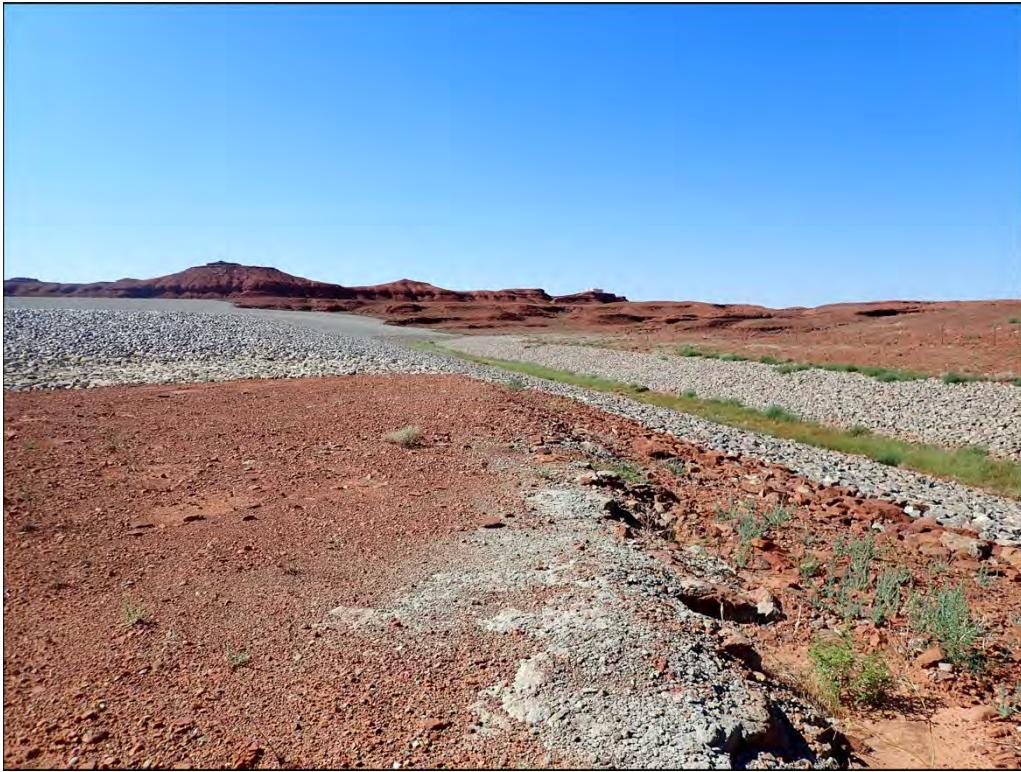
PL-9. Vegetation in the Northeast Toe Drain

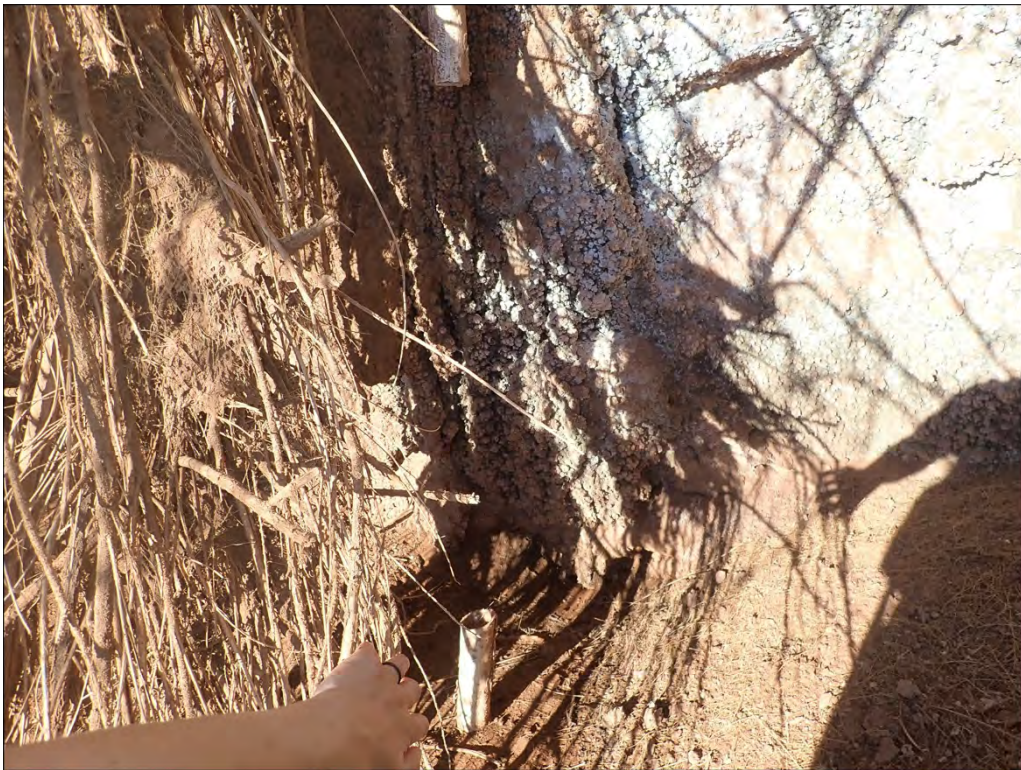
Observational documentation consists of photographing seeps (PL-10 through PL-16) and providing descriptions of the conditions observed at the seven designated seeps. Since 2010, groundwater discharge from seeps had been observed at cross-gradient seep 0248, which typically exhibits dripping conditions; during the 2022 inspection, seep 0248 was dripping and showed new vegetation growth (PL-10).

PL-10. Seep 0248 (Dripping)

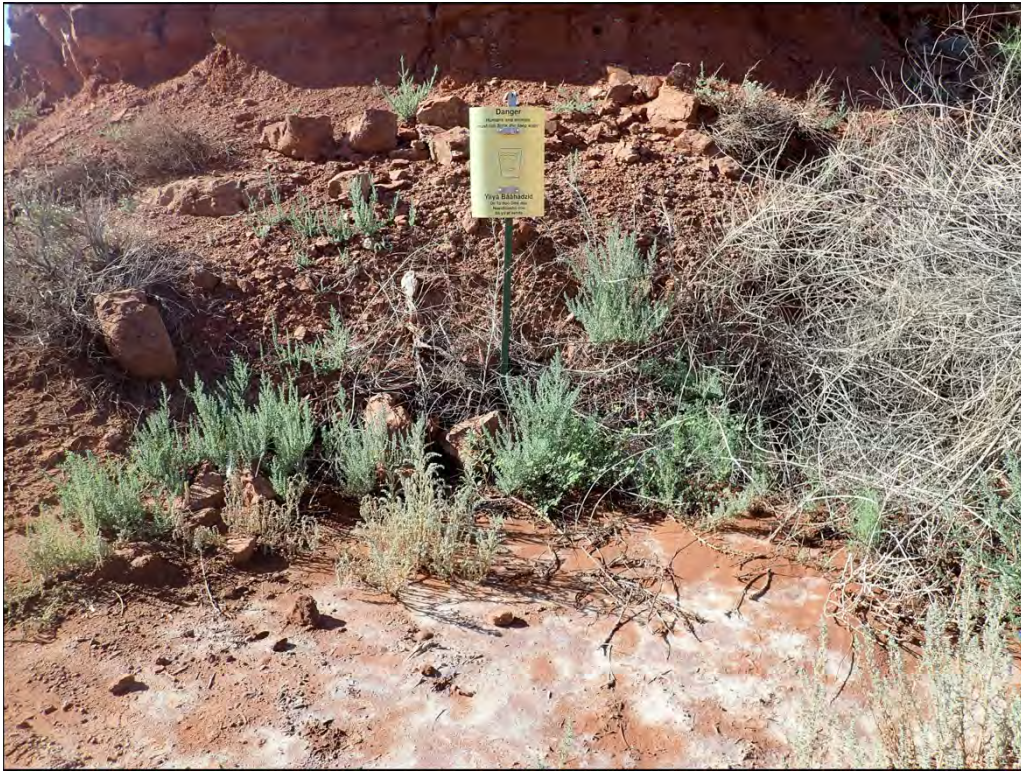
PL-15. Seep 0264 (Damp)

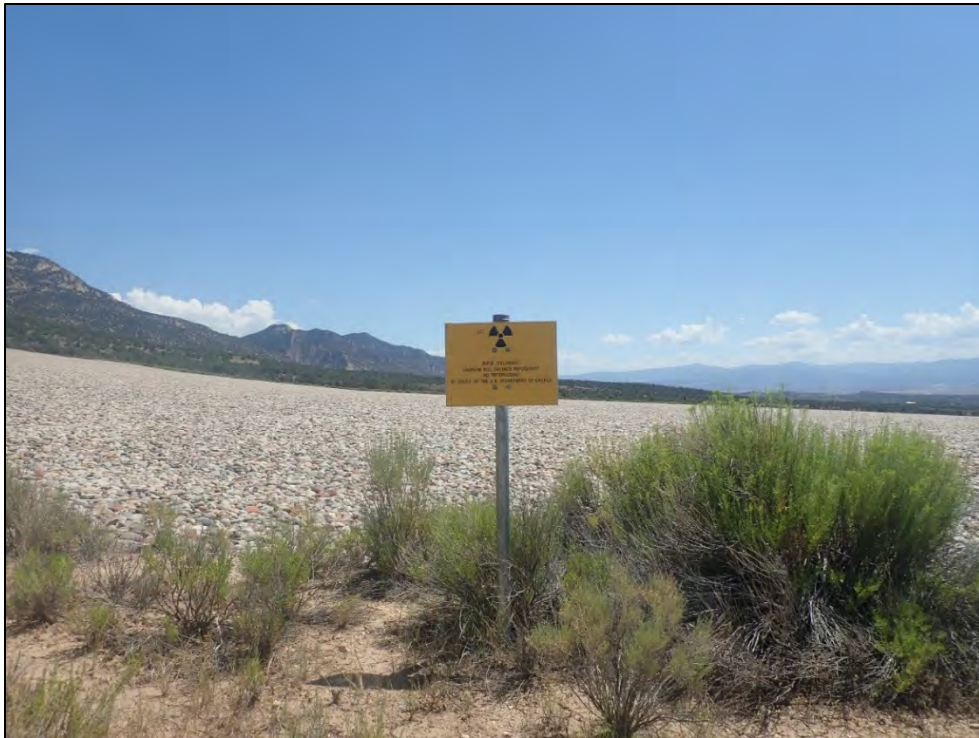
PL-2. Perimeter Sign P22

There are 27 perimeter signs positioned along the site perimeter. Perimeter signs P0 through P11 are attached to the stock fence, and signs P12 through P26 are attached to steel posts set in concrete and set back 5 ft from the boundary. Perimeter signs P15 and P19 have bullet damage but remain legible. Perimeter signs P1, P3, P16, P18, P22, P24, and P26 have minor cracks and peeling but remain legible (PL-2). No maintenance needs were identified.

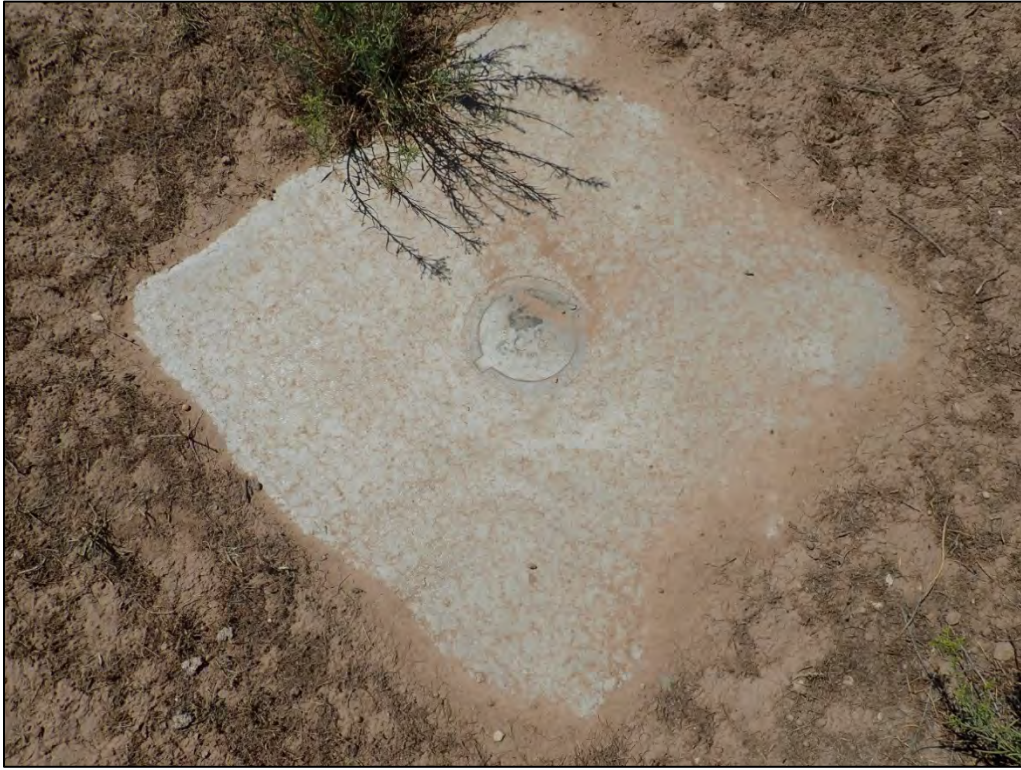
PL-5. Aerial Survey Quality Control Monument QC-8

Nine aerial survey quality control monuments were inspected during the 2022 annual inspection. Inspectors noted minor sediment accumulation on quality control monuments QC-5 and QC-8 (PL-5). An aerial survey collected lidar data in July 2022. No maintenance needs were identified.

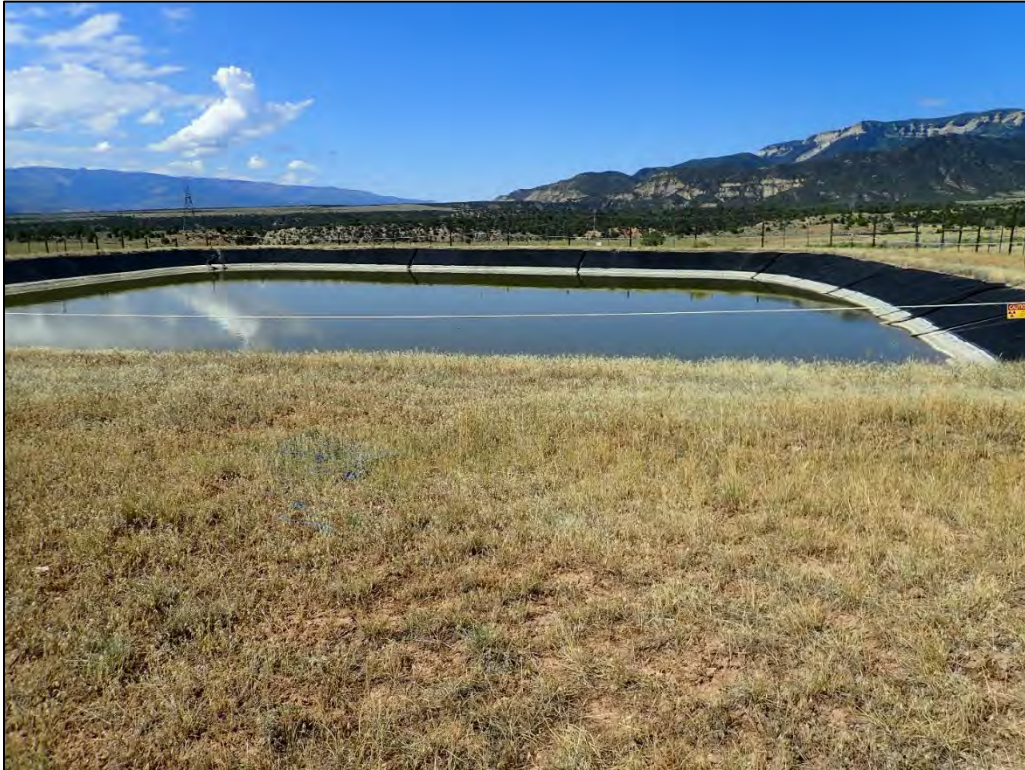
PL-7. Evaporation Pond

A lined evaporation pond was constructed adjacent to the disposal cell in 2001 to receive water pumped from standpipes SP-02 and SP-03. The pond contained water at the time of the inspection (PL-7). Evaluation of the pond liner's integrity was completed in fall 2020 by a professional geosynthetic liner installation and inspection company. Two minor holes, approximately 2 inches in diameter, were identified at the top slope of the liner and repaired in May 2021. Evaluation of the liner by a testing laboratory indicated that the liner is in good condition for its age. LM plans to replace the pond liner in fiscal year 2024, barring further damage that would necessitate earlier replacement. Inspectors will continue to monitor this before the planned liner preplacement.

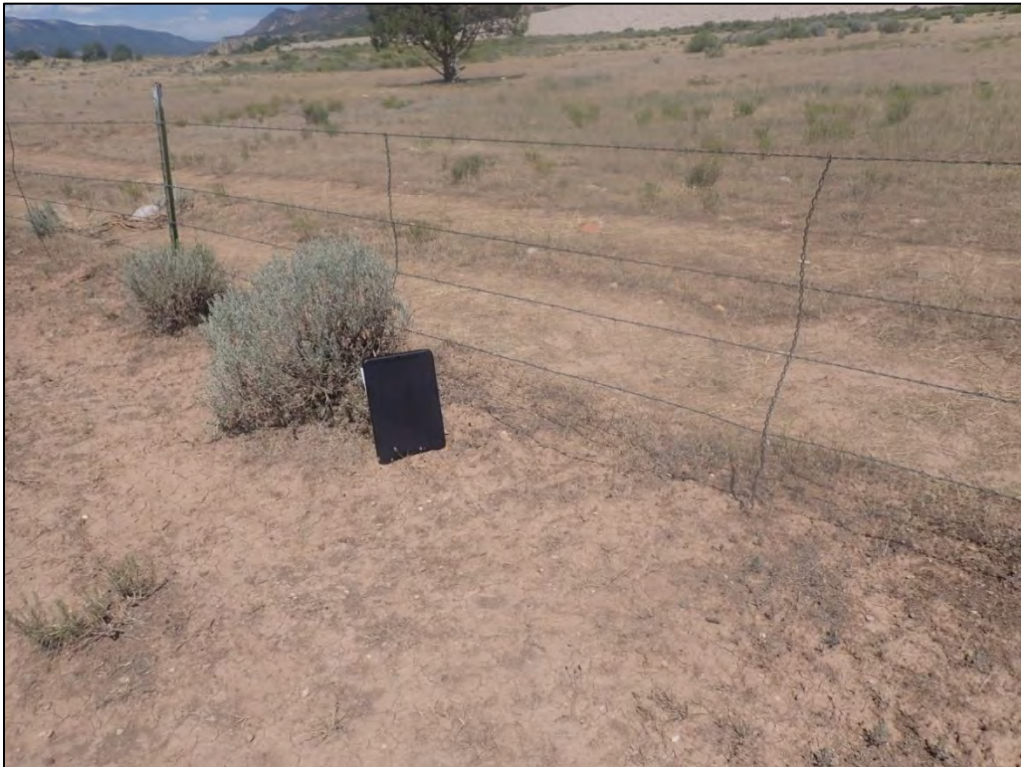
PL-10. Signs of Animal Burrowing Under Fence

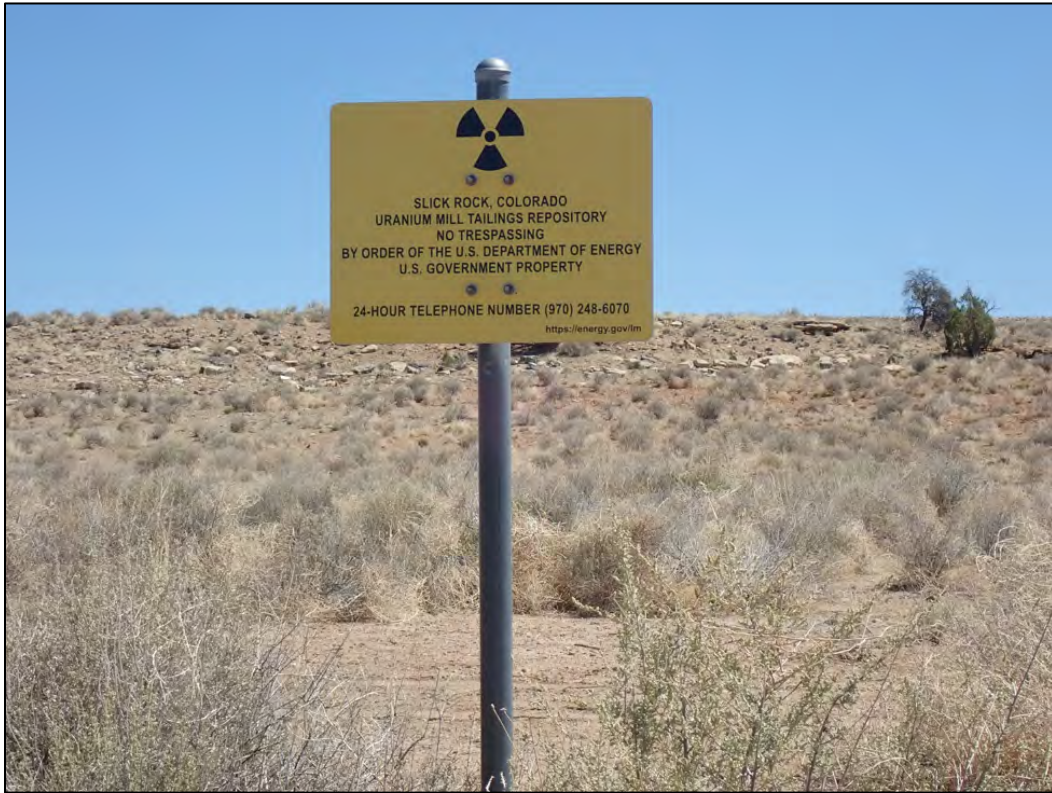
PL-1. Entrance Sign
