U.S. DEPARTMENT OF
ENERGY

Legacy
Management

2022 Annual Site Inspection and Monitoring Report for Uranium Mill Tailings Radiation Control Act Title I Disposal Sites

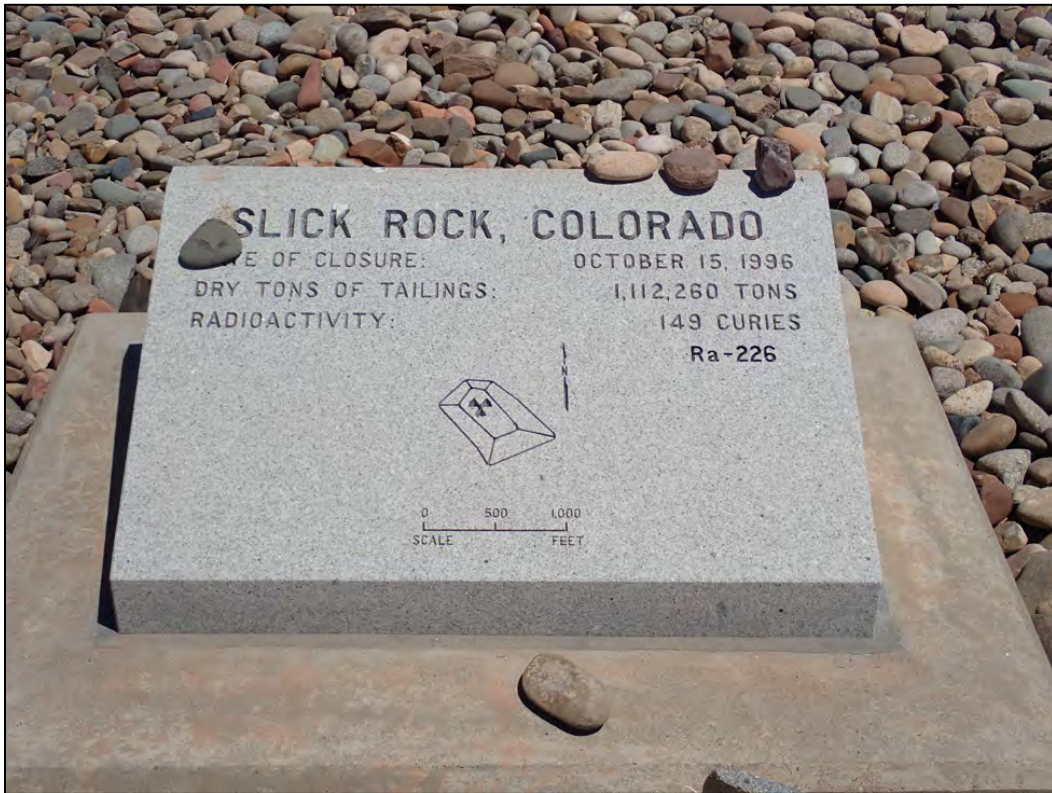
PL-2. Site Marker SMK-2

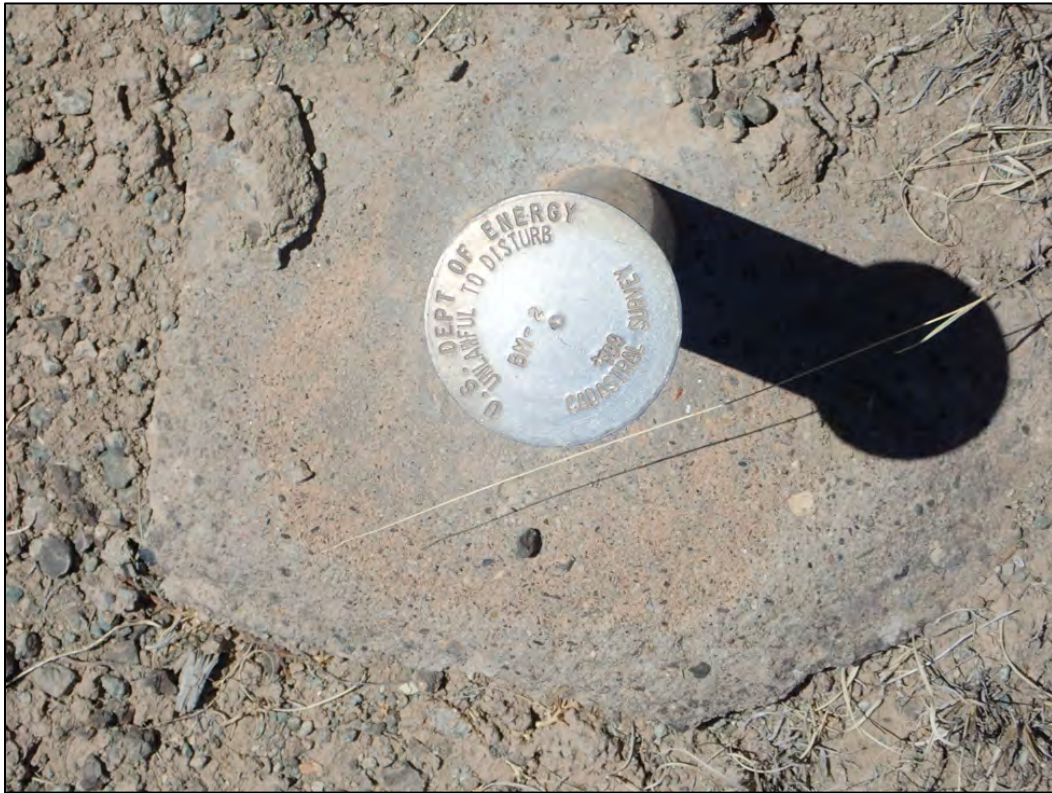
PL-3. Boundary Monument BM-2

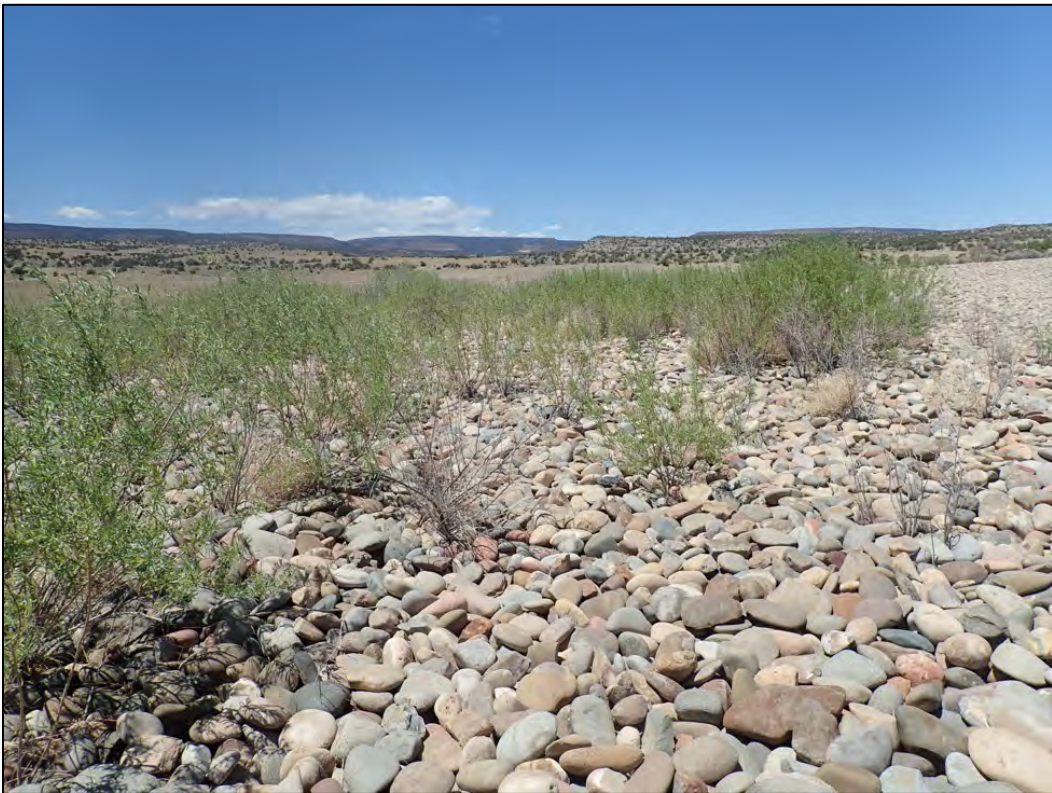
PL-6. Willows Growing in Apron

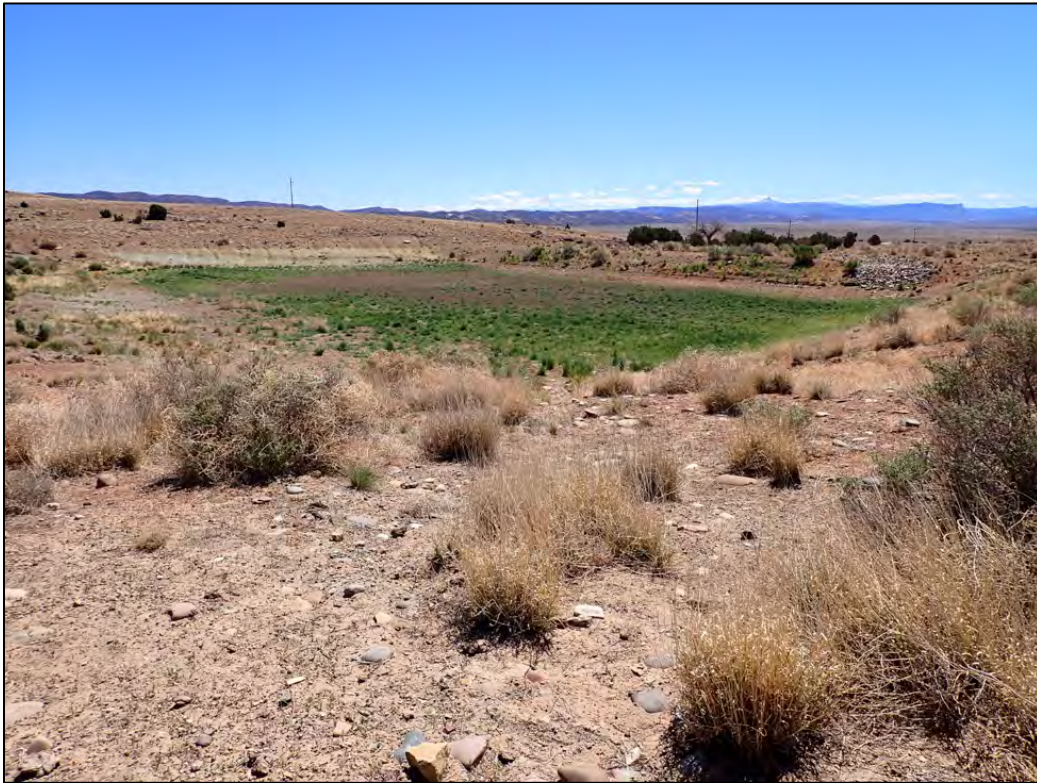
PL-7. Retention Pond

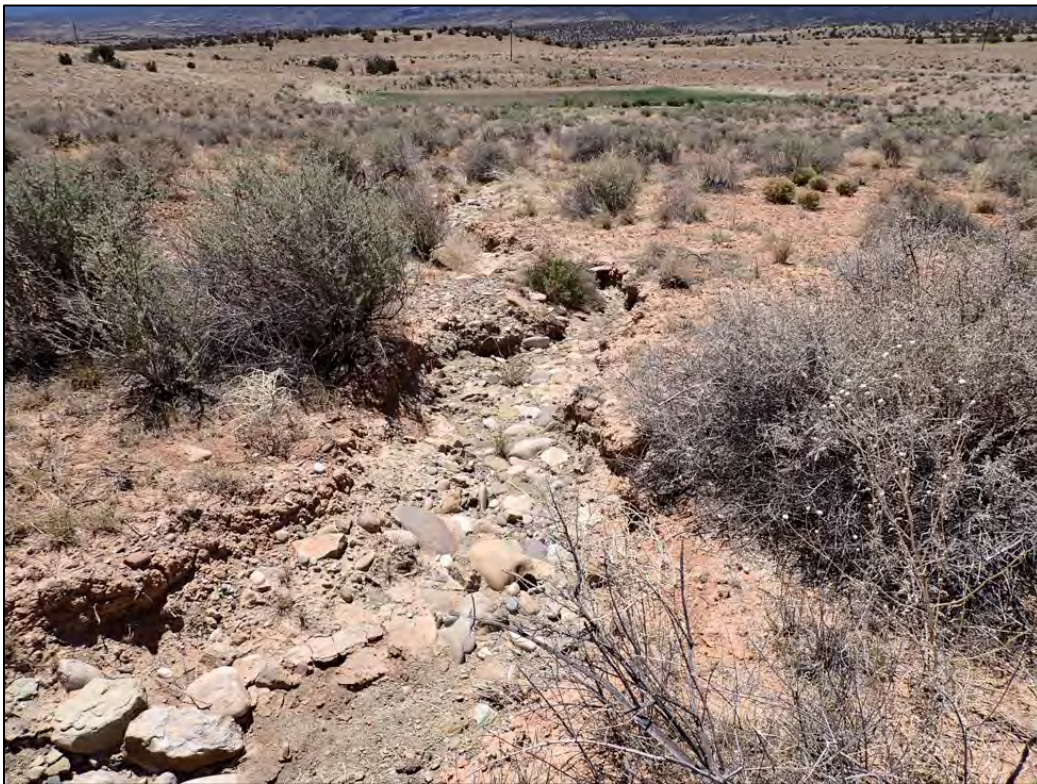
PL-8. Gullies on South Area Between Disposal Cell and Site Boundary

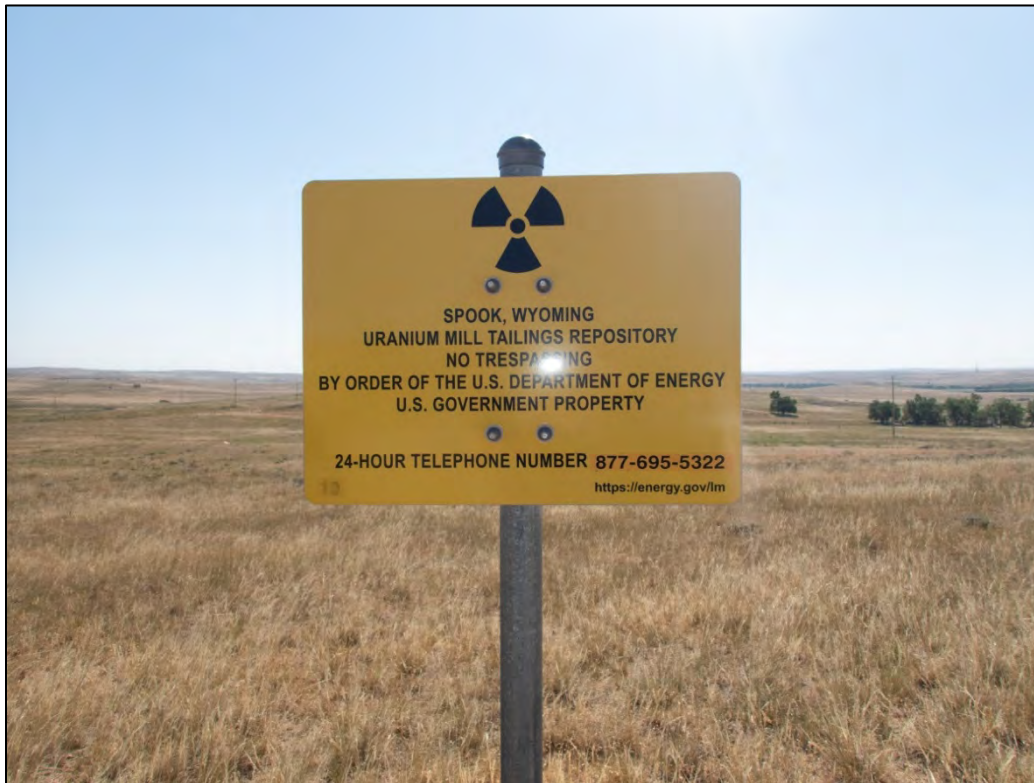
There are 10 perimeter signs (PL-1) attached to steel posts set in concrete and positioned around the site outside the unfenced property boundary. The 2021 inspection noted that perimeter sign P5 showed signs of weathering and was delaminating. The sign was replaced after the 2022 inspection. Perimeter sign P1 is plastic and warped but still legible. Soil around the concrete base of perimeter sign P3 is eroded but remains stable (PL-2). The phone numbers on perimeter signs P6 and P7 were updated during the inspection. No other maintenance needs were identified.

PL-1. Perimeter Sign P10

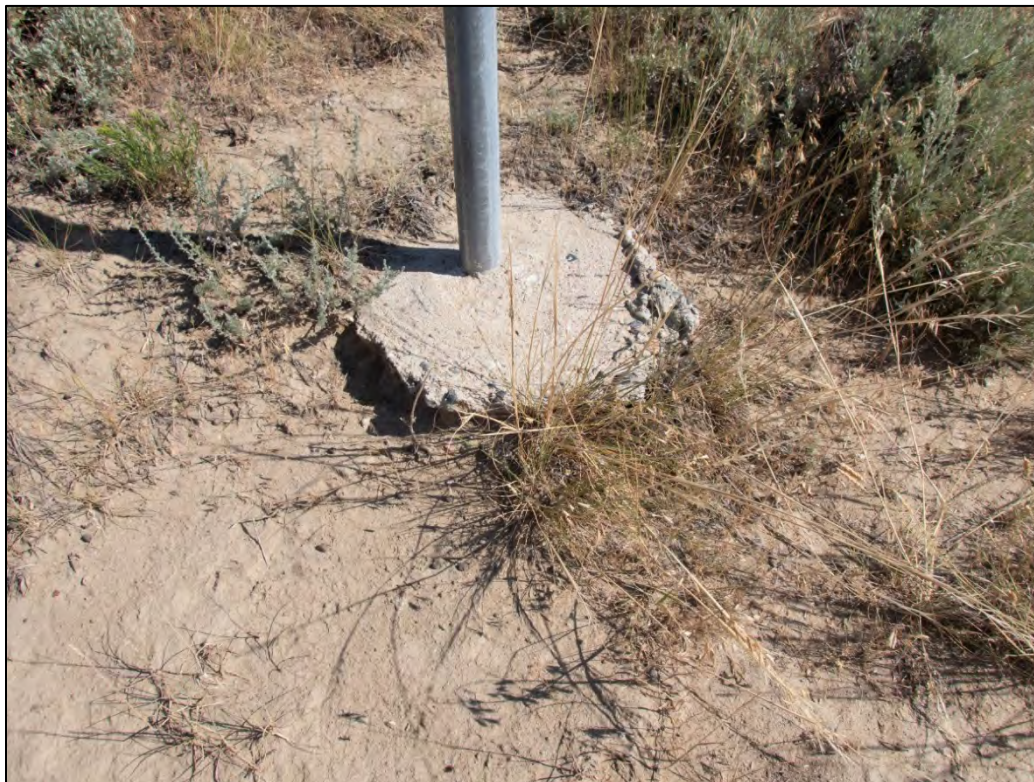
PL-2. Erosion Around Base of Perimeter Sign P3

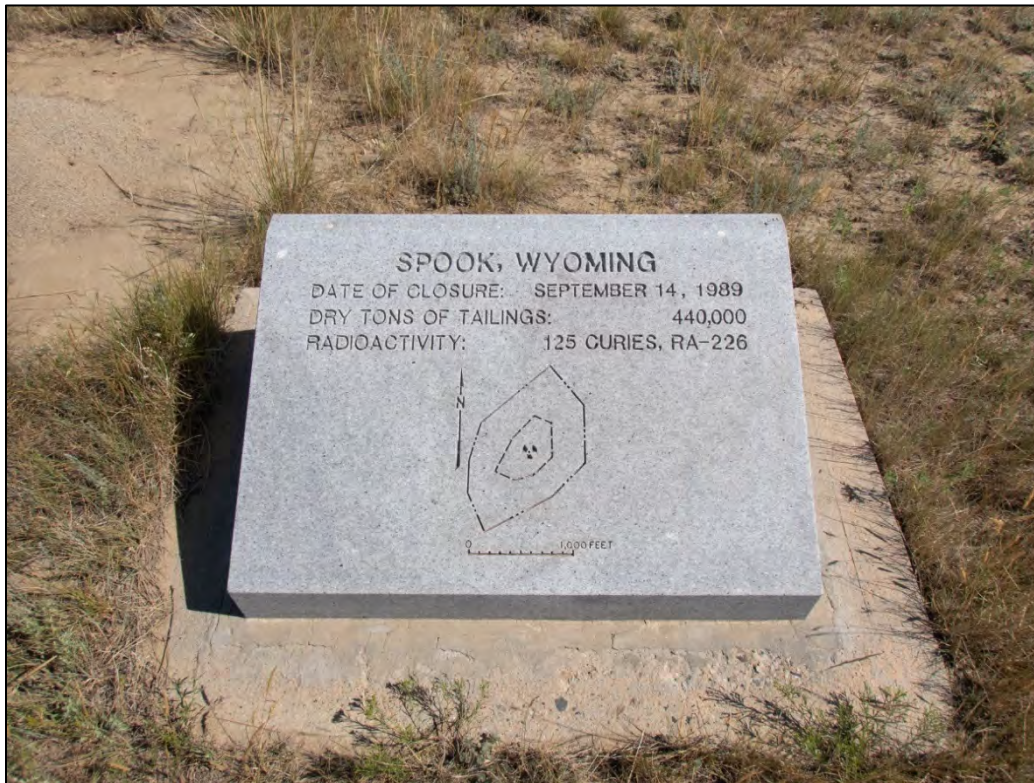
The site has two granite site markers. Site marker SMK-1 is at the south side of the disposal cell. Its concrete base is damaged due to spalling but is stable; there were no apparent changes from the previous year. Site marker SMK-2 is at the north side of the disposal cell (PL-3). No maintenance needs were identified.

PL-3. Site Marker SMK-2

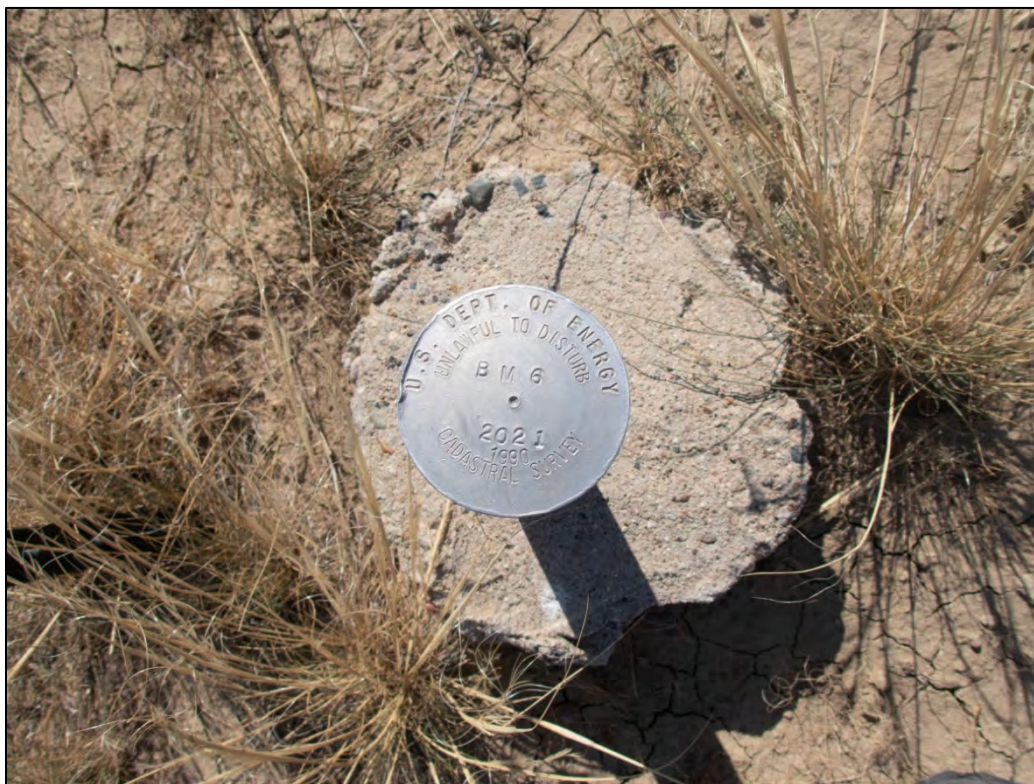
PL-4. Boundary Monument BM-6

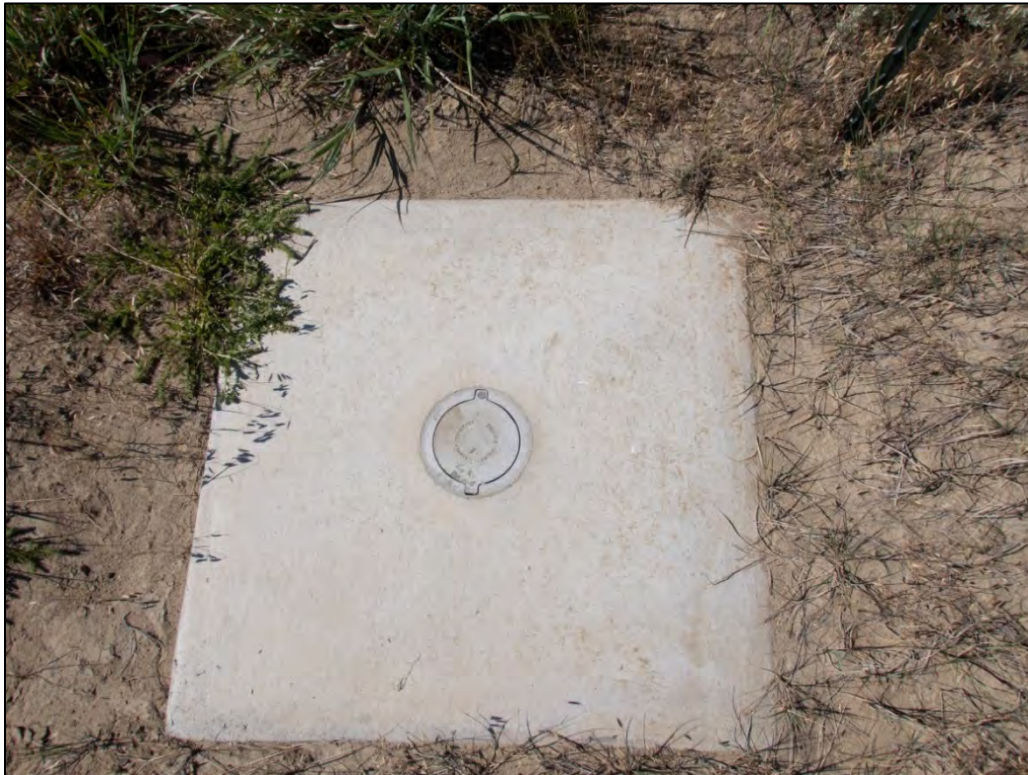
PL-5. Quality Control Monument QC-4

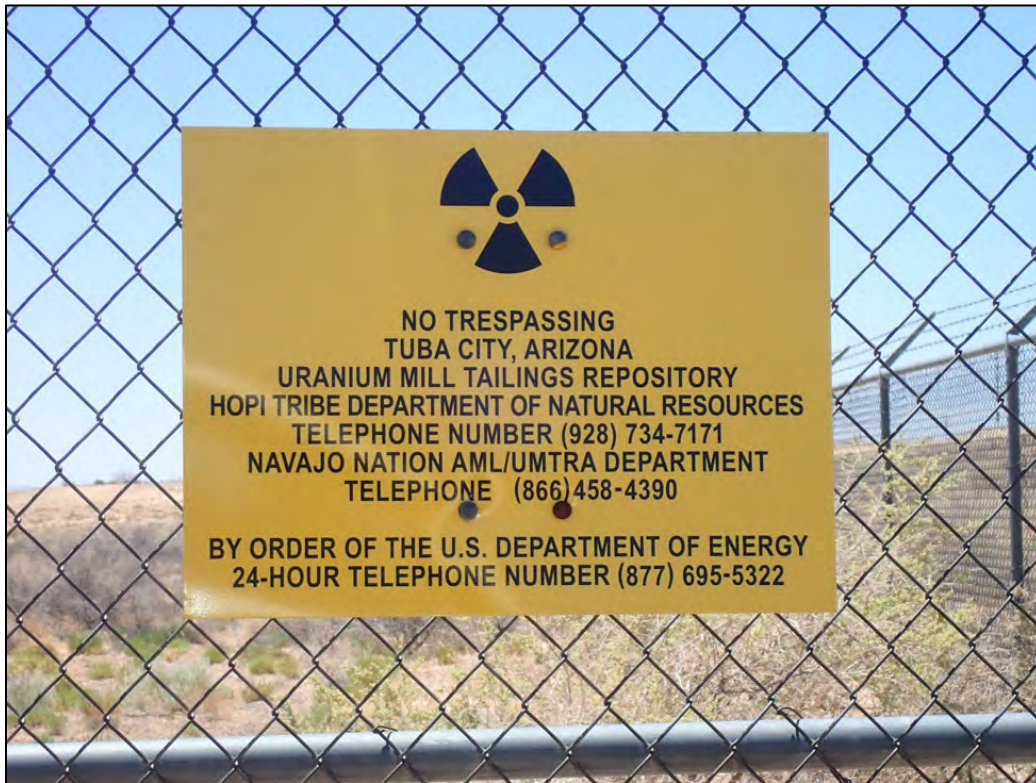
PL-1. Entrance Sign

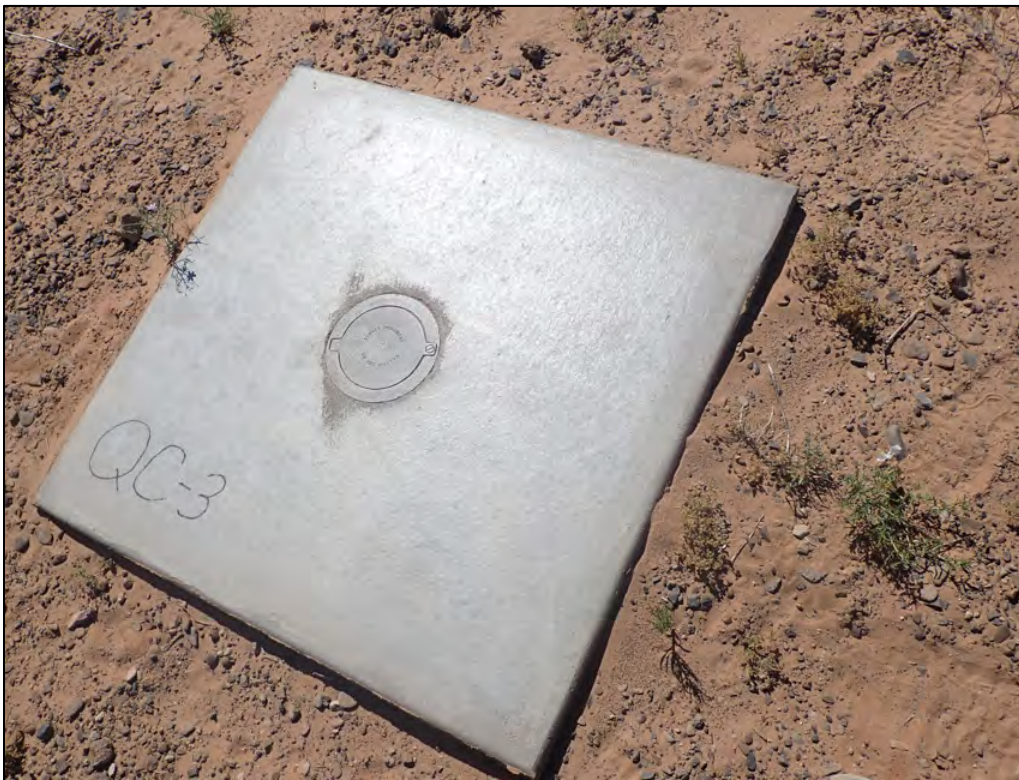
Five aerial survey quality control (QC) monuments were installed before the 2022 inspection as identified in Figure 19-1. All were located and in good condition (PL-6). No maintenance needs were identified.

PL-6. Quality Control Monument QC-3

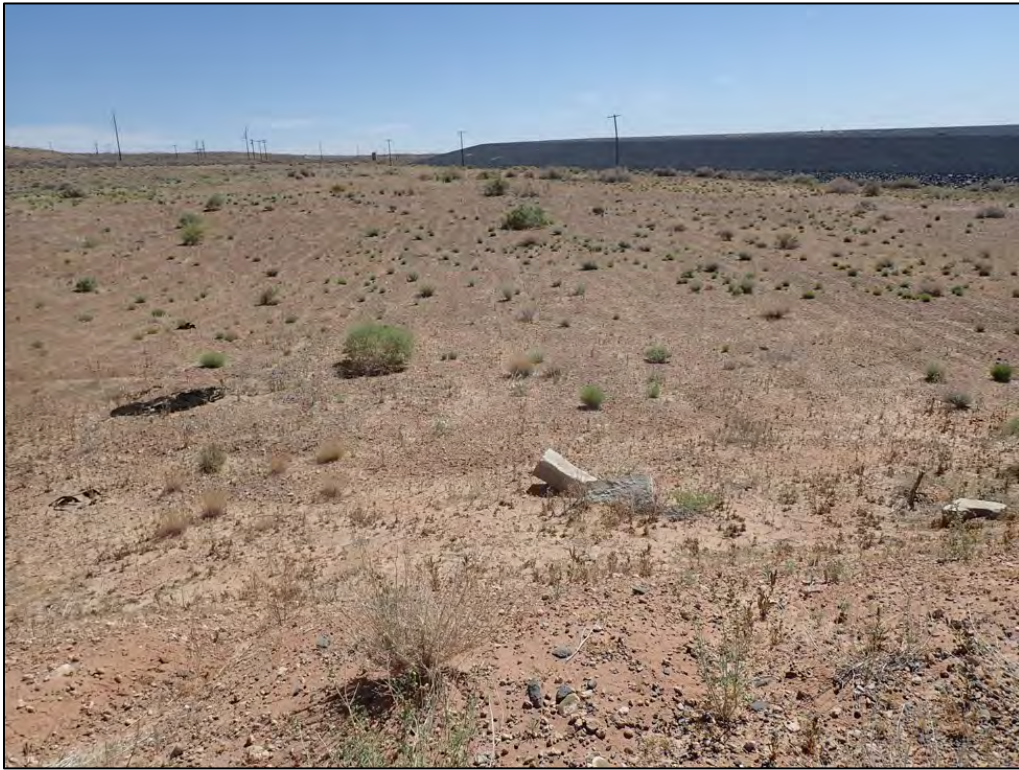
PL-9. Revegetated Area of Former Evaporation Ponds
